Expertise

Protocol number: 46707931  
Order No. / Reference: 26602932  
Inspection date: 23 Jul 2026

Manufacturer: Ford

Model: Ranger 2,0 I EcoBlue Autm. Wildtrak

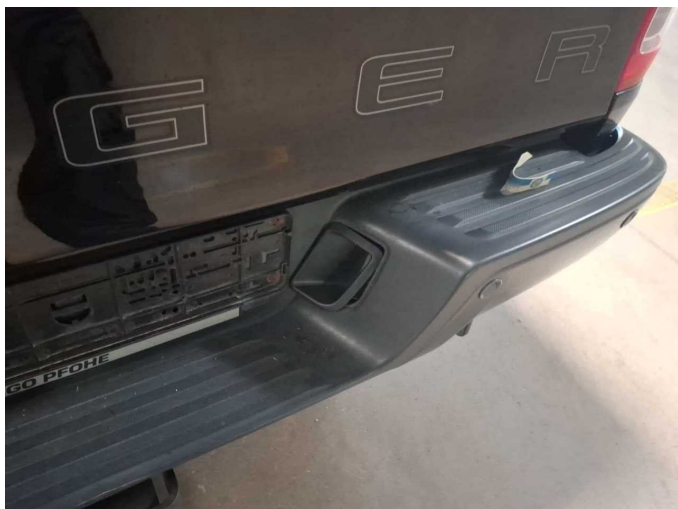
| No. | Component group | Description |
|---|---|---|
| 3 | Tail light | License plate lamp - right side (Halter) - Loose - Replace |

**Damage 3:** Tail light: License plate lamp - right side (Halter) - Loose - Replace

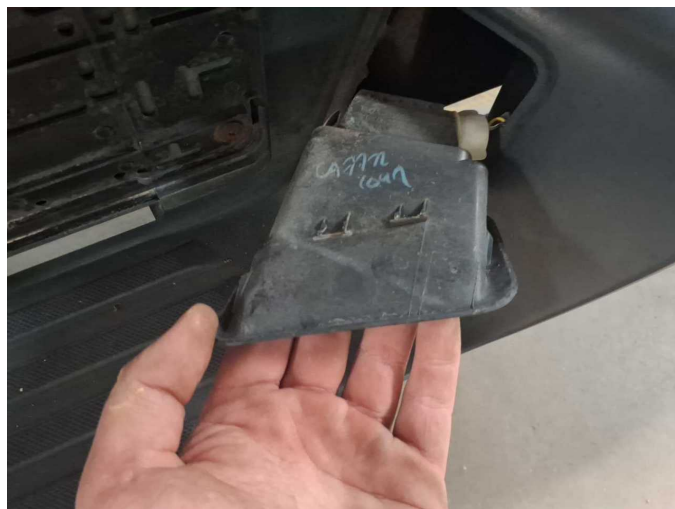
**Damage 3:** Tail light: License plate lamp - right side (Halter) - Loose - Replace

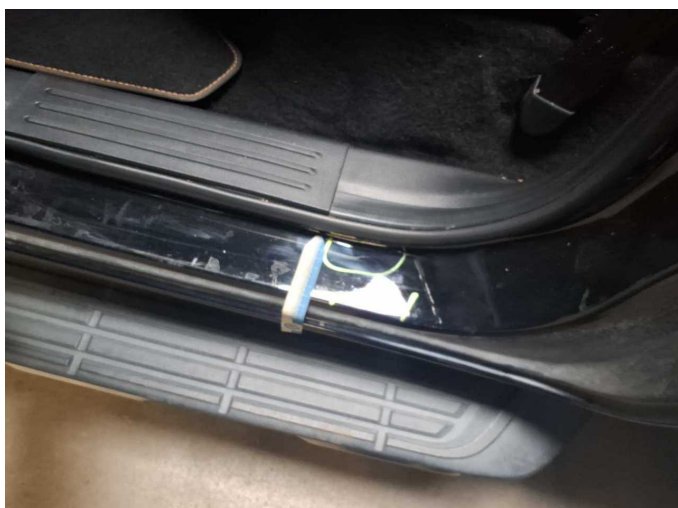
| No. | Component group | Description |
|---|---|---|
| 5 | Side panel - rear left side | Sill - dent(s) - Smooth repair work |

**Damage 5:** Side panel - rear left side: Sill - dent(s) - Smooth repair work

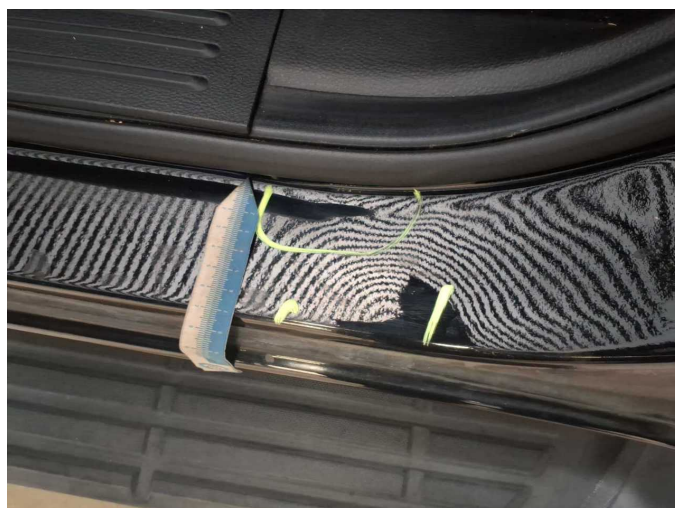
**Damage 5:** Side panel - rear left side: Sill - dent(s) - Smooth repair work

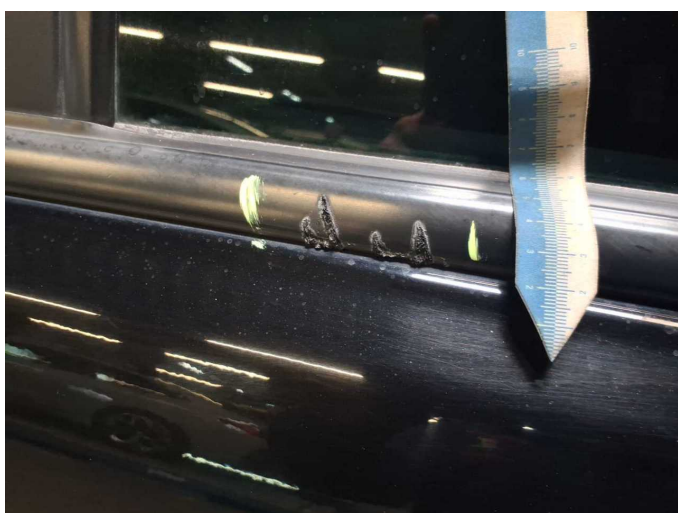
| No. | Component group | Description |
|---|---|---|
| 6 | Door - rear left side | Strip - outer - Scratched - Replace |

**Damage 6:** Door - rear left side: Strip - outer - Scratched - Replace

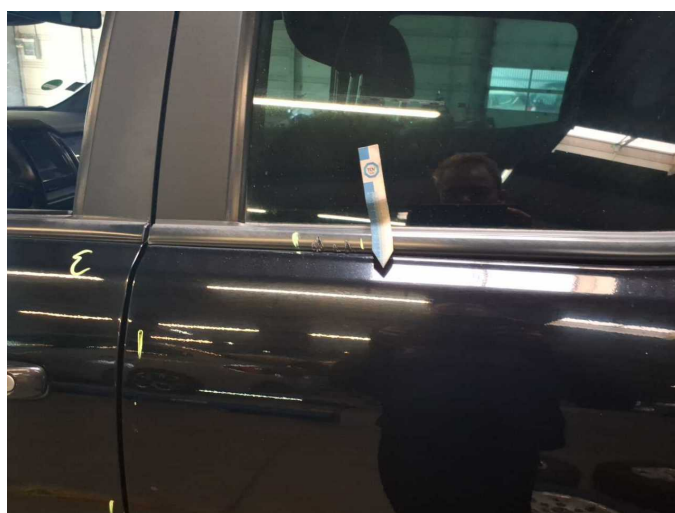
**Damage 6:** Door - rear left side: Strip - outer - Scratched - Replace

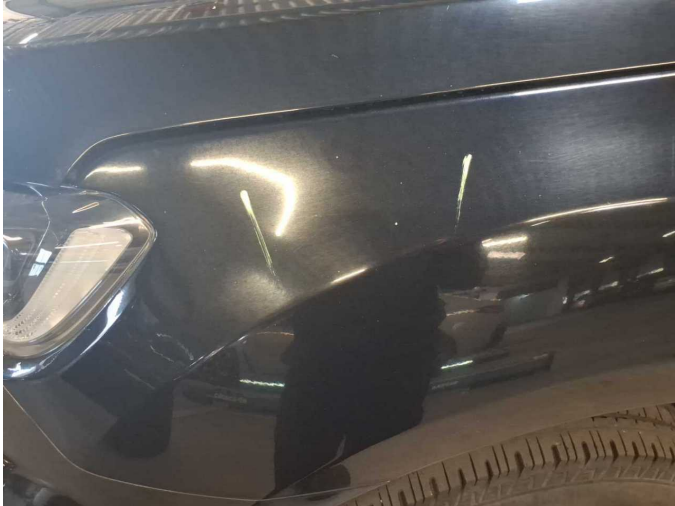
| No. | Component group | Description |
|---|---|---|
| 7 | Mudguard - left side | Mudguard - left side - Stone chips - Smart repair |

**Damage 7:** Mudguard - left side: Mudguard - left side - Stone chips - Smart repair

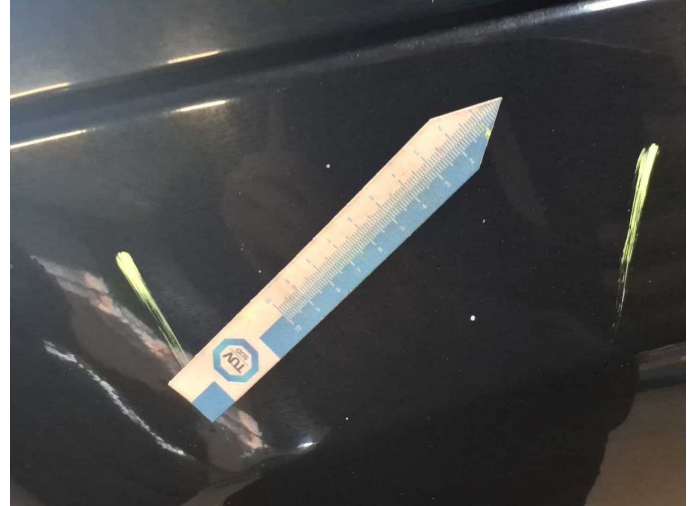
**Damage 7:** Mudguard - left side: Mudguard - left side - Stone chips - Smart repair

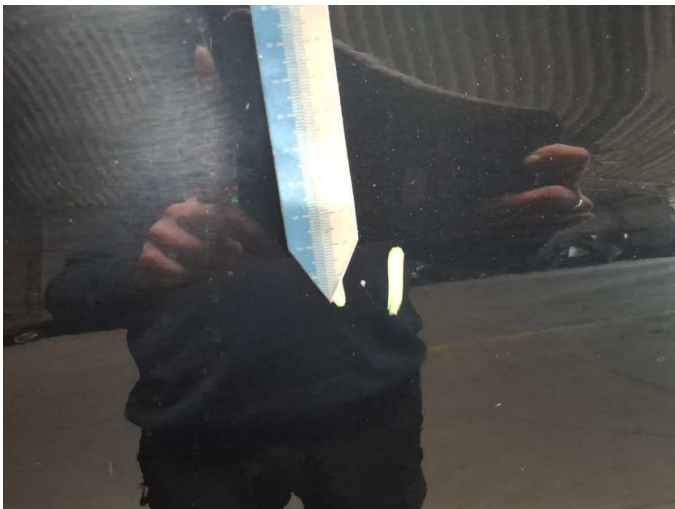
| No. | Component group | Description |
|---|---|---|
| 8 | Side panel - rear right side | Side panel - Stone chips - Smart repair |

**Damage 8:** Side panel - rear right side: Side panel - Stone chips - Smart repair

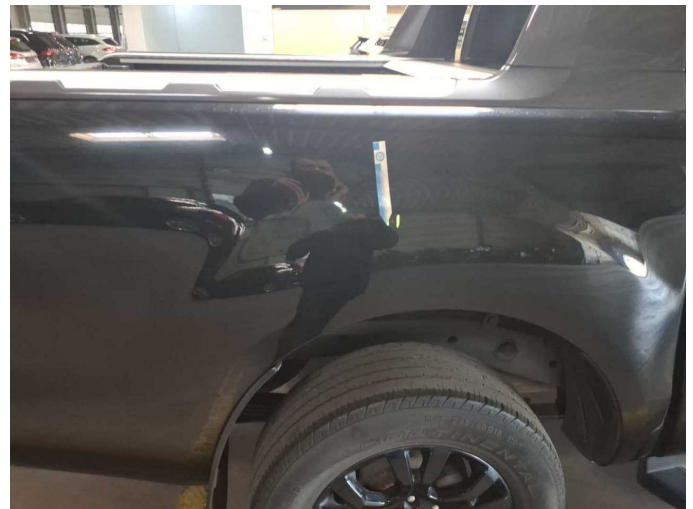
**Damage 8:** Side panel - rear right side: Side panel - Stone chips - Smart repair

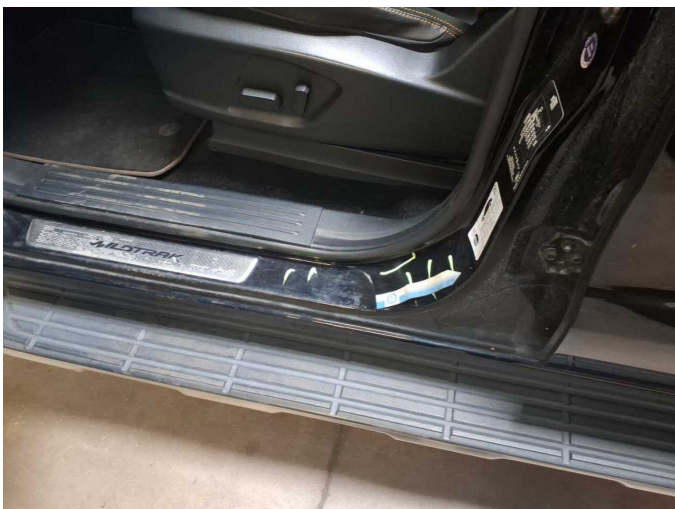
| No. | Component group | Description |
|---|---|---|
| 9 | Sill - left side | Sill - dent(s) - Smooth repair work |

**Damage 9:** Sill - left side: Sill - dent(s) - Smooth repair work

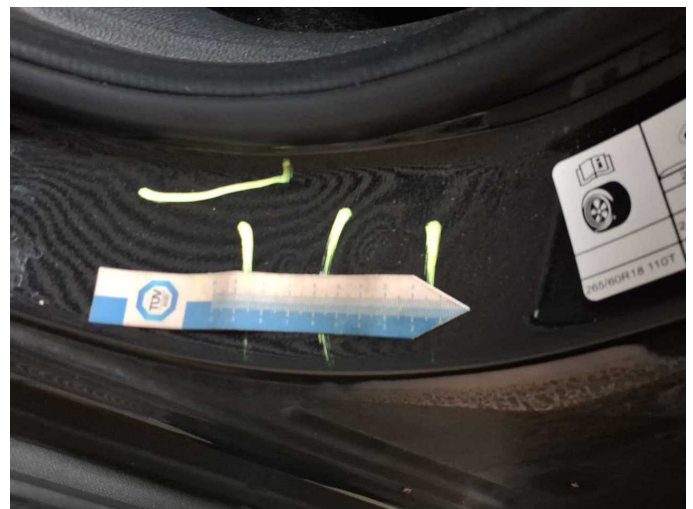
**Damage 9:** Sill - left side: Sill - dent(s) - Smooth repair work

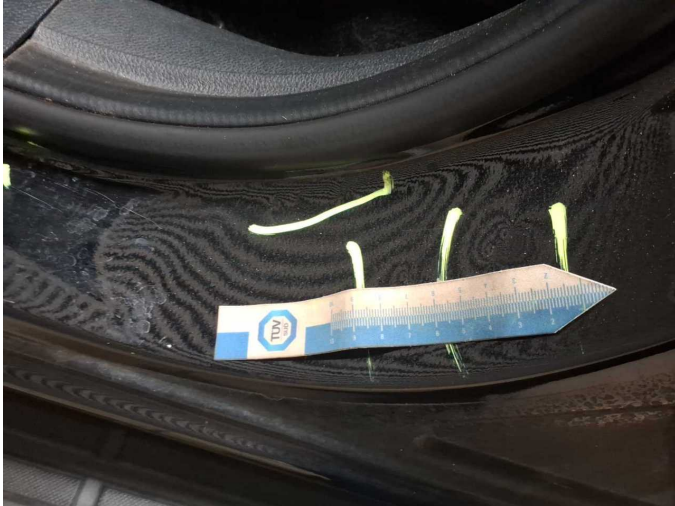
**Damage 9:** Sill - left side: Sill - dent(s) - Smooth repair work

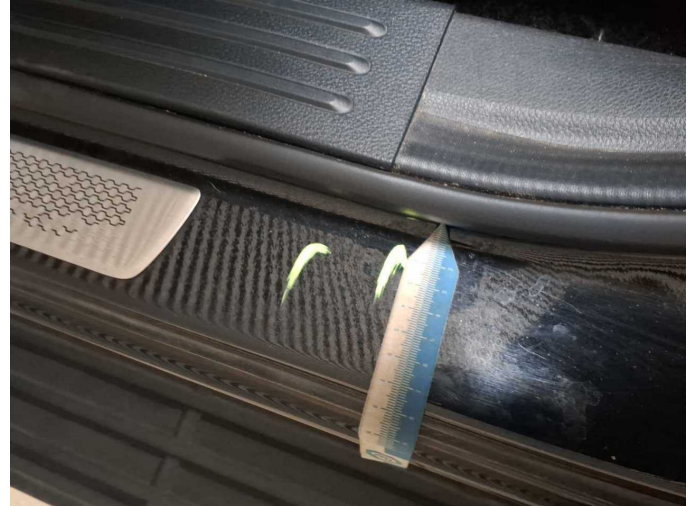
**Damage 9:** Sill - left side: Sill - dent(s) - Smooth repair work

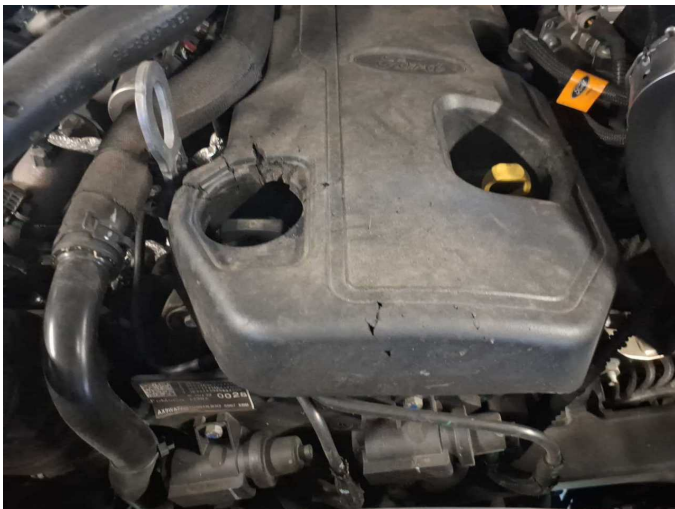
| No. | Component group | Description |
|---|---|---|
| 10 | Engine | Engine cover - Damage caused by marten / rodent - Replace |

**Damage 10:** Engine: Engine cover - Damage caused by martensite / rodent - Replace

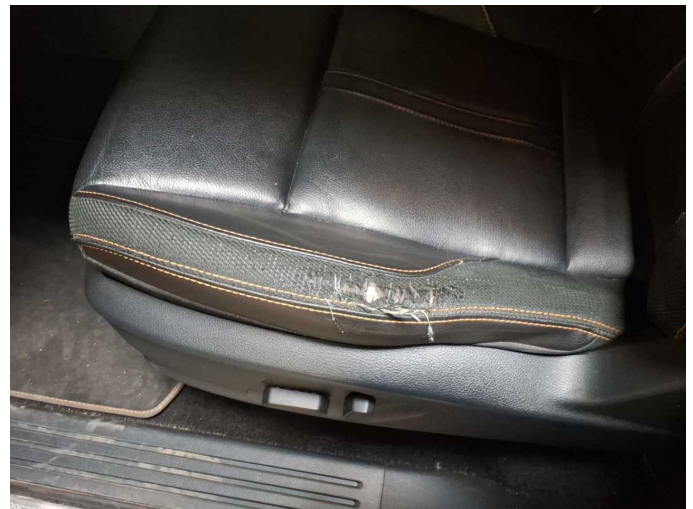
| No. | Component group | Description |
|---|---|---|
| 11 | Seat - front | Seat cover - left side - Broken / torn - Replace |

**Damage 11:** Seat - front: Seat cover - left side - Broken / torn - Replace

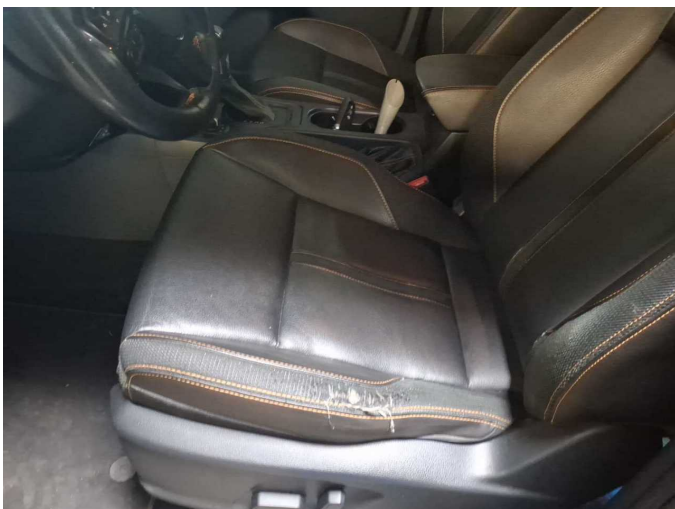
**Damage 11:** Seat - front: Seat cover - left side - Broken / torn - Replace

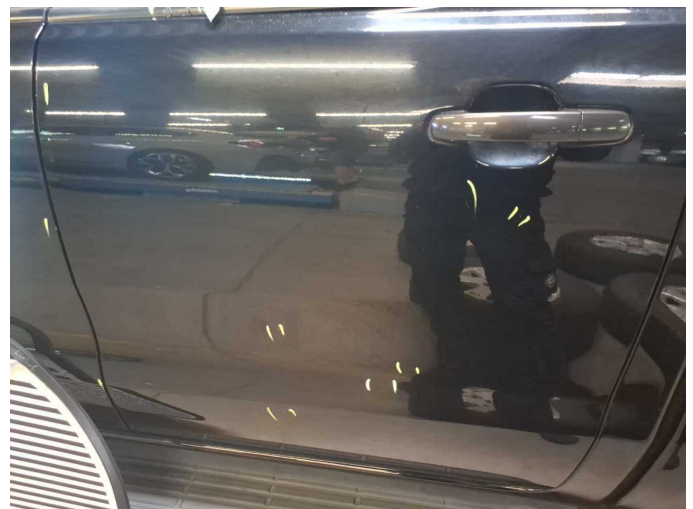
| No. | Component group | Description |
|---|---|---|
| 12 | Door - rear left side | Door - Scratched - Paint |

**Damage 12:** Door - rear left side: Door - Scratched - Paint

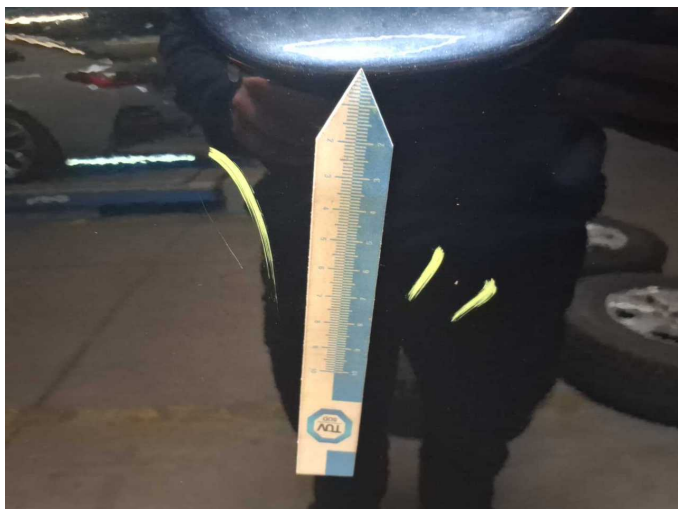
**Damage 12:** Door - rear left side: Door - Scratched - Paint

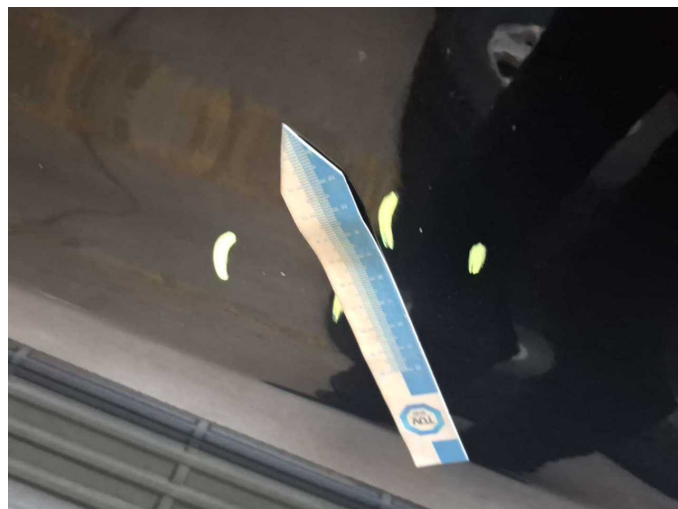
**Damage 12:** Door - rear left side: Door - Scratched - Paint

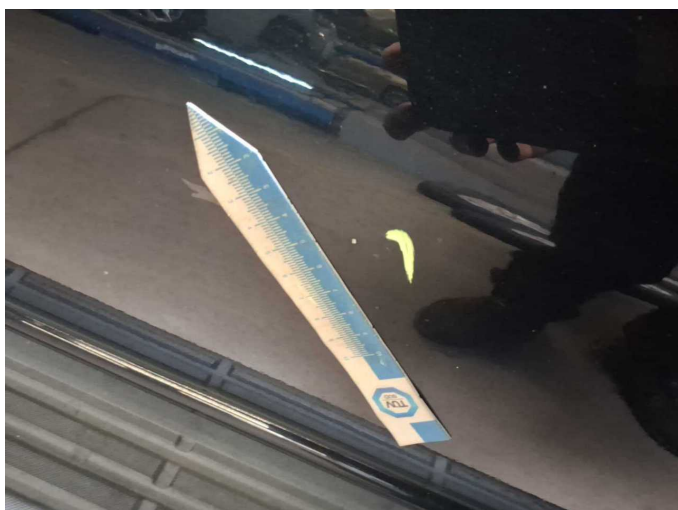
**Damage 12:** Door - rear left side: Door - Scratched - Paint

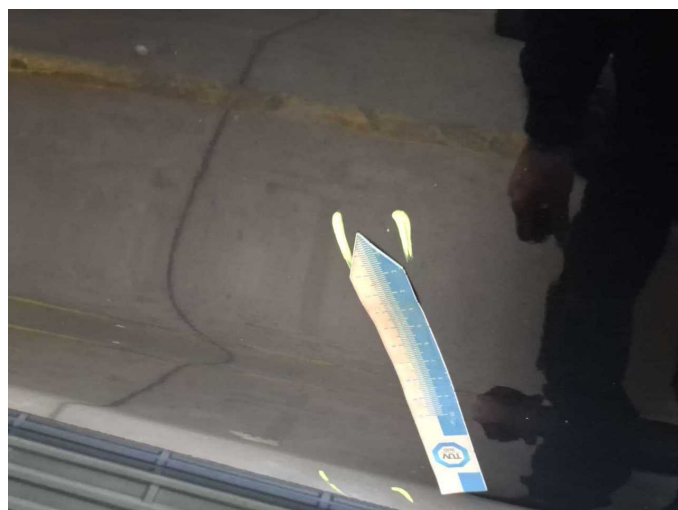
**Damage 12:** Door - rear left side: Door - Scratched - Paint

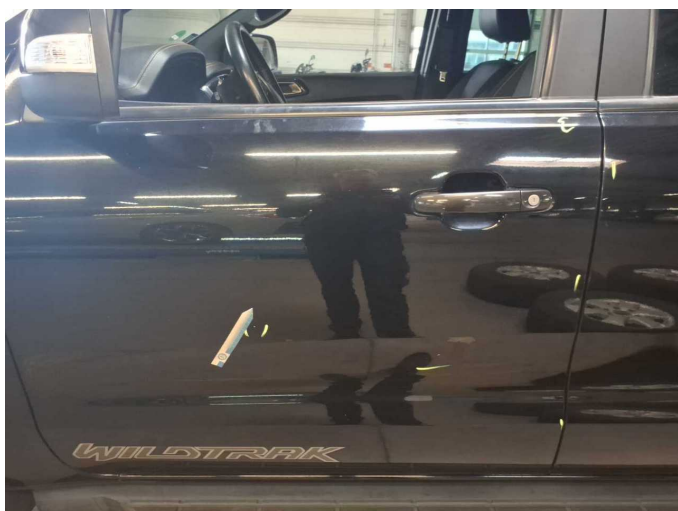
| No. | Component group | Description |
|---|---|---|
| 13 | Door - front left side | Door - Stone chips - Paint |

**Damage 13:** Door - front left side: Door - Stone chips - Paint

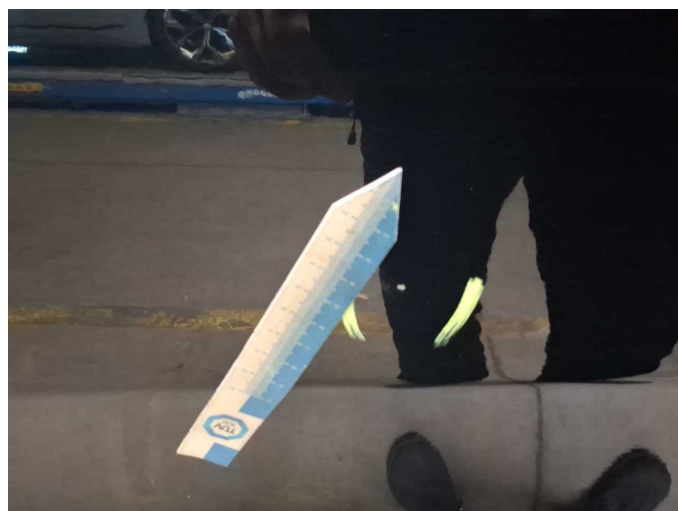
**Damage 13:** Door - front left side: Door - Stone chips - Paint

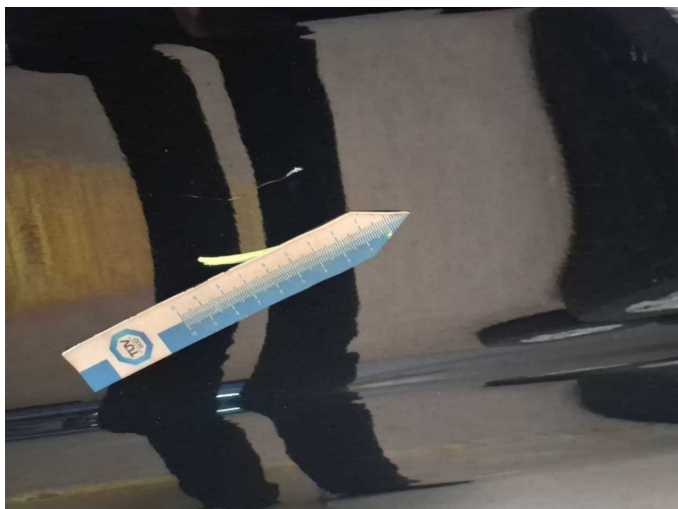
**Damage 13:** Door - front left side: Door - Stone chips - Paint

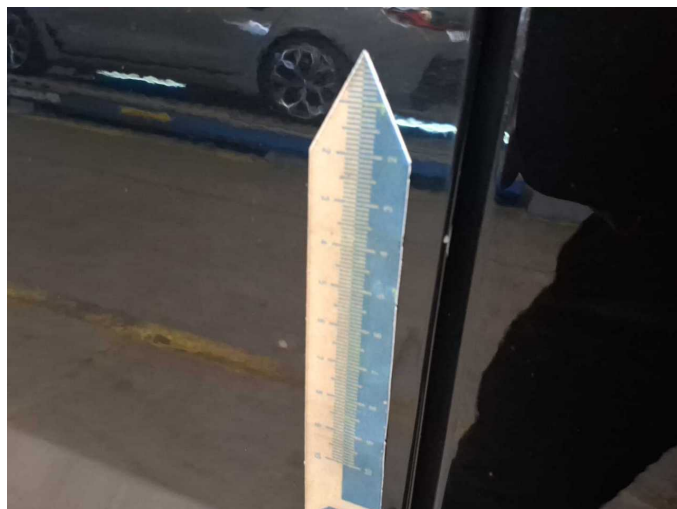
**Damage 13:** Door - front left side: Door - Stone chips - Paint

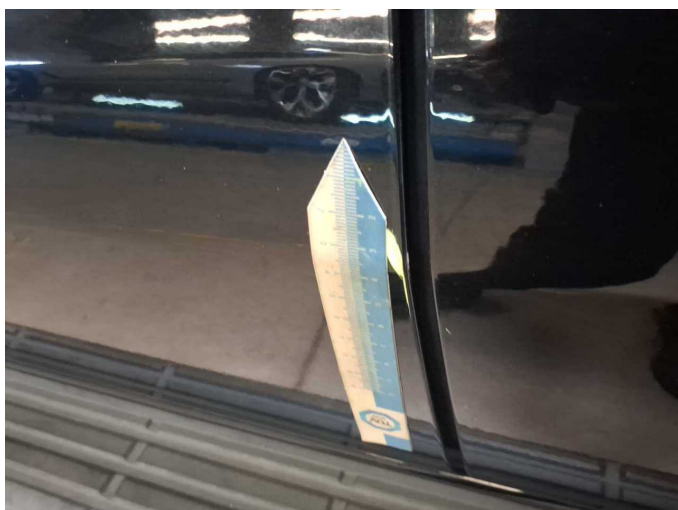
**Damage 13:** Door - front left side: Door - Stone chips - Paint

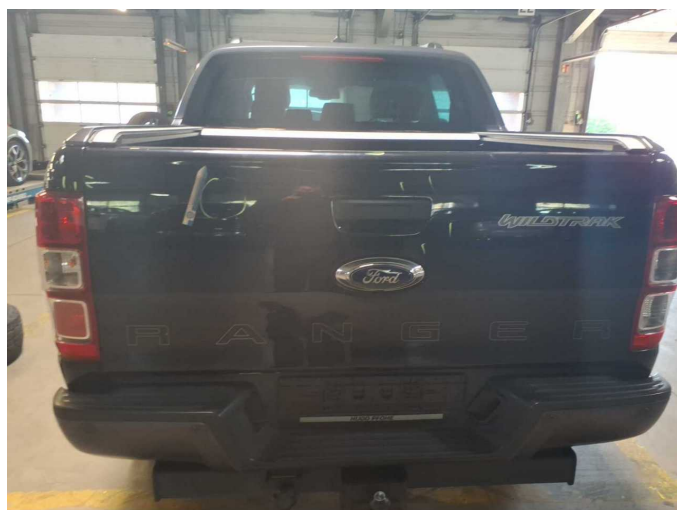
| No. | Component group | Description |
|---|---|---|
| 14 | Boot lid / rear door | Boot lid - Dent / paintcoat damage - Repair and paint |

**Damage 14:** Boot lid / rear door: Boot lid - Dent / paintcoat damage - Repair and paint

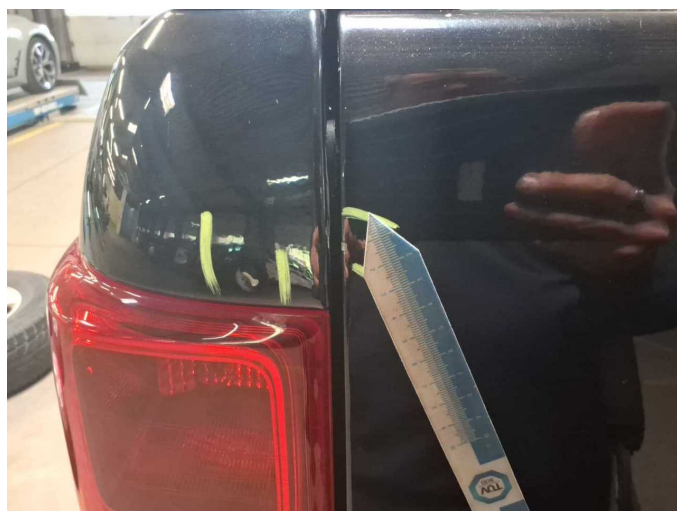
**Damage 14:** Boot lid / rear door: Boot lid - Dent / paintcoat damage - Repair and paint

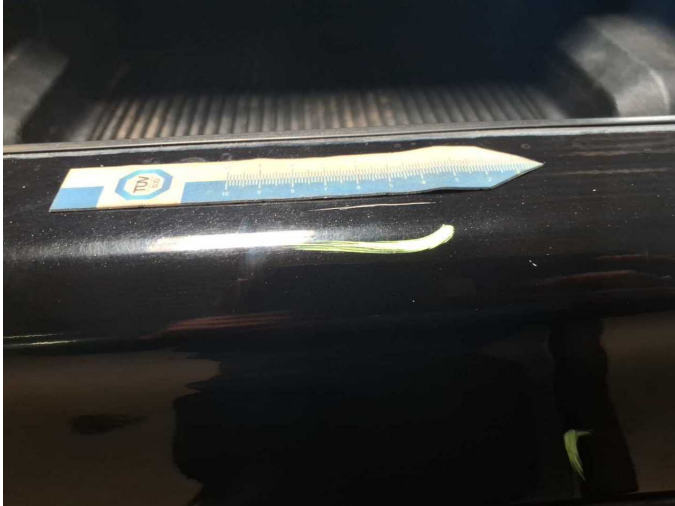
**Damage 14:** Boot lid / rear door: Boot lid - Dent / paintcoat damage - Repair and paint

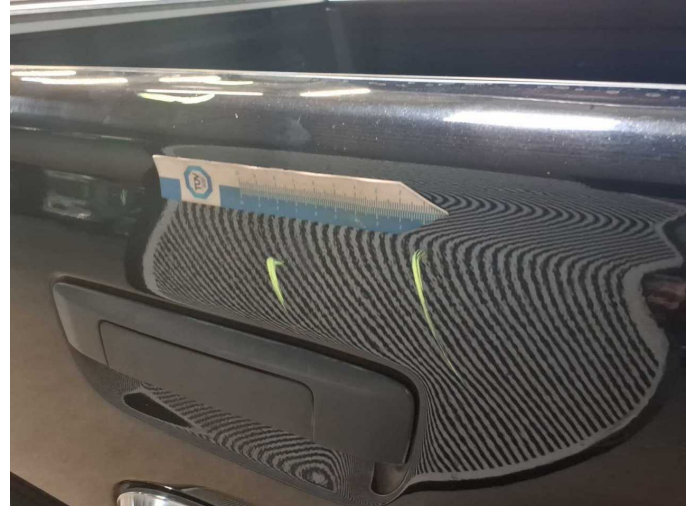
**Damage 14:** Boot lid / rear door: Boot lid - Dent / paintcoat damage - Repair and paint

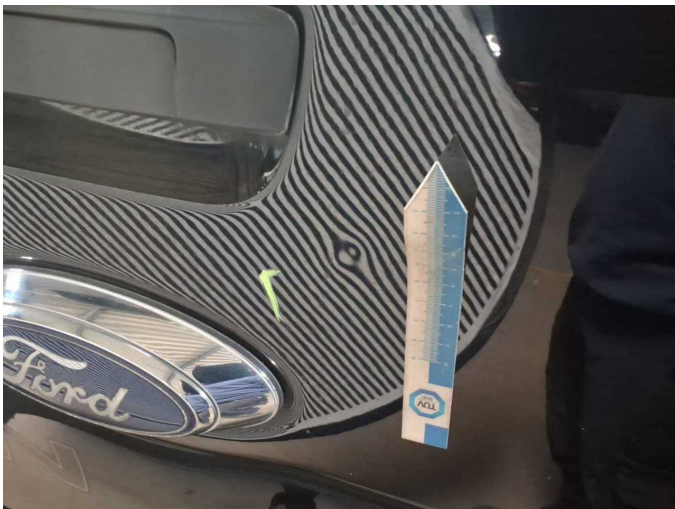
**Damage 14:** Boot lid / rear door: Boot lid - Dent / paintcoat damage - Repair and paint

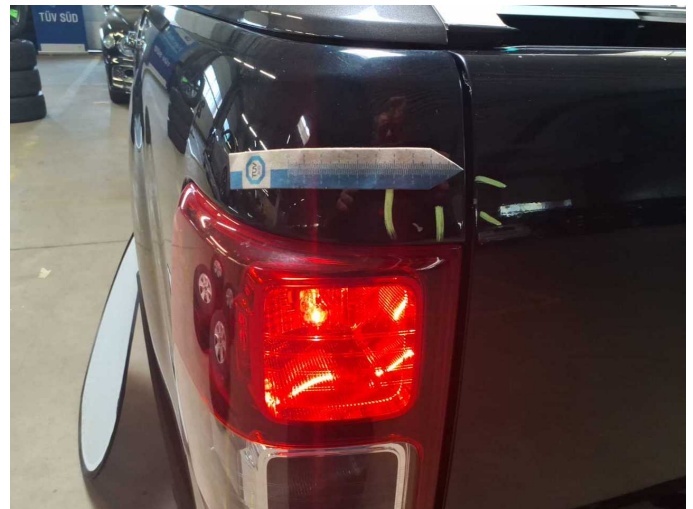
| No. | Component group | Description |
|---|---|---|
| 15 | Side panel - rear left side | Side panel - Dent / paintcoat damage - Repair and paint |

**Damage 15:** Side panel - rear left side: Side panel - Dent / paintcoat damage - Repair and paint

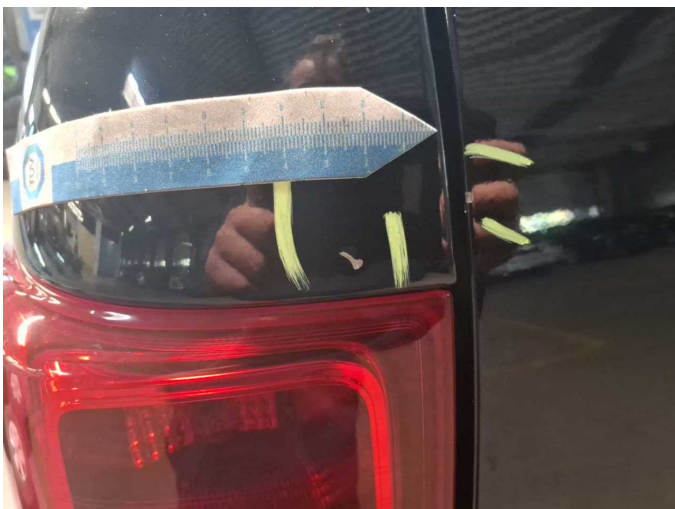
**Damage 15:** Side panel - rear left side: Side panel - Dent / paintcoat damage - Repair and paint

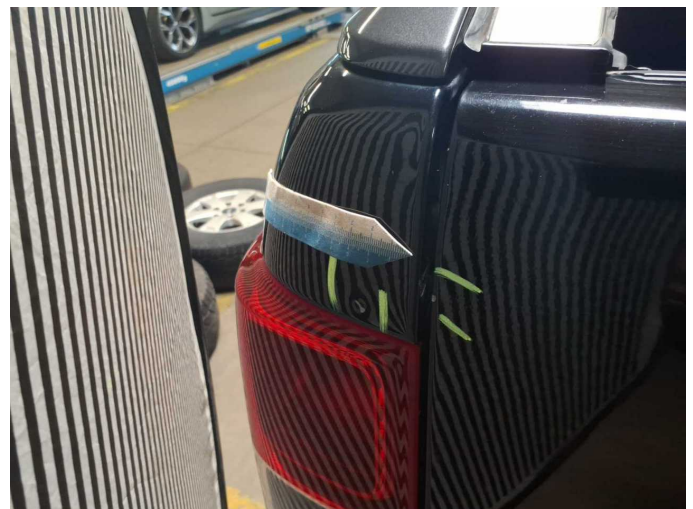
**Damage 15:** Side panel - rear left side: Side panel - Dent / paintcoat damage - Repair and paint

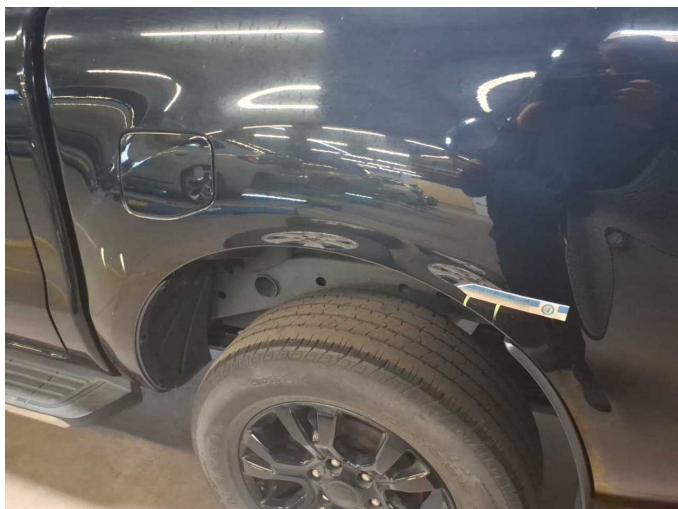
**Damage 15:** Side panel - rear left side: Side panel - Dent / paintcoat damage - Repair and paint

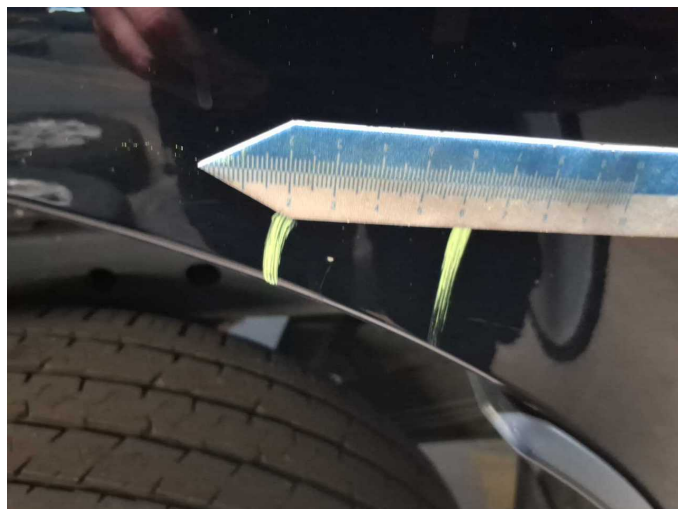
**Damage 15:** Side panel - rear left side: Side panel - Dent / paintcoat damage - Repair and paint

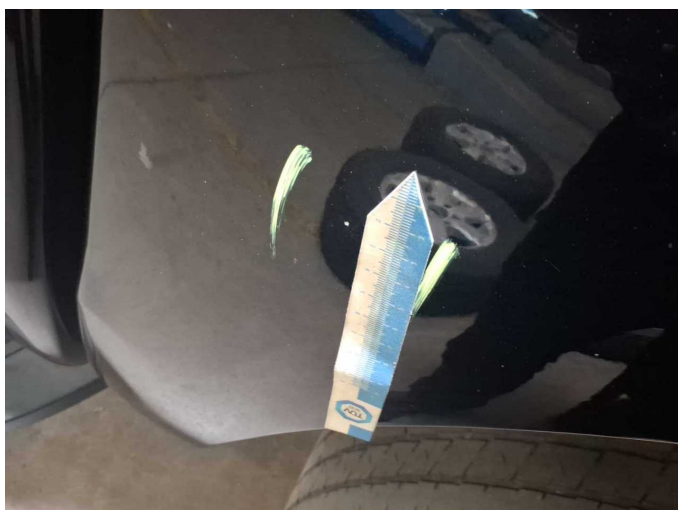
**Damage 15:** Side panel - rear left side: Side panel - Dent / paintcoat damage - Repair and paint

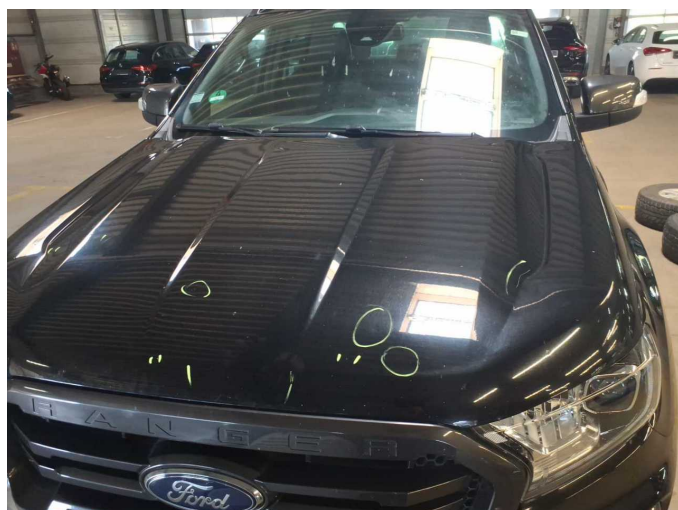
| No. | Component group | Description |
|---|---|---|
| 16 | Bonnet | Bonnet - Dent / paintcoat damage - Repair and paint |

**Damage 16:** Bonnet: Bonnet - Dent / paintcoat damage - Repair and paint

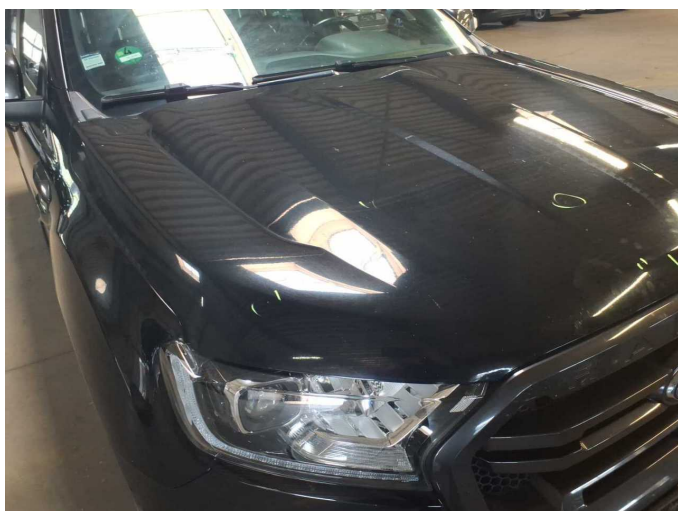
**Damage 16:** Bonnet: Bonnet - Dent / paintcoat damage - Repair and paint

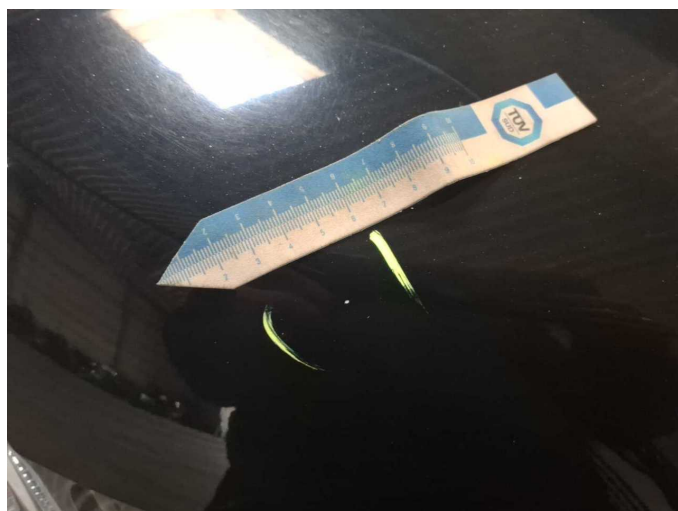
**Damage 16:** Bonnet: Bonnet - Dent / paintcoat damage - Repair and paint

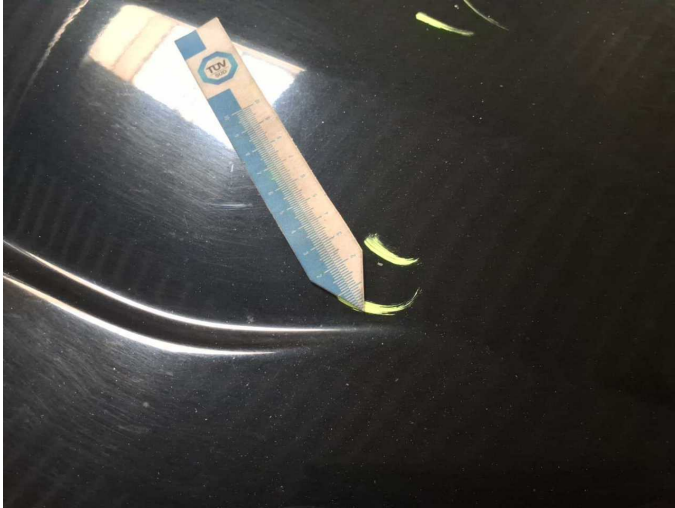
**Damage 16:** Bonnet: Bonnet - Dent / paintcoat damage - Repair and paint

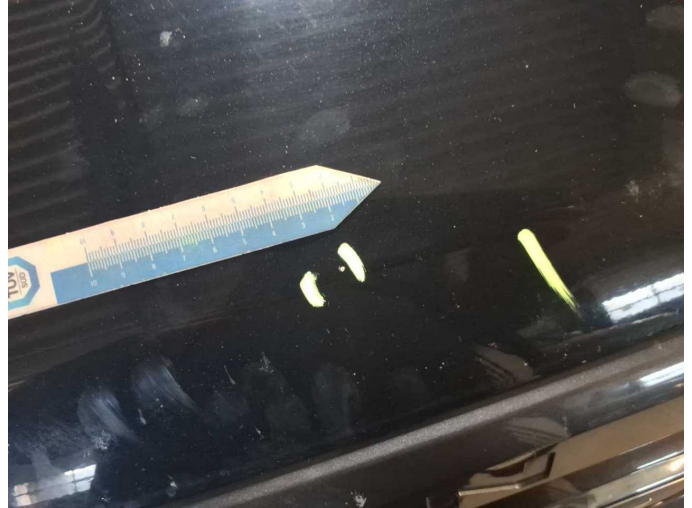
**Damage 16:** Bonnet: Bonnet - Dent / paintcoat damage - Repair and paint

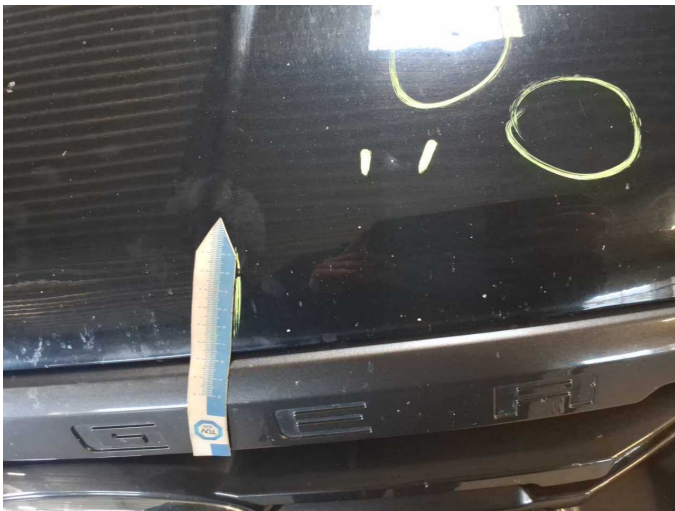
**Damage 16:** Bonnet: Bonnet - Dent / paintcoat damage - Repair and paint

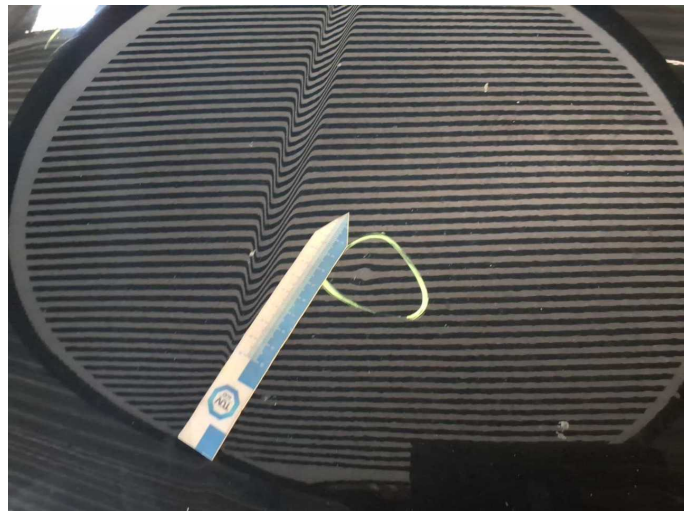
**Damage 16:** Bonnet: Bonnet - Dent / paintcoat damage - Repair and paint

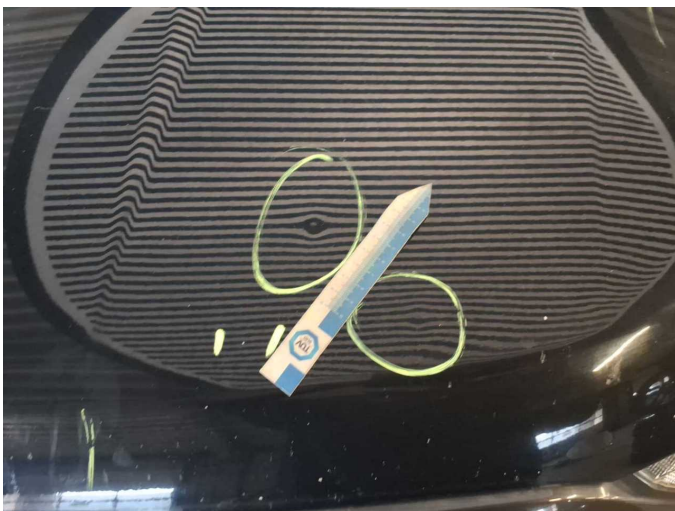
**Damage 16:** Bonnet: Bonnet - Dent / paintcoat damage - Repair and paint

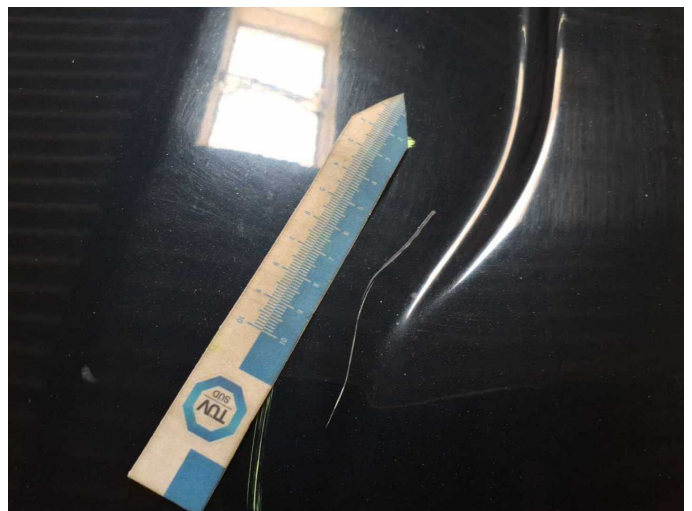
**Damage 16:** Bonnet: Bonnet - Dent / paintcoat damage - Repair and paint
