Expertise

Protocol number: 46679765  
Order No. / Reference: 26617305  
Inspection date: 15 Jul 2026

Manufacturer: Mercedes-Benz

Model: Vito 110 CDI Kompakt HA BASE

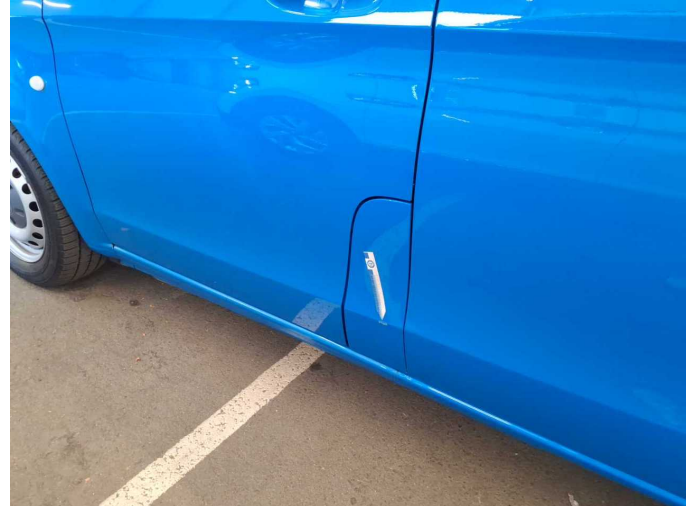
| No. | Component group | Description |
|---|---|---|
| 1 | Fuel system | Tank cap - Paint defect - Smart repair |

**Damage 1:** Fuel system: Tank cap - Paint defect - Smart repair

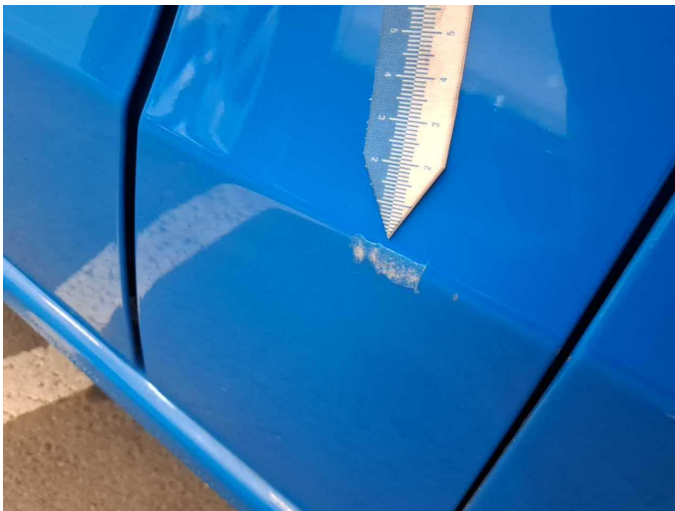
**Damage 1:** Fuel system: Tank cap - Paint defect - Smart repair

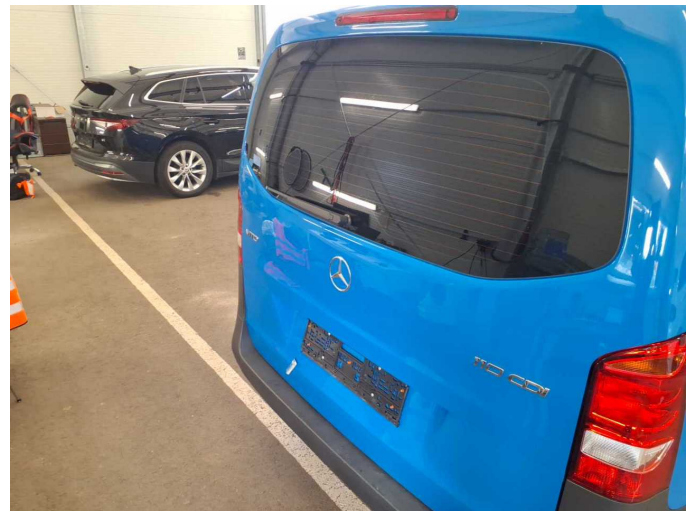
| No. | Component group | Description |
|---|---|---|
| 2 | Boot lid / rear door | Boot lid - Scratch(es) - Smart repair |

**Damage 2:** Boot lid / rear door: Boot lid - Scratch(es) - Smart repair

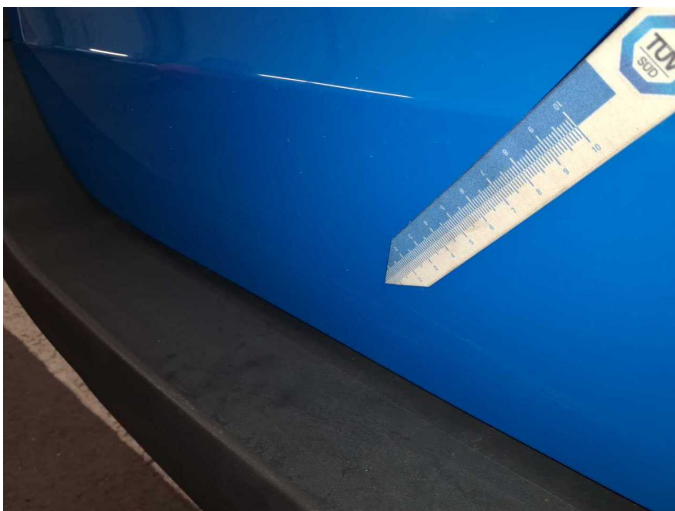
**Damage 2:** Boot lid / rear door: Boot lid - Scratch(es) - Smart repair

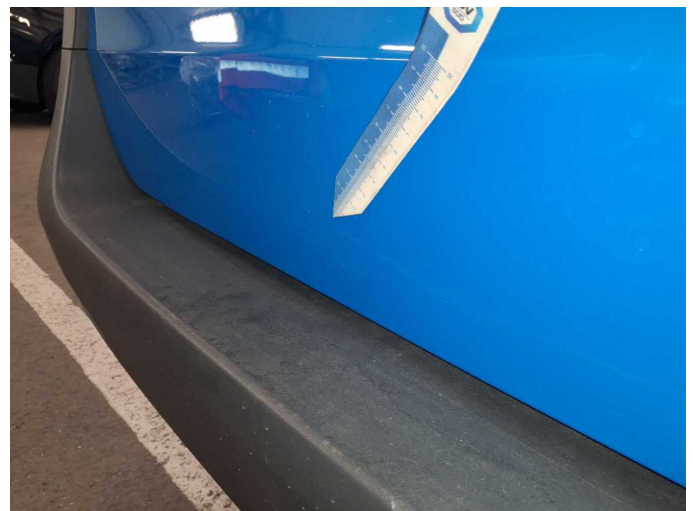
**Damage 2:** Boot lid / rear door: Boot lid - Scratch(es) - Smart repair

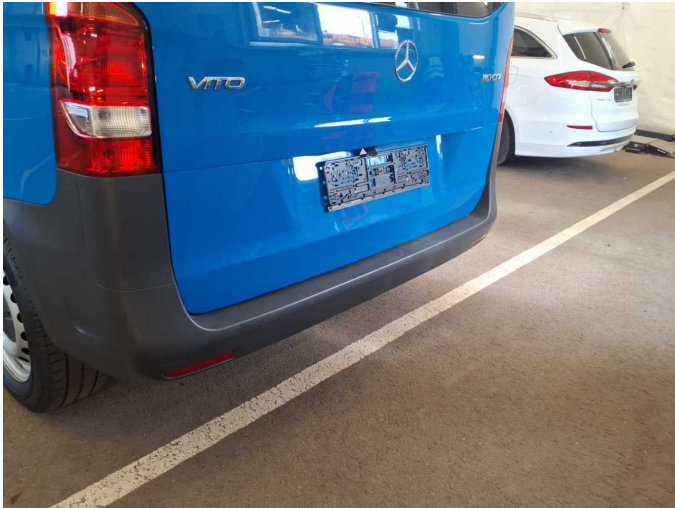
| No. | Component group | Description |
|---|---|---|
| 3 | Rear bumper | Rear bumper - Scratch(es) - Loss in value |

**Damage 3:** Rear bumper: Rear bumper - Scratch(es) - Loss in value

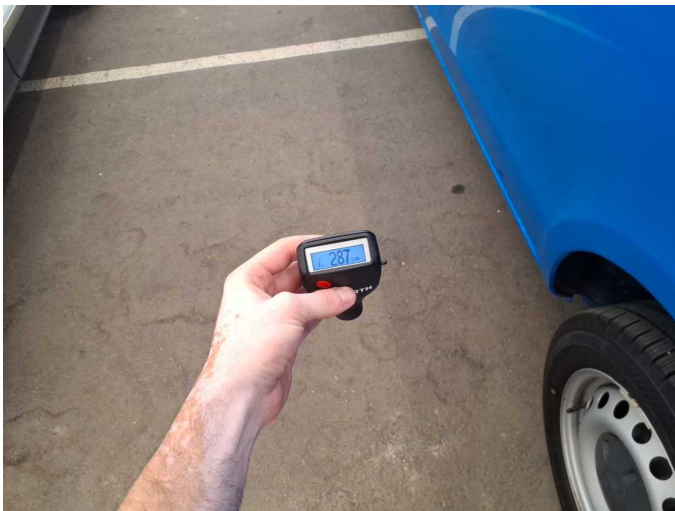
| No. | Repainting |
|---|---|
| 1 | Side panel - rear left side |

| Side panel - rear left side | 287 µm |

**Repainting 1:** Side panel - rear left side

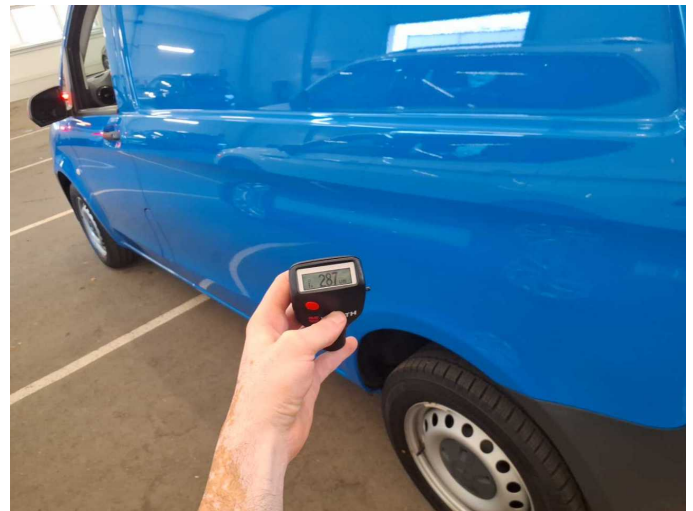
**Repainting 1:** Side panel - rear left side
