Expertise

Protocol number: 46416444  
Order No. / Reference: 26678563  
Inspection date: 9 Jul 2026

Manufacturer: Ford

Model: Transit 350 L4H3 Lkw HA Trend

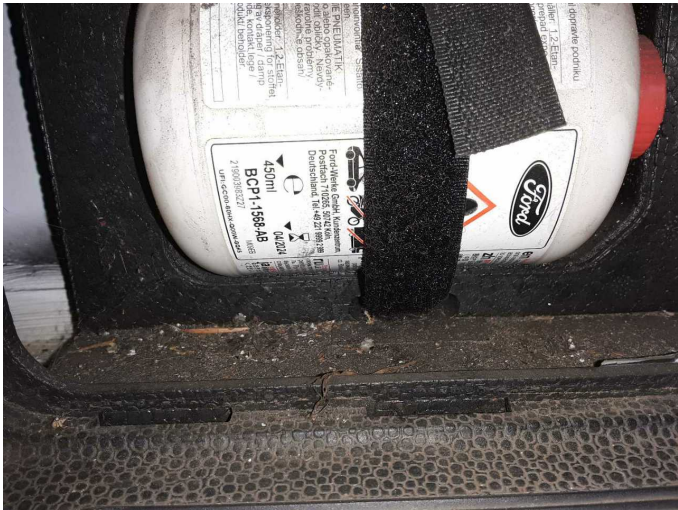
| No. | Component group | Description |
|---|---|---|
| 1 | Equipment | Tirefit filler - Due - Replace |

Damage 1: Equipment: Tirefit filler - Due - Replace

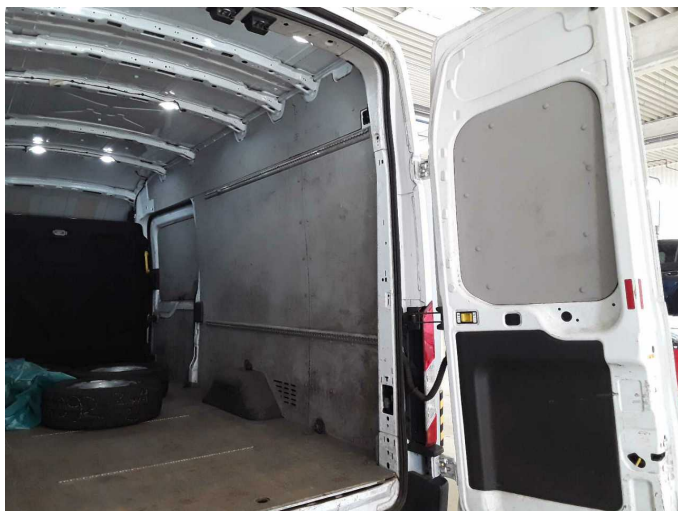
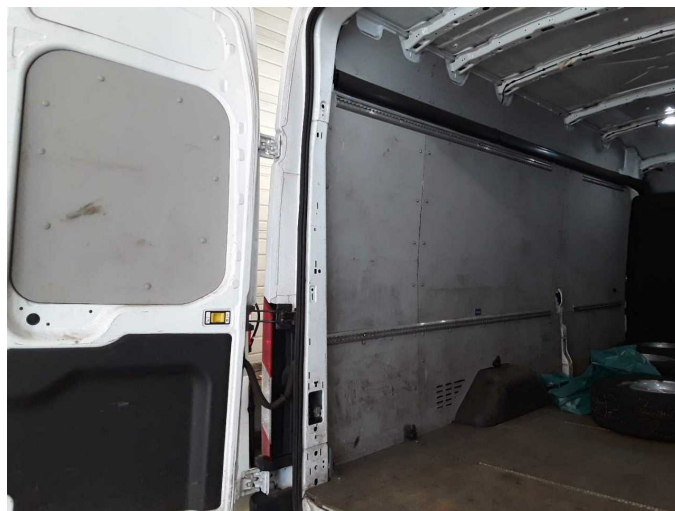
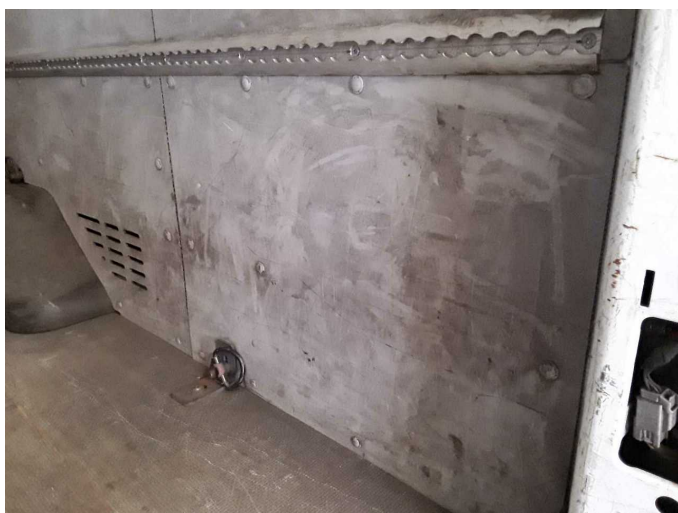
| No. | Component group | Description |
|---|---|---|
| 2 | Trim / covers | Boot lining - Soiled - Clean |

**Damage 2:** Trim / covers: Boot lining - Soiled - Clean

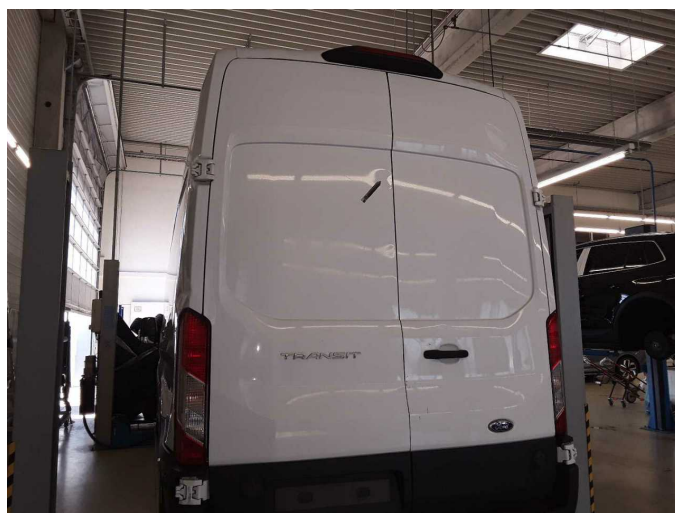
| No. | Component group | Description |
|---|---|---|
| 3 | Boot lid / rear door | Rear door - left side - dent(s) - Smart repair |

**Damage 3:** Boot lid / rear door: Rear door - left side - dent(s) - Smart repair

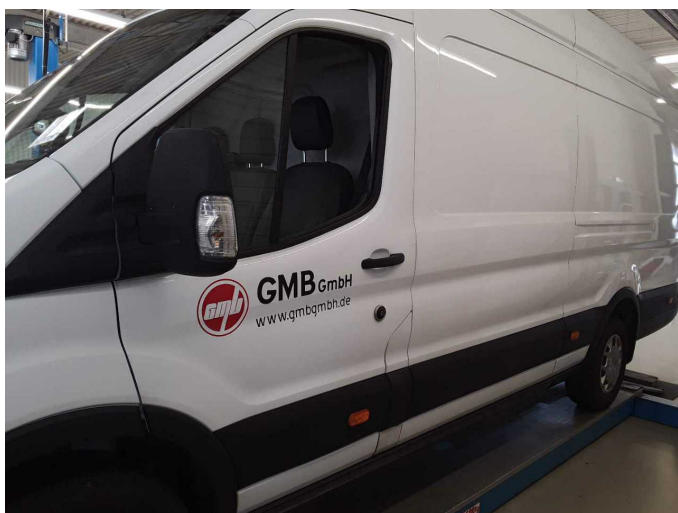
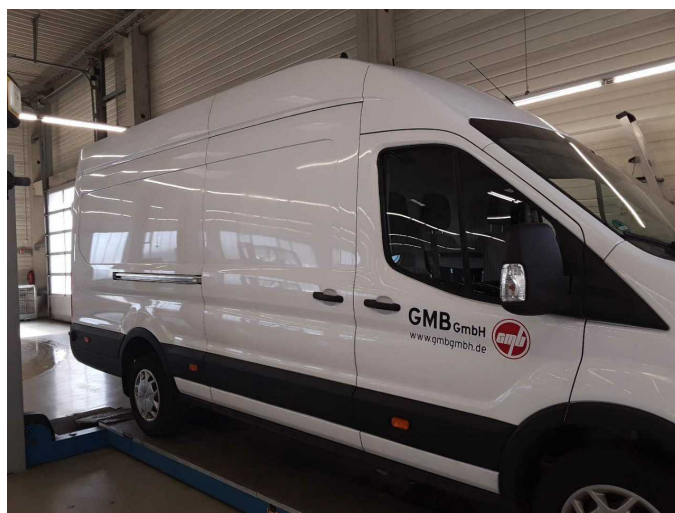
| No. | Component group | Description |
|---|---|---|
| 4 | Body | Body - Glued / labelled - De-glue / neutralise |

**Damage 4:** Body: Body - Glued / labelled - De-glue / neutralise

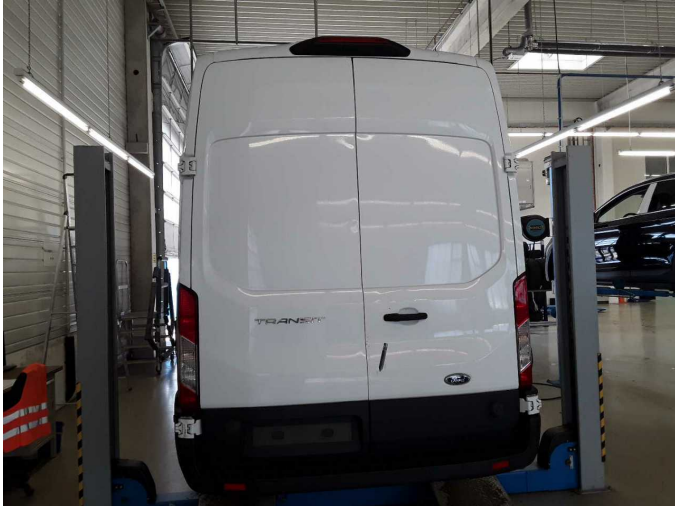
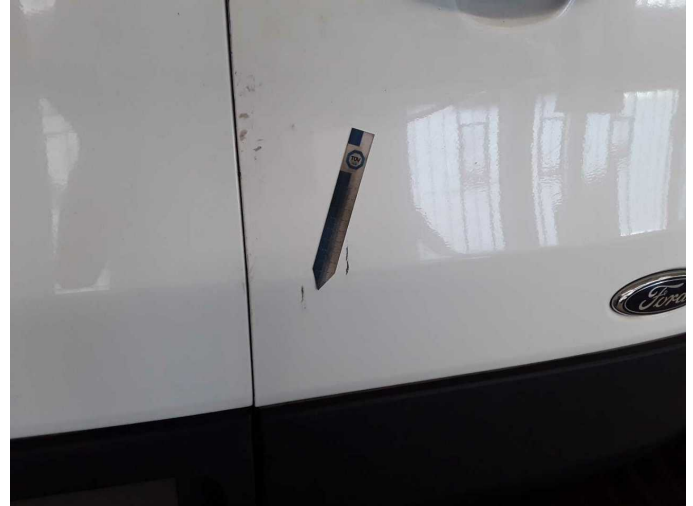
| No. | Component group | Description |
|---|---|---|
| 5 | Boot lid / rear door | Rear door - right side - Scratch(es) - Smart repair |

**Damage 5:** Boot lid / rear door: Rear door - right side - Scratch(es) - Smart repair

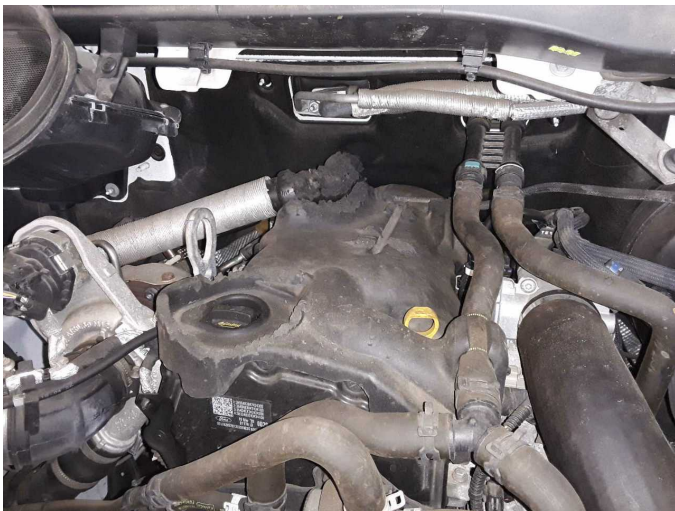
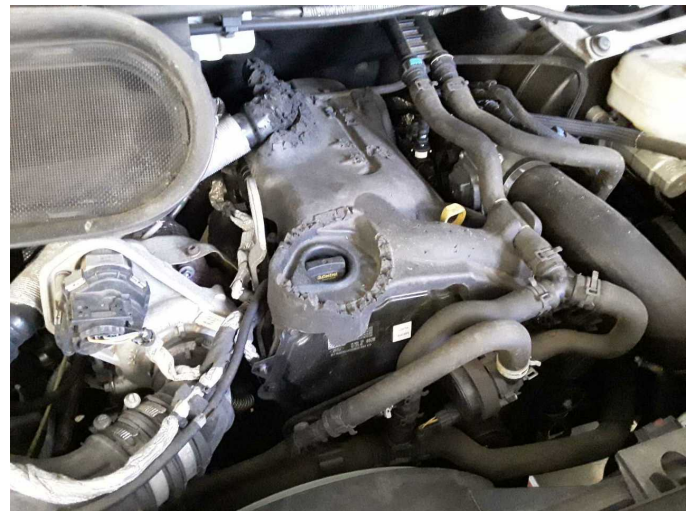
| No. | Component group | Description |
|---|---|---|
| 6 | Engine | Engine cover - Broken / torn - Replace |

**Damage 6:** Engine: Engine cover - Broken / torn - Replace

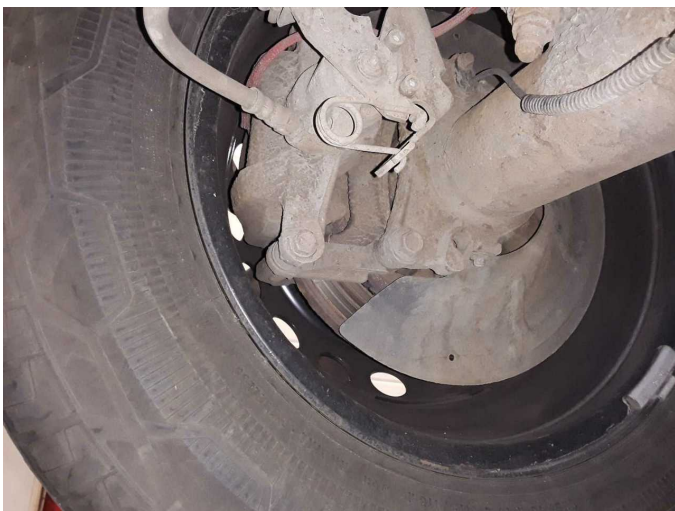
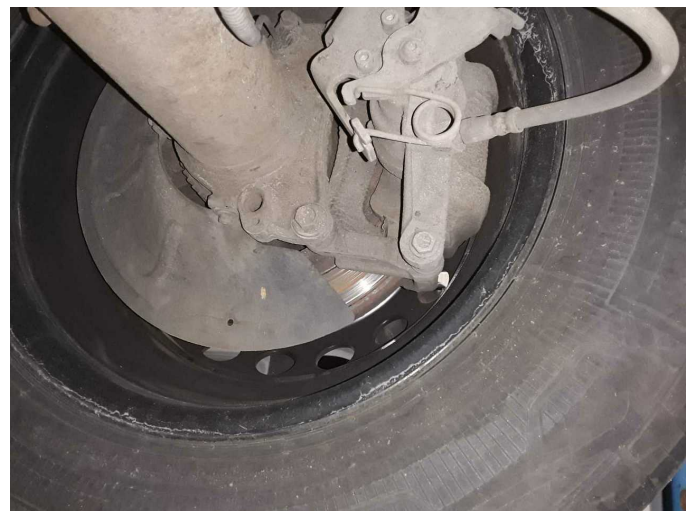
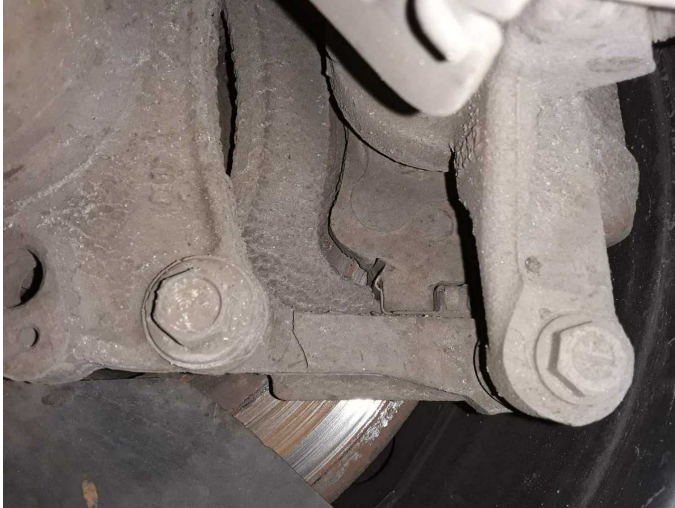
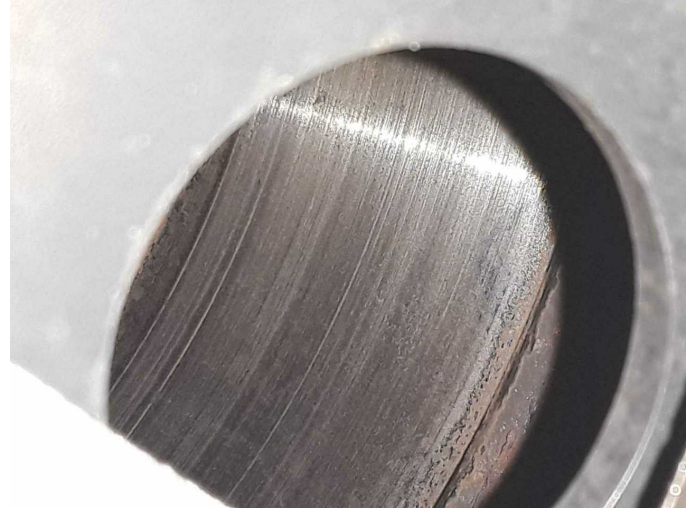
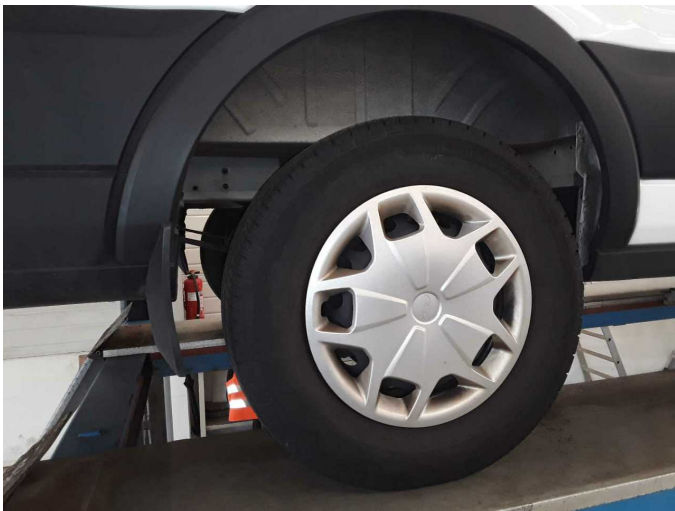
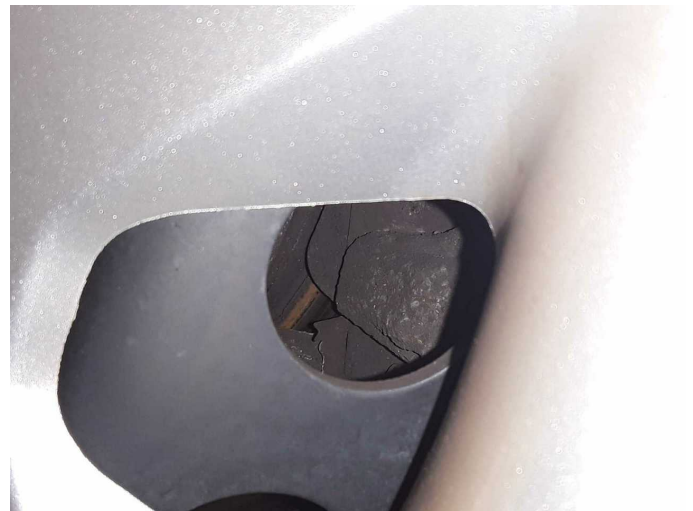
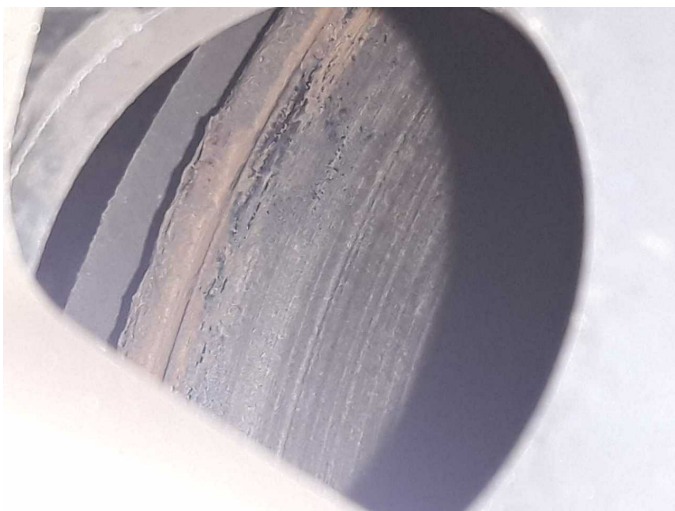
| No. | Component group | Description |
|---|---|---|
| 7 | Braking system | Brake discs and pads - rear - Corrosion - Replace |

**Damage 7:** Braking system: Brake discs and pads - rear - Corrosion - Replace

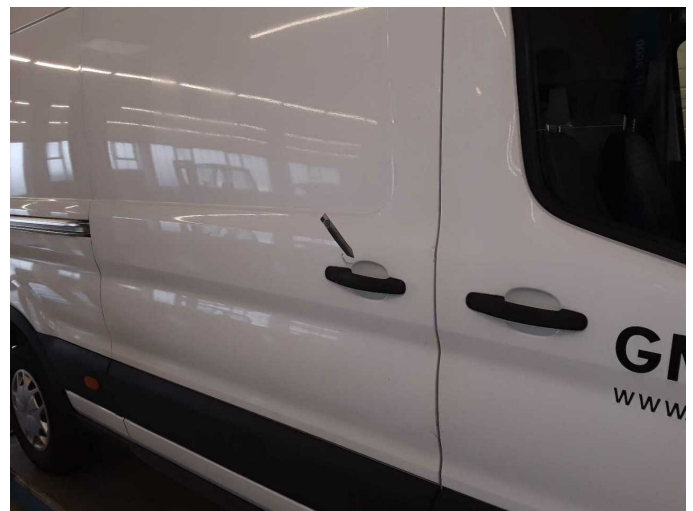
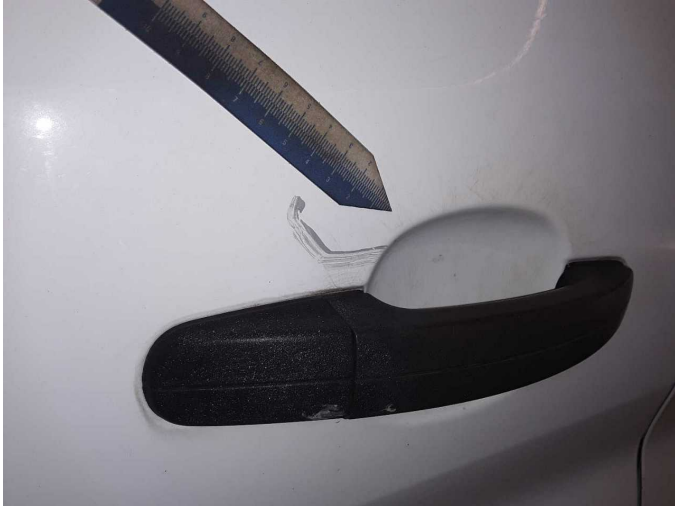
| No. | Component group | Description |
|---|---|---|
| 8 | Sliding door, right | Sliding door - Scratch(es) - Paint |

**Damage 8:** Sliding door, right: Sliding door - Scratch(es) - Paint

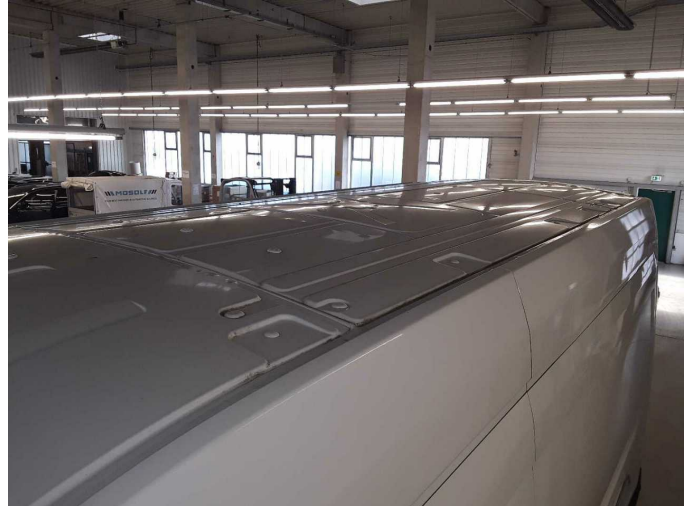
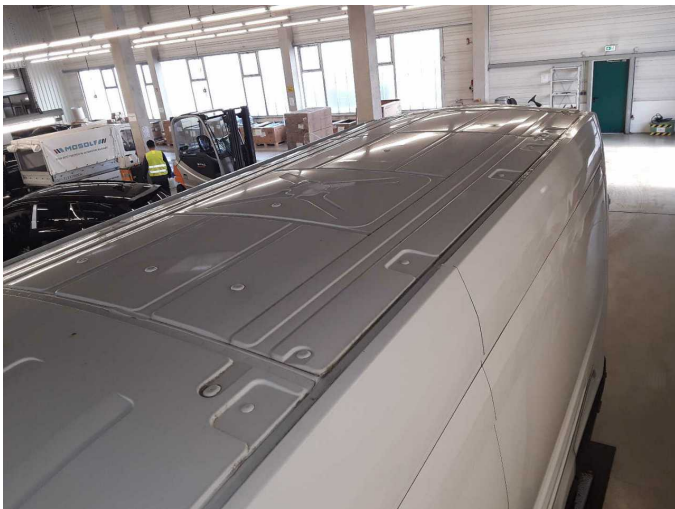
| No. | Component group | Description |
|---|---|---|
| 1 | Roof | Roof - dent(s) - No deduction |

**Wear and tear 1:** Roof: Roof - dent(s) - No deduction

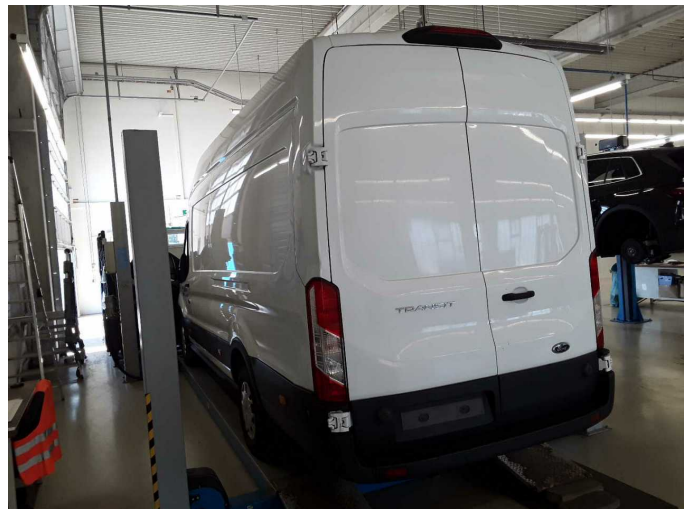
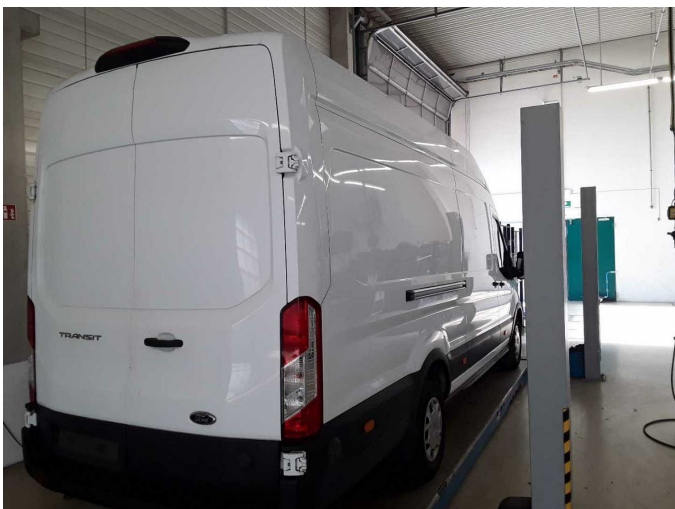
| No. | Component group | Description |
|---|---|---|
| 2 | Body | Body - Scratch(es) - No deduction |

**Wear and tear 2:** Body: Body - Scratch(es) - No deduction

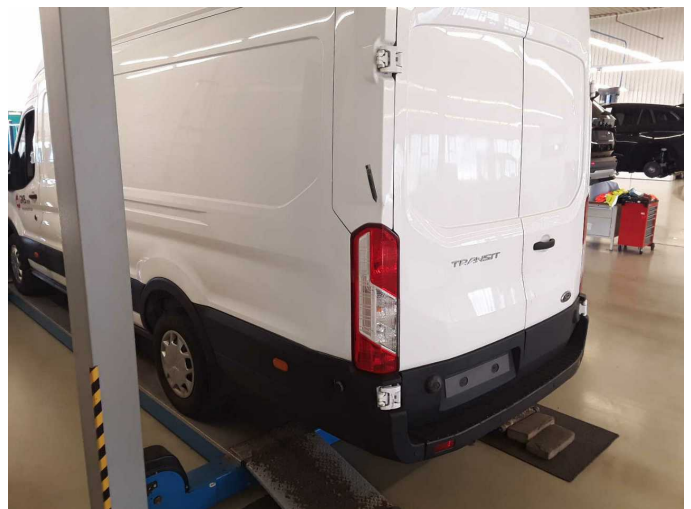
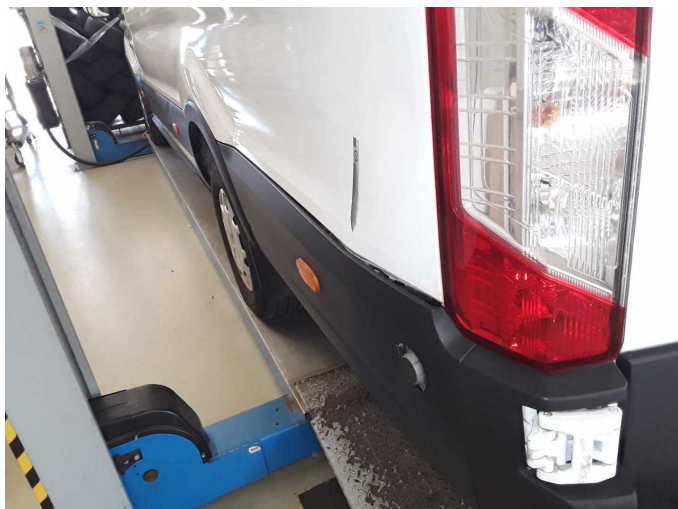
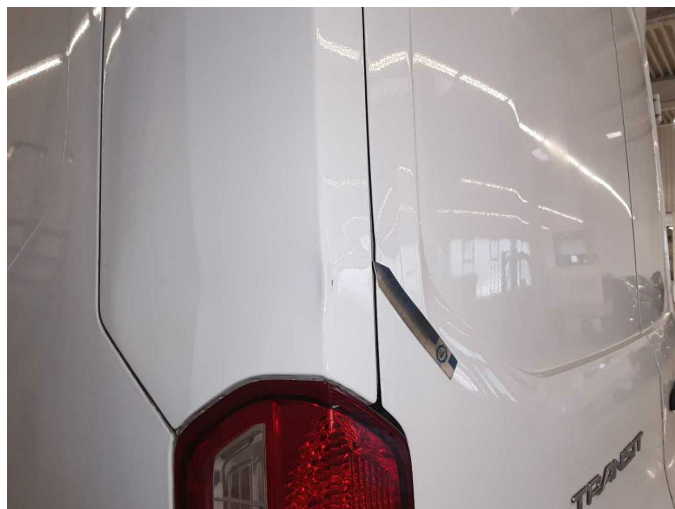
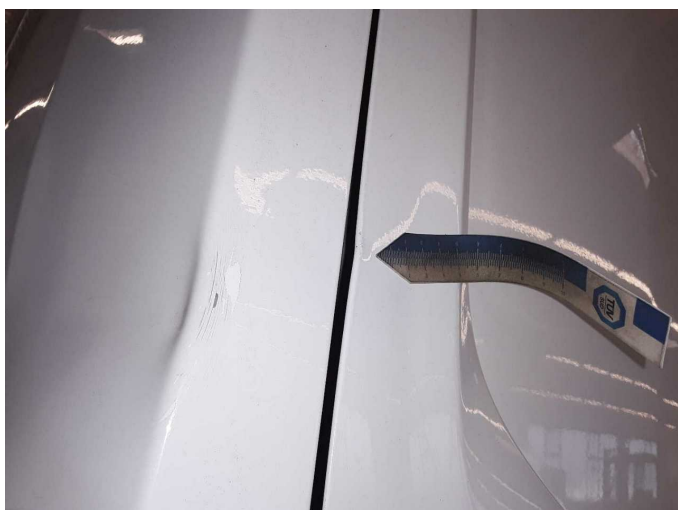
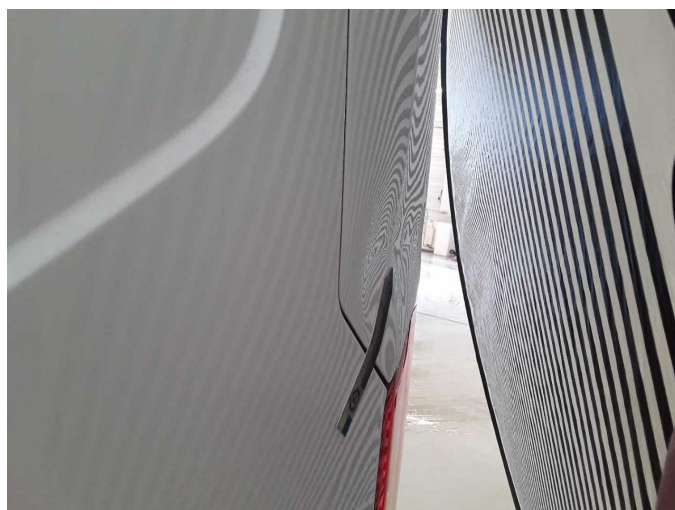
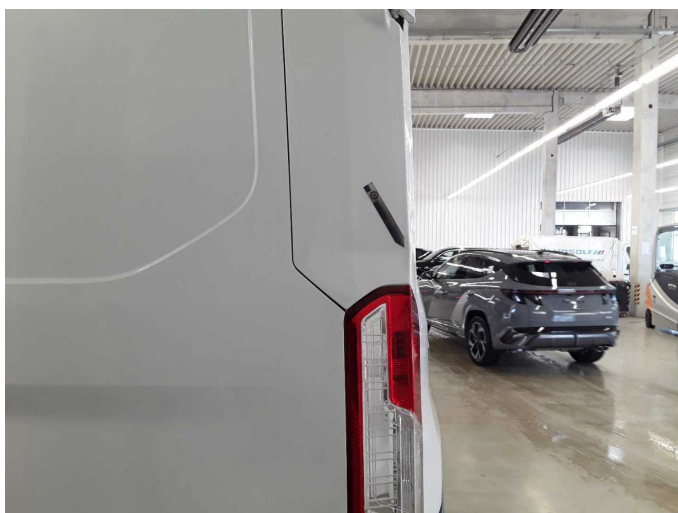
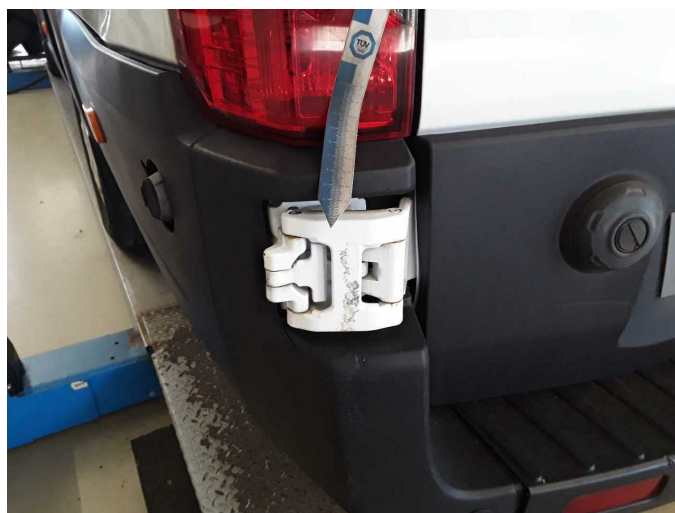
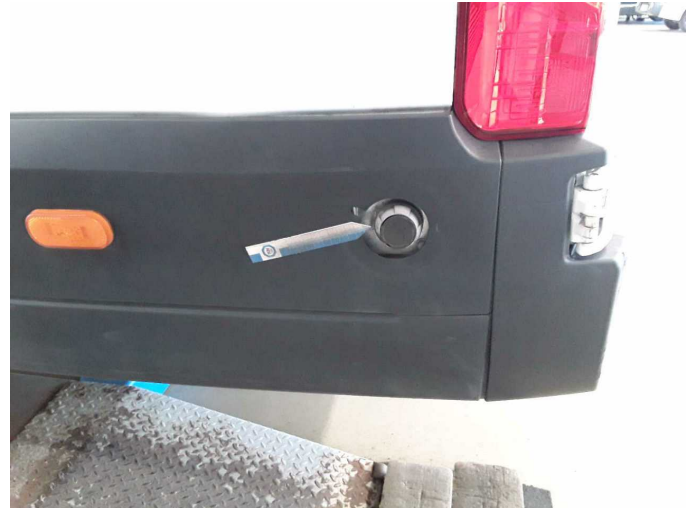
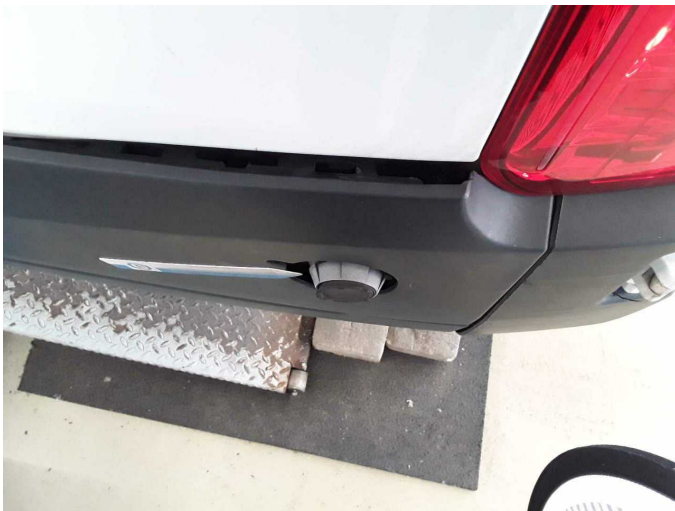
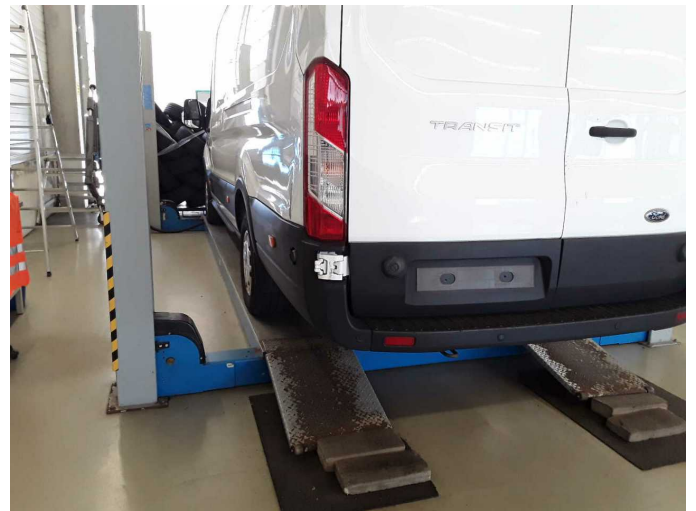
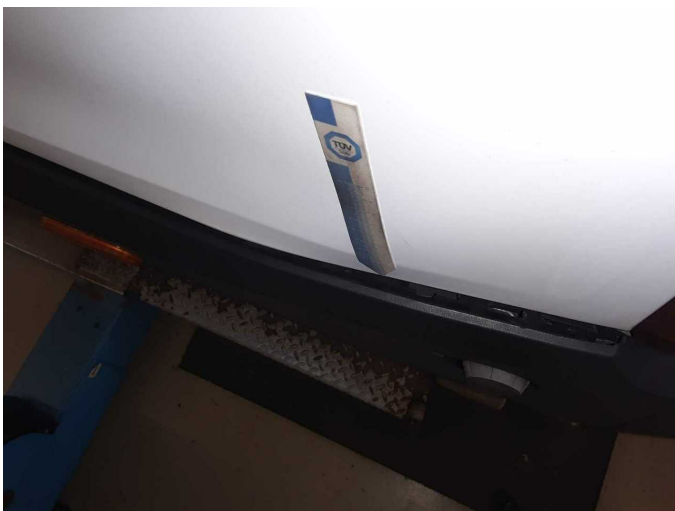
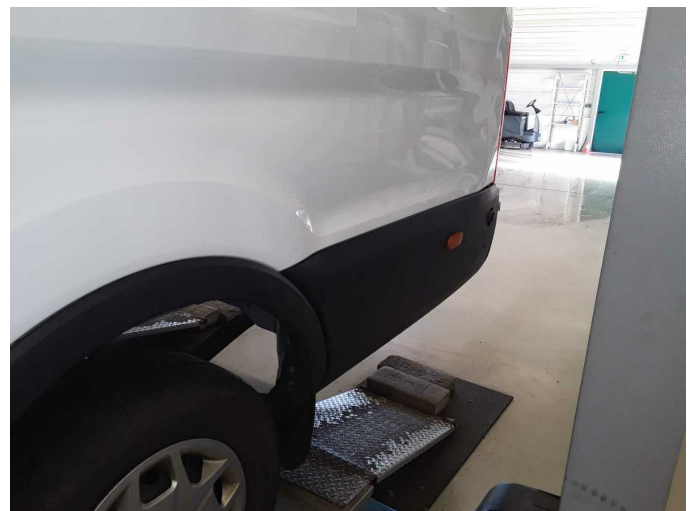
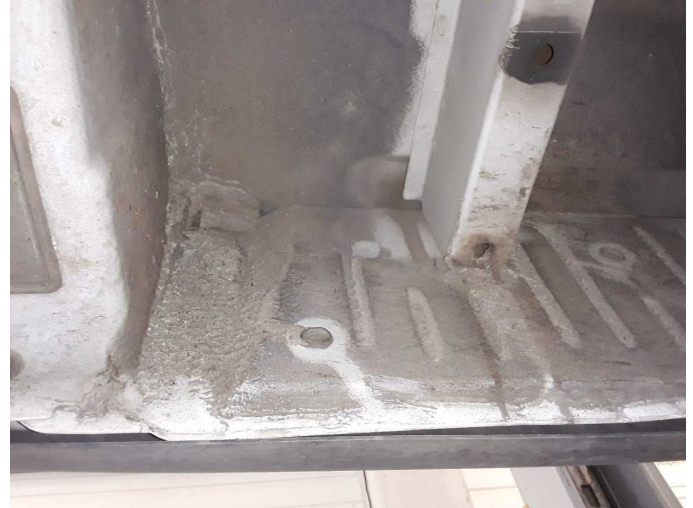
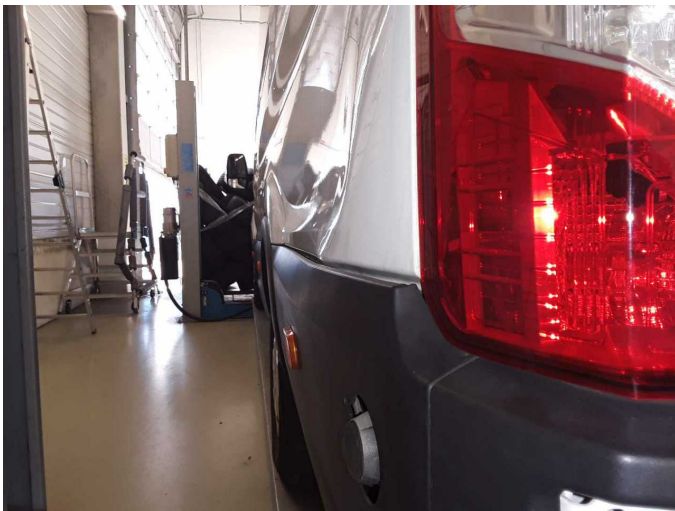
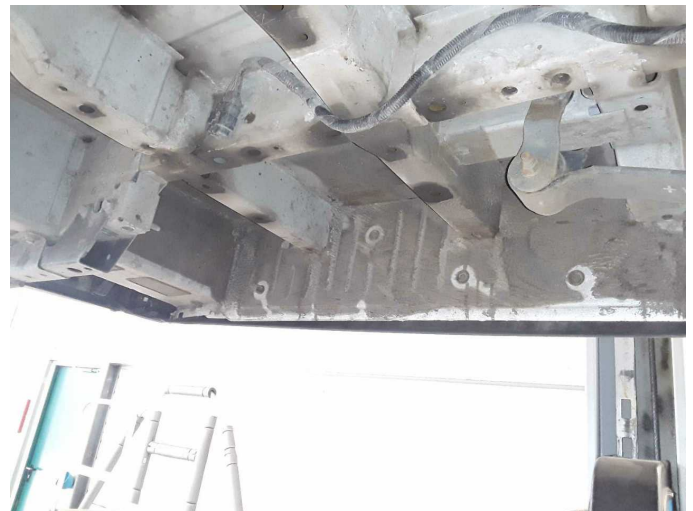
| No. | Accident |
|---|---|
| 1 | Rear, Side - left |

**Accident 1:** Rear, Side - left

**Accident 1: Rear, Side - left**
