## Expertise

Protocol number: 46116961  
Order No. / Reference: 26440743  
Inspection date: 23 Jun 2026

Model: Mustang Mach-E Premium

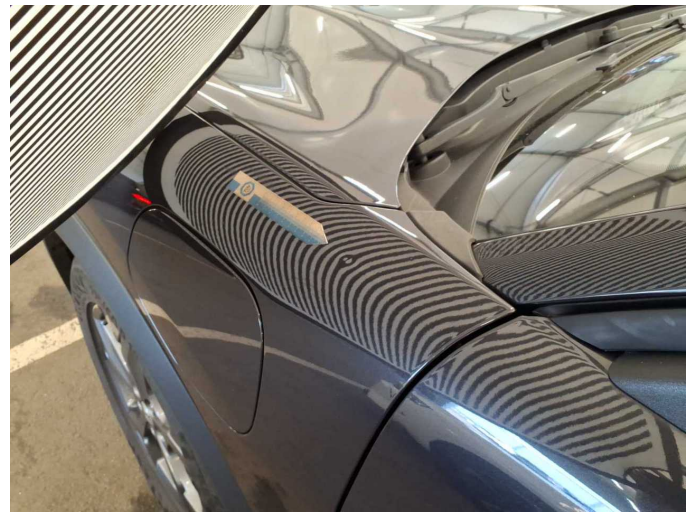
Damage 2: Mudguard - left side: Mudguard - left side - dent(s) - Smooth repair work

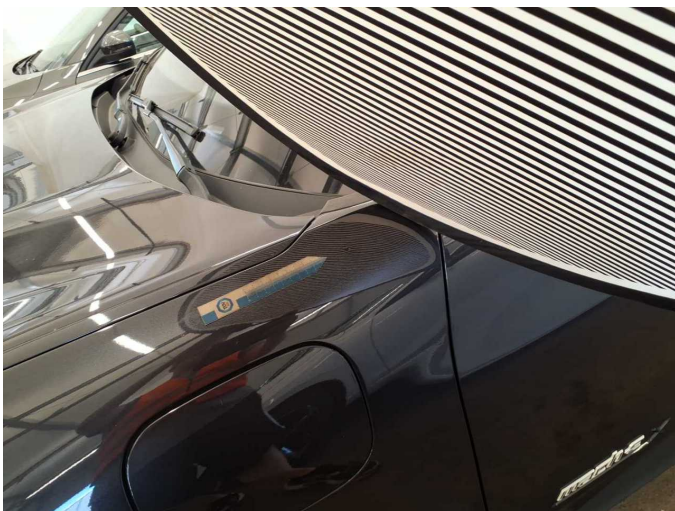
Damage 2: Mudguard - left side: Mudguard - left side - dent(s) - Smooth repair work

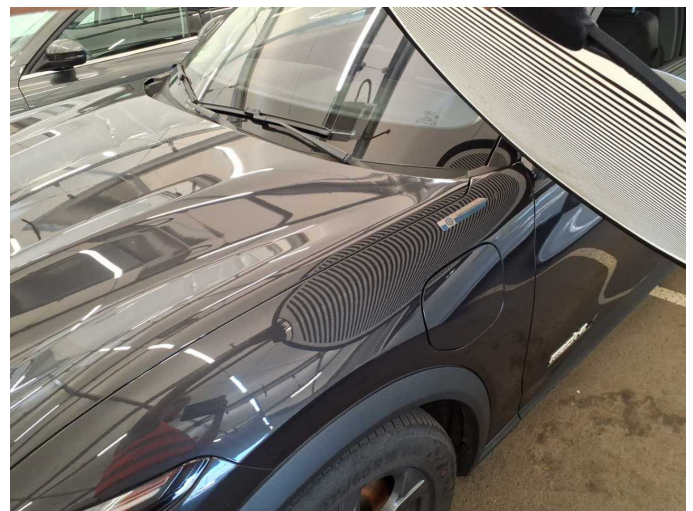
Damage 2: Mudguard - left side: Mudguard - left side - dent(s) - Smooth repair work

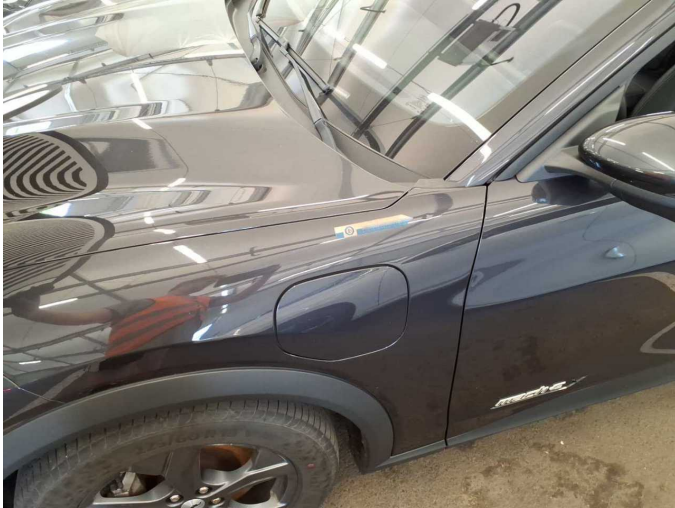
**Damage 2:** Mudguard - left side: Mudguard - left side - dent(s) - Smooth repair work

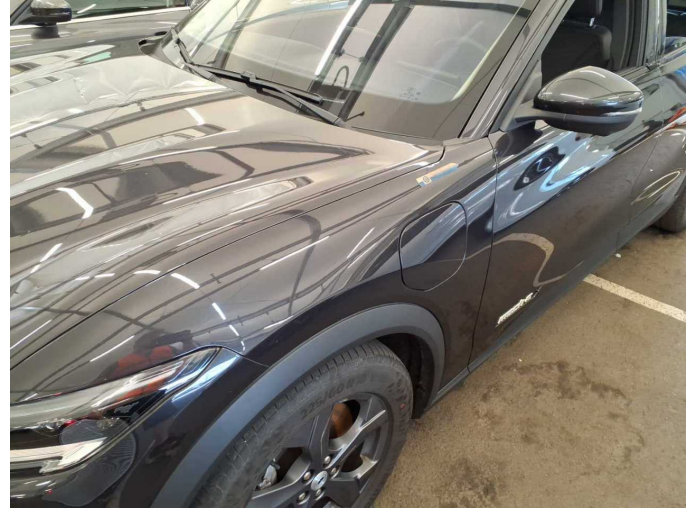
**Damage 2:** Mudguard - left side: Mudguard - left side - dent(s) - Smooth repair work

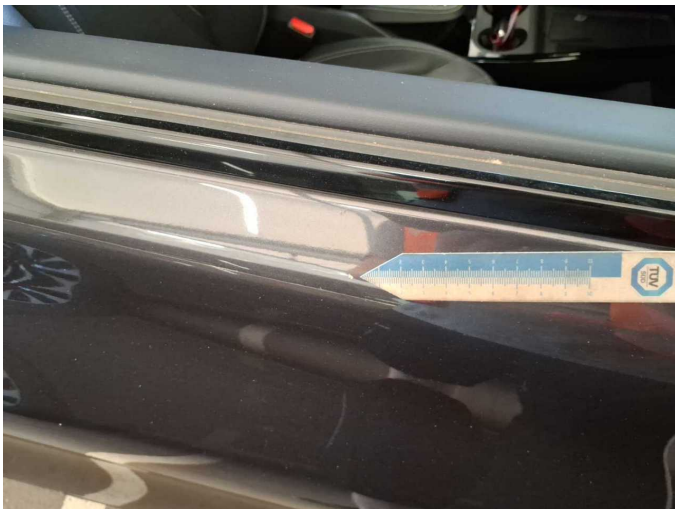
**Damage 3:** Door - front right side: Door - Dent / paintcoat damage - Repair and paint

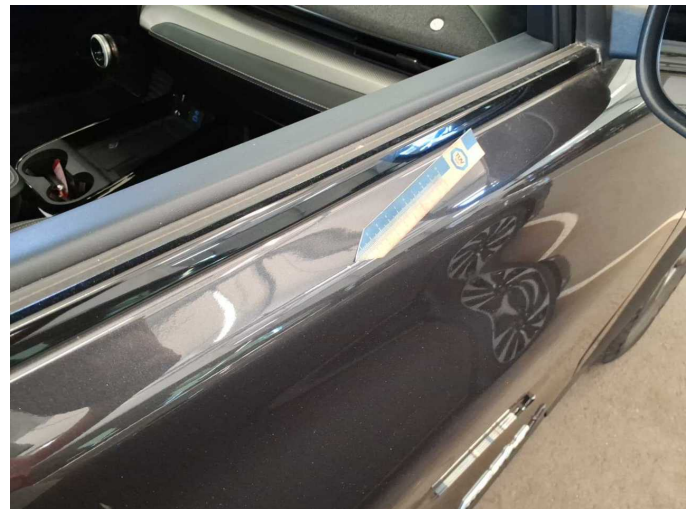
**Damage 3:** Door - front right side: Door - Dent / paintcoat damage - Repair and paint

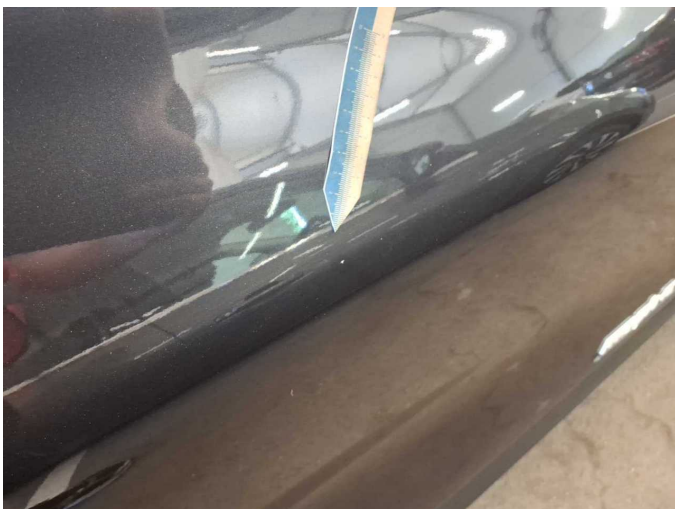
**Damage 3:** Door - front right side: Door - Dent / paintcoat damage - Repair and paint

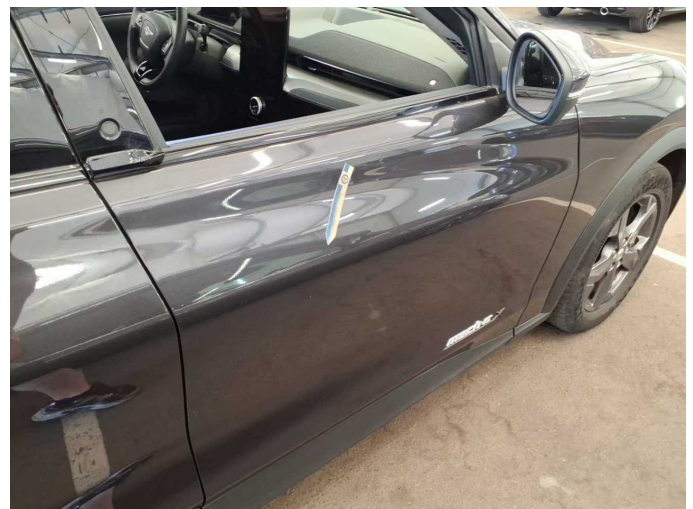
**Damage 3:** Door - front right side: Door - Dent / paintcoat damage - Repair and paint

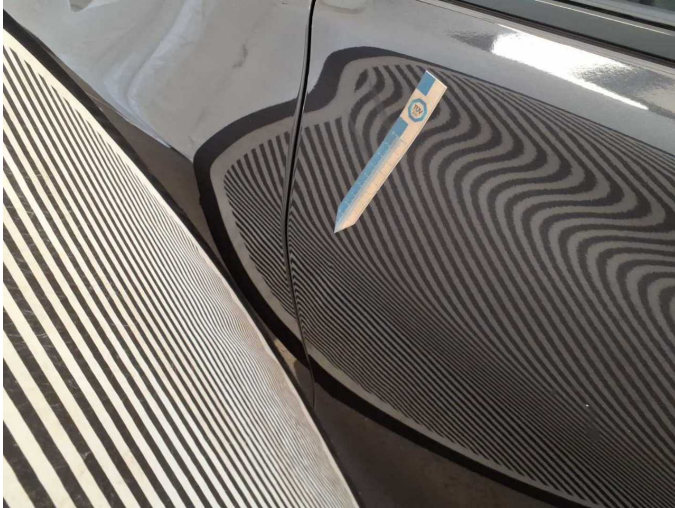
**Damage 3:** Door - front right side: Door - Dent / paintcoat damage - Repair and paint

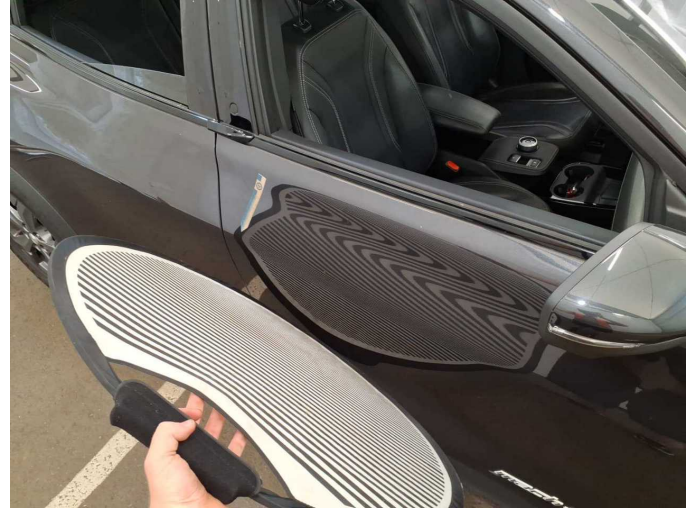
**Damage 3:** Door - front right side: Door - Dent / paintcoat damage - Repair and paint

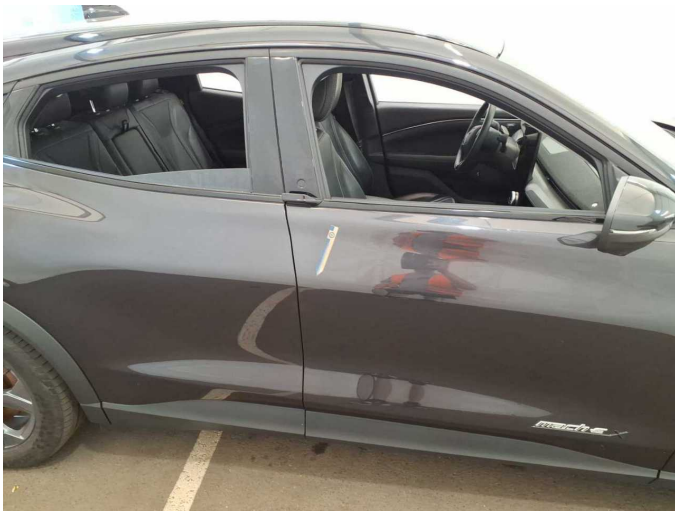
**Damage 3:** Door - front right side: Door - Dent / paintcoat damage - Repair and paint

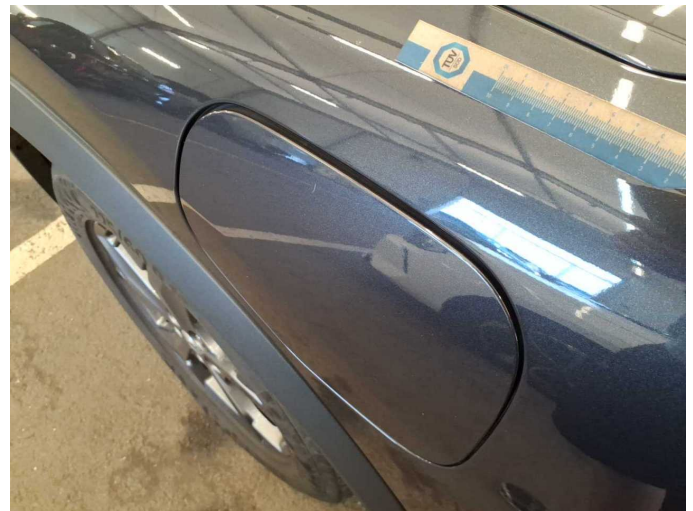
**Wear and tear 1:** Fuel system: Tank cap - Scratch(es) - No deduction

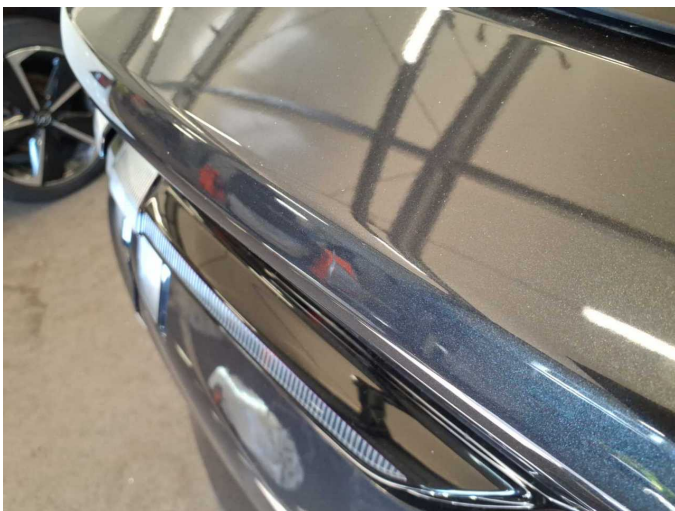
**Wear and tear 2:** Boot lid / rear door: Boot lid - Scratch(es) - No deduction

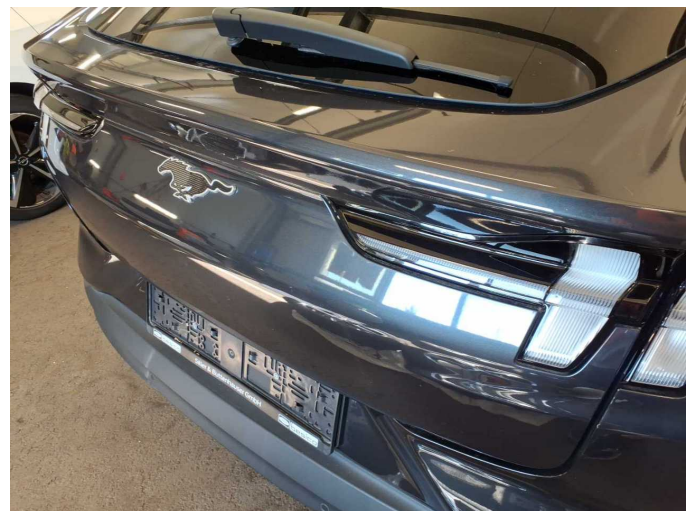
**Wear and tear 2:** Boot lid / rear door: Boot lid - Scratch(es) - No deduction

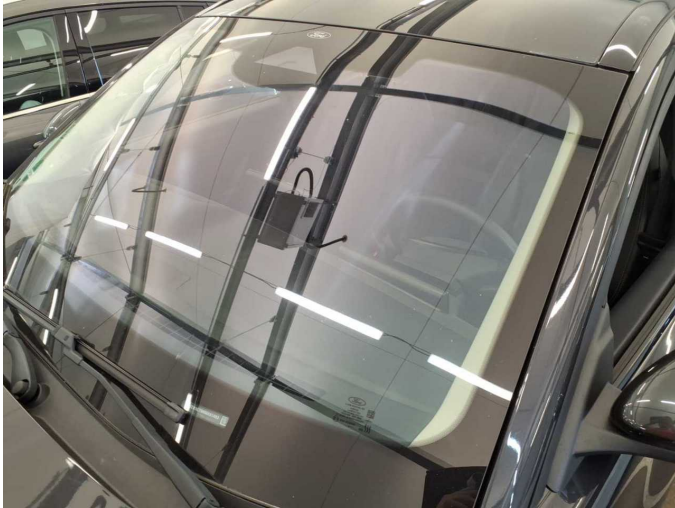
**Wear and tear 3:** Vehicle glazing: Windscreen - Stone chips - No deduction

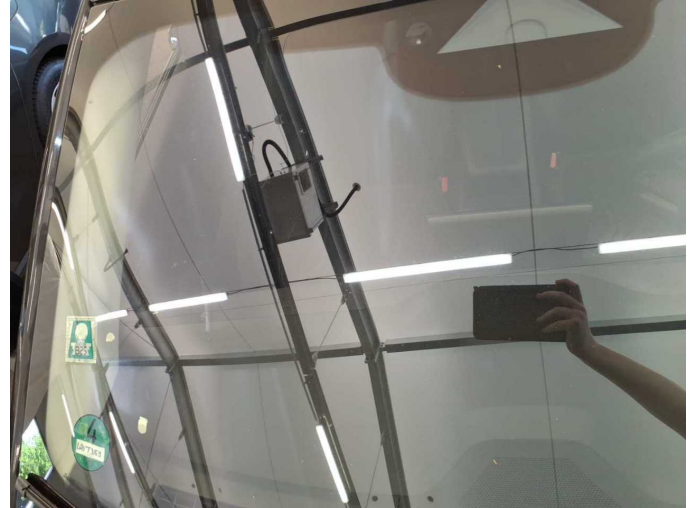
**Wear and tear 3:** Vehicle glazing: Windscreen - Stone chips - No deduction

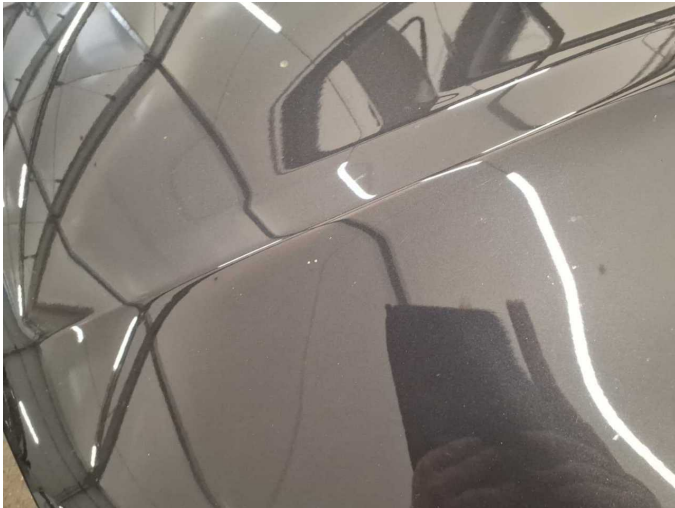
**Wear and tear 4:** Bonnet: Bonnet - Stone chips - No deduction

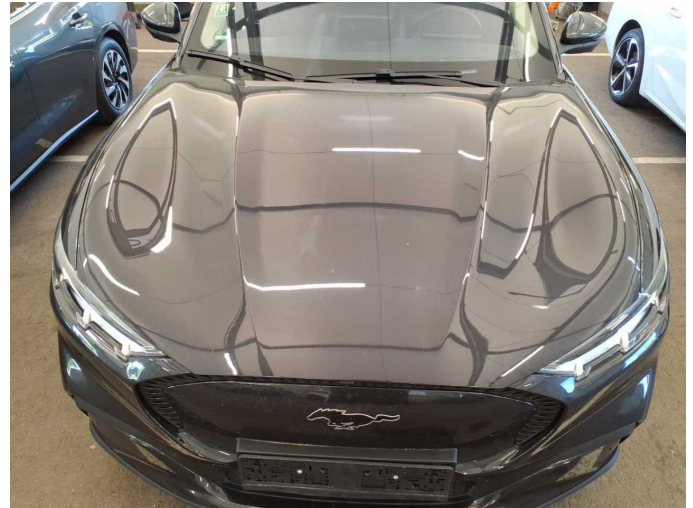
**Wear and tear 4:** Bonnet: Bonnet - Stone chips - No deduction

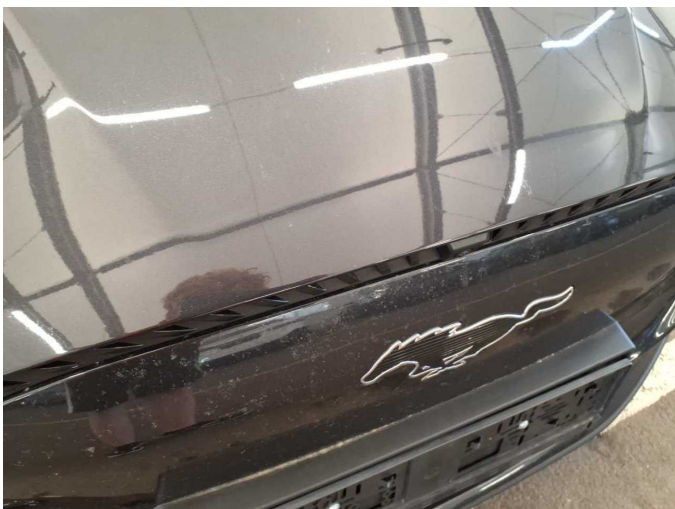
**Wear and tear 4:** Bonnet: Bonnet - Stone chips - No deduction

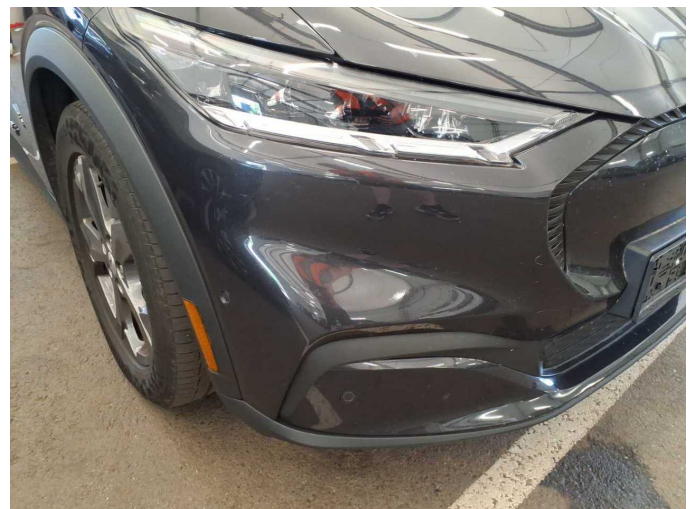
**Wear and tear 5:** Front bumper: Front bumper - Stone chips - No deduction

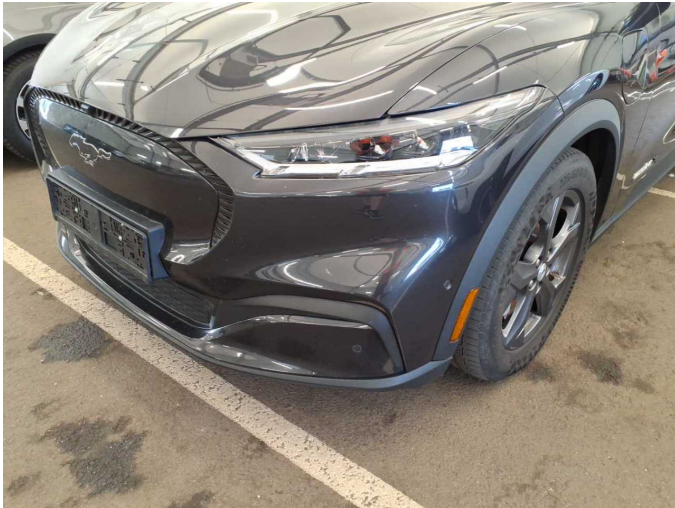
**Wear and tear 5:** Front bumper: Front bumper - Stone chips - No deduction

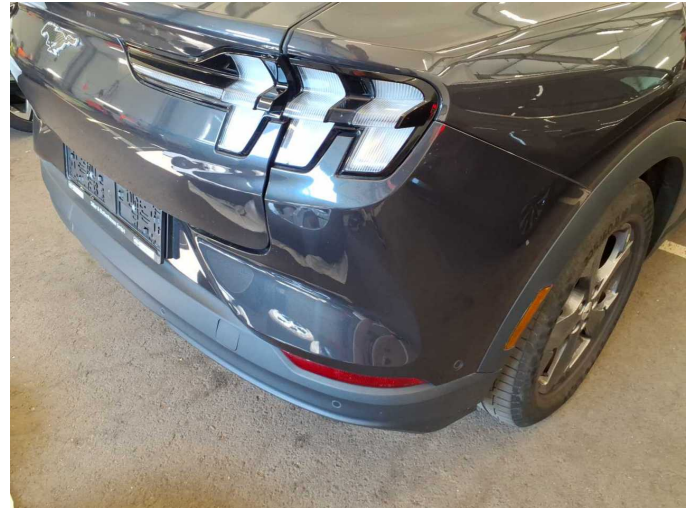
**Wear and tear 6:** Rear bumper: Rear bumper - Scratch(es) - No deduction

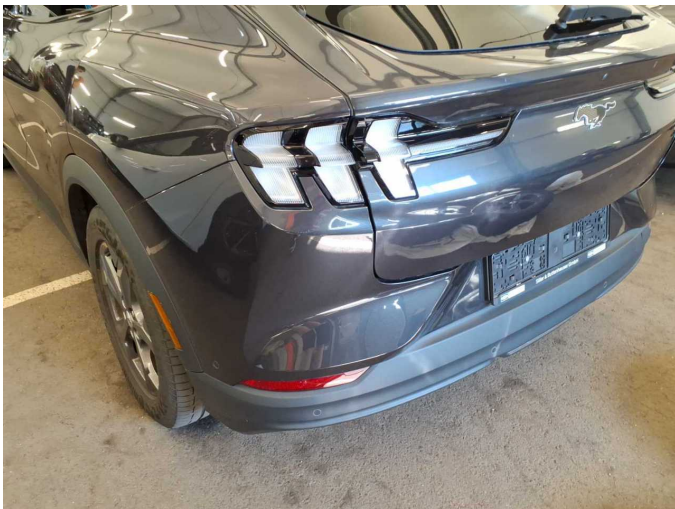
**Wear and tear 6:** Rear bumper: Rear bumper - Scratch(es) - No deduction

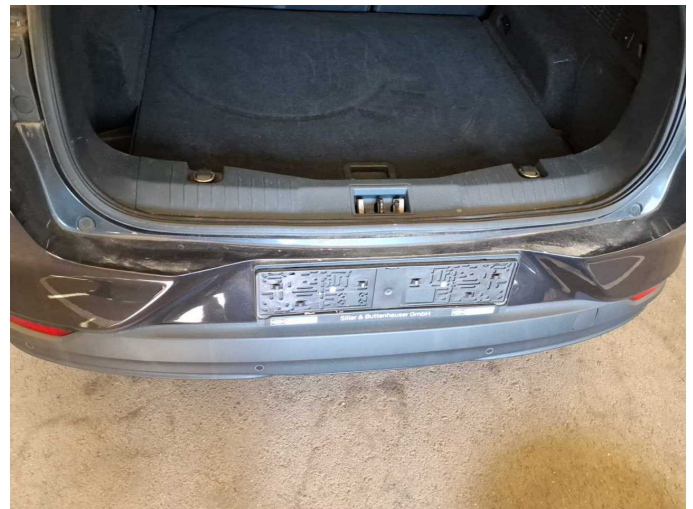
**Wear and tear 6:** Rear bumper: Rear bumper - Scratch(es) - No deduction

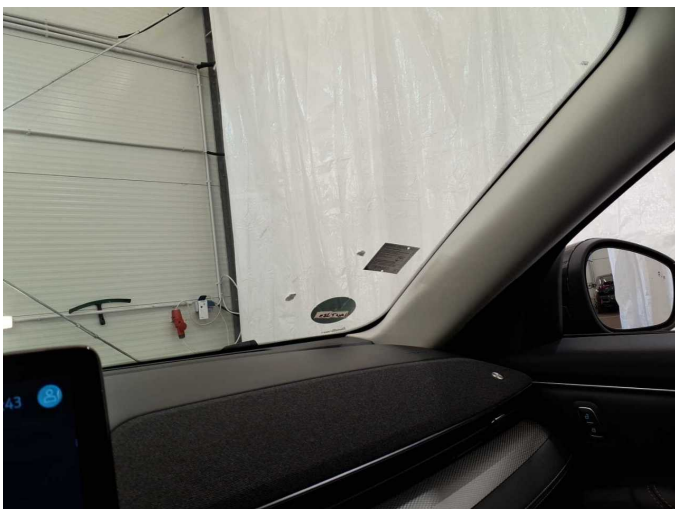
**Wear and tear 7:** Vehicle glazing: Windscreen - Glued / labelled - No deduction
