Expertise

Protocol number: 46403894  
Order No. / Reference: 26577257  
Inspection date: 8 Jul 2026

Manufacturer: Citroën

Model: C5 Aircross Hybrid 225 e.EAT8 SHINE PACK

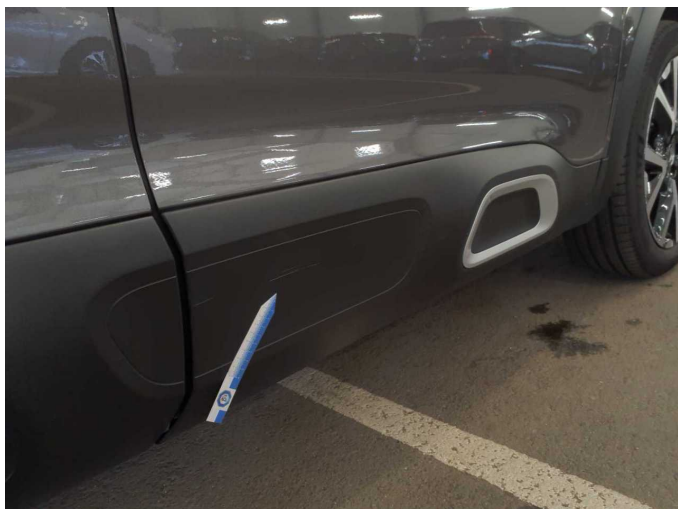
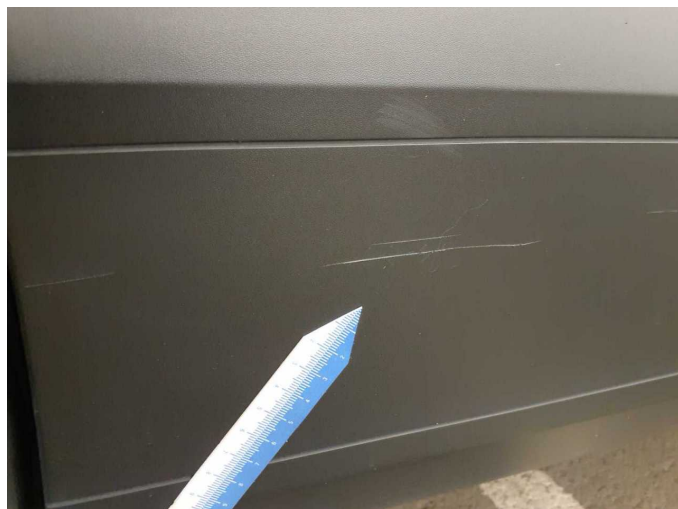
| No. | Component group | Description |
|---|---|---|
| 1 | Door - front right side | Brightware - lower - Scratch(es) - Loss in value |

**Damage 1:** Door - front right side: Brightware - lower - Scratch(es) - Loss in value

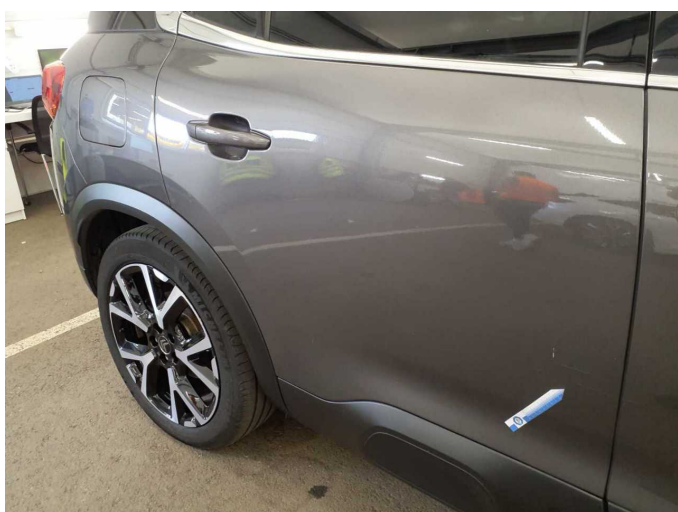
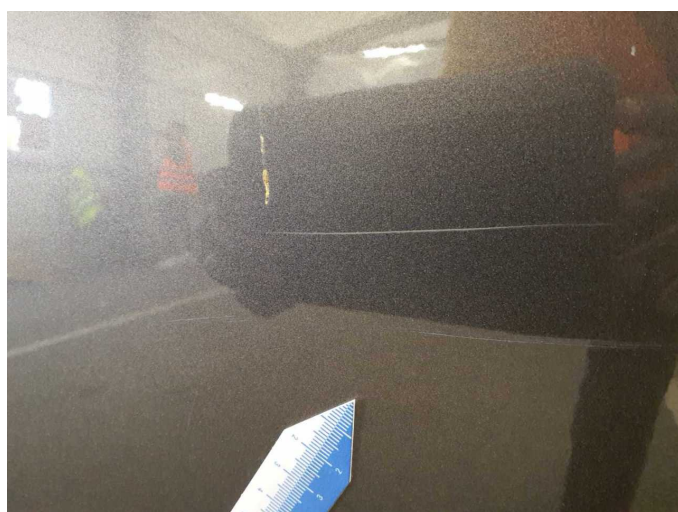
| No. | Component group | Description |
|---|---|---|
| 2 | Door - rear right side | Door - Scratch(es) - Smart repair |

**Damage 2:** Door - rear right side: Door - Scratch(es) - Smart repair

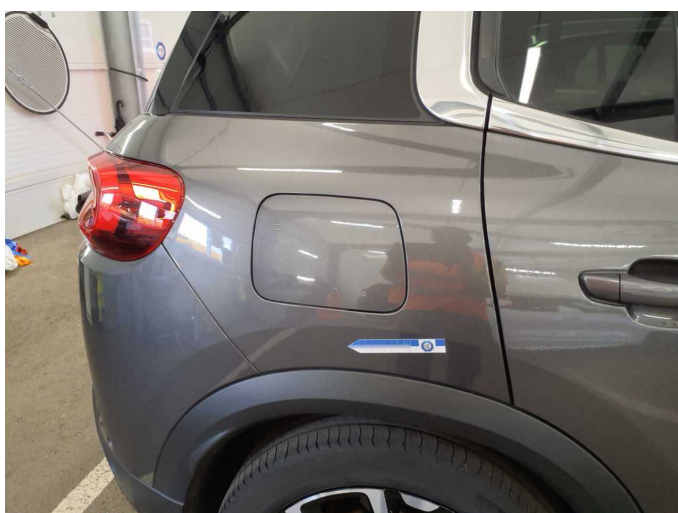
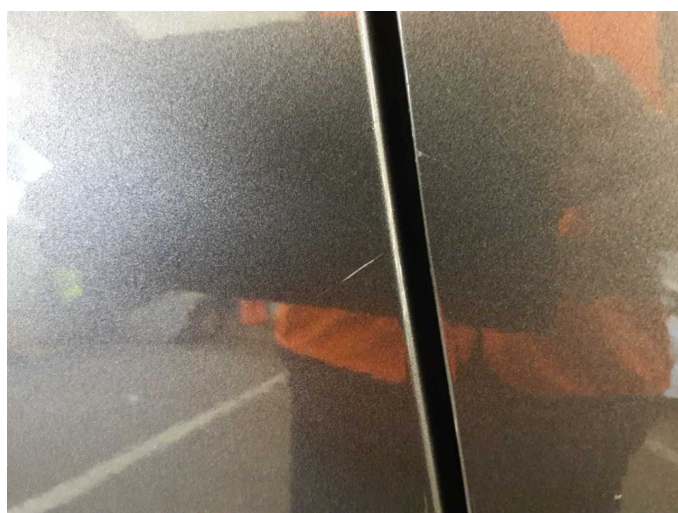
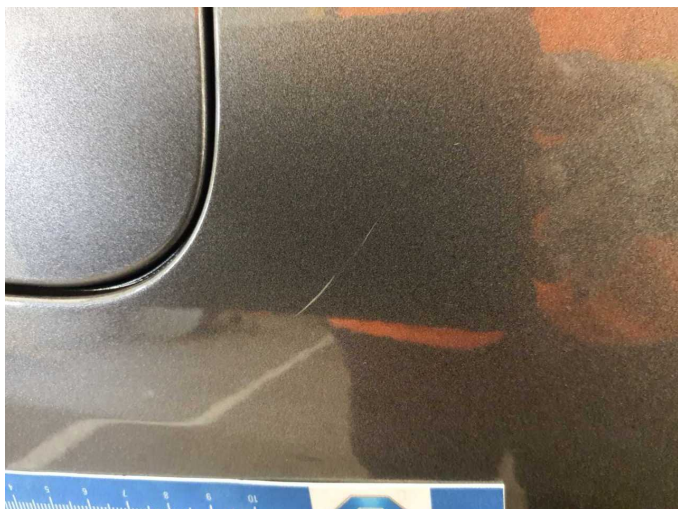
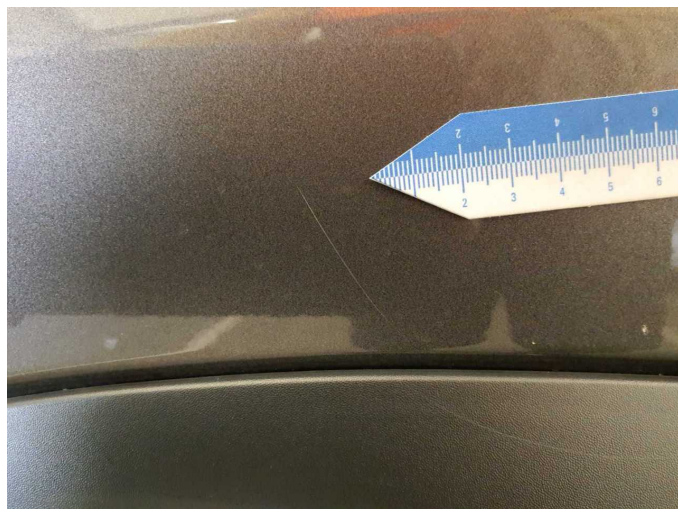
| No. | Component group | Description |
|---|---|---|
| 3 | Side panel - rear right side | Side panel - Scratch(es) - Smart repair |

**Damage 3:** Side panel - rear right side: Side panel - Scratch(es) - Smart repair

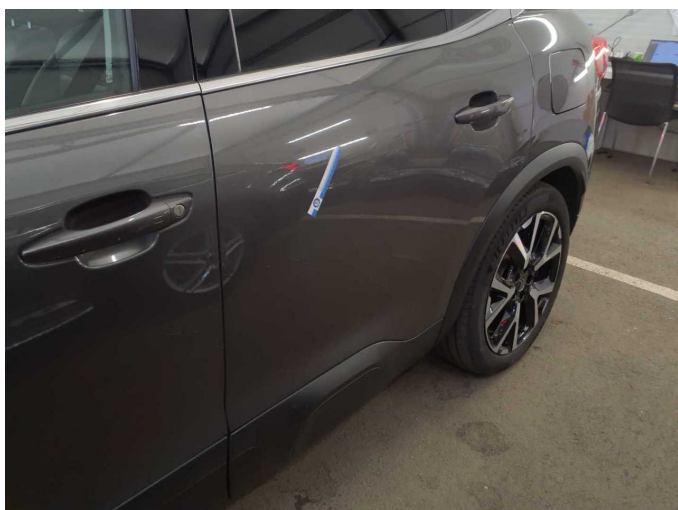
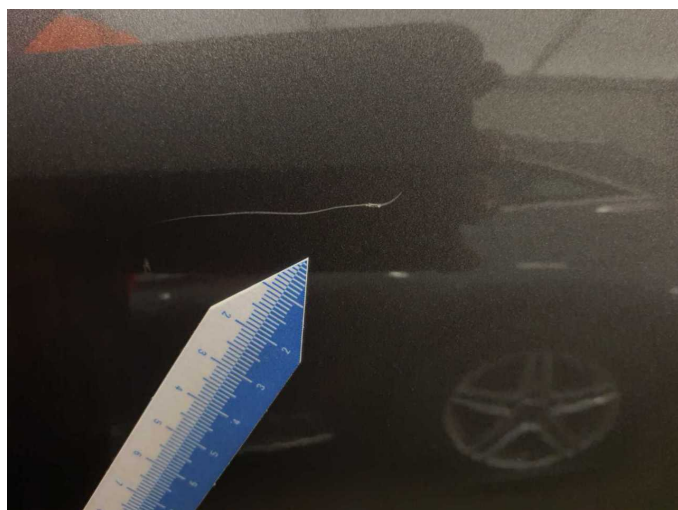
| No. | Component group | Description |
|---|---|---|
| 4 | Door - rear left side | Door - Scratch(es) - Paint |

**Damage 4:** Door - rear left side: Door - Scratch(es) - Paint

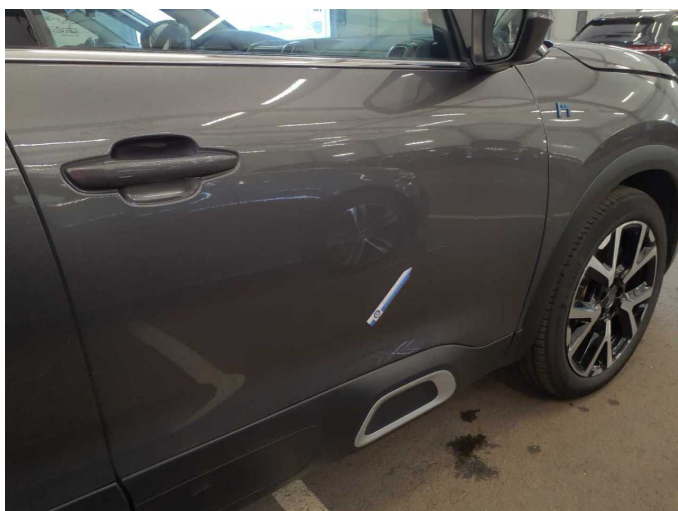
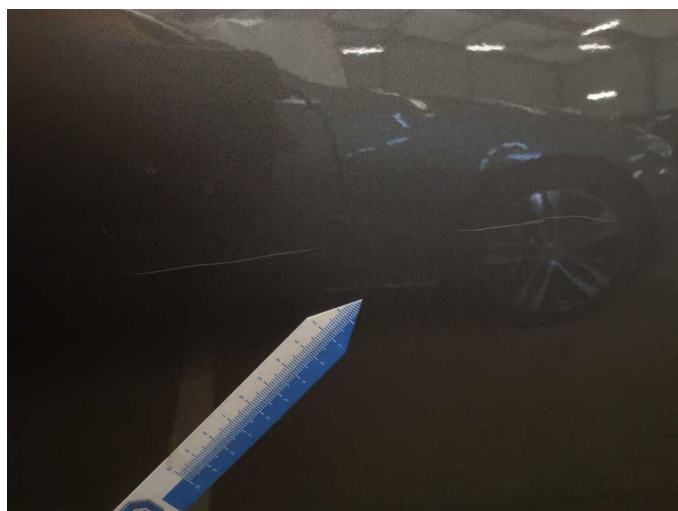
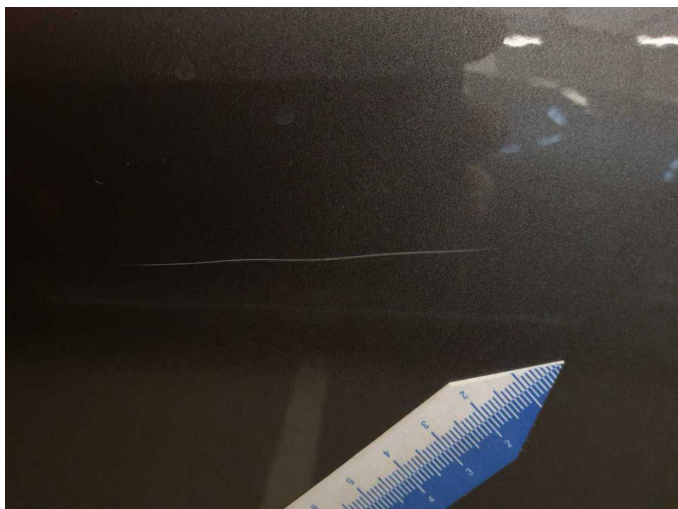
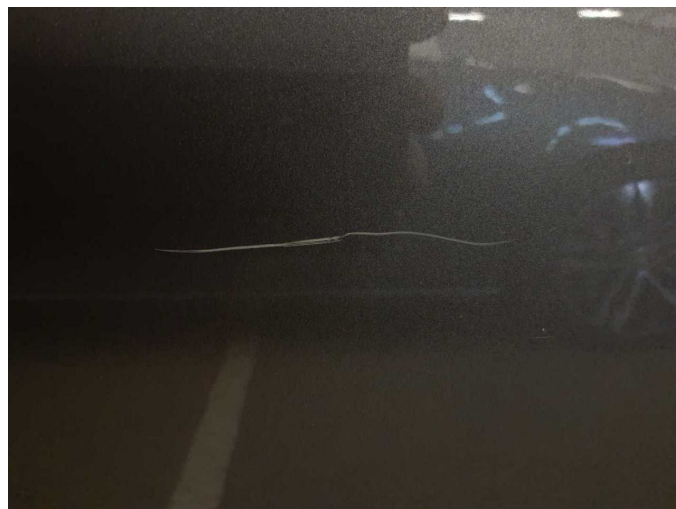
| No. | Component group | Description |
|---|---|---|
| 5 | Door - front right side | Door - Scratch(es) - Paint |

**Damage 5:** Door - front right side: Door - Scratch(es) - Paint
