Mercedes-Benz CLA SB '19

Vehicle information

Damage summary

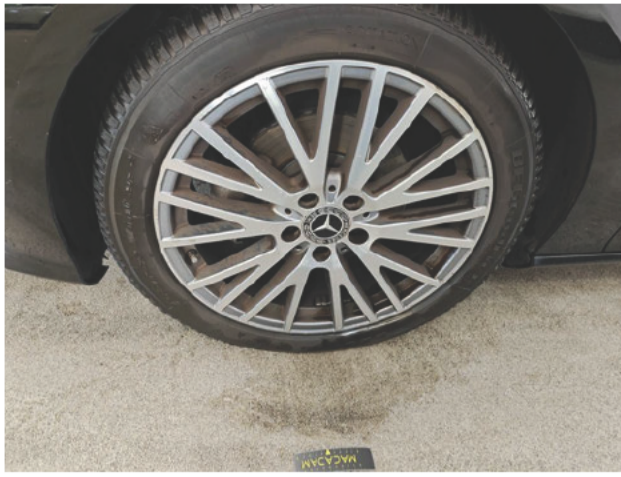
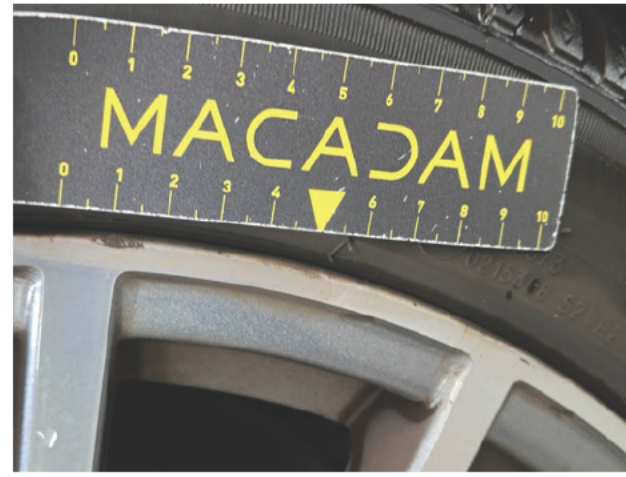
Alloy rim FL

Scratch(es)
Repair and paint (complete)
Left

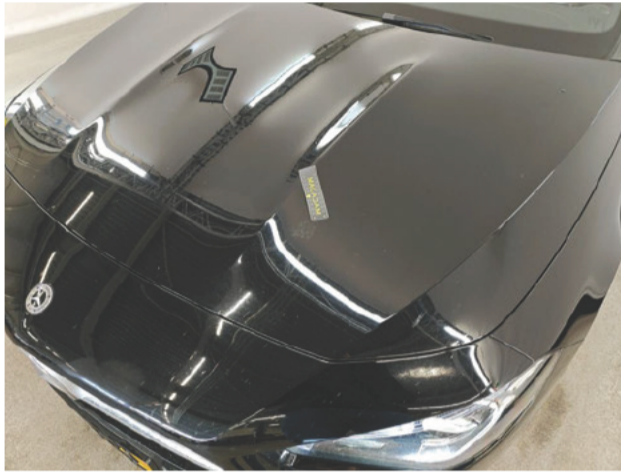
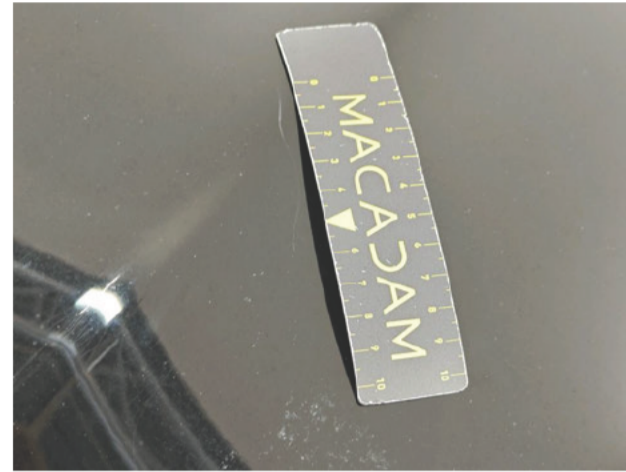
Bonnet

Scratch(es)
Repair and paint (complete)
Front

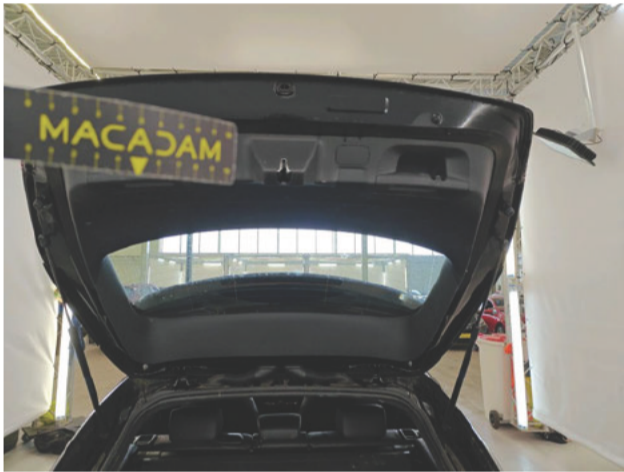
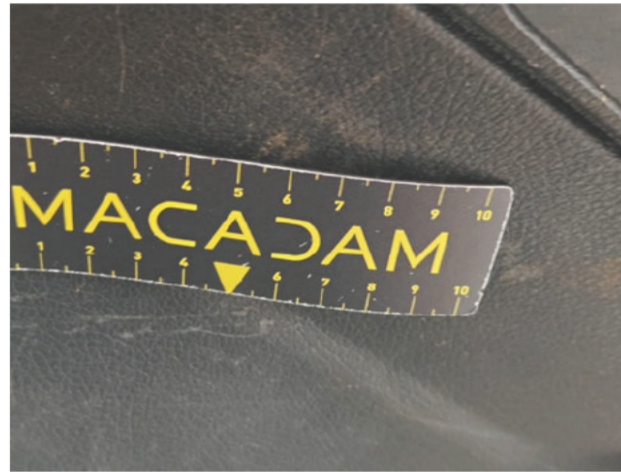
Boot lid covering R

Scratch(es)
Smart repair
Rear

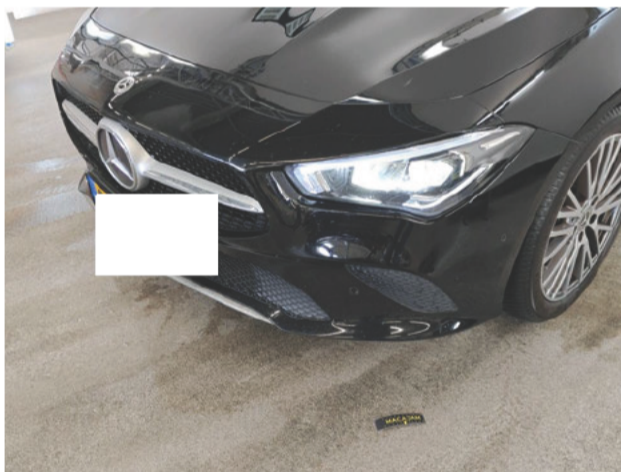
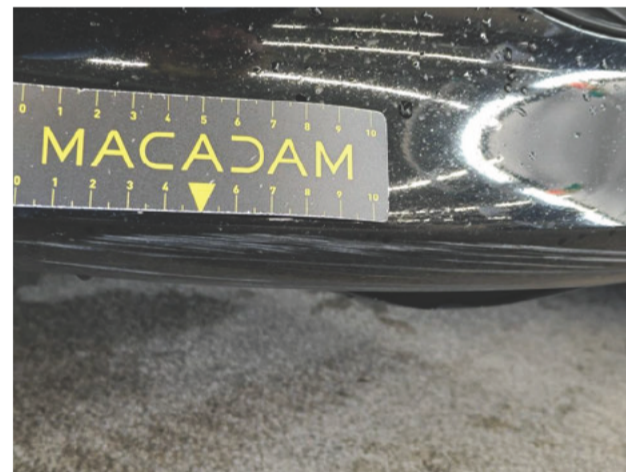
Bumper F

Scratch(es)
Repair and paint (complete)
Front

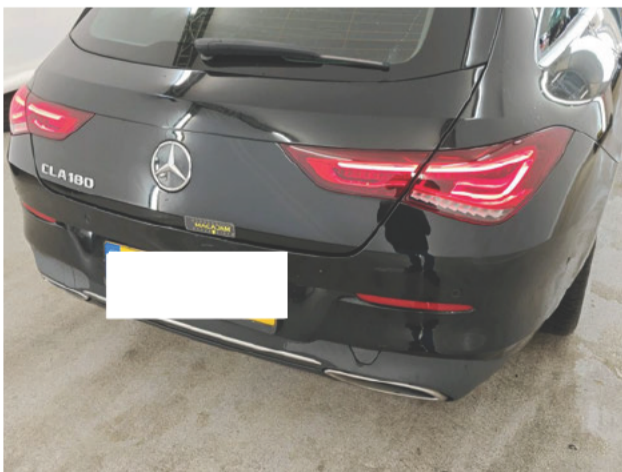
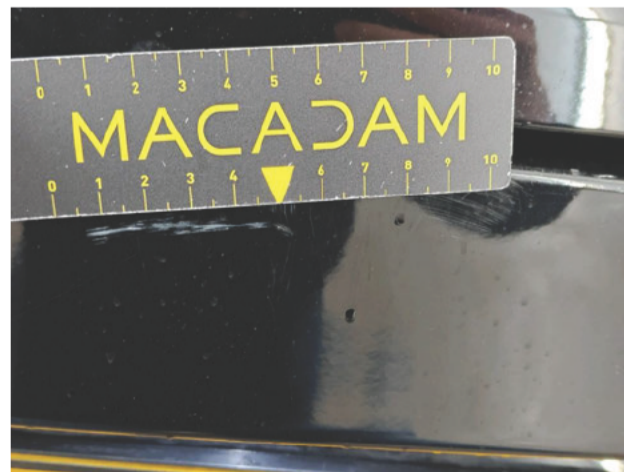
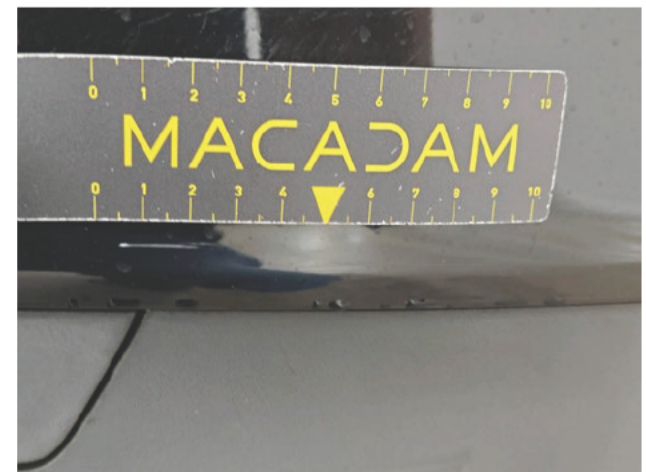
Bumper R

Scratch(es)
Repair and paint (complete)
Rear

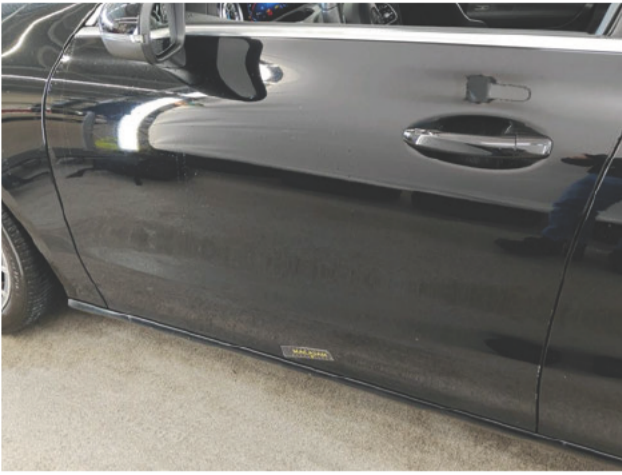
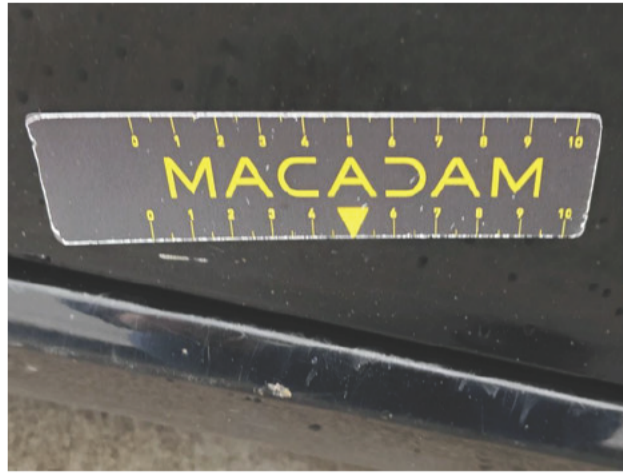
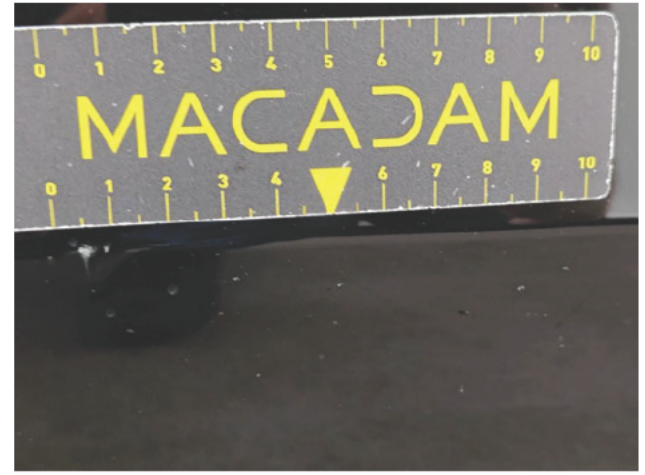
Door FL

Scratch(es)

Repair and paint (partial)

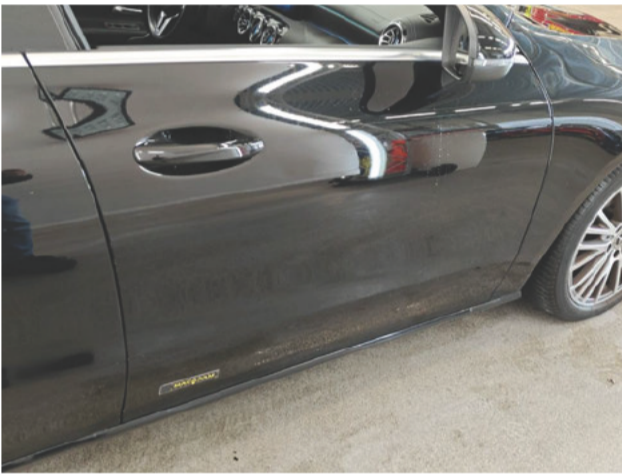
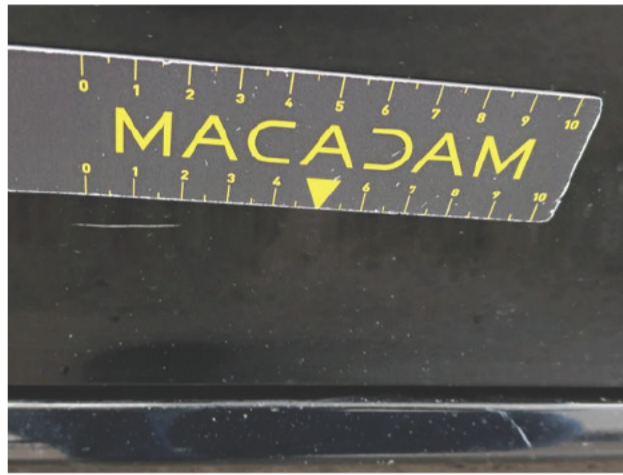
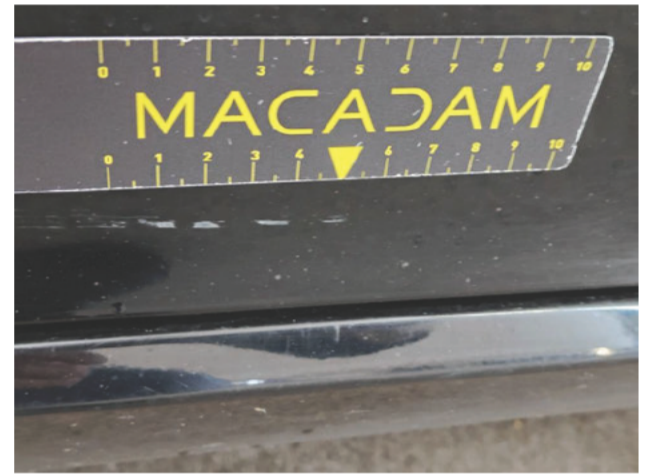
Door FR

Scratch(es)

Repair and paint (partial)

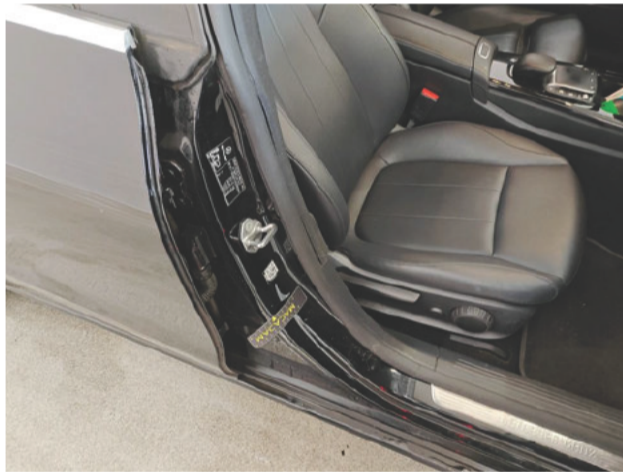
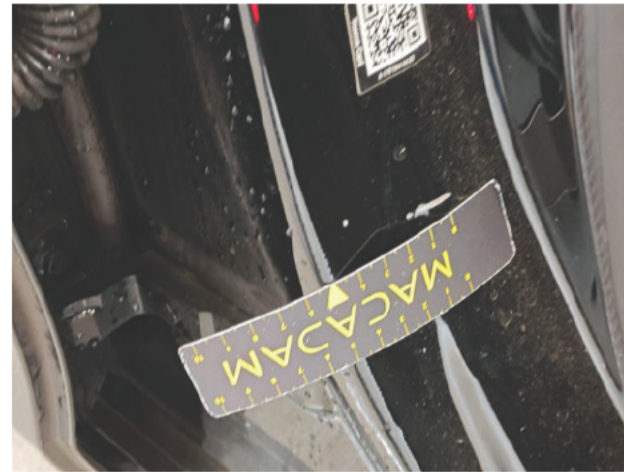
Door frame FR

Scratch(es)

Repair and paint (partial)

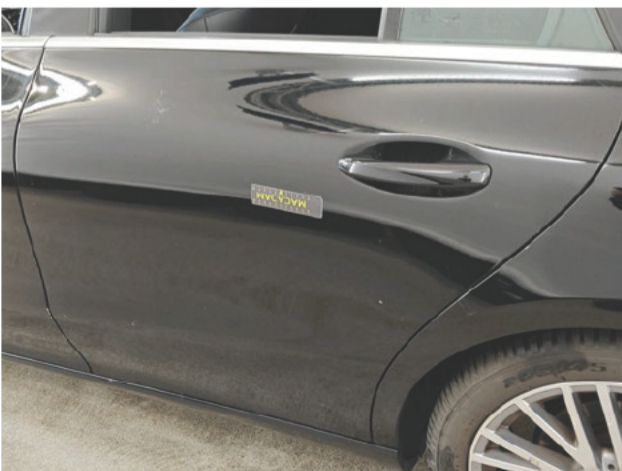
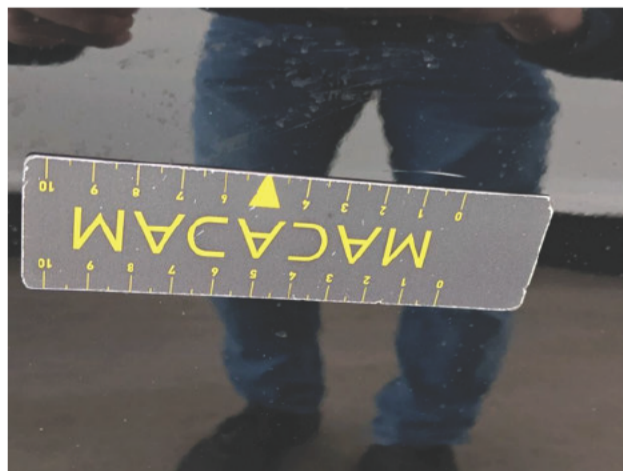
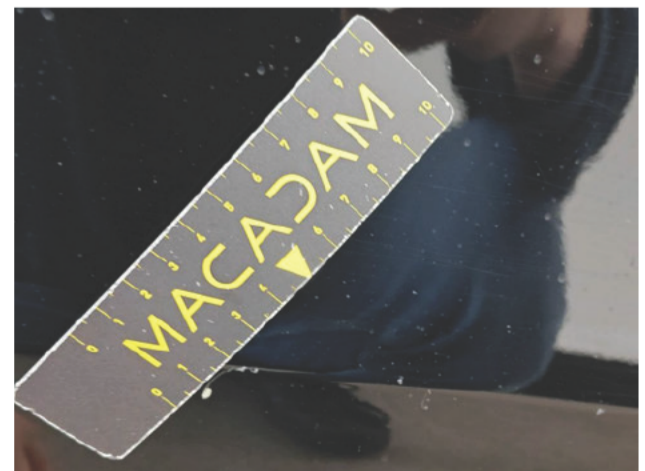
Door RL

Scratch(es)

Repair and paint (partial)

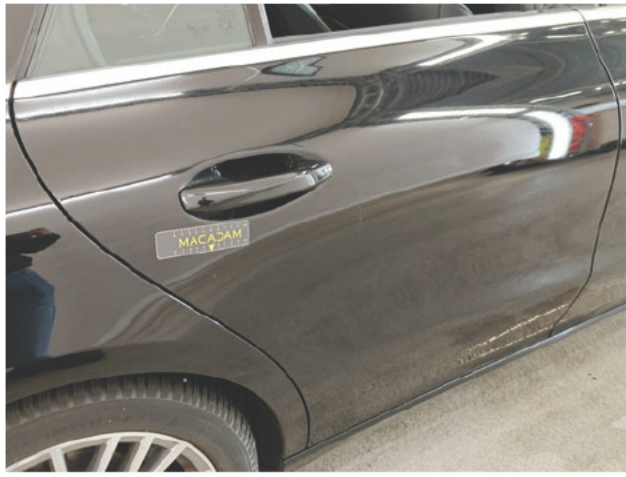
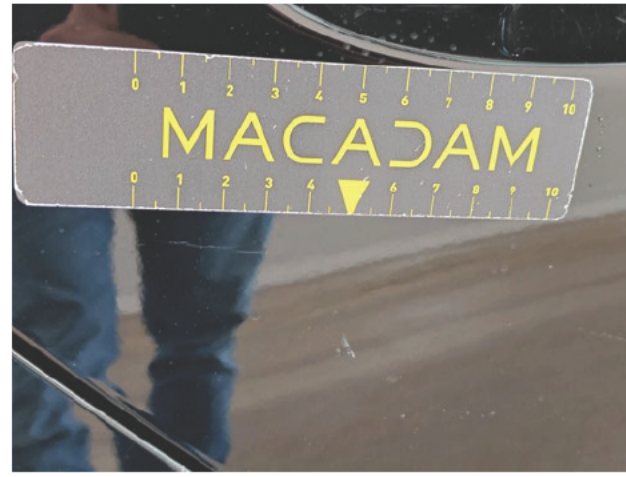
Door RR
Scratch(es)
Repair and paint (partial)
Right

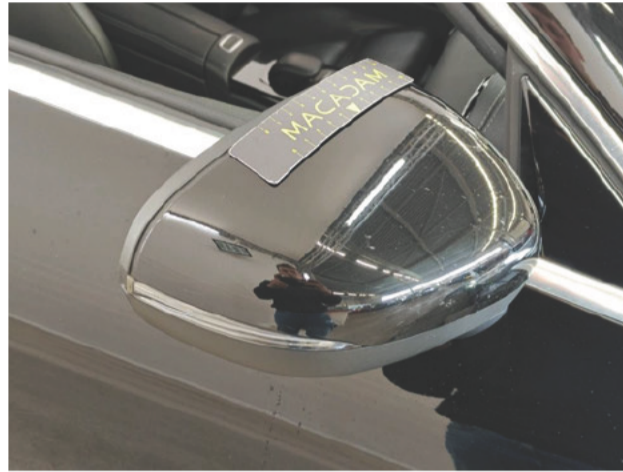
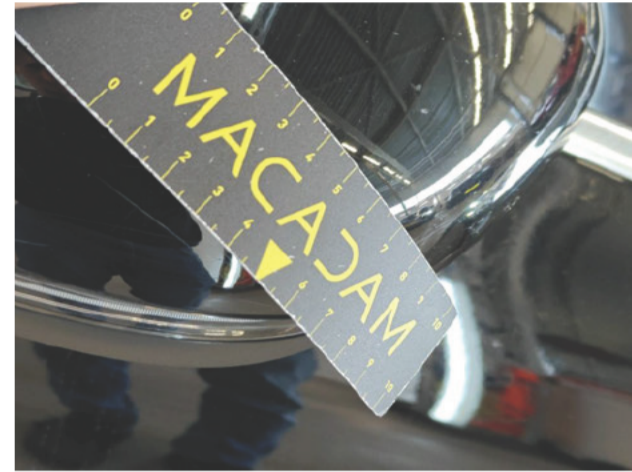
Outside rear-view mirror housing R
Scratch(es)
Replace and paint
Right

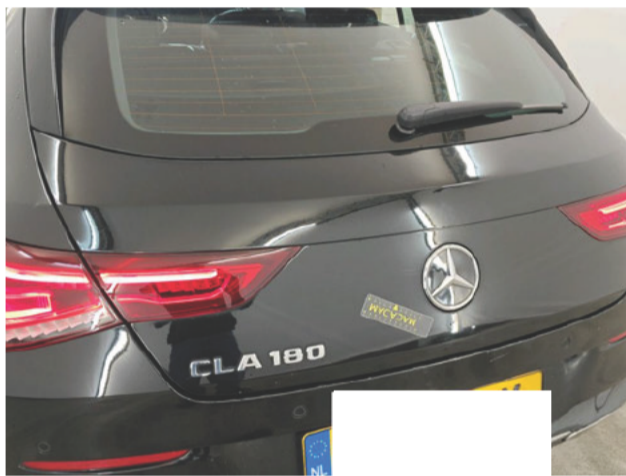
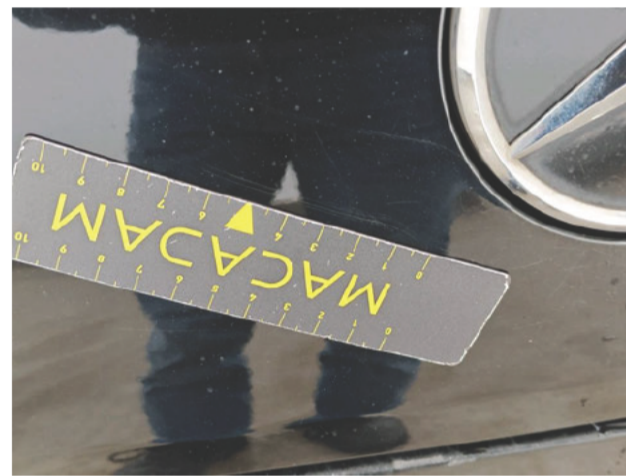
Tailgate / Boot
Scratch(es)
Repair and paint (partial)
Rear

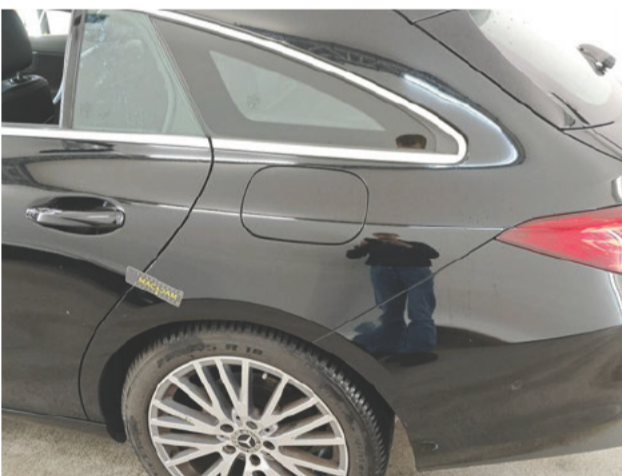
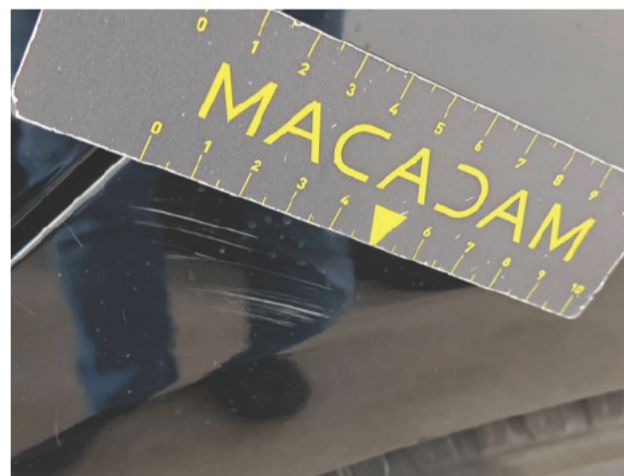
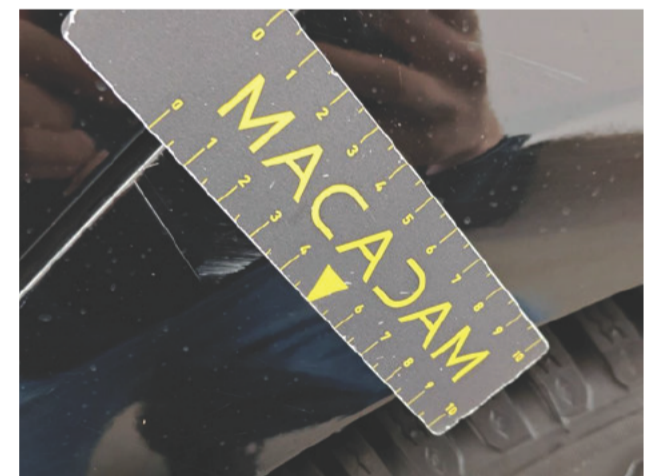
Wing RL
Scratch(es)
Repair and paint (complete)
Left

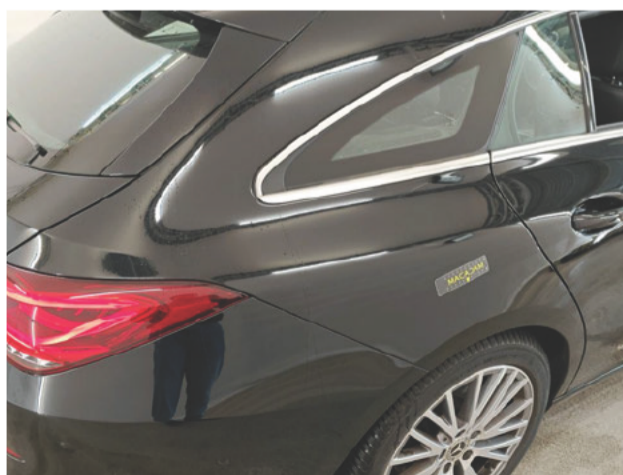
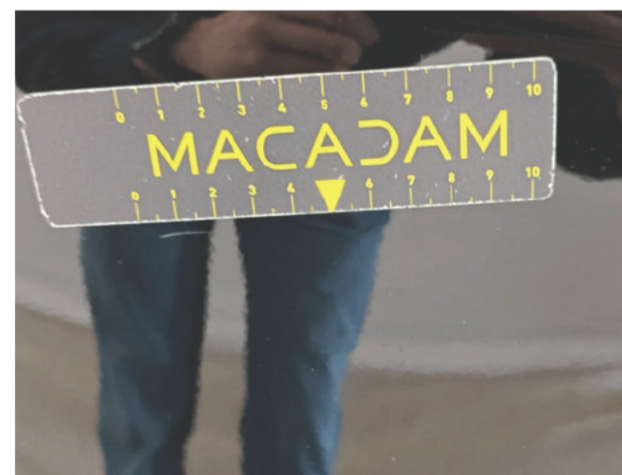
Wing RR
Scratch(es)
Repair and paint (complete)
Right
