## Expertise

Protocol number: 46291807  
Order No. / Reference: 26153034  
Inspection date: 7 Apr 2026

Model: Vito 116 CDI Tourer Extralang Aut. PRO

VIN: W1VVLGFZ2T4546641

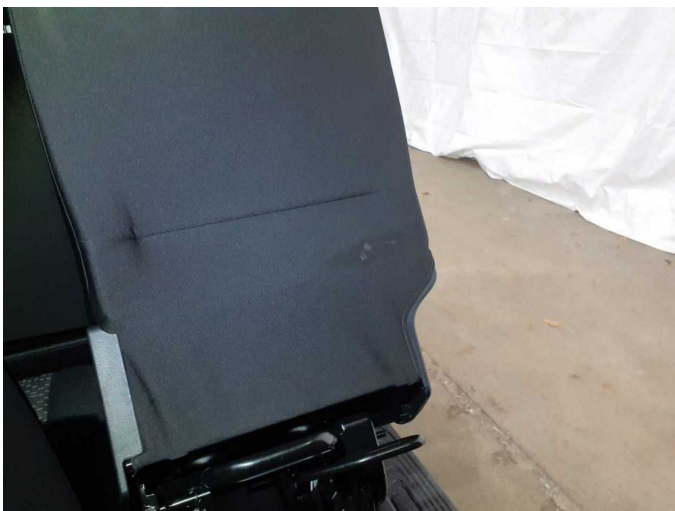
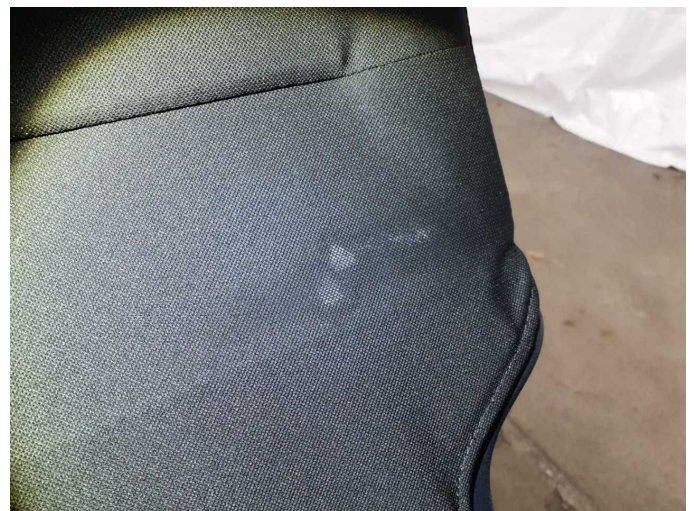
Damage 2: Seat - rear: Backrest cover - 2nd row (Rechts) - Soiled - Clean

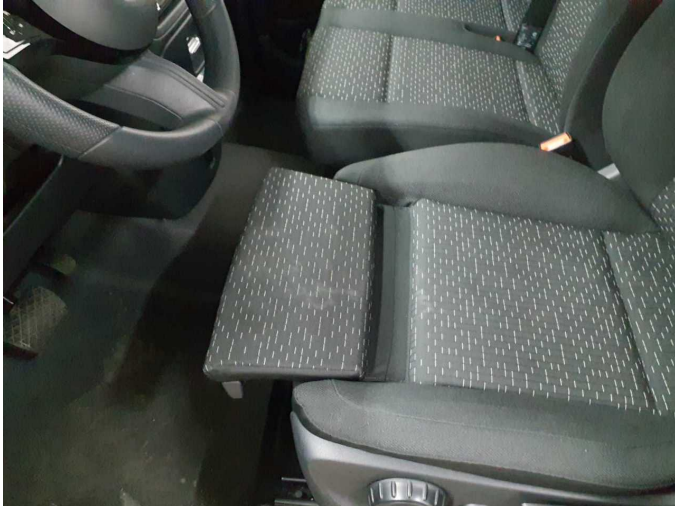
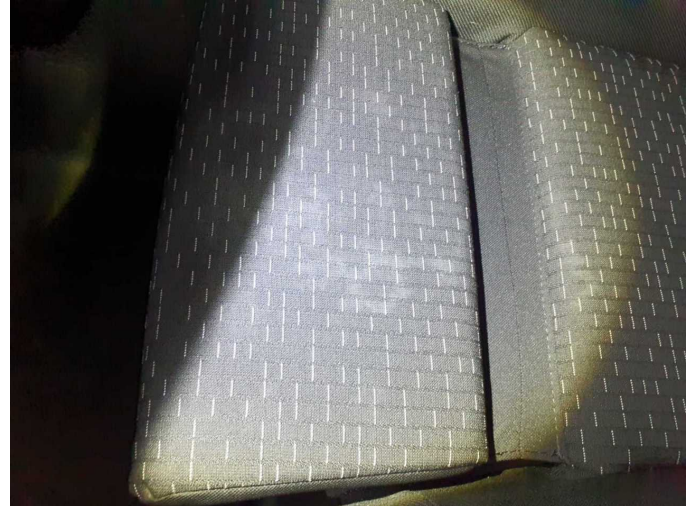
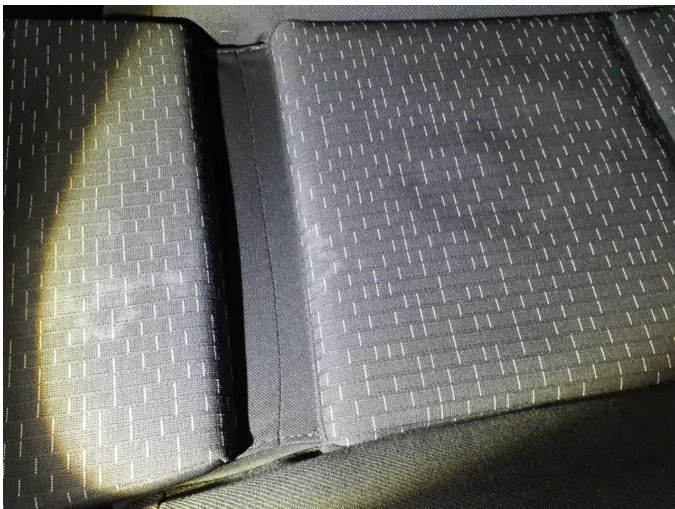
**Damage 3:** Seat - front: Seat cover - left side - Soiled - Clean

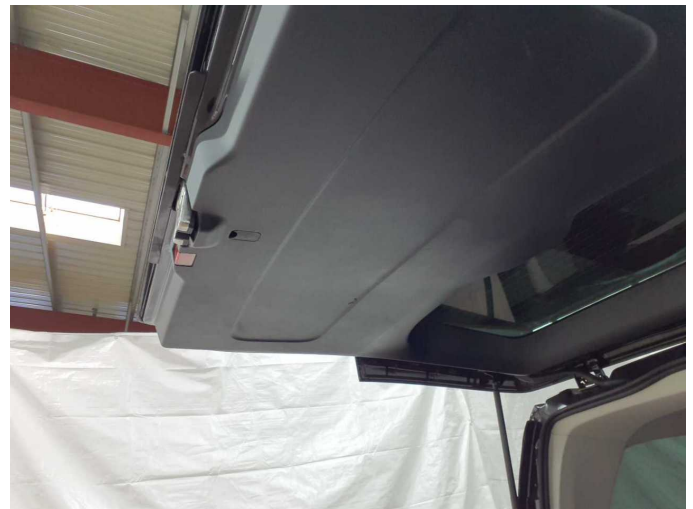
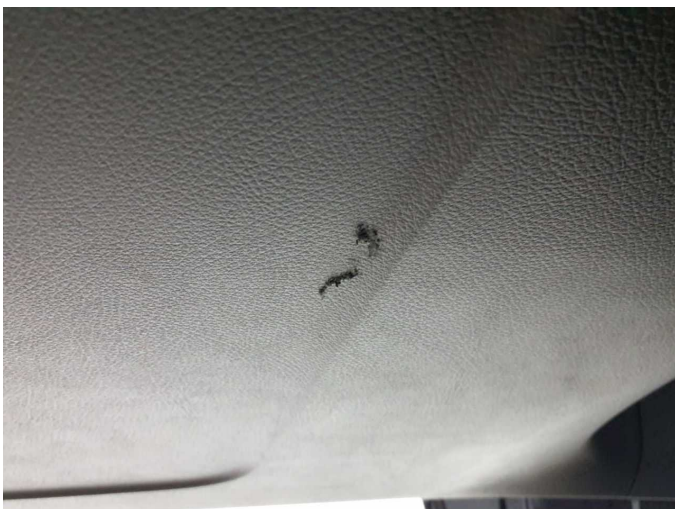
**Damage 4:** Boot lid / rear door: Trim - standard - lower - Scratch(es) - Loss in value

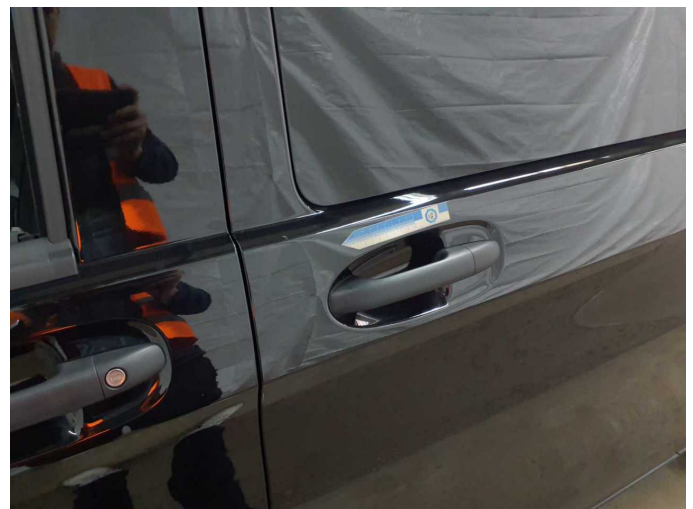
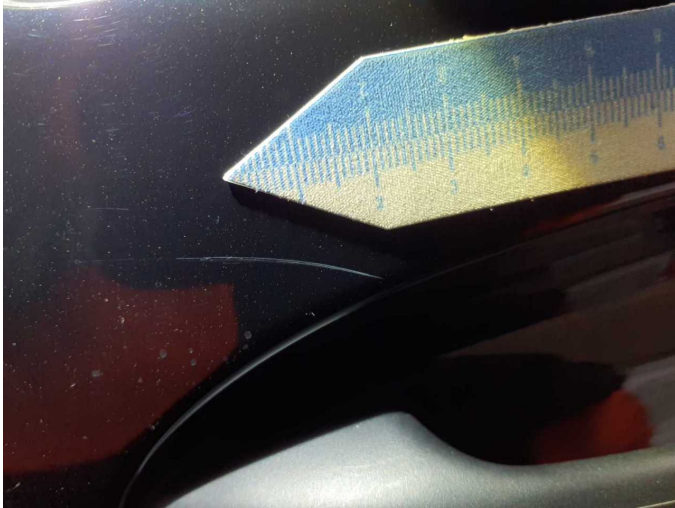
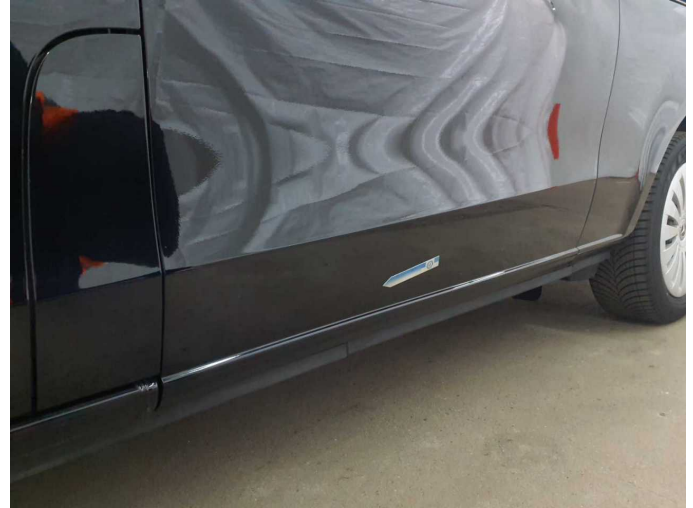
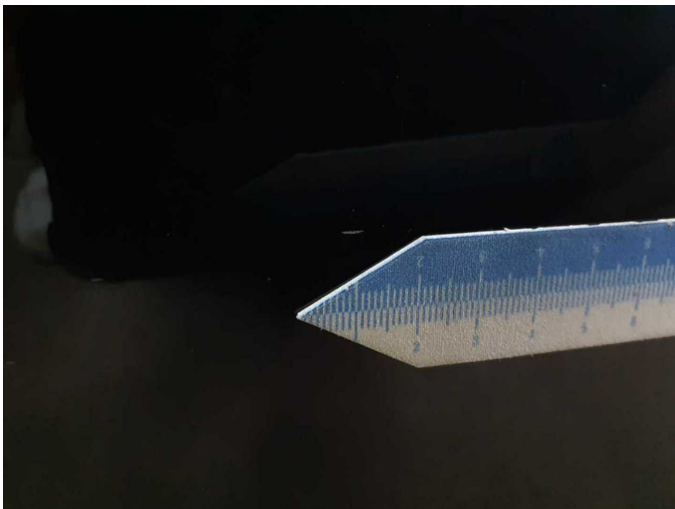
**Damage 5:** Sliding door - left side: Sliding door - Scratch(es) - Smart repair

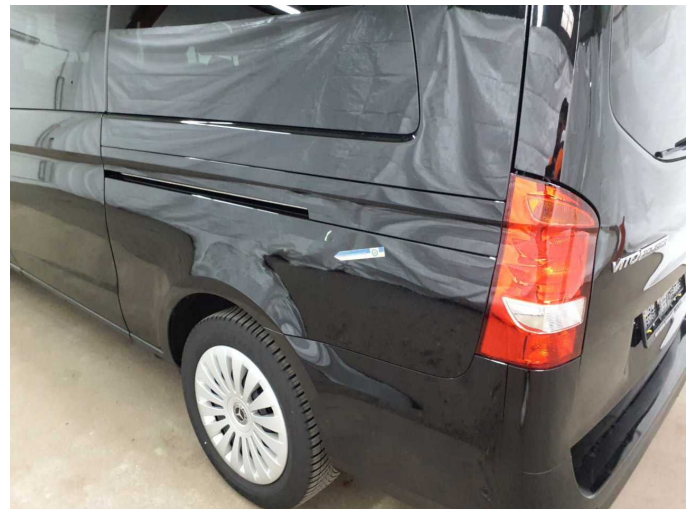
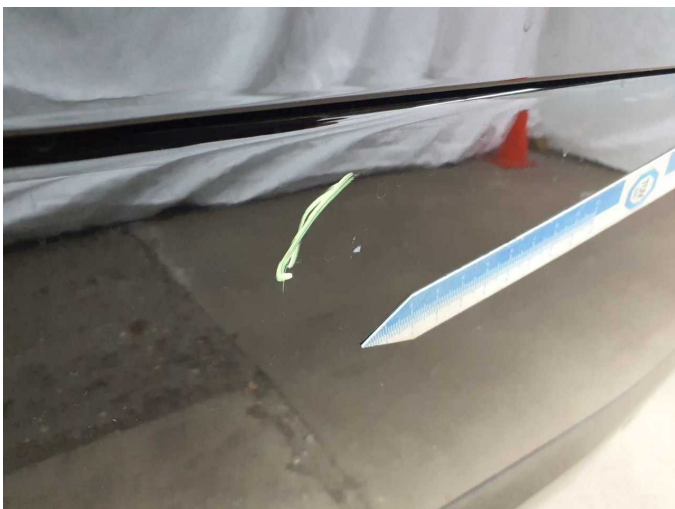
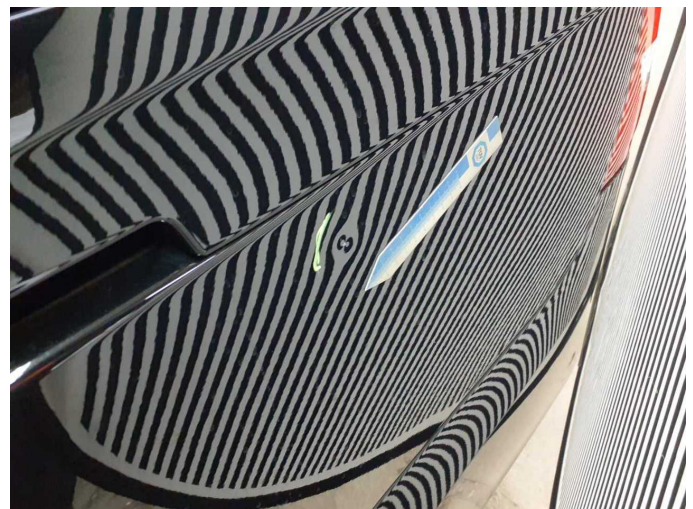
**Damage 6:** Side panel - rear left side: Side panel - Dent / paintcoat damage - Smart repair

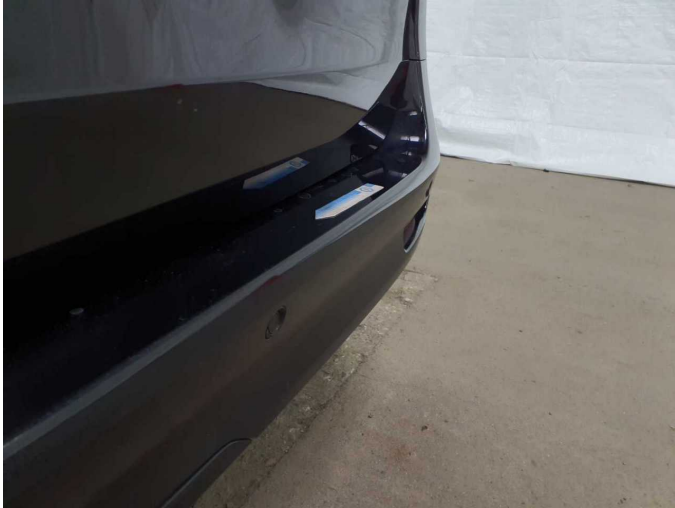
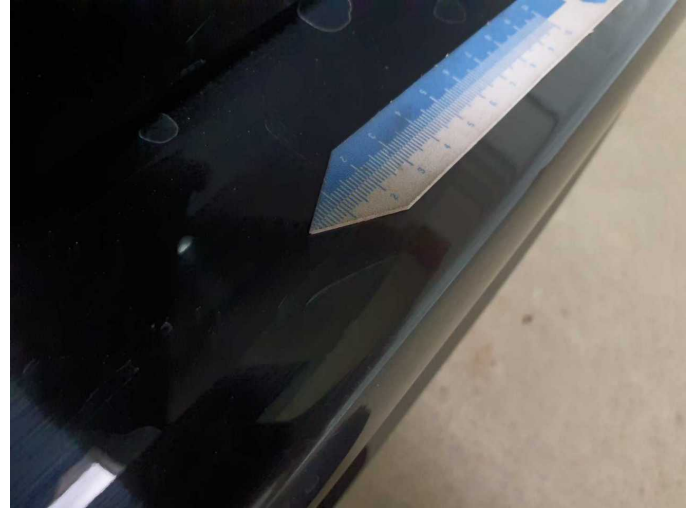
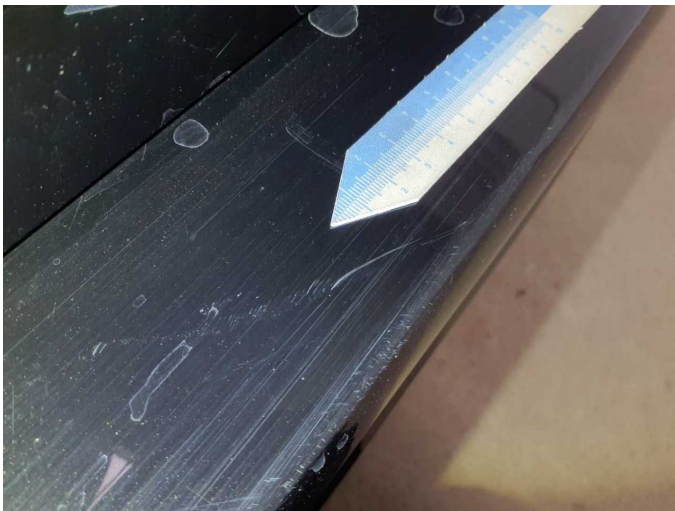
**Damage 7:** Rear bumper: Rear bumper - Scratch(es) - Smart repair

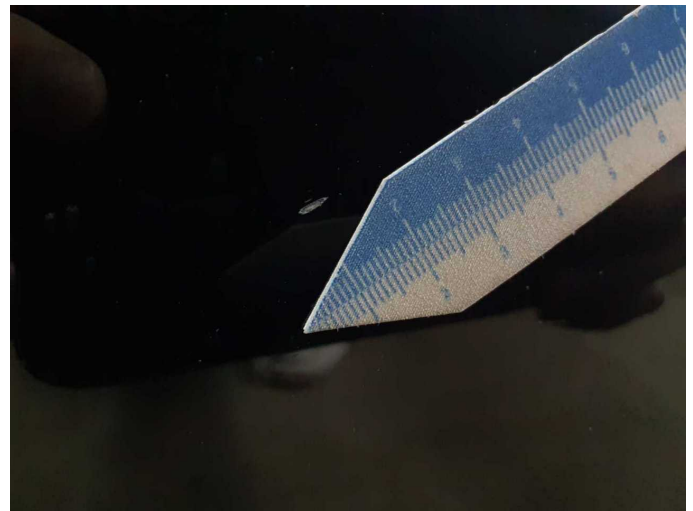
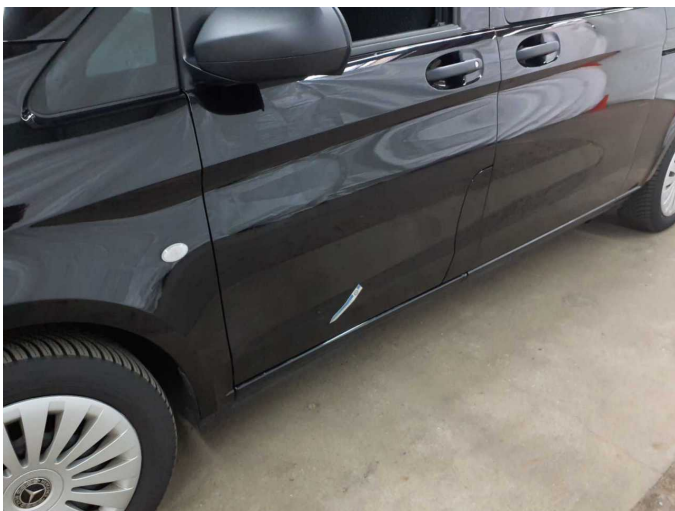
**Damage 8:** Door - front left side: Door - Scratch(es) - Smart repair

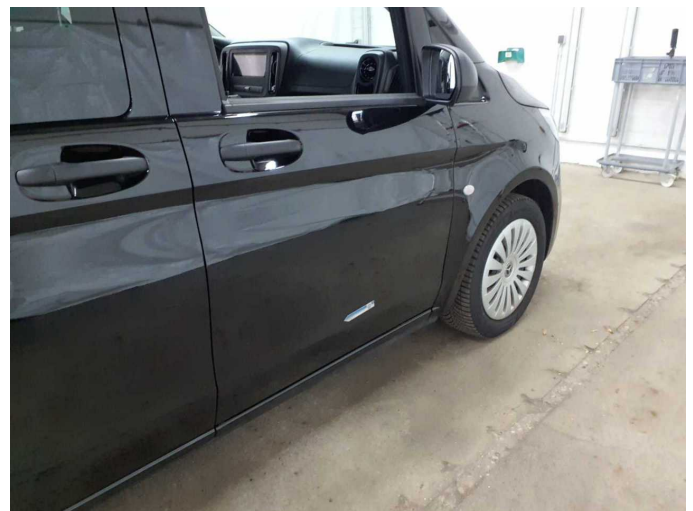
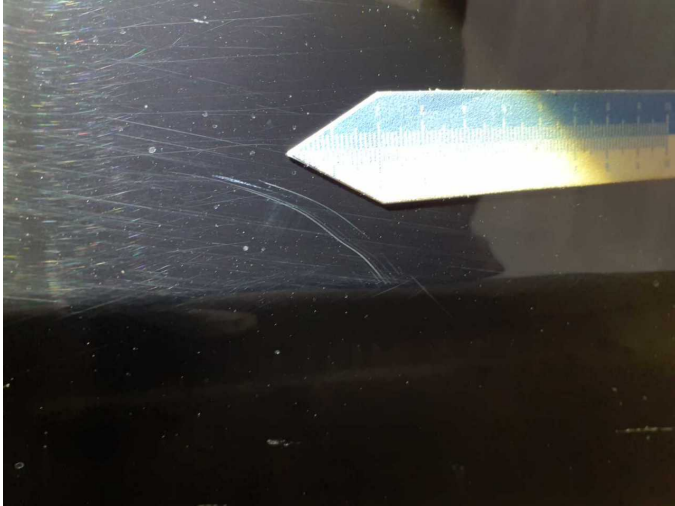
**Damage 9:** Door - front right side: Door - Scratch(es) - Smart repair

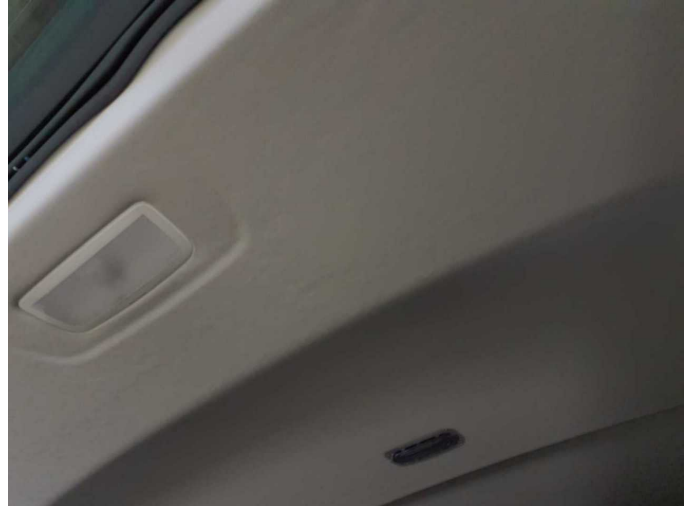
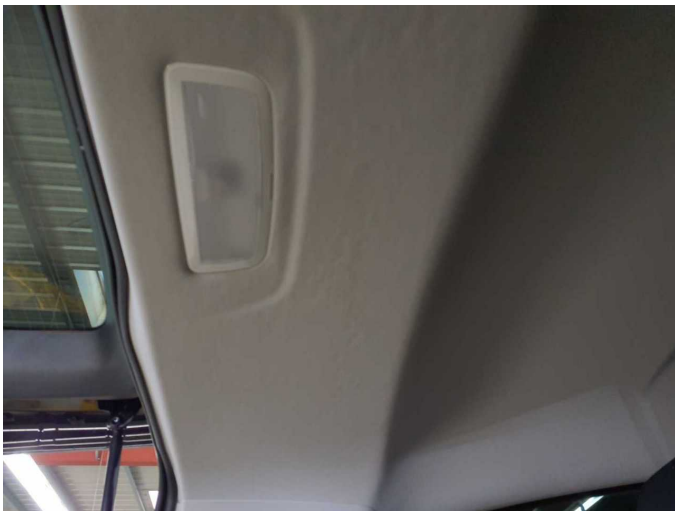
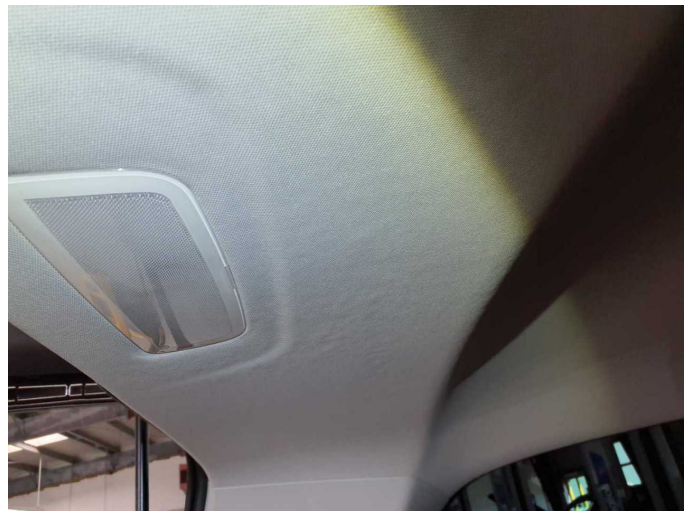
**Damage 10:** Trim / covers: Roof lining (Wellig) - Loss in value

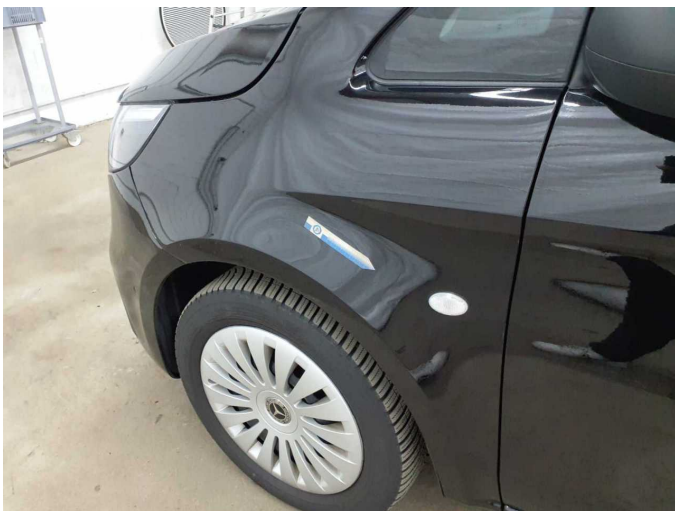
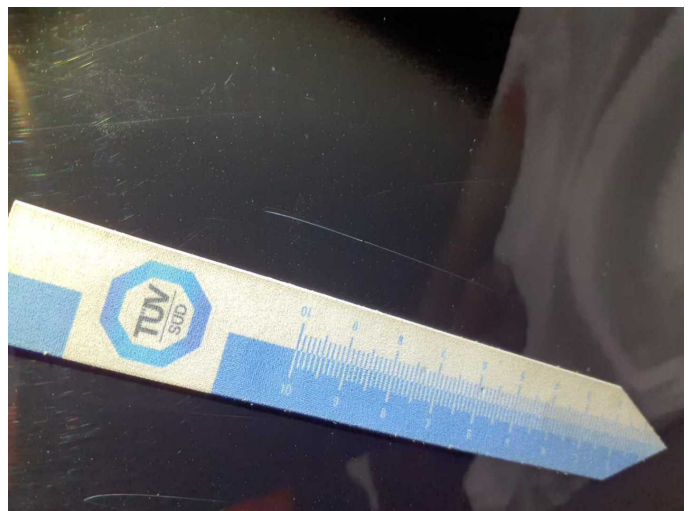
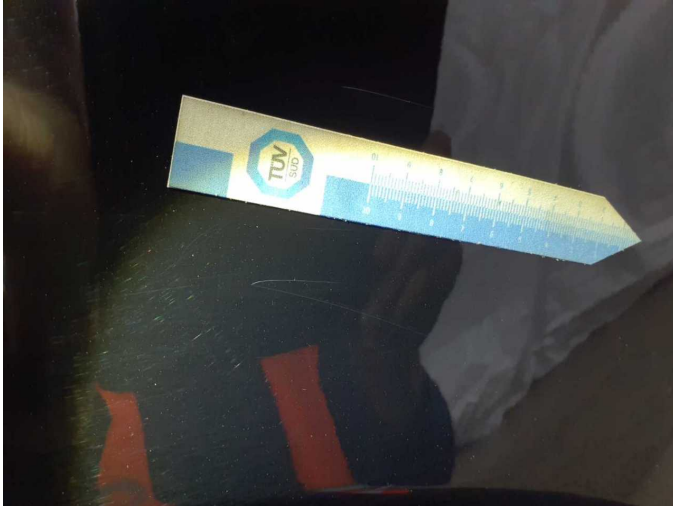
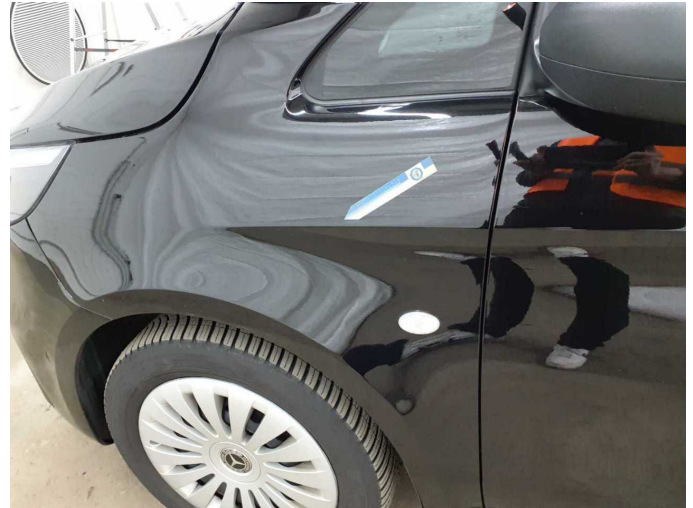
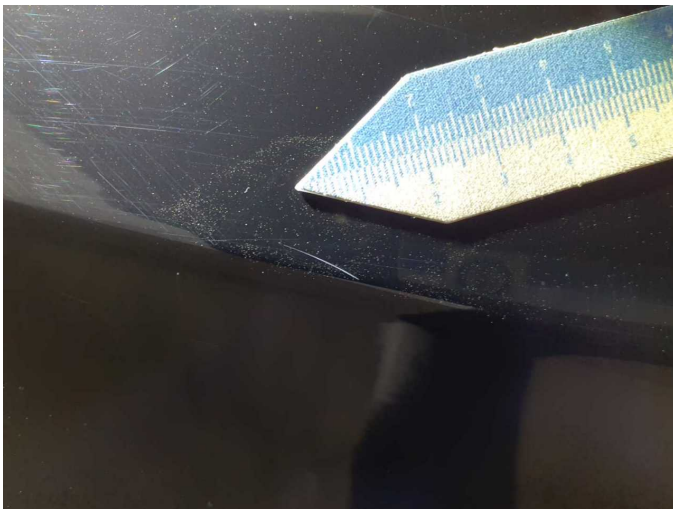
**Damage 11:** Mudguard - left side: Mudguard - left side - Scratch(es) - Paint

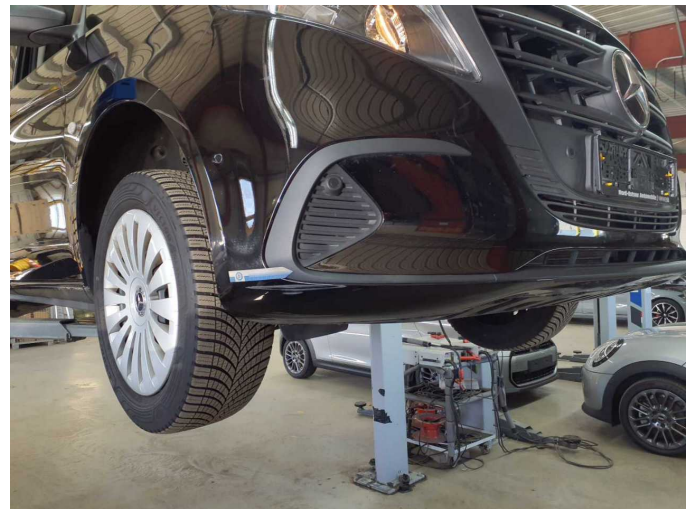
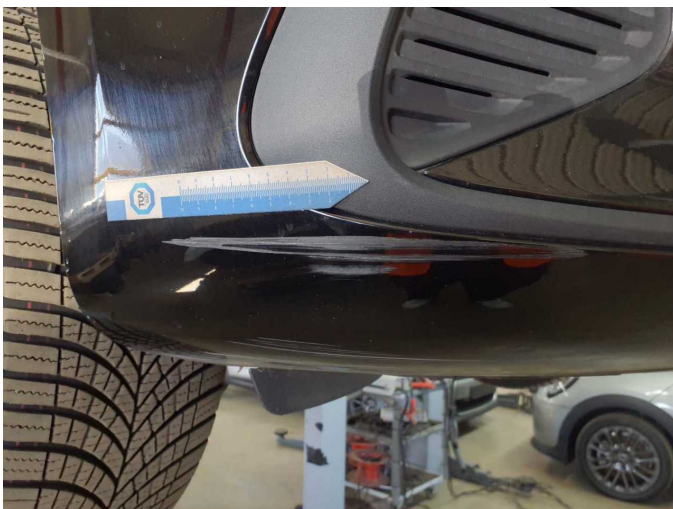
**Damage 12:** Front bumper: Front bumper - Scratched - Paint

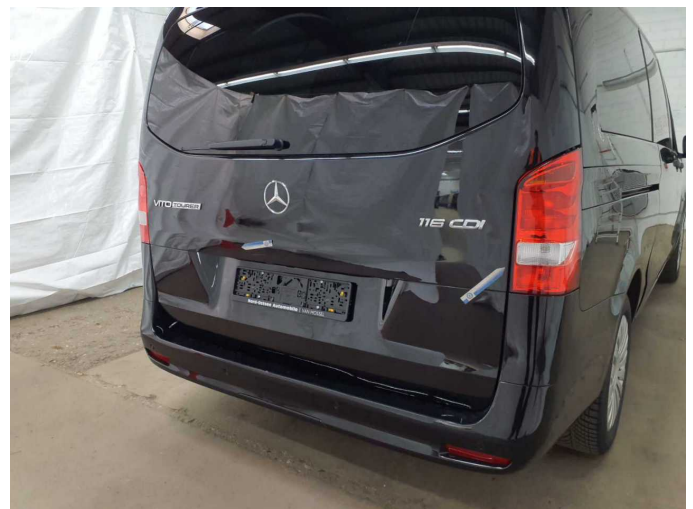
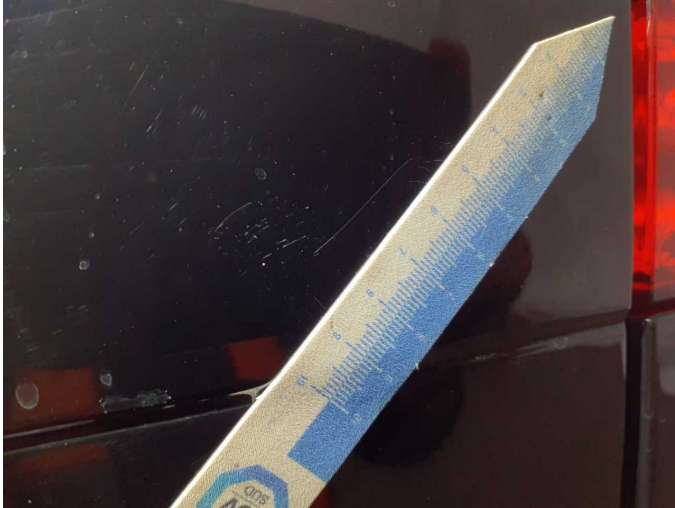
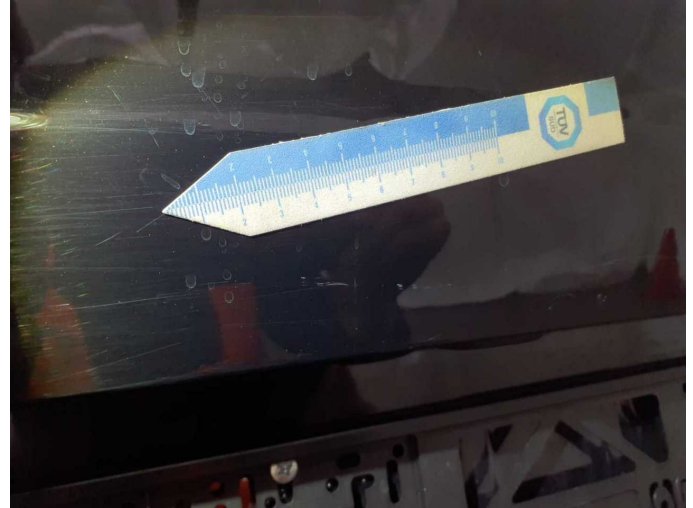
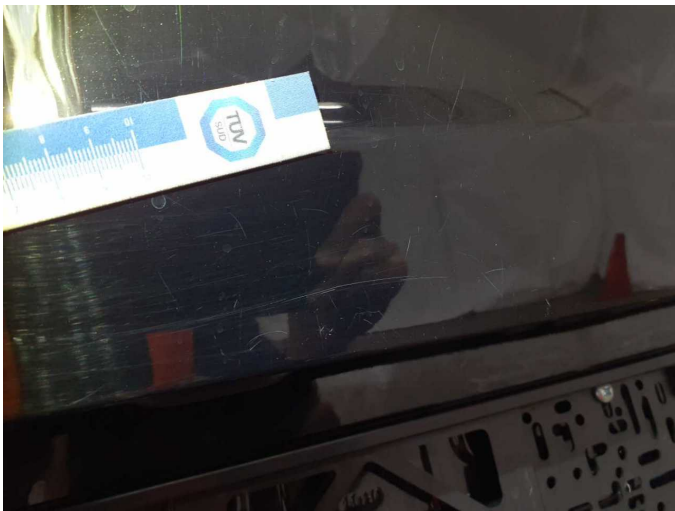
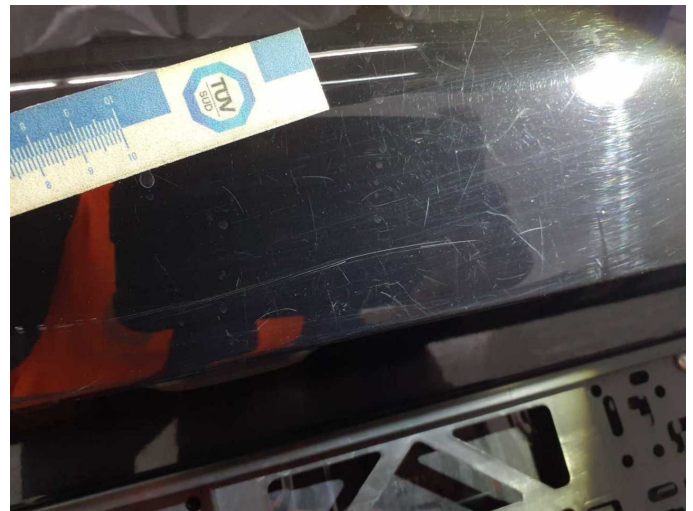
**Damage 13:** Boot lid / rear door: Boot lid - Scratch(es) - Paint

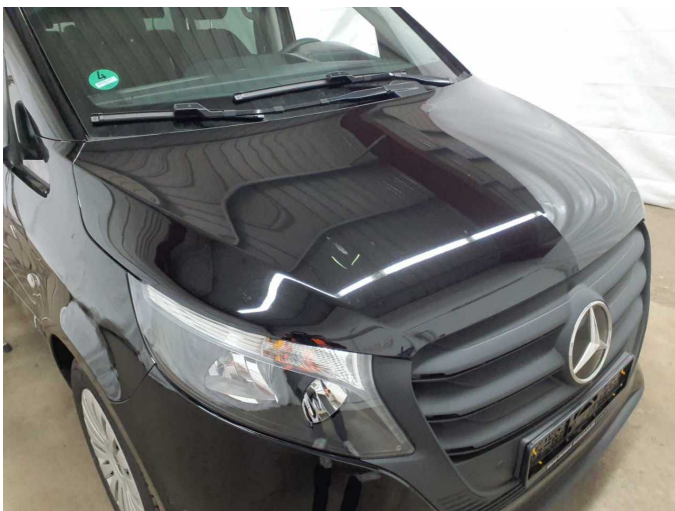
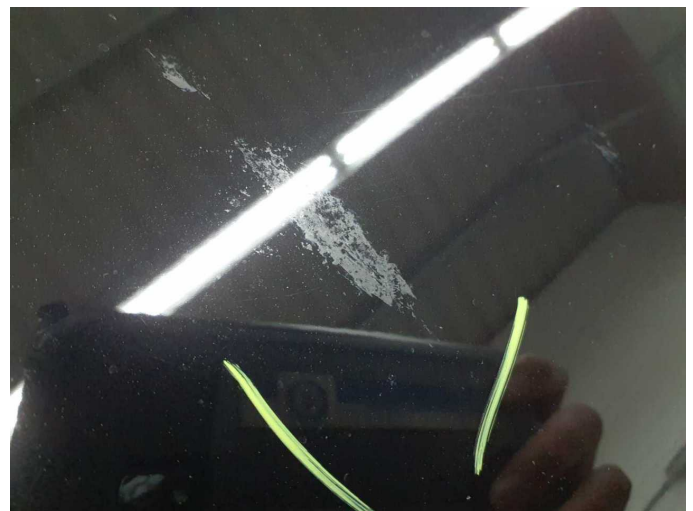
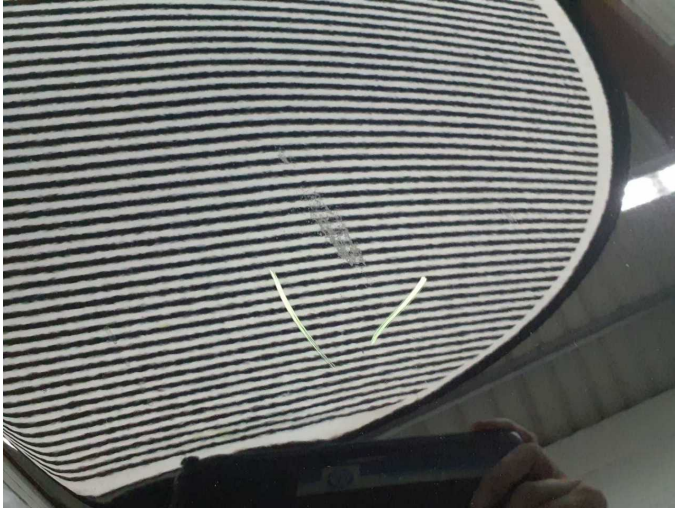
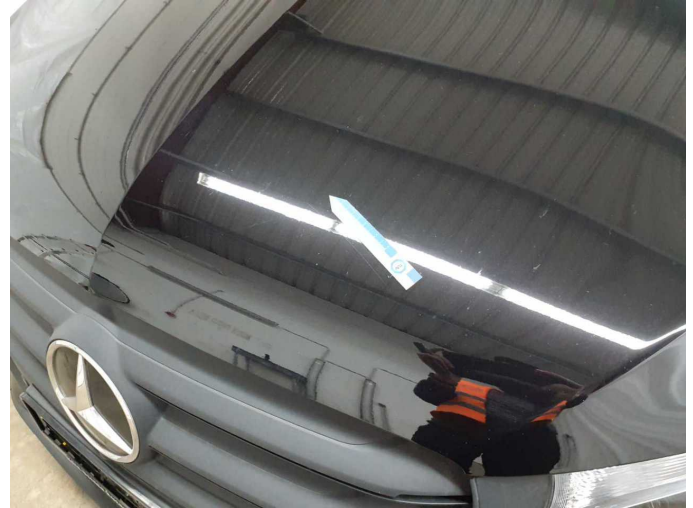
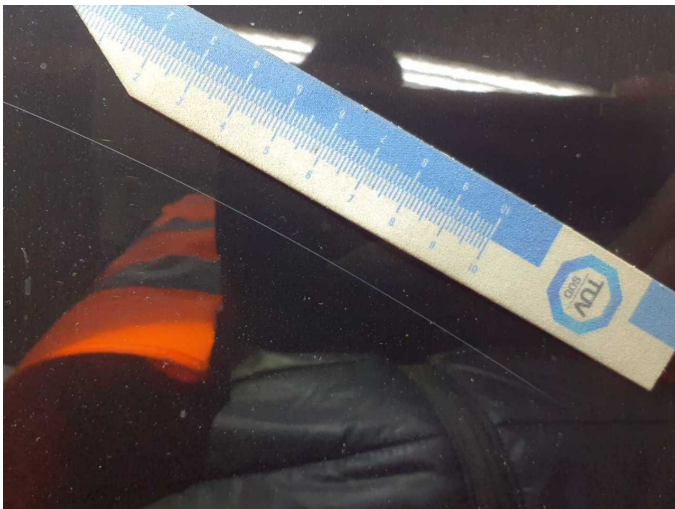
**Damage 14:** Bonnet: Bonnet (Anätzung/Kratzer) - Paint defect - Repair and paint

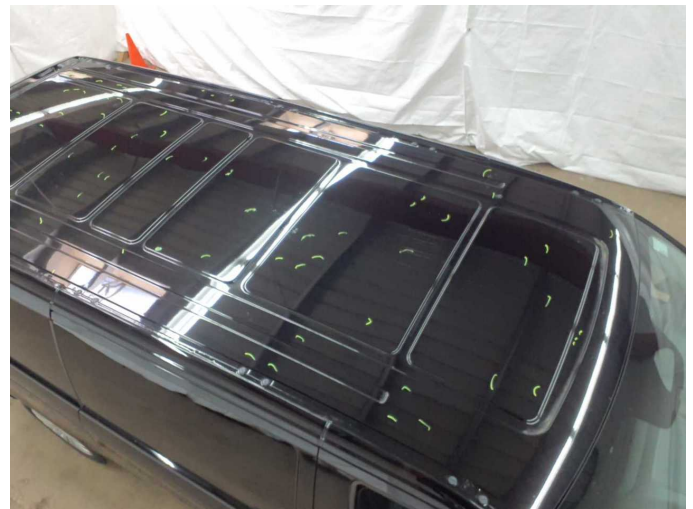
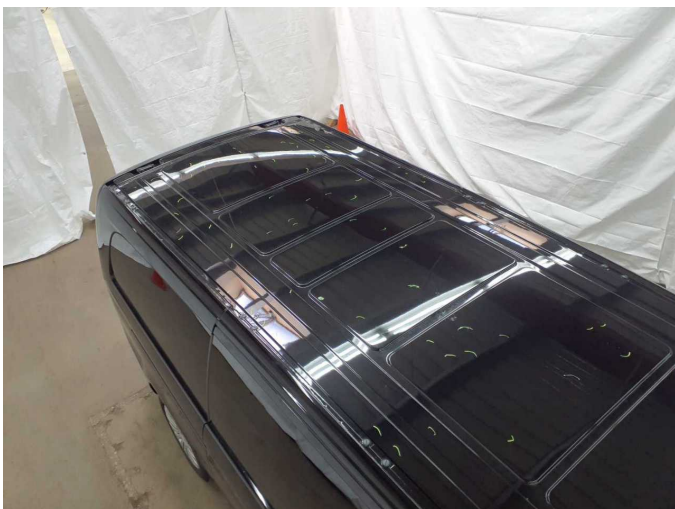
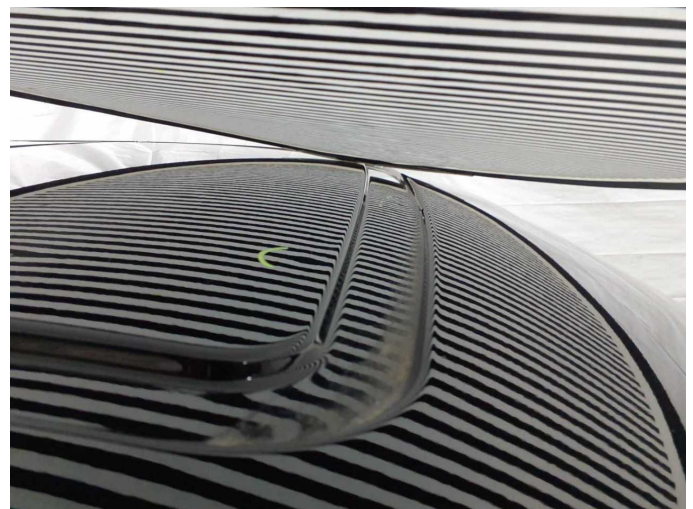
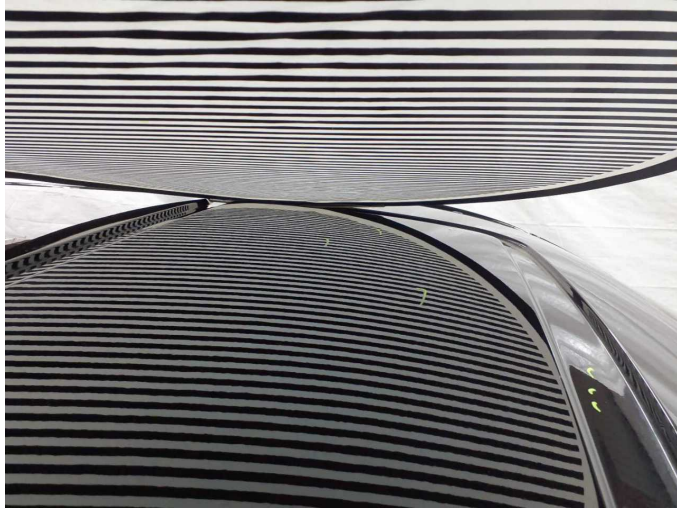
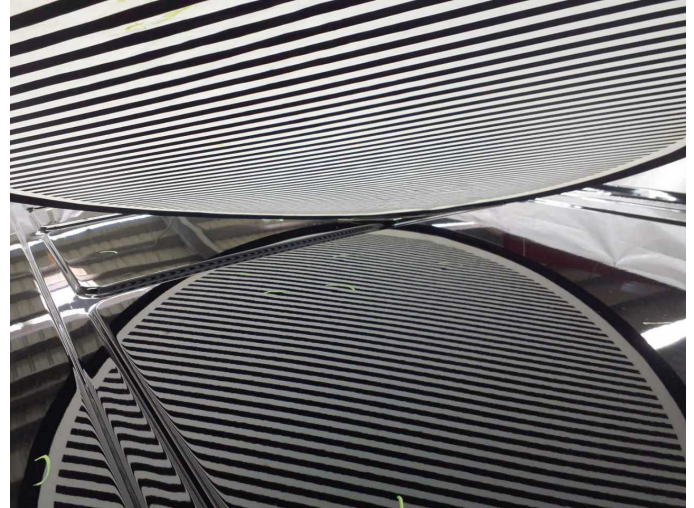
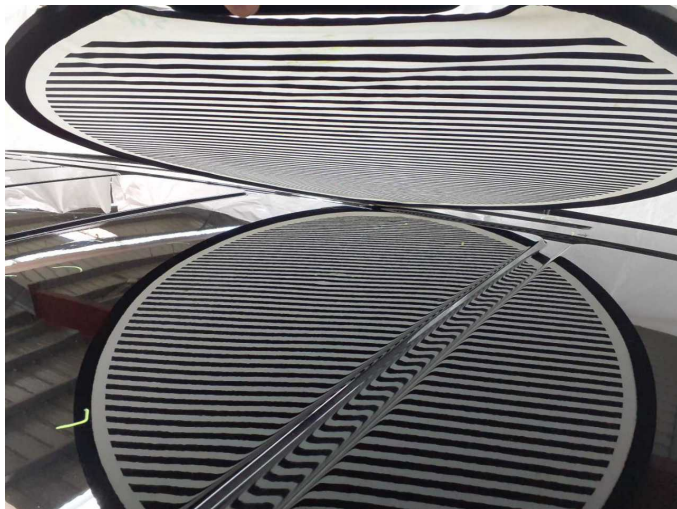
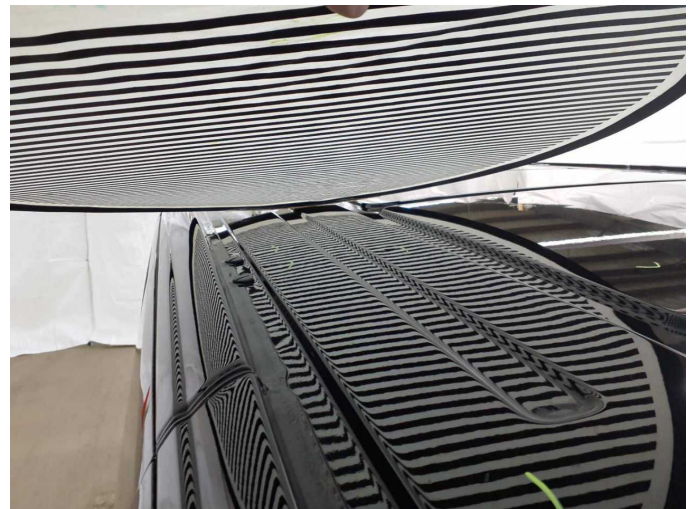
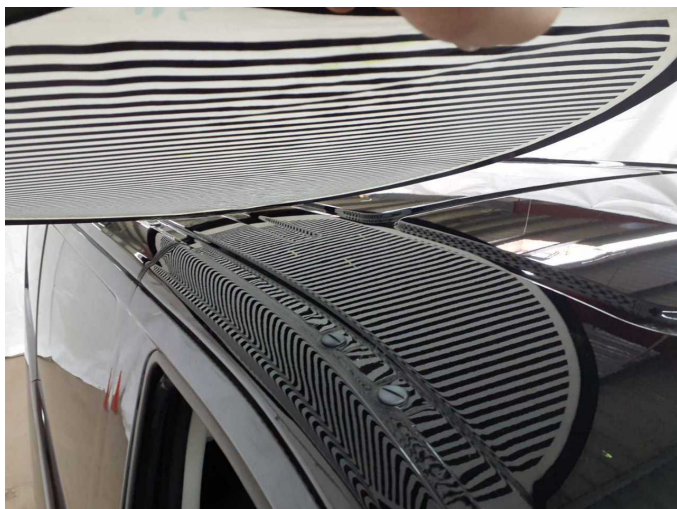
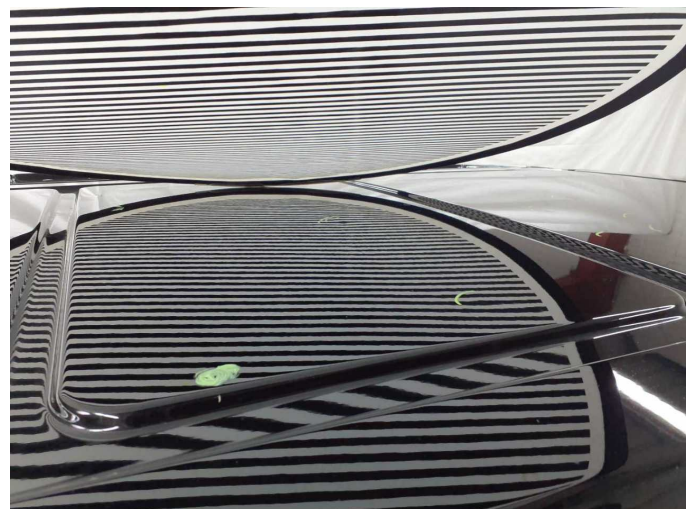
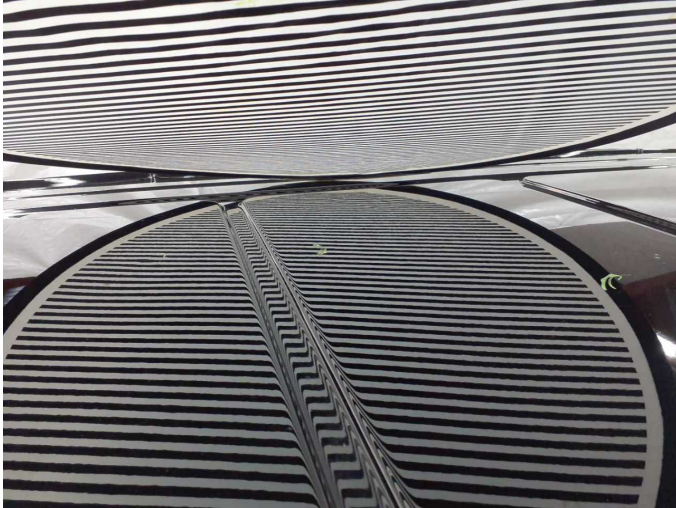
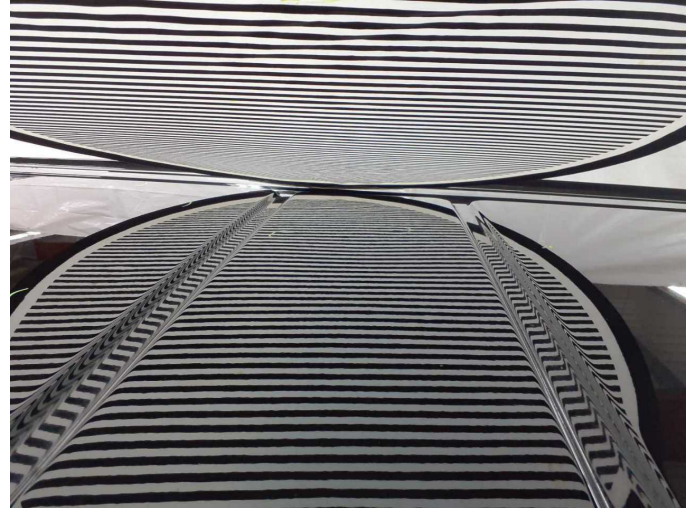
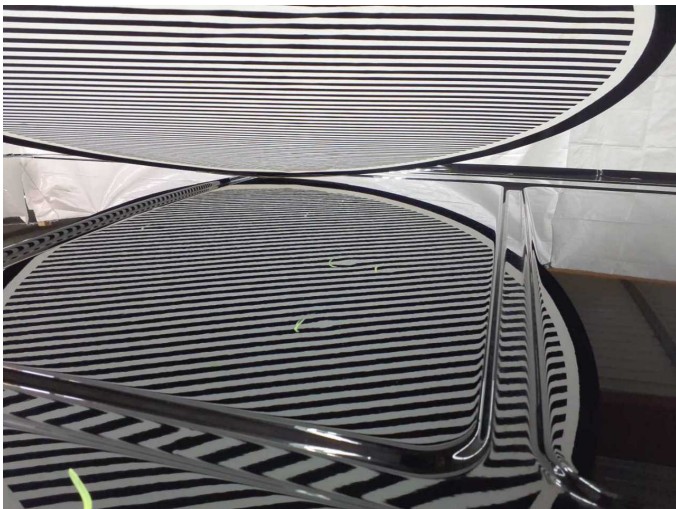
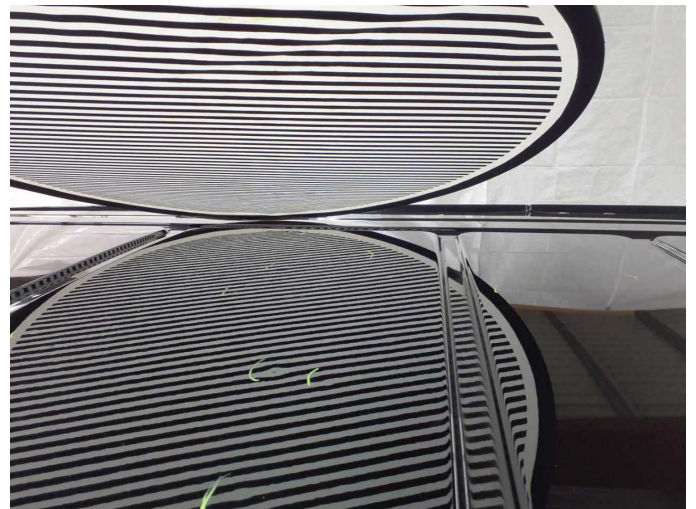
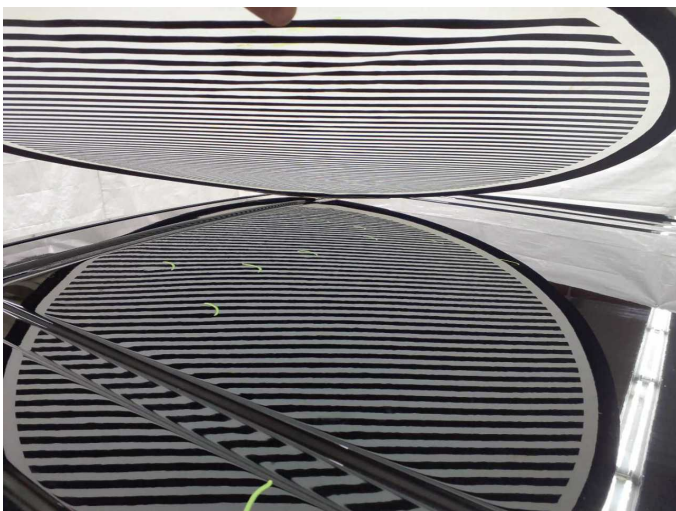
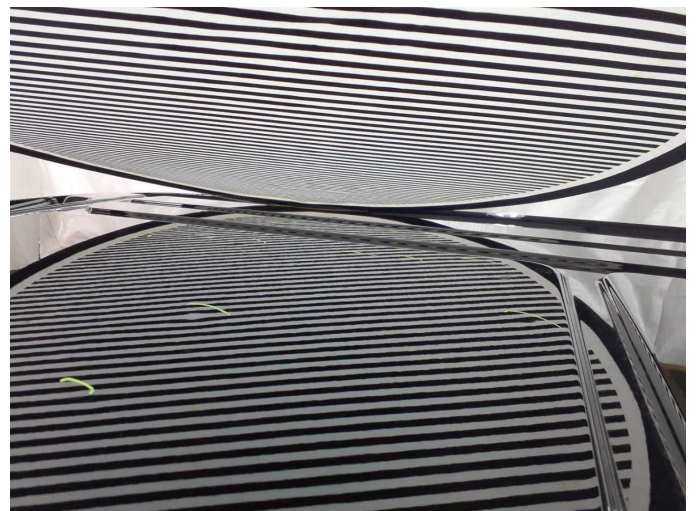
**Damage 15:** Roof: Roof (Anätzung) - Damage by hail - Repair and paint
