## Expertise

Protocol number: 46216820  
Order No. / Reference: 26508572  
Inspection date: 25 Jun 2026

Manufacturer: Ford

Model: Transit 350 L3H2 Lkw VA Trend

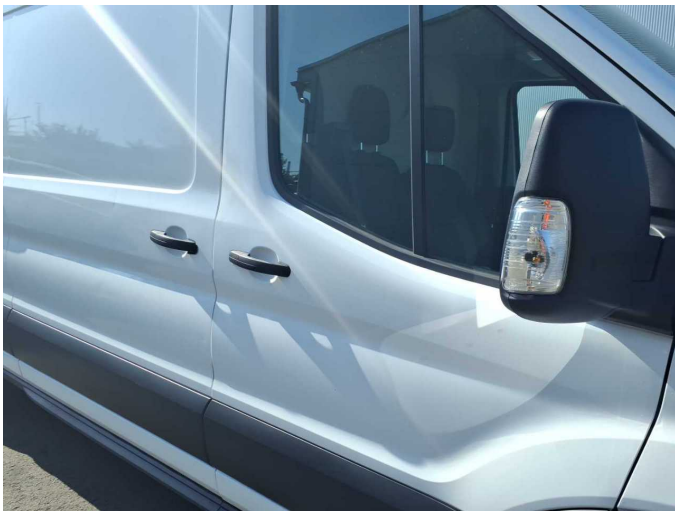
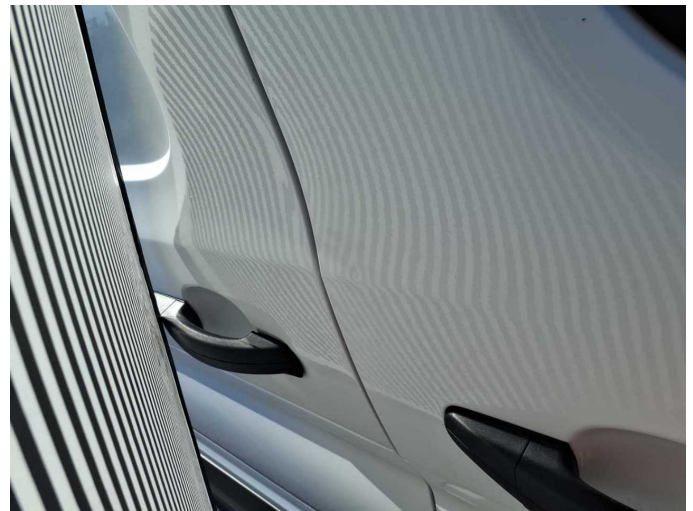
Damage 1: Door - front right side: Door - dent(s) - Smooth repair work

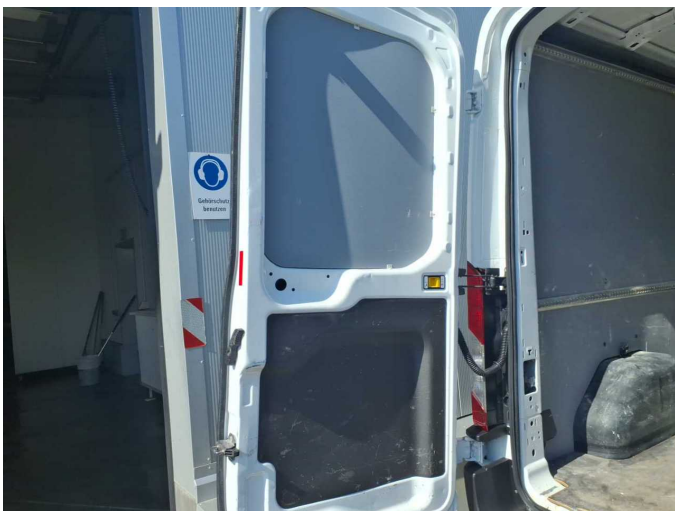
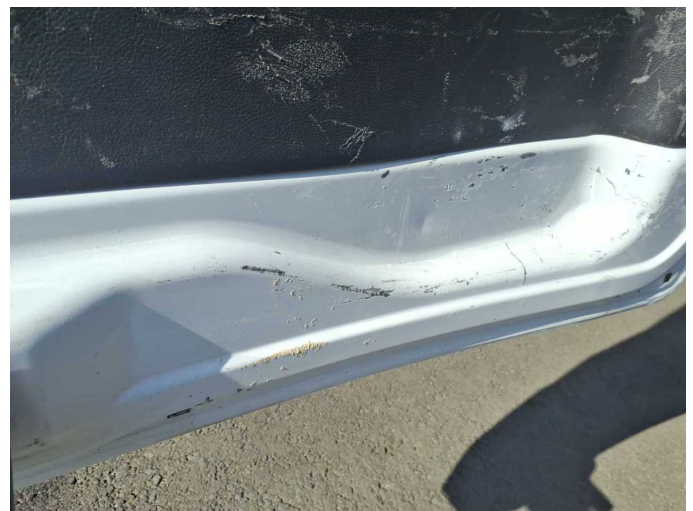
Damage 2: Boot lid / rear door: Rear door - left side (Innenseite) - Scratched - Smart repair

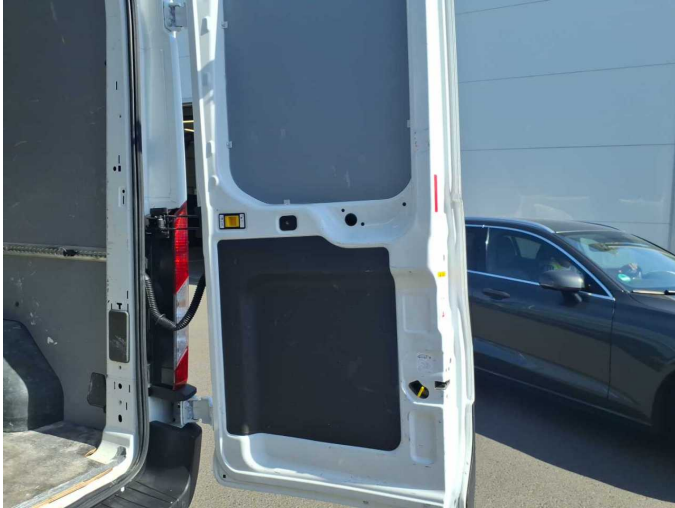
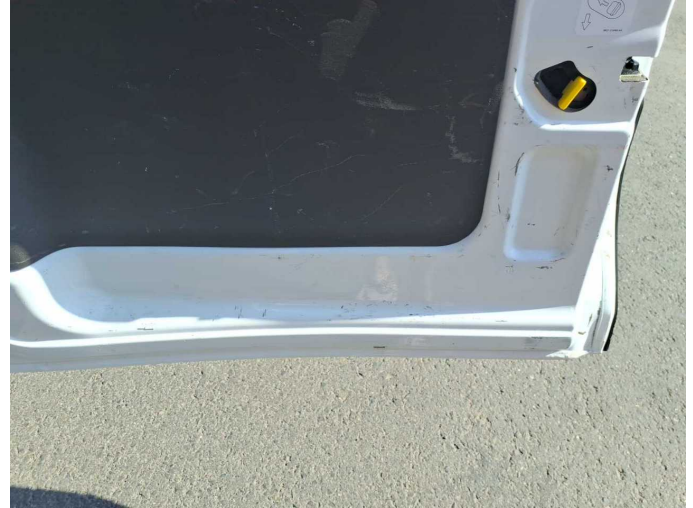
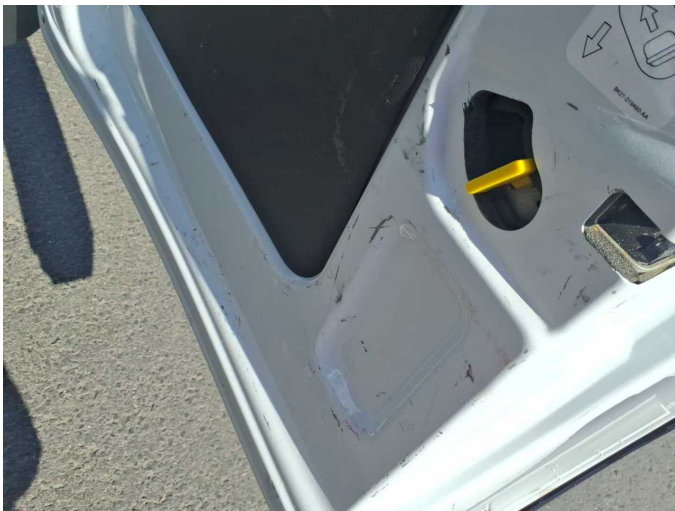
**Damage 3:** Boot lid / rear door: Rear door - right side (Innenseite) - Scratched - Smart repair

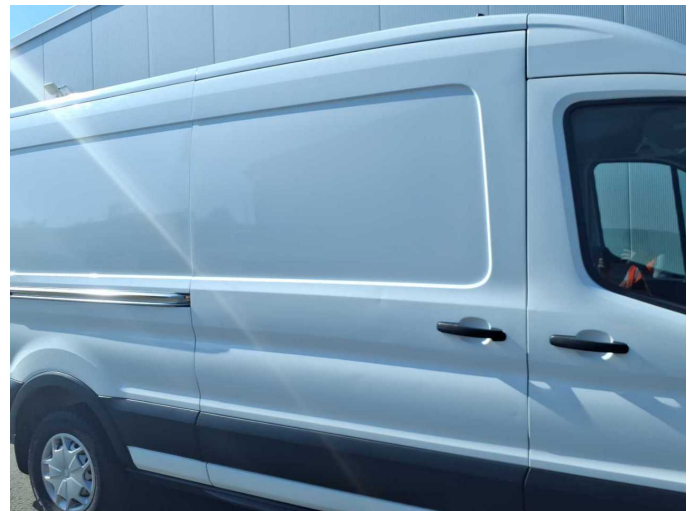
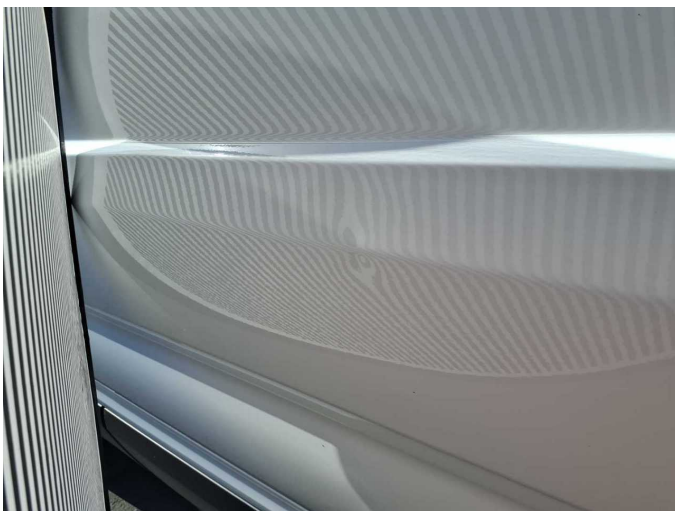
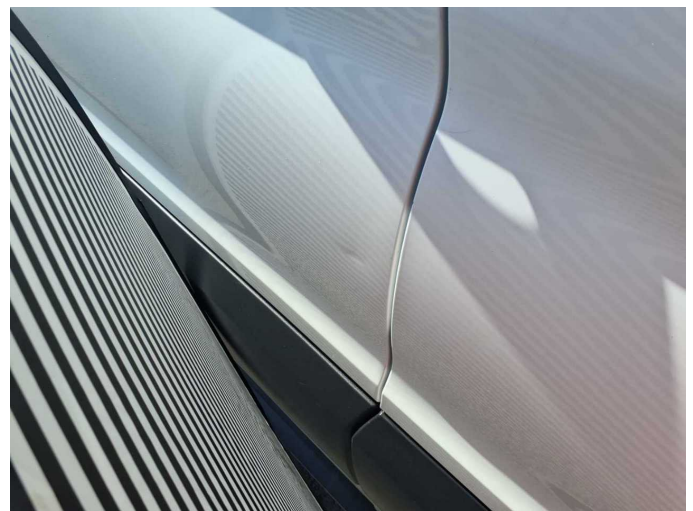
**Damage 4:** Sliding door - left side: Sliding door (Mit Mehraufwand) - dent(s) - Smooth repair work
