## Expertise

Protocol number: 46088800  
Order No. / Reference: 26484716-1  
Inspection date: 17 Jun 2026

Manufacturer: Ford

Model: Transit Connect 1,5 I EcoBlue mit L1 Trend

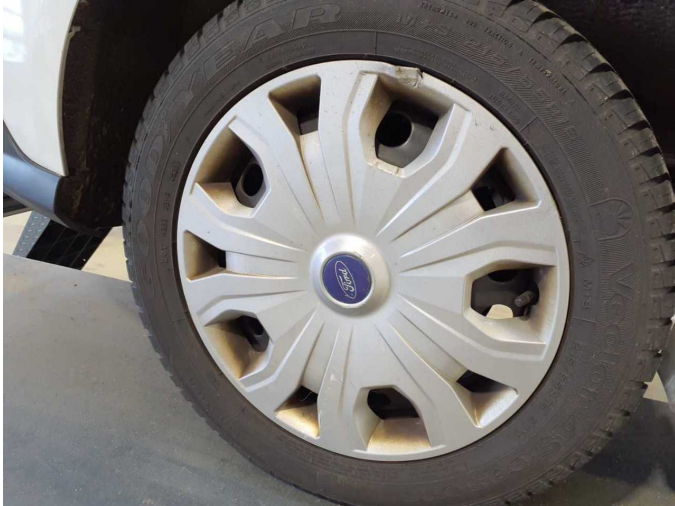
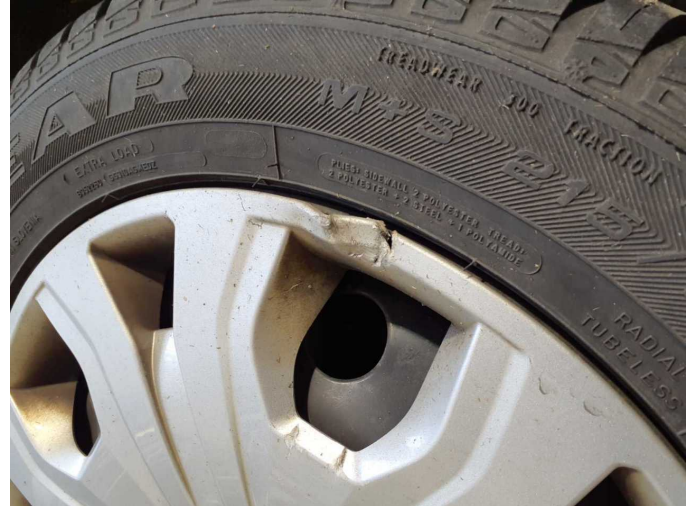
**Damage 1:** Wheel / tyres: Wheel cover - rear right side - Broken / torn - Replace

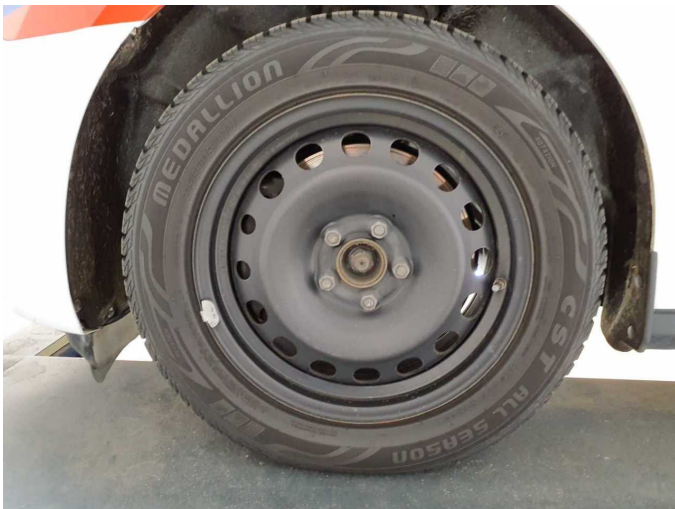
**Damage 2:** Wheel / tyres: Wheel cover - front left side - Missing - Replace

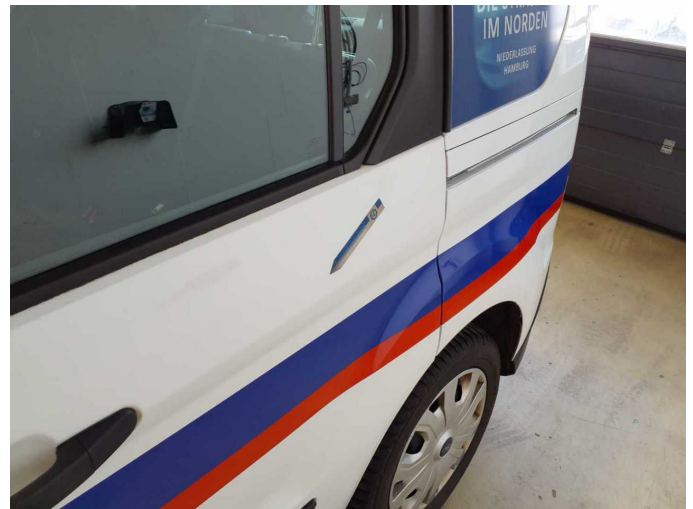
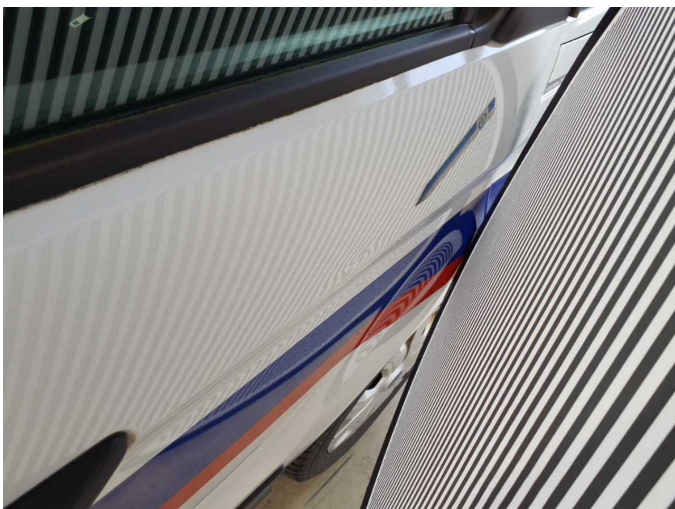
**Damage 3:** Sliding door - left side: Sliding door - dent(s) - Smooth repair work

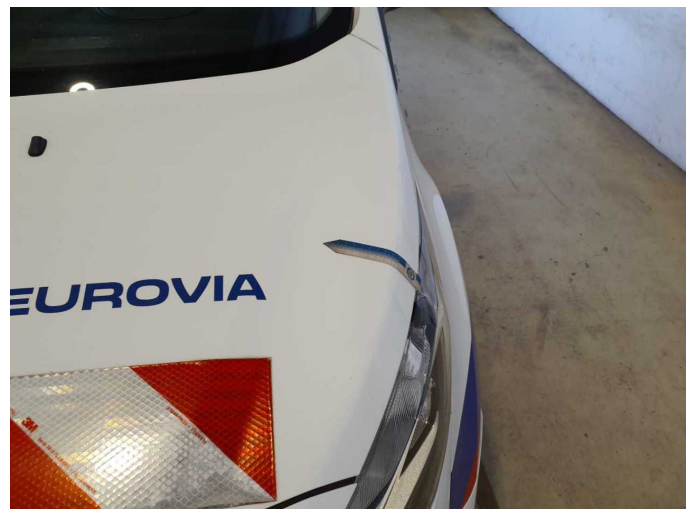
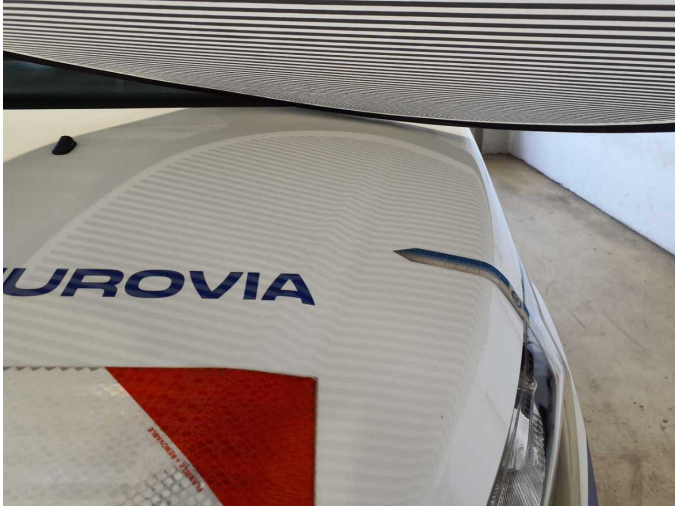
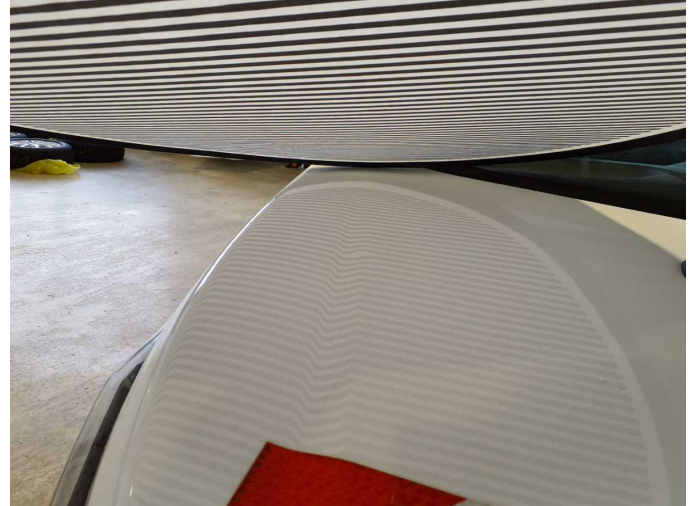
**Damage 4:** Bonnet: Bonnet - dent(s) - Smooth repair work

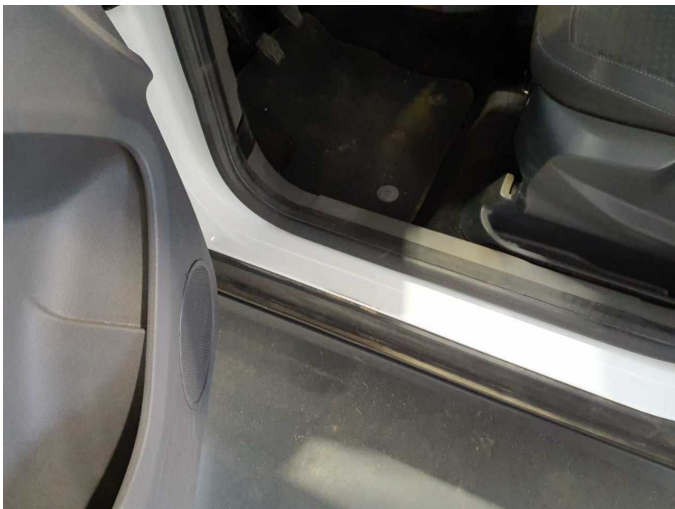
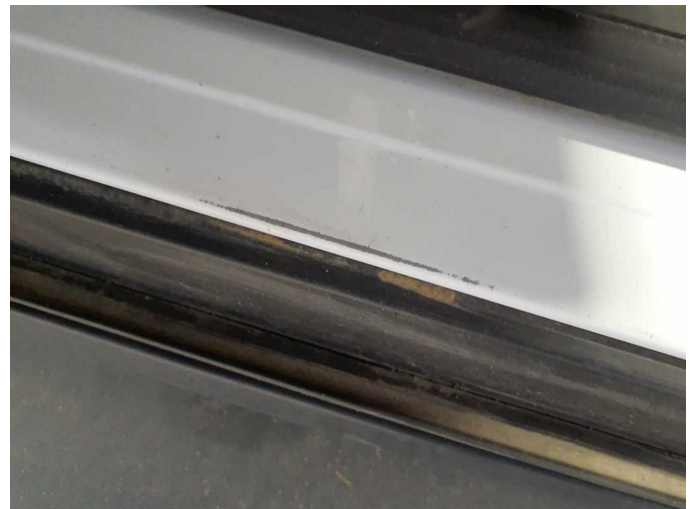
**Damage 5:** Sill - left side: Sill - Scratch(es) - Smart repair

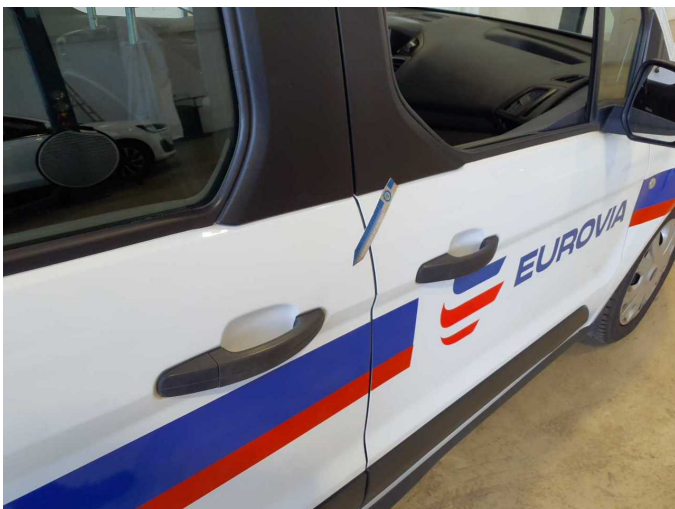
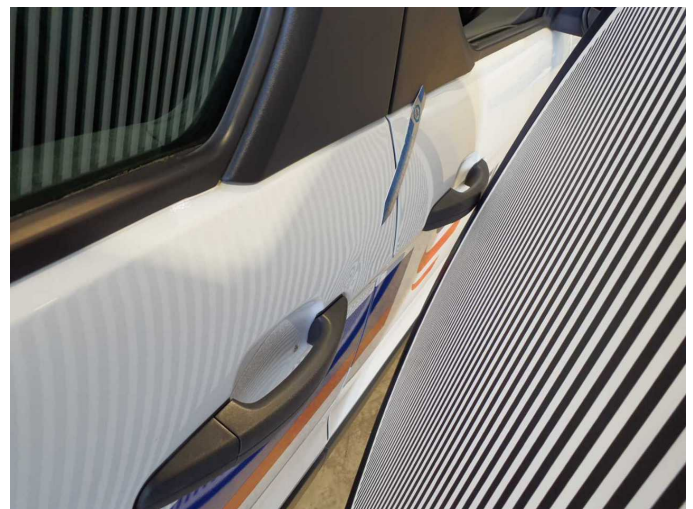
**Damage 6:** Sliding door, right: Sliding door - dent(s) - Smart repair

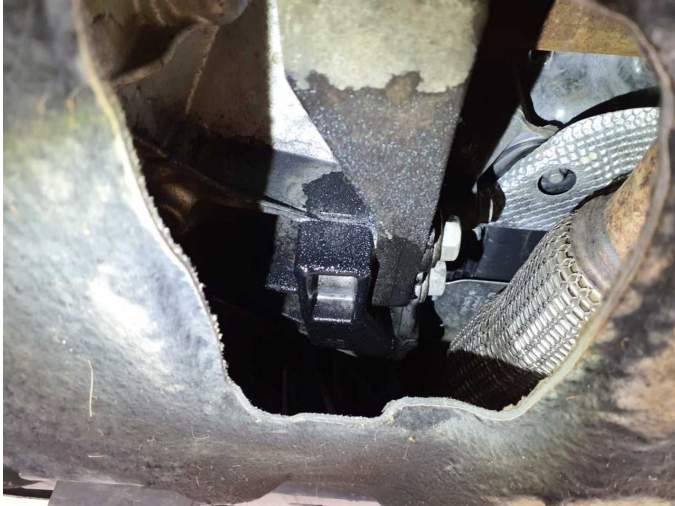
**Damage 7:** Engine: Engine - Leaking - Perform diagnosis

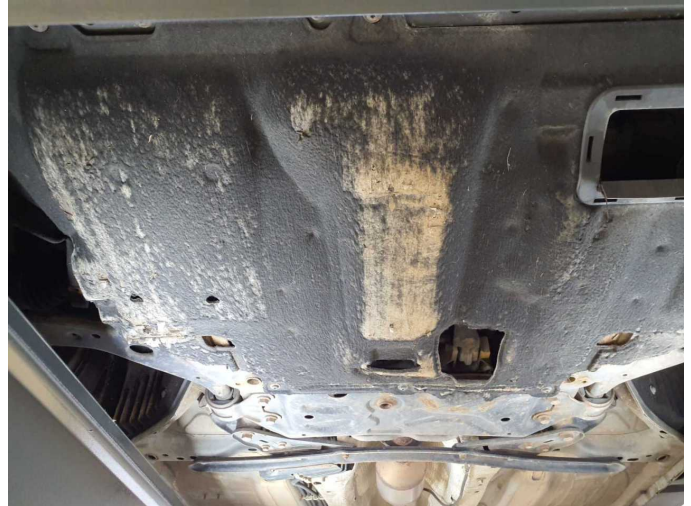
**Damage 8:** Body: Underbody panelling - Scratch(es) - Loss in value

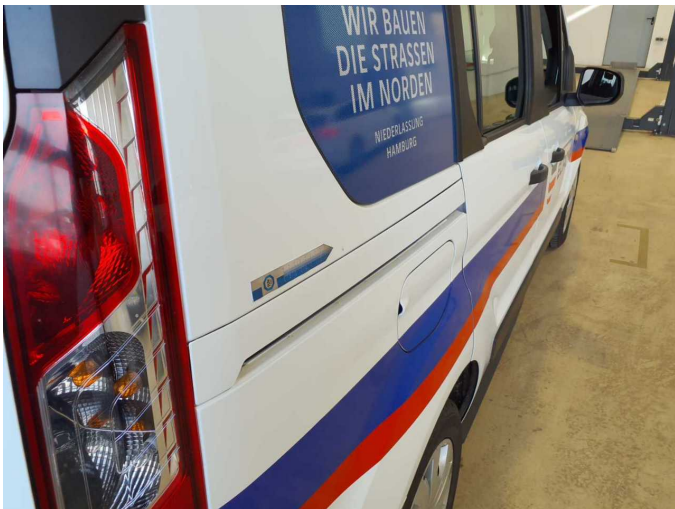
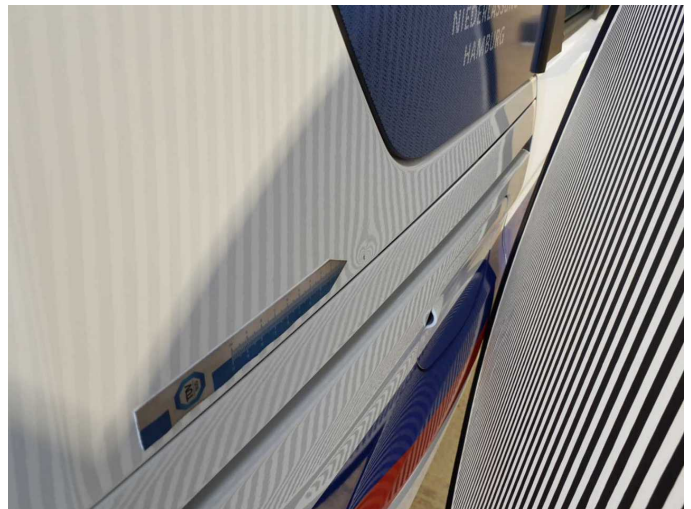
**Damage 9:** Side panel - rear right side: Side panel - Dent / paintcoat damage - Smart repair

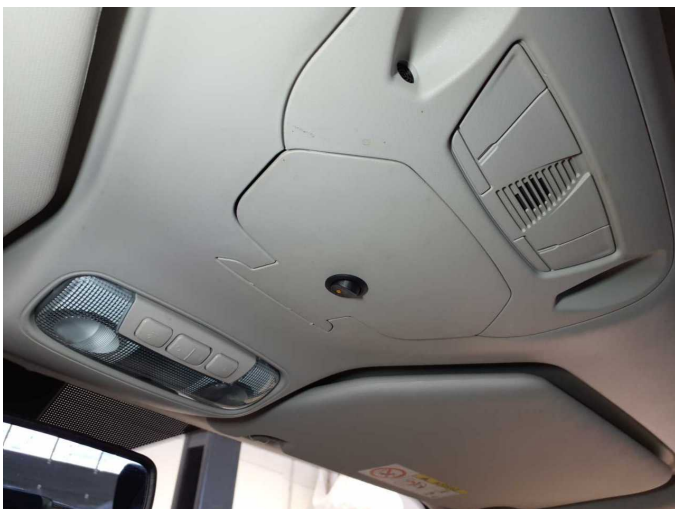
**Damage 10:** Trim / covers: Trim / covers - Differs from the original configuration - Replace

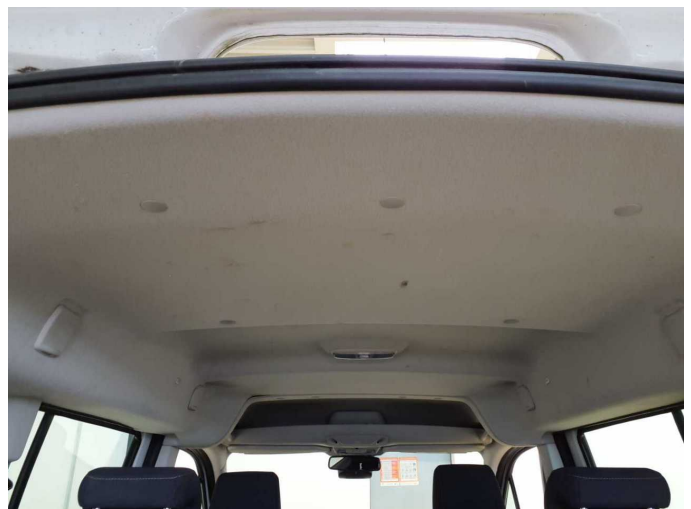
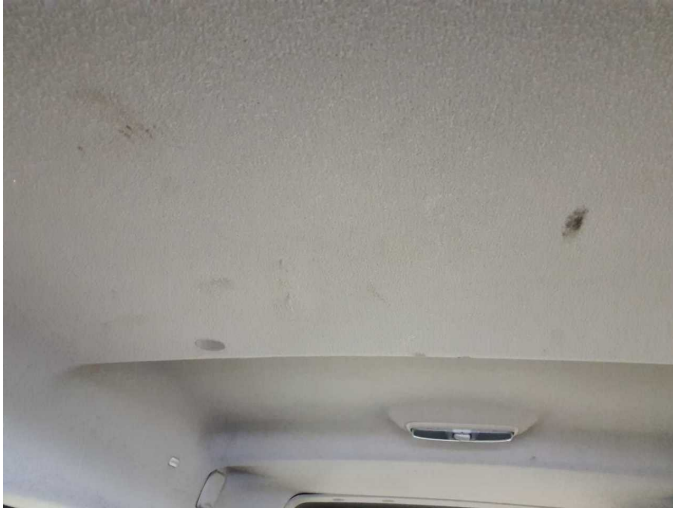
**Damage 11:** Trim / covers: Roof lining - Scratch(es) - Smart repair

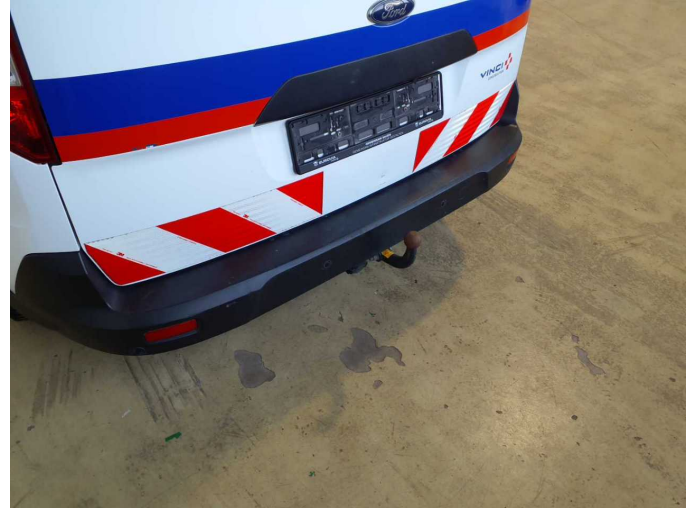
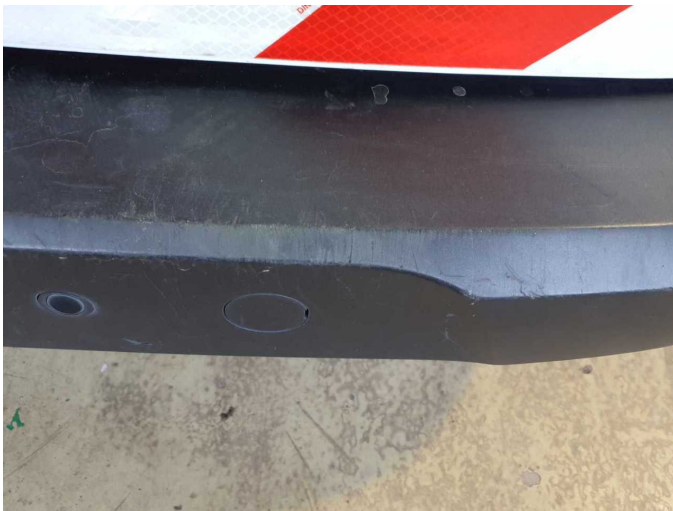
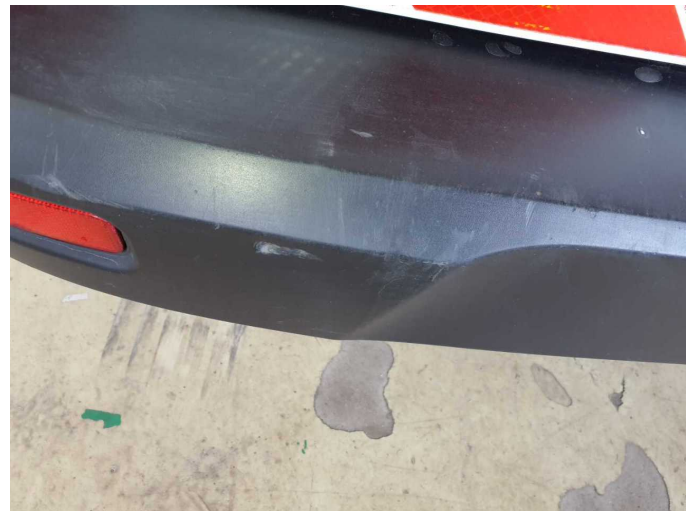
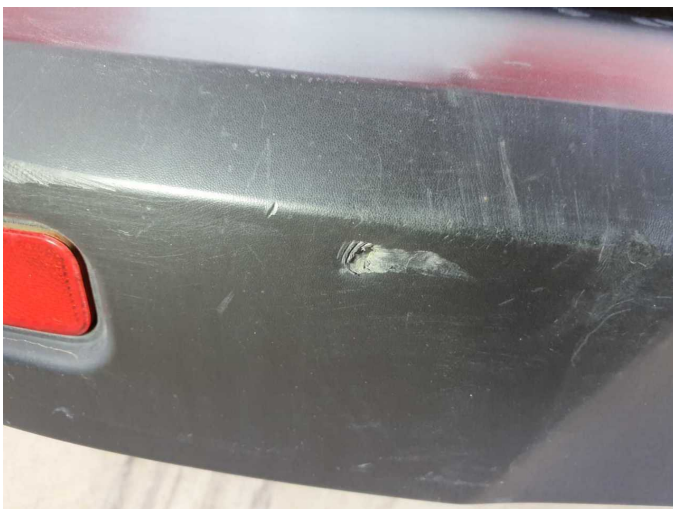
**Damage 12:** Rear bumper: Rear bumper - Dent / paintcoat damage - Loss in value

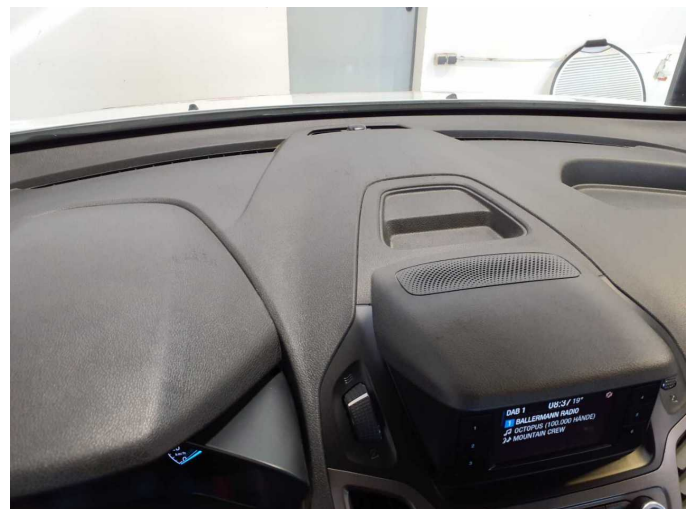
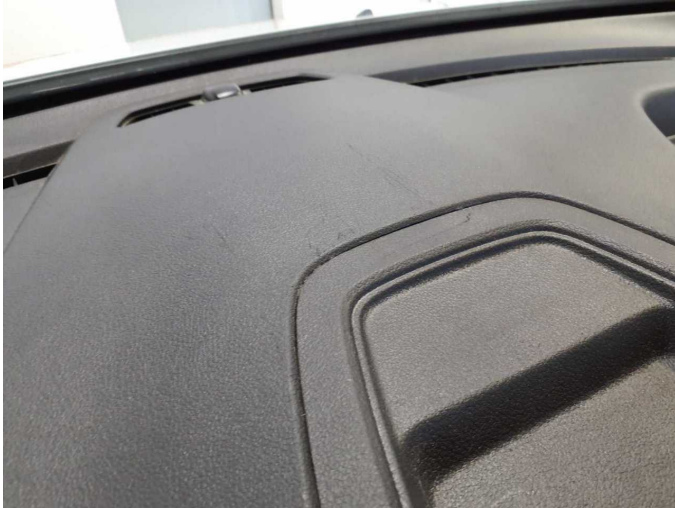
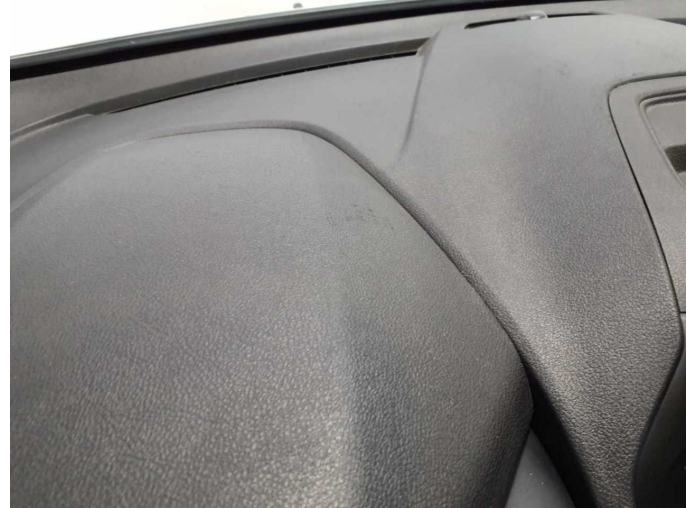
**Damage 13:** Instrument panel: Centre console - front - Scratch(es) - Loss in value

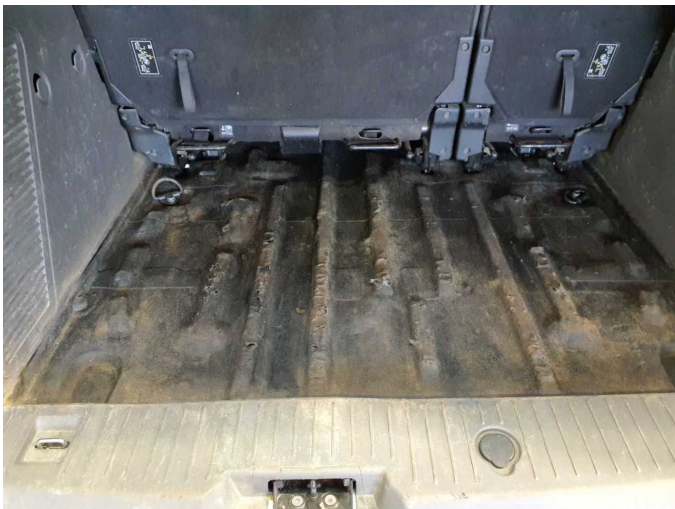
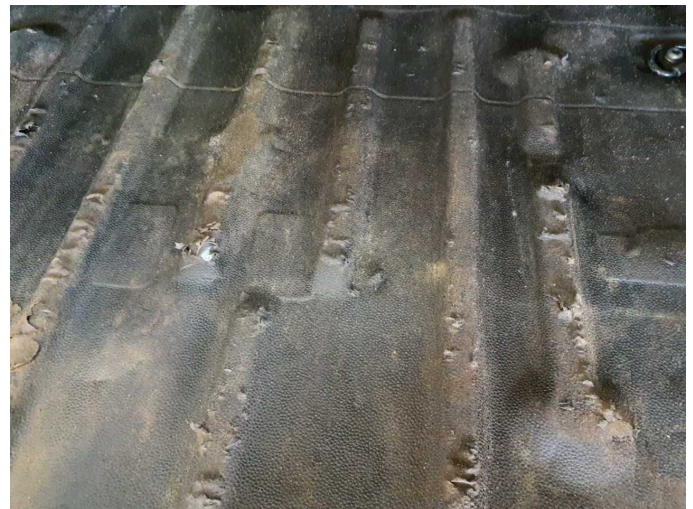
**Damage 14:** Interior: Cargo area floor (Bodenbelag) - Broken / torn - Replace

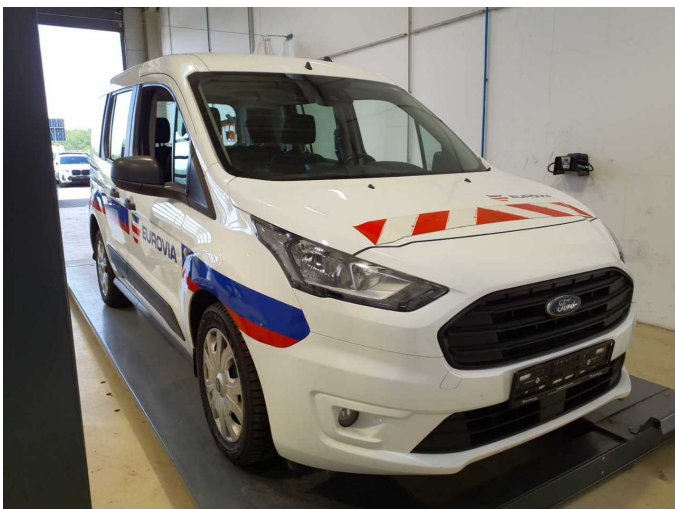
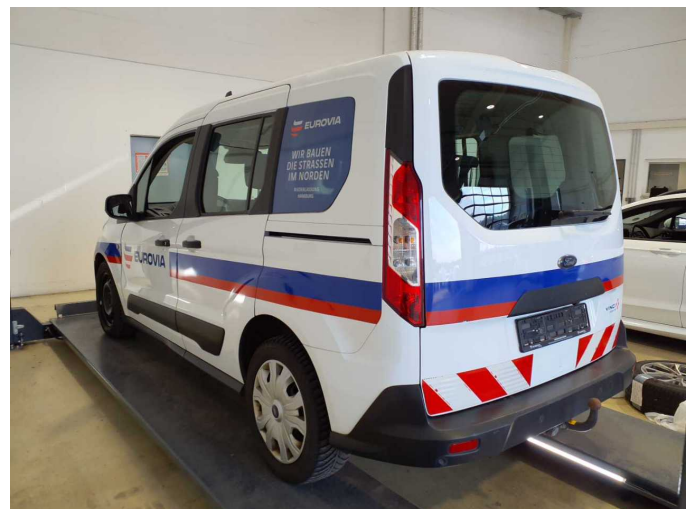
**Damage 15:** Body: Body - Glued / labelled - De-glue / neutralise

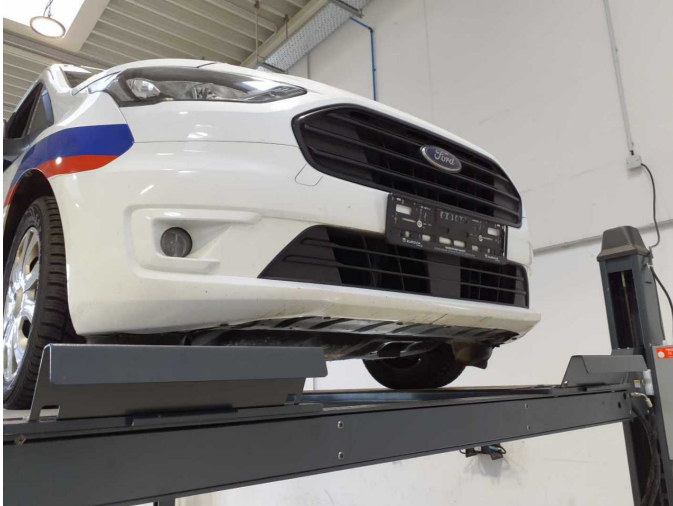
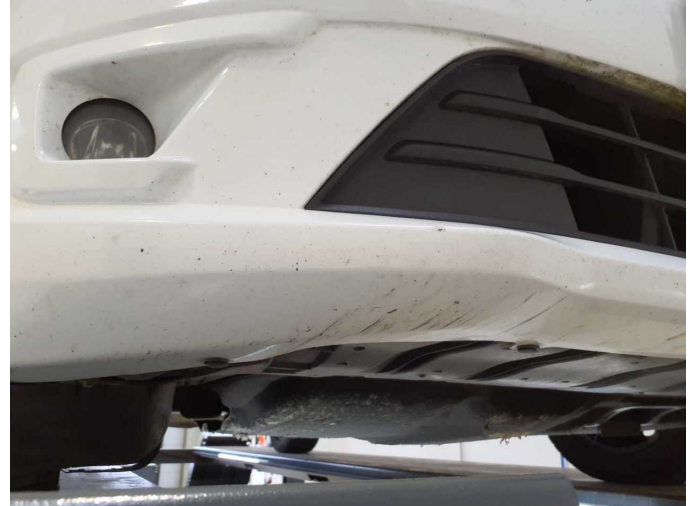
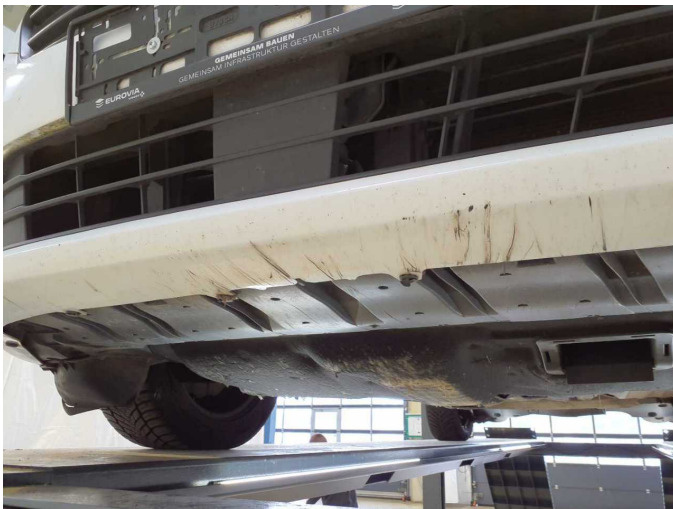
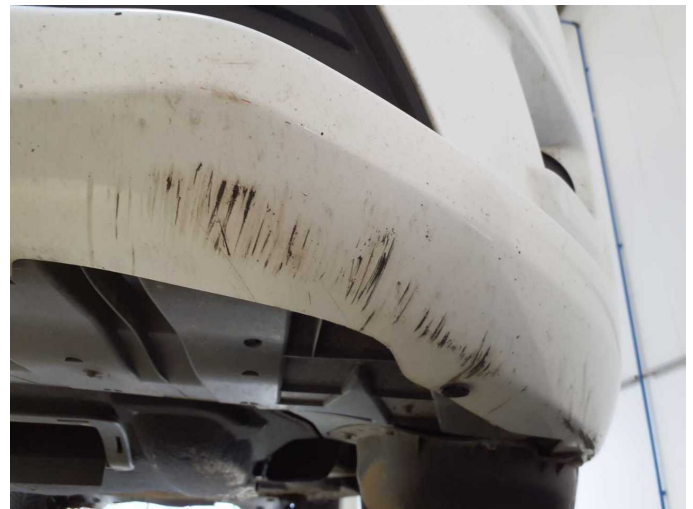
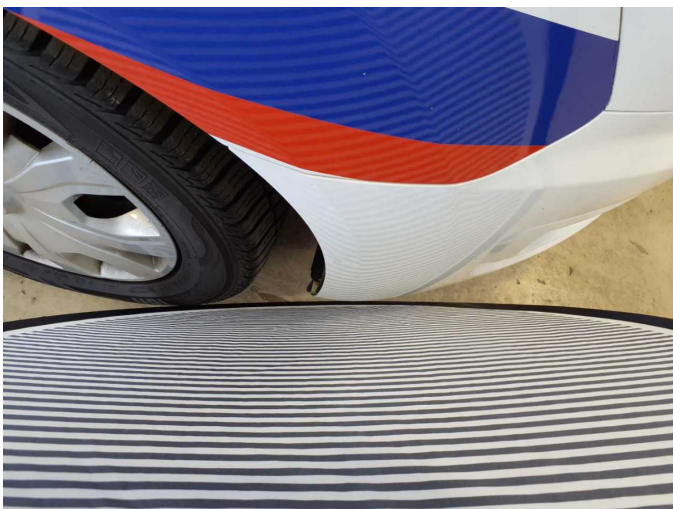
**Damage 16:** Front bumper: Front bumper - Dent / paintcoat damage - Repair and paint

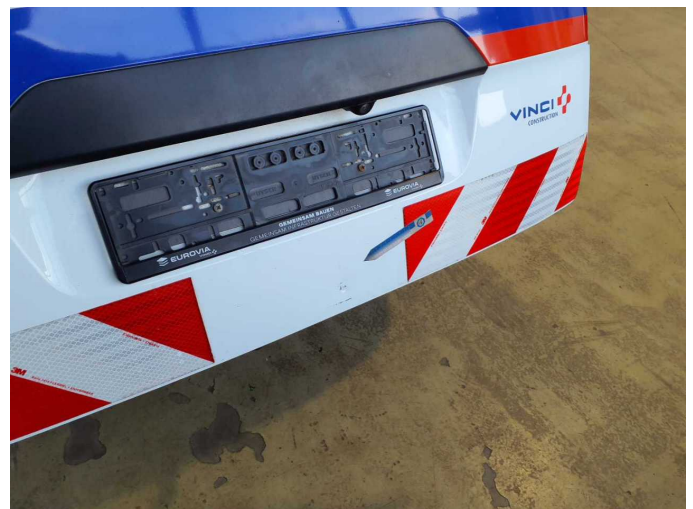
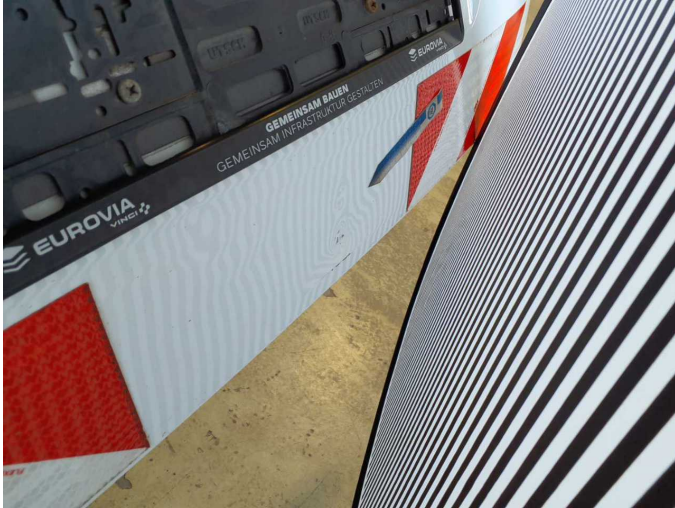
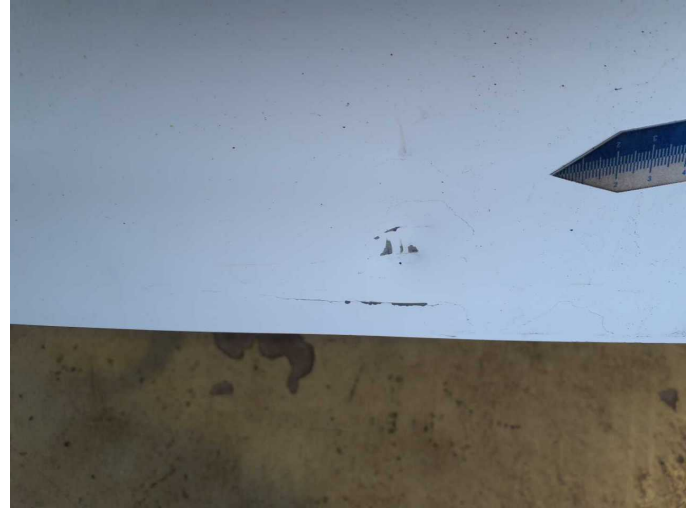
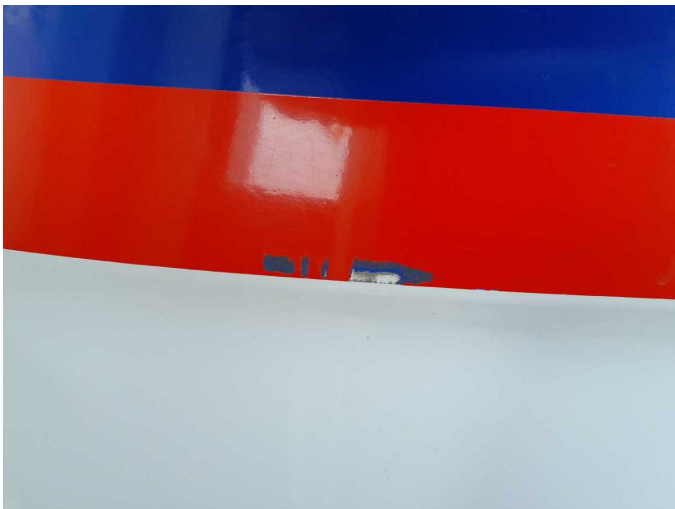
**Damage 17:** Boot lid / rear door: Boot lid - Dent / paintcoat damage - Repair and paint

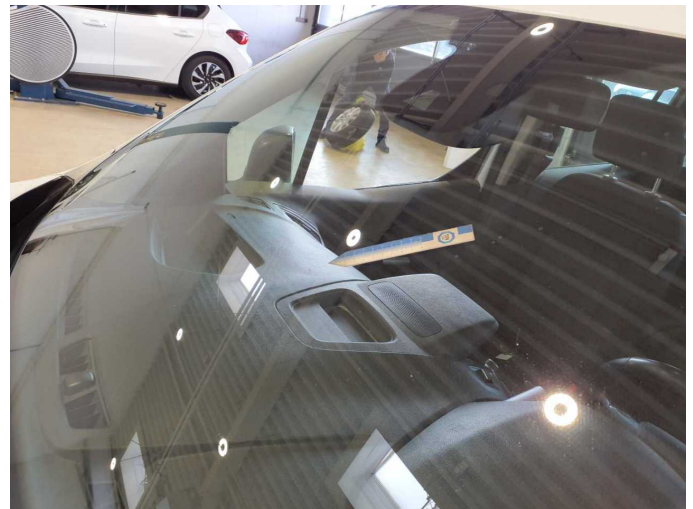
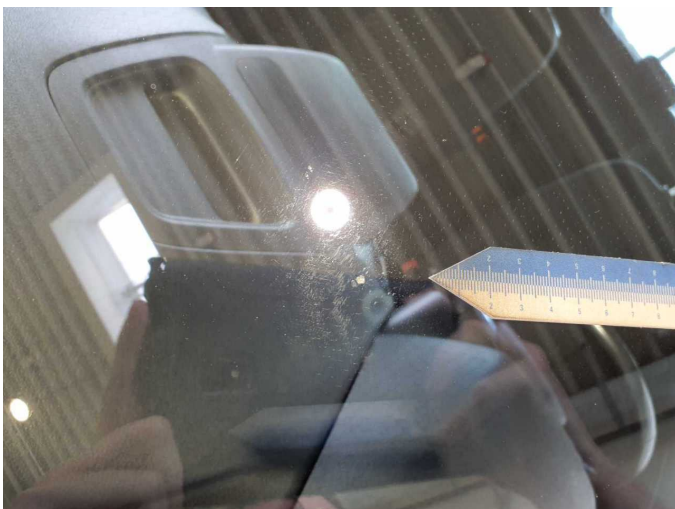
**Damage 18:** Vehicle glazing: Windscreen (kein Staubschutz) - Stone chips - Replace

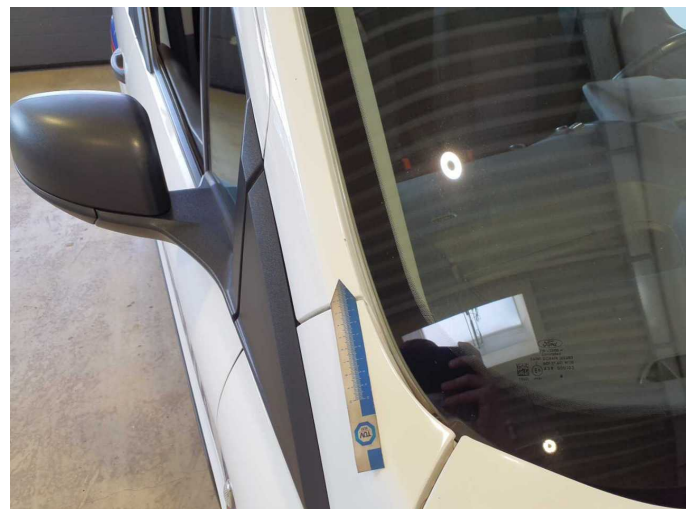
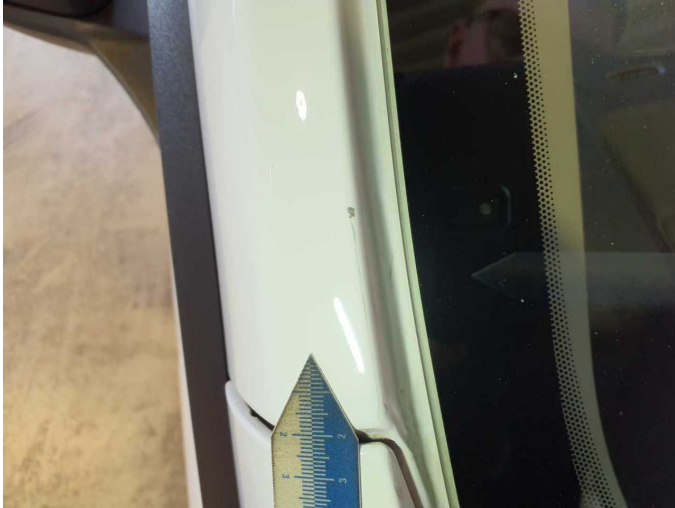
**Wear and tear 1:** Body: A-pillar - right side - Scratch(es) - Smart repair

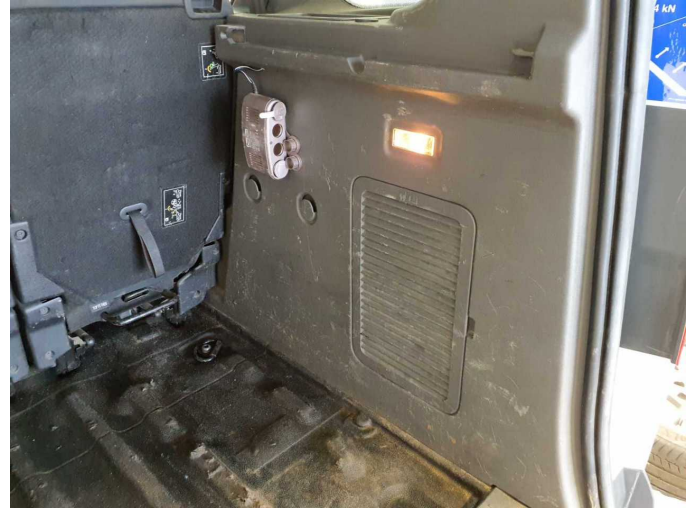
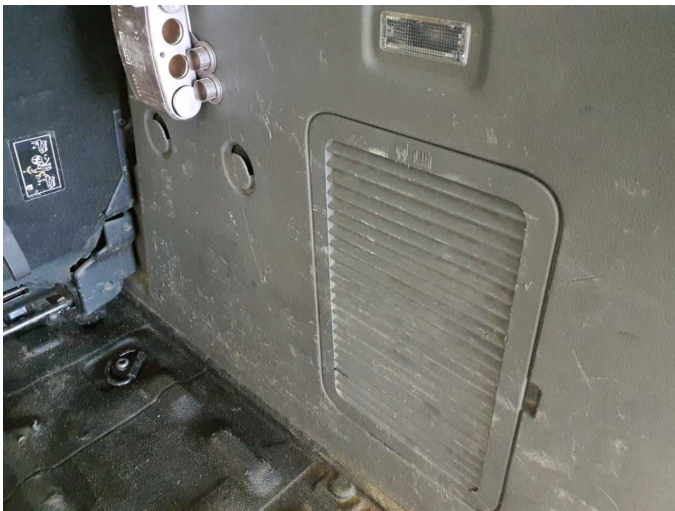
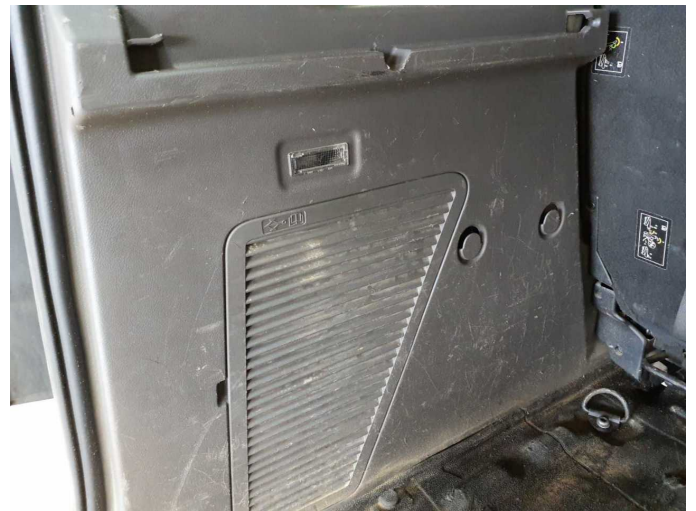
**Wear and tear 2:** Trim / covers: Boot lining - Scratch(es) - No deduction
