Expertise

Protocol number: 45994362
Order No. / Reference: 26472476
Inspection date: 17 Jun 2026

Manufacturer: Skoda

Model: Superb Combi 2.0 TDI DSG Style

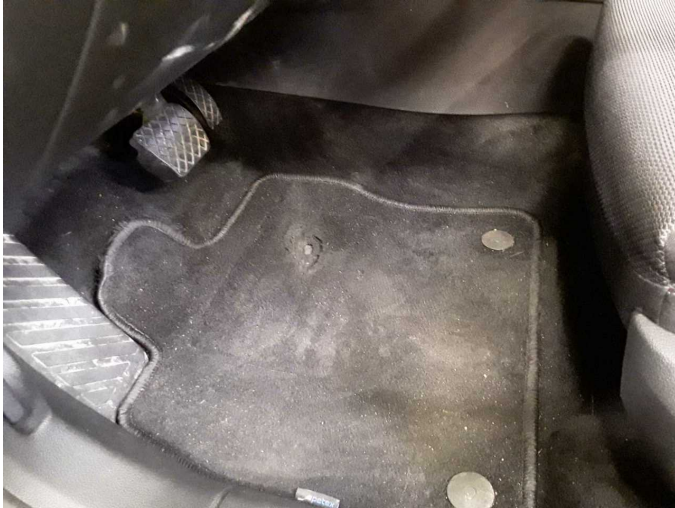
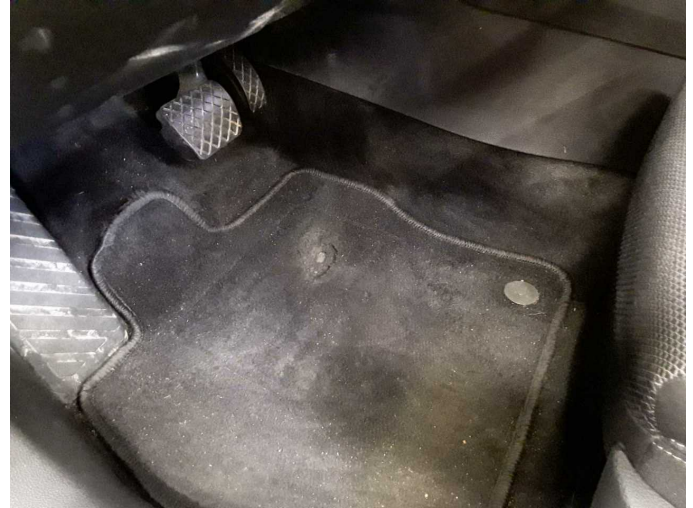
No.	Component group	Description
1	Trim / covers	Floor mats - Damaged - Replace
2	Side panel - rear left side	Side panel - dent(s) - Smooth repair work
3	Rear bumper	Rear bumper - Scratch(es) - Paint

Damage 1: Trim / covers: Floor mats - Damaged - Replace

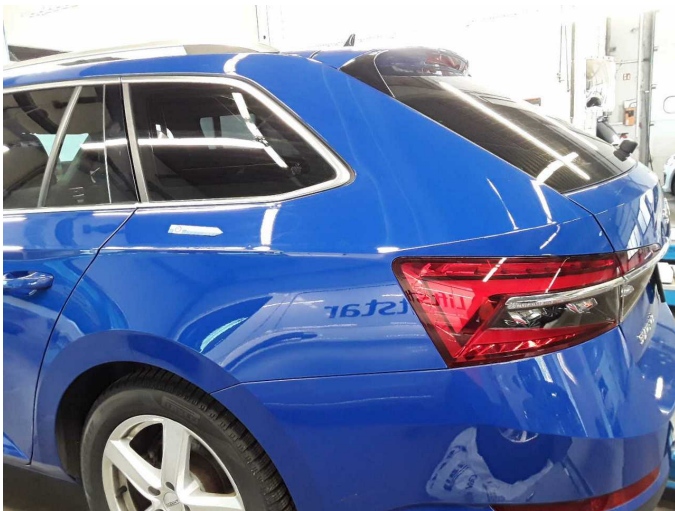
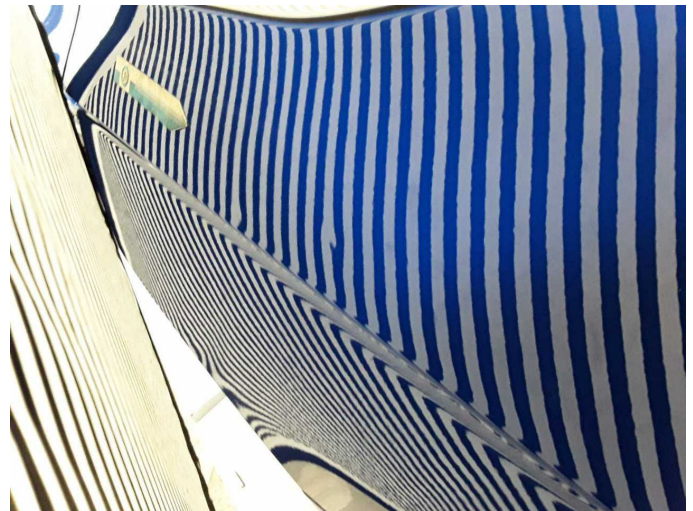
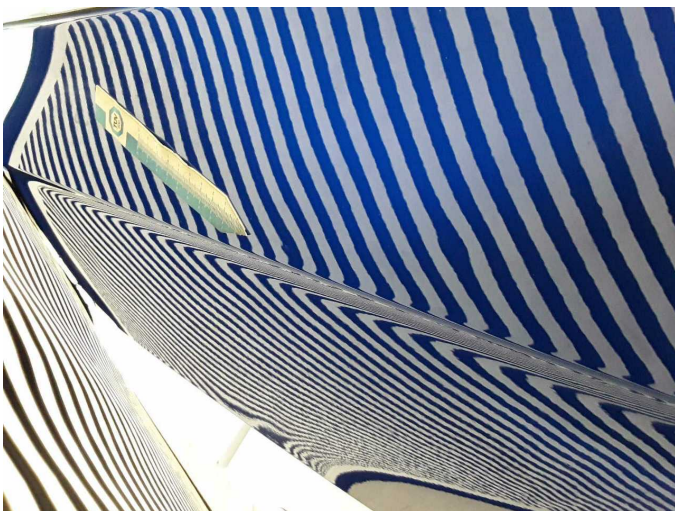
Damage 2: Side panel - rear left side: Side panel - dent(s) - Smooth repair work

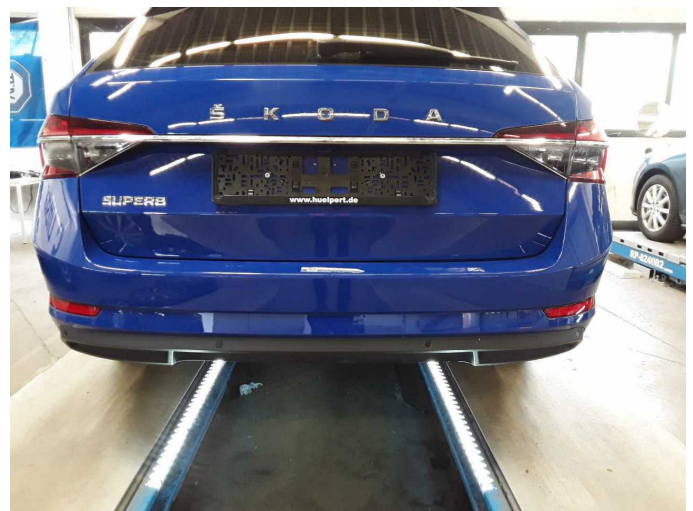
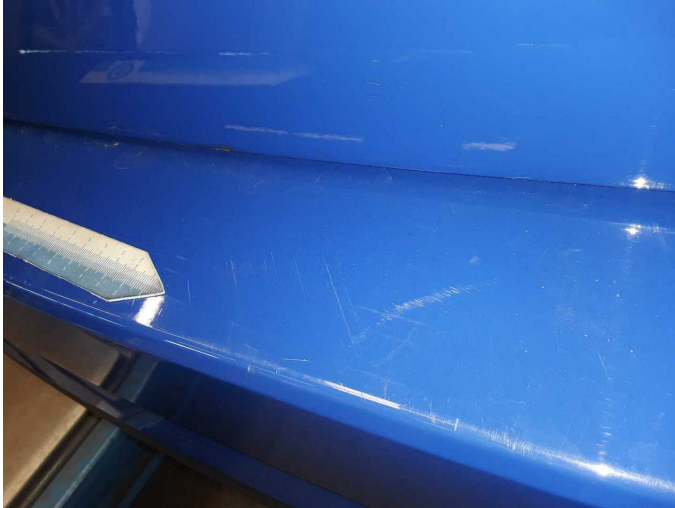
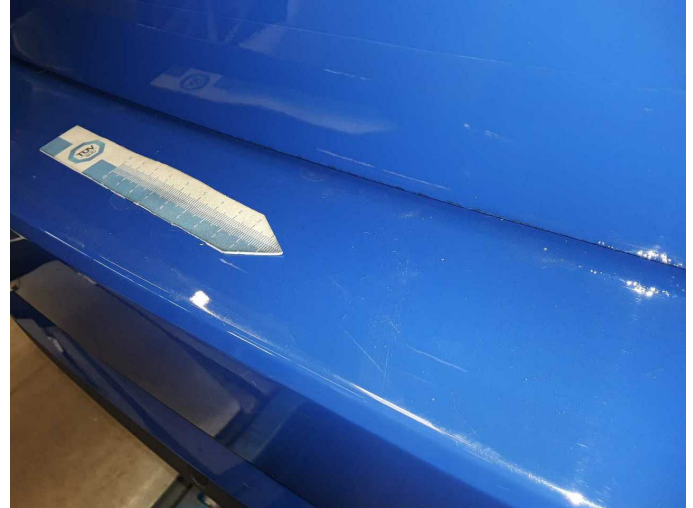
Damage 3: Rear bumper: Rear bumper - Scratch(es) - Paint

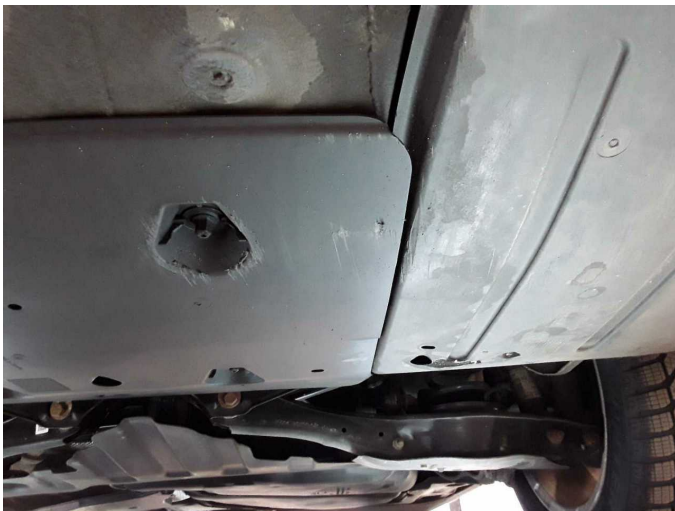
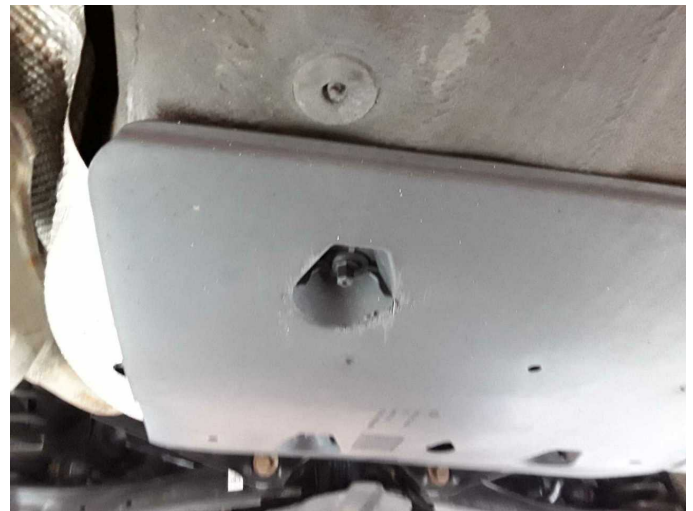
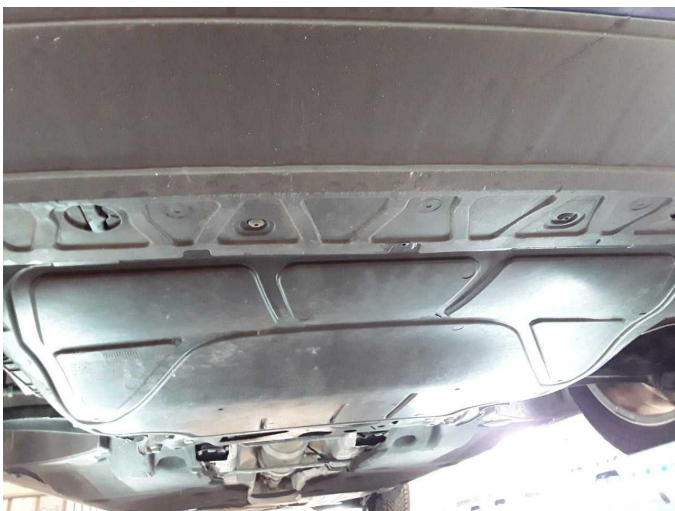
No.	Component group	Description
1	Body	Underbody panelling - Scratched - No deduction
2	Bonnet	Bonnet - Stone chips - No deduction
3	Vehicle glazing	Windscreen - Stone chips - No deduction

Wear and tear 1: Body: Underbody panelling - Scratched - No deduction

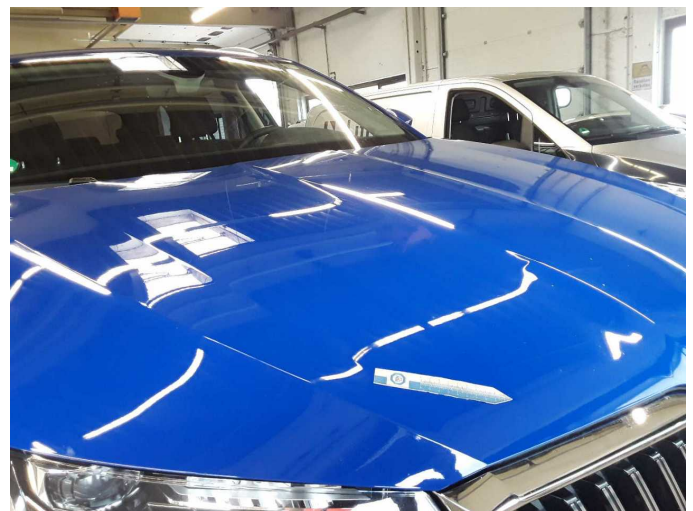
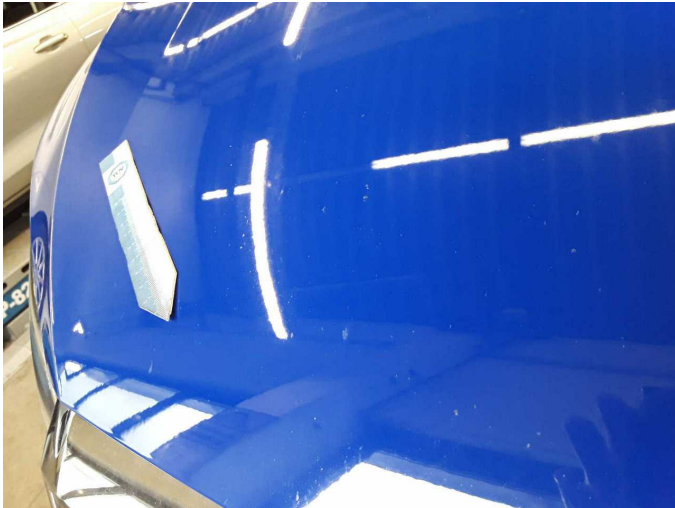
Wear and tear 2: Bonnet: Bonnet - Stone chips - No deduction

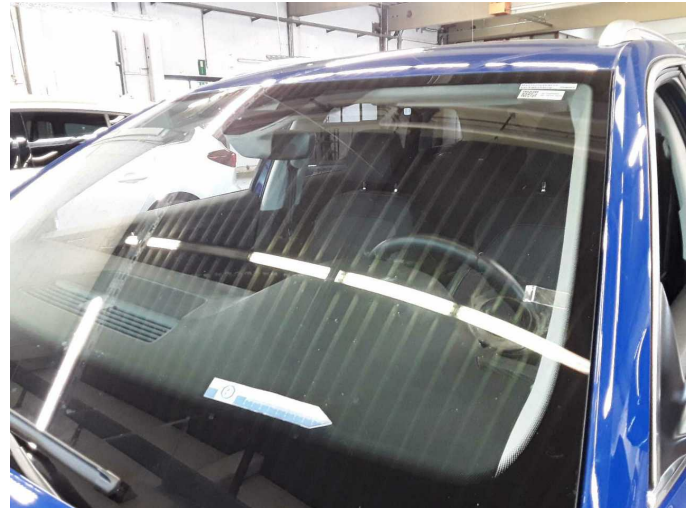
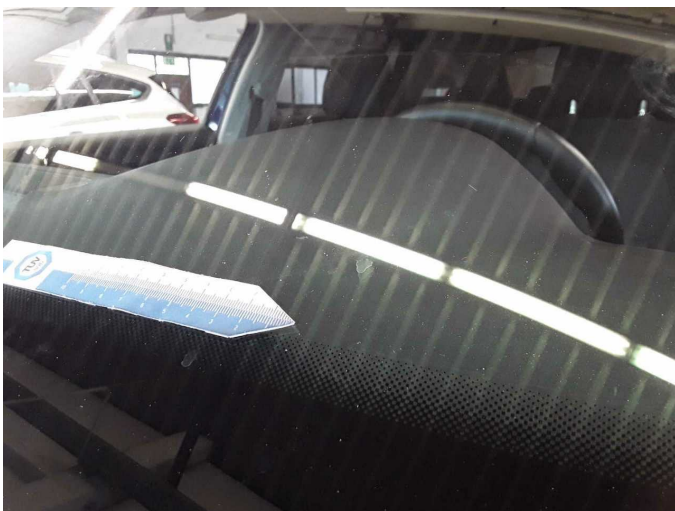
Wear and tear 3: Vehicle glazing: Windscreen - Stone chips - No deduction

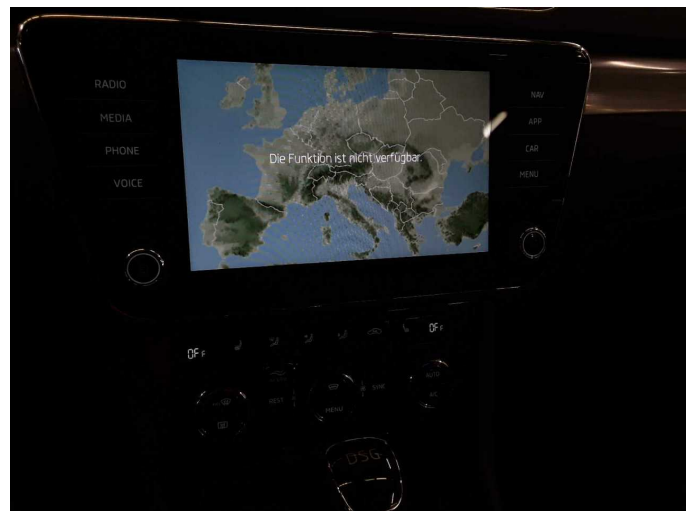
Multimedia system - Navigation data storage

Missing part 1: Multimedia system: Navigation data storage - Missing - Replace

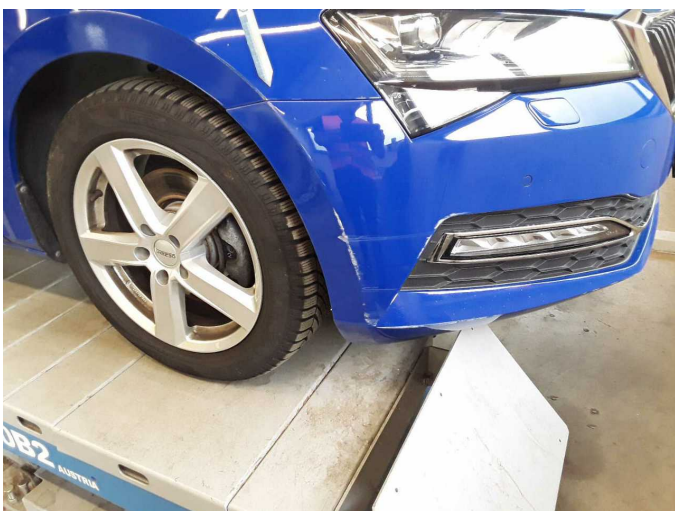
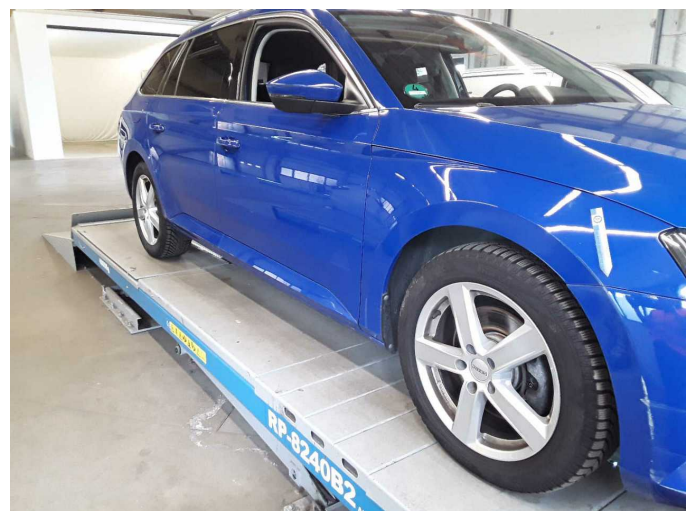
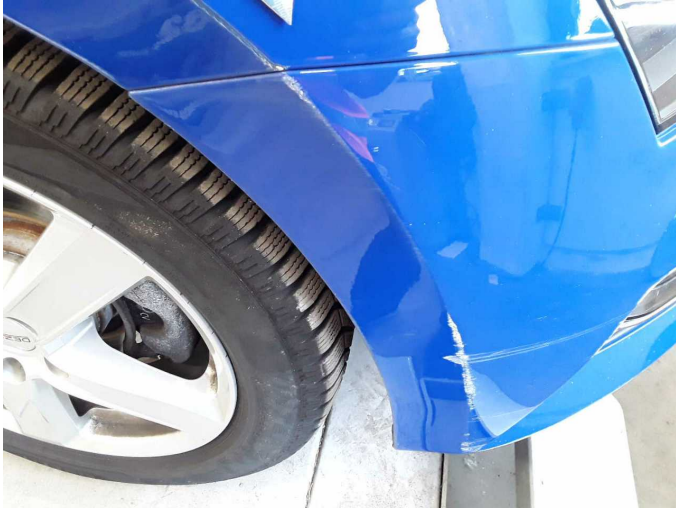
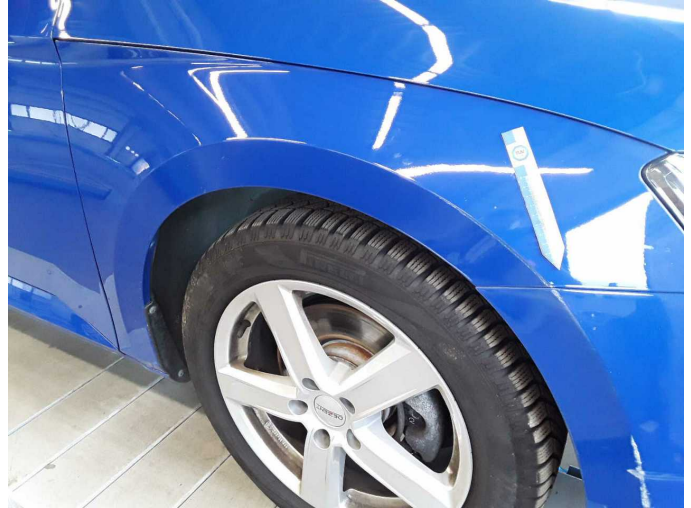
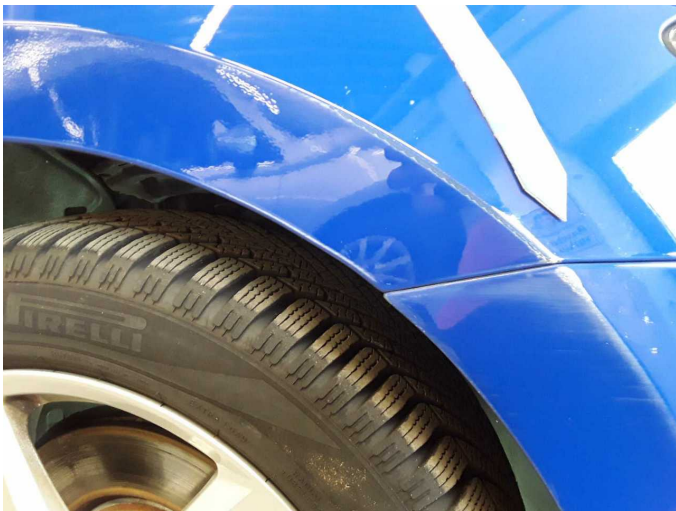
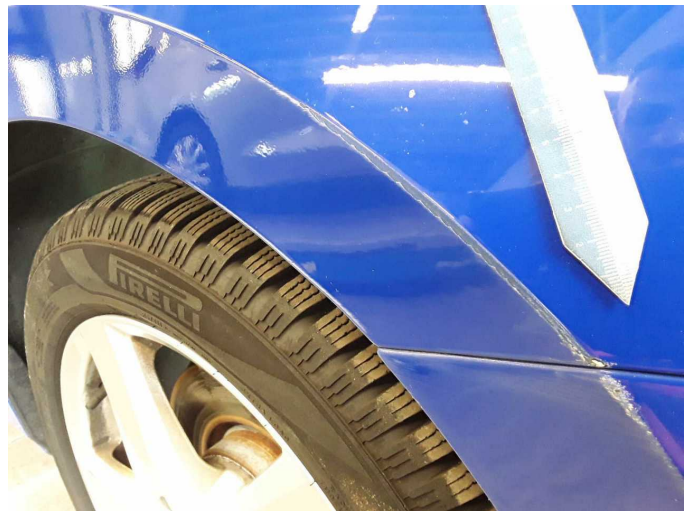
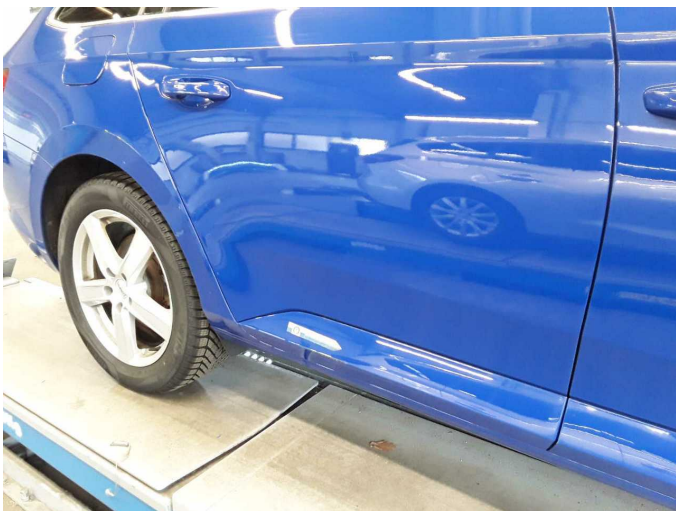
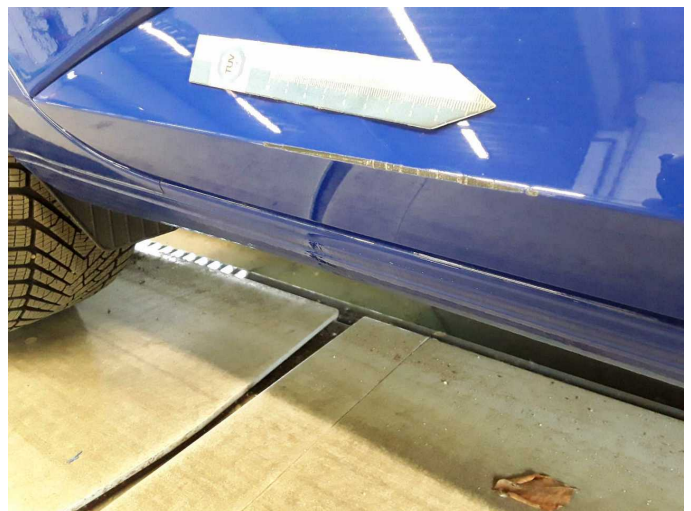
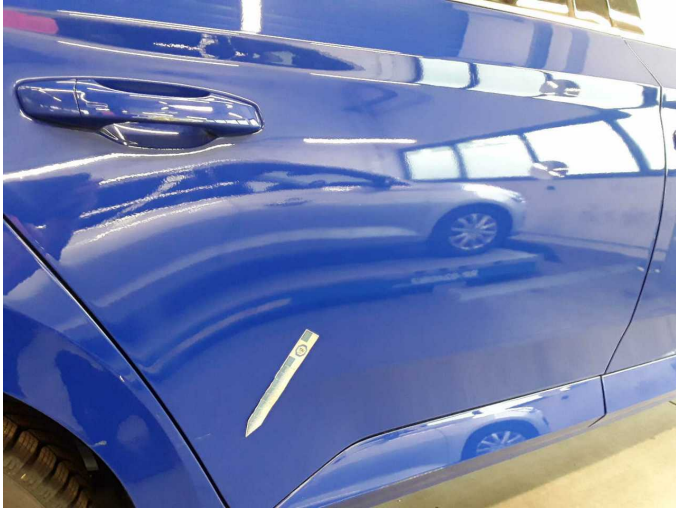
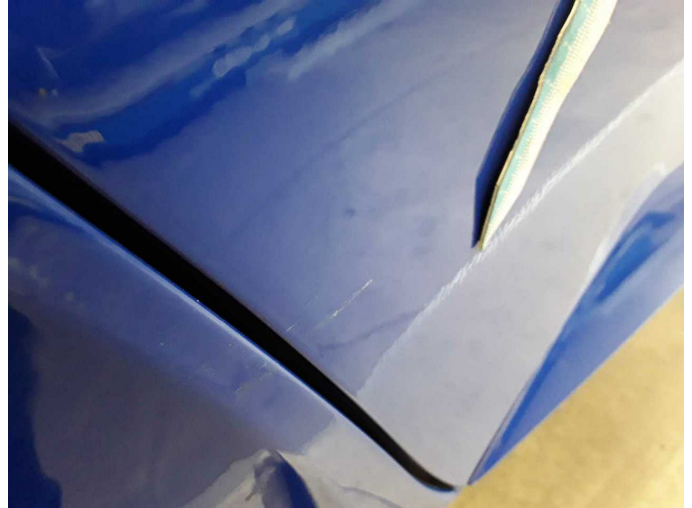
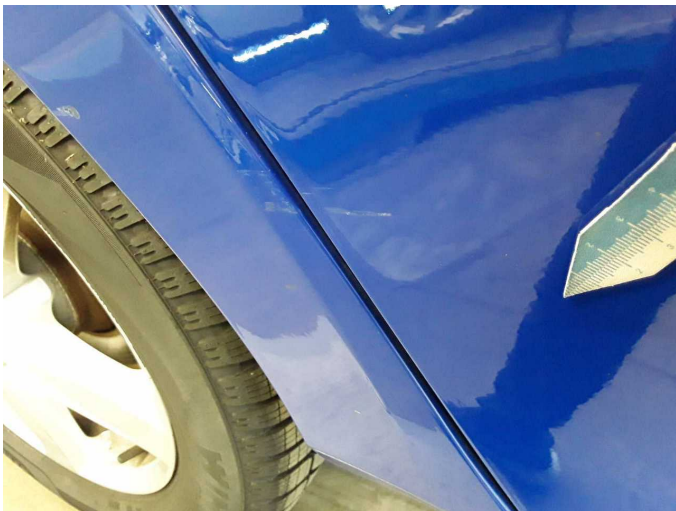
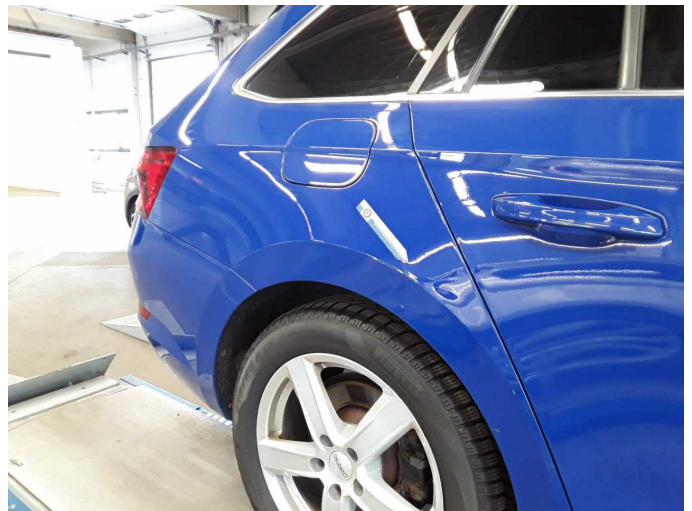
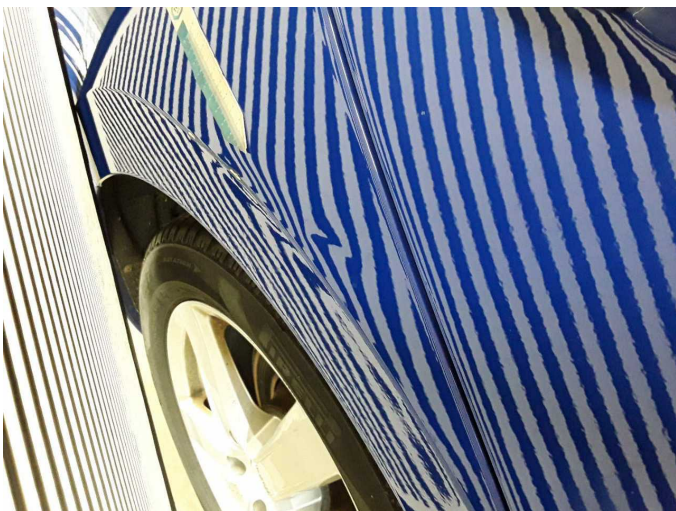
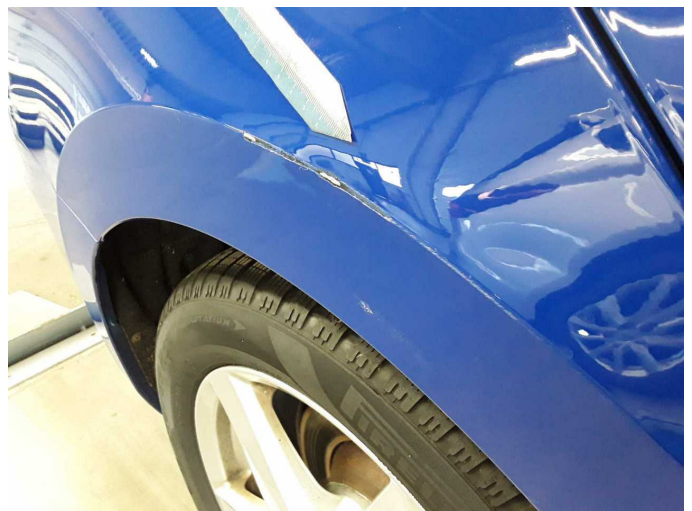
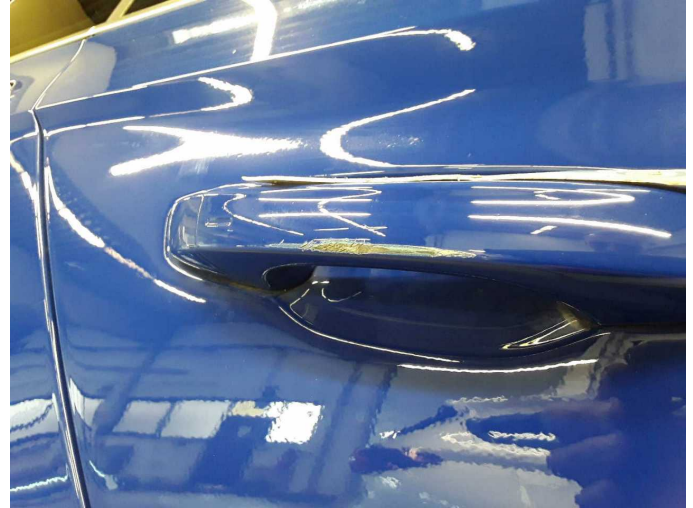
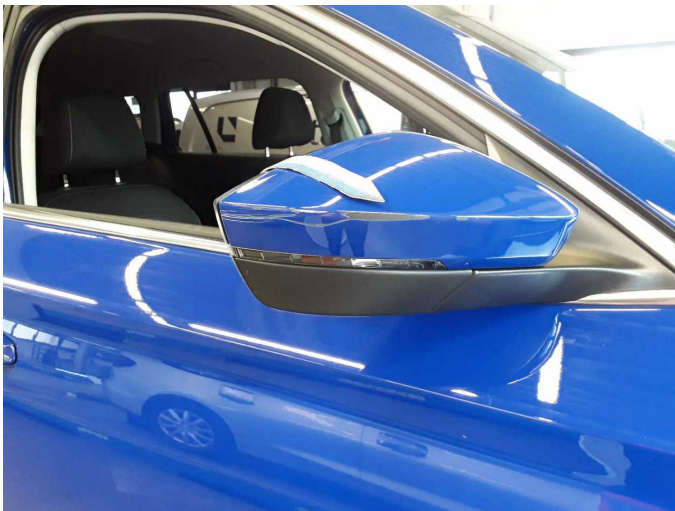
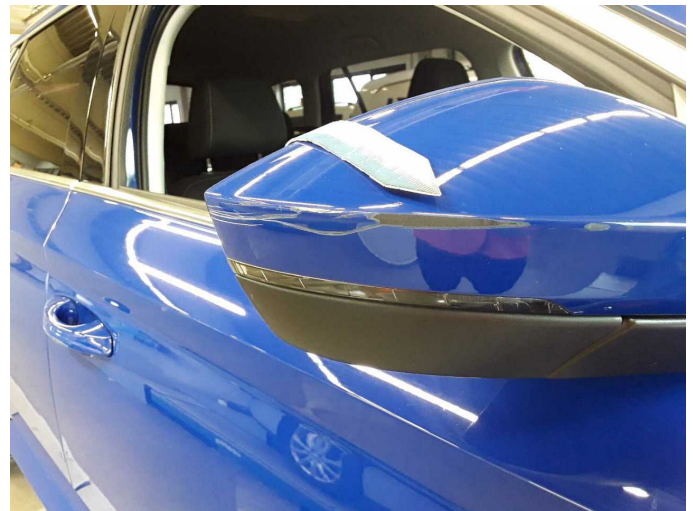
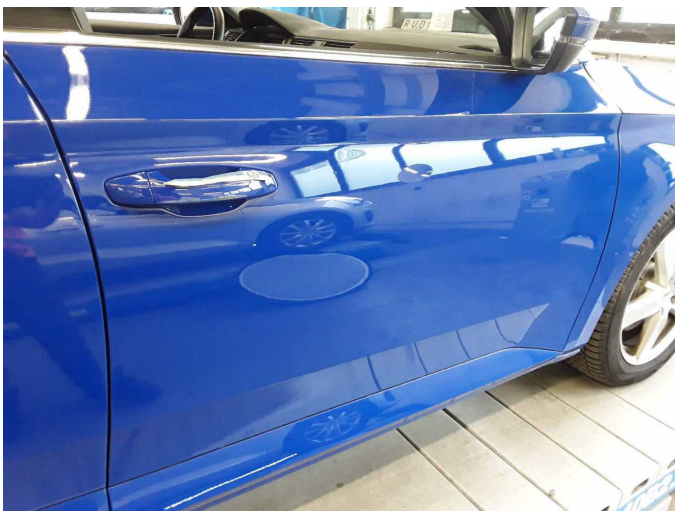
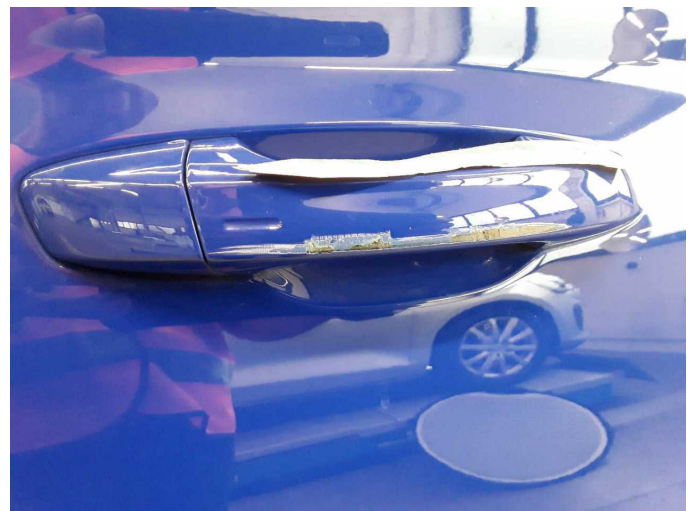
1 Front, Side right

Accident 1: Front, Side right

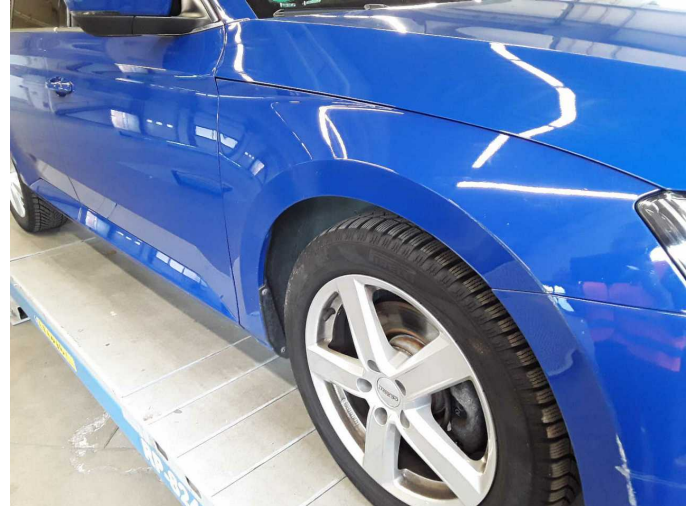
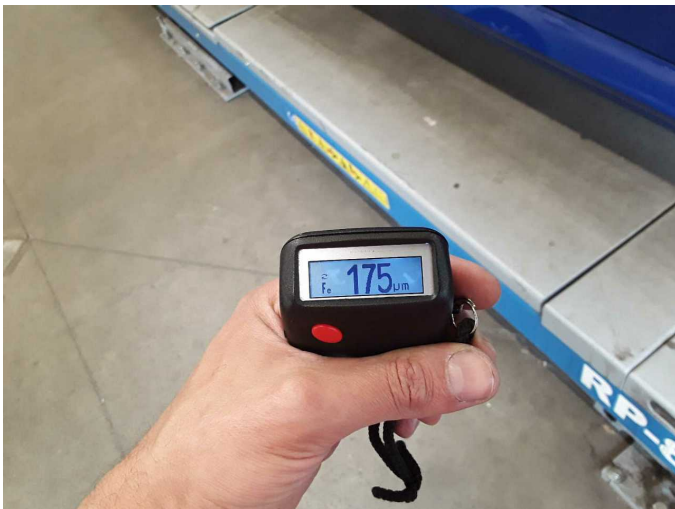
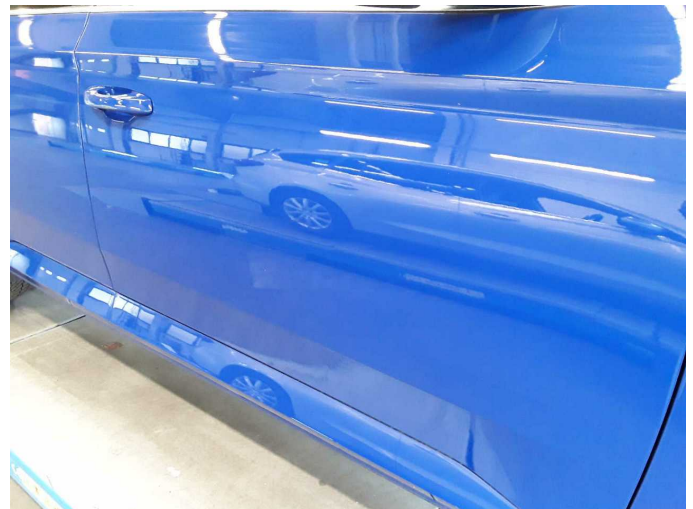
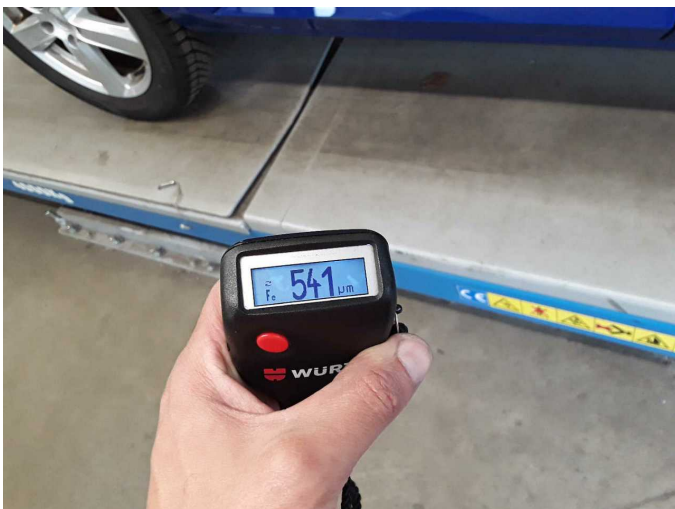
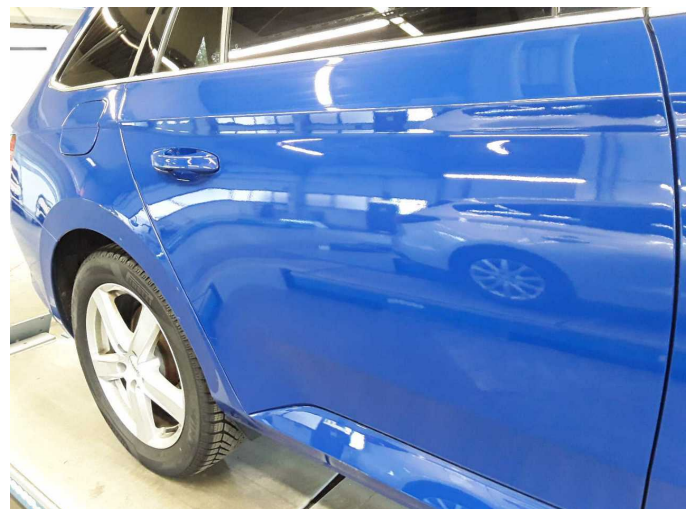
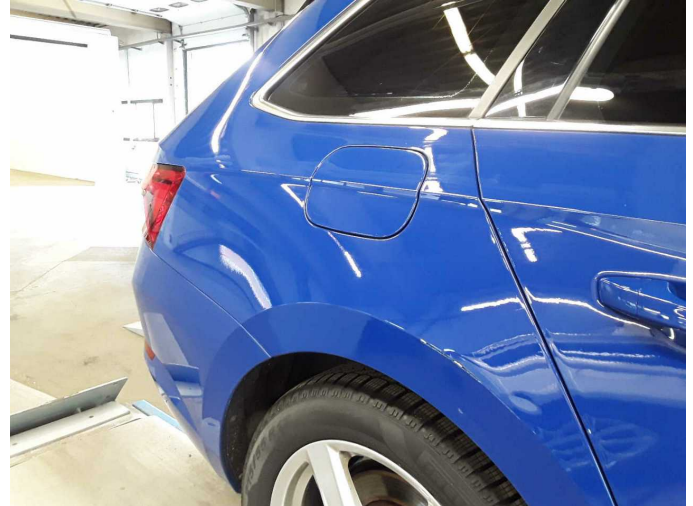
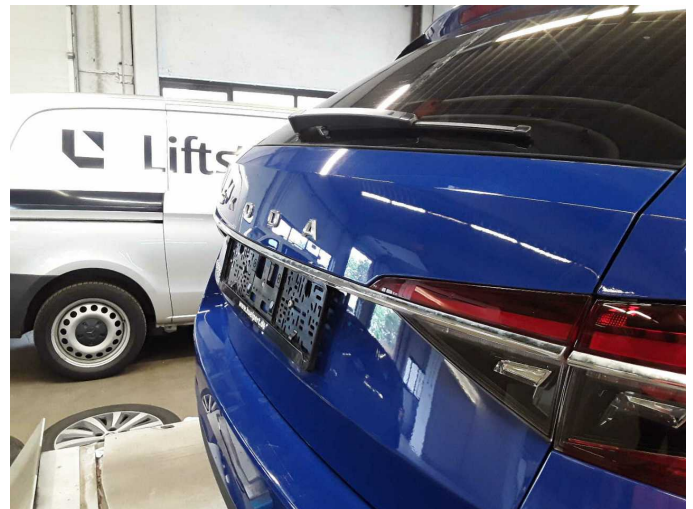
- 1 Boot lid / rear door, Mudguard - right side, Side panel - rear right side, Door - rear right side, Door - front right side, Professionally carried out, Invoice of repair done Non-existent

Boot lid / rear door	211 µm	Mudguard - right side	180 µm
Side panel - rear right side	237 µm	Door - rear right side	541 µm
Door - front right side	175 µm

Repainting 1: Boot lid / rear door, Mudguard - right side, Side panel - rear right side, Door - rear right side, Door - front right side
