Expertise

Protocol number: 45828070
Order No. / Reference: 26326540
Inspection date: 27 May 2026

Model: 308 SW BlueHDi 130 EAT8 Allure

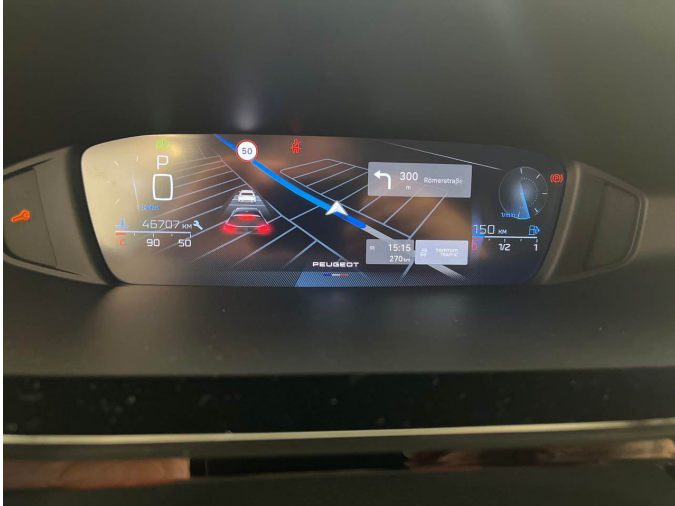
Figure 7: Instrument cluster

Mileage (Read) 46,707 km

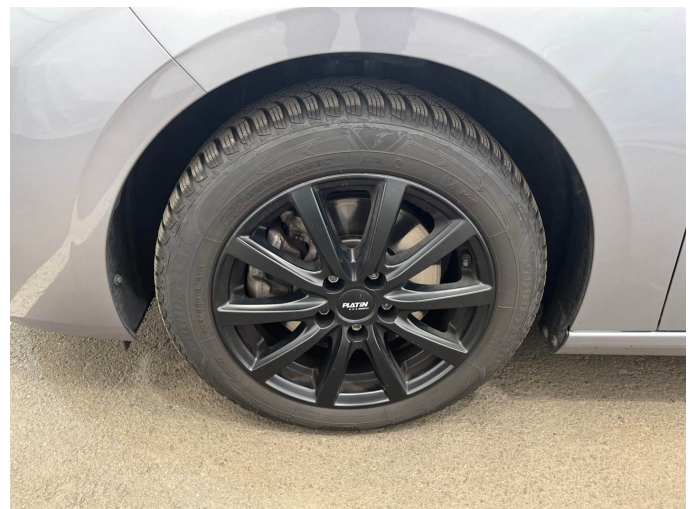
Figure 12: Mounted tyres

#	Tyre size	Type of tyre	Manufacturer	Tread depth
1)	205/55 R16 91H	Winter tyres on Light alloy	Goodyear	5mm / 5mm
2)	205/55 R16 91H	Winter tyres on Light alloy	Goodyear	5mm / 5mm

- Die Unterbodenbesichtigung war nur ebenerdig & eingeschränkt möglich. Mehrkosten möglich.
- Für den montierten Radsatz wurde kein Nachweis erbracht.
- Winterradsatz ist kein Bestandteil des Auslieferungsumfangs.

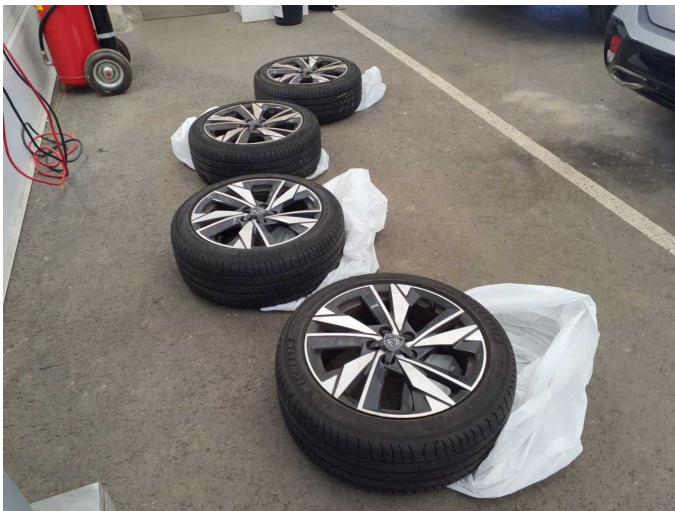
Figure 15: Additional tyres

#	Tyre size	Type of tyre	Manufacturer	Tread depth
1)	225/45 R17 94V	Summer tyres on Light alloy	Michelin	5mm / 5mm
2)	225/45 R17 94V	Summer tyres on Light alloy	Michelin	5mm / 5mm

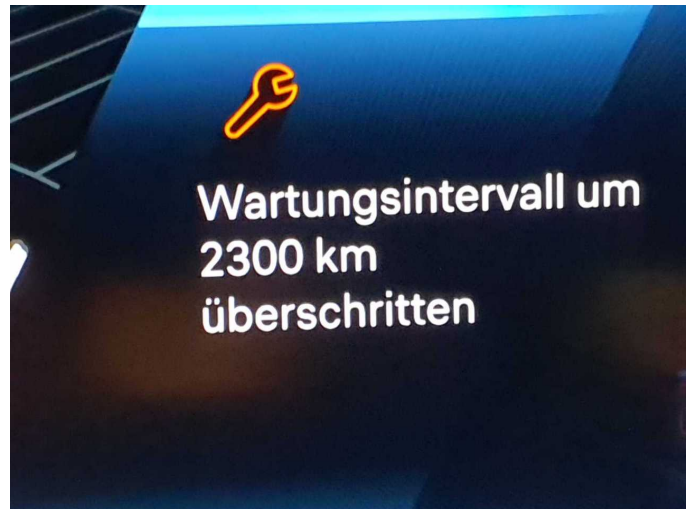
No.	Component group	Description
1	Misc.	Inspection / maintenance (Nachweis Unvollständig, fällige Wartung um 2300km überzogen) - No evidence - No deduction
2	Misc.	Main inspection - Expired - Perform
3	Misc.	Inspection / maintenance - Due - Perform

Damage 3: Misc.: Inspection / maintenance - Due - Perform
