Expertise

Protocol number: 45296696
Order No. / Reference: 26191102-1
Inspection date: 30 Mar 2026

Model: 308 SW BlueHDi 130 EAT8 Allure Pack

VIN: VR3FCYHZTNY580628

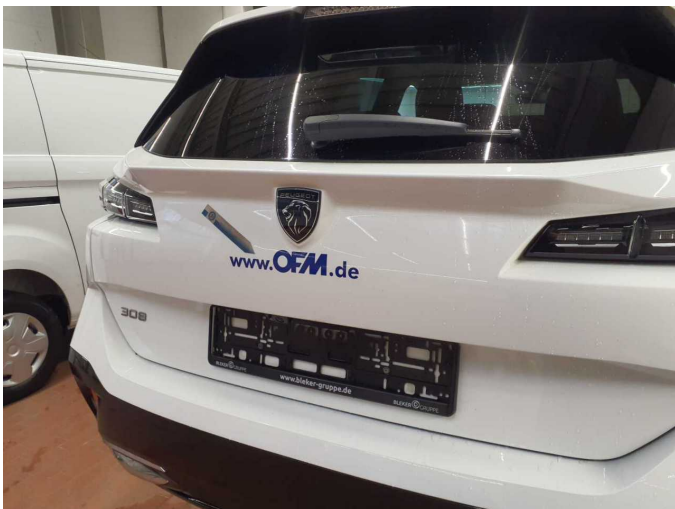
Damage 2: Boot lid / rear door: Boot lid - Glued / labelled - De-glue / neutralise

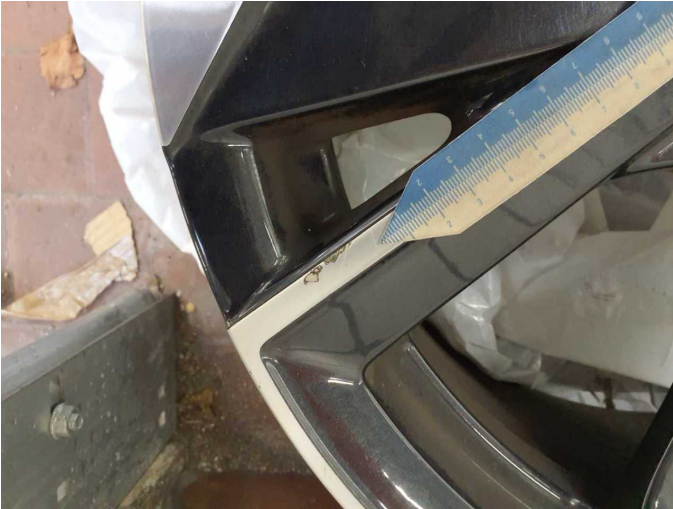
Damage 3: 2nd wheel set: 1 alloy rim - Scratch(es) - Loss in value

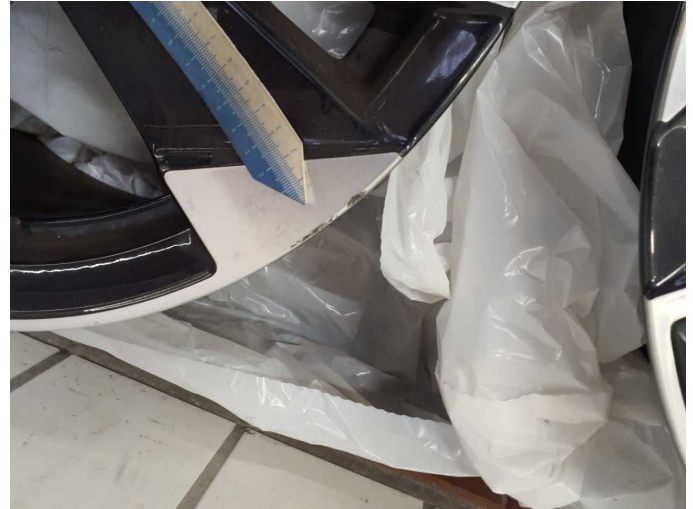
Damage 3: 2nd wheel set: 1 alloy rim - Scratch(es) - Loss in value

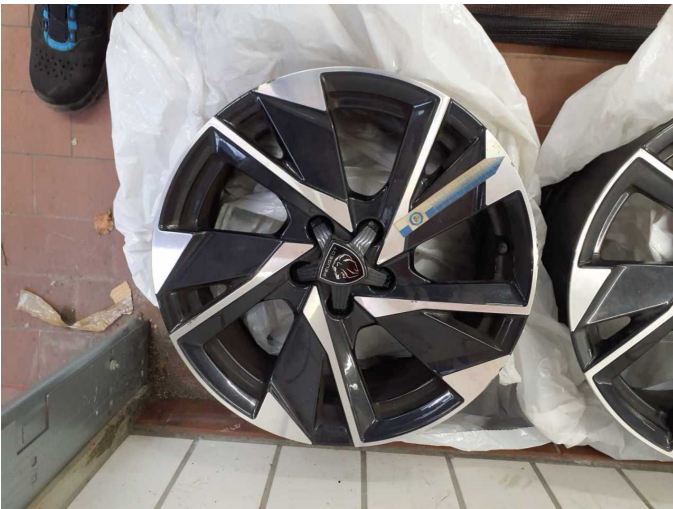
Damage 3: 2nd wheel set: 1 alloy rim - Scratch(es) - Loss in value

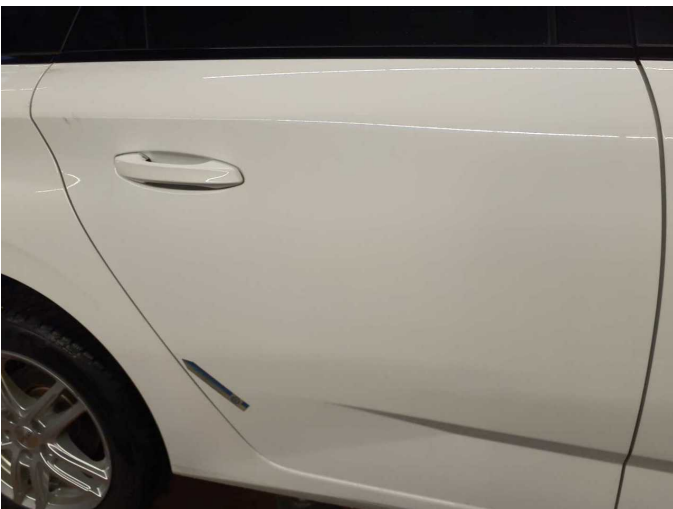
Damage 4: Door - rear right side: Door - Scratch(es) - Smart repair

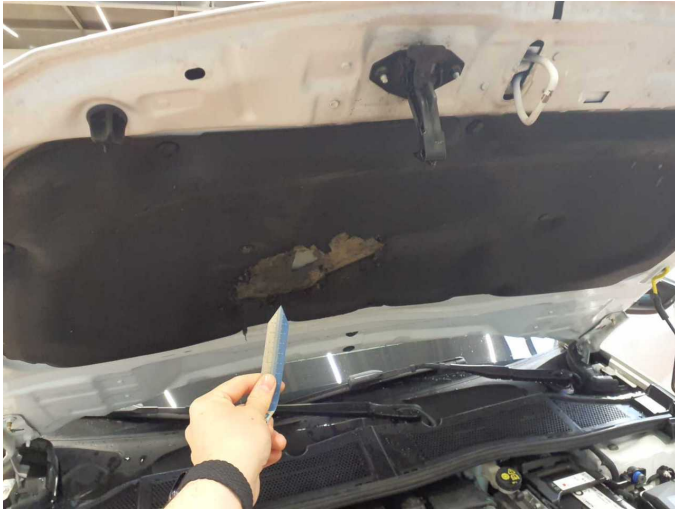
Damage 5: Bonnet: Insulation lining - Broken / torn - Replace

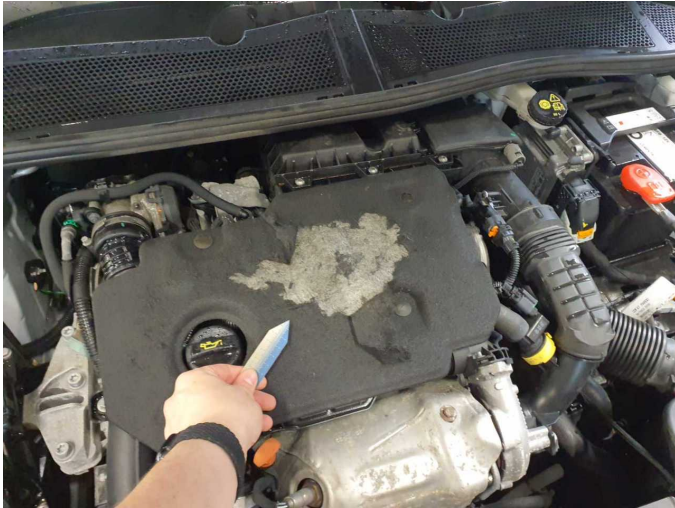
Damage 6: Engine: Engine cover - Broken / torn - Replace

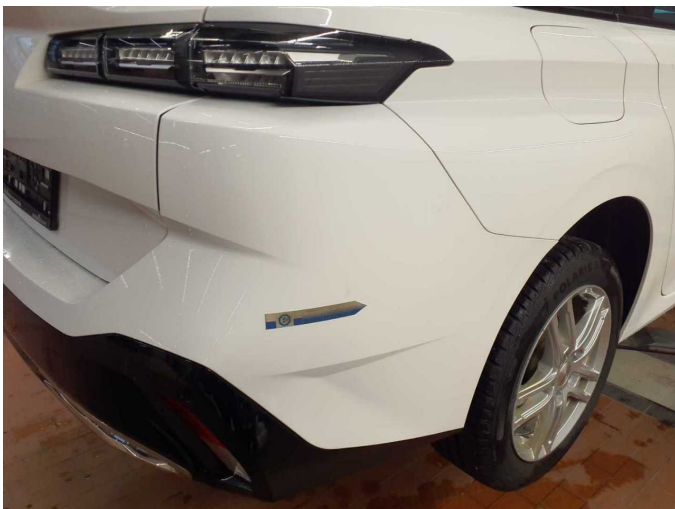
Damage 7: Rear bumper: Rear bumper - Scratch(es) - Paint

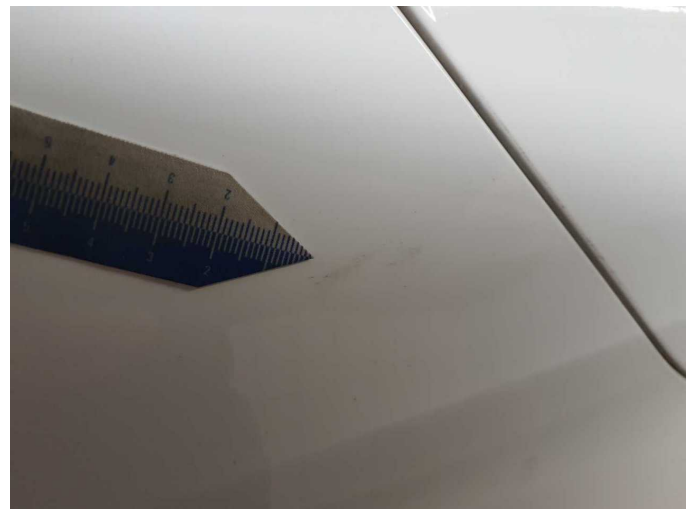
Damage 7: Rear bumper: Rear bumper - Scratch(es) - Paint

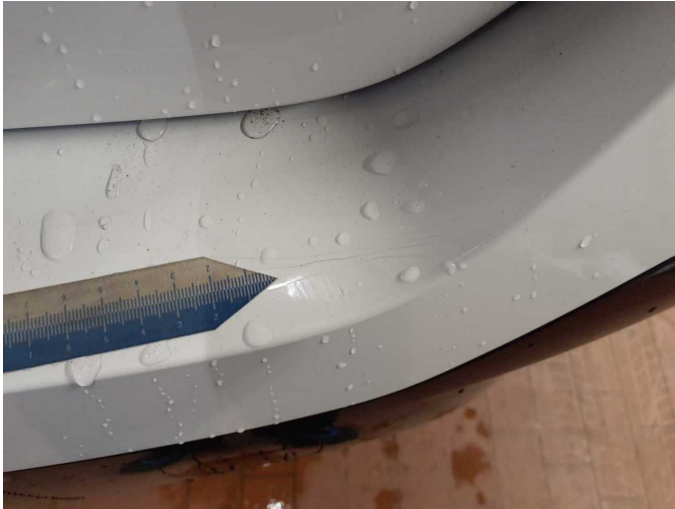
Damage 7: Rear bumper: Rear bumper - Scratch(es) - Paint

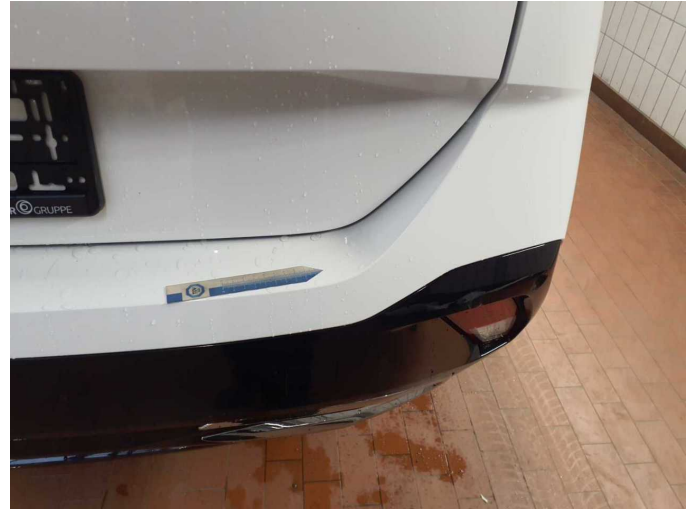
Damage 7: Rear bumper: Rear bumper - Scratch(es) - Paint

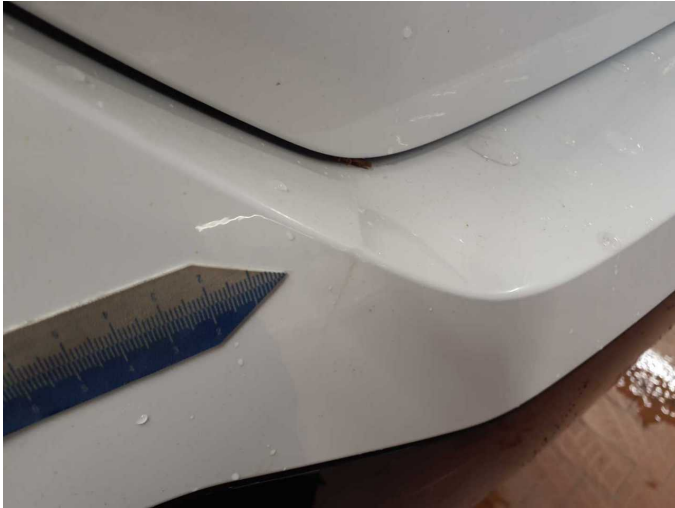
Damage 7: Rear bumper: Rear bumper - Scratch(es) - Paint

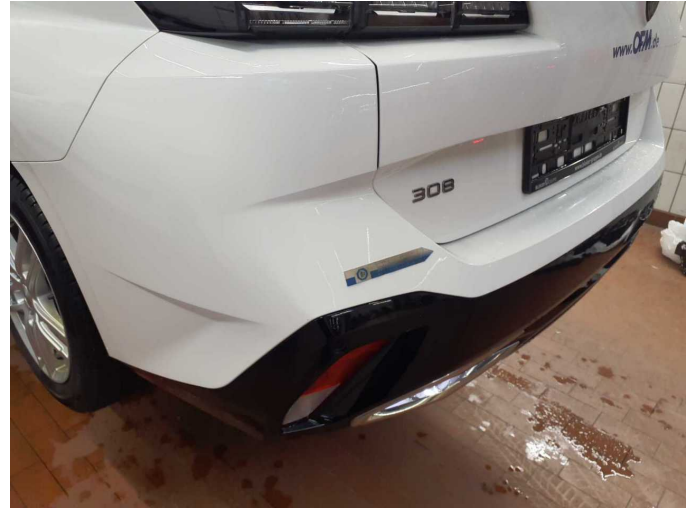
Damage 7: Rear bumper: Rear bumper - Scratch(es) - Paint

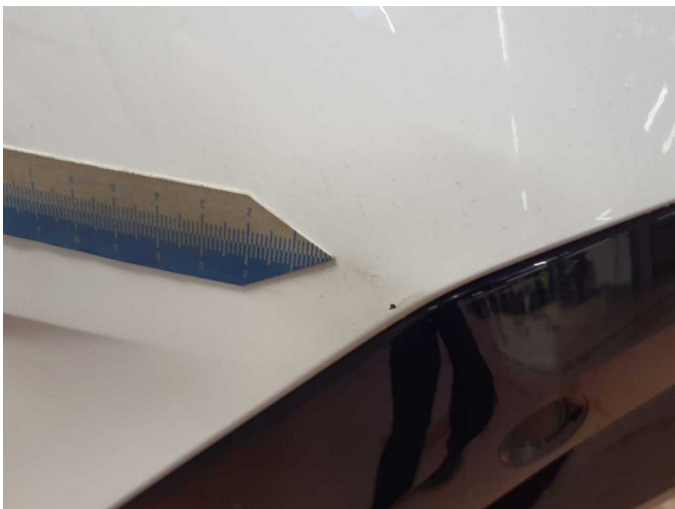
Damage 7: Rear bumper: Rear bumper - Scratch(es) - Paint

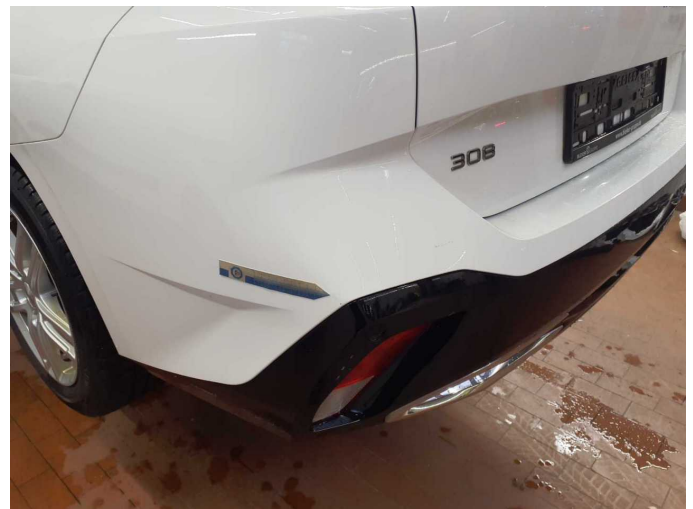
Damage 7: Rear bumper: Rear bumper - Scratch(es) - Paint

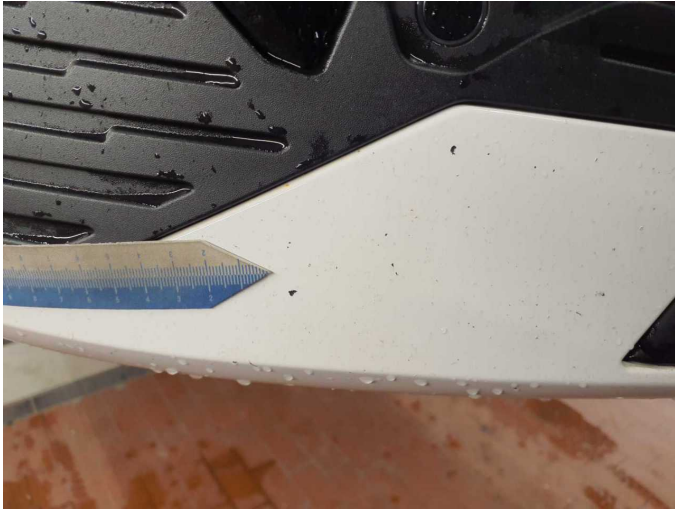
Damage 7: Rear bumper: Rear bumper - Scratch(es) - Paint

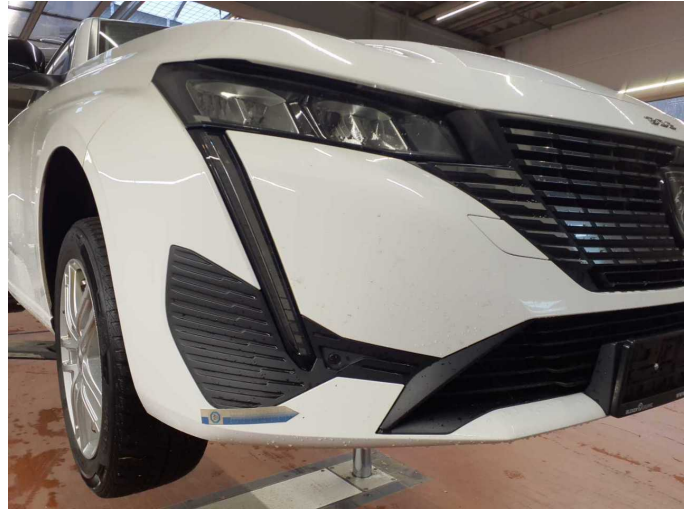
Damage 8: Front bumper: Front bumper - Scratched - Paint

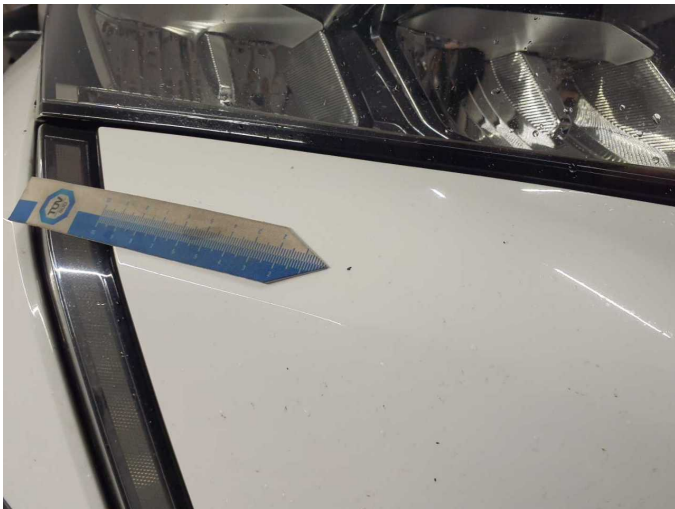
Damage 8: Front bumper: Front bumper - Scratched - Paint

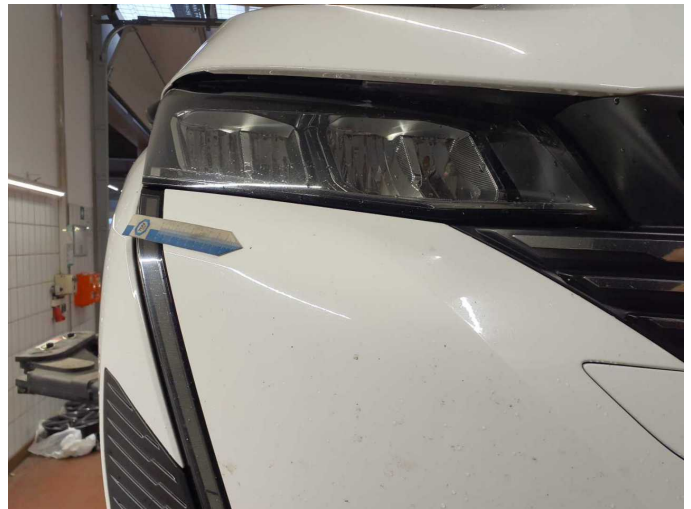
Damage 8: Front bumper: Front bumper - Scratched - Paint

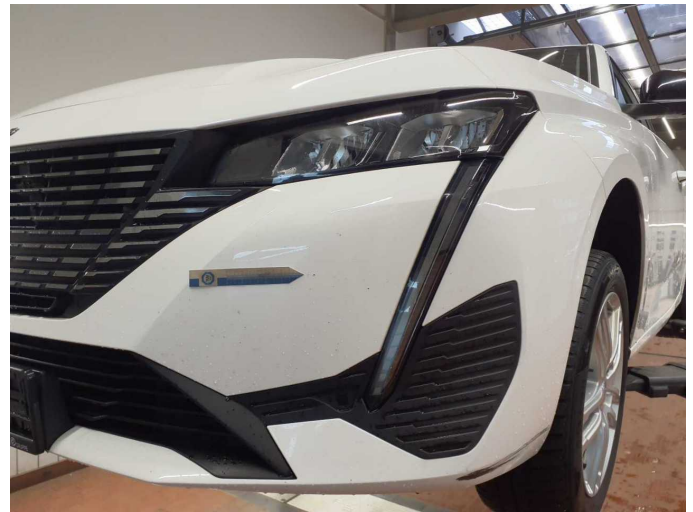
Damage 8: Front bumper: Front bumper - Scratched - Paint

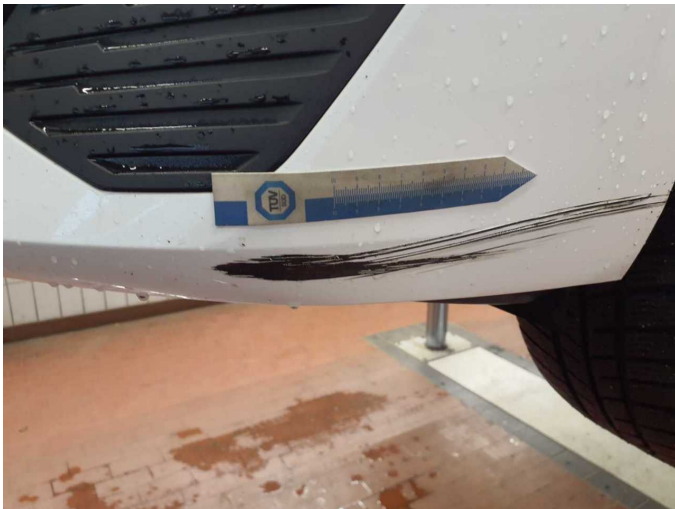
Damage 8: Front bumper: Front bumper - Scratched - Paint

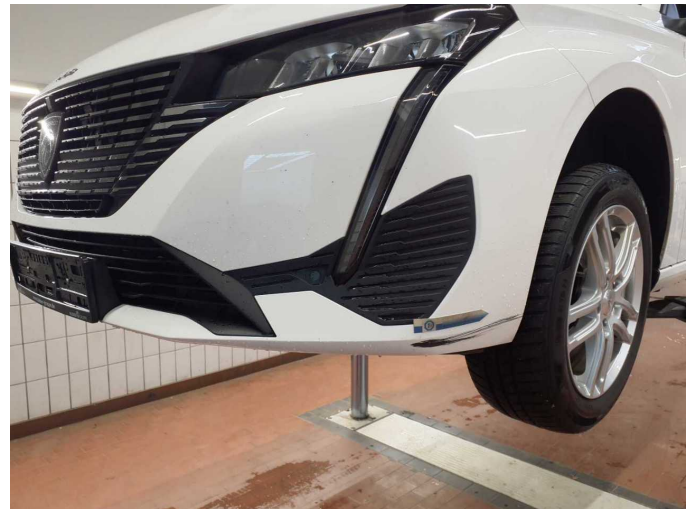
Damage 8: Front bumper: Front bumper - Scratched - Paint

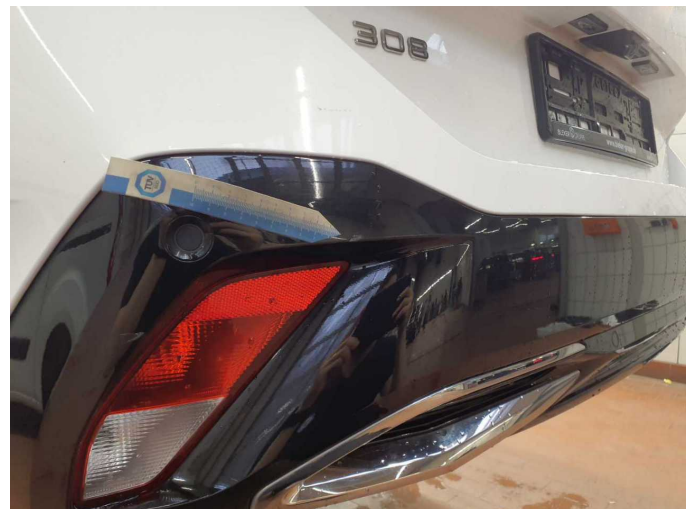
Damage 9: Rear bumper: Spoiler - Scratch(es) - Replace

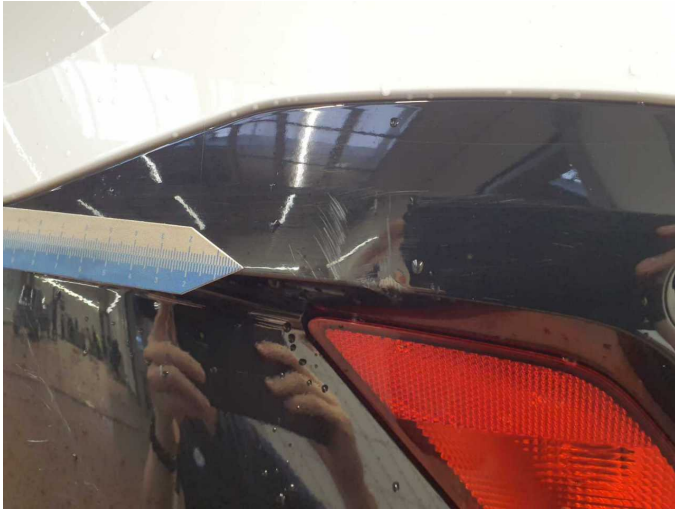
Damage 9: Rear bumper: Spoiler - Scratch(es) - Replace

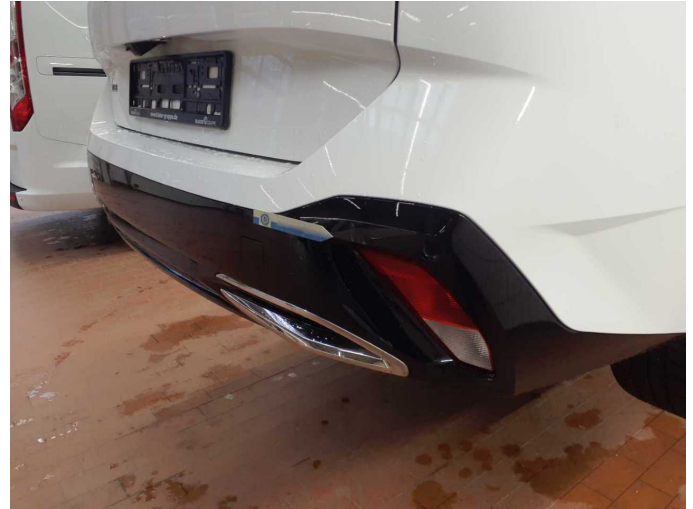
Damage 9: Rear bumper: Spoiler - Scratch(es) - Replace

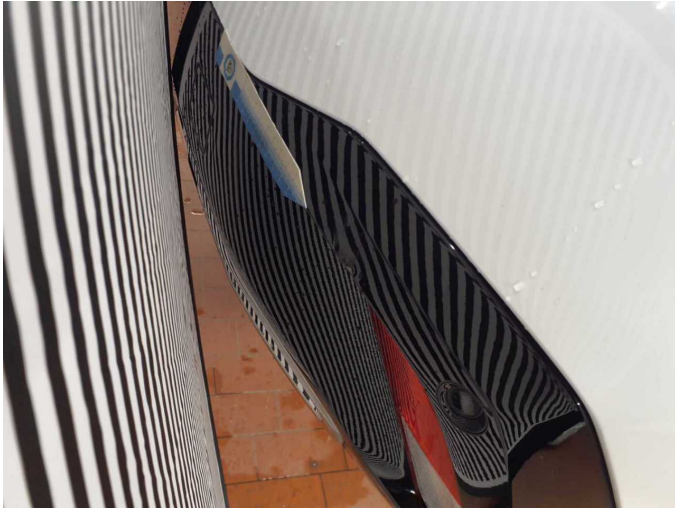
Damage 9: Rear bumper: Spoiler - Scratch(es) - Replace

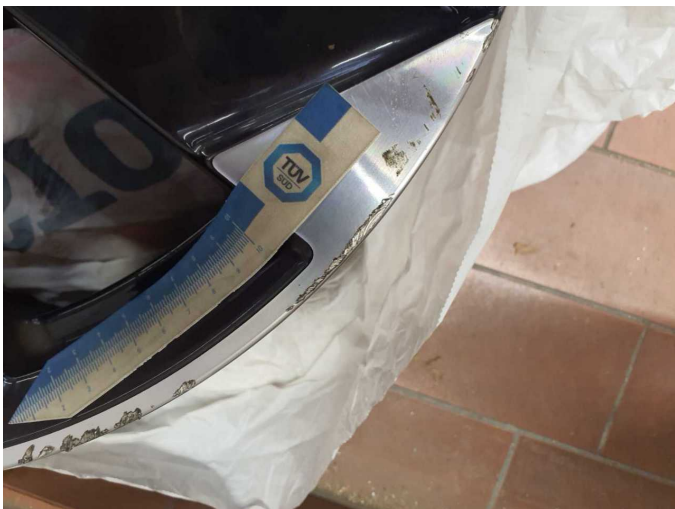
Damage 10: 2nd wheel set: 3 alloy rims - Scratched - Replace

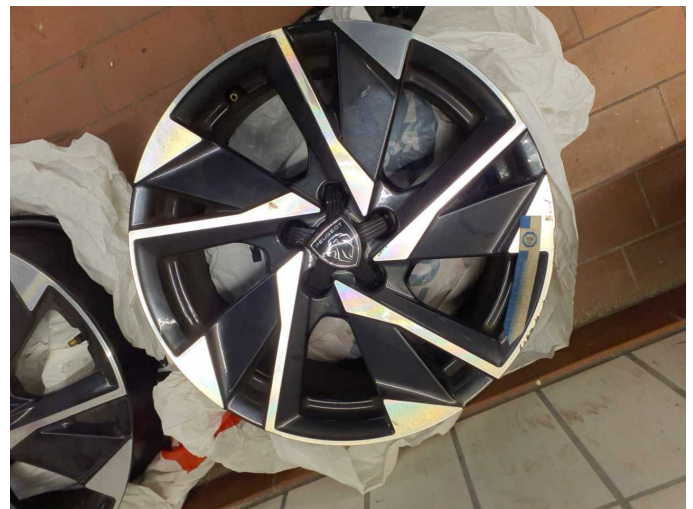
Damage 10: 2nd wheel set: 3 alloy rims - Scratched - Replace

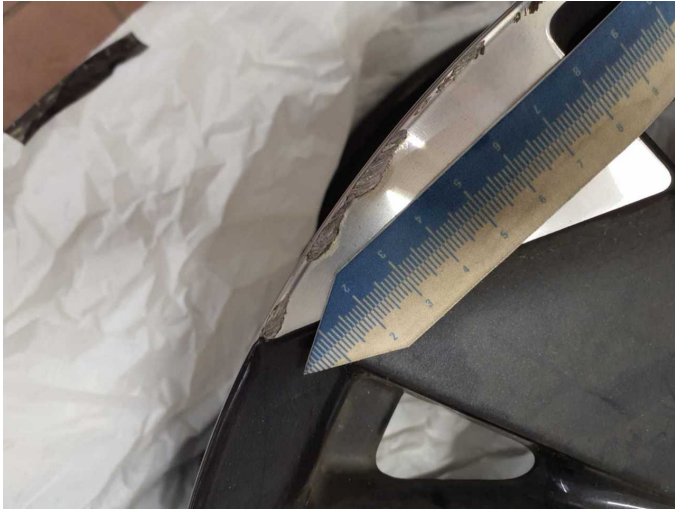
Damage 10: 2nd wheel set: 3 alloy rims - Scratched - Replace

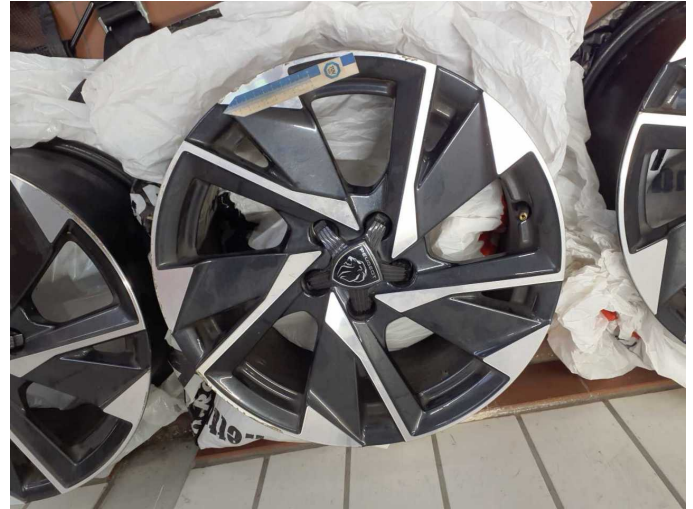
Damage 10: 2nd wheel set: 3 alloy rims - Scratched - Replace

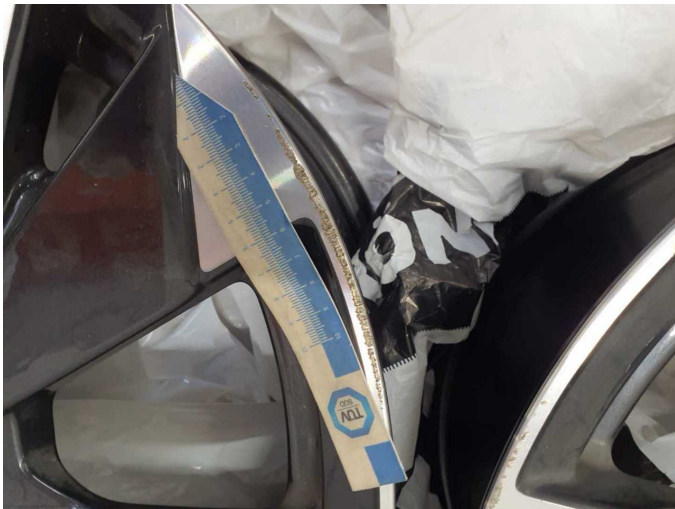
Damage 10: 2nd wheel set: 3 alloy rims - Scratched - Replace

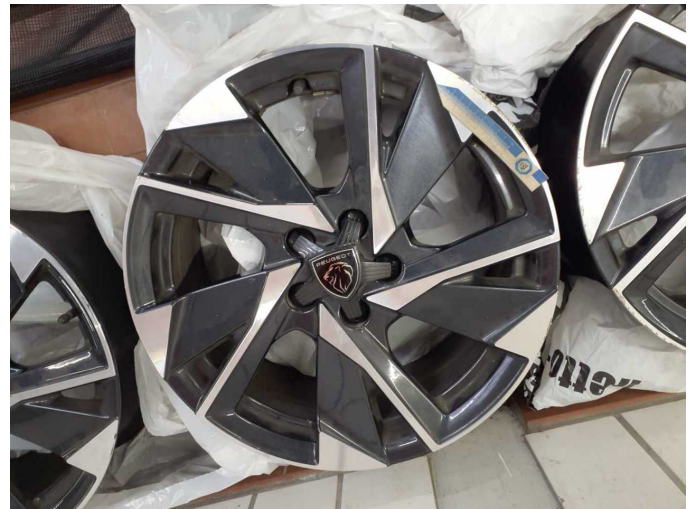
Damage 10: 2nd wheel set: 3 alloy rims - Scratched - Replace

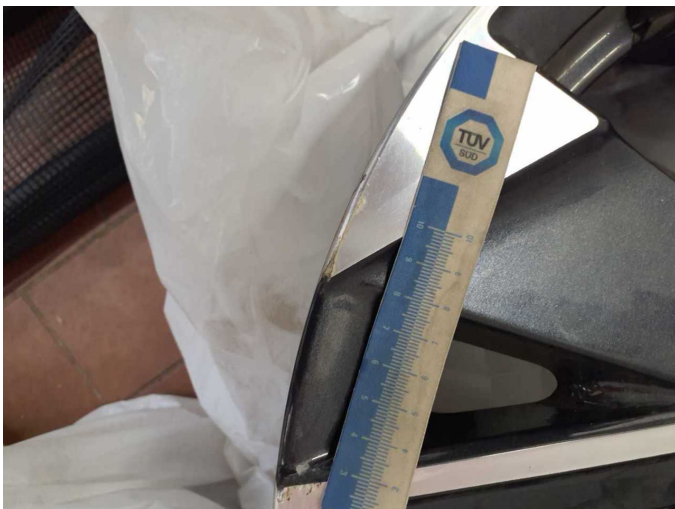
Damage 10: 2nd wheel set: 3 alloy rims - Scratched - Replace

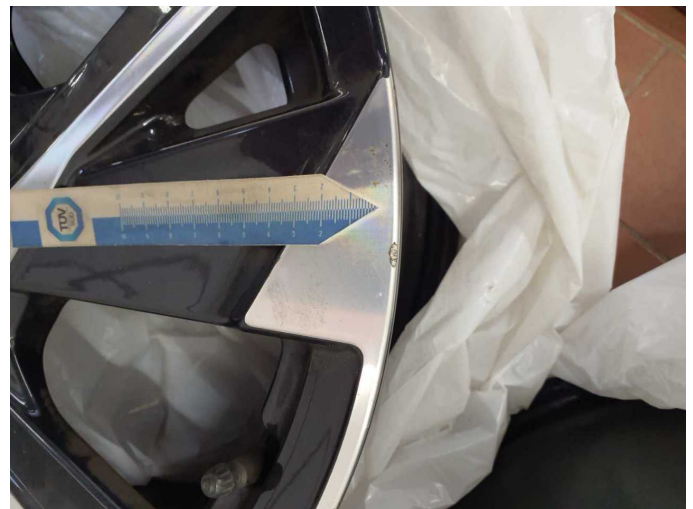
Damage 10: 2nd wheel set: 3 alloy rims - Scratched - Replace

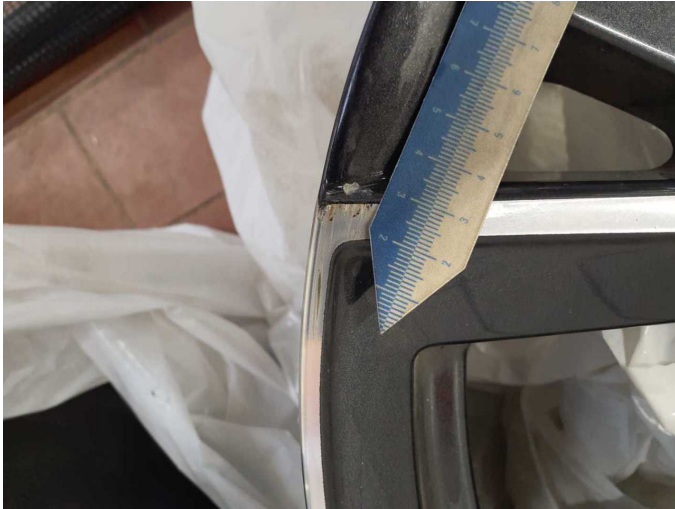
Damage 10: 2nd wheel set: 3 alloy rims - Scratched - Replace

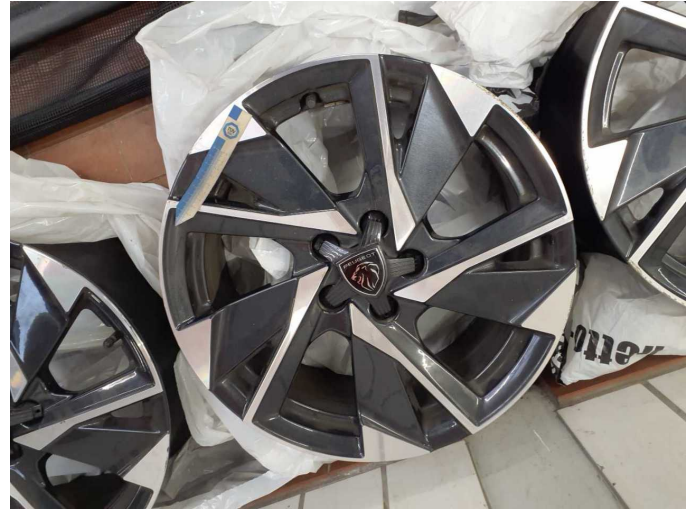
Damage 10: 2nd wheel set: 3 alloy rims - Scratched - Replace

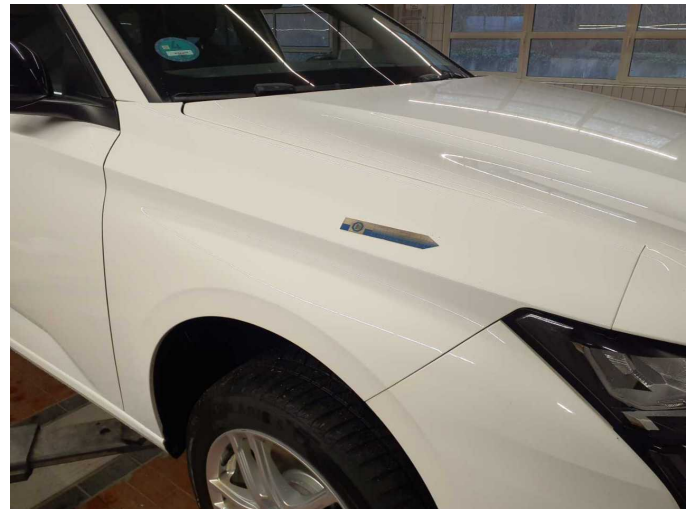
Wear and tear 1: Mudguard - right side: Mudguard - right side - Stone chips - No deduction

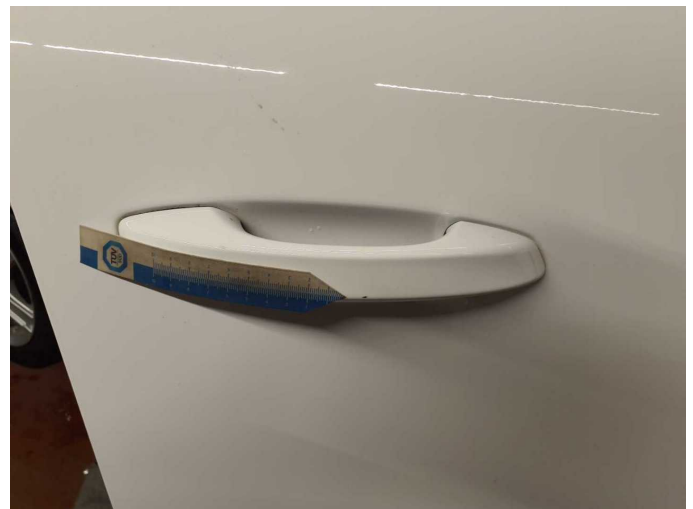
Wear and tear 2: Door - front right side: Door handle - outside - Scratch(es) - No deduction

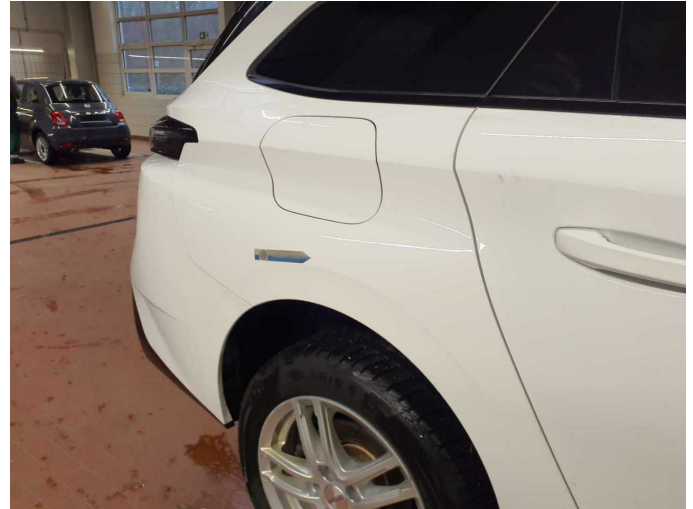
Wear and tear 3: Side panel - rear right side: Side panel (Auslegen / Polieren) - Scratch(es) - No deduction

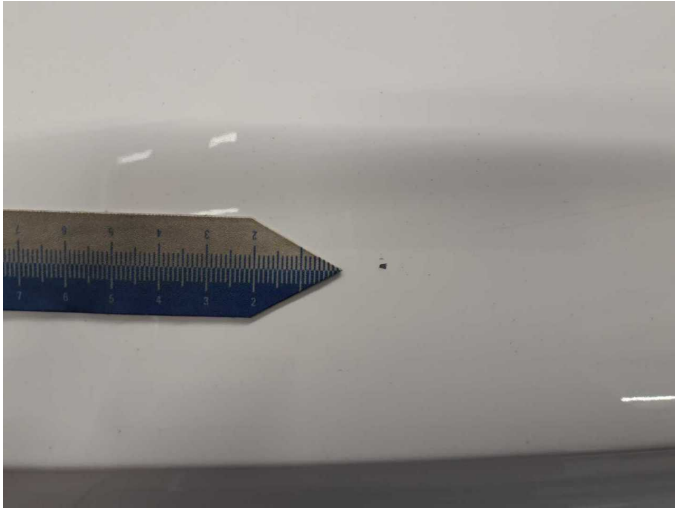
Wear and tear 3: Side panel - rear right side: Side panel (Auslegen / Polieren) - Scratch(es) - No deduction

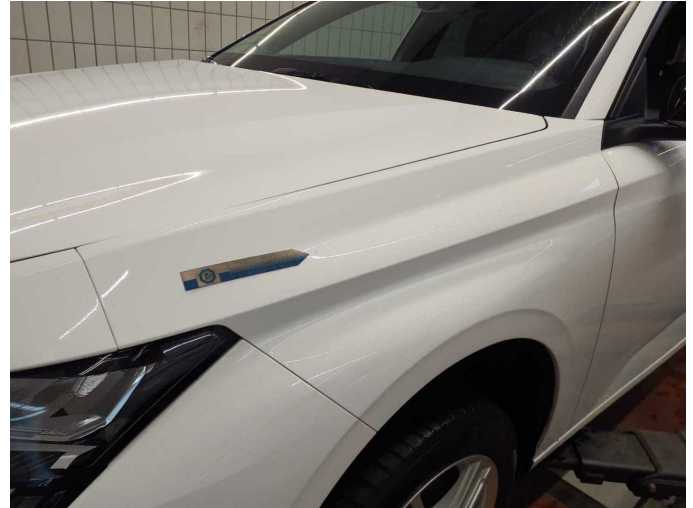
Wear and tear 4: Mudguard - left side: Mudguard - left side - Stone chips - No deduction

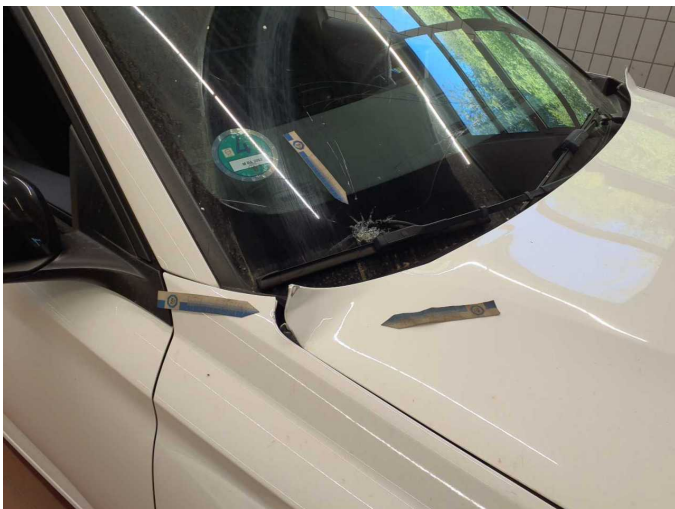
Wear and tear 4: Mudguard - left side: Mudguard - left side - Stone chips - No deduction
