Expertise

Protocol number: 46311059
Order No. / Reference: 26543486
Inspection date: 2 Jul 2026

Model: Mondeo Turnier 2.0 EcoBlue Aut. VIGNALE

VIN: WF0FXXWPCFNS68620

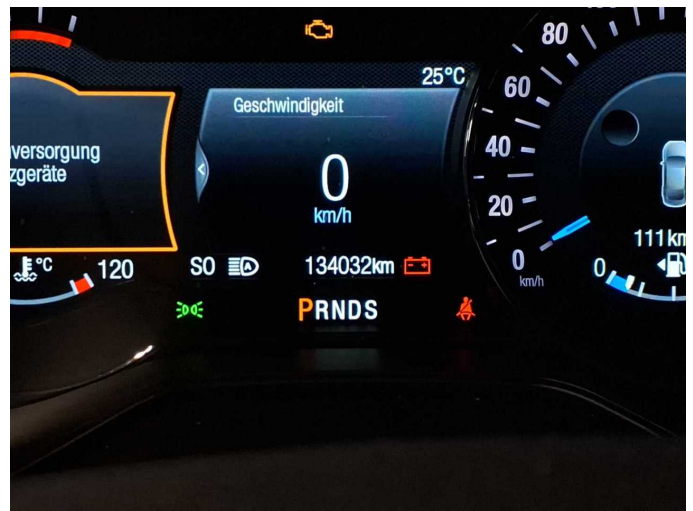
Damage 2: Misc.: Inspection / maintenance - No evidence - No deduction

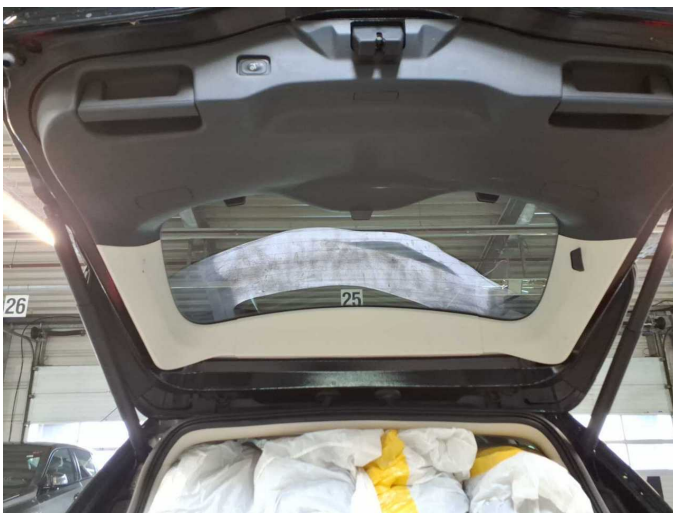
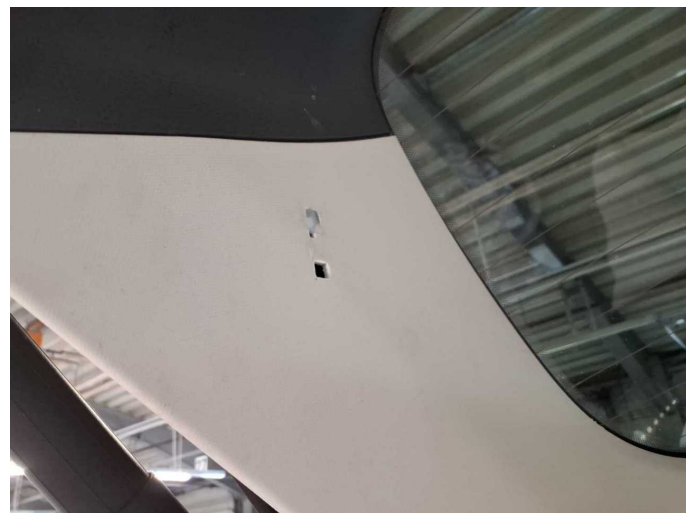
Damage 3: Trim / covers: Boot lid - interior trim (Halter) - Missing - Repair

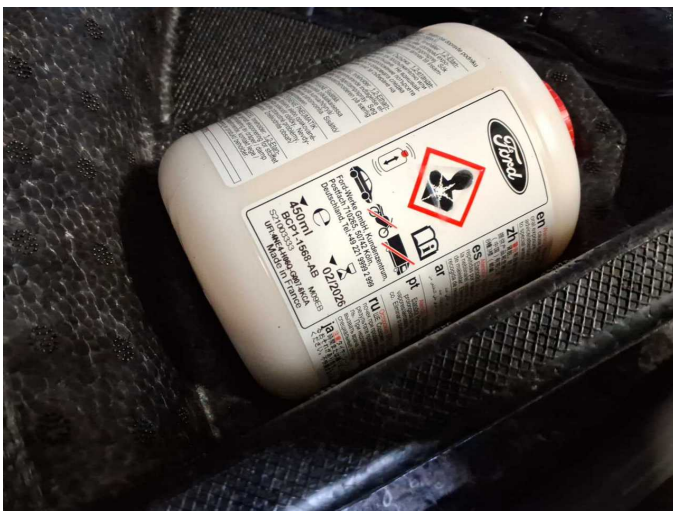
Damage 4: Equipment: Tirefit filler - Expired - Replace

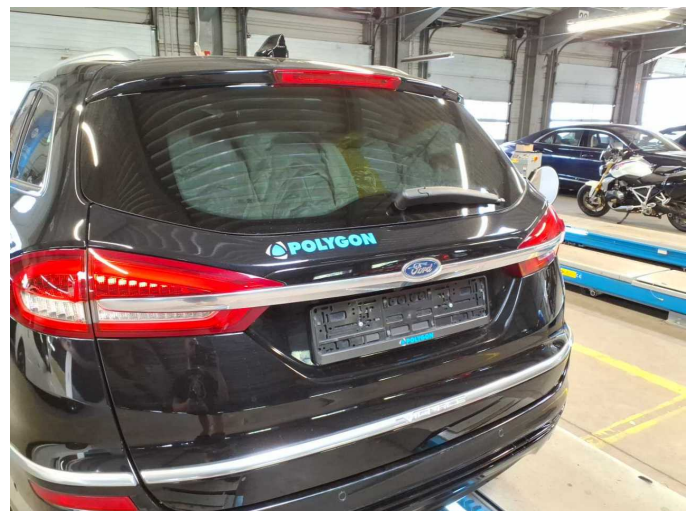
Damage 5: Body: Body - Glued / labelled - De-glue / neutralise

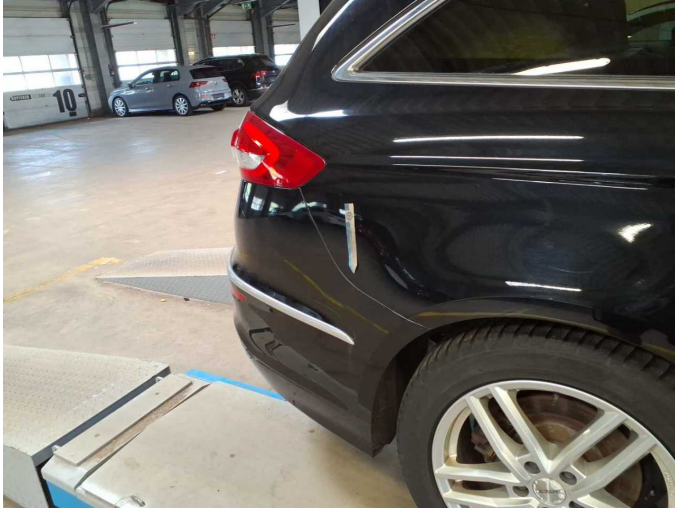
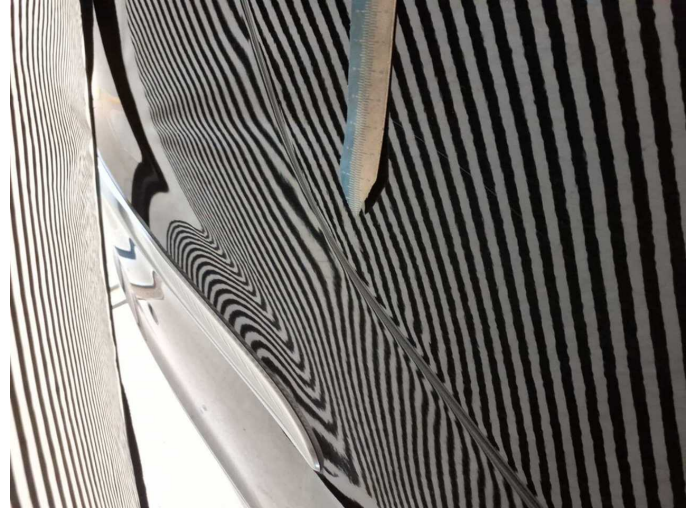
Damage 6: Side panel - rear right side: Side panel - dent(s) - Smooth repair work

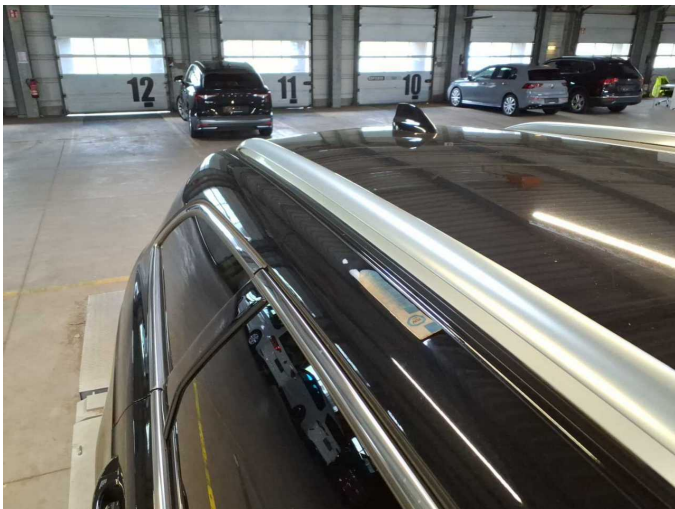
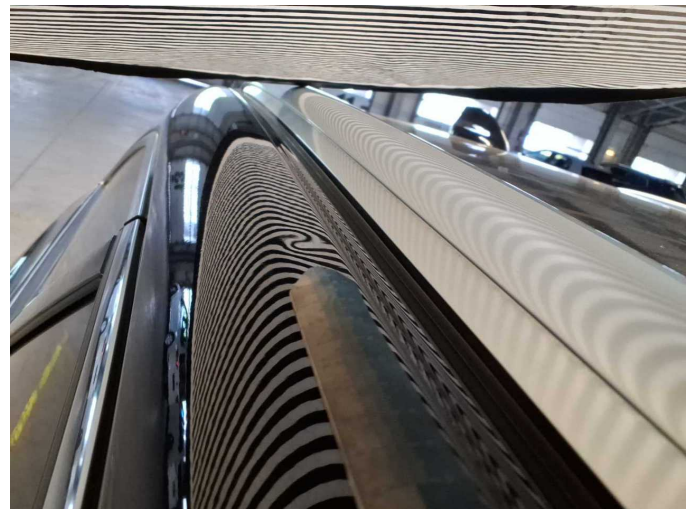
Damage 7: Roof: Roof rail - right side - dent(s) - Smooth repair work

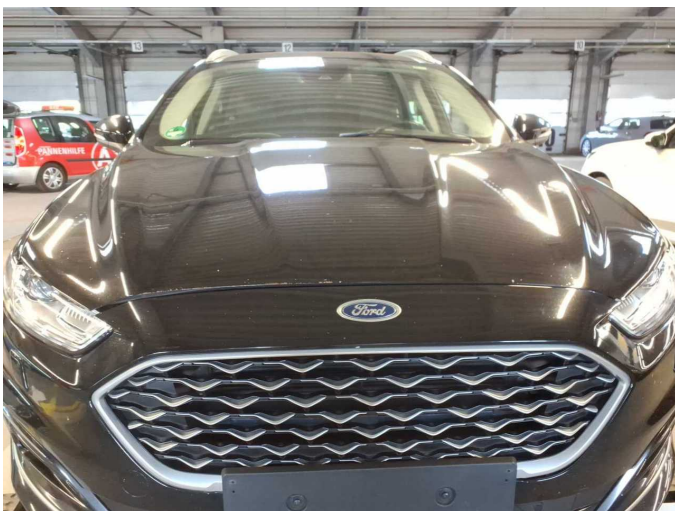
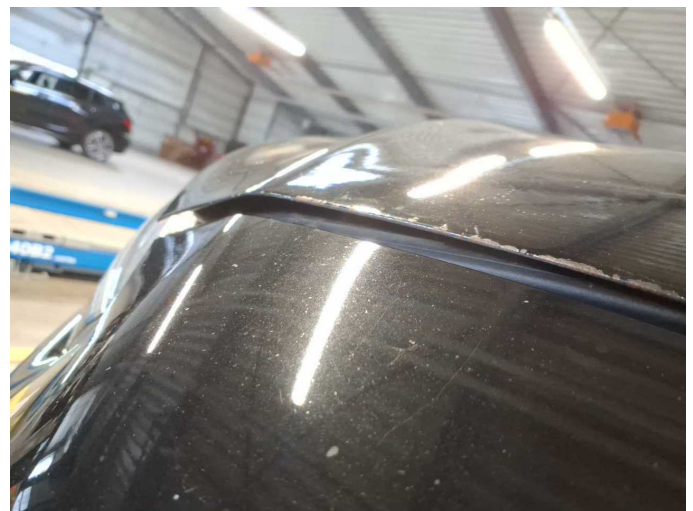
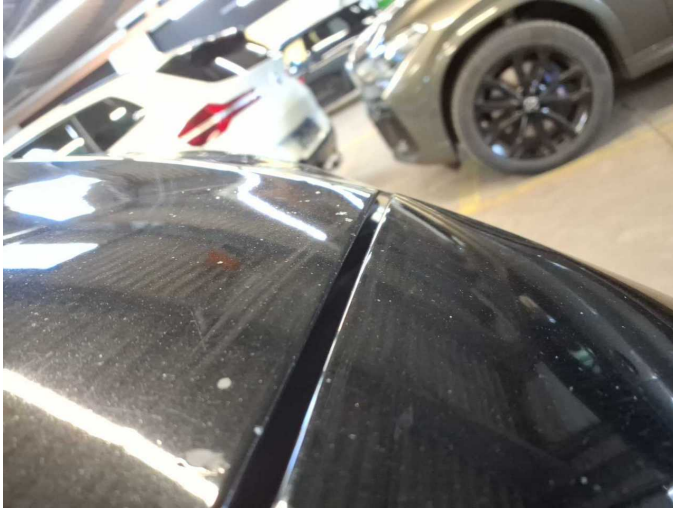
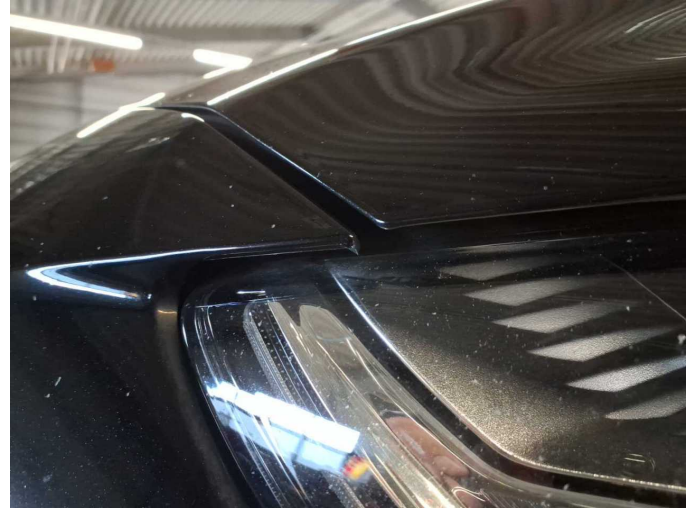
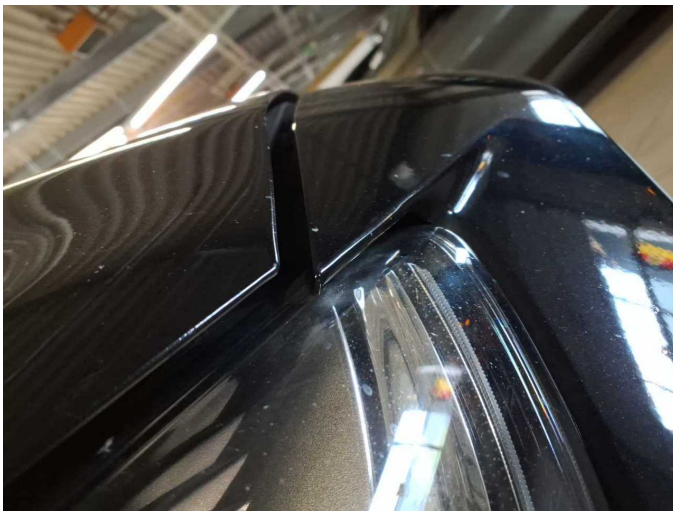
Damage 8: Bonnet: Bonnet - Malposition - Set / adjust

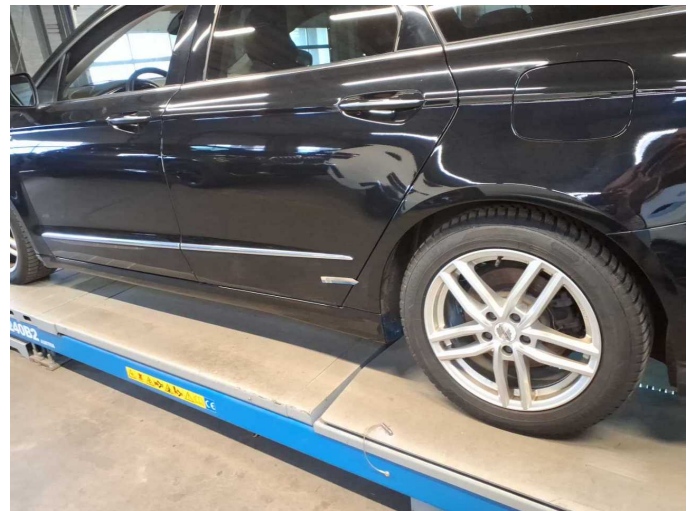
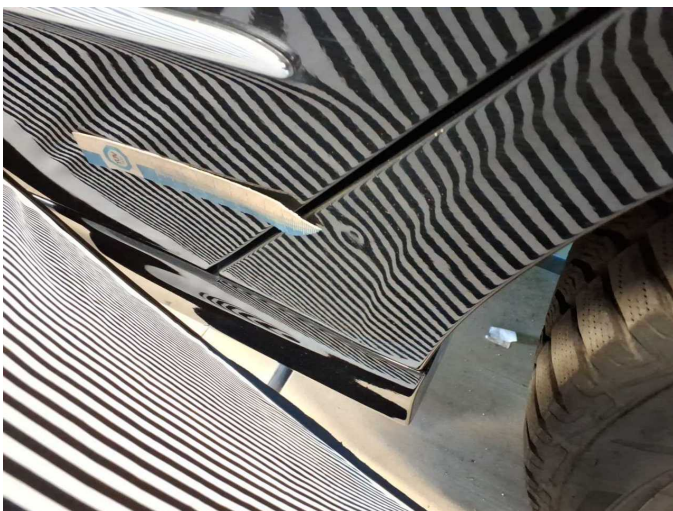
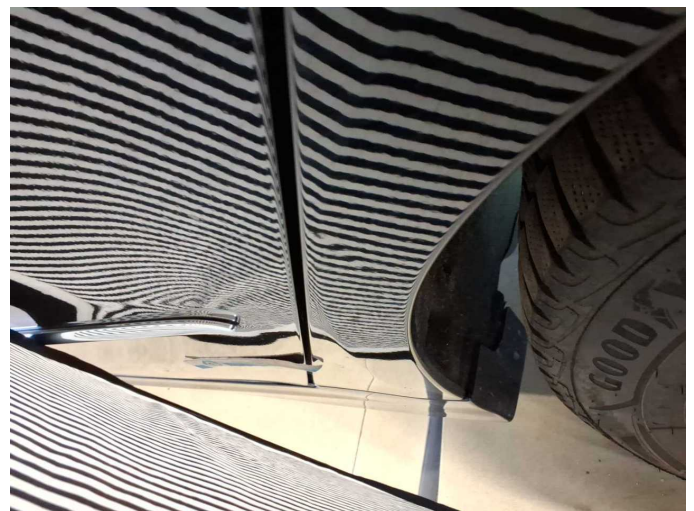
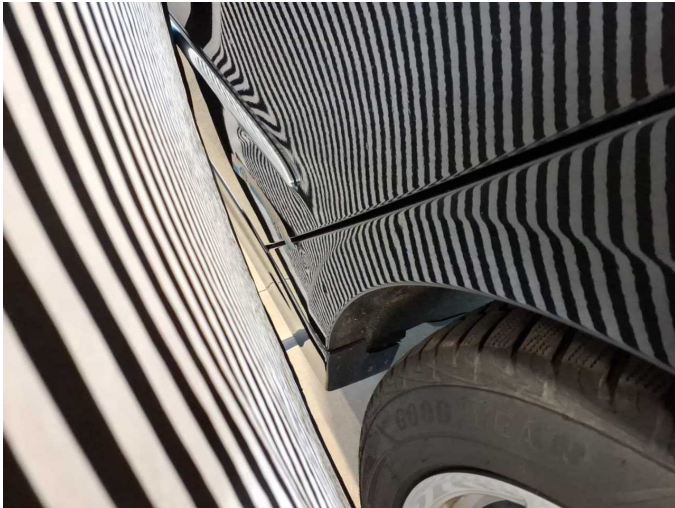
Damage 9: Side panel - rear left side: Side panel - dent(s) - Smooth repair work

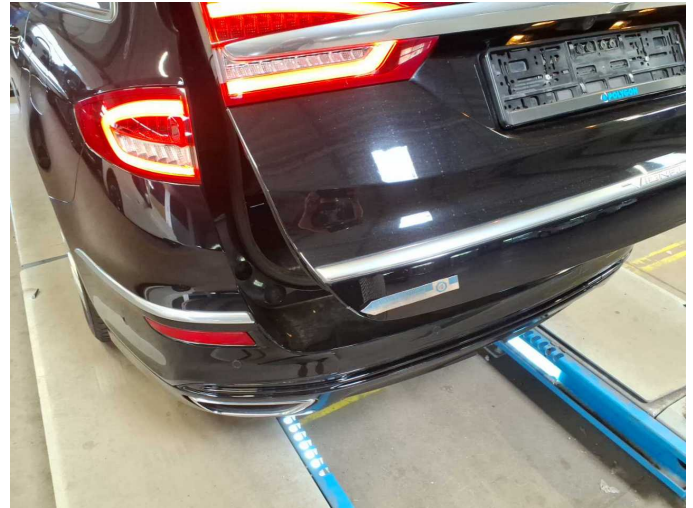
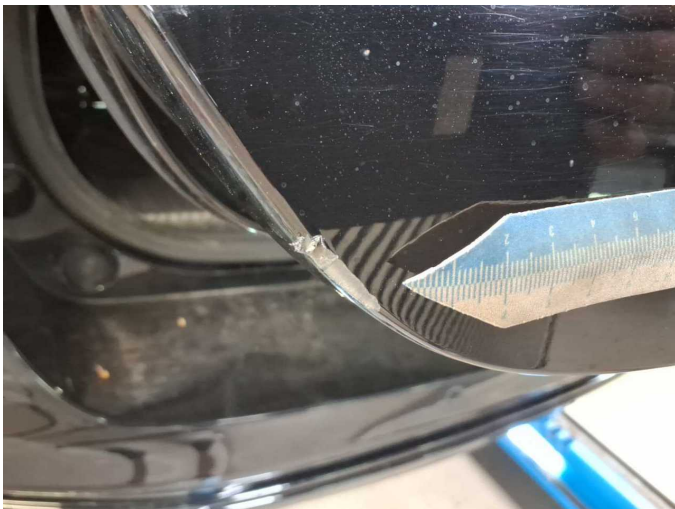
Damage 10: Boot lid / rear door: Boot lid - Scratch(es) - Smart repair

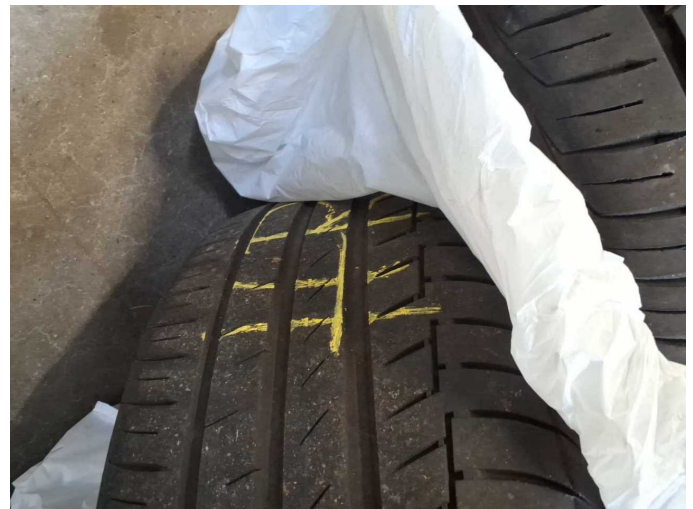
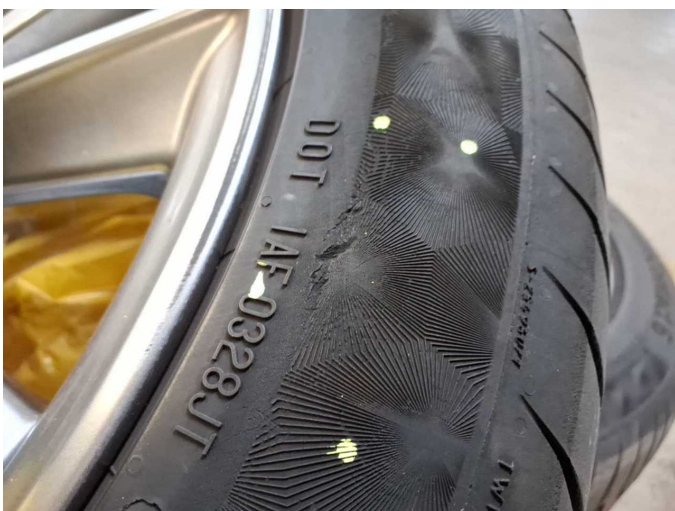
Damage 11: 2nd wheel set: 1 tyre (Flanke) - Damaged - Replace

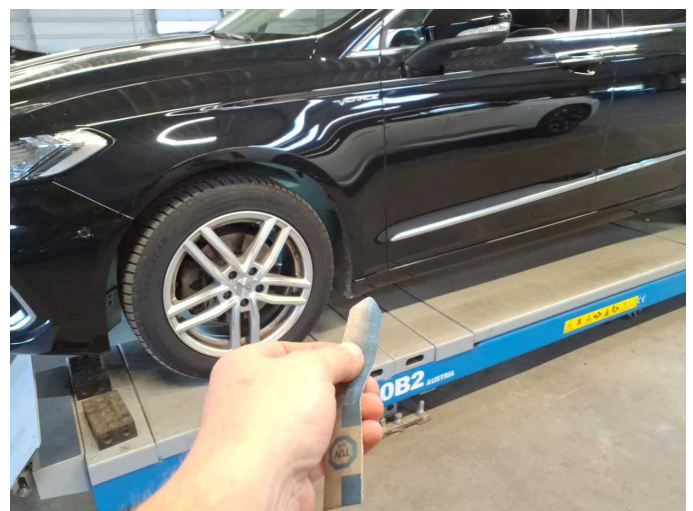
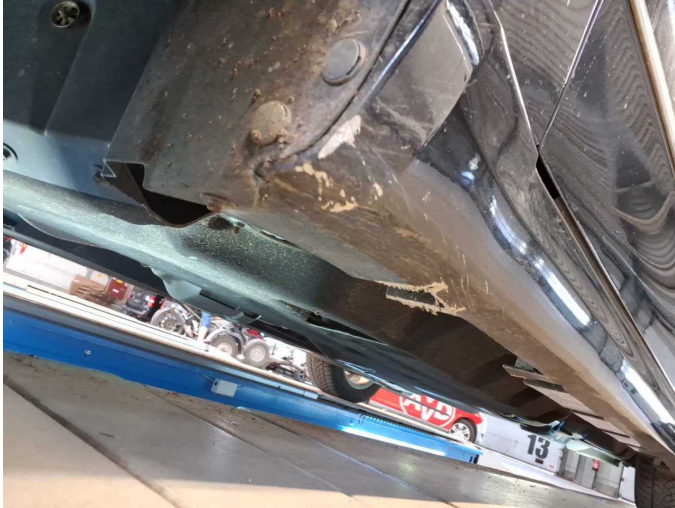
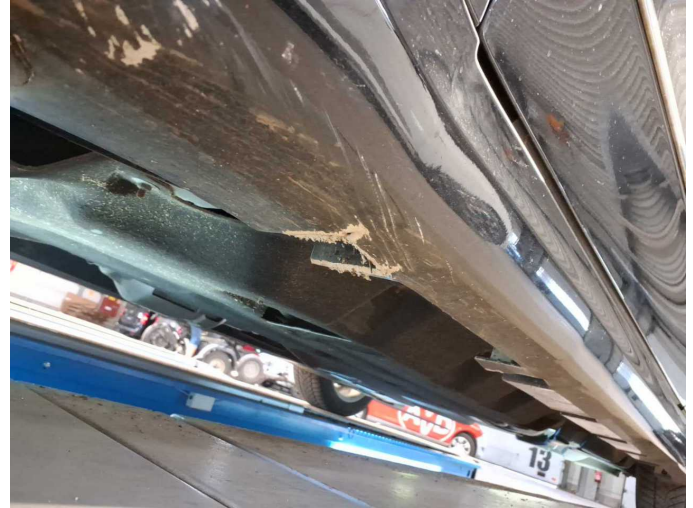
Damage 12: Sill - left side: Sill (Verkleidung) - Scratched - Replace

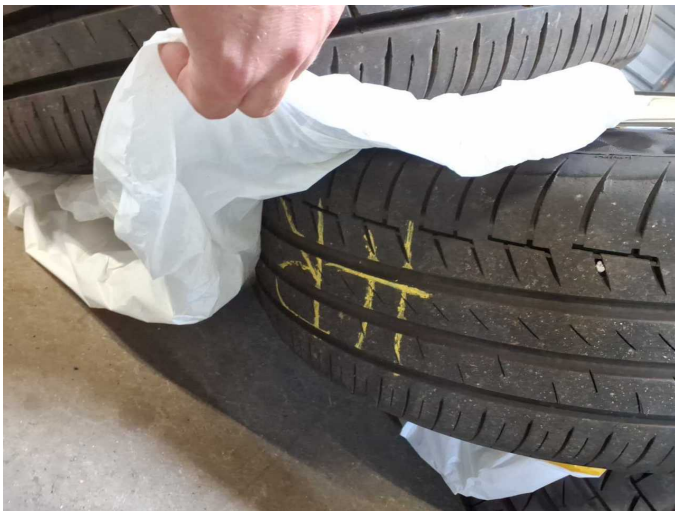
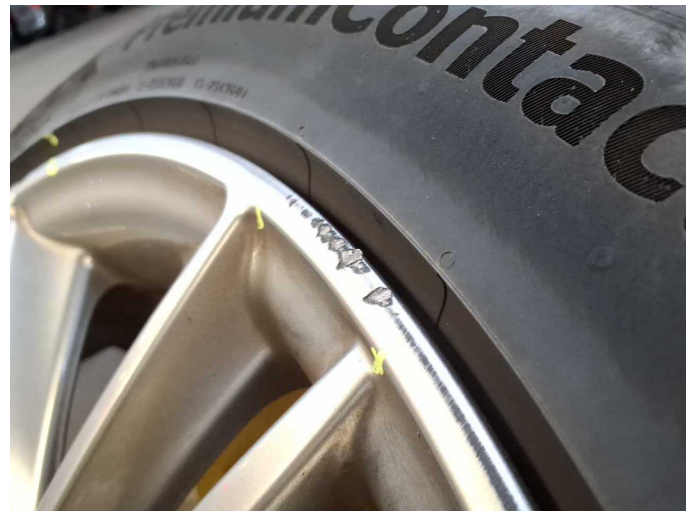
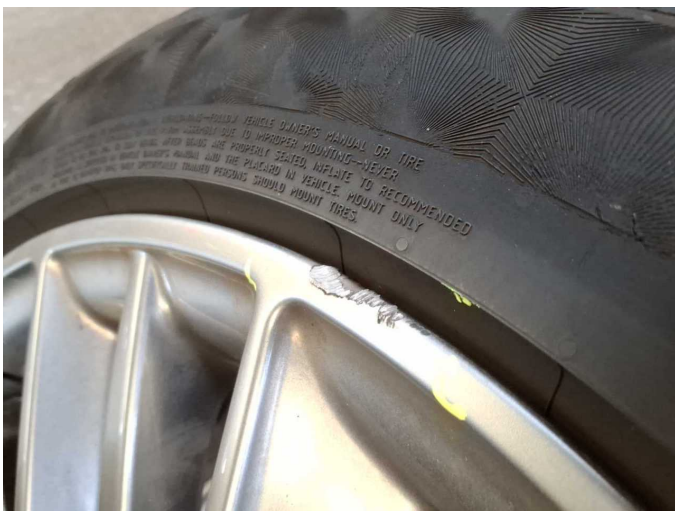
Damage 13: 2nd wheel set: 1 alloy rim (Materialabtrag) - Scratched - Replace

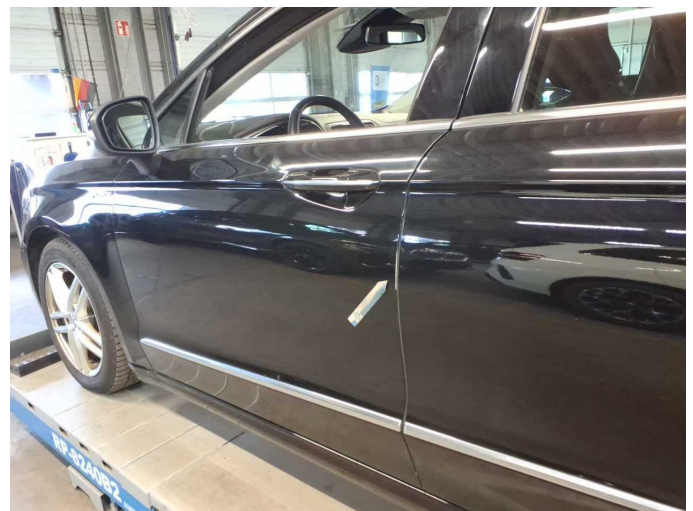
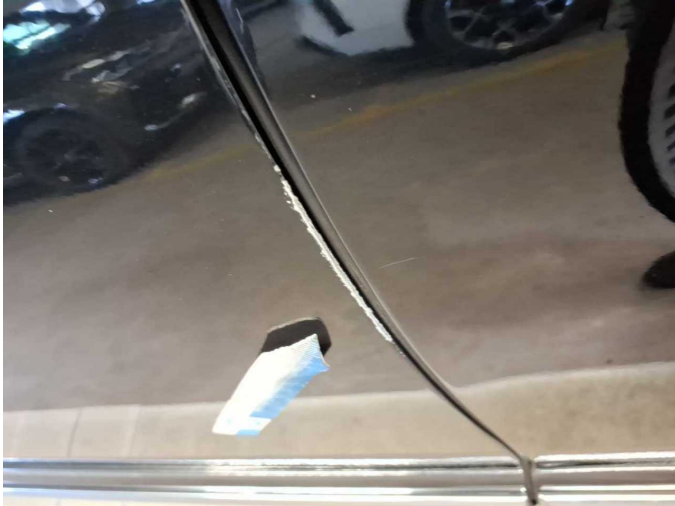
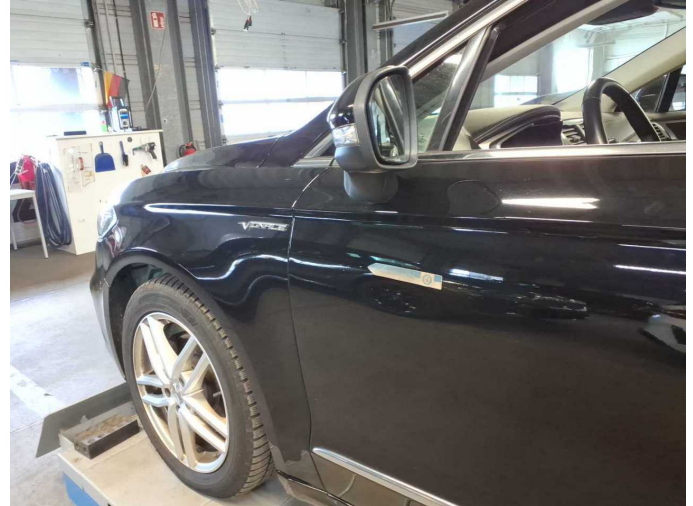
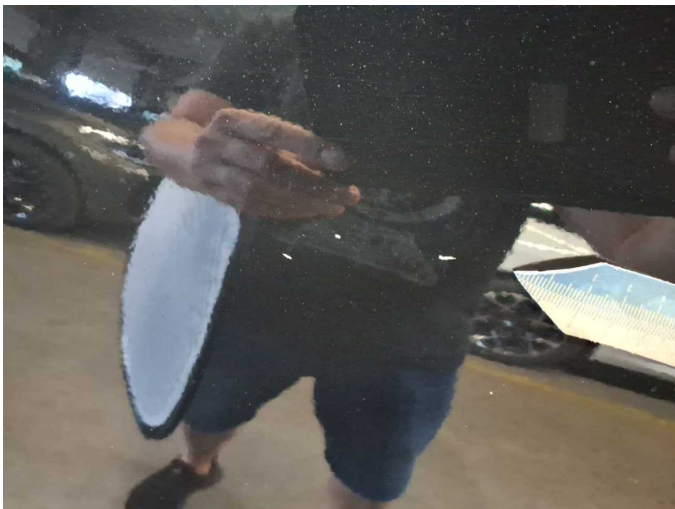
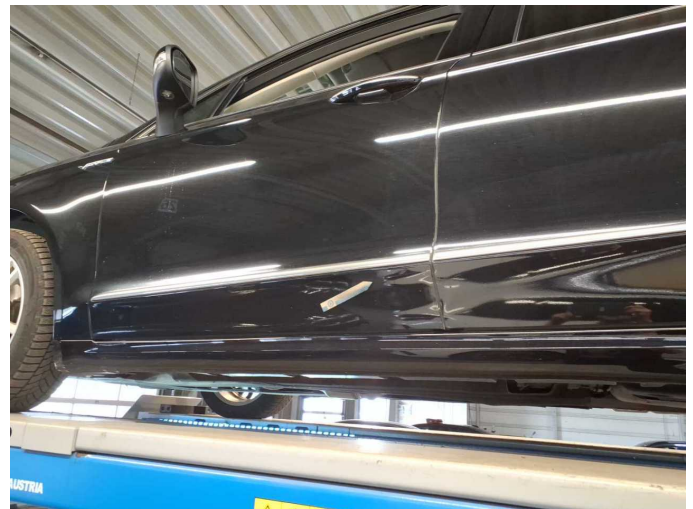
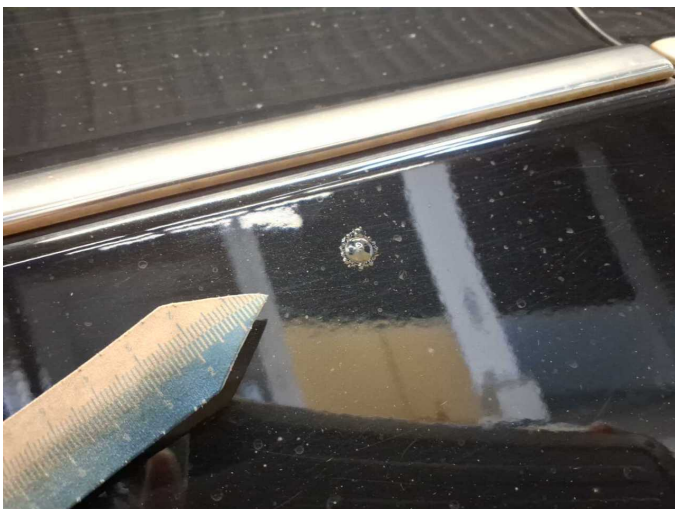
Damage 14: Door - front left side: Door (Rostpickel) - Scratched - Repair and paint

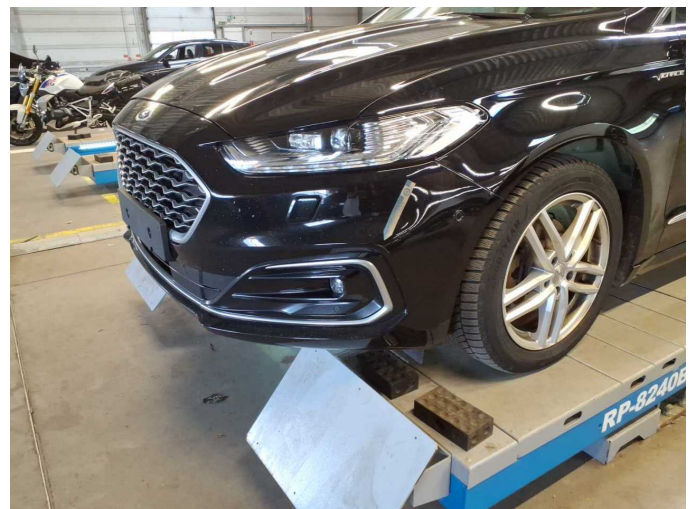
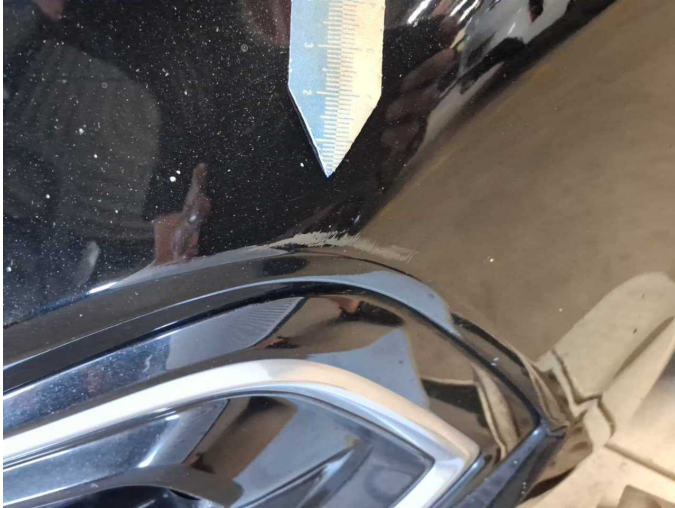
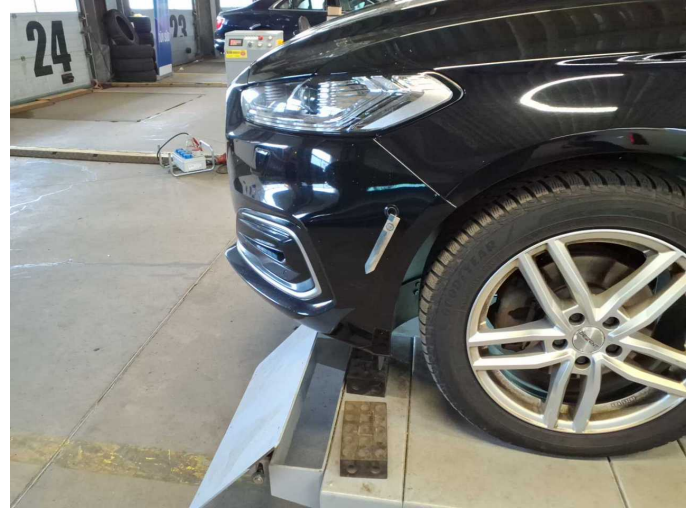
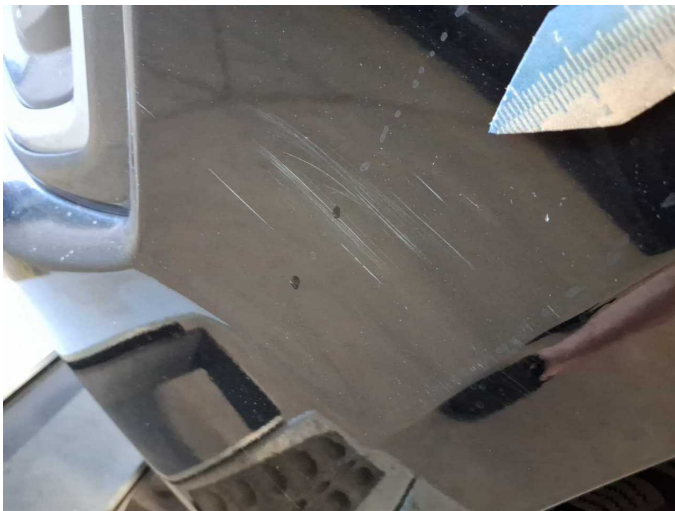
Damage 15: Front bumper: Front bumper - Scratched - Paint

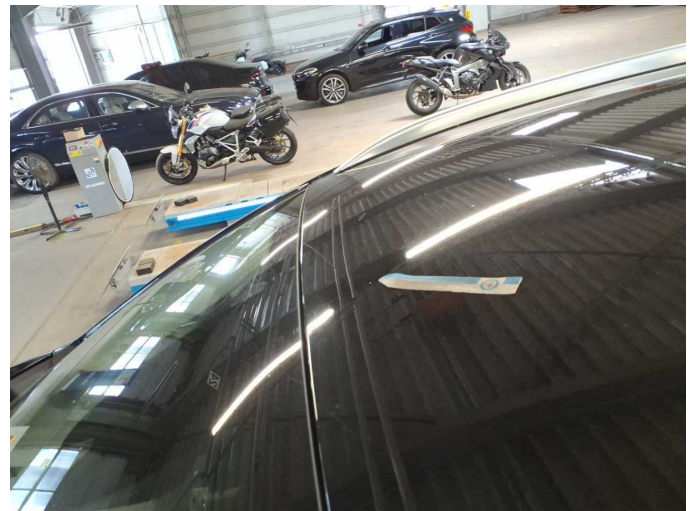
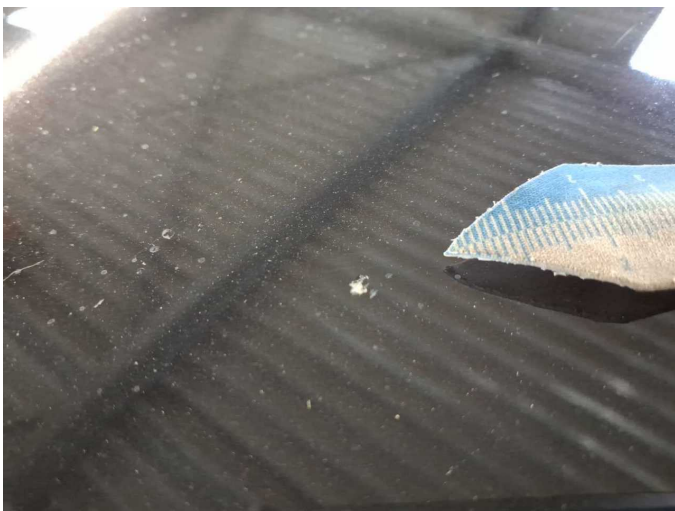
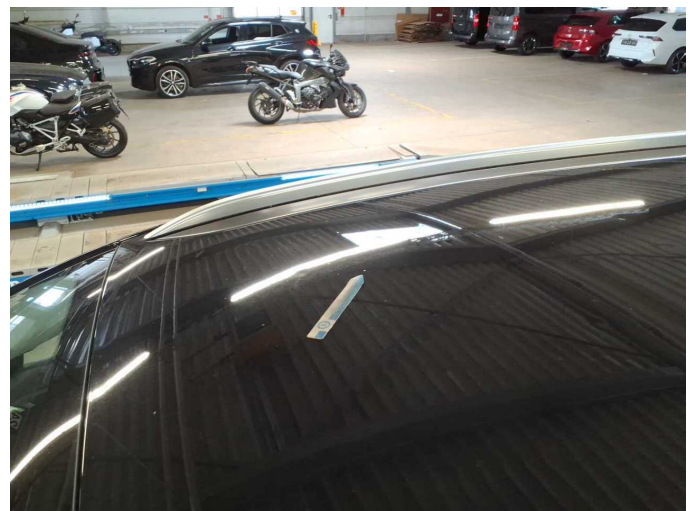
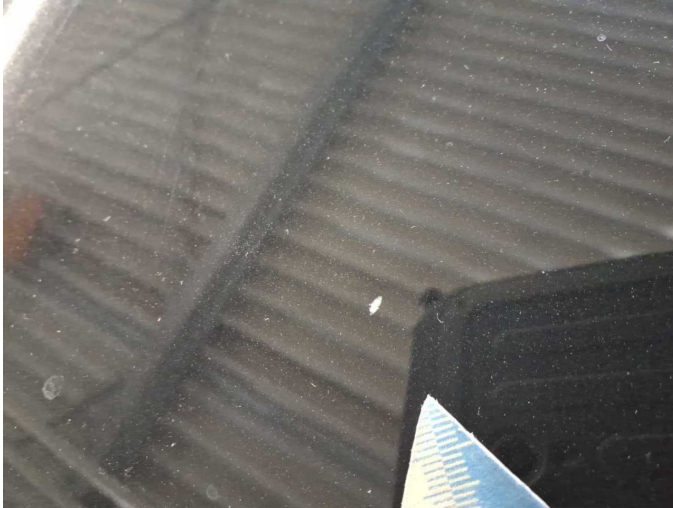
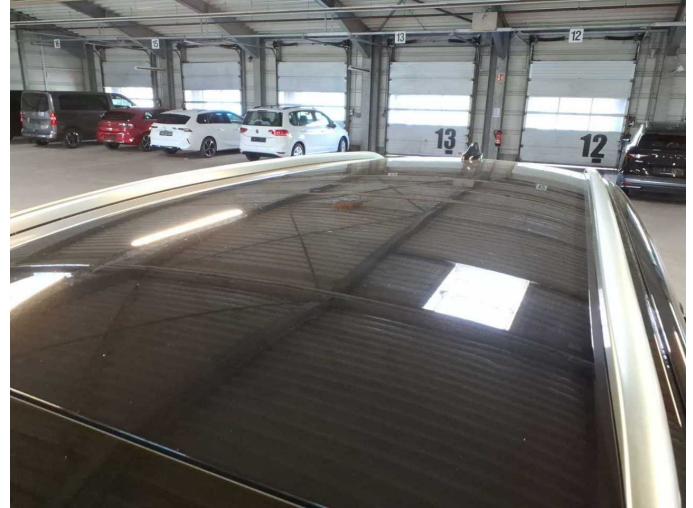
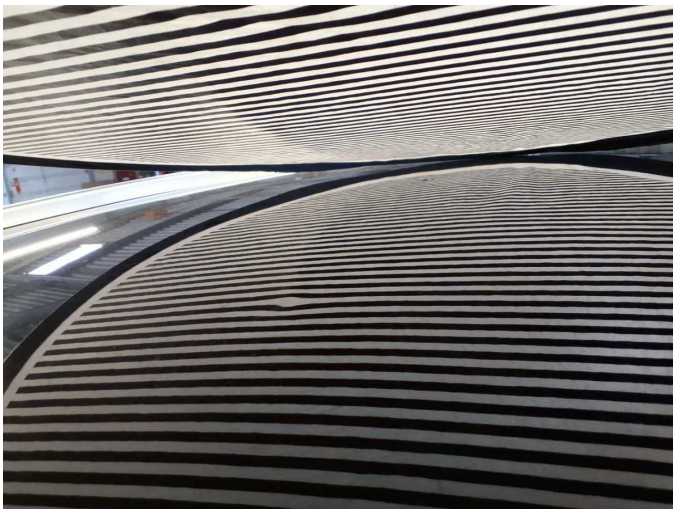
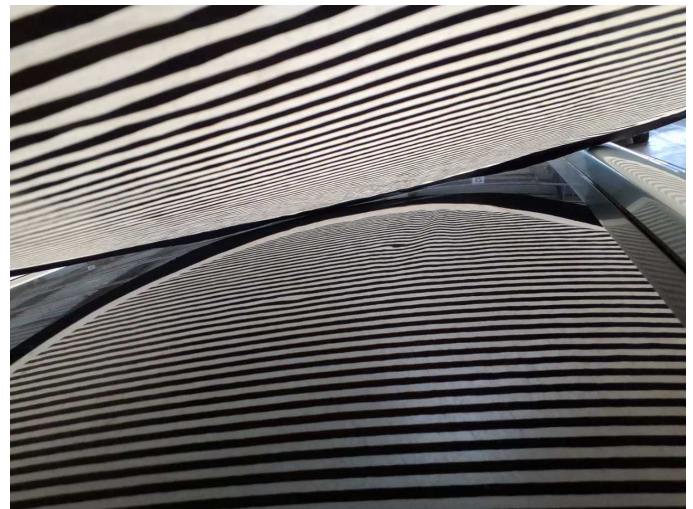
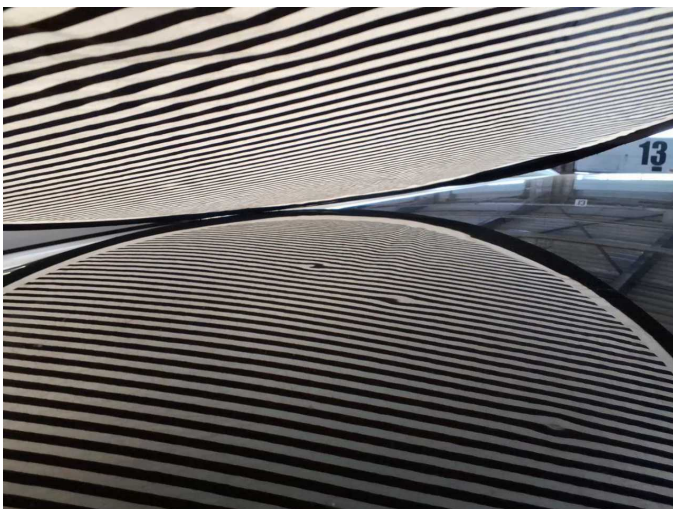
Damage 16: Roof: Roof - dent(s) - Smooth repair work

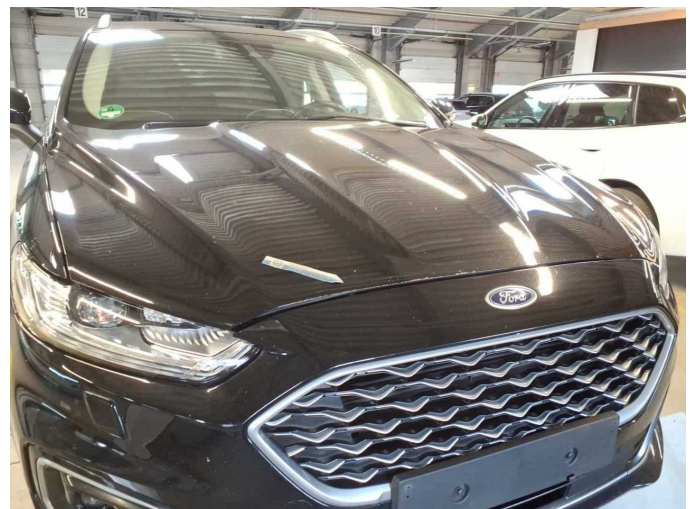
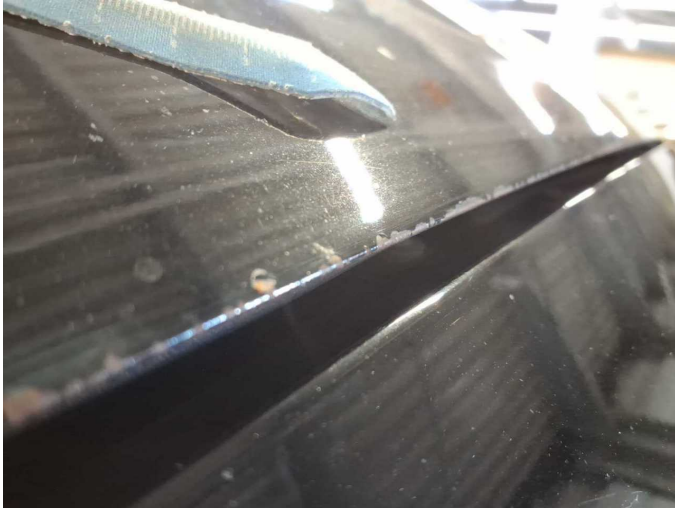
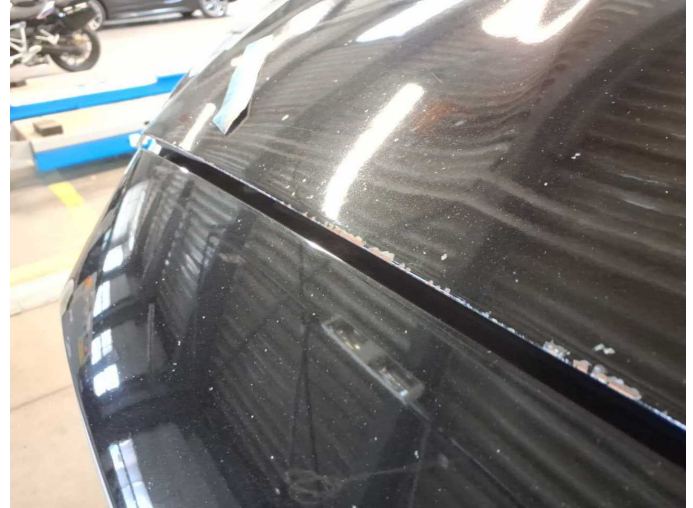
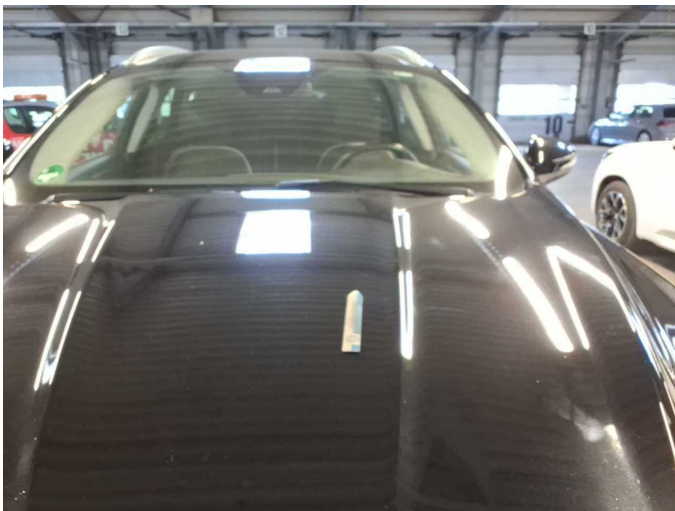
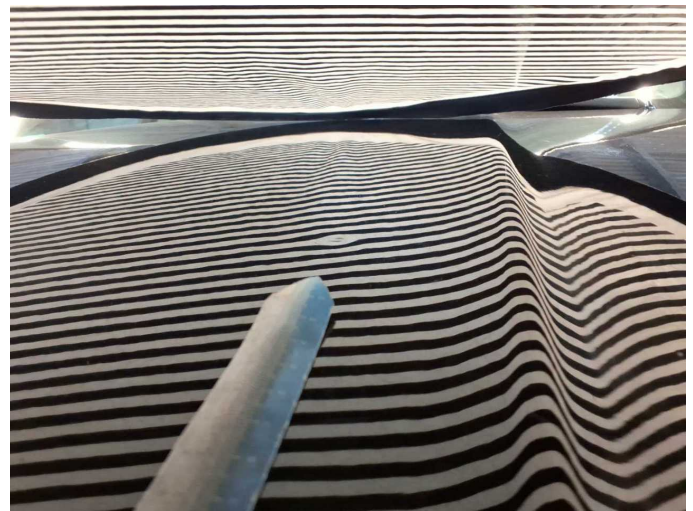
Damage 17: Bonnet: Bonnet (Dellen) - Corrosion - Repair and paint

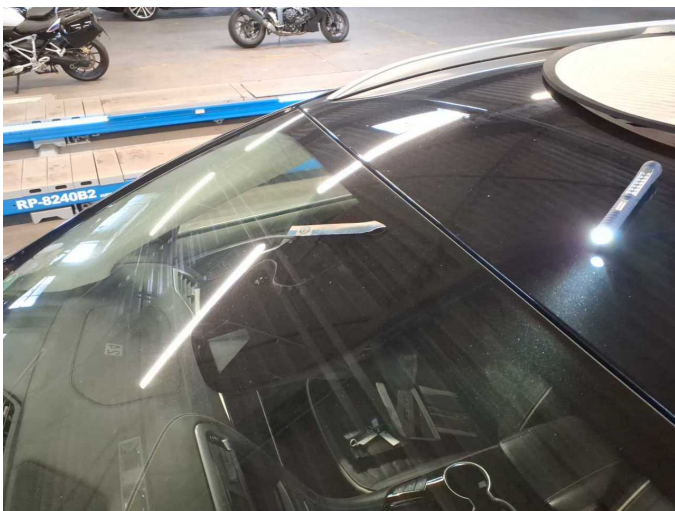
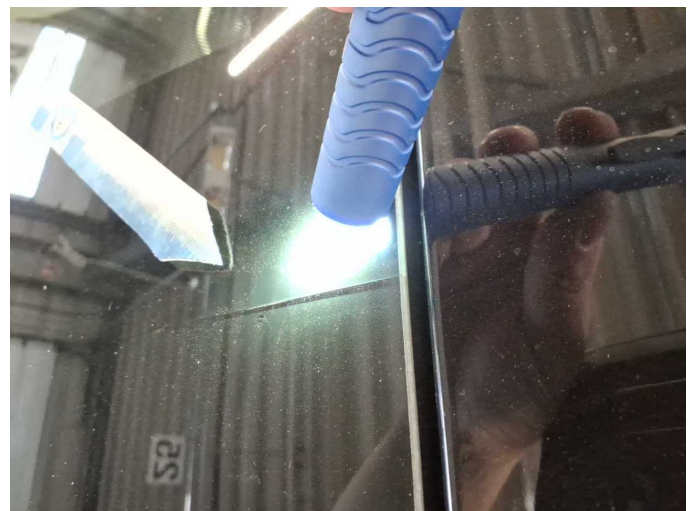
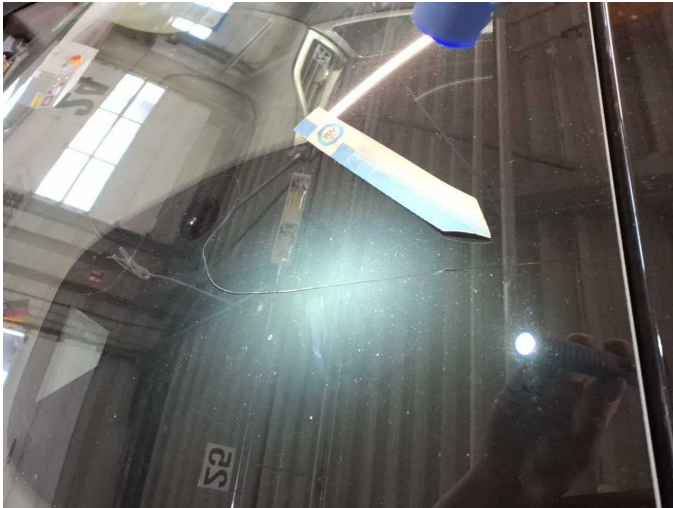
Damage 18: Vehicle glazing: Windscreen - Broken / torn - repair according to calculation

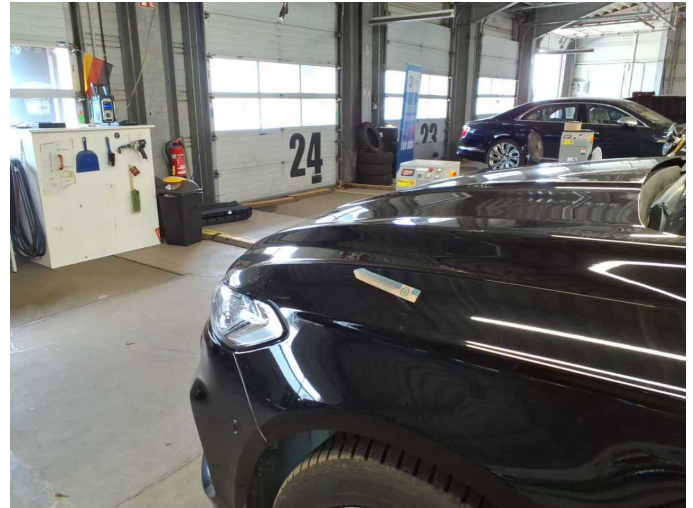
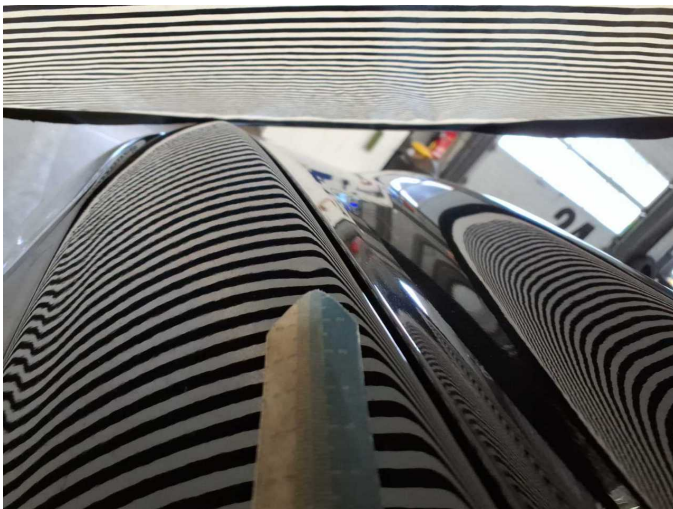
Wear and tear 3: Mudguard - left side: Mudguard - left side - dent(s) - Smooth repair work

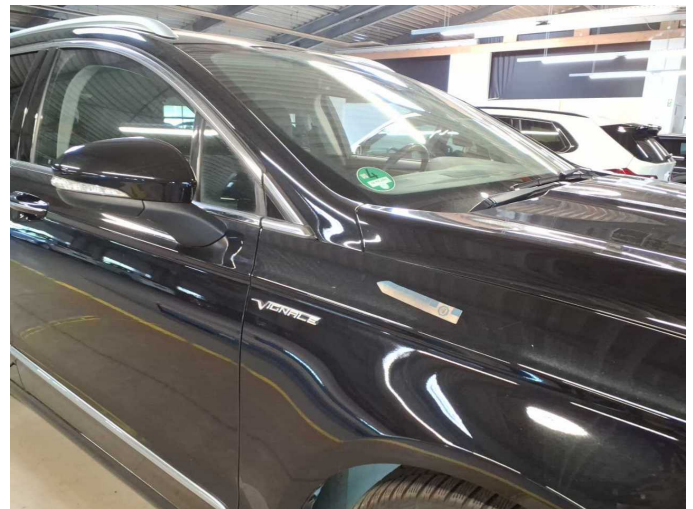
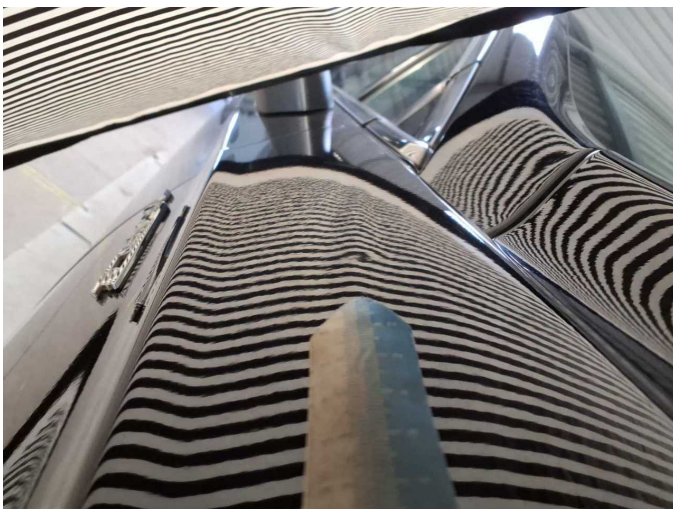
Wear and tear 4: Mudguard - right side: Mudguard - right side - dent(s) - Smooth repair work

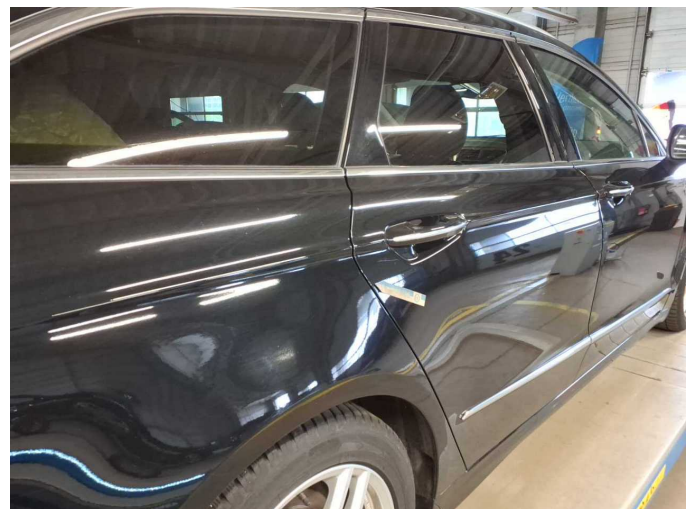
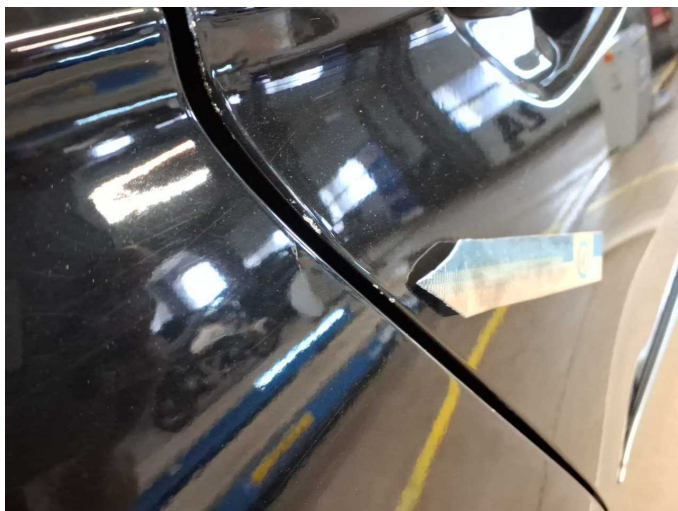
Wear and tear 5: Door - rear right side: Door edge - Scratch(es) - Smart repair

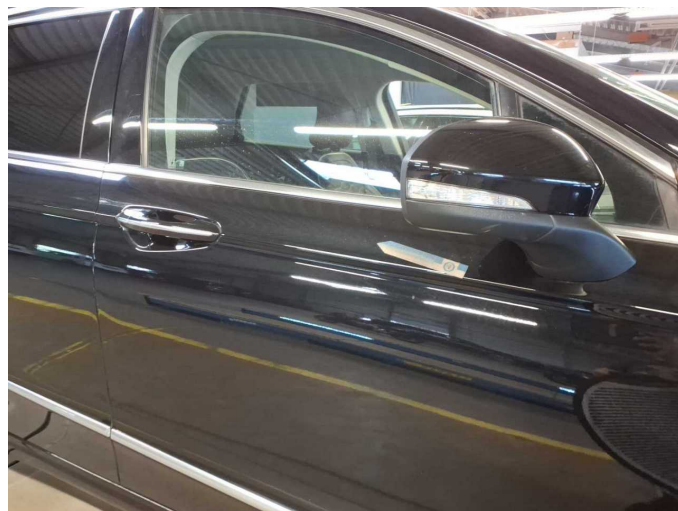
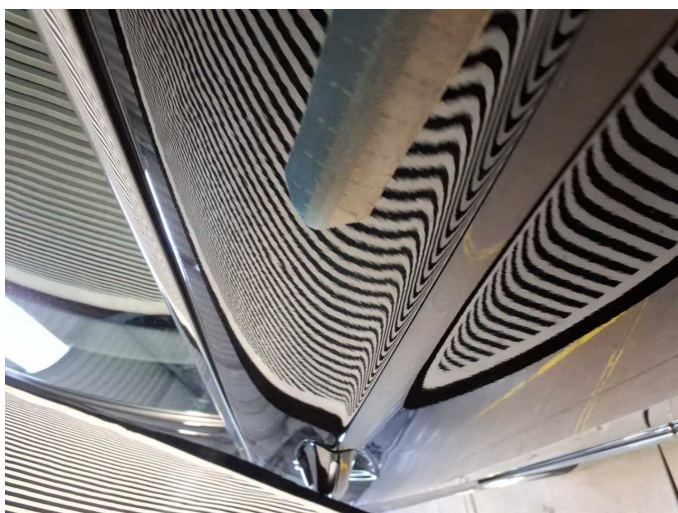
Wear and tear 6: Door - front right side: Door - dent(s) - Smooth repair work

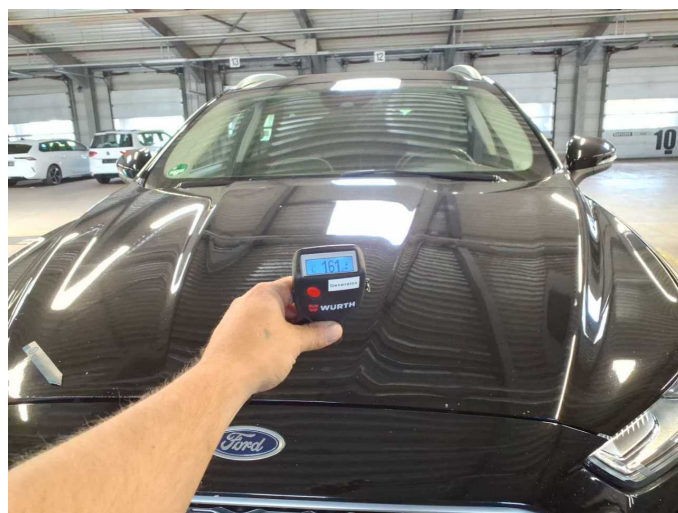
1 Bonnet, Professionally carried out, Invoice of repair done Non-existent

Repainting 1: Bonnet
