Expertise

Protocol number: 45444058
Order No. / Reference: 26406183
Inspection date: 12 May 2026

Model: Superb Combi 2.0 TDI 4x4 DSG L&K

VIN: TMBLR7NP7P7030728

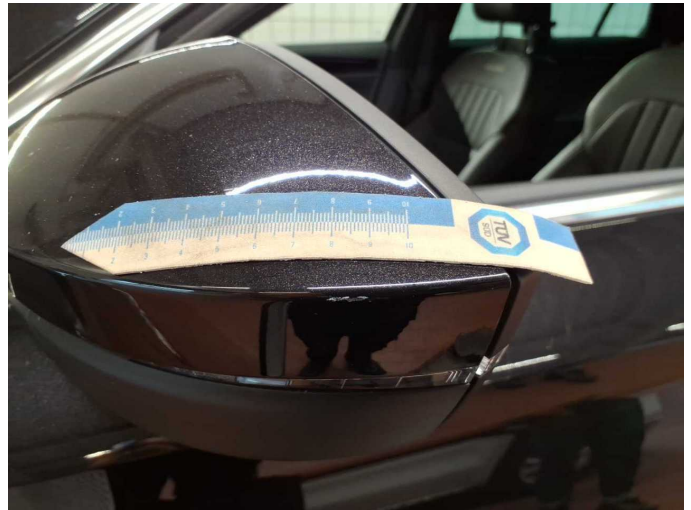
Damage 1: Wing mirror - left side: Cap - Scratch(es) - Smart repair

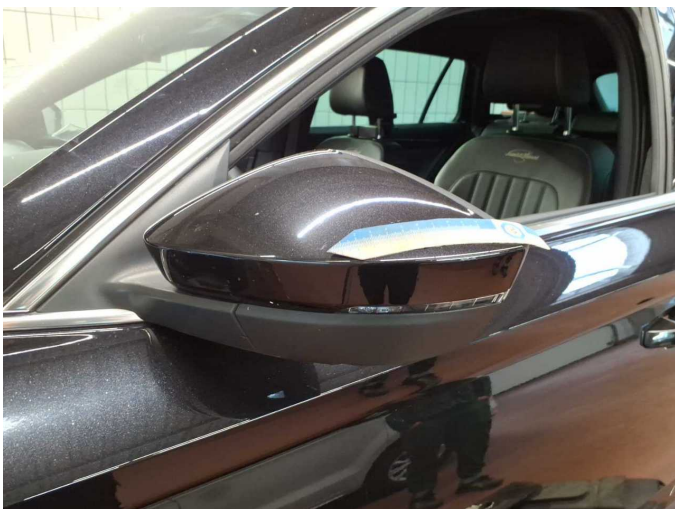
Damage 1: Wing mirror - left side: Cap - Scratch(es) - Smart repair

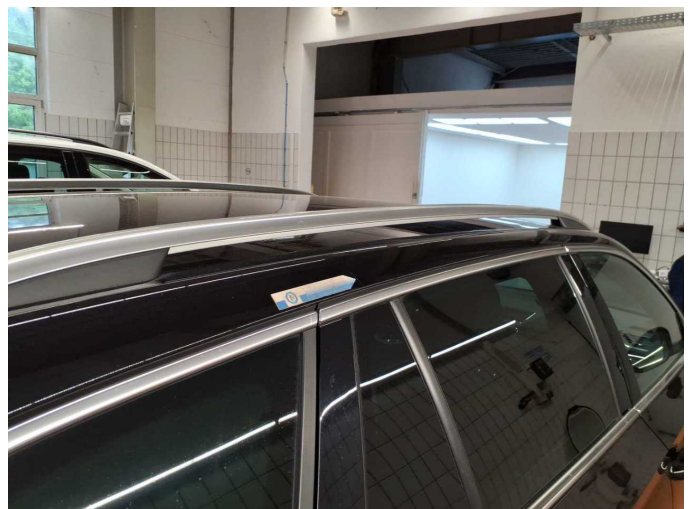
Damage 3: Roof: Roof rail - right side - Scratch(es) - Smart repair

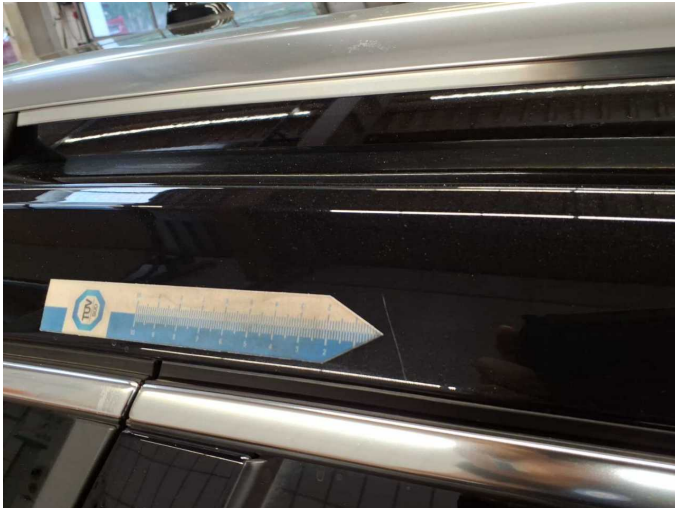
Damage 3: Roof: Roof rail - right side - Scratch(es) - Smart repair

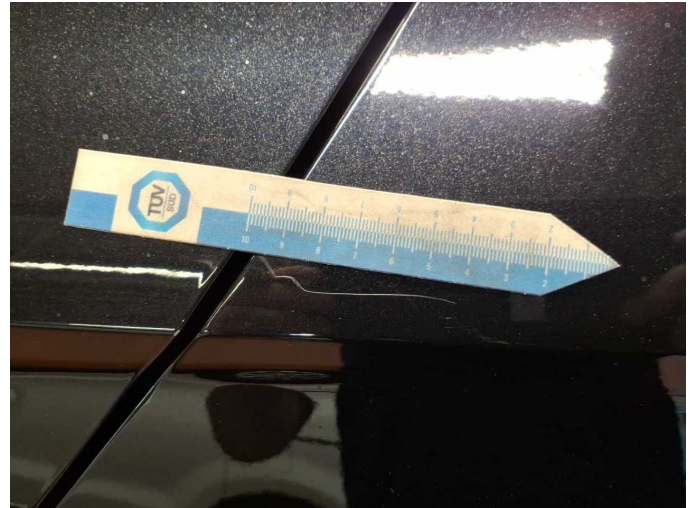
Damage 4: Side panel - rear left side: Side panel - Scratch(es) - Paint

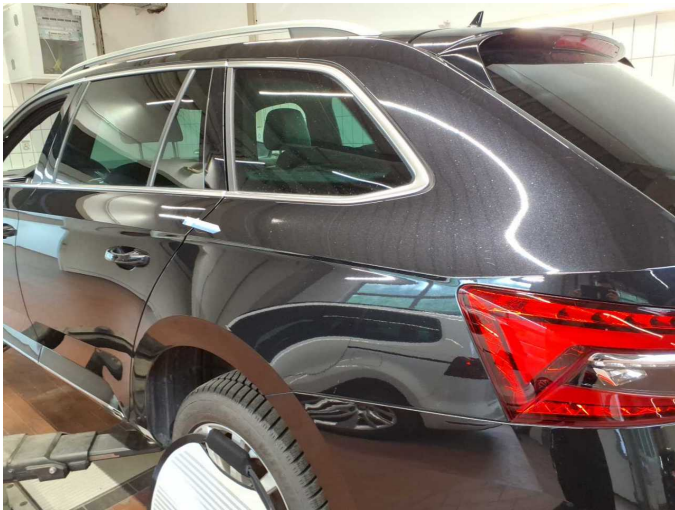
Damage 4: Side panel - rear left side: Side panel - Scratch(es) - Paint

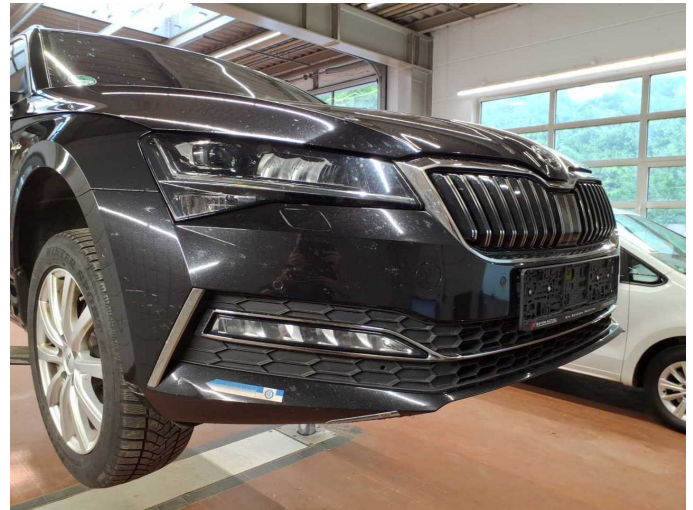
Damage 5: Front bumper: Front bumper - Deformed - Repair and paint

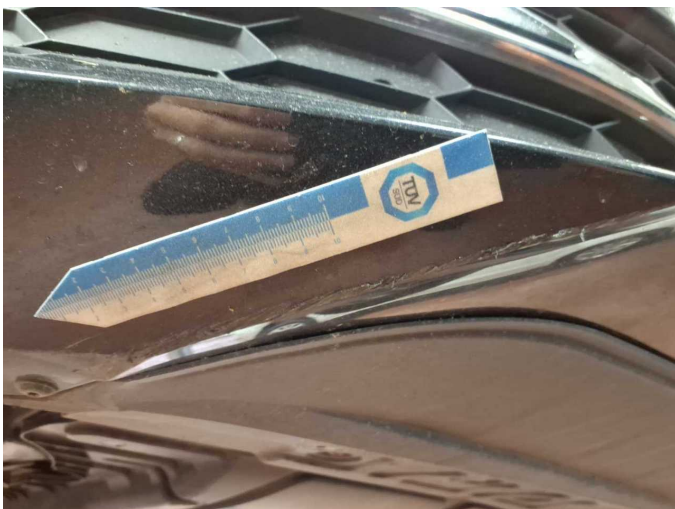
Damage 5: Front bumper: Front bumper - Deformed - Repair and paint

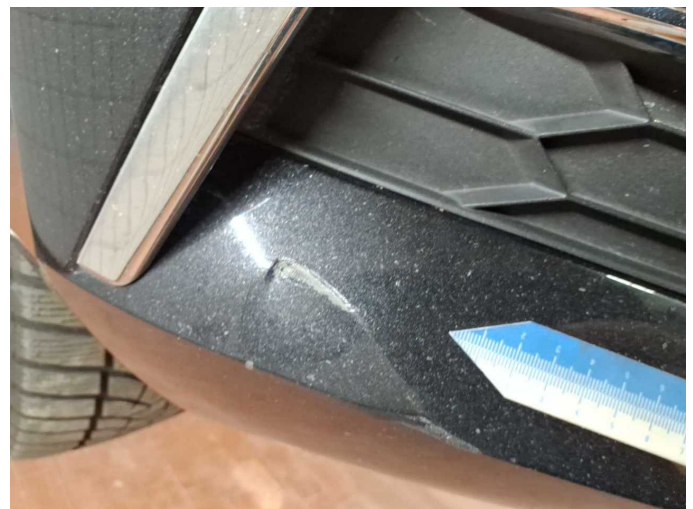
Damage 5: Front bumper: Front bumper - Deformed - Repair and paint

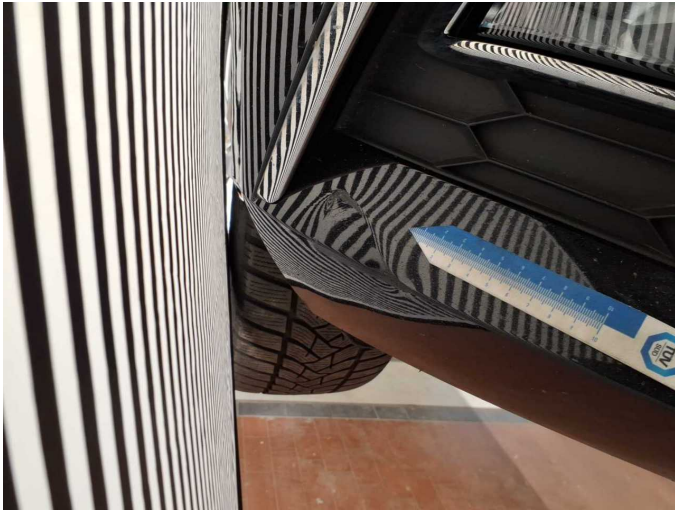
Damage 5: Front bumper: Front bumper - Deformed - Repair and paint

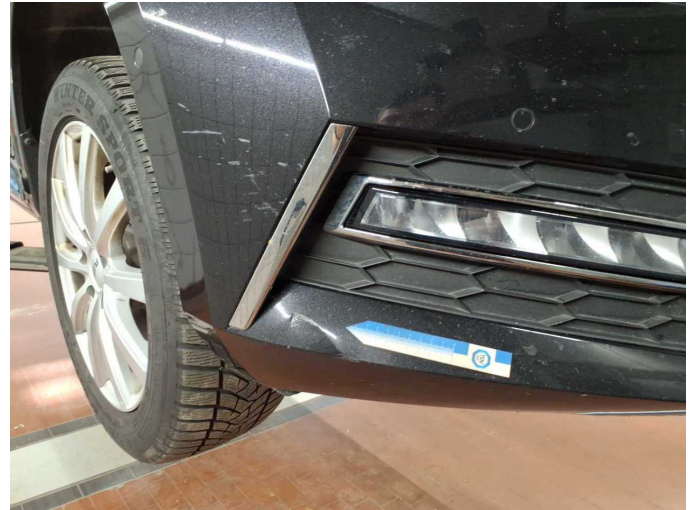
Damage 5: Front bumper: Front bumper - Deformed - Repair and paint

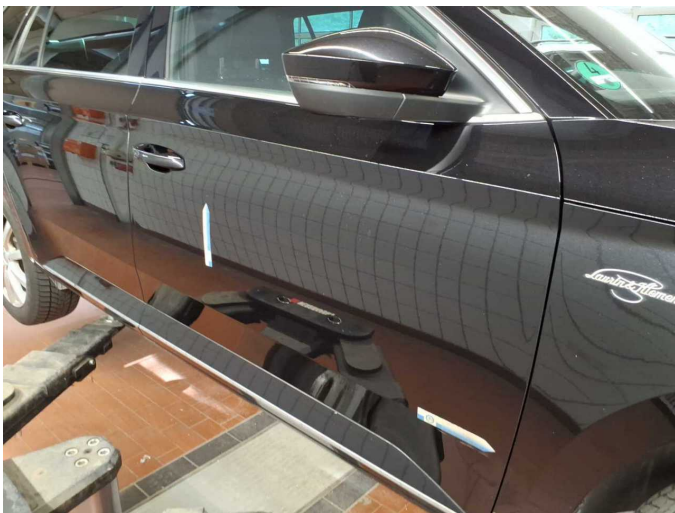
Damage 6: Door - front right side: Door - Dent / paintcoat damage - Repair and paint

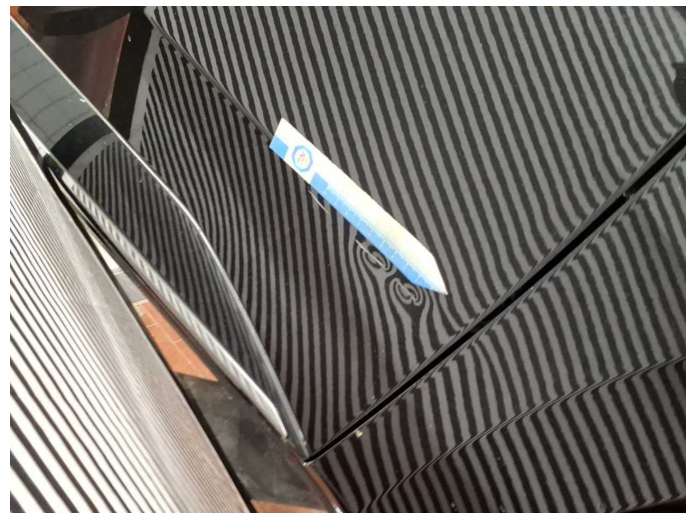
Damage 6: Door - front right side: Door - Dent / paintcoat damage - Repair and paint

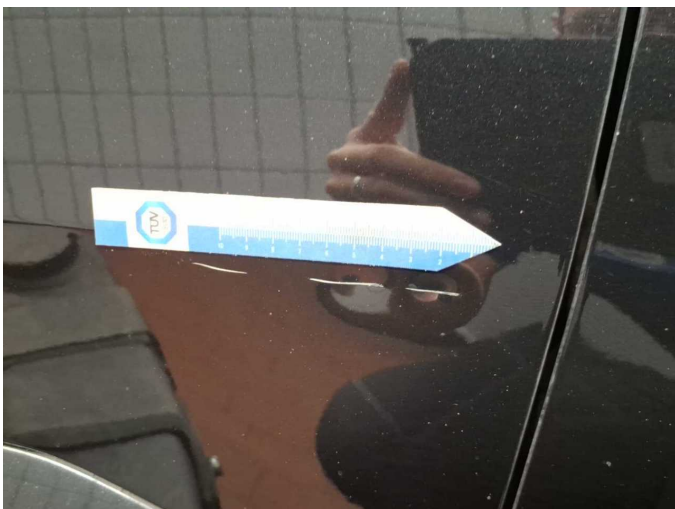
Damage 6: Door - front right side: Door - Dent / paintcoat damage - Repair and paint

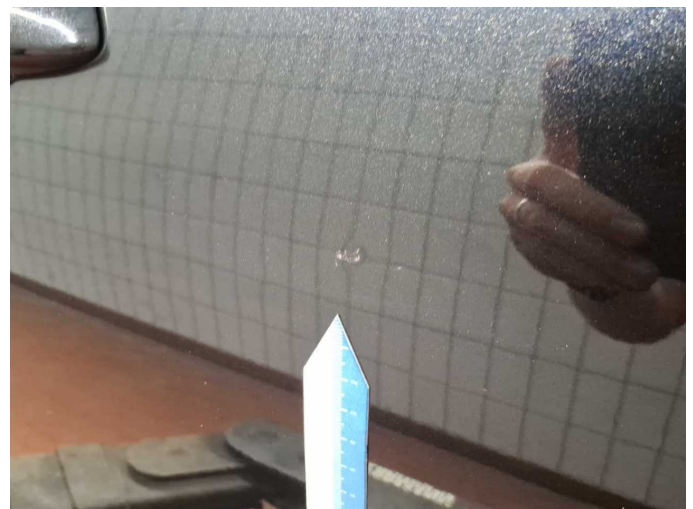
Damage 6: Door - front right side: Door - Dent / paintcoat damage - Repair and paint

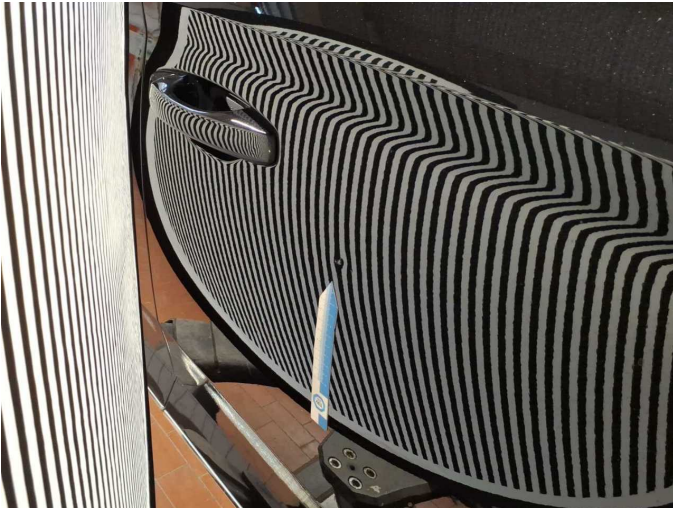
Damage 6: Door - front right side: Door - Dent / paintcoat damage - Repair and paint

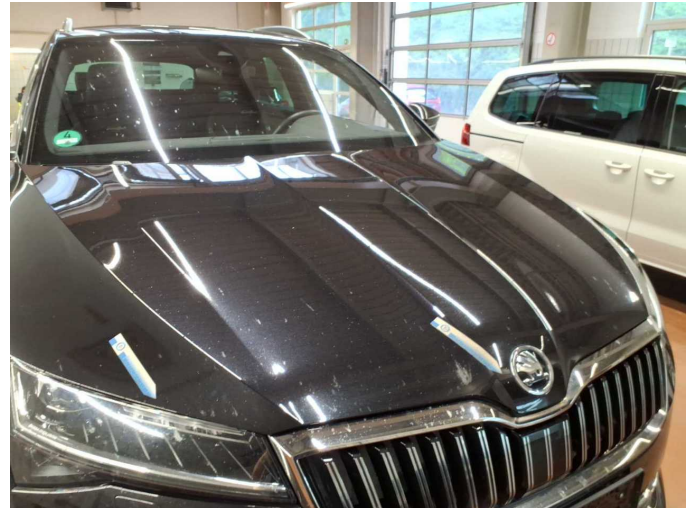
Wear and tear 1: Bonnet: Bonnet - Stone chips - No deduction

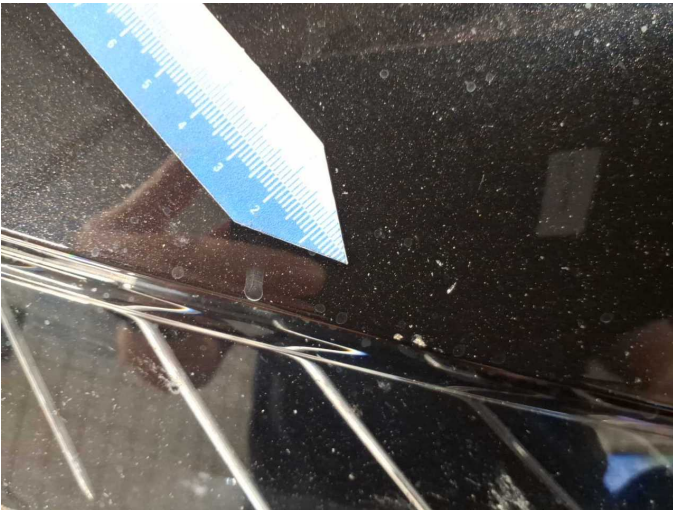
Wear and tear 1: Bonnet: Bonnet - Stone chips - No deduction

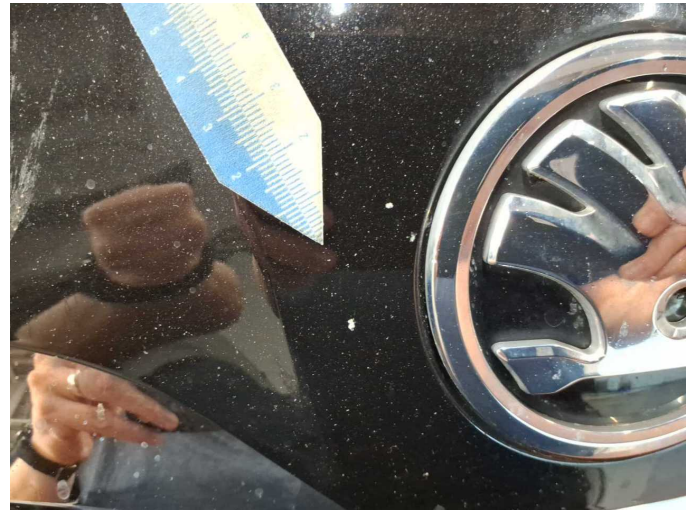
Wear and tear 1: Bonnet: Bonnet - Stone chips - No deduction

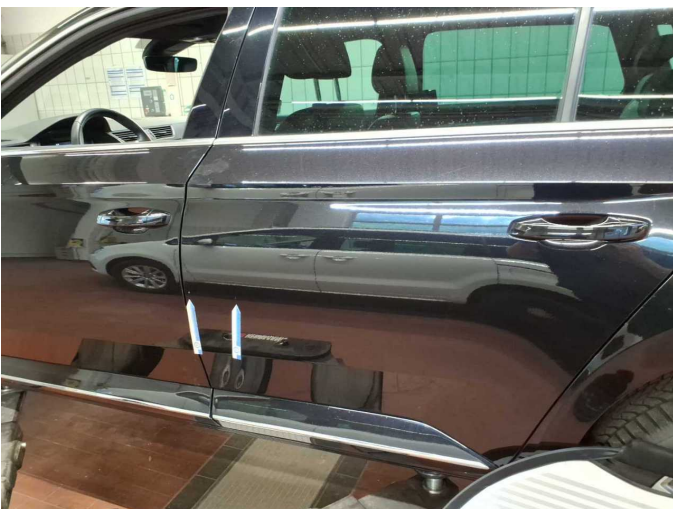
Wear and tear 2: Door - rear left side: Door - Scratch(es) - No deduction

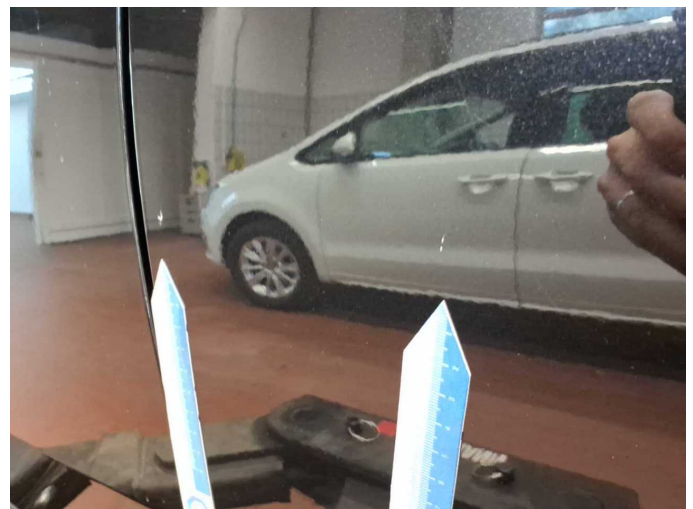
Wear and tear 2: Door - rear left side: Door - Scratch(es) - No deduction

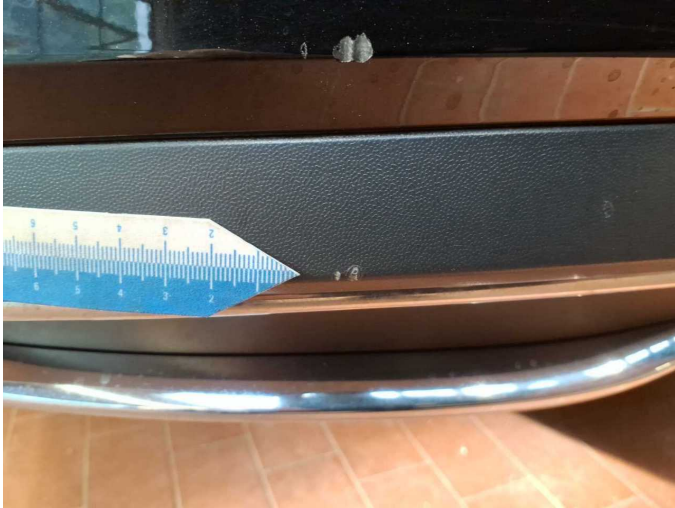
Wear and tear 4: Rear bumper: Spoiler - Scratch(es) - No deduction

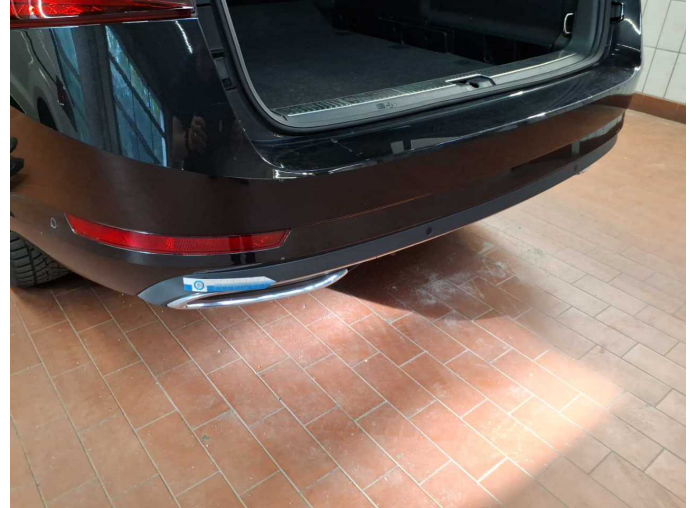
Wear and tear 4: Rear bumper: Spoiler - Scratch(es) - No deduction

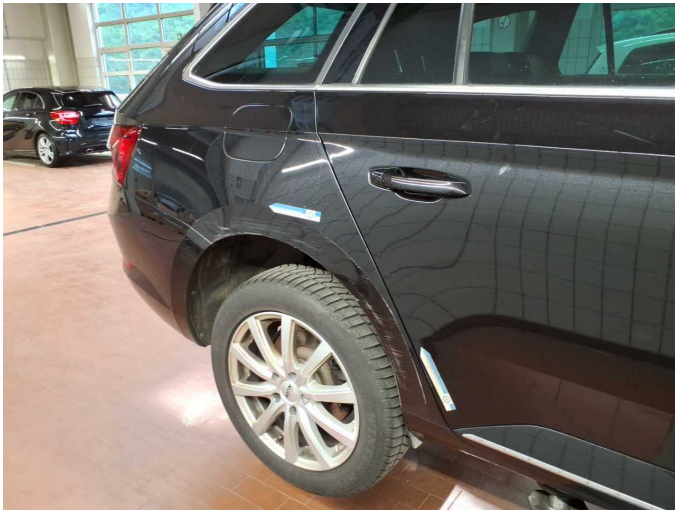
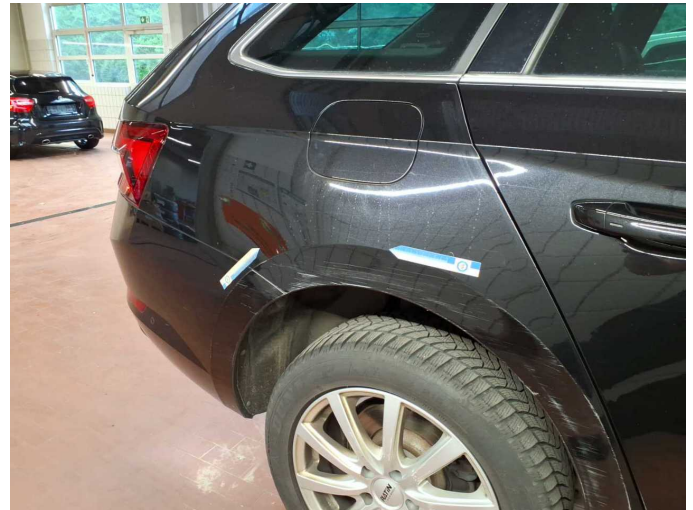
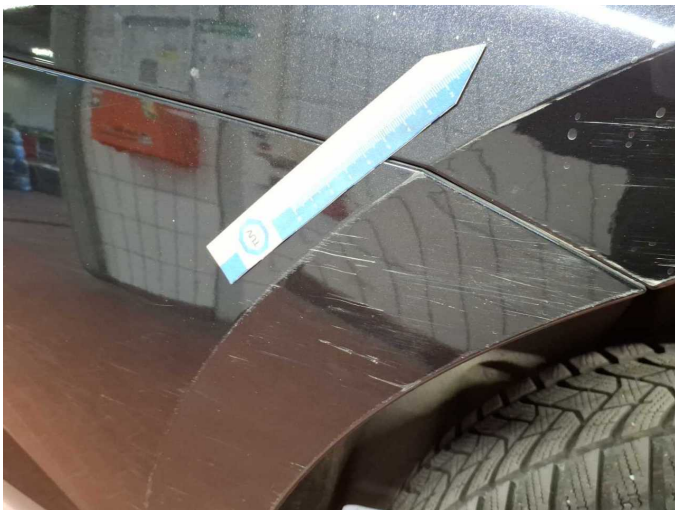
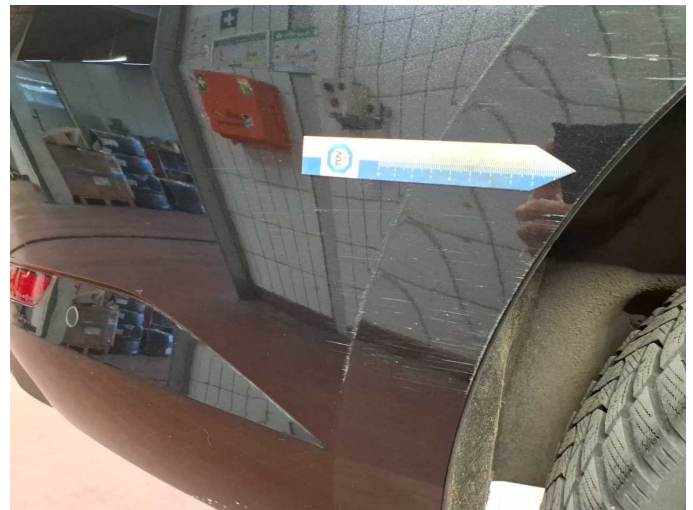
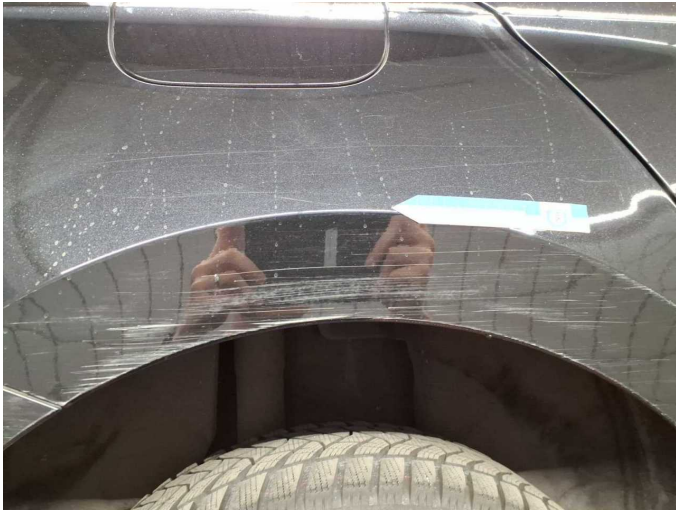
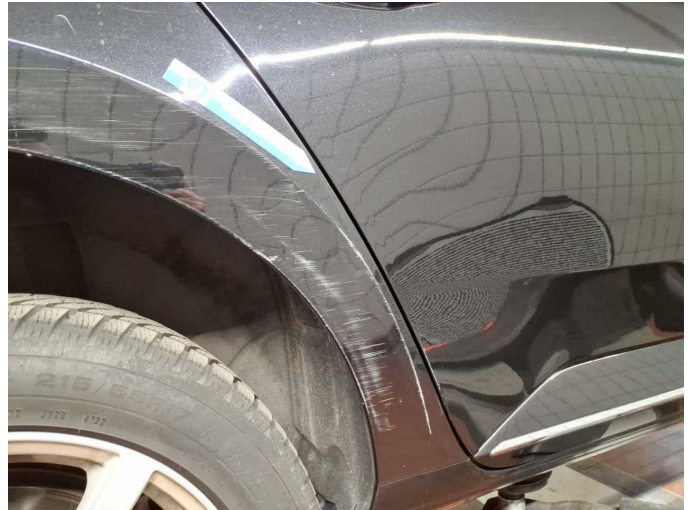
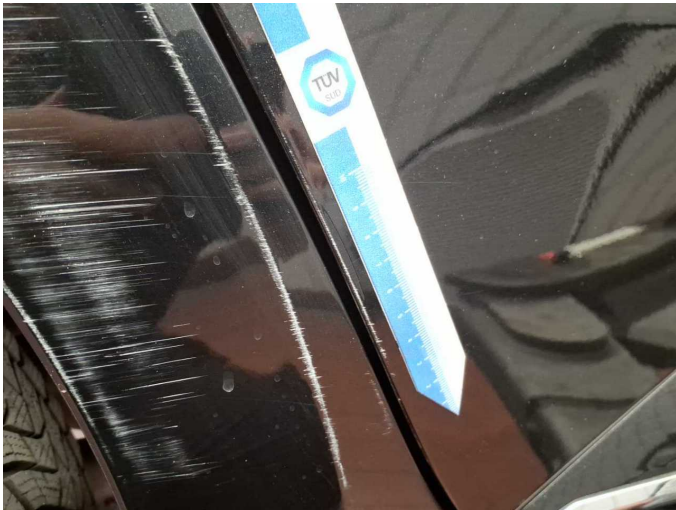
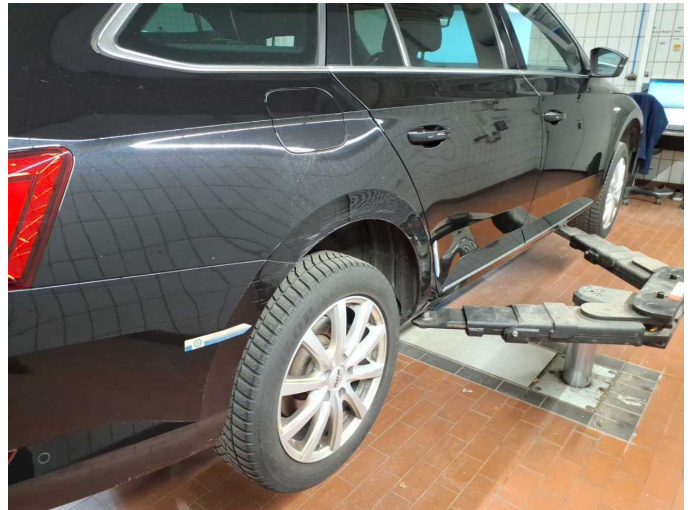
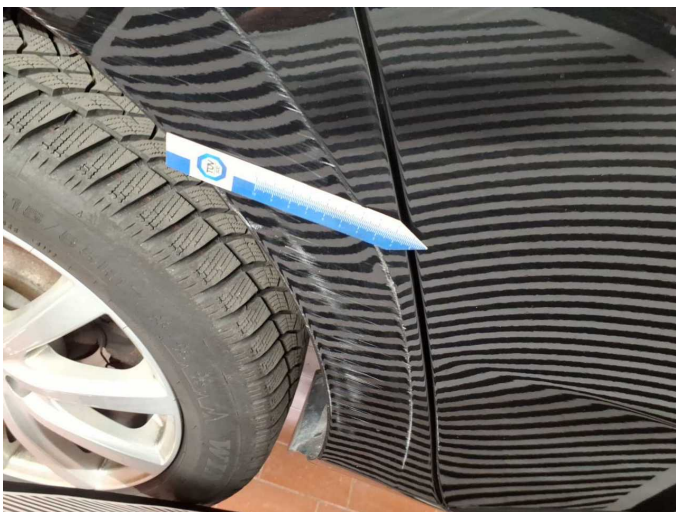
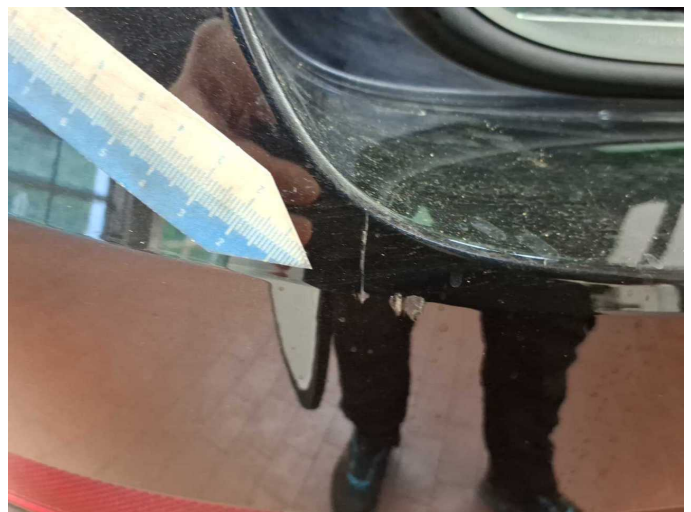
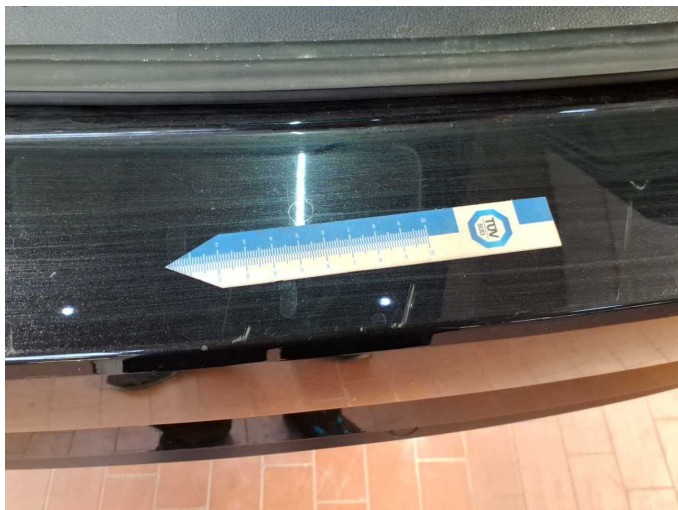
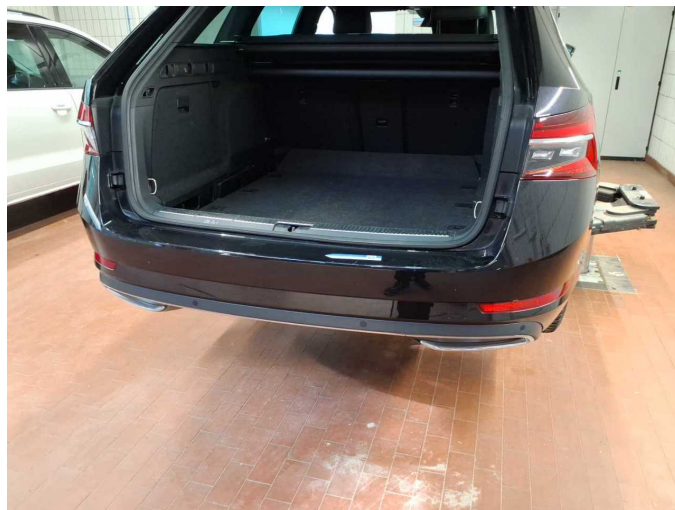
No.	Accident
1	Rear, Side right

Non-repaired previous damages were found at the vehicle. The necessary repair costs are listed in the expert report or if necessary, are listed in detail in a separately enclosed repair cost calculation.

Accident 1: Rear, Side right
