Expertise

Protocol number: 46282926
Order No. / Reference: 26566467
Inspection date: 2 Jul 2026

Model: Tiguan 1.4 eHybrid OPF DSG Life

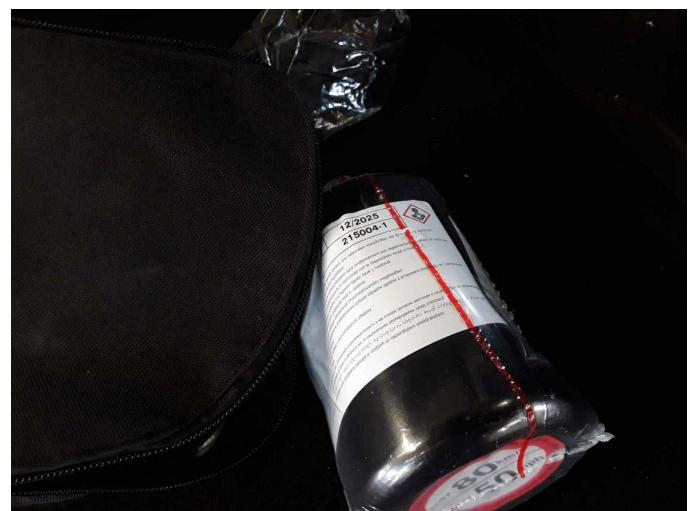
Damage 2: Equipment: Tirefit filler - Expired - Replace

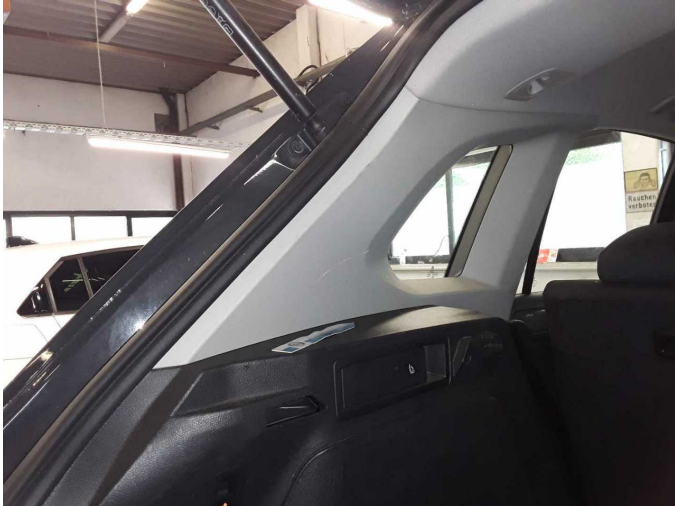
Damage 3: Trim / covers: D-pillar trim - interior, left side - Scratch(es) - Smart repair

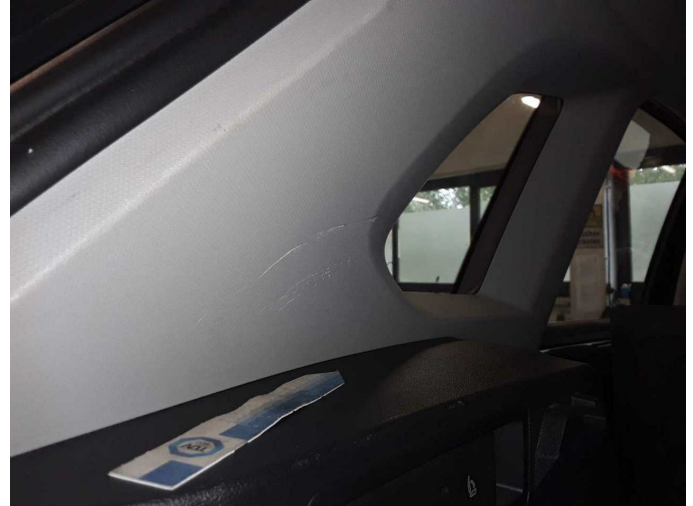
Damage 3: Trim / covers: D-pillar trim - interior, left side - Scratch(es) - Smart repair

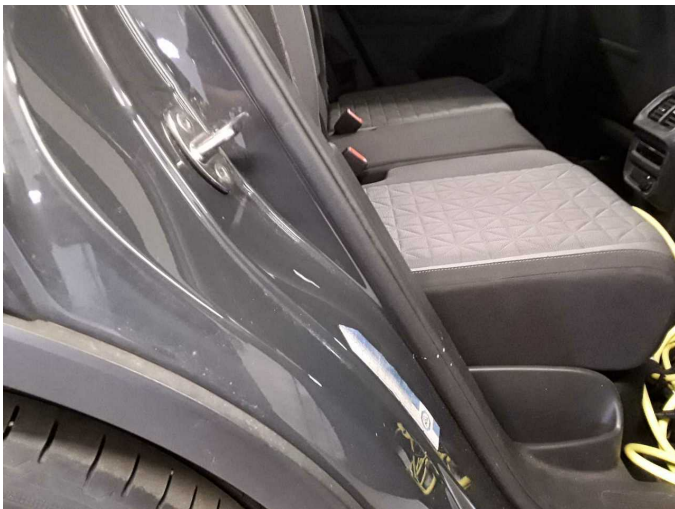
Damage 4: Side panel - rear right side: Sill - Scratch(es) - Smart repair

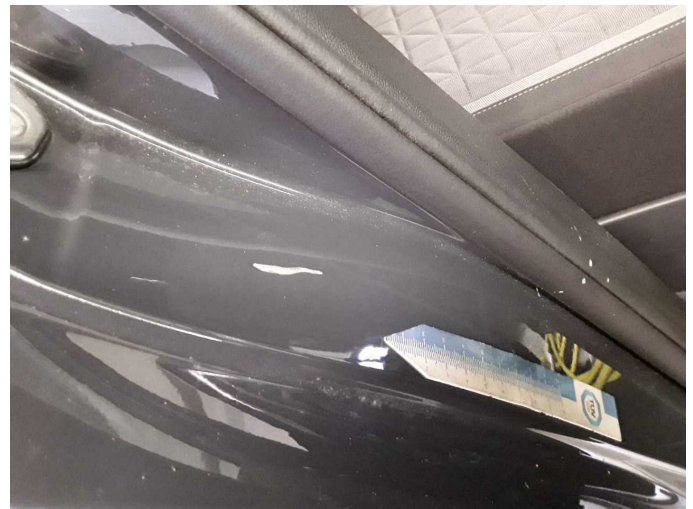
Damage 4: Side panel - rear right side: Sill - Scratch(es) - Smart repair

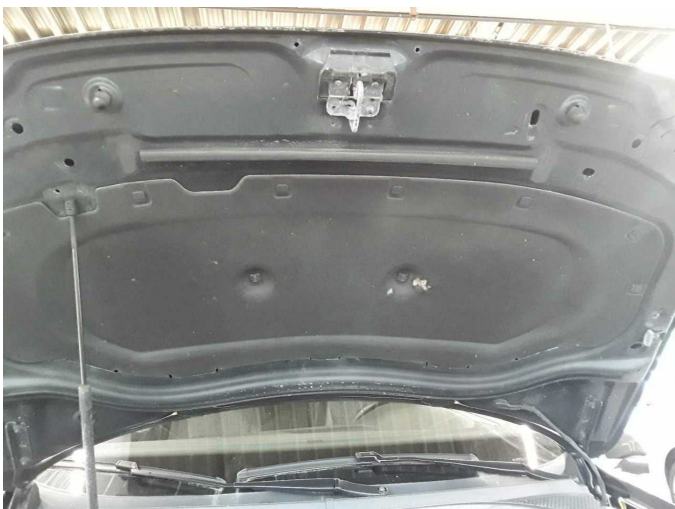
Damage 5: Bonnet: Insulation lining - Damaged - Replace

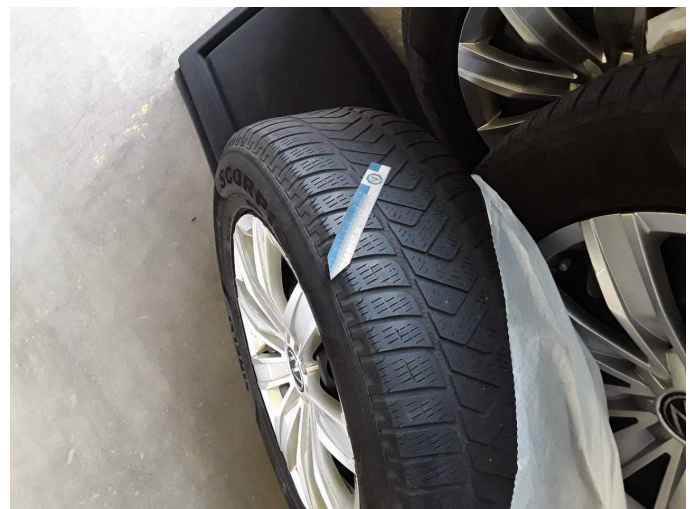
Damage 6: 2nd wheel set: 2 tyres - Does not meet the leasing specifications - Replace

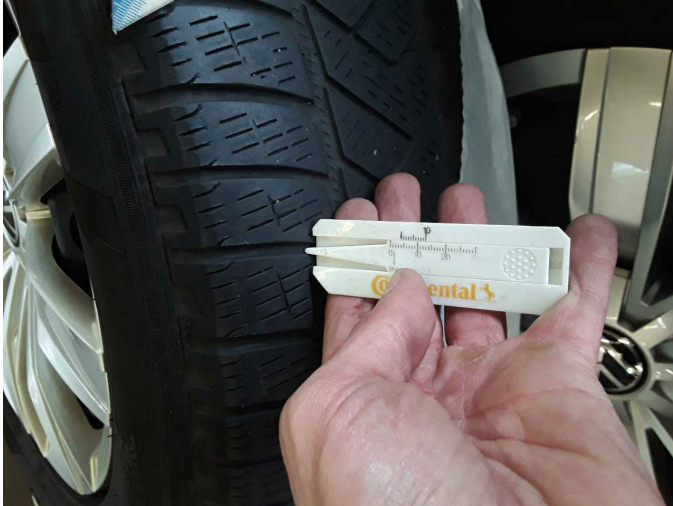
Damage 6: 2nd wheel set: 2 tyres - Does not meet the leasing specifications - Replace

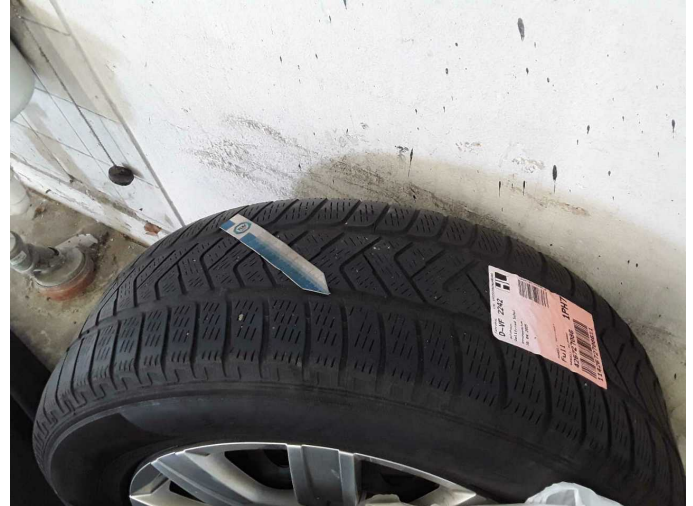
Damage 6: 2nd wheel set: 2 tyres - Does not meet the leasing specifications - Replace

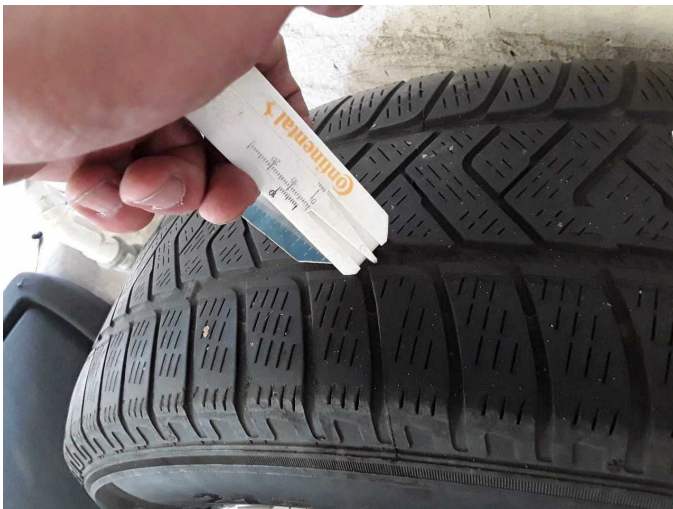
Damage 6: 2nd wheel set: 2 tyres - Does not meet the leasing specifications - Replace

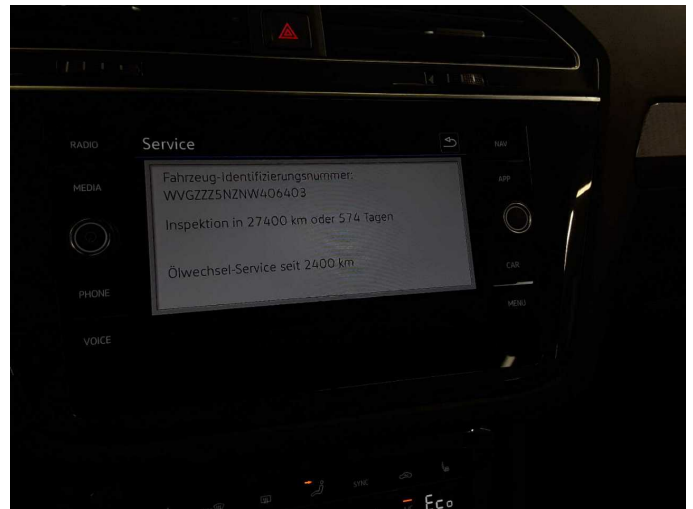
Damage 7: Misc.: Inspection / maintenance (Ölservice) - Due - Perform

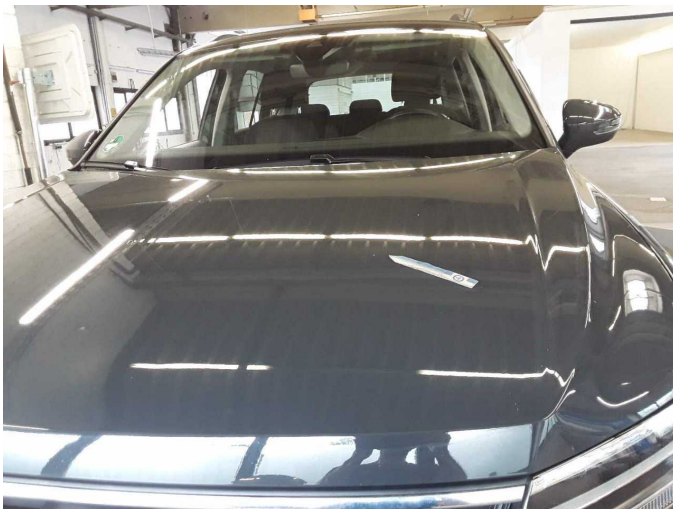
Damage 8: Bonnet: Bonnet - Dent / paintcoat damage - Repair and paint

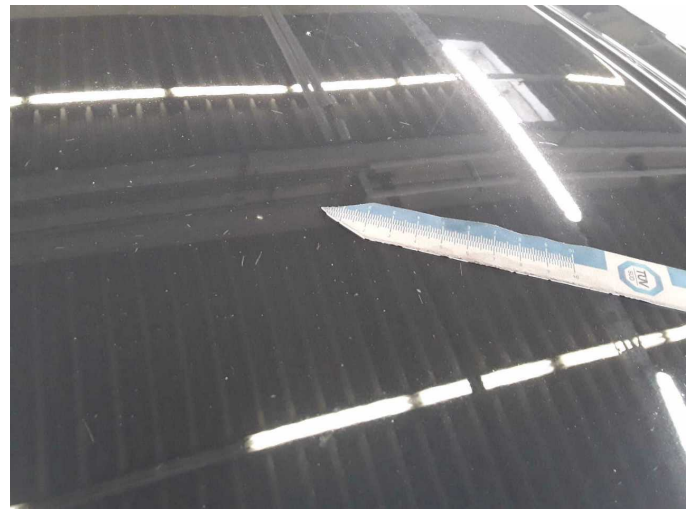
Damage 8: Bonnet: Bonnet - Dent / paintcoat damage - Repair and paint

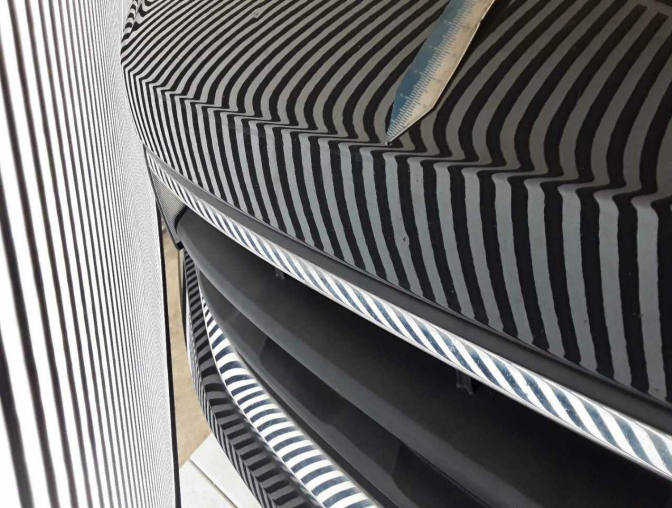
Damage 8: Bonnet: Bonnet - Dent / paintcoat damage - Repair and paint

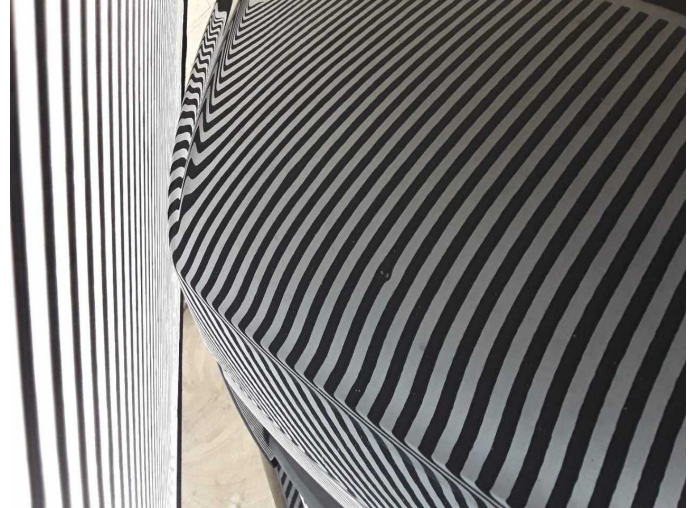
Damage 8: Bonnet: Bonnet - Dent / paintcoat damage - Repair and paint

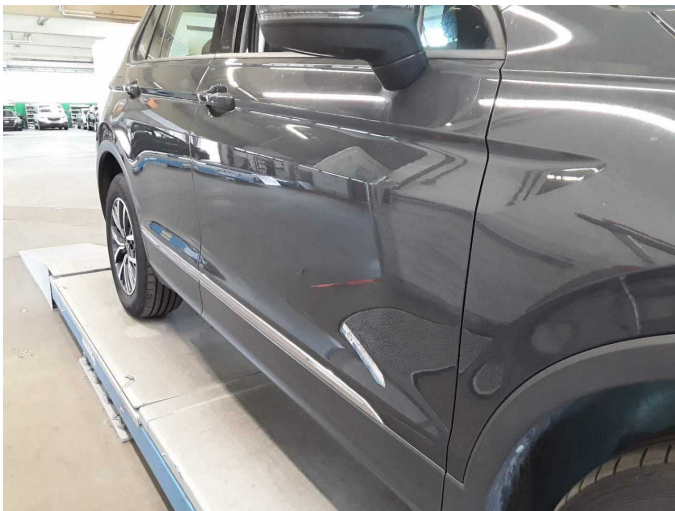
Damage 9: Door - front right side: Door - Dent / paintcoat damage - Repair and paint

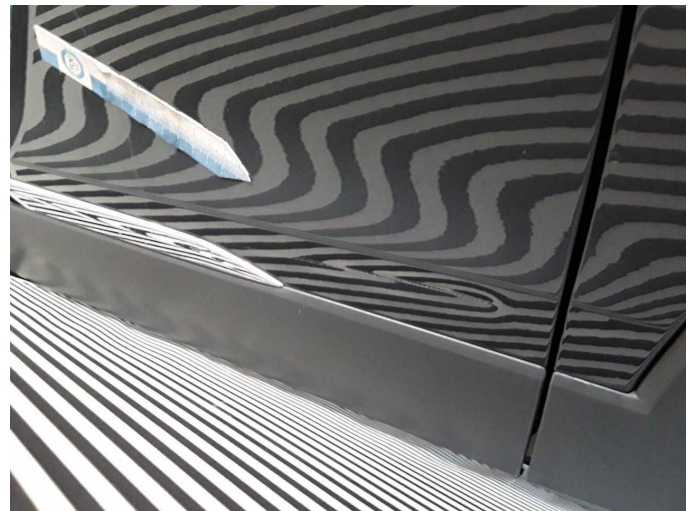
Damage 9: Door - front right side: Door - Dent / paintcoat damage - Repair and paint

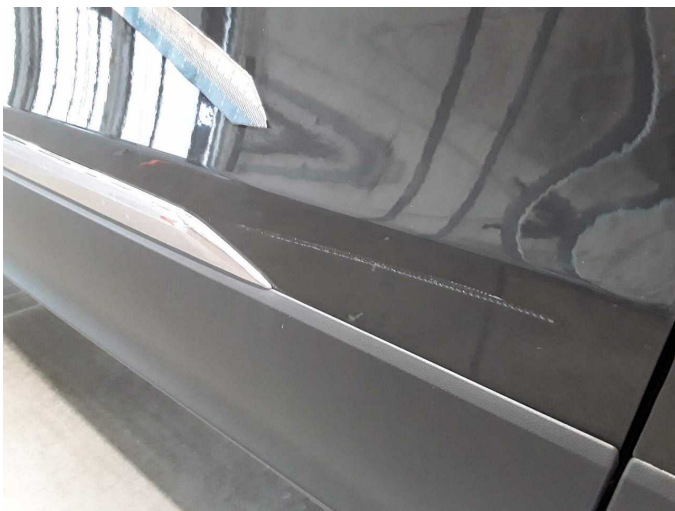
Damage 9: Door - front right side: Door - Dent / paintcoat damage - Repair and paint

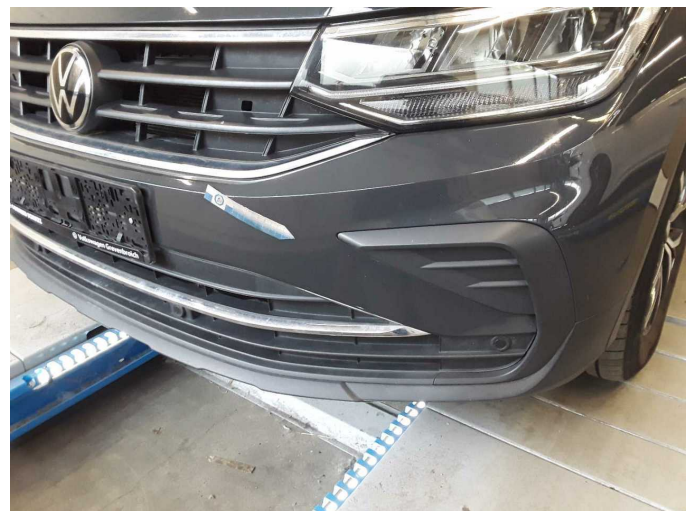
Wear and tear 1: Front bumper: Front bumper - Stone chips - No deduction

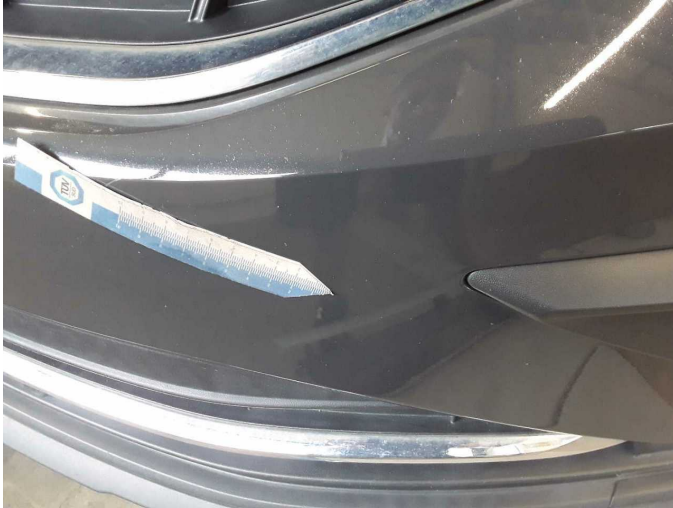
Wear and tear 1: Front bumper: Front bumper - Stone chips - No deduction

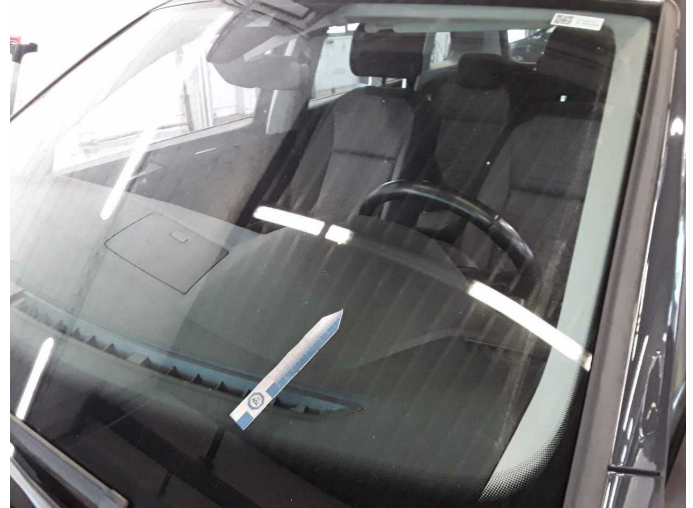
Wear and tear 3: Vehicle glazing: Windscreen - Stone chips - No deduction

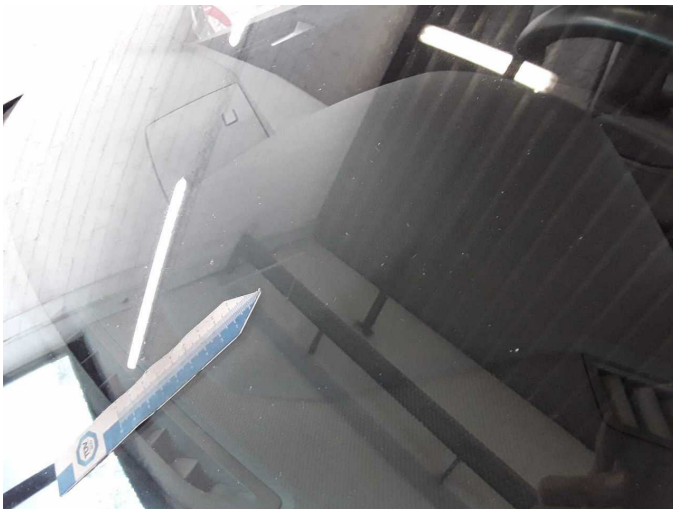
Wear and tear 3: Vehicle glazing: Windscreen - Stone chips - No deduction

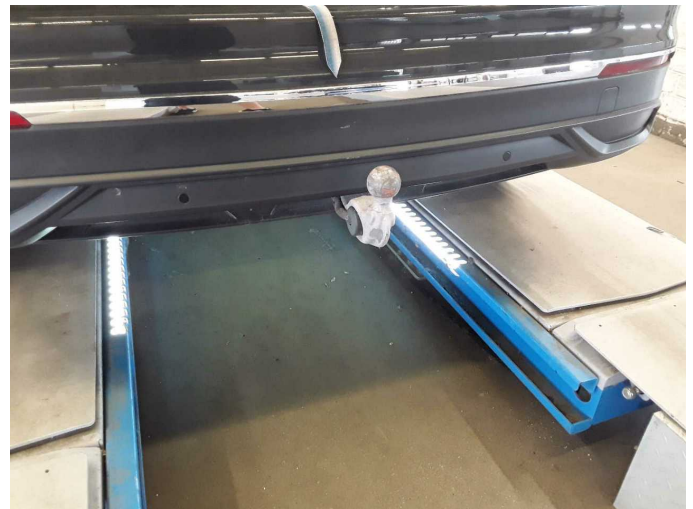
Wear and tear 4: Rear bumper: Spoiler - Scratch(es) - No deduction

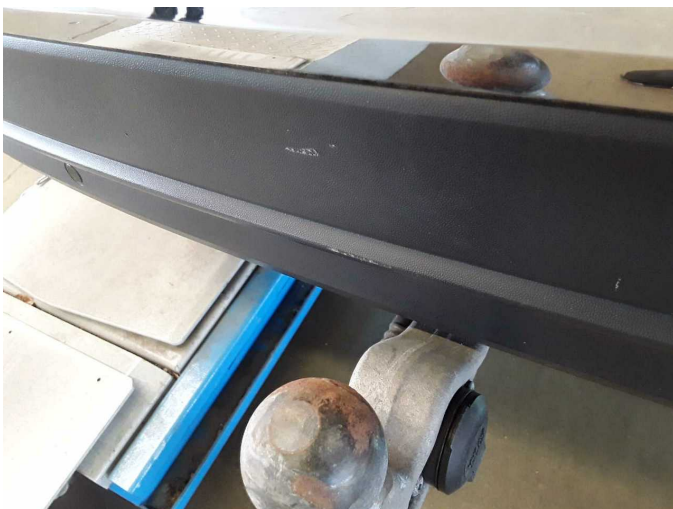
Wear and tear 4: Rear bumper: Spoiler - Scratch(es) - No deduction
