Expertise

Protocol number: 45922693
Order No. / Reference: 26407426
Inspection date: 11 Jun 2026

Manufacturer: Mercedes-Benz

Model: Citan 109 CDI lang

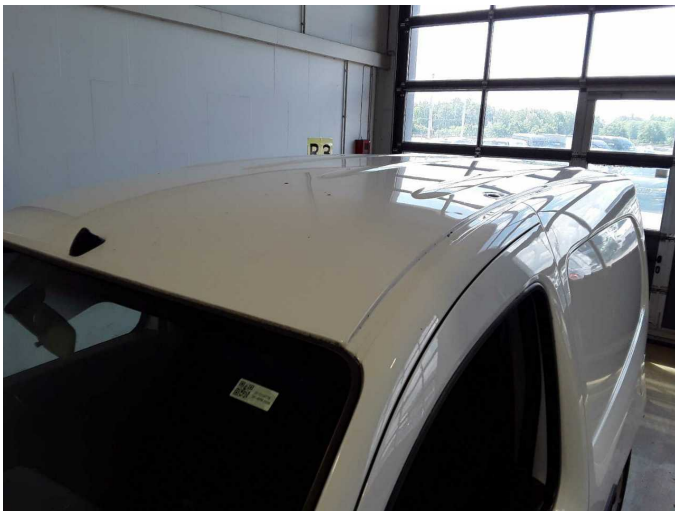
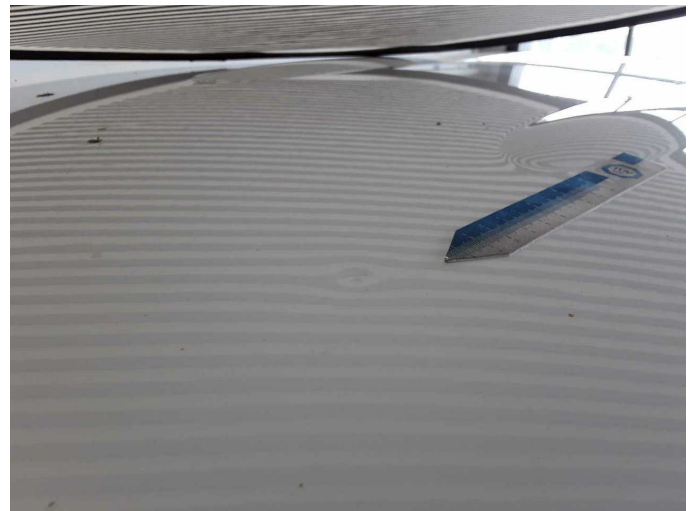
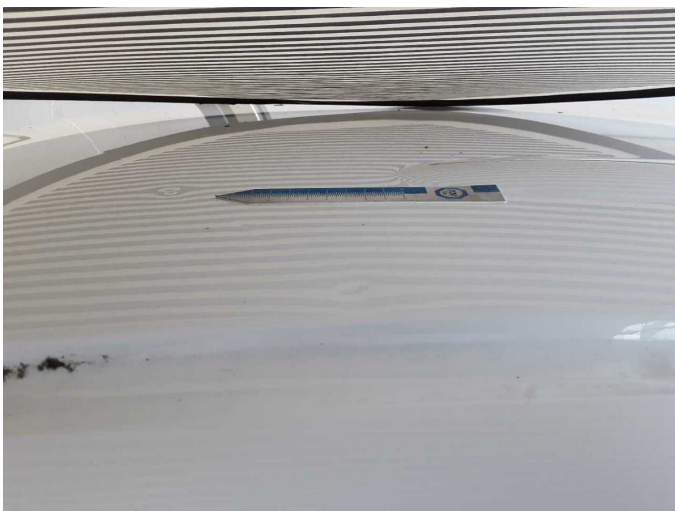
Damage 2: Roof: Roof - dent(s) - Smooth repair work

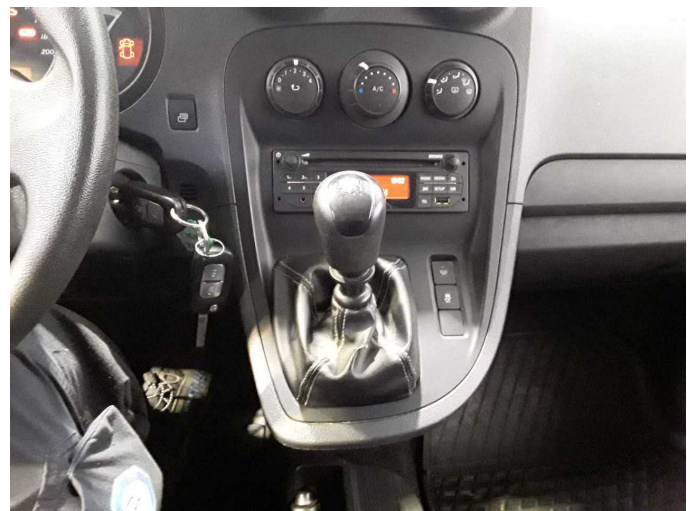
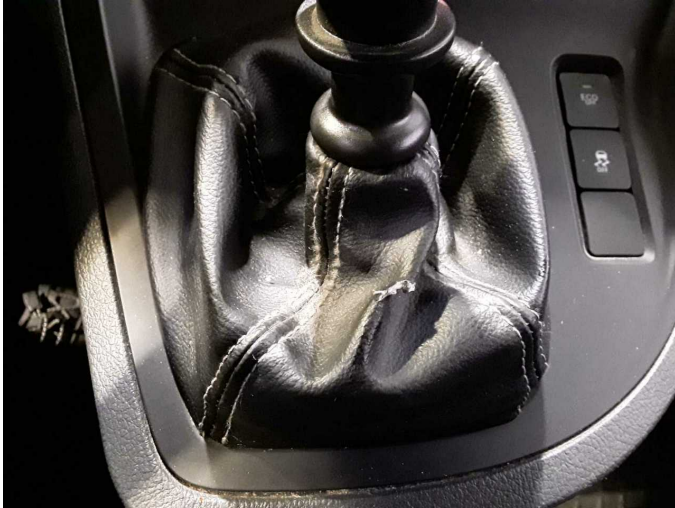
Damage 3: Gearbox: Gear stick collar - Broken / torn - Replace

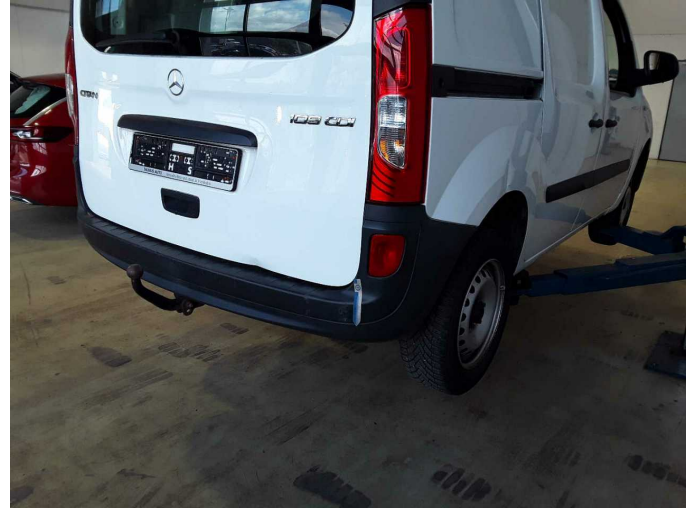
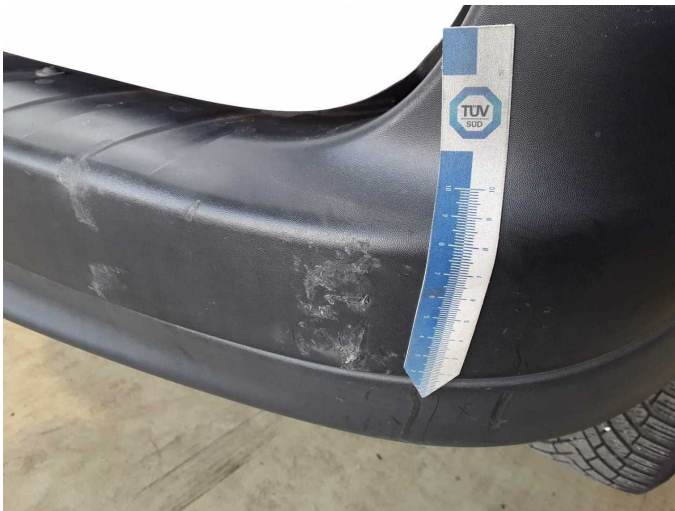
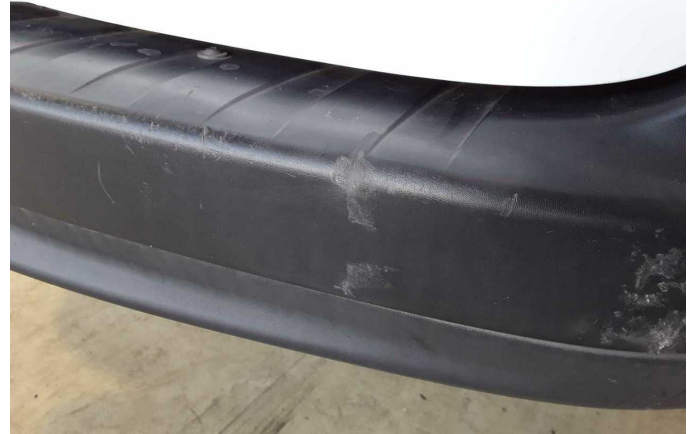
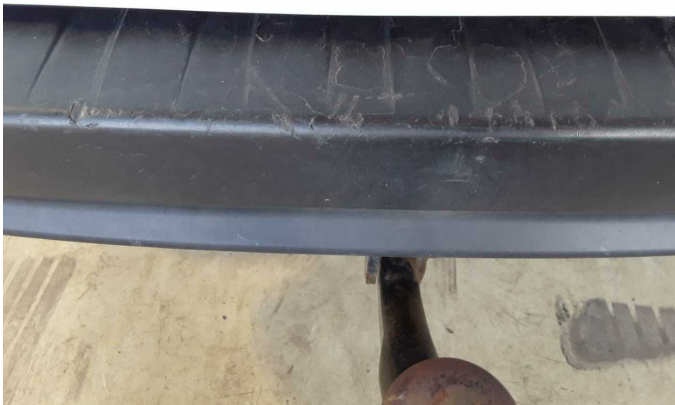
Damage 4: Rear bumper: Rear bumper - Scratch(es) - Loss in value

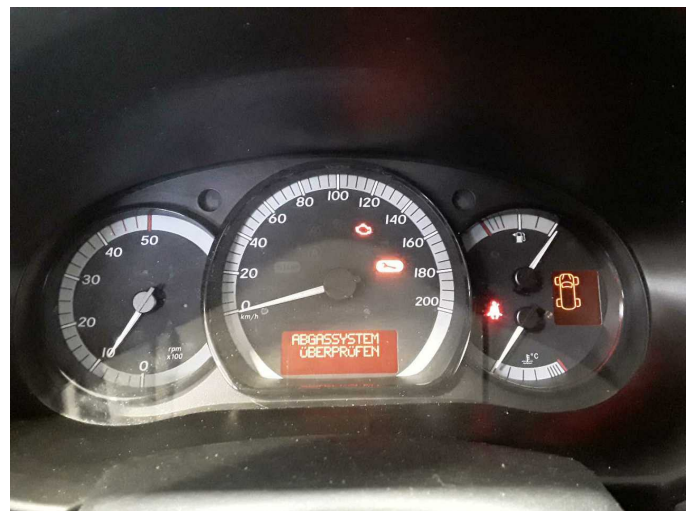
Damage 5: Instrument panel: Indicator light (Motorkontrolle) - on - Perform diagnosis

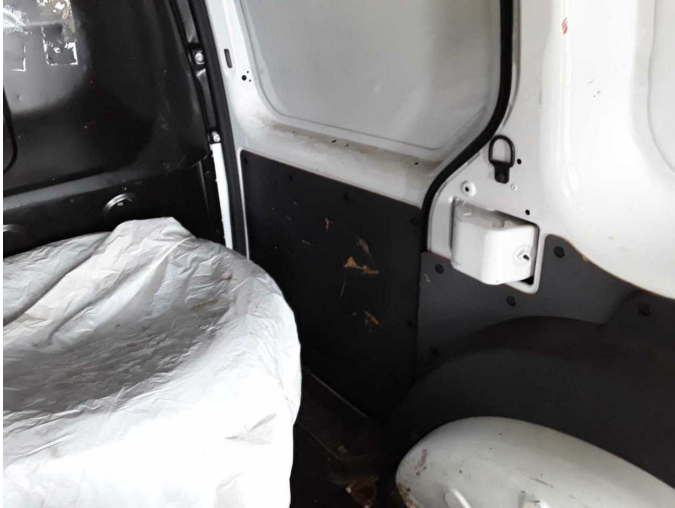
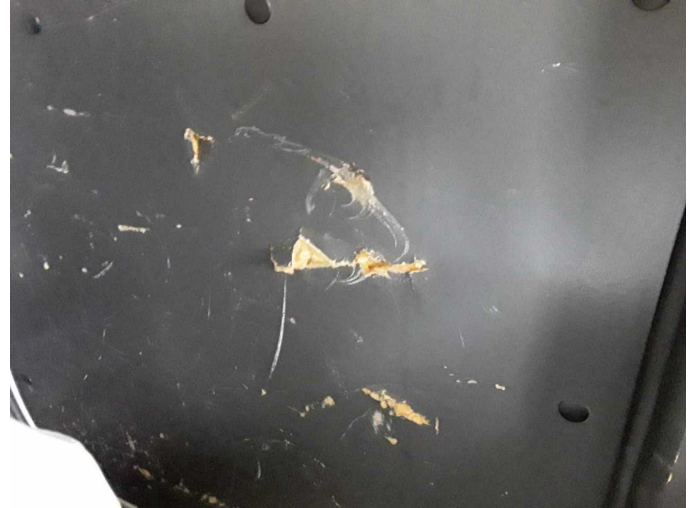
Damage 6: Sliding door, right: Trim - Broken / torn - Replace

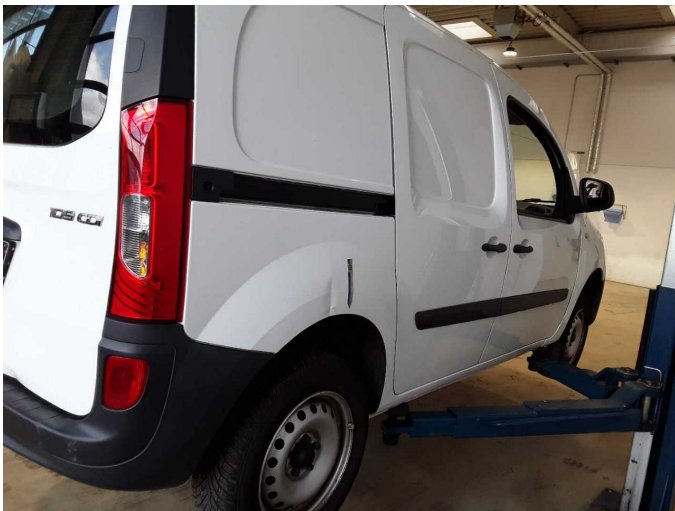
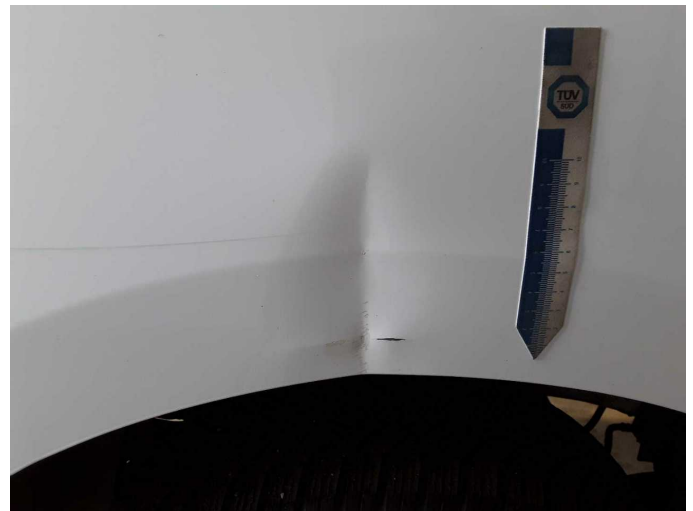
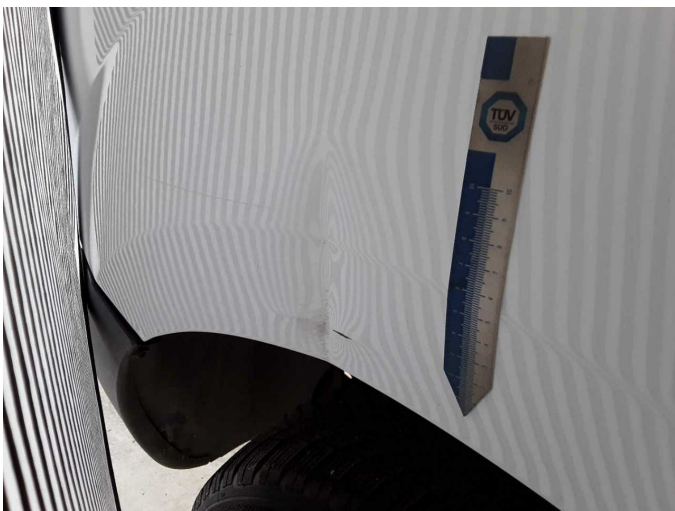
Damage 7: Side panel - rear right side: Side panel (Unterhalb) - Deformed - Repair and paint

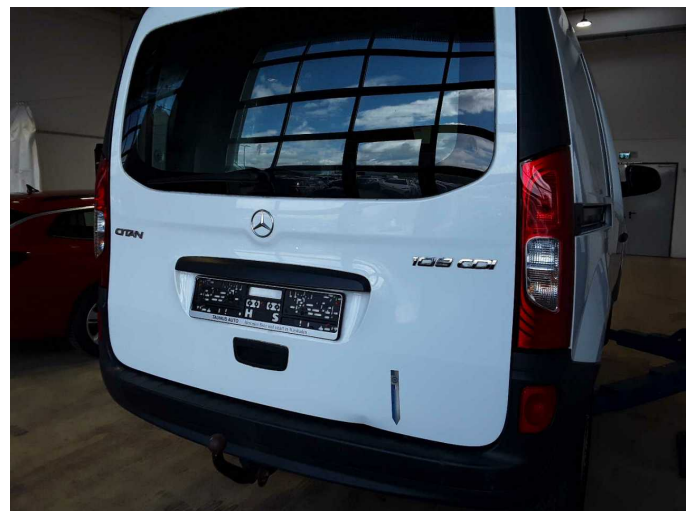
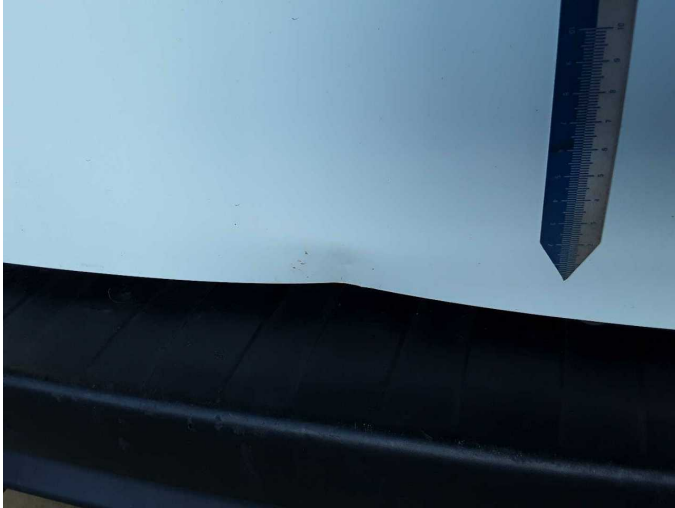
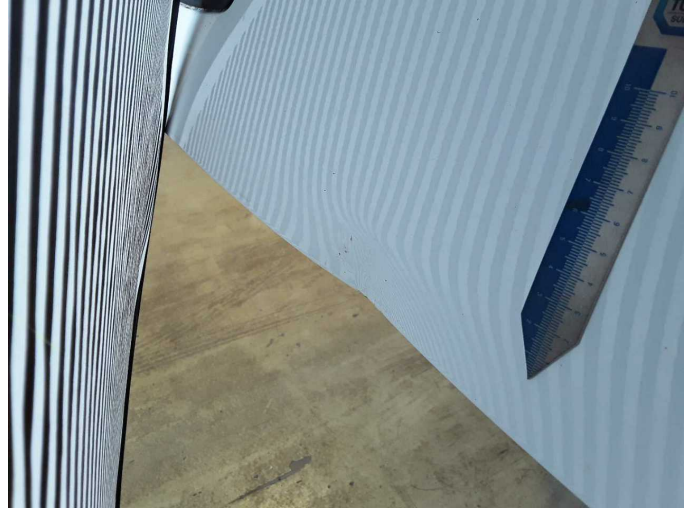
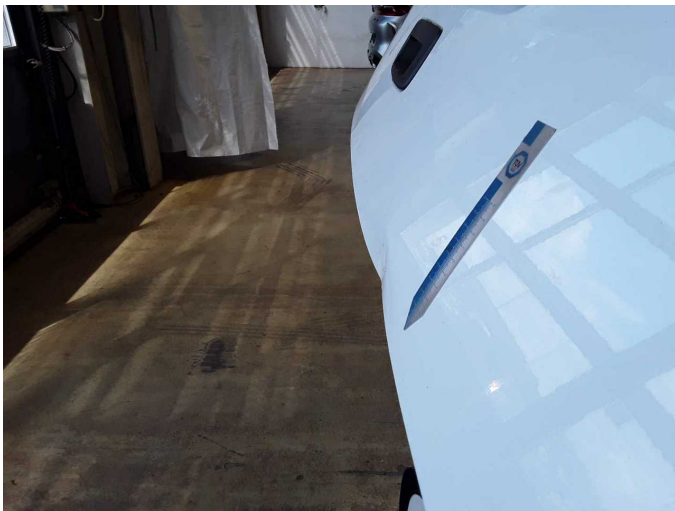
Damage 8: Boot lid / rear door: Boot lid - Deformed - Repair and paint

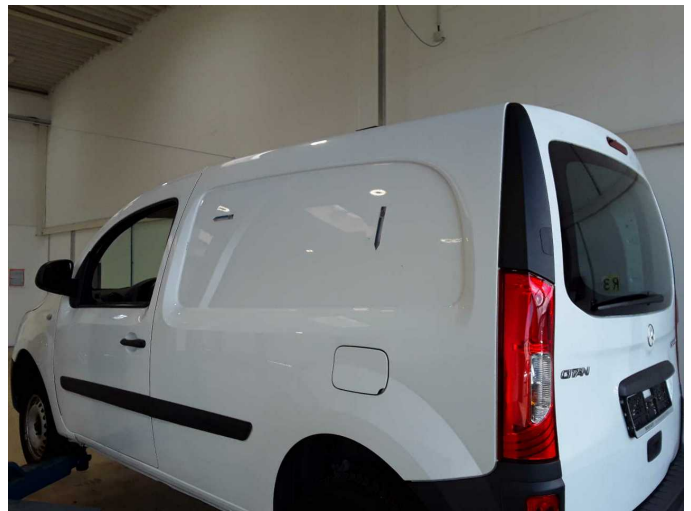
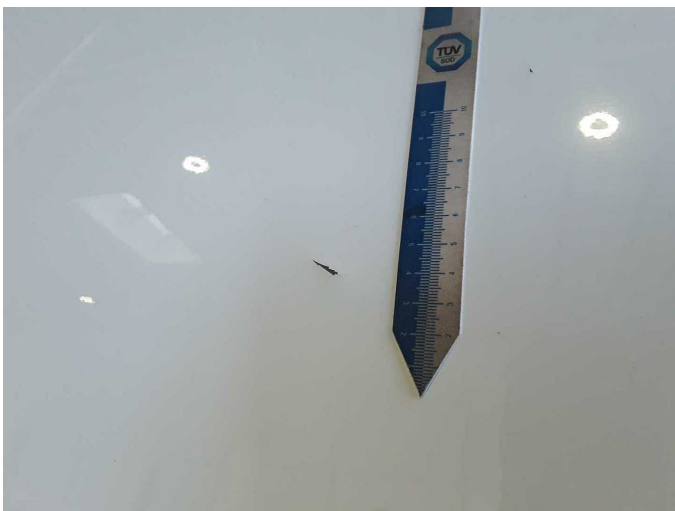
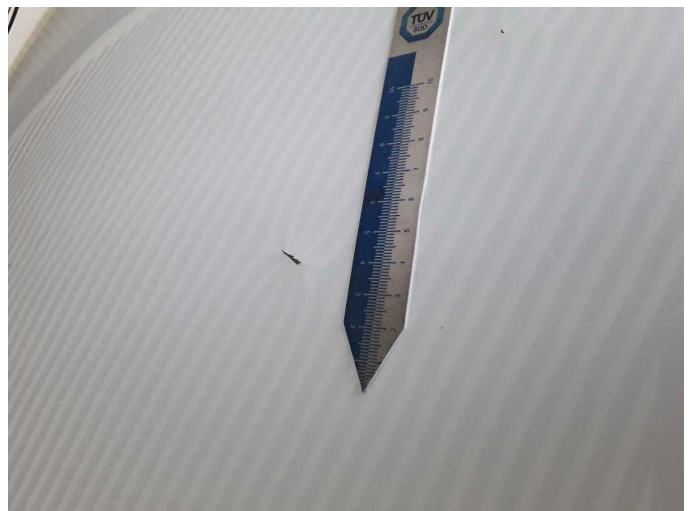
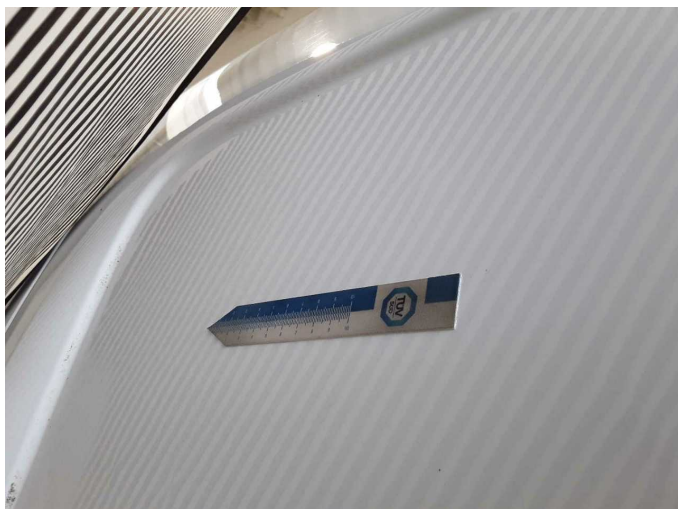
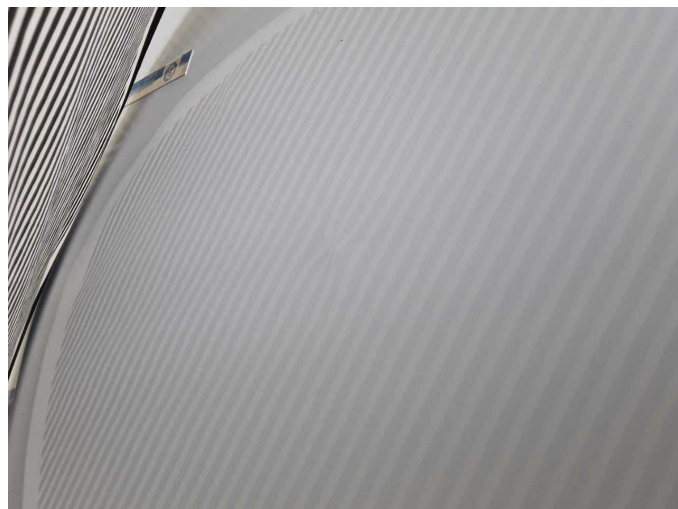
Damage 9: Side panel - rear left side: Side panel - Dent / paintcoat damage - Repair and paint
