Expertise

Protocol number: 46466705  
Order No. / Reference: 26600651  
Inspection date: 10 Jul 2026

Manufacturer: Volvo

Model: XC60 T6 AWD Recharge Essential

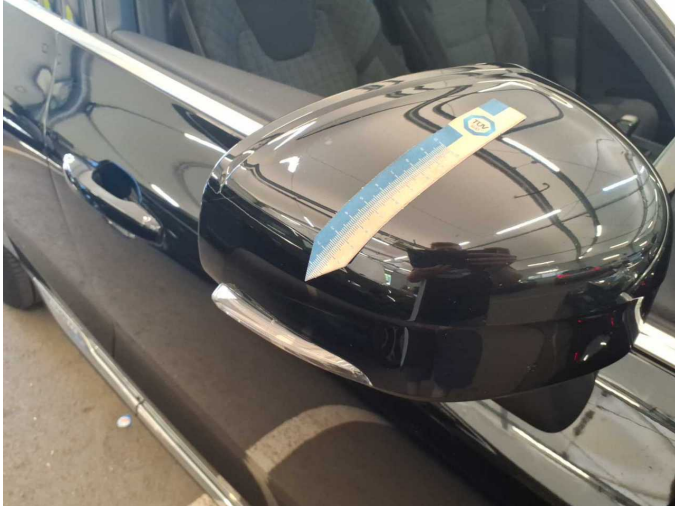
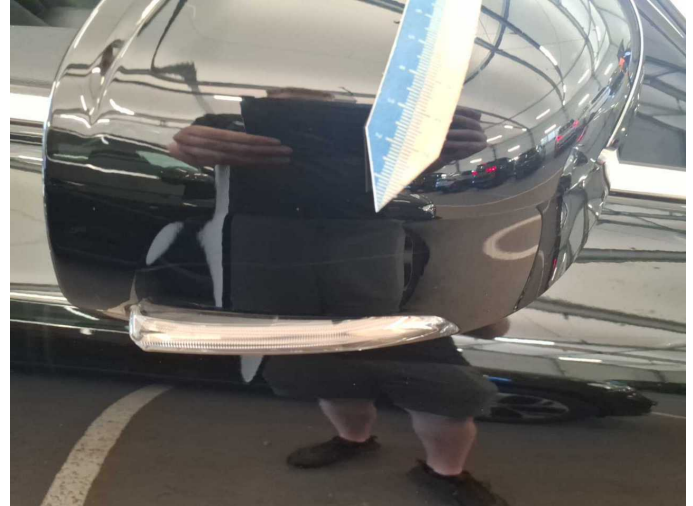
| No. | Component group | Description |
|---|---|---|
| 1 | Wing mirror - right side | Cap - Scratch(es) - Smart repair |

**Damage 1:** Wing mirror - right side: Cap - Scratch(es) - Smart repair

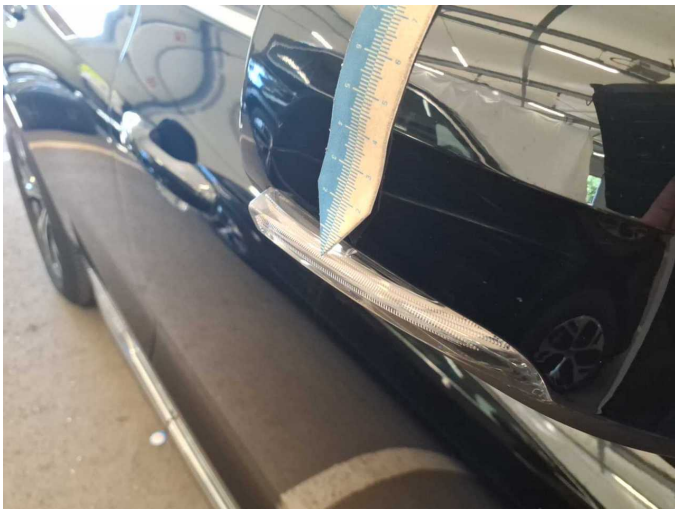
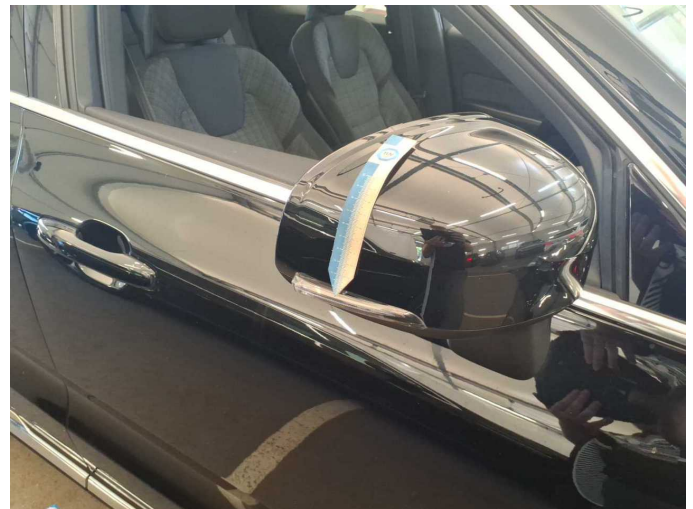
| No. | Component group | Description |
|---|---|---|
| 2 | Indicator - front | Mirror - right side - Scratch(es) - Replace |

**Damage 2:** Indicator - front: Mirror - right side - Scratch(es) - Replace

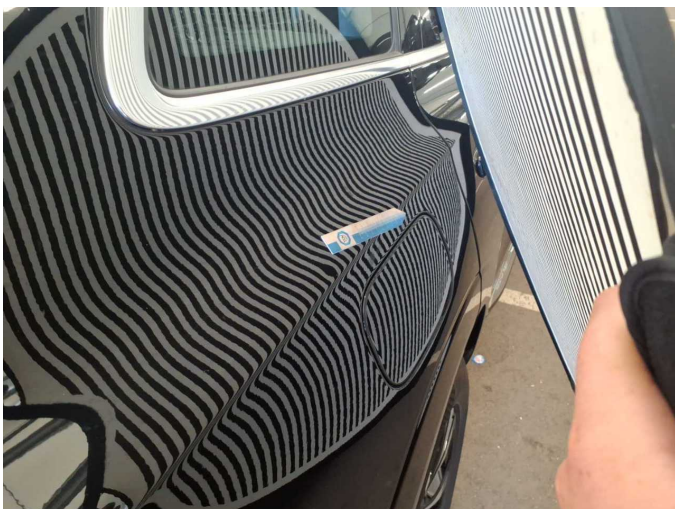
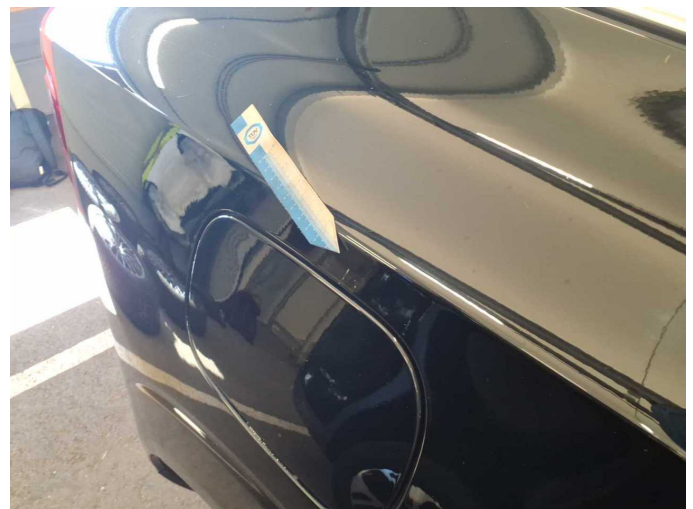
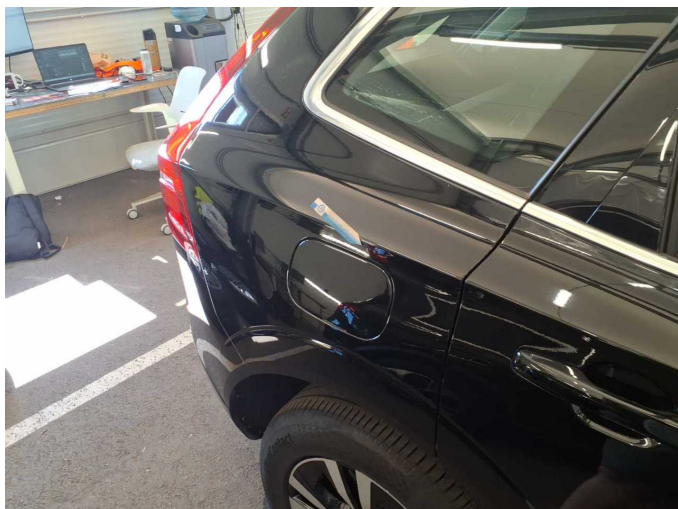
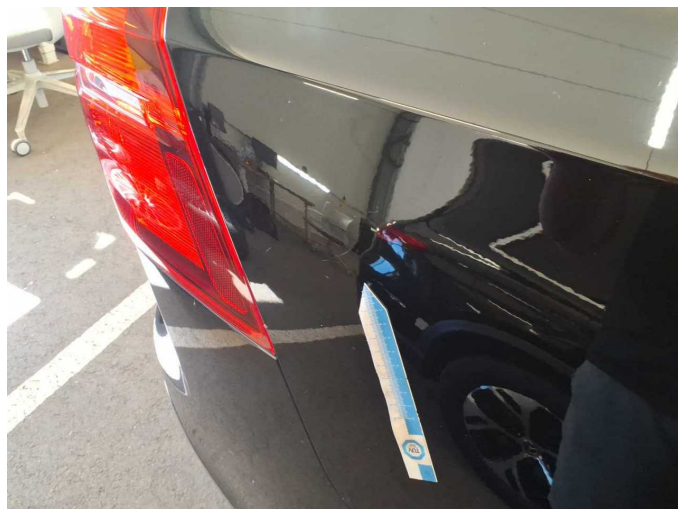
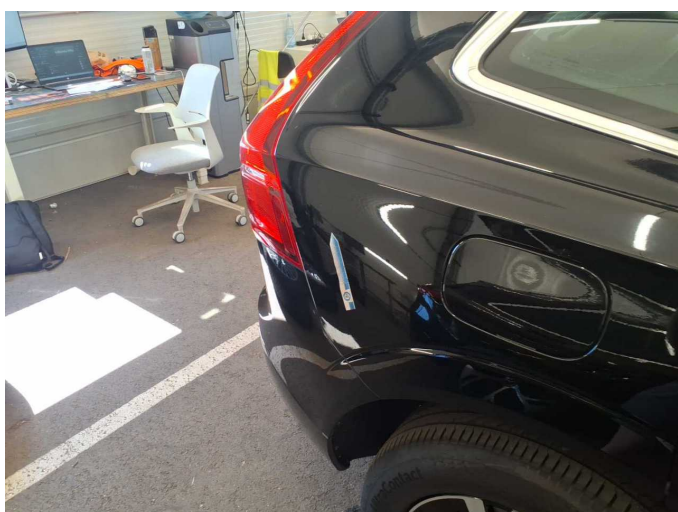
| No. | Component group | Description |
|---|---|---|
| 3 | Side panel - rear right side | Side panel - Dent / paintcoat damage - Repair and paint |

**Damage 3:** Side panel - rear right side: Side panel - Dent / paintcoat damage - Repair and paint

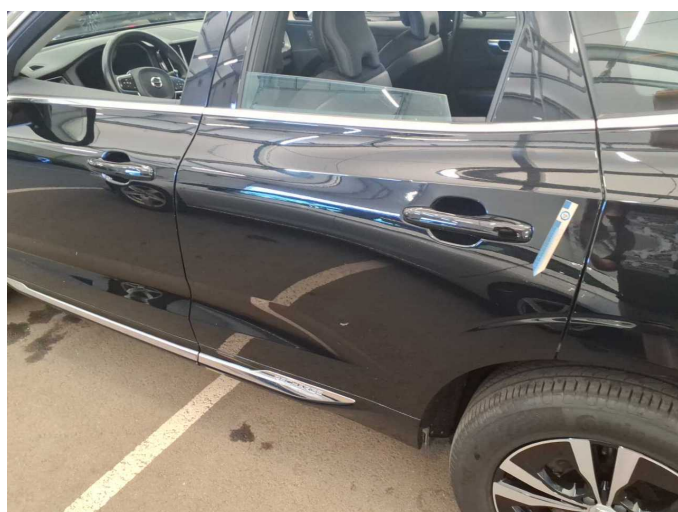
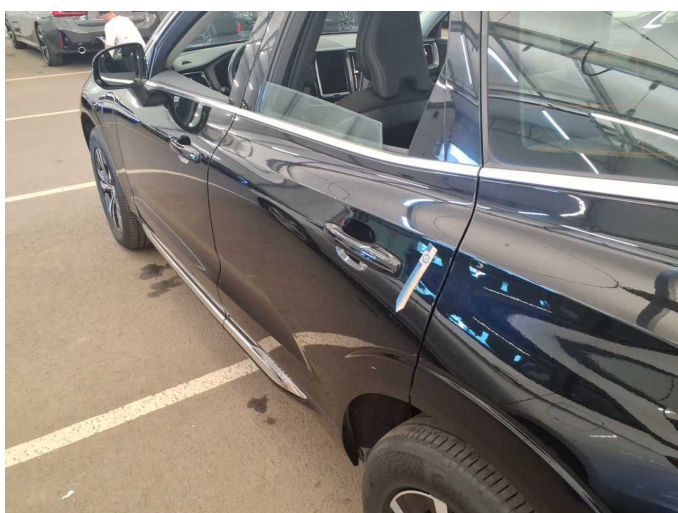
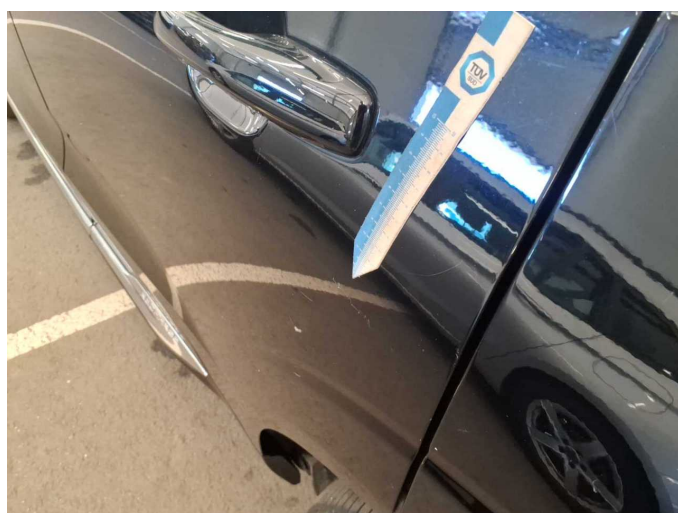
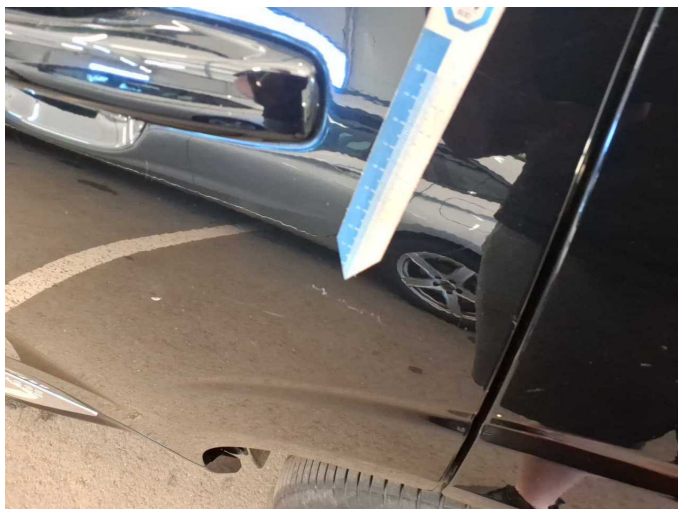
| No. | Component group | Description |
|---|---|---|
| 4 | Door - rear left side | Door - Scratch(es) - Paint |

**Damage 4:** Door - rear left side: Door - Scratch(es) - Paint

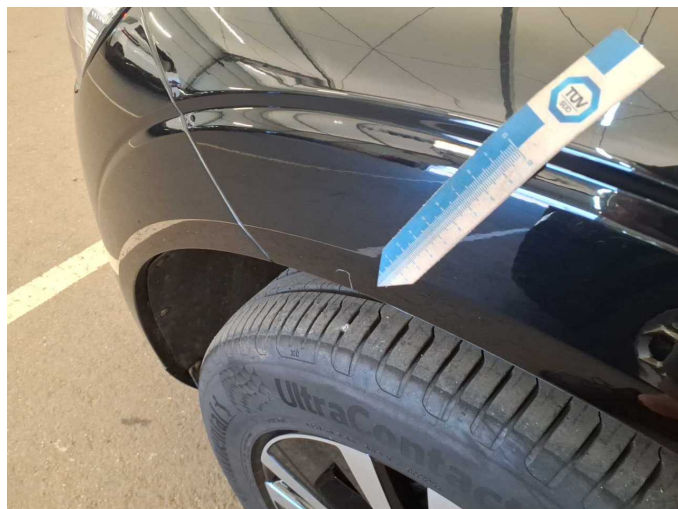
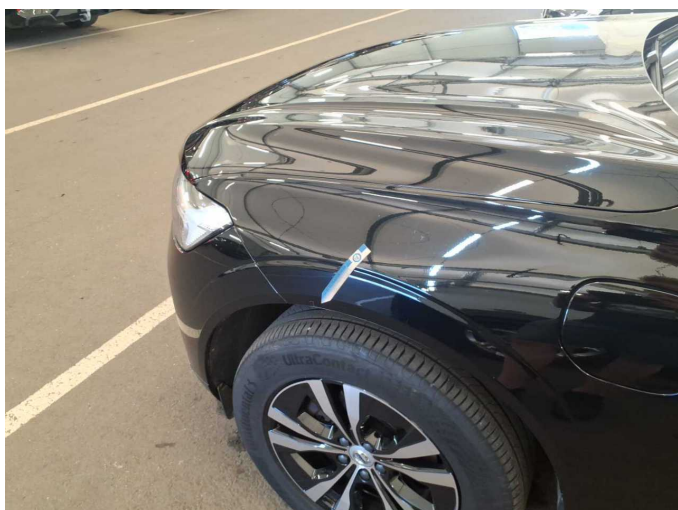
| No. | Component group | Description |
|---|---|---|
| 5 | Mudguard - left side | Mudguard - left side - Scratch(es) - Paint |

**Damage 5:** Mudguard - left side: Mudguard - left side - Scratch(es) - Paint

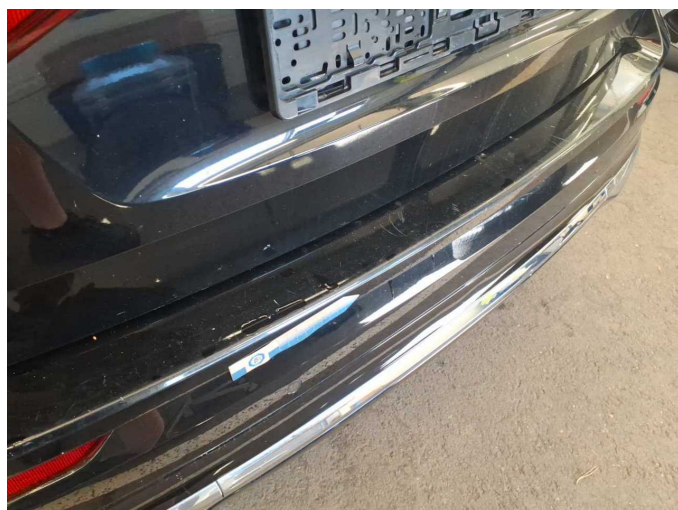
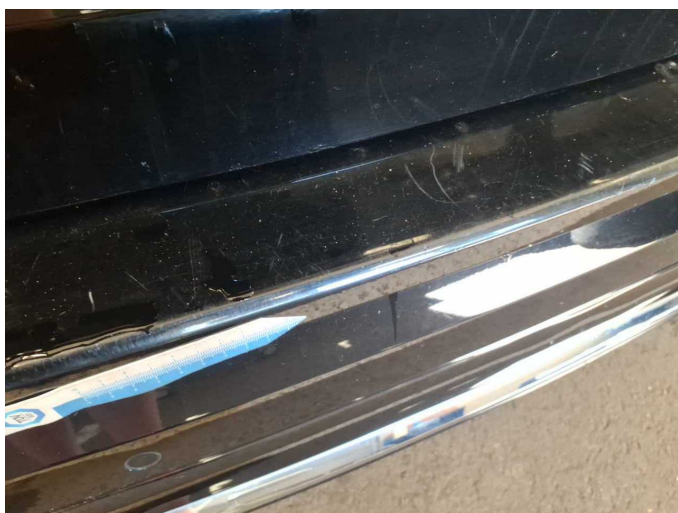
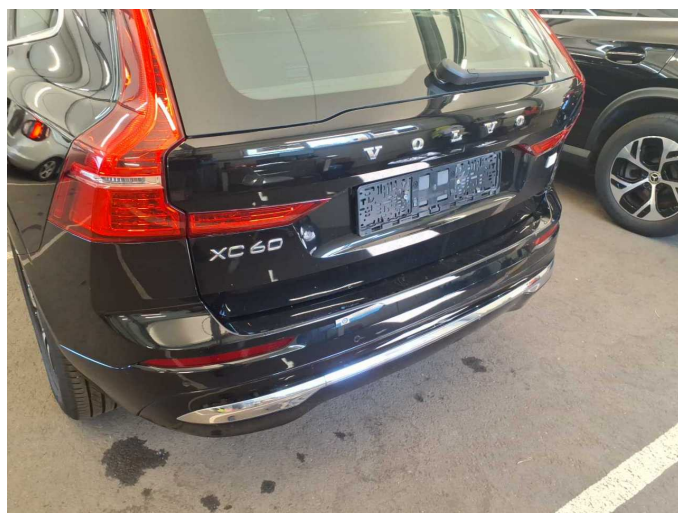
| No. | Component group | Description |
|---|---|---|
| 6 | Rear bumper | Rear bumper - Scratch(es) - Paint |

**Damage 6:** Rear bumper: Rear bumper - Scratch(es) - Paint

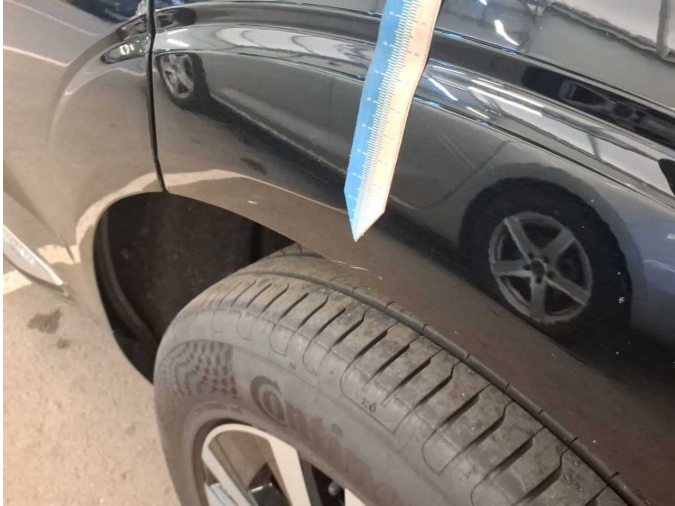
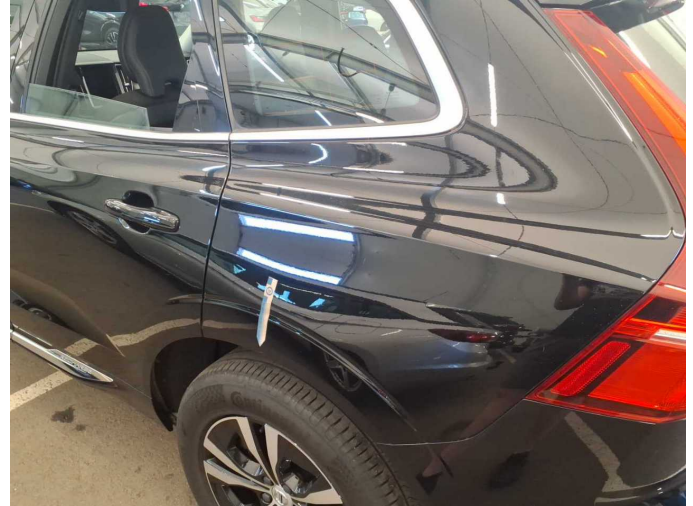
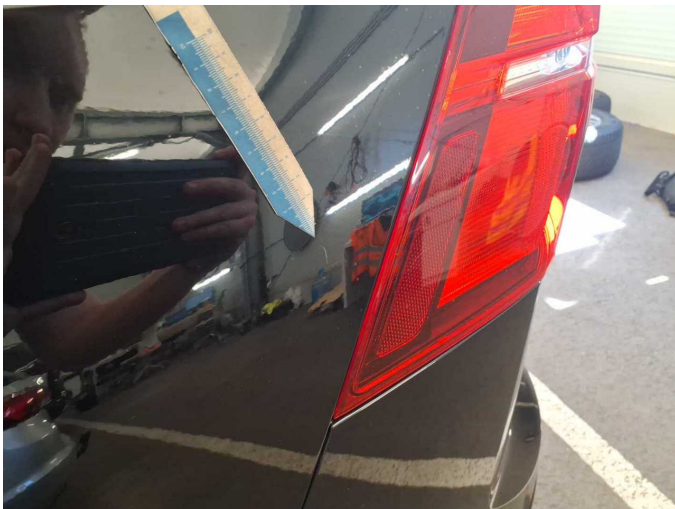
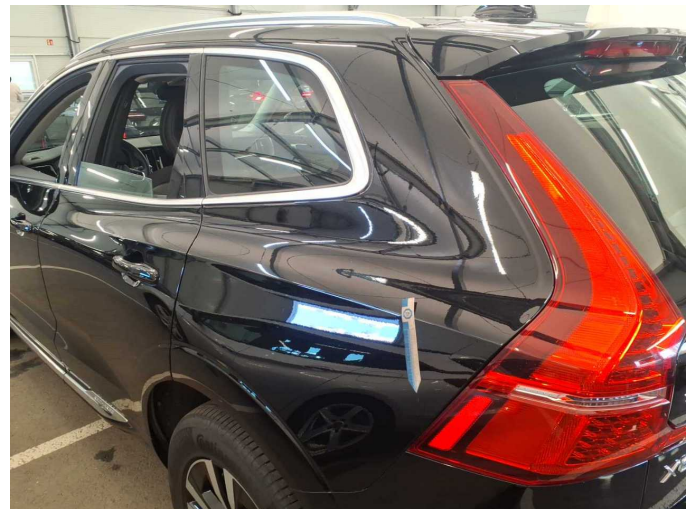
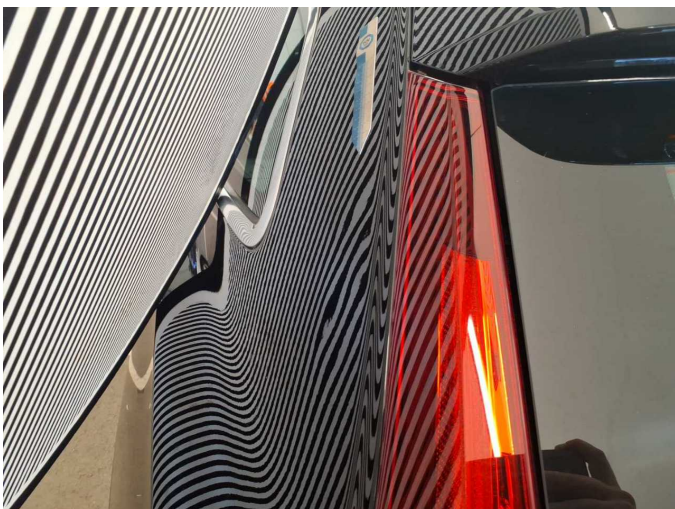
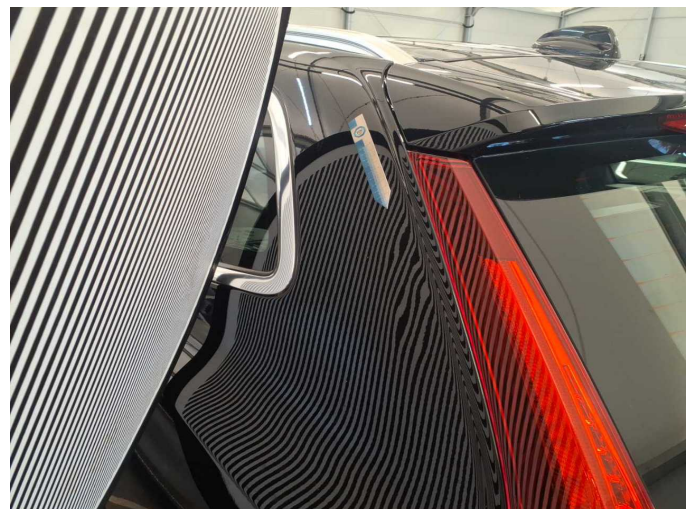
| No. | Component group | Description |
|---|---|---|
| 7 | Side panel - rear left side | Side panel - Dent / paintcoat damage - Repair and paint |

**Damage 7:** Side panel - rear left side: Side panel - Dent / paintcoat damage - Repair and paint

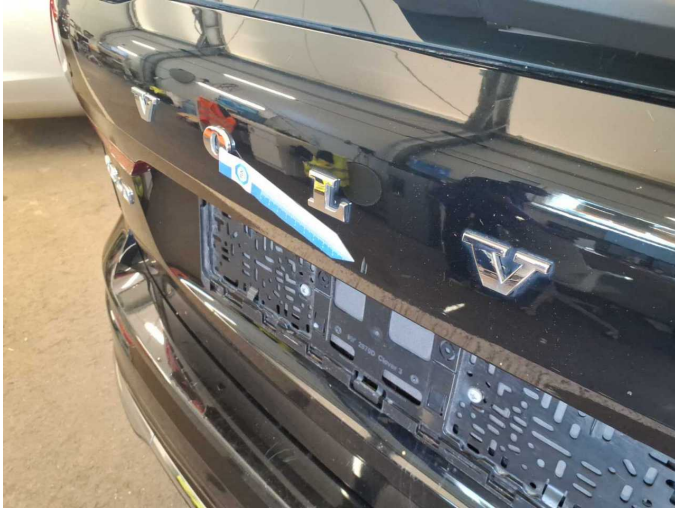
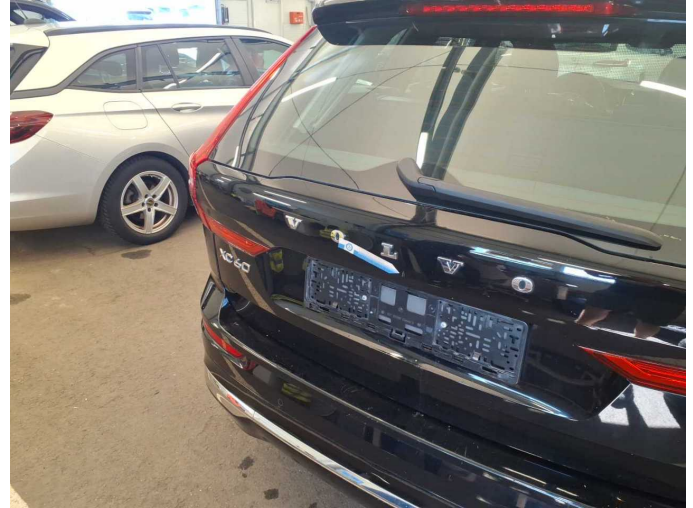
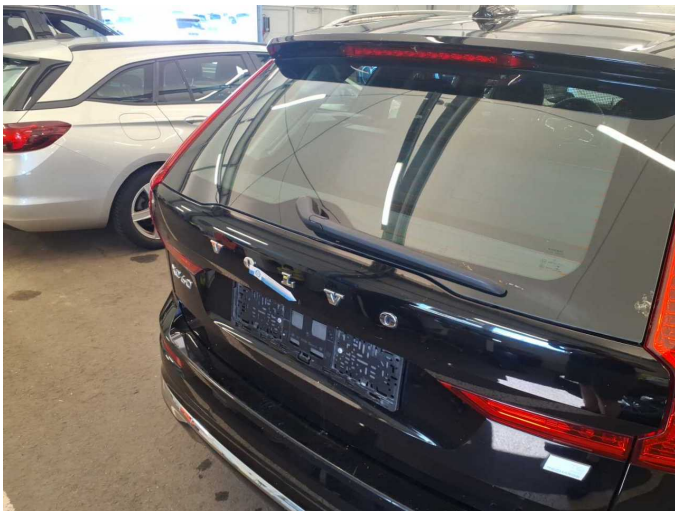
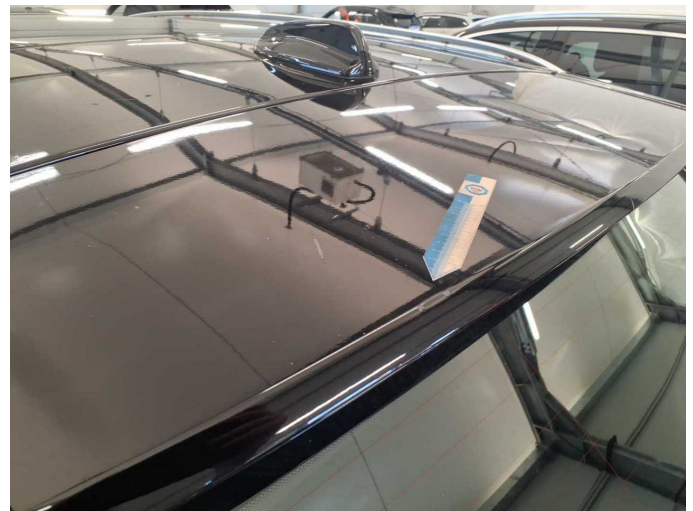
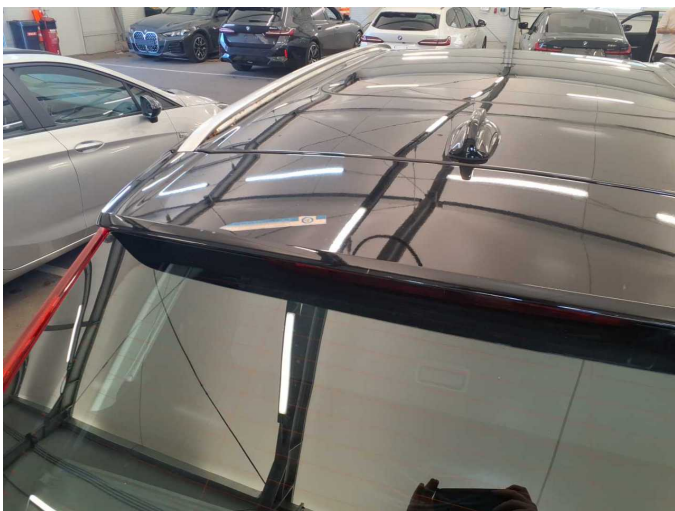
| No. | Component group | Description |
|---|---|---|
| 8 | Boot lid / rear door | Boot lid - Scratch(es) - Paint |

**Damage 8:** Boot lid / rear door: Boot lid - Scratch(es) - Paint

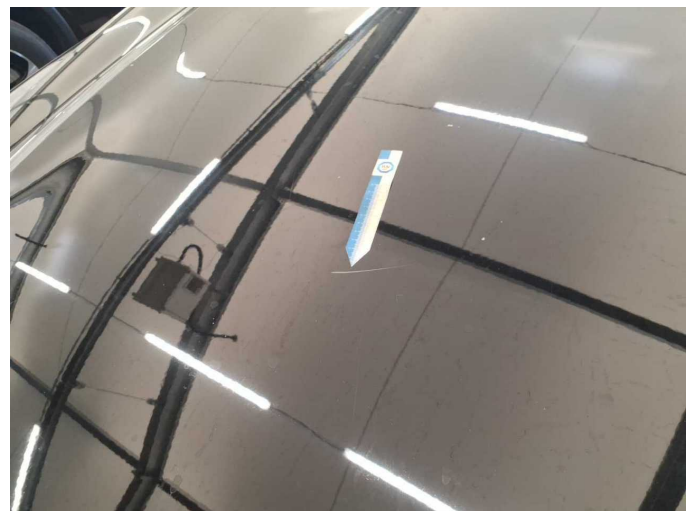
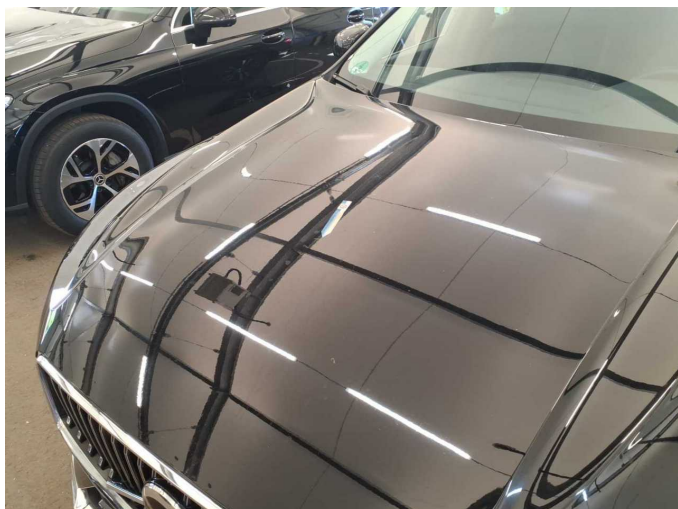
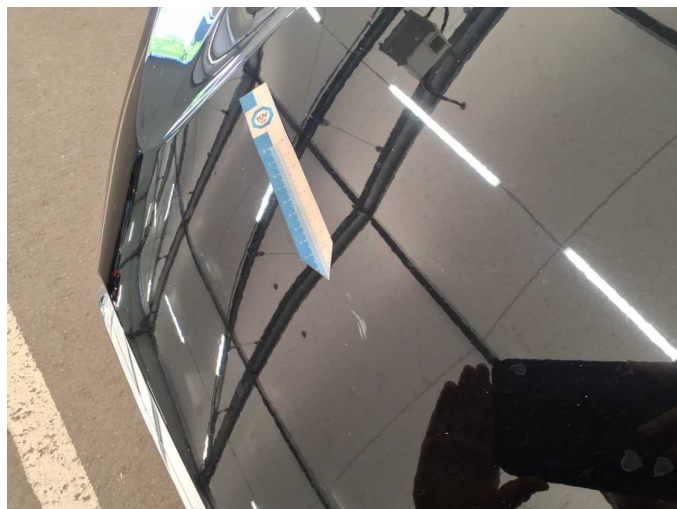
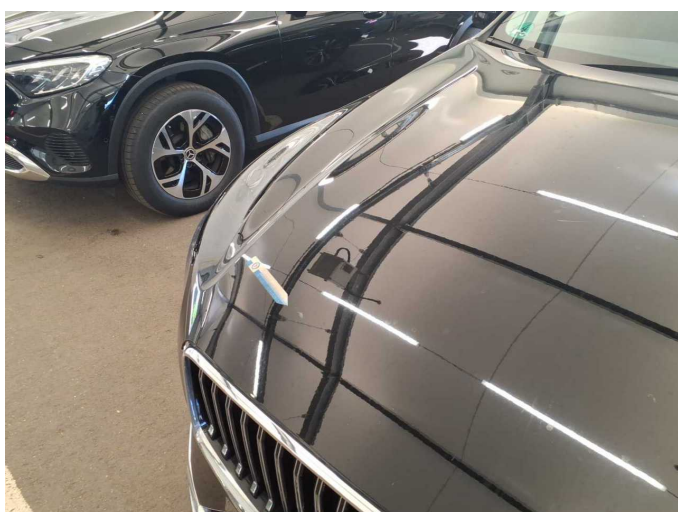
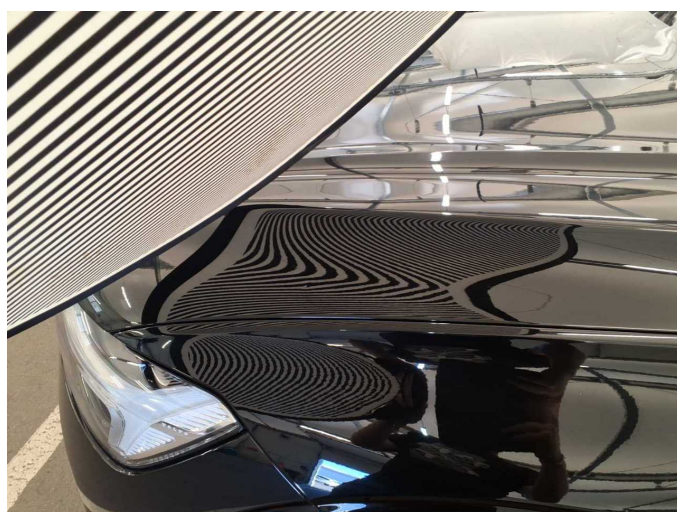
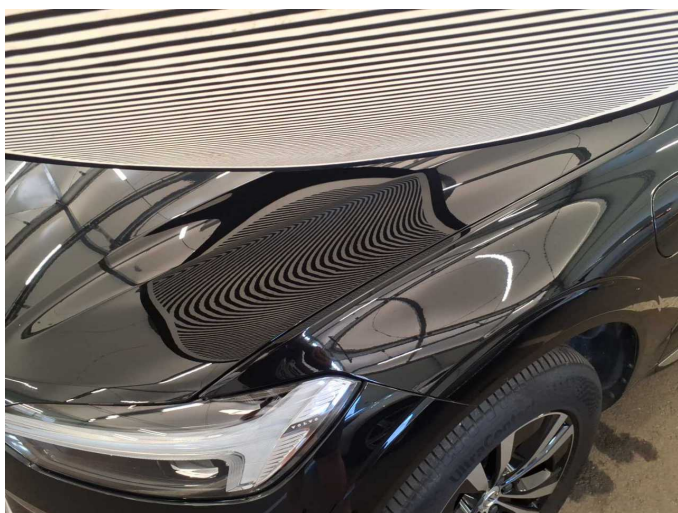
| No. | Component group | Description |
|---|---|---|
| 9 | Bonnet | Bonnet - Dent / paintcoat damage - Paint |

**Damage 9:** Bonnet: Bonnet - Dent / paintcoat damage - Paint

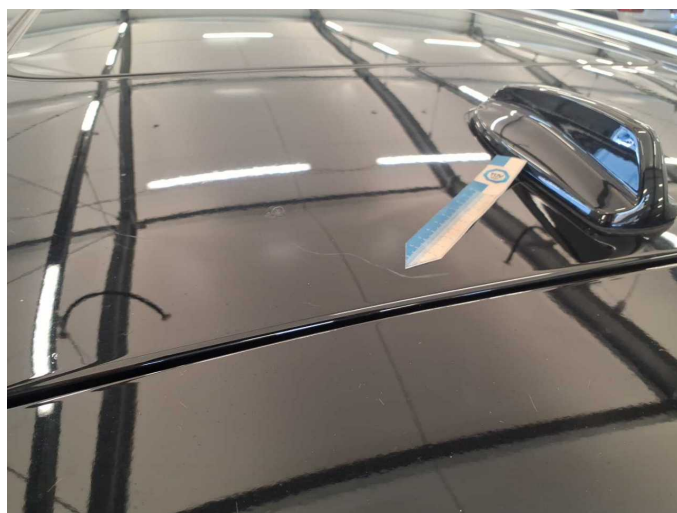
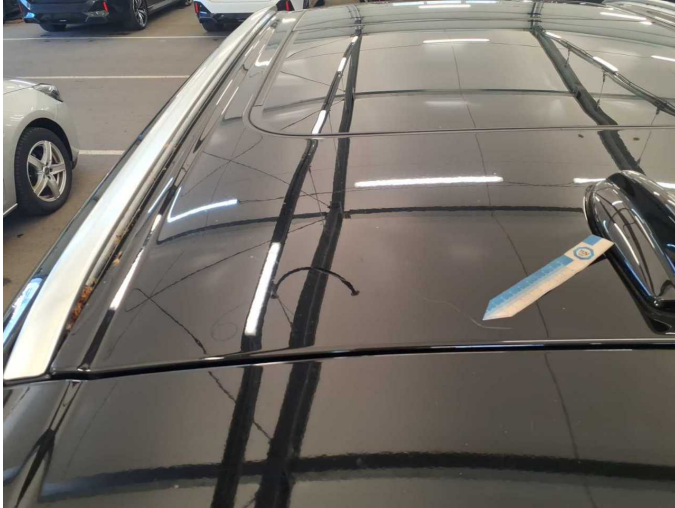
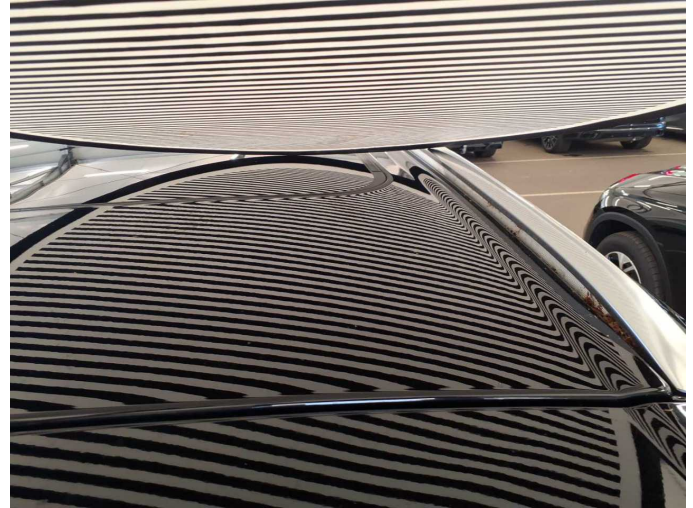
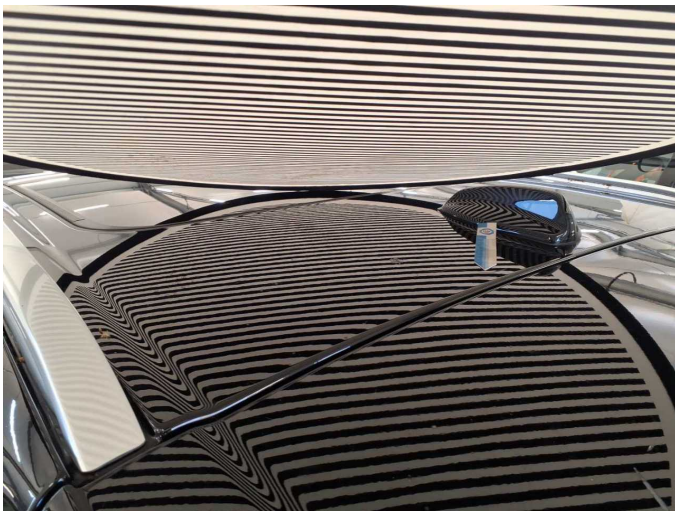
| No. | Component group | Description |
|---|---|---|
| 10 | Roof | Roof - Dent / paintcoat damage - Paint |

**Damage 10:** Roof: Roof - Dent / paintcoat damage - Paint

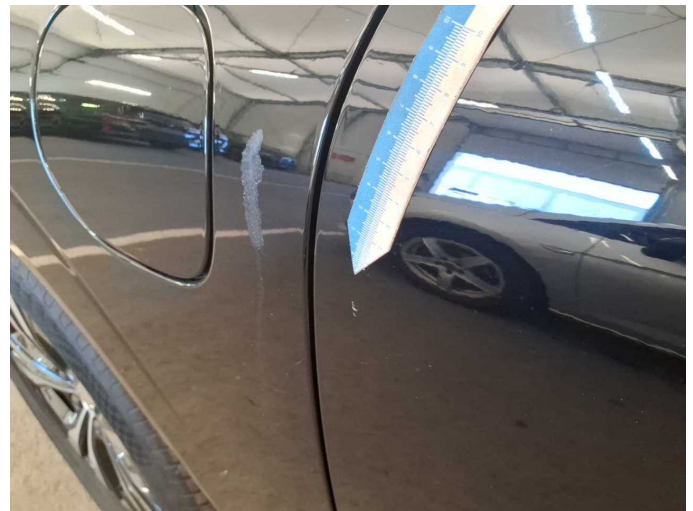
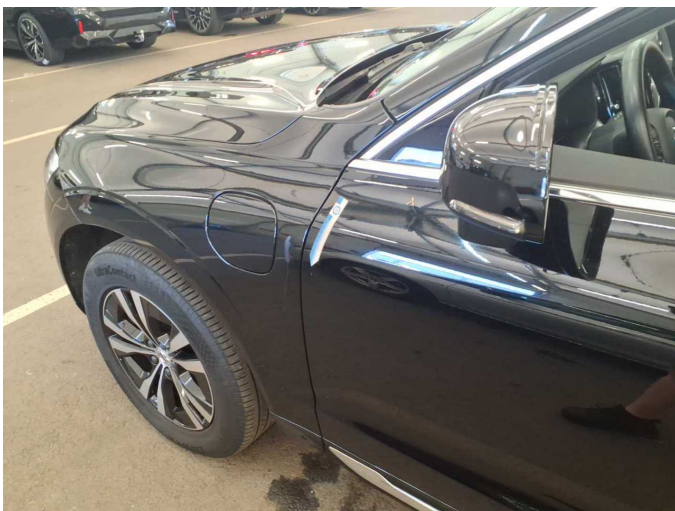
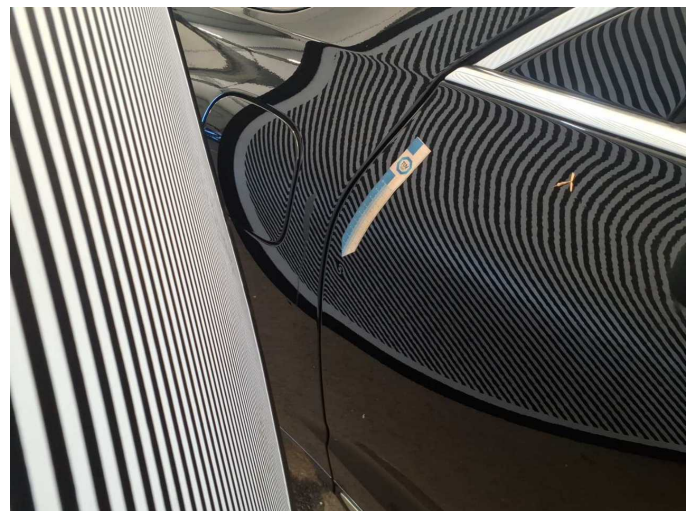
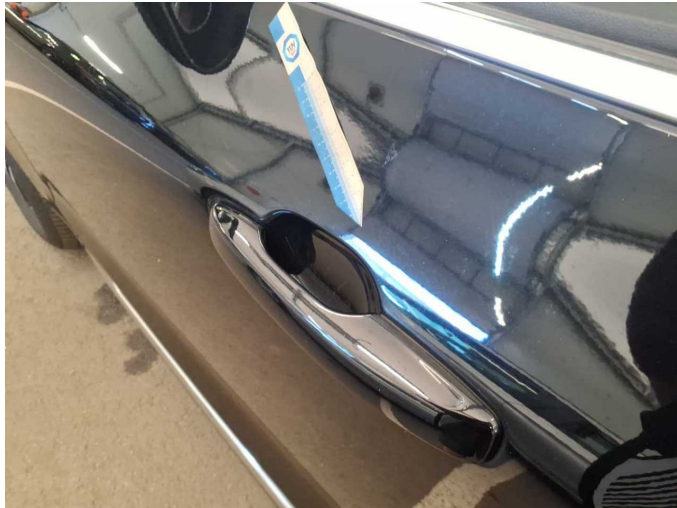
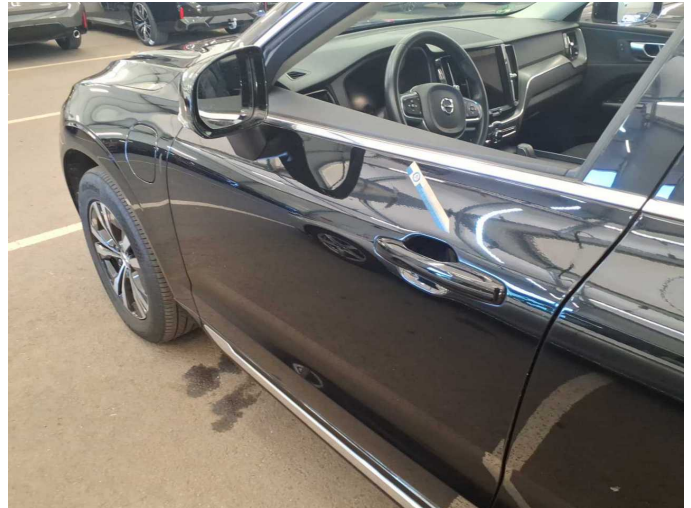
| No. | Component group | Description |
|---|---|---|
| 11 | Door - front left side | Door - Dent / paintcoat damage - Repair and paint |

**Damage 11:** Door - front left side: Door - Dent / paintcoat damage - Repair and paint

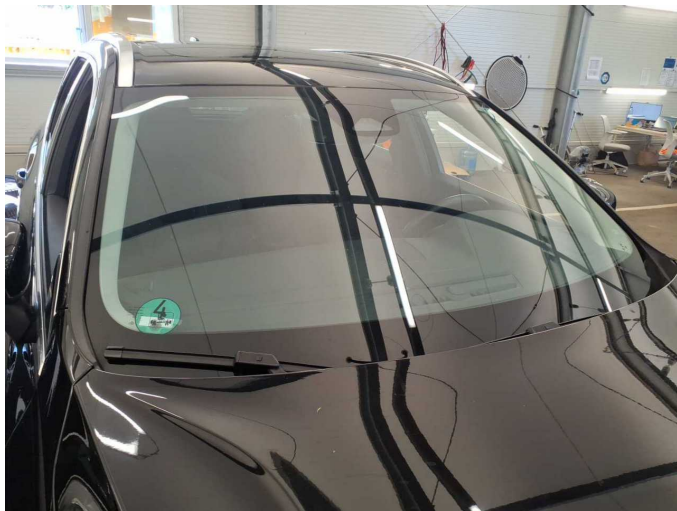
| No. | Component group | Description |
|---|---|---|
| 1 | Vehicle glazing | Windscreen - Stone chips - No deduction |

**Wear and tear 1:** Vehicle glazing: Windscreen - Stone chips - No deduction

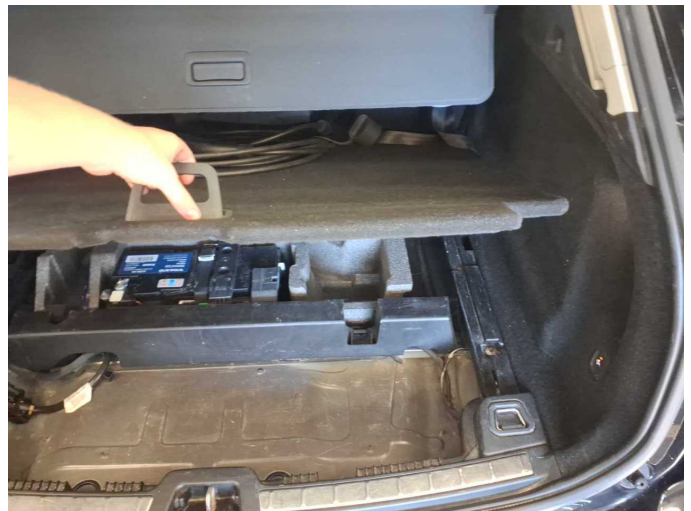
Equipment - Tirefit complete

**Missing part 1:** Equipment: Tirefit complete - Missing - Replace

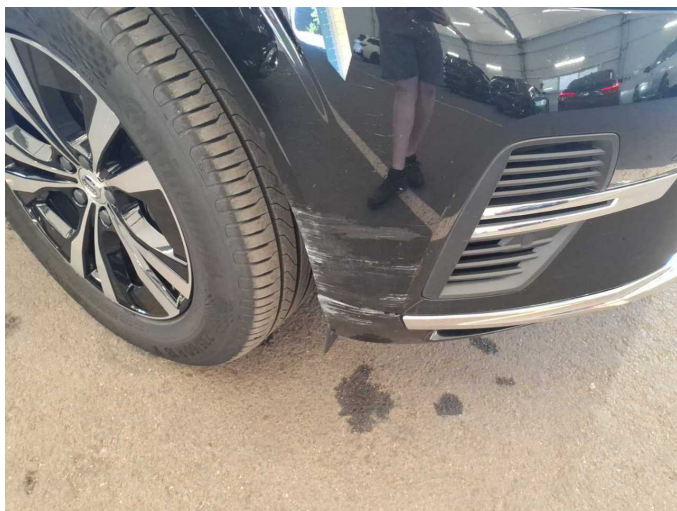
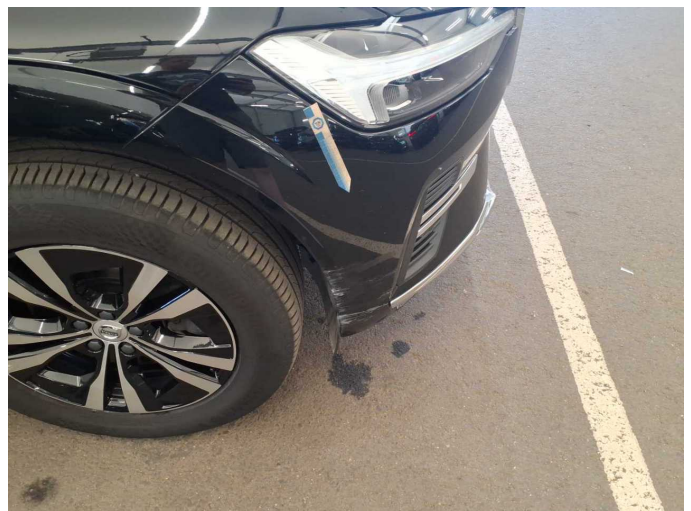
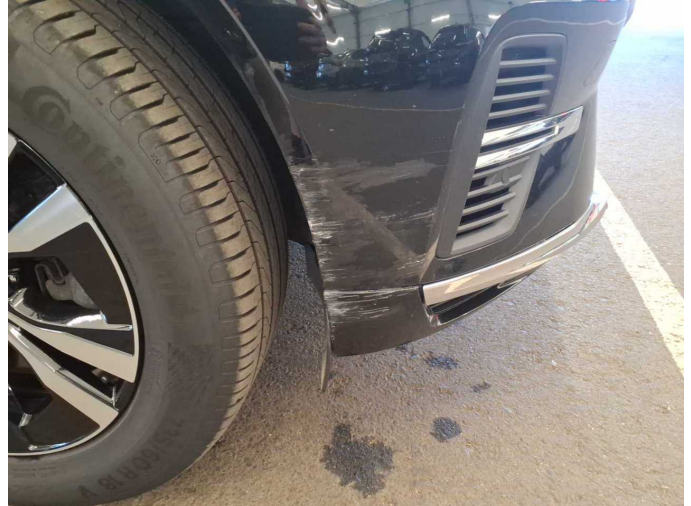
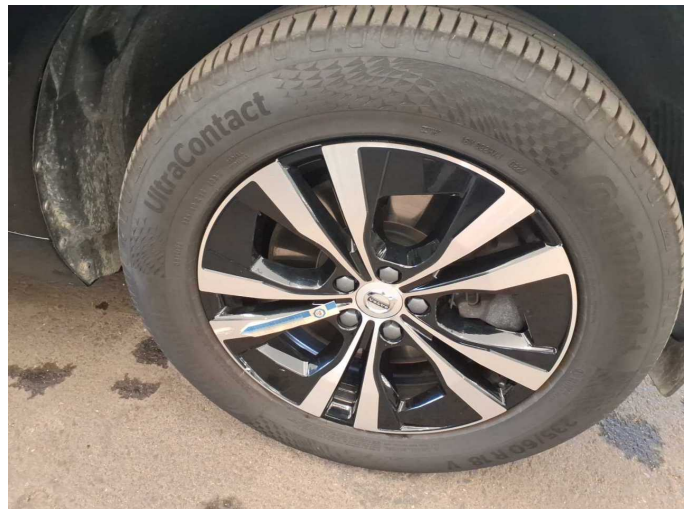
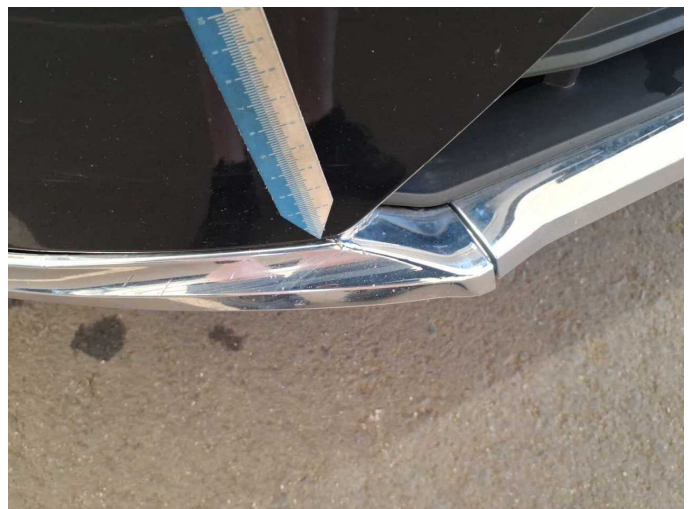
**Accident 1:** Front

**Accident 1: Front**
