Expertise

Protocol number: 46230839
Order No. / Reference: 26153796
Inspection date: 15 Jun 2026

Model: Vito 116 CDI 4MATIC Tourer Extralang HA Aut. PRO

VIN: W1VVLGTZ2T4564139

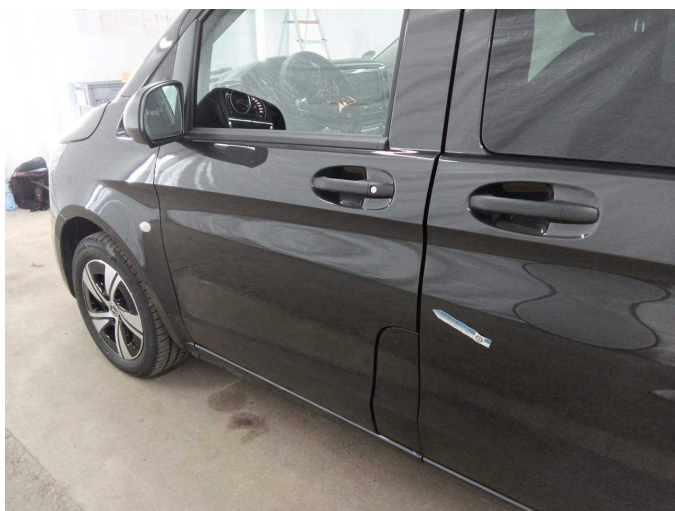
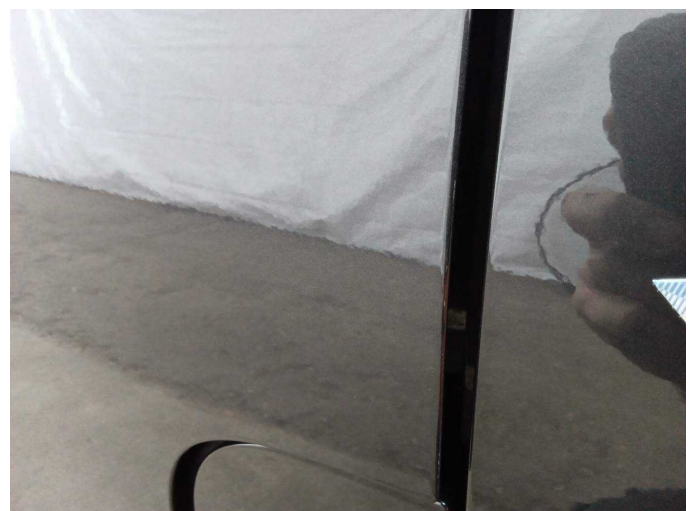
Damage 1: Door - front left side: Door edge - Scratch(es) - Smart repair

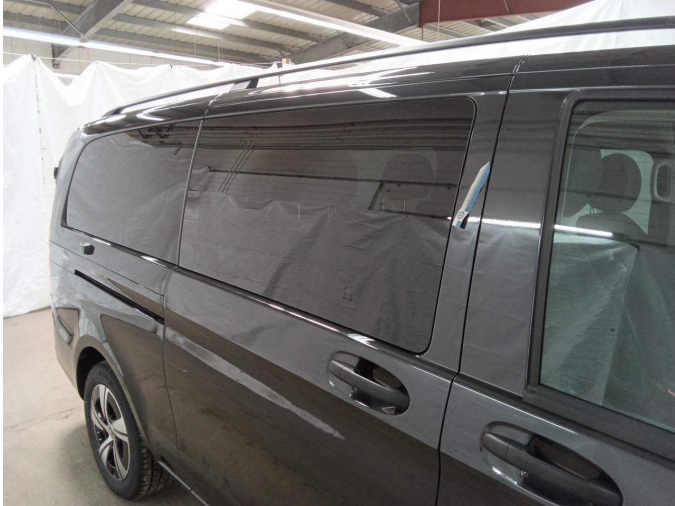
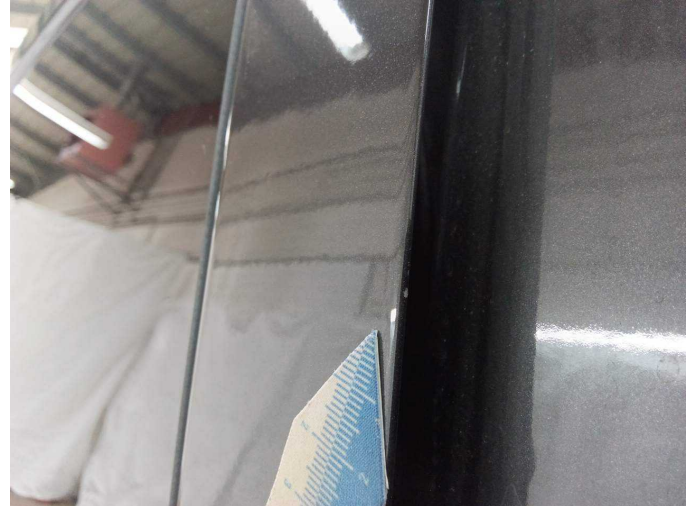
Damage 2: Door - rear right side: Door edge - Scratch(es) - Smart repair

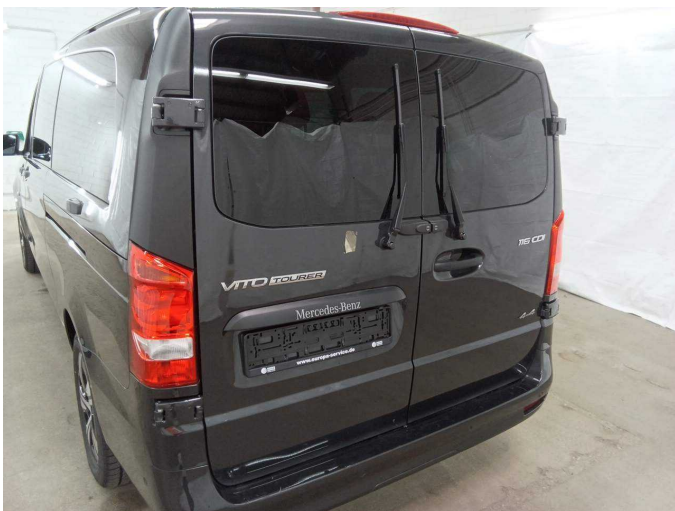
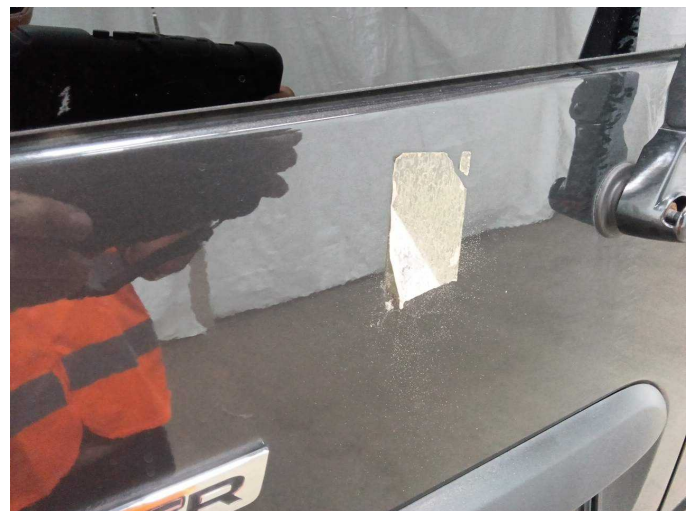
Damage 3: Body: Body - Glued / labelled - De-glug / neutralise

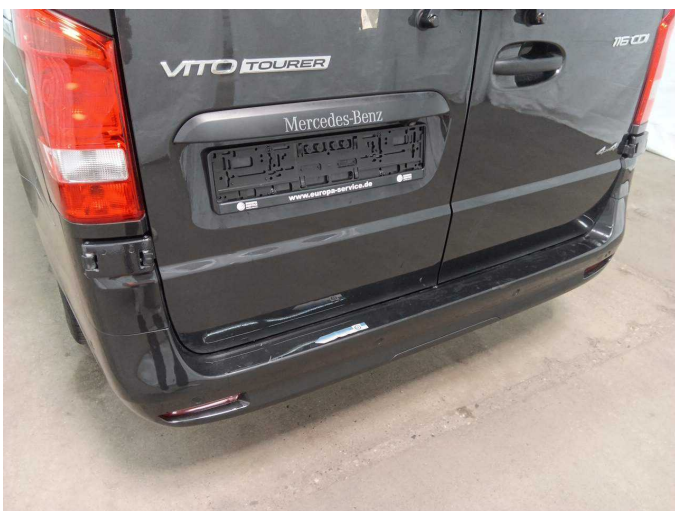
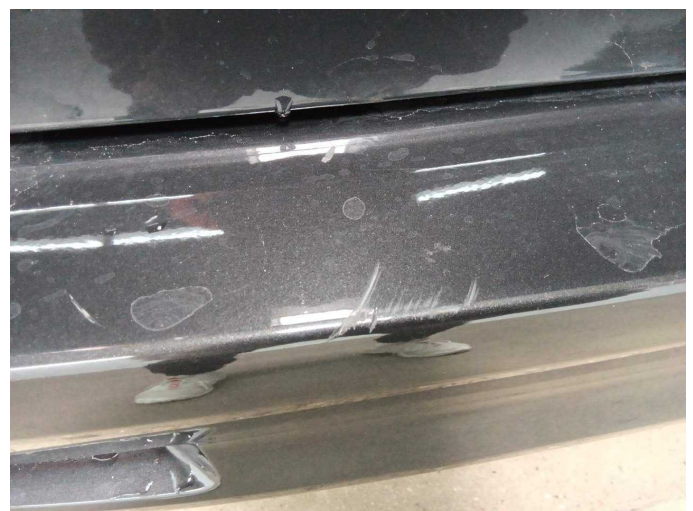
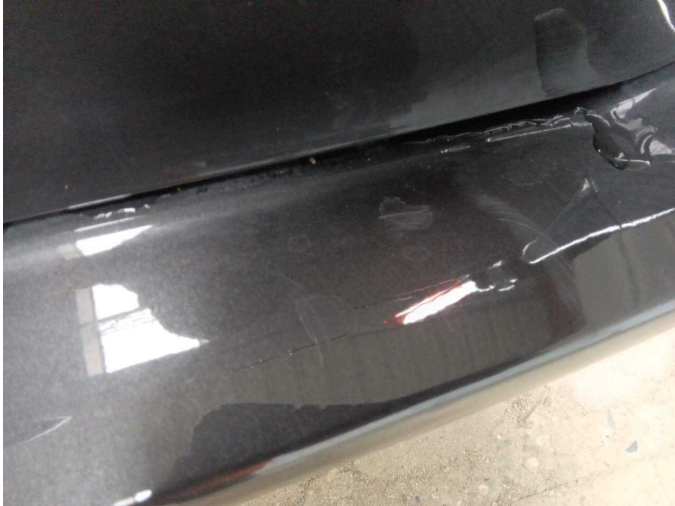
Damage 4: Rear bumper: Rear bumper - Scratch(es) - Paint

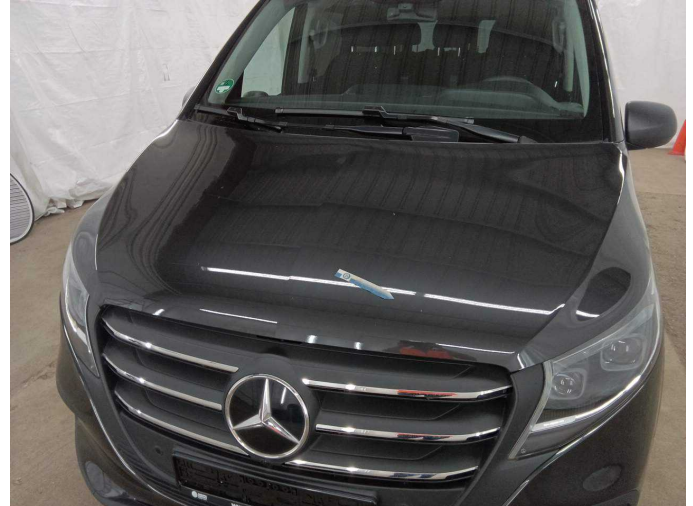
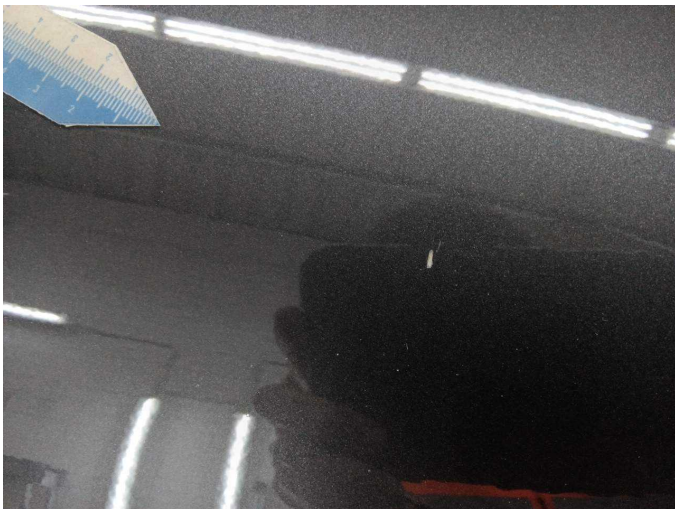
Damage 5: Bonnet: Bonnet - Stone chips - Paint

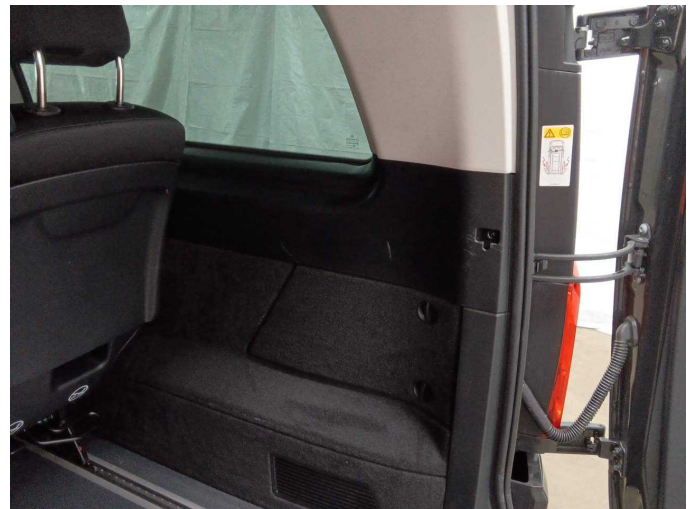
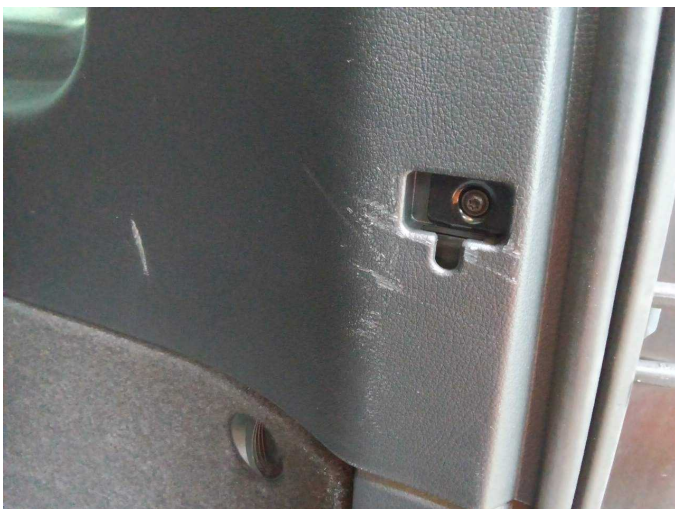
Wear and tear 5: Trim / covers: Boot lining (Rechts) - Scratch(es) - No deduction

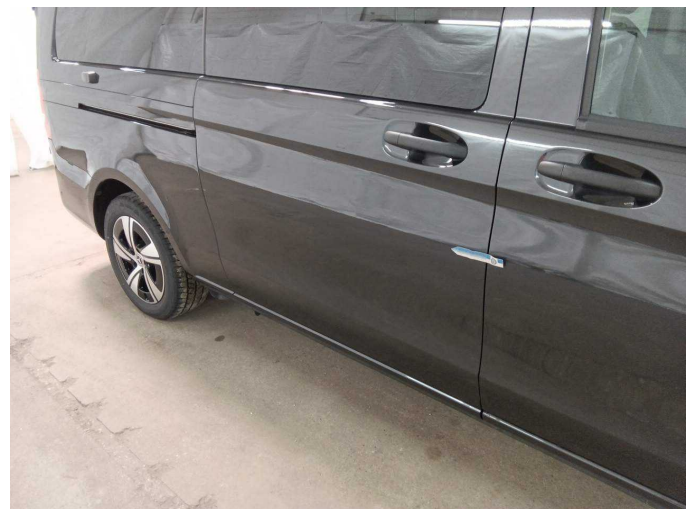
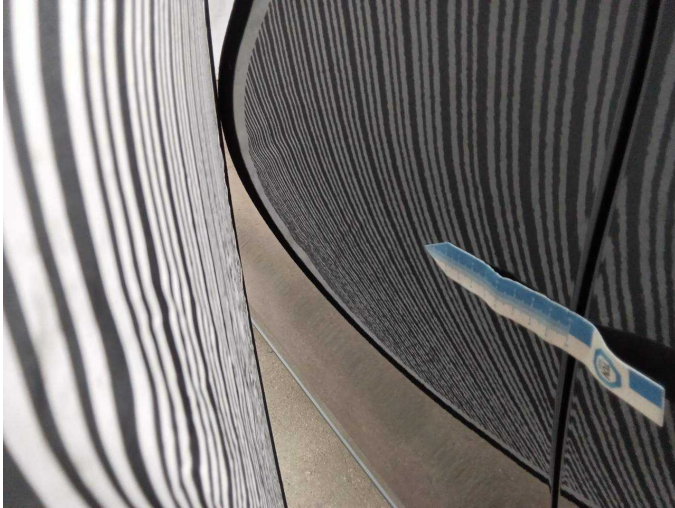
Wear and tear 6: Sliding door, right: Sliding door - dent(s) - No deduction

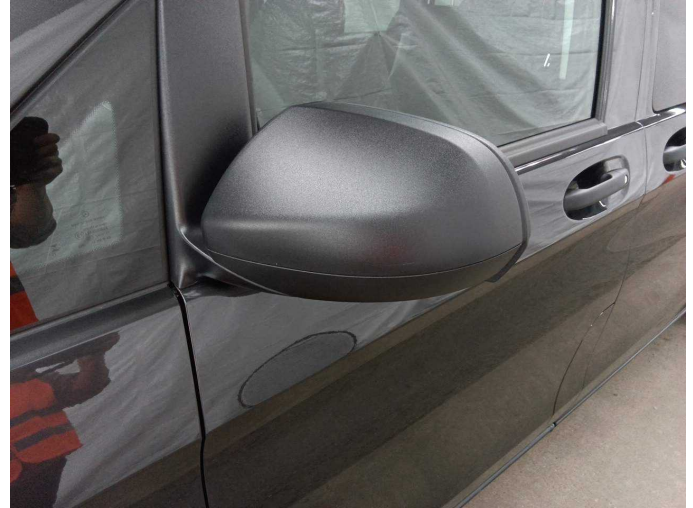
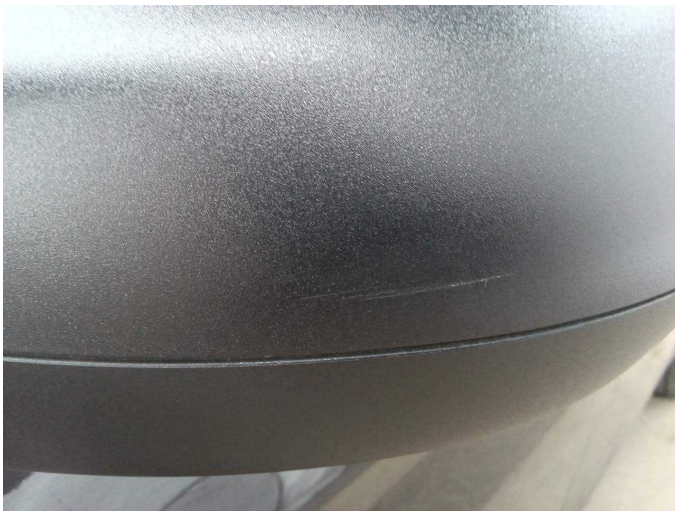
Wear and tear 7: Wing mirror - left side: Cap - Scratch(es) - No deduction

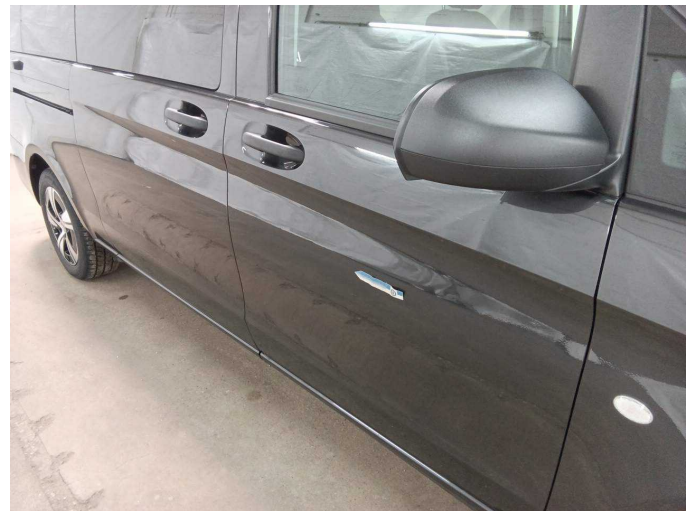
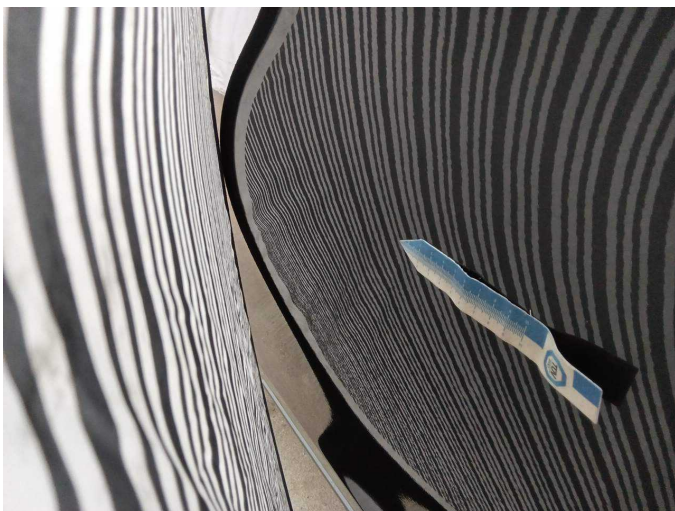
Wear and tear 8: Door - front right side: Door - dent(s) - No deduction
