Expertise

Protocol number: 46594226  
Order No. / Reference: 26550548  
Inspection date: 17 Jul 2026

| Manufacturer: Opel | Model: Insignia Sports Tourer 2.0 Diesel Aut. Business |

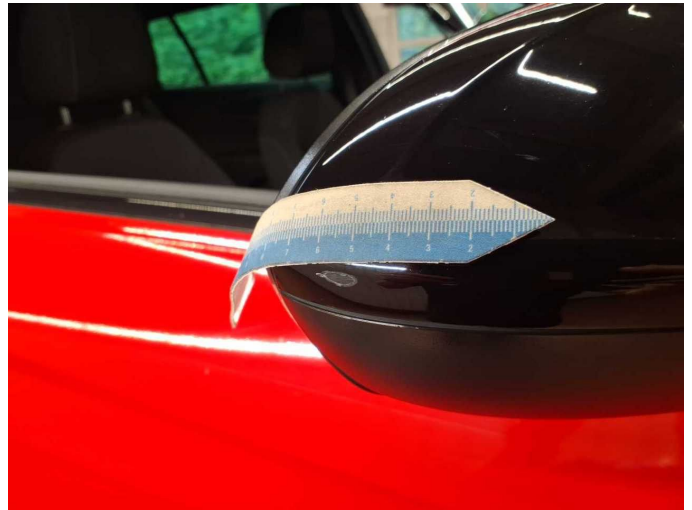
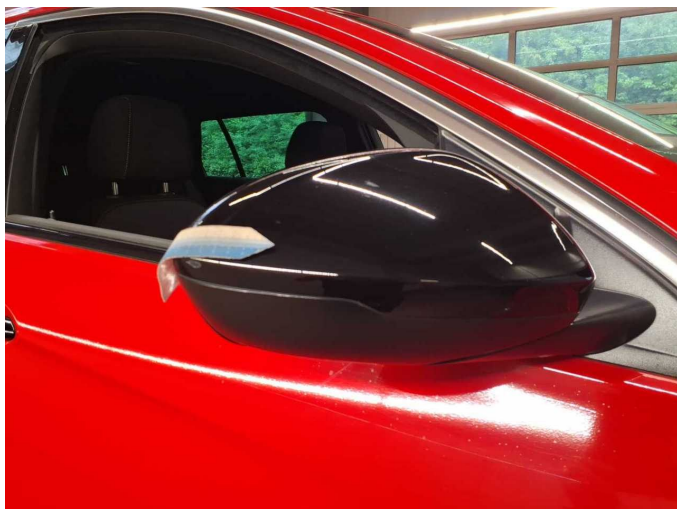
| No. | Component group | Description |
|---|---|---|
| 1 | Wing mirror - right side | Cap - Scratch(es) - Smart repair |

Damage 1: Wing mirror - right side: Cap - Scratch(es) - Smart repair

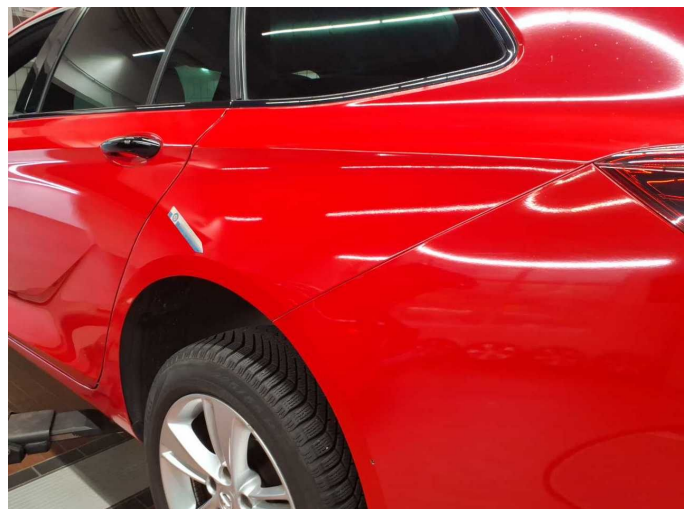
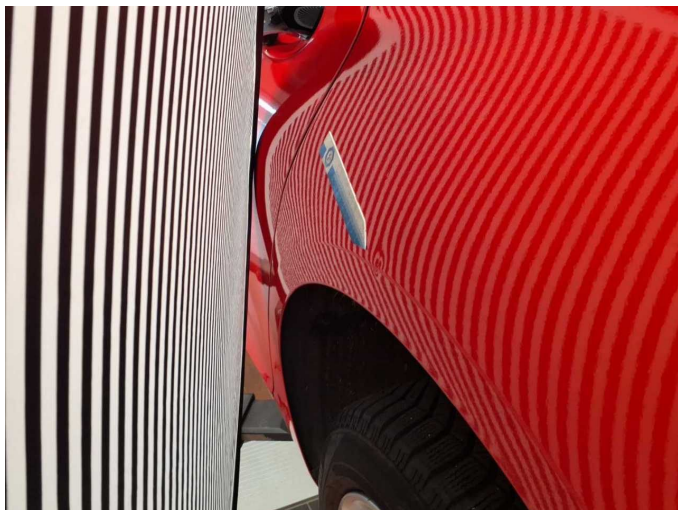
| No. | Component group | Description |
|---|---|---|
| 2 | Side panel - rear left side | Side panel - dent(s) - Smart repair |

Damage 2: Side panel - rear left side: Side panel - dent(s) - Smart repair

**Damage 2:** Side panel - rear left side: Side panel - dent(s) - Smart repair

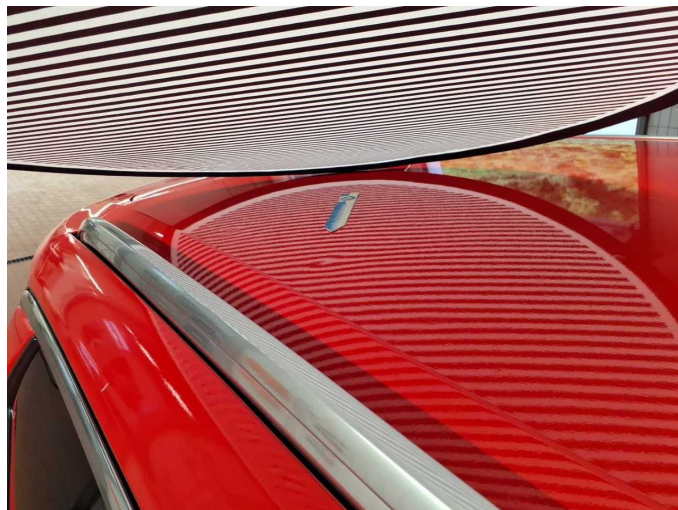
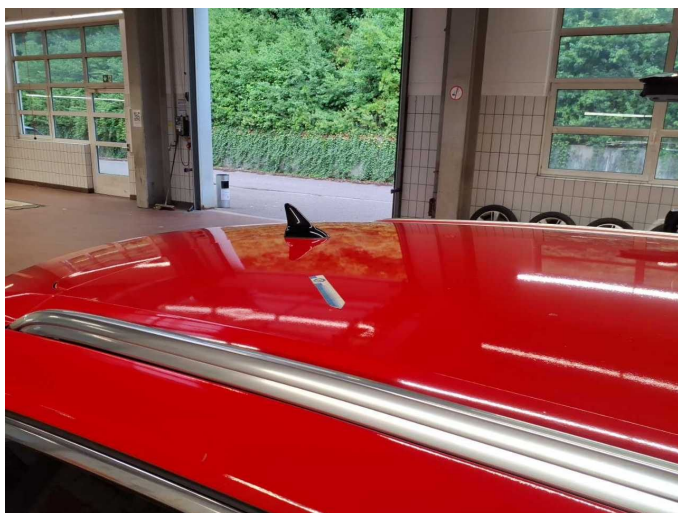
| No. | Component group | Description |
|---|---|---|
| 3 | Roof | Roof - dent(s) - Smooth repair work |

**Damage 3:** Roof: Roof - dent(s) - Smooth repair work

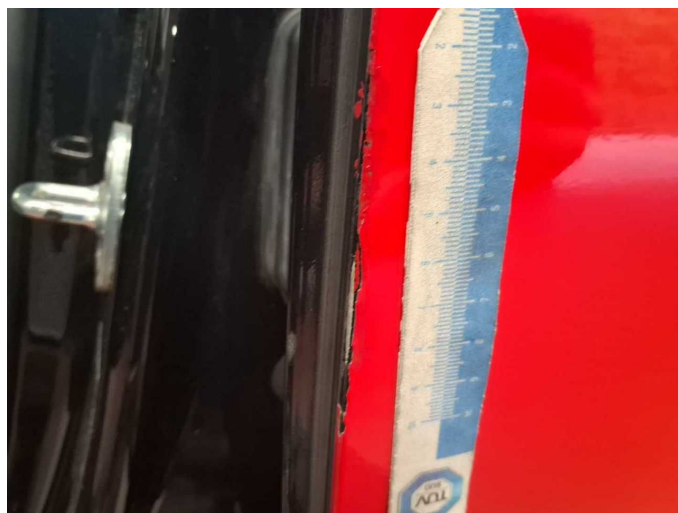
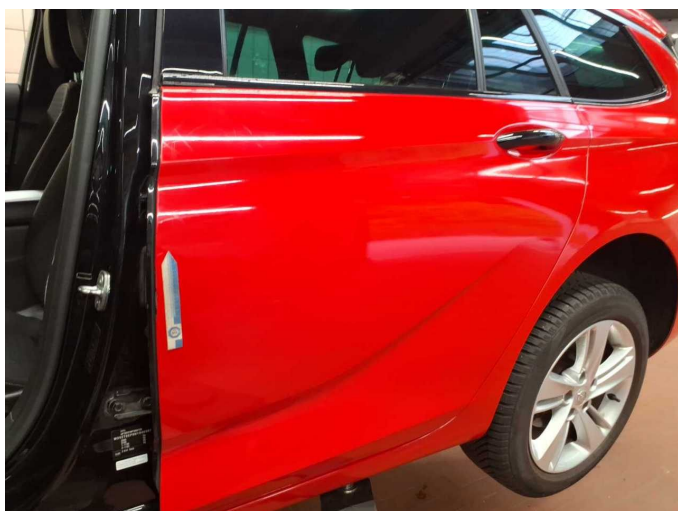
| No. | Component group | Description |
|---|---|---|
| 4 | Door - rear left side | Door - Scratch(es) - Smart repair |

**Damage 4:** Door - rear left side: Door - Scratch(es) - Smart repair

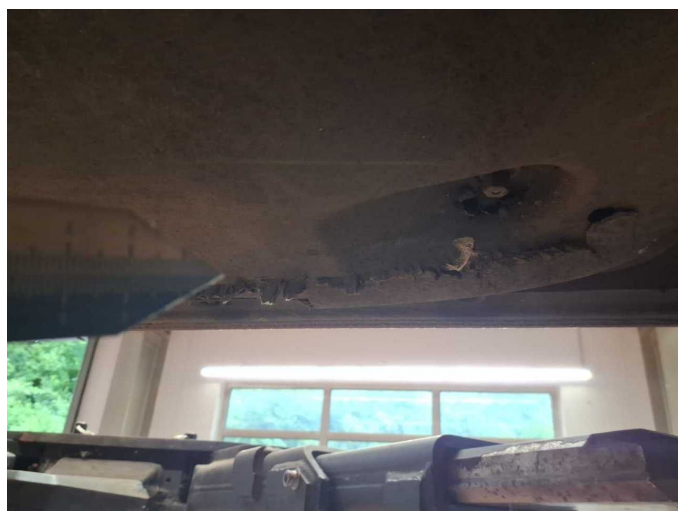
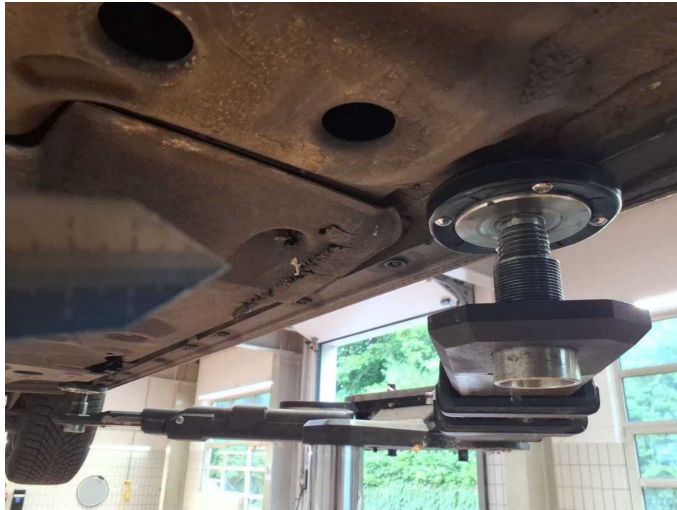
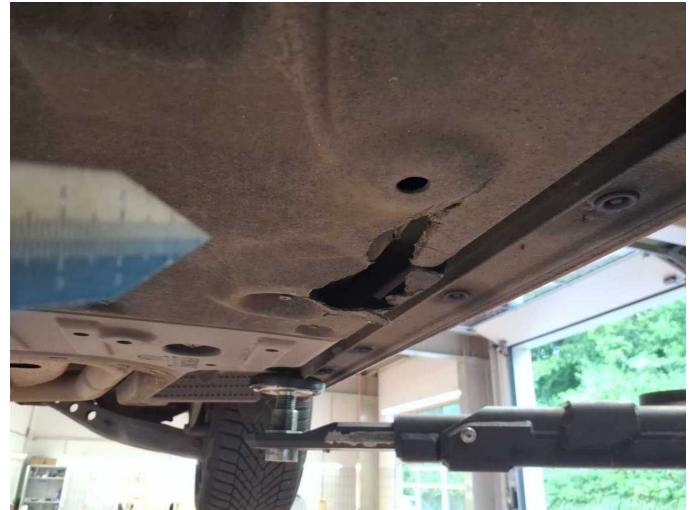
| No. | Component group | Description |
|---|---|---|
| 6 | Body | Underbody panelling - Broken / torn - Replace |

**Damage 6:** Body: Underbody panelling - Broken / torn - Replace

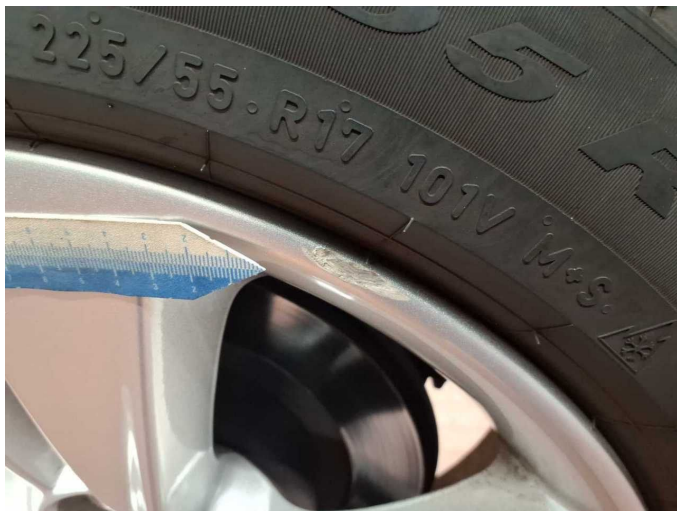
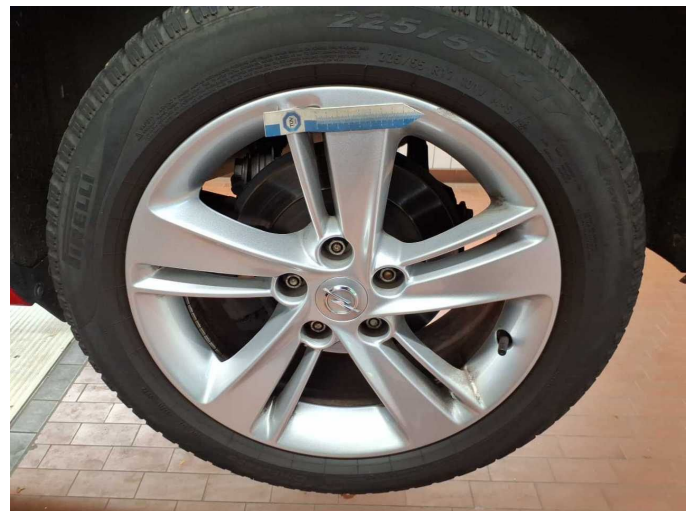
| No. | Component group | Description |
|---|---|---|
| 7 | Wheel / tyres | Alloy rim - rear left side - Scratch(es) - Loss in value |

**Damage 7:** Wheel / tyres: Alloy rim - rear left side - Scratch(es) - Loss in value

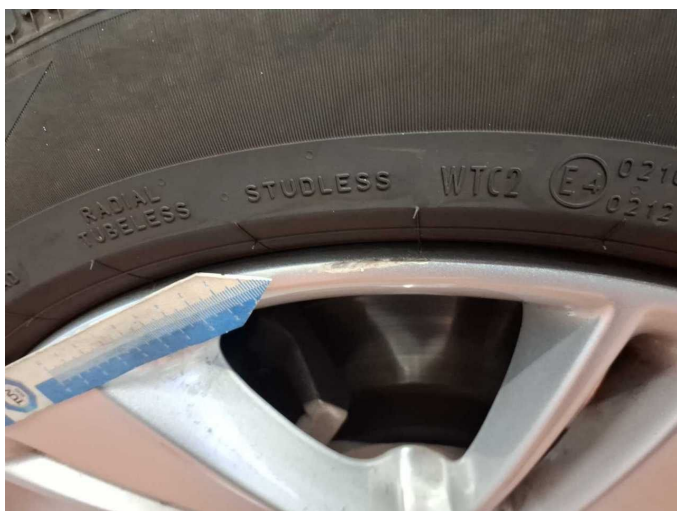
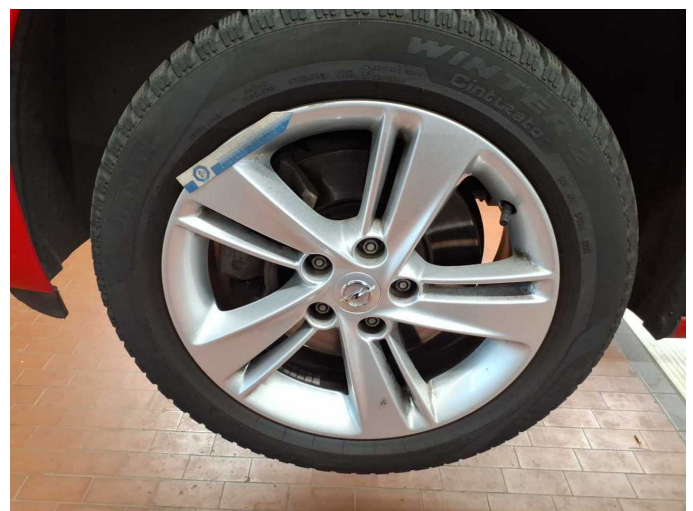
| No. | Component group | Description |
|---|---|---|
| 8 | Wheel / tyres | Alloy rim - front left side - Scratch(es) - Loss in value |

**Damage 8:** Wheel / tyres: Alloy rim - front left side - Scratch(es) - Loss in value

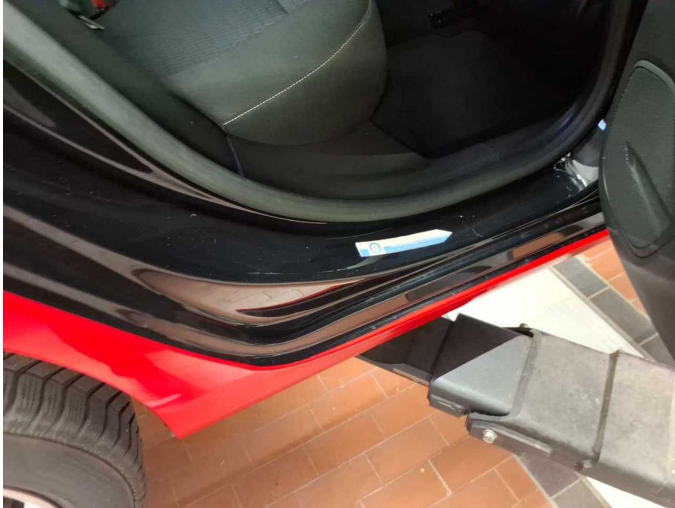
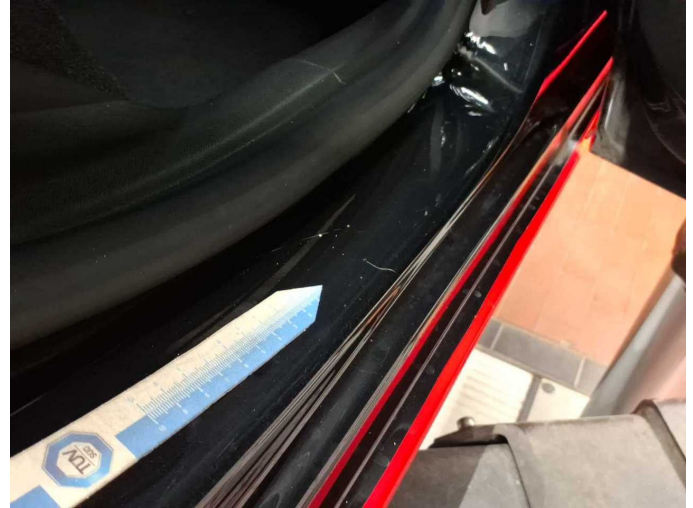
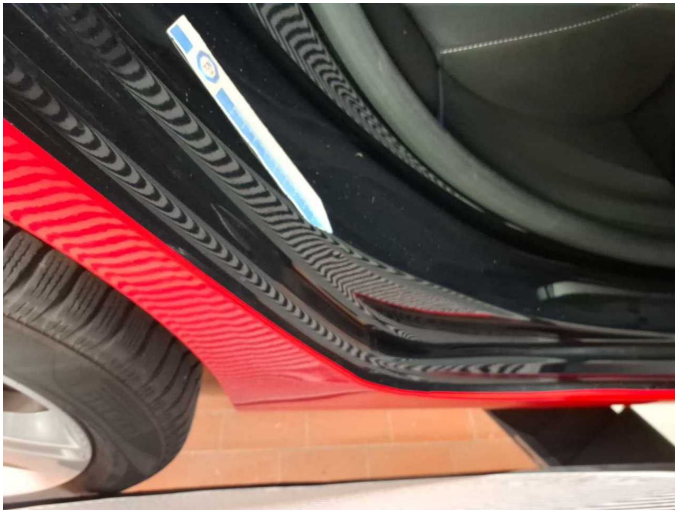
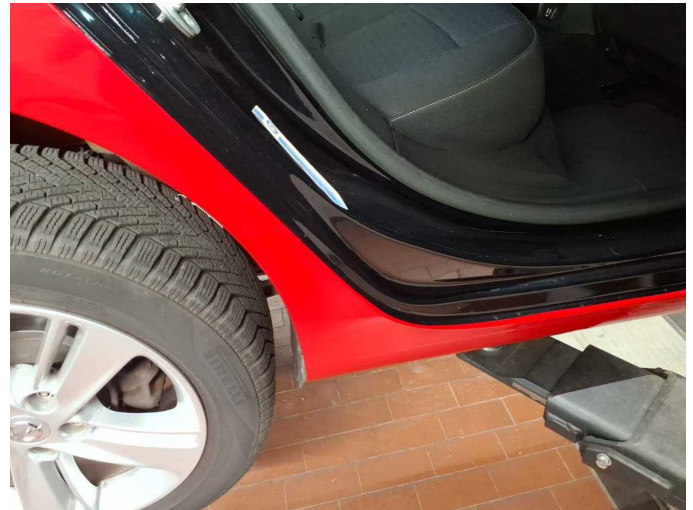
| No. | Component group | Description |
|---|---|---|
| 9 | Side panel - rear right side | Sill - Dent / paintcoat damage - Smart repair |

**Damage 9:** Side panel - rear right side: Sill - Dent / paintcoat damage - Smart repair

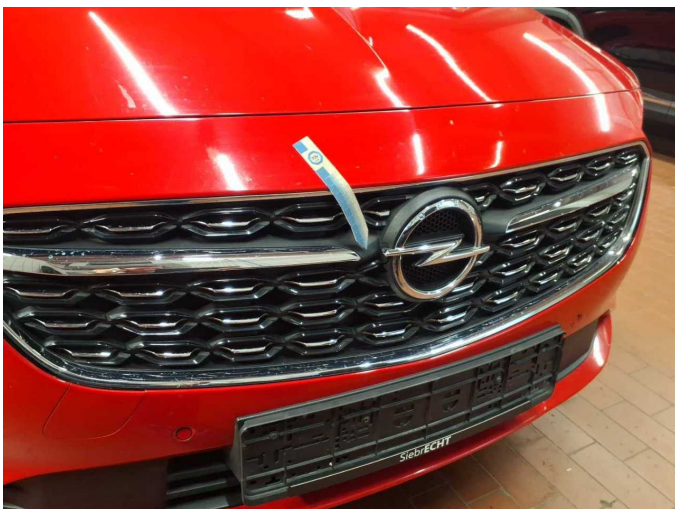
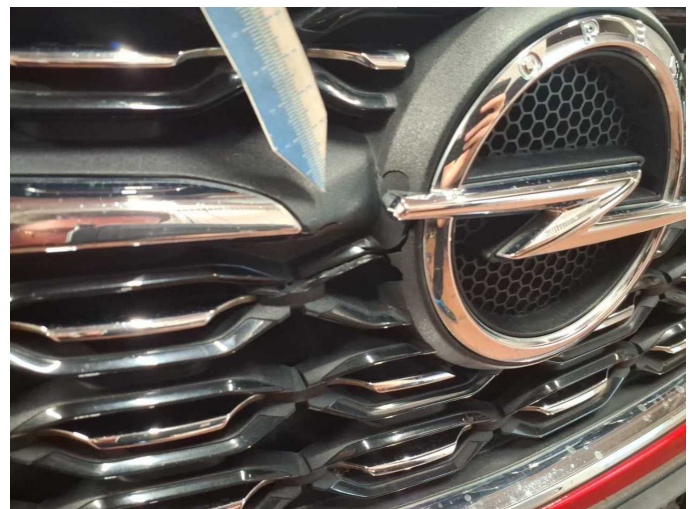
| No. | Component group | Description |
|---|---|---|
| 10 | Front bumper | Grille - Broken / torn - Replace |

**Damage 10:** Front bumper: Grille - Broken / torn - Replace

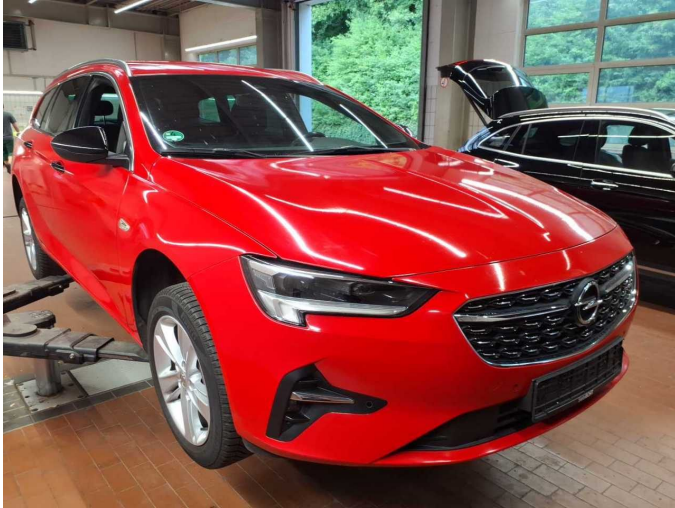
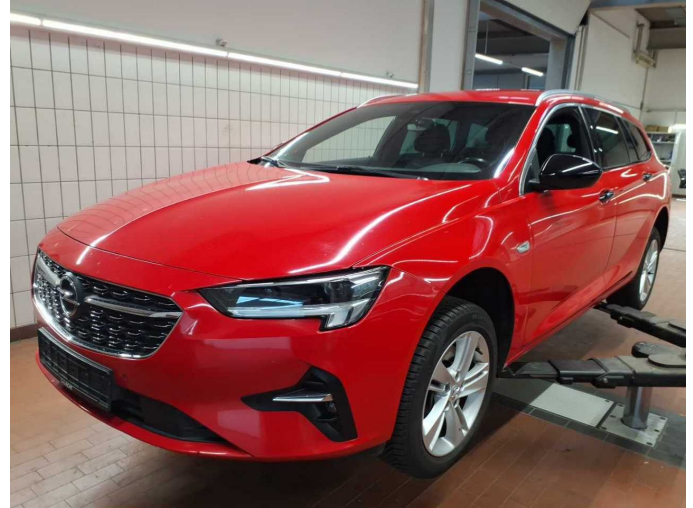
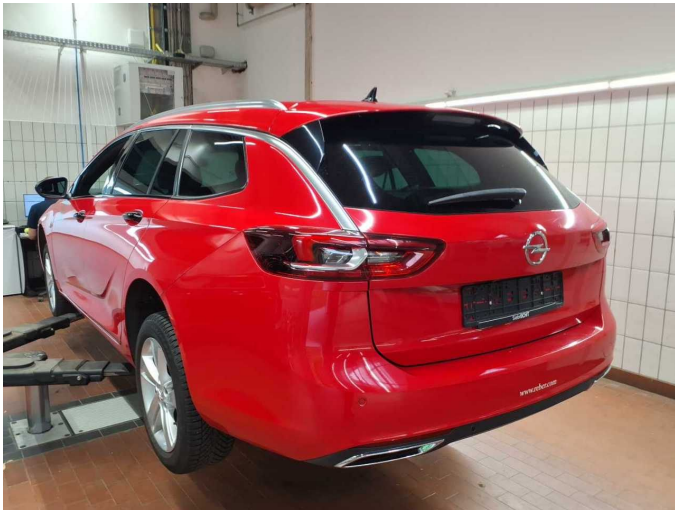
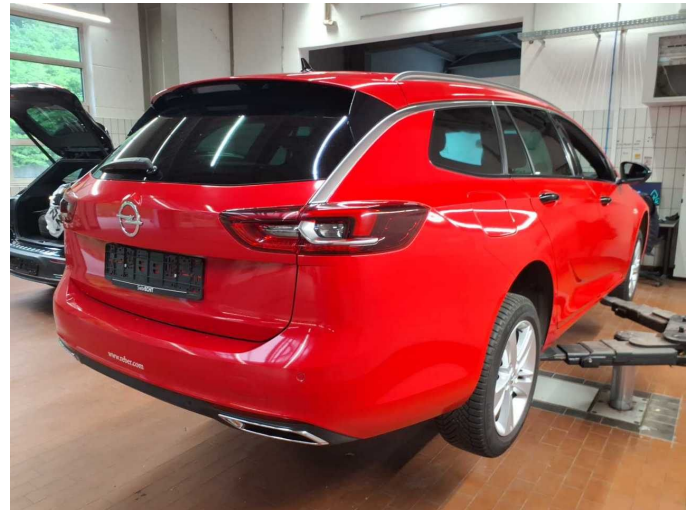
| No. | Component group | Description |
|---|---|---|
| 11 | Body | Body - Glued / labelled - De-glue / neutralise |

**Damage 11:** Body: Body - Glued / labelled - De-glue / neutralise

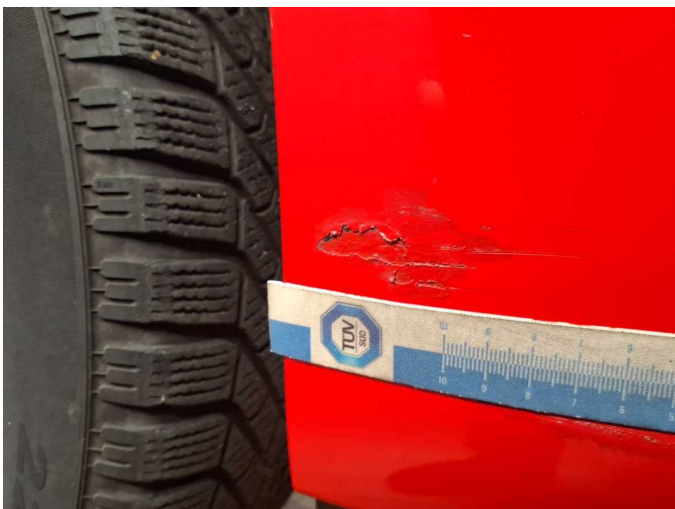
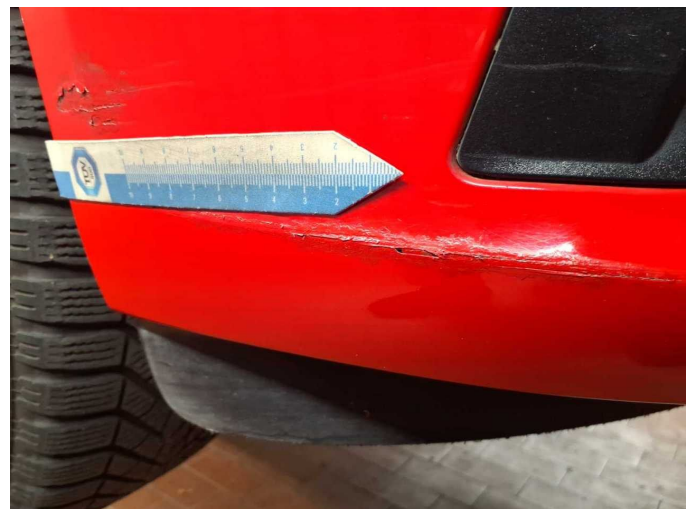
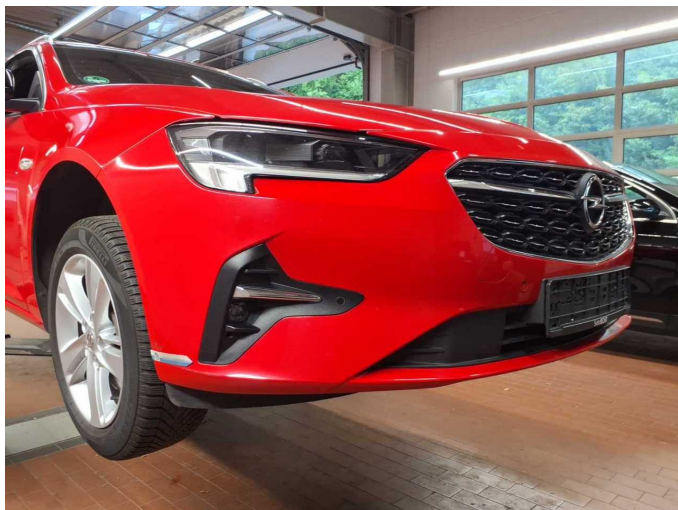
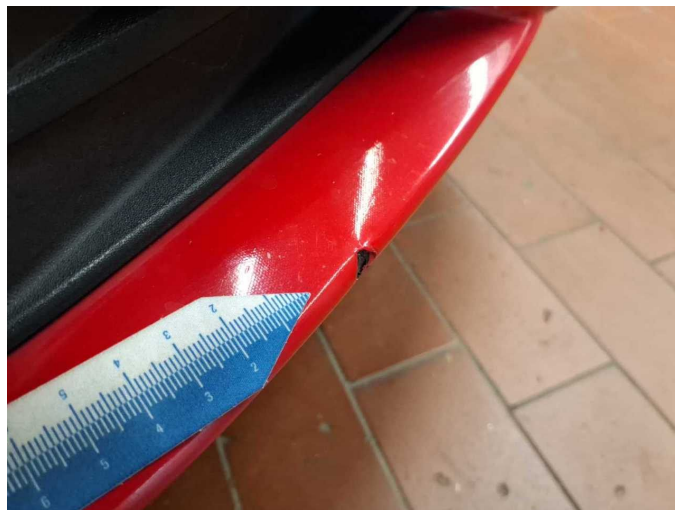
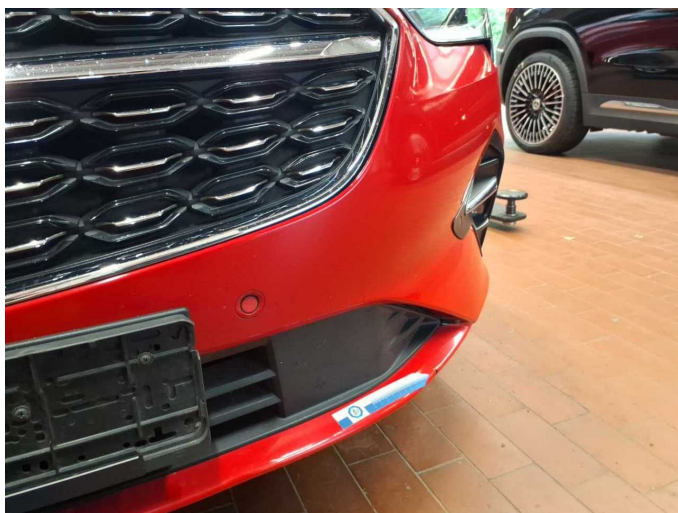
| No. | Component group | Description |
|---|---|---|
| 12 | Front bumper | Front bumper - Scratched - Paint |

**Damage 12:** Front bumper: Front bumper - Scratched - Paint
