Expertise

Protocol number: 46583189  
Order No. / Reference: 26653066  
Inspection date: 17 Jul 2026

Manufacturer: Mazda

Model: 2 e-SKYACTIV G 90 M HYBRID Homura

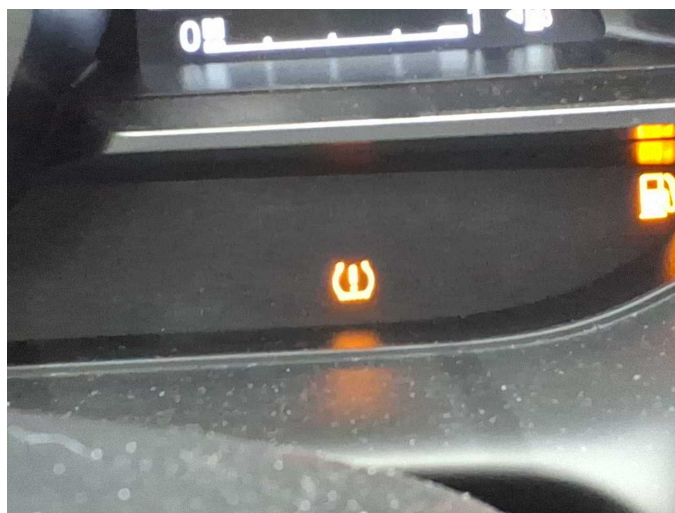
| No. | Component group | Description |
|---|---|---|
| 2 | Instrument panel | Indicator light (Reifendruckkontrollsystem) - on - Perform diagnosis |

Damage 2: Instrument panel: Indicator light (Reifendruckkontrollsystem) - on - Perform diagnosis

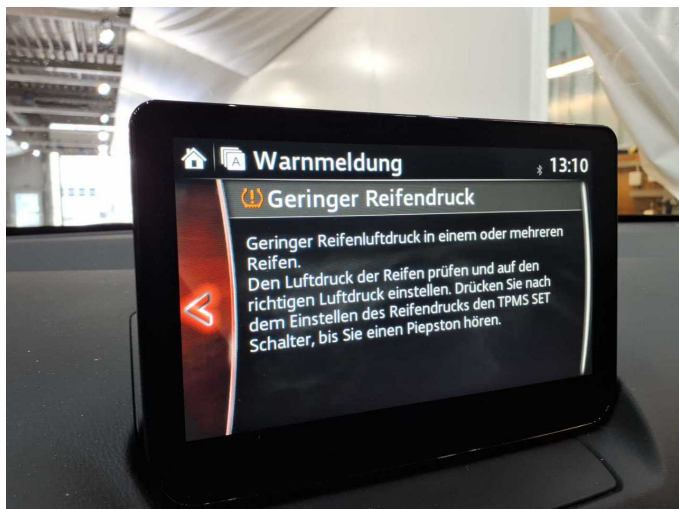
**Damage 2:** Instrument panel: Indicator light (Reifendruckkontrollsystem) - on - Perform diagnosis

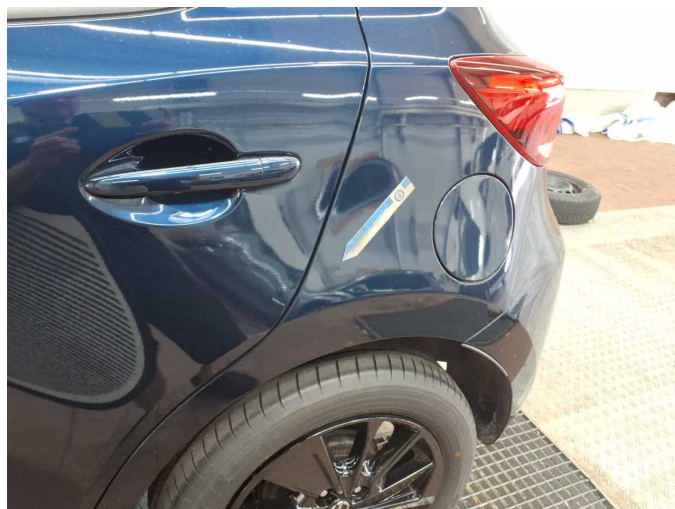
| No. | Component group | Description |
|---|---|---|
| 3 | Side panel - rear left side | Side panel - dent(s) - Smart repair |

**Damage 3:** Side panel - rear left side: Side panel - dent(s) - Smart repair

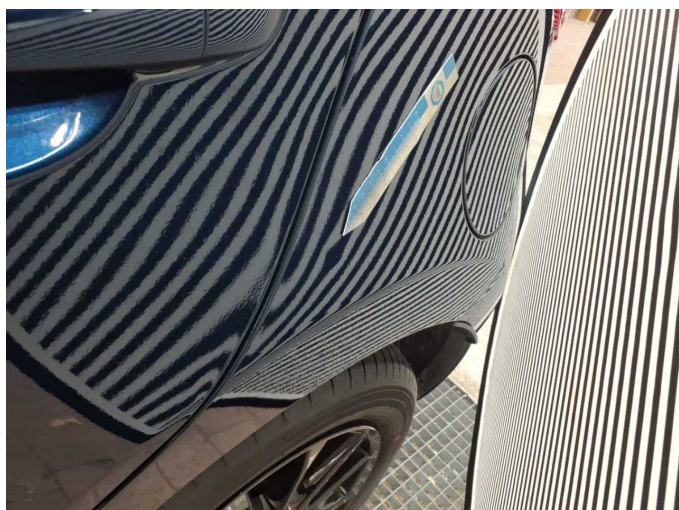
**Damage 3:** Side panel - rear left side: Side panel - dent(s) - Smart repair
