Expertise

Protocol number: 46470470  
Order No. / Reference: 26630030  
Inspection date: 13 Jul 2026

Manufacturer: Seat

Model: Cupra Born 170kW/58kWh

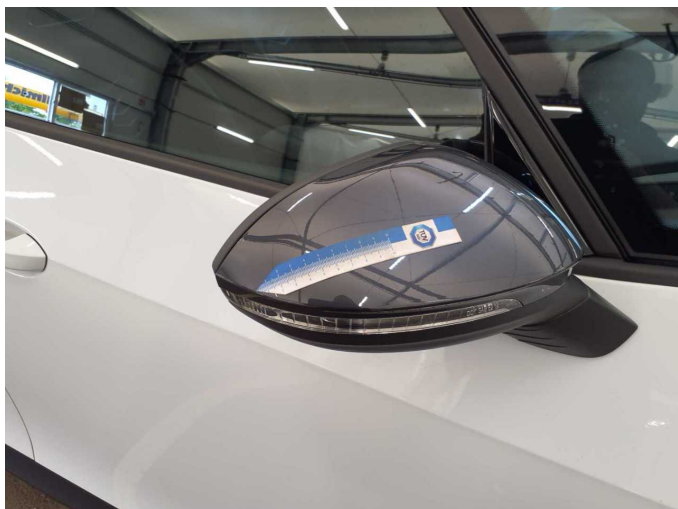
| No. | Component group | Description |
|---|---|---|
| 1 | Wing mirror - right side | Cap - Scratch(es) - Smart repair |

**Damage 1:** Wing mirror - right side: Cap - Scratch(es) - Smart repair

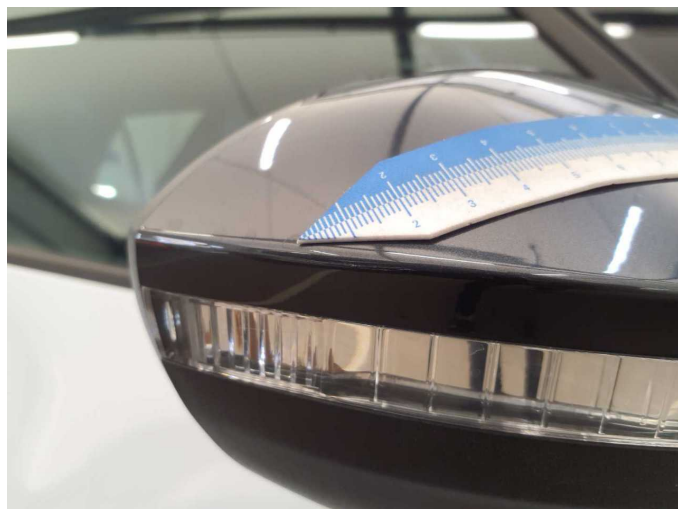
**Damage 1:** Wing mirror - right side: Cap - Scratch(es) - Smart repair

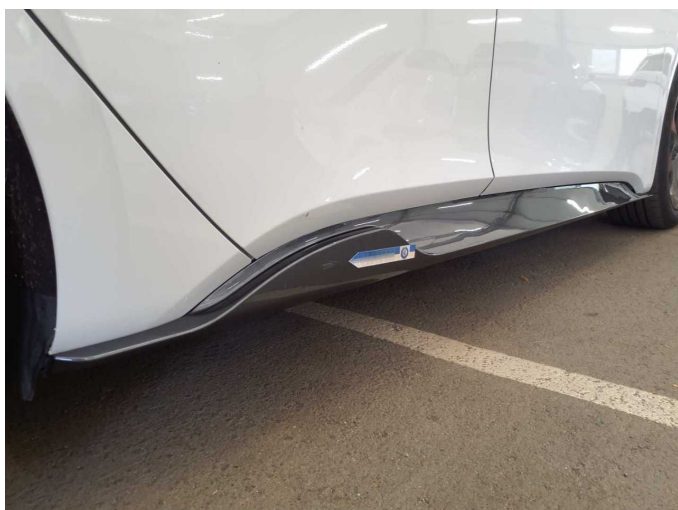
| No. | Component group | Description |
|---|---|---|
| 2 | Sill - right side | Trim - Scratch(es) - Smart repair |

**Damage 2:** Sill - right side: Trim - Scratch(es) - Smart repair

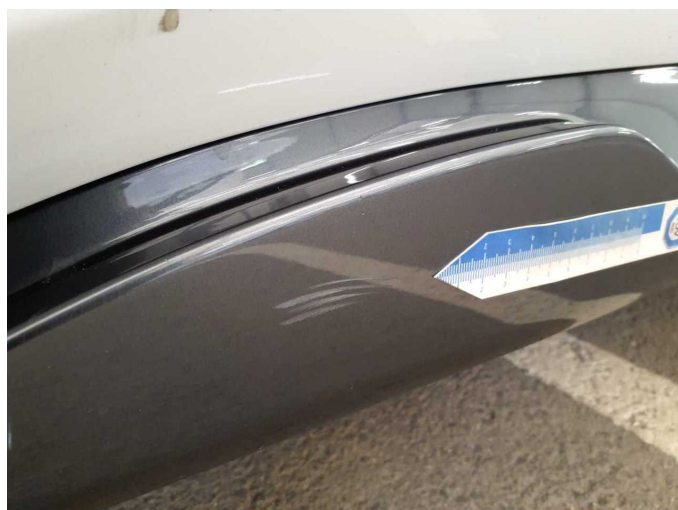
**Damage 2:** Sill - right side: Trim - Scratch(es) - Smart repair

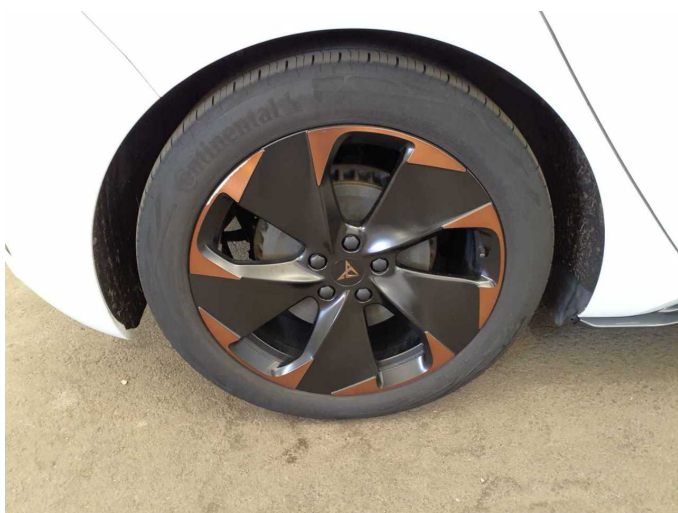
| No. | Component group | Description |
|---|---|---|
| 3 | Wheel / tyres | Alloy rim - rear right side - Scratched - Replace |

**Damage 3:** Wheel / tyres: Alloy rim - rear right side - Scratched - Replace

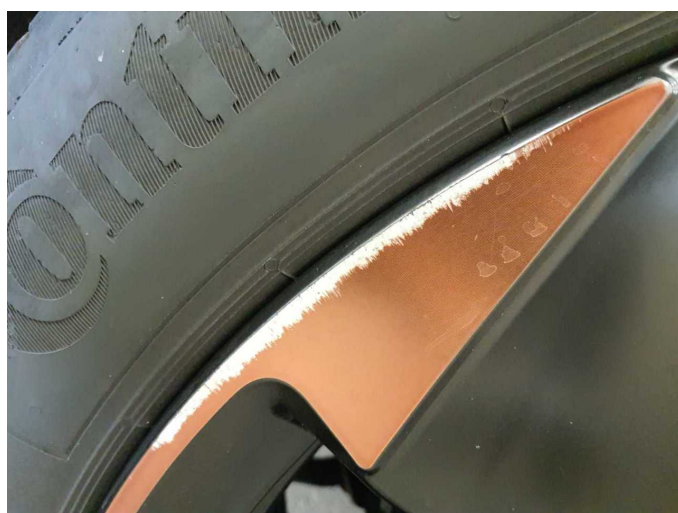
**Damage 3:** Wheel / tyres: Alloy rim - rear right side - Scratched - Replace
