Expertise

Protocol number: 46505869  
Order No. / Reference: 26562613  
Inspection date: 7 Jul 2026

Manufacturer: Skoda  
VIN: TMBLR9NPXP7043663

Model: Superb Combi 2.0 TDI 4x4 DSG L&K

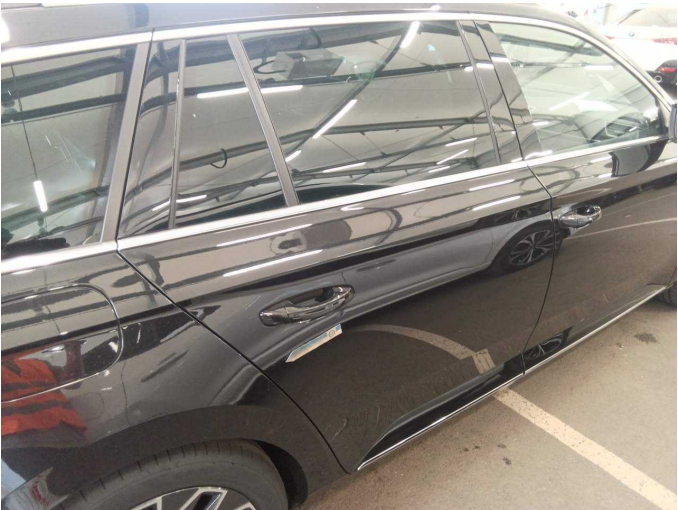
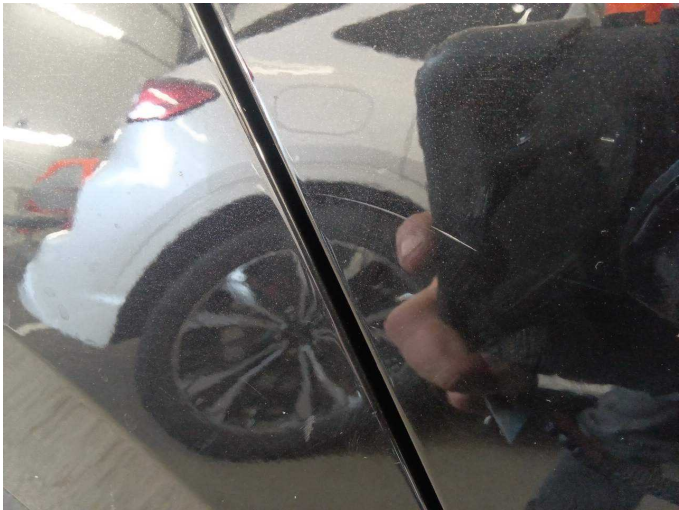
| No. | Component group | Description |
|---|---|---|
| 4 | Door - rear right side | Door - Scratch(es) - Smart repair |

Damage 4: Door - rear right side: Door - Scratch(es) - Smart repair

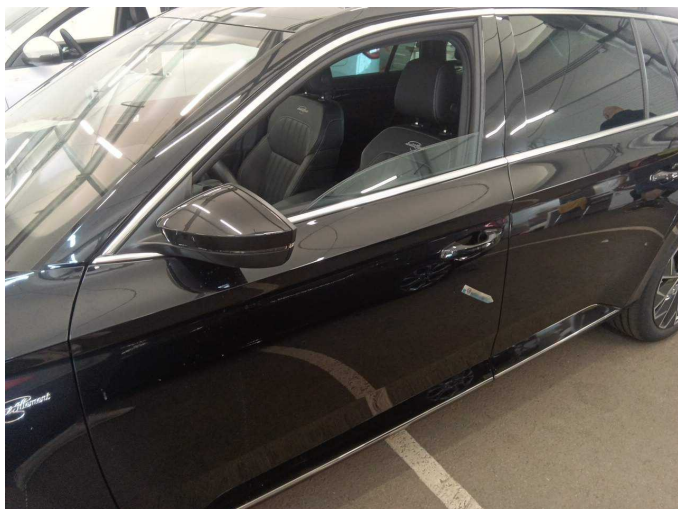
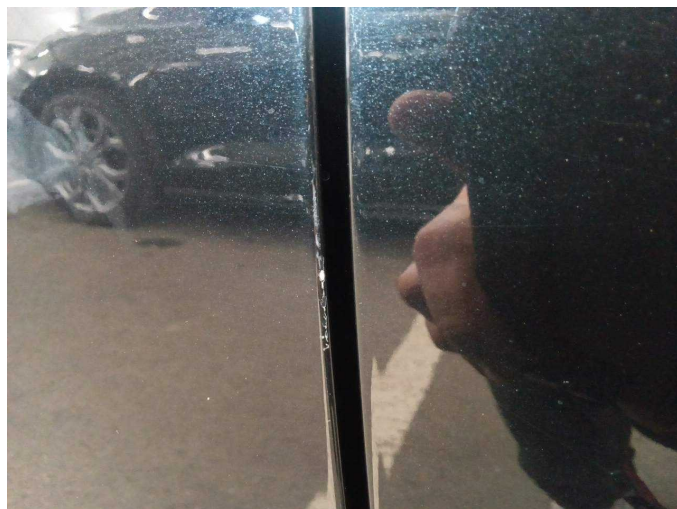
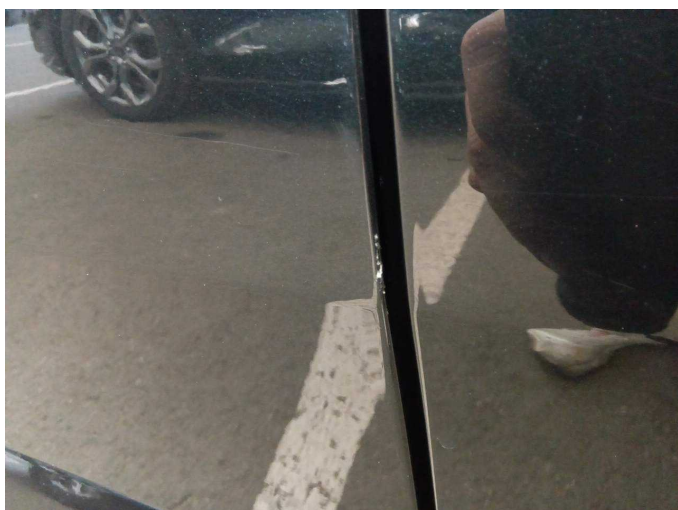
| No. | Component group | Description |
|---|---|---|
| 5 | Door - front left side | Door edge - Scratch(es) - Smart repair |

**Damage 5:** Door - front left side: Door edge - Scratch(es) - Smart repair

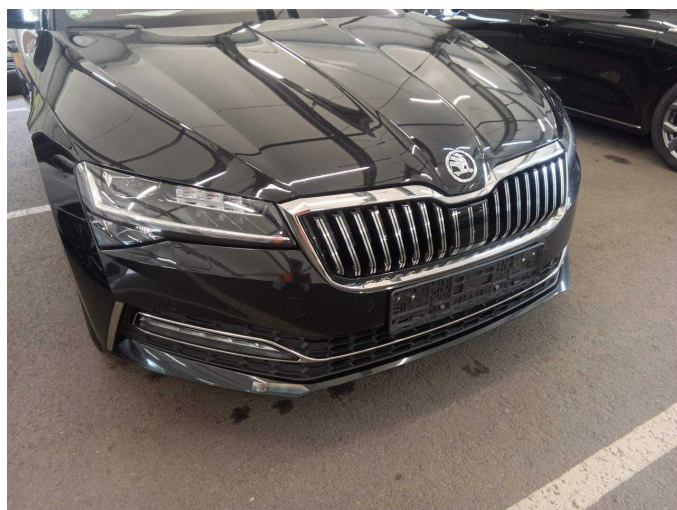
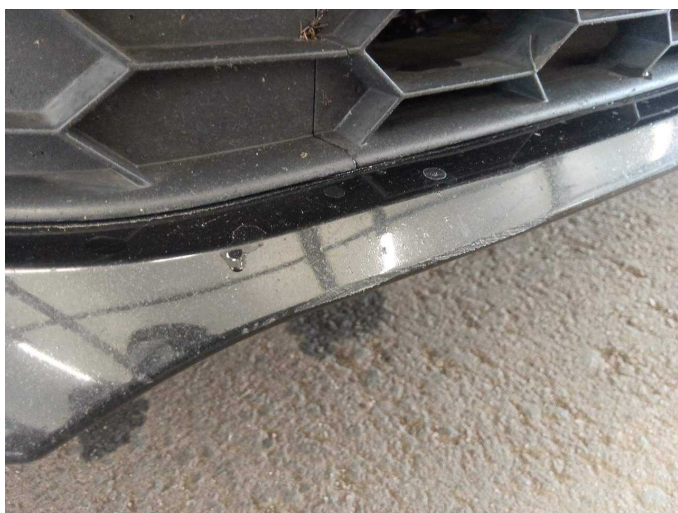
| No. | Component group | Description |
|---|---|---|
| 6 | Front bumper | Front bumper - Scratch(es) - Smart repair |

**Damage 6:** Front bumper: Front bumper - Scratch(es) - Smart repair

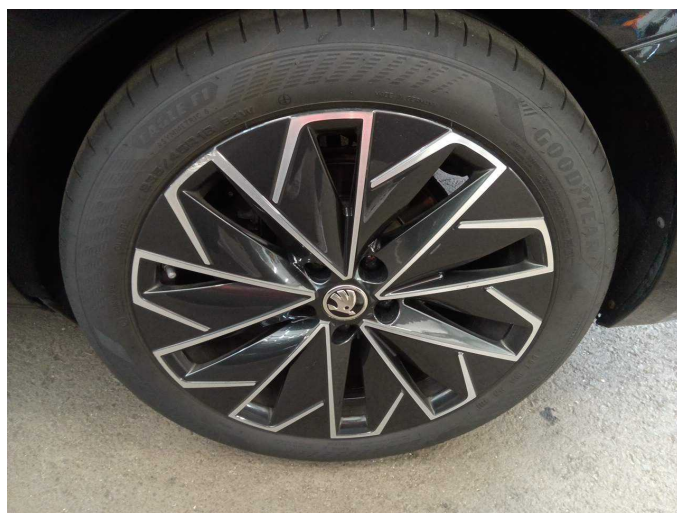
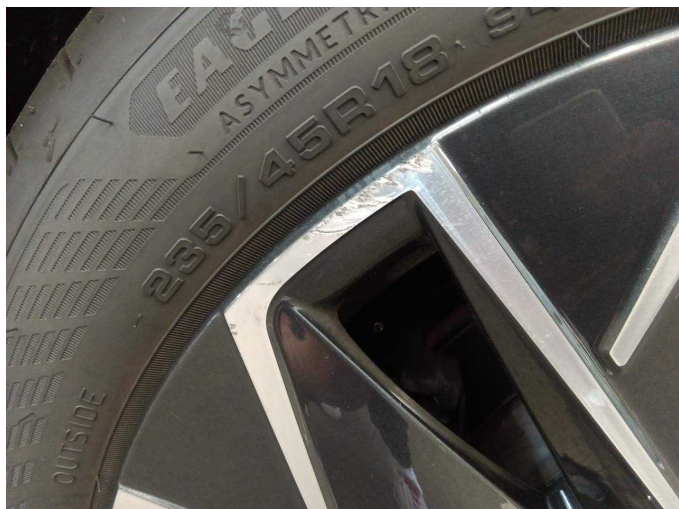
| No. | Component group | Description |
|---|---|---|
| 7 | Wheel / tyres | Alloy rim - rear left side - Scratch(es) - Loss in value |

**Damage 7:** Wheel / tyres: Alloy rim - rear left side - Scratch(es) - Loss in value

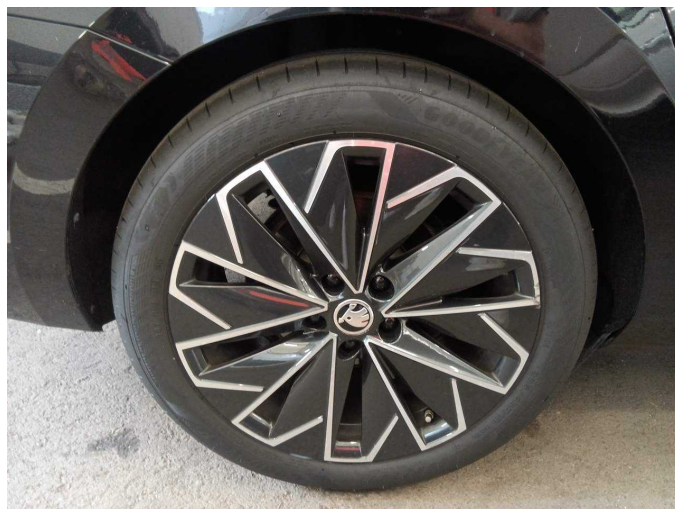
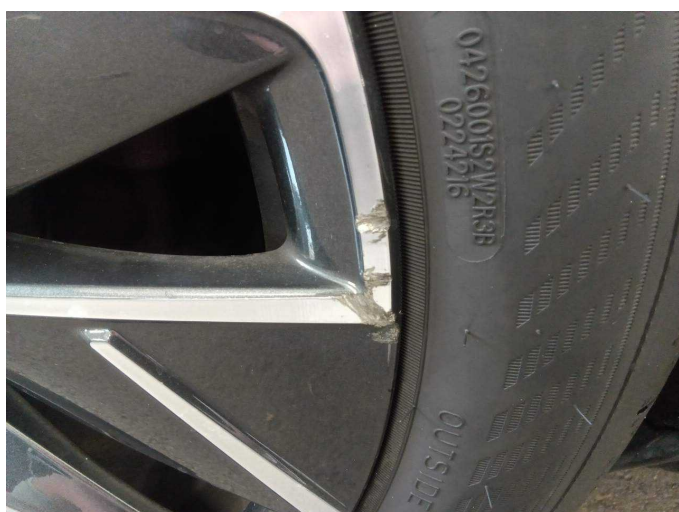
| No. | Component group | Description |
|---|---|---|
| 8 | Wheel / tyres | Alloy rim - rear right side (Mit Materialabtrag) - Scratched - Replace |

**Damage 8:** Wheel / tyres: Alloy rim - rear right side (Mit Materialabtrag) - Scratched - Replace

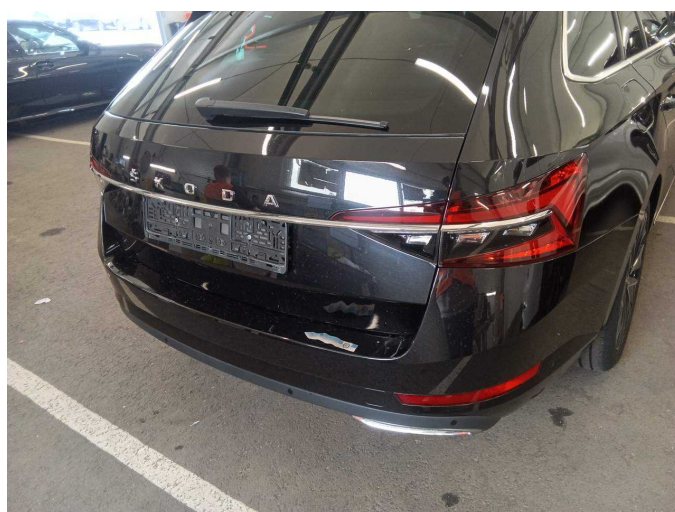
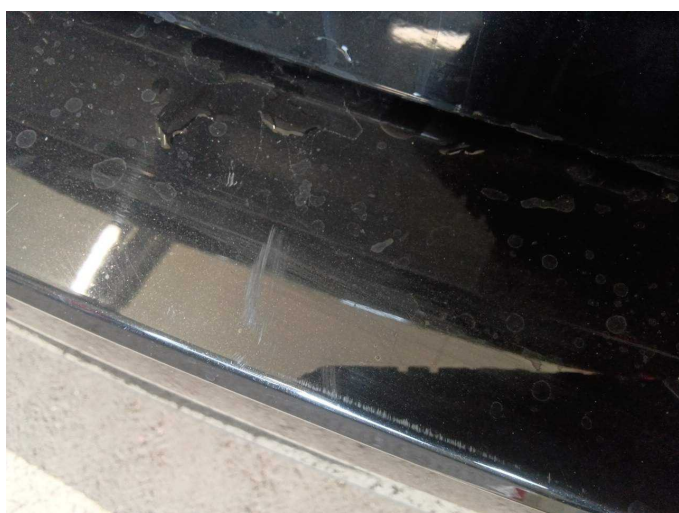
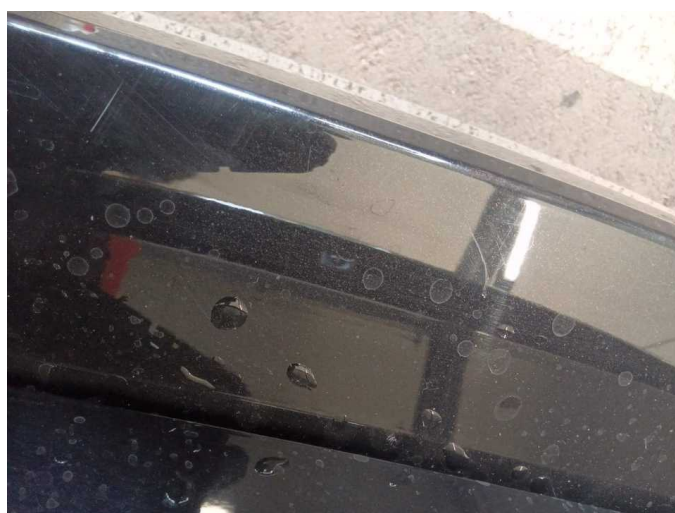
| No. | Component group | Description |
|---|---|---|
| 9 | Rear bumper | Rear bumper - Scratch(es) - Paint |

**Damage 9:** Rear bumper: Rear bumper - Scratch(es) - Paint

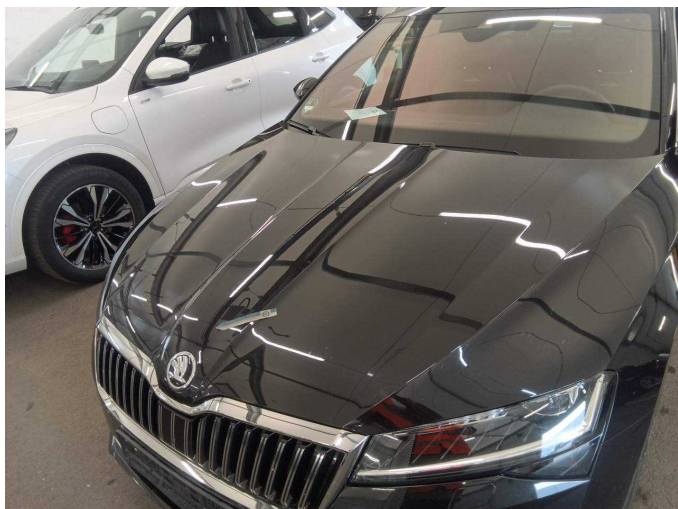
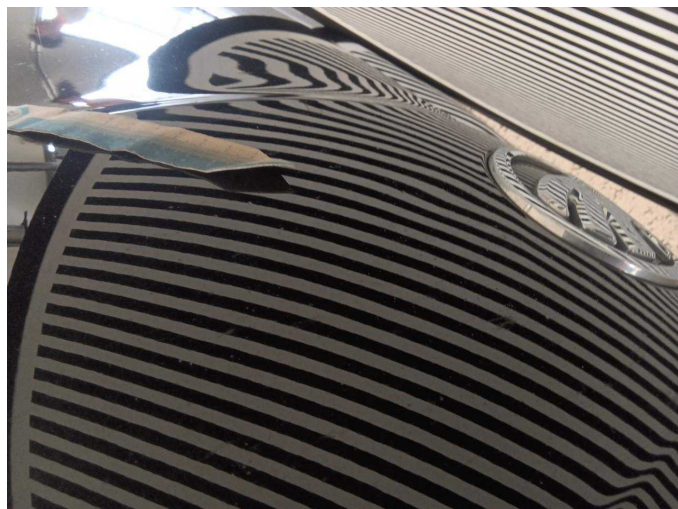
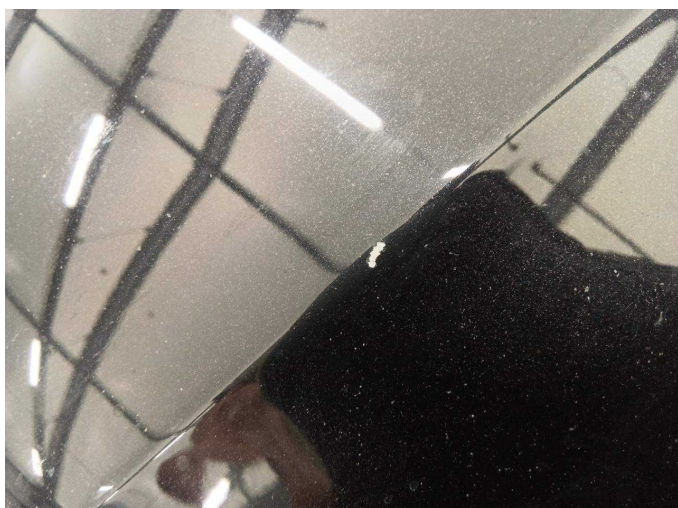
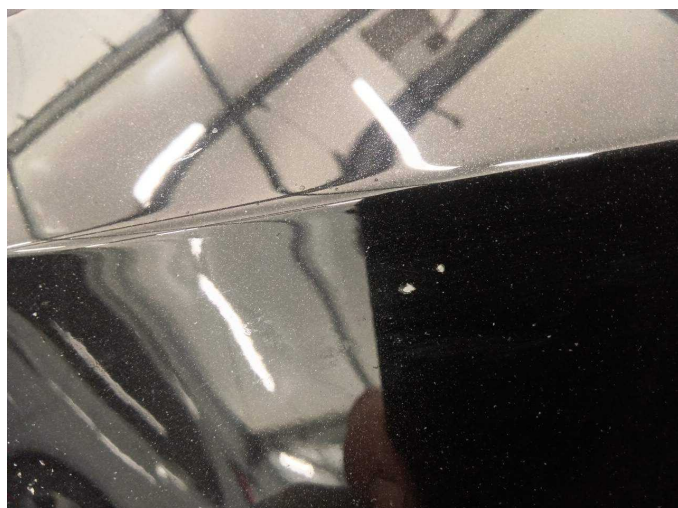
| No. | Component group | Description |
|---|---|---|
| 10 | Bonnet | Bonnet (Delle & übermäßige Steinschläge) - Dent / paintcoat damage - Paint |

**Damage 10:** Bonnet: Bonnet (Delle & übermäßige Steinschläge) - Dent / paintcoat damage - Paint

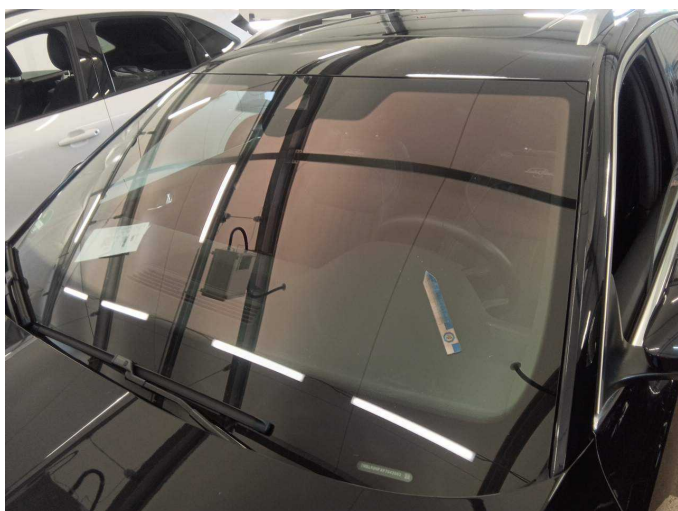
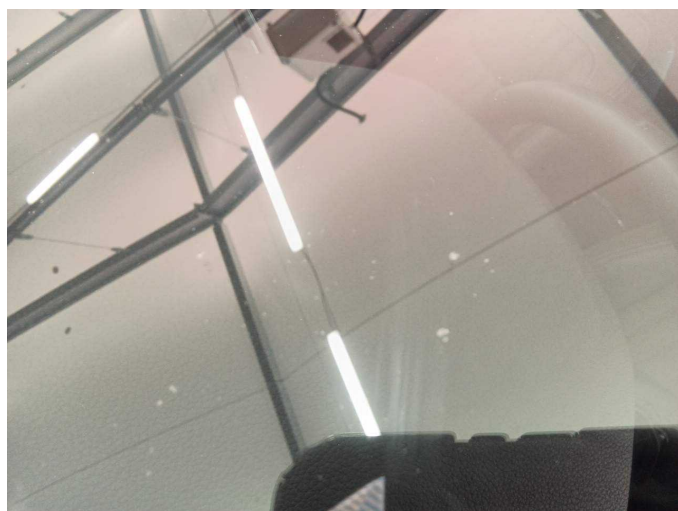
| No. | Component group | Description |
|---|---|---|
| 1 | Vehicle glazing | Windscreen - Stone chips - No deduction |

**Wear and tear 1:** Vehicle glazing: Windscreen - Stone chips - No deduction
