Expertise

Protocol number: 46762528  
Order No. / Reference: 26716035  
Inspection date: 29 Jul 2026

Manufacturer: MAN

Model: TGE 3.140 4X2F SB

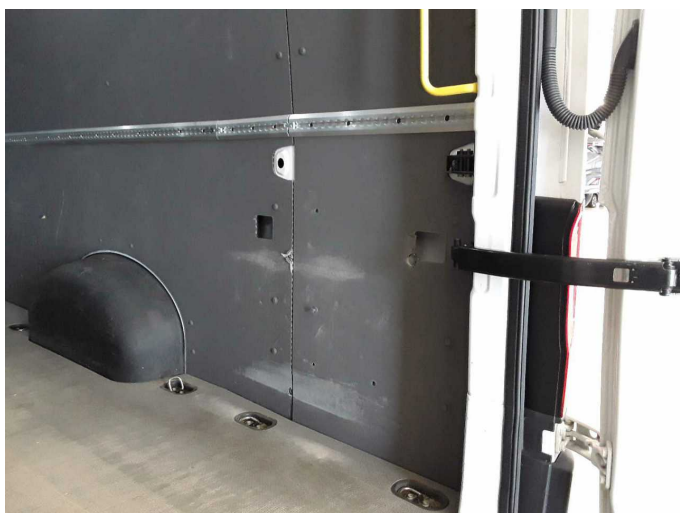
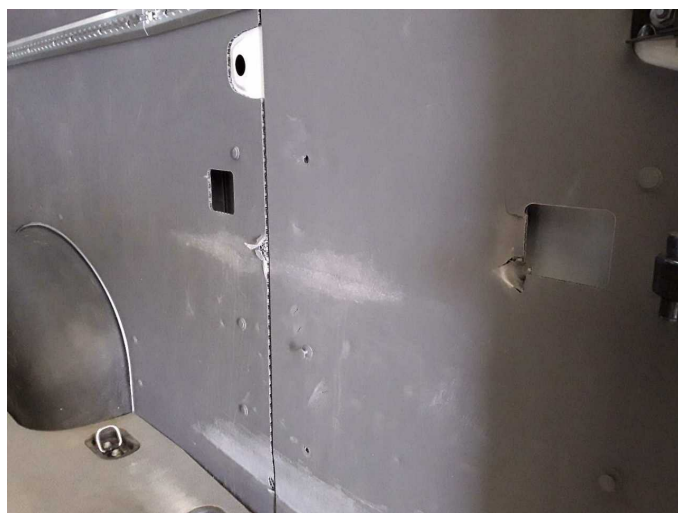
| No. | Component group | Description |
|---|---|---|
| 1 | Interior | Interior (Laderaumverkleidungen) - Broken / torn - Replace |

**Damage 1:** Interior: Interior (Laderaumverkleidungen) - Broken / torn - Replace

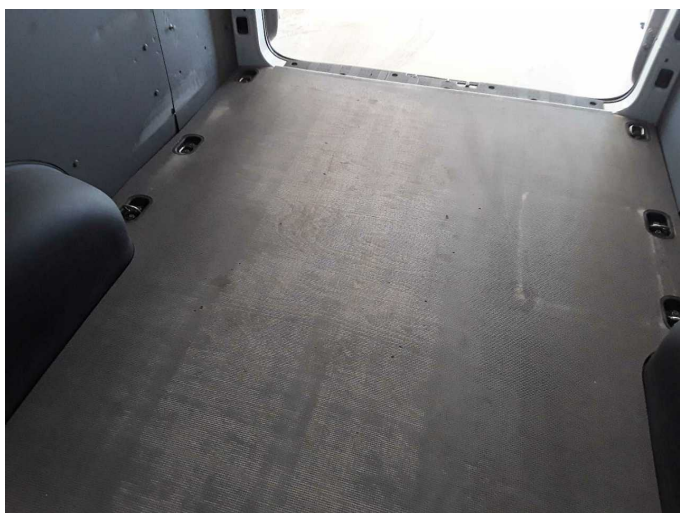
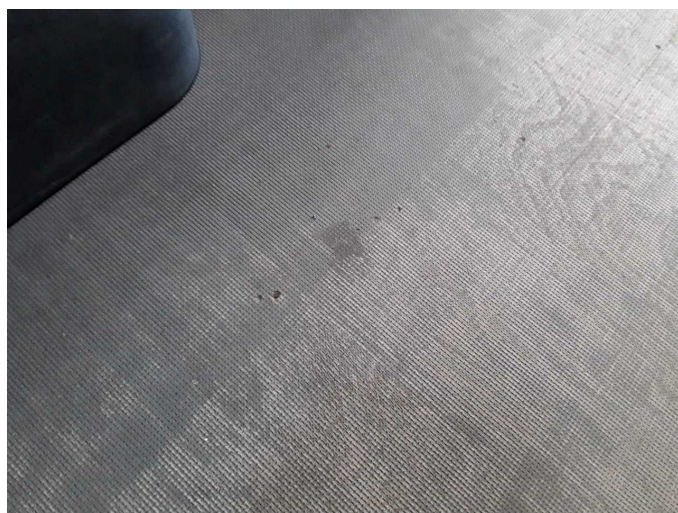
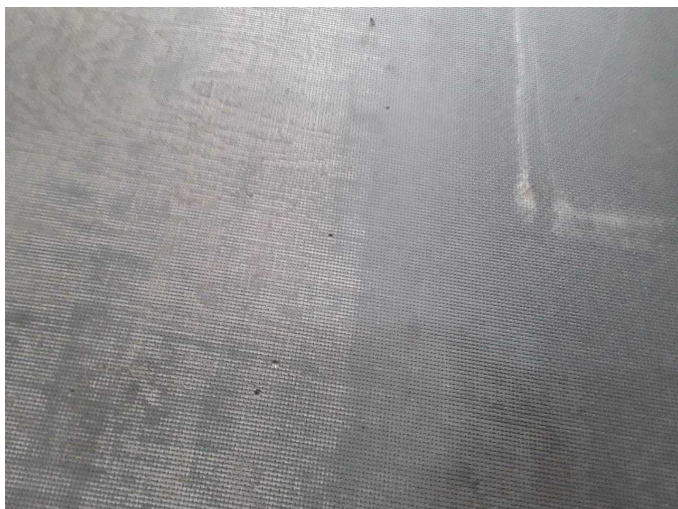
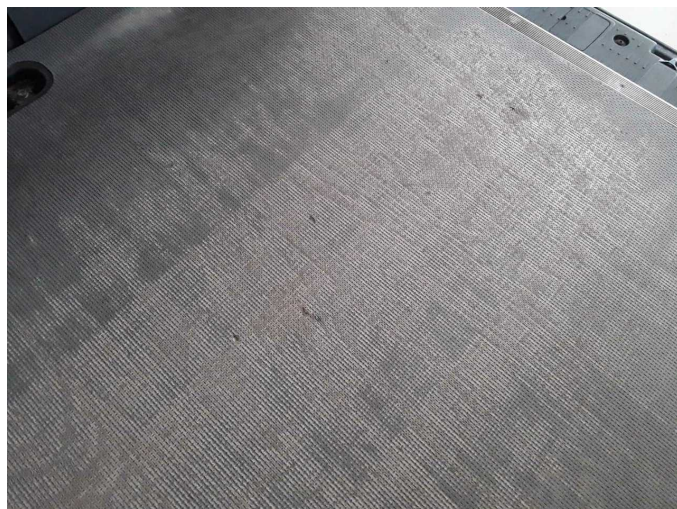
| No. | Component group | Description |
|---|---|---|
| 2 | Rear of vehicle | Wooden floor - Scratched - Loss in value |

**Damage 2:** Rear of vehicle: Wooden floor - Scratched - Loss in value
