Expertise

Protocol number: 46850071  
Order No. / Reference: 26644712  
Inspection date: 3 Aug 2026

Manufacturer: Opel

Model: Grandland 1.5 D Automatik Elegance

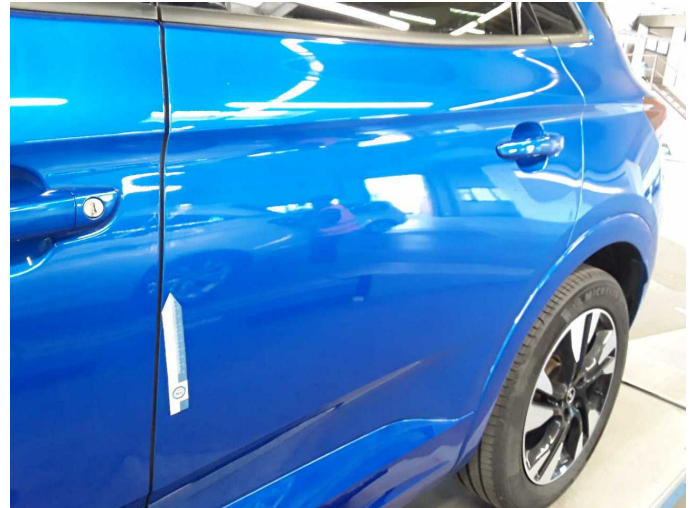
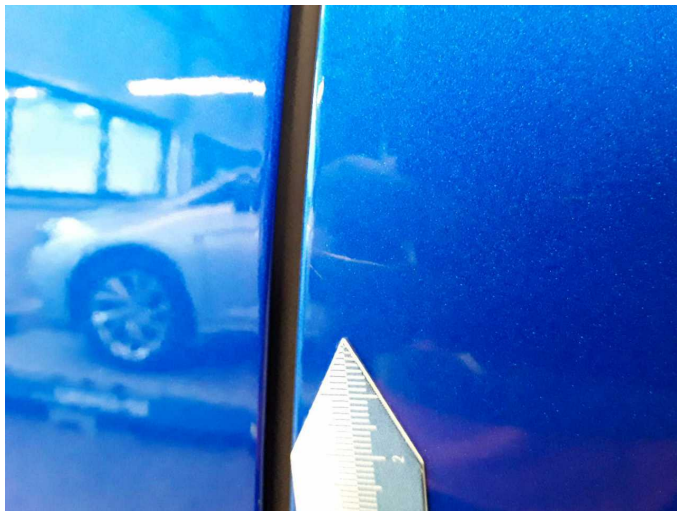
| No. | Component group | Description |
|---|---|---|
| 1 | Door - rear left side | Door - Scratch(es) - Cover / polish |

**Damage 1:** Door - rear left side: Door - Scratch(es) - Cover / polish

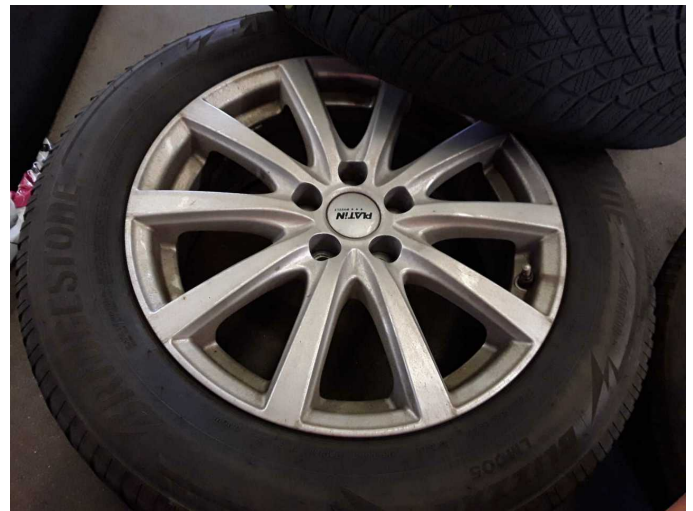
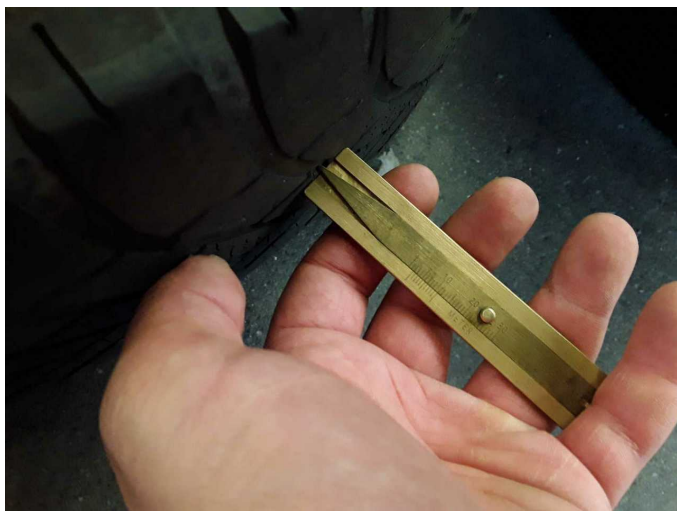
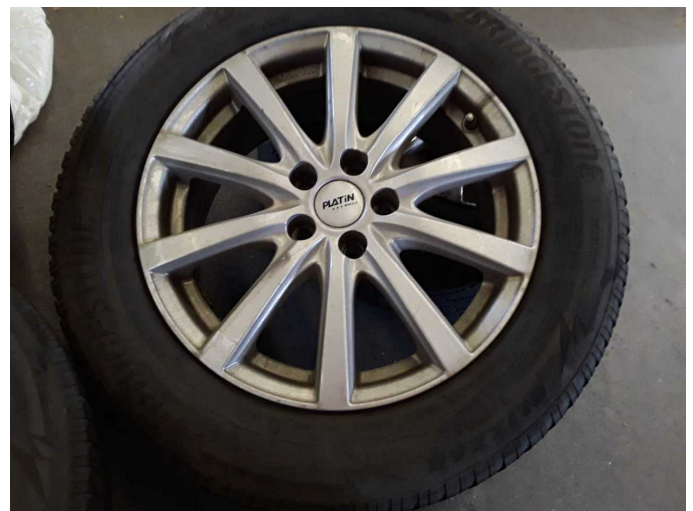
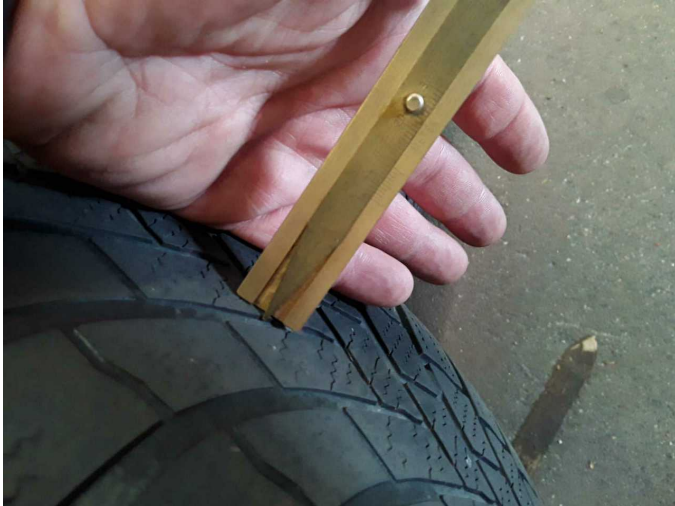
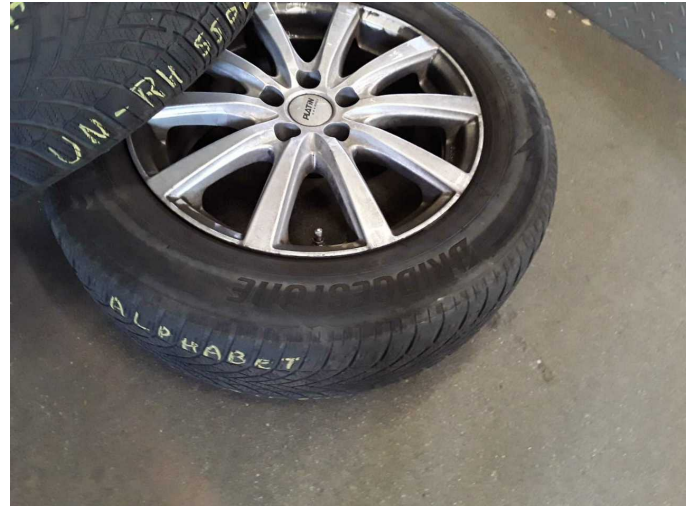
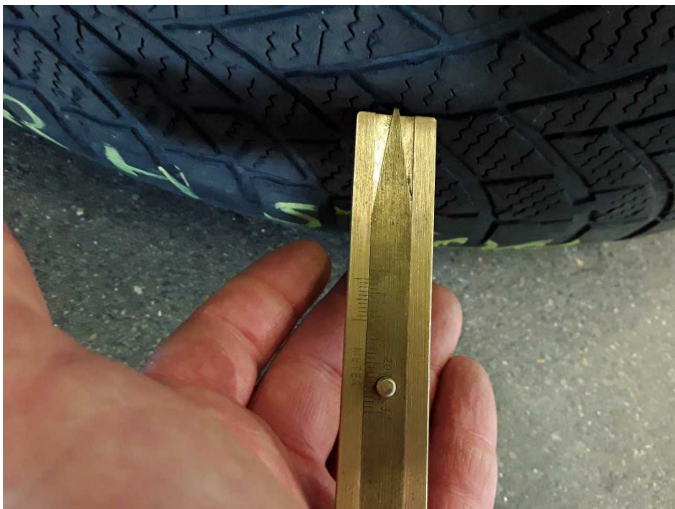
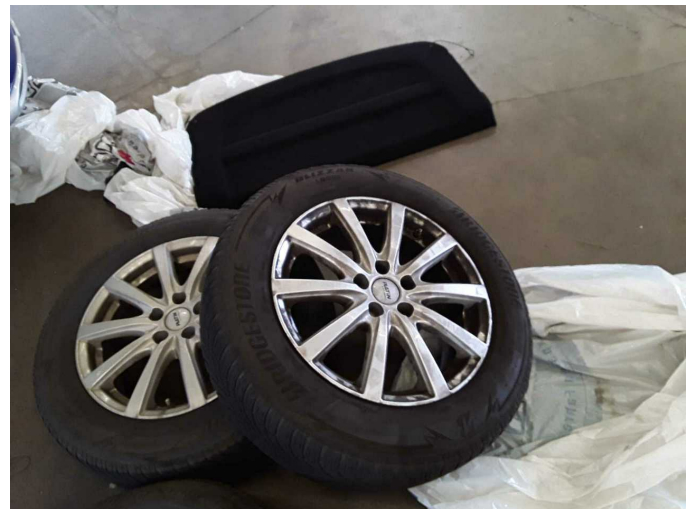
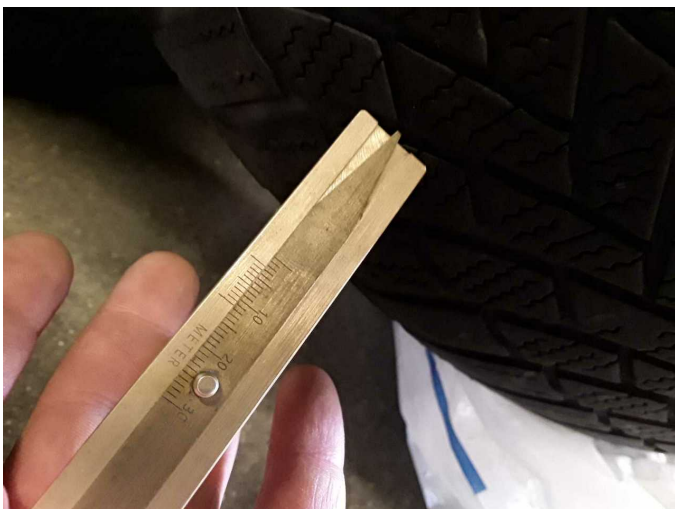
| # | Tyre size | Type of tyre | Manufacturer | Tread depth |
|---|---|---|---|---|
| 1) | 215/65 R17 103H | Winter tyres on Light alloy | Bridgestone | 2mm / 2mm |
| 2) | 215/65 R17 103H | Winter tyres on Light alloy | Bridgestone | 3mm / 3mm |

| No. | Component group | Description |
|---|---|---|
| 2 | 2nd wheel set | Tyres - complete set (215,65,17 w.) - Worn - Replace |

**Damage 2:** 2nd wheel set: Tyres - complete set (215,65,17 w.) - Worn - Replace

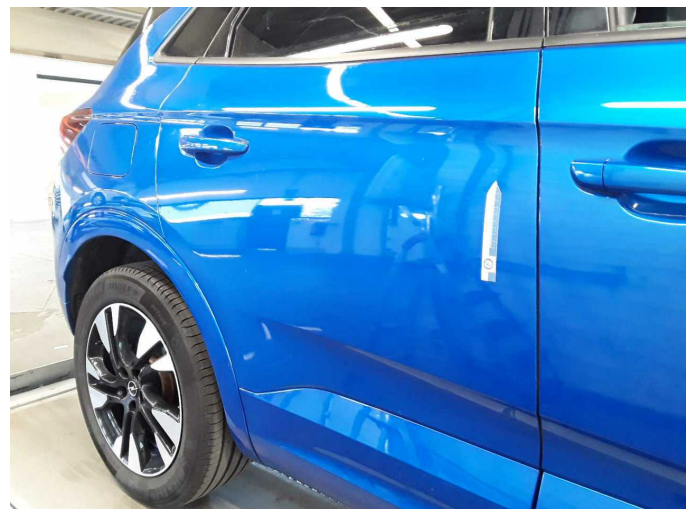
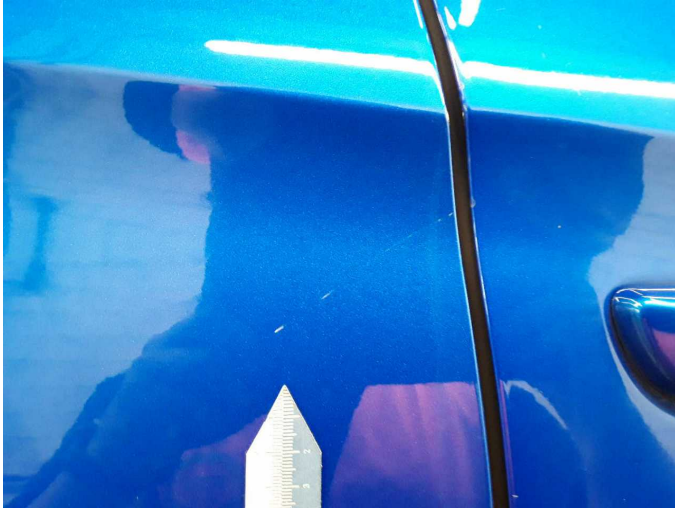
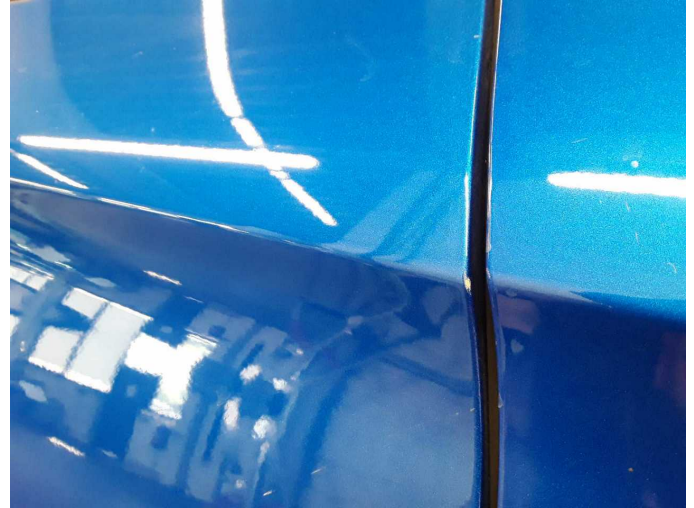
| No. | Component group | Description |
|---|---|---|
| 3 | Door - rear right side | Door - Scratch(es) - Paint |

**Damage 3:** Door - rear right side: Door - Scratch(es) - Paint

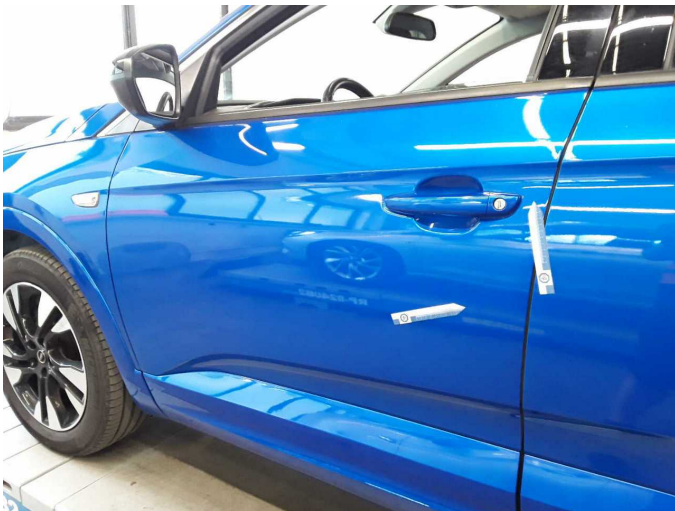
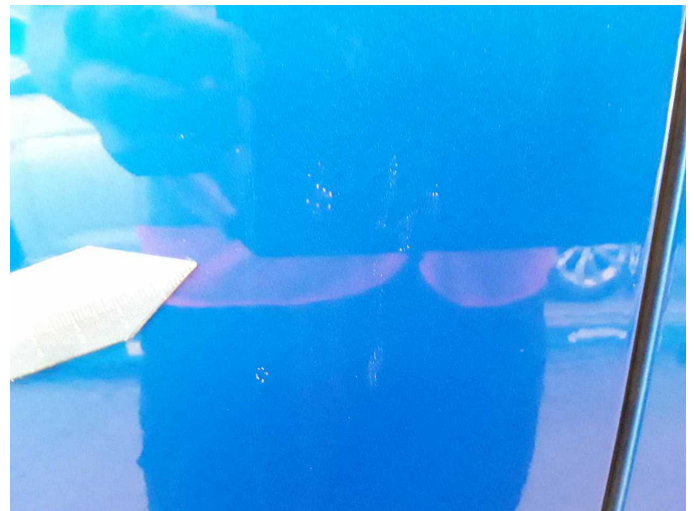
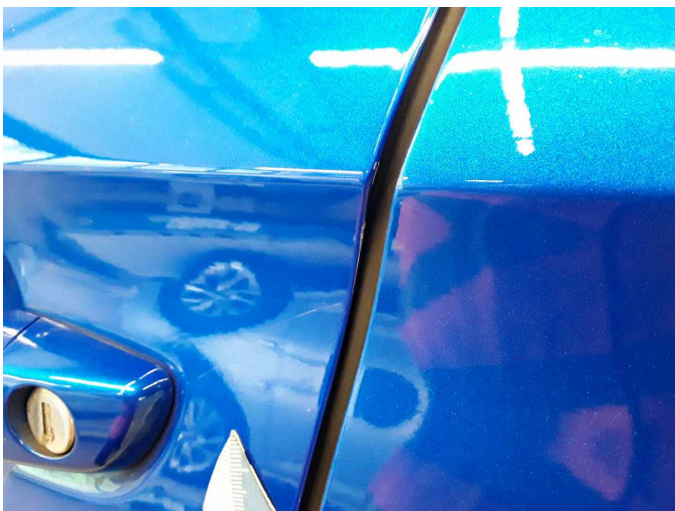
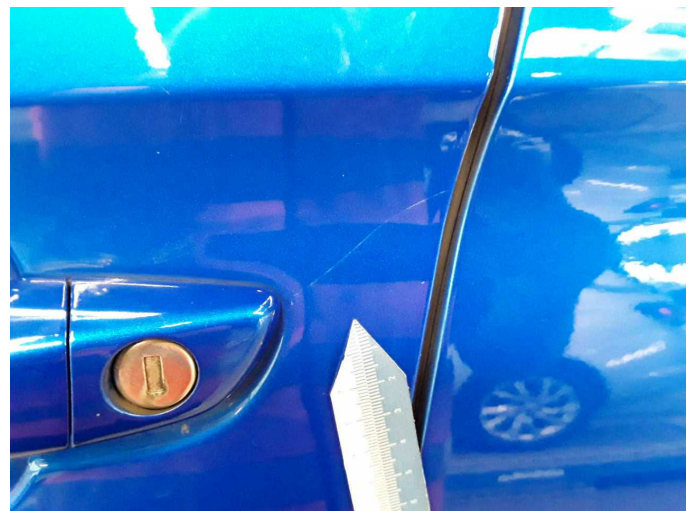
| No. | Component group | Description |
|---|---|---|
| 4 | Door - front left side | Door - Scratched - Paint |

**Damage 4:** Door - front left side: Door - Scratched - Paint

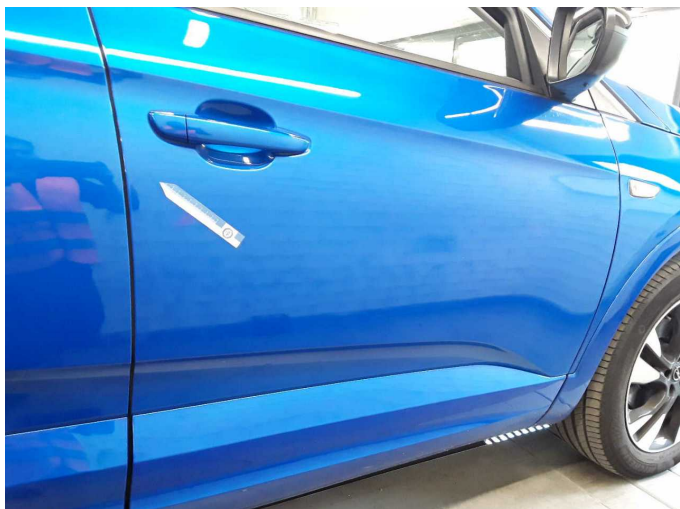
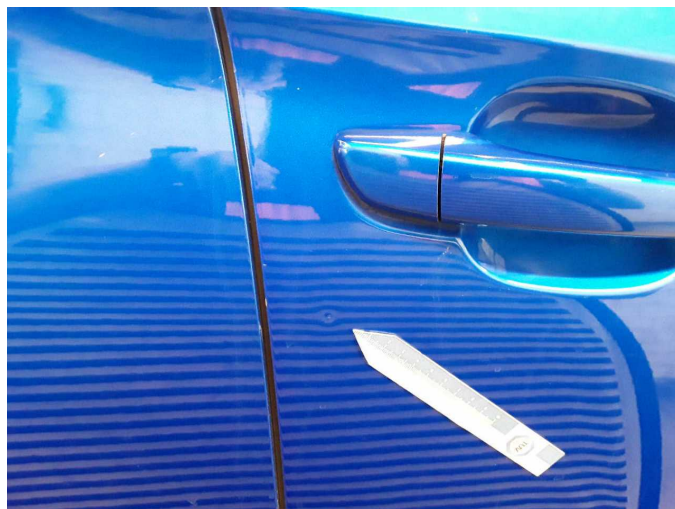
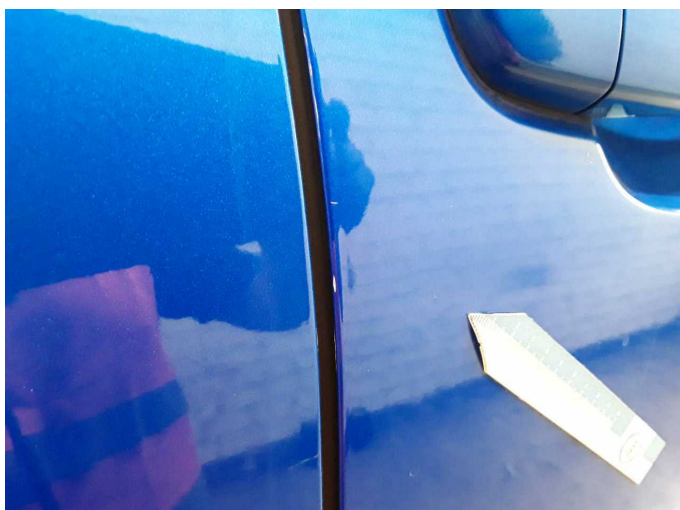
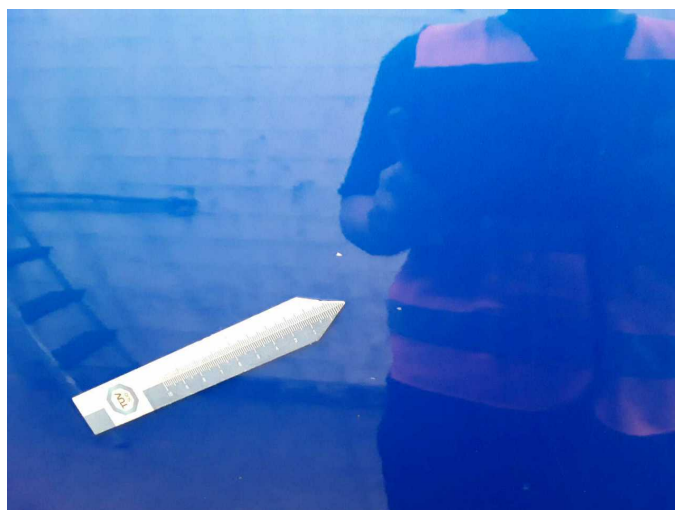
| No. | Component group | Description |
|---|---|---|
| 5 | Door - front right side | Door - Dent / paintcoat damage - Repair and paint |

**Damage 5:** Door - front right side: Door - Dent / paintcoat damage - Repair and paint

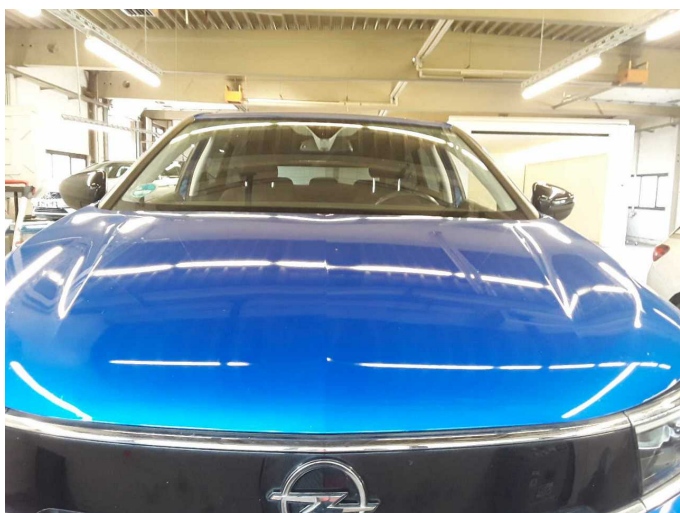
| No. | Component group | Description |
|---|---|---|
| 1 | Bonnet | Bonnet - Stone chips - No deduction |

**Wear and tear 1:** Bonnet: Bonnet - Stone chips - No deduction

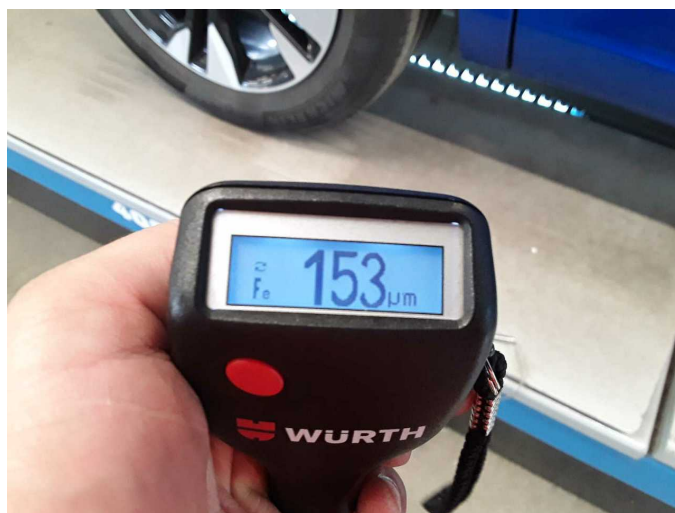
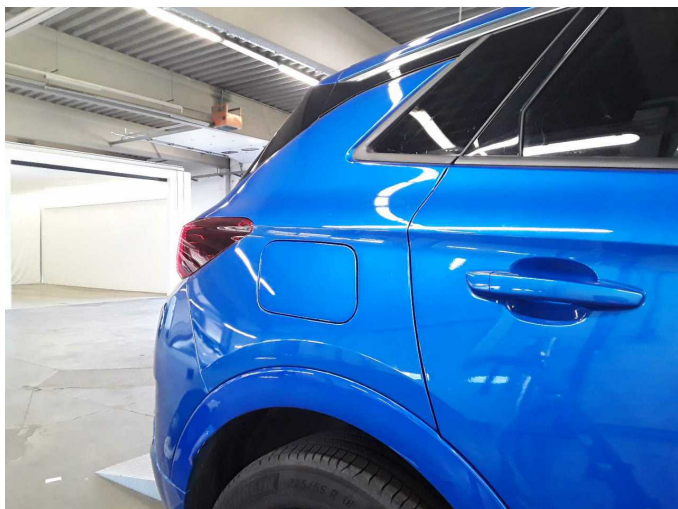
| No. | Repainting |
|---|---|
| 1 | Side panel - rear right side |

| Side panel - rear right side | 150 µm |

**Repainting 1:** Side panel - rear right side
