Protocol number: 46279999
Order No. / Reference: 26536692
Inspection date: 29 Jun 2026

Manufacturer: Peugeot

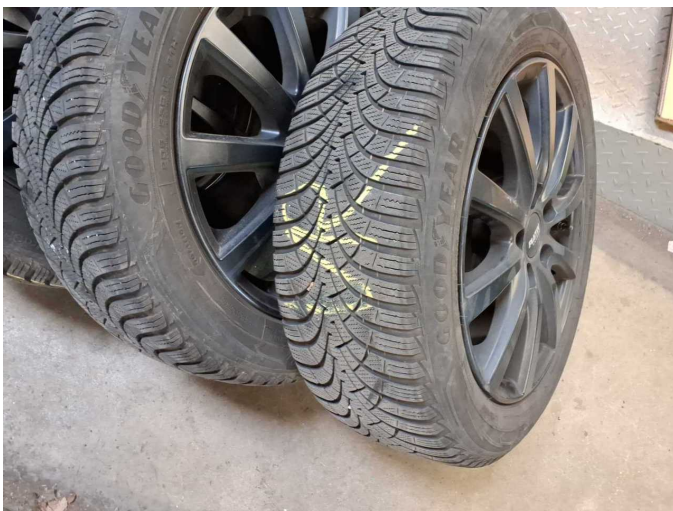
Damage 2: 2nd wheel set: 1 tyre (kein Bestandteil der Ausstattung) - Damaged - No deduction

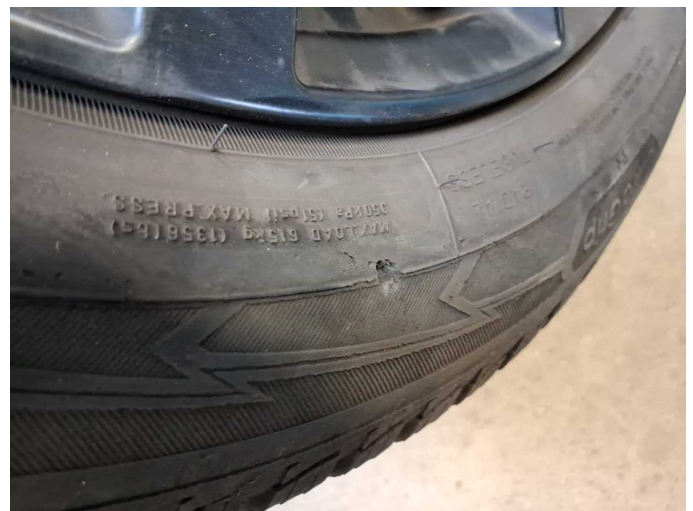
Damage 2: 2nd wheel set: 1 tyre (kein Bestandteil der Ausstattung) - Damaged - No deduction

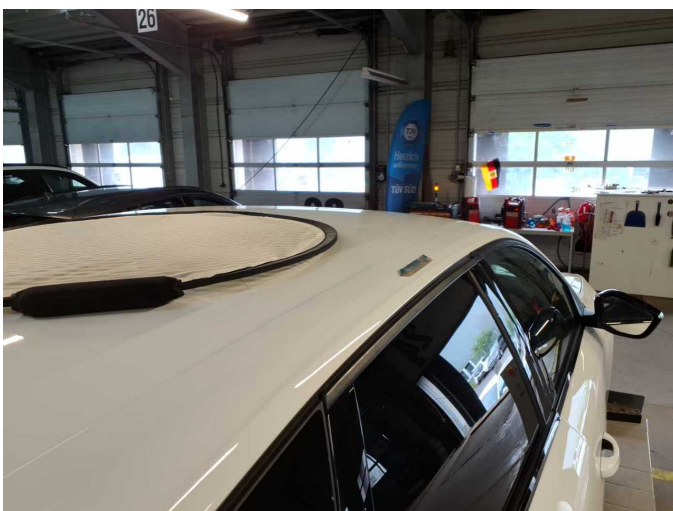
Damage 3: Roof: Roof rail - right side - dent(s) - Smooth repair work

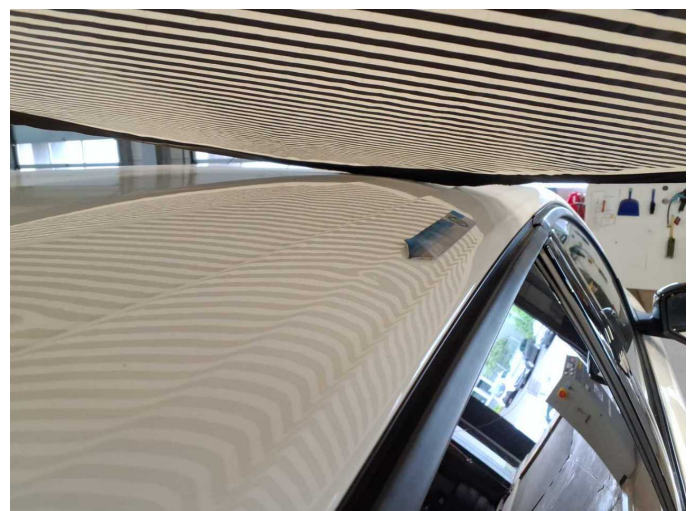
Damage 3: Roof: Roof rail - right side - dent(s) - Smooth repair work

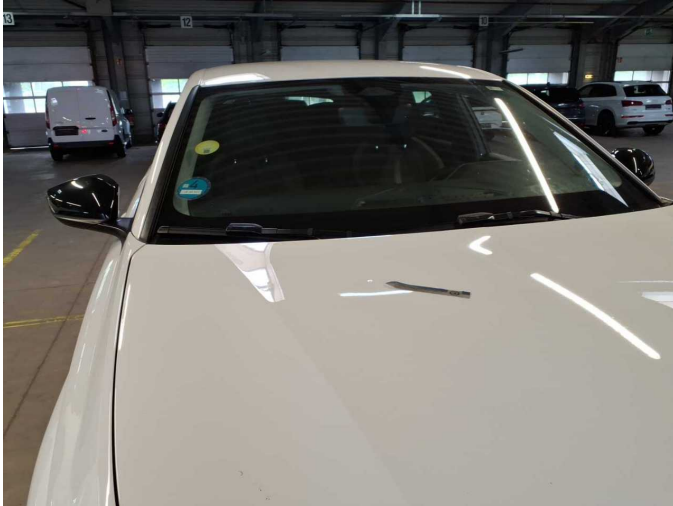
Damage 4: Bonnet: Bonnet - dent(s) - Smooth repair work

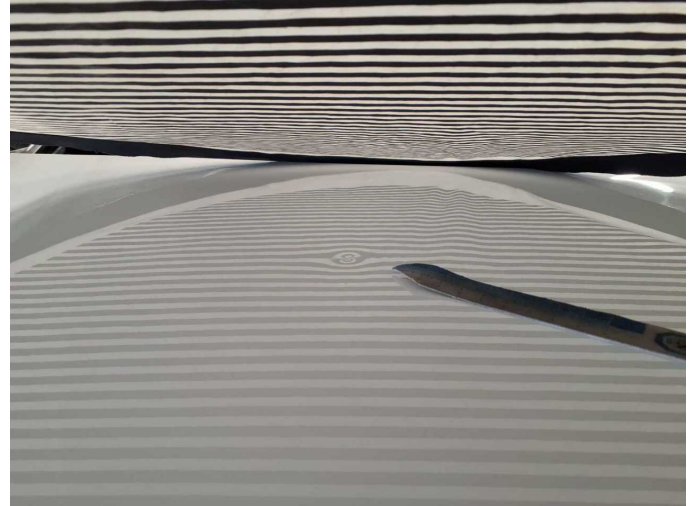
Damage 4: Bonnet: Bonnet - dent(s) - Smooth repair work

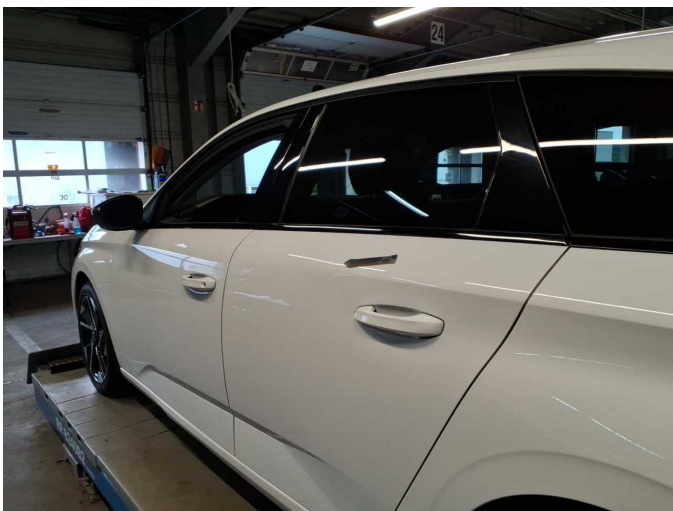
Damage 5: Door - rear left side: Door - dent(s) - Smooth repair work

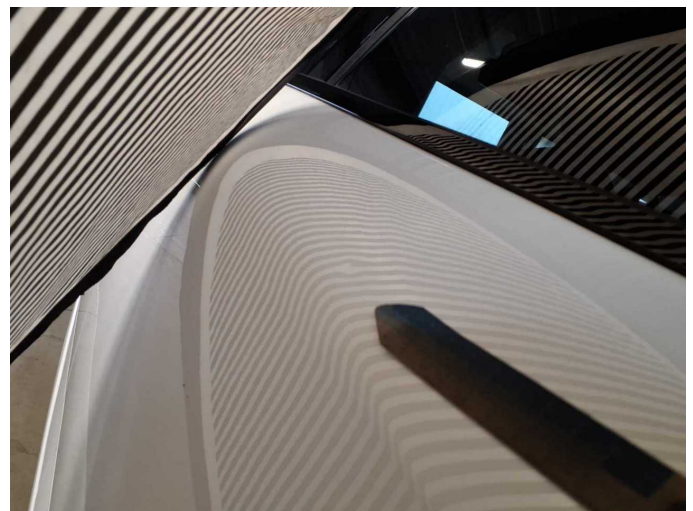
Damage 5: Door - rear left side: Door - dent(s) - Smooth repair work

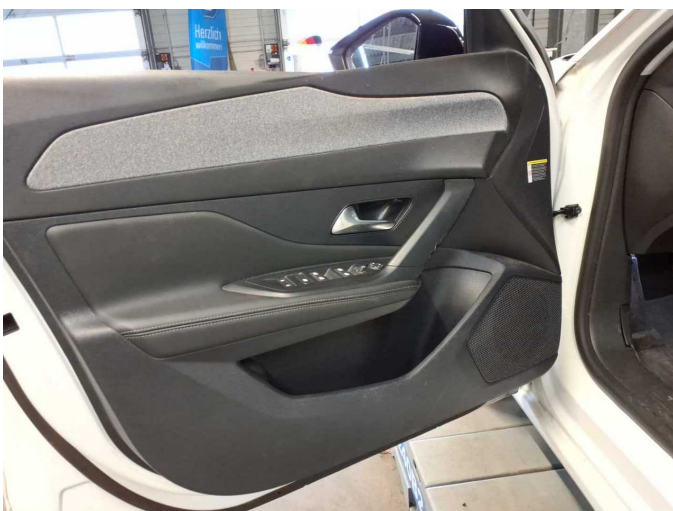
Damage 6: Door - front left side: Door handle - inside - Scratched - Replace

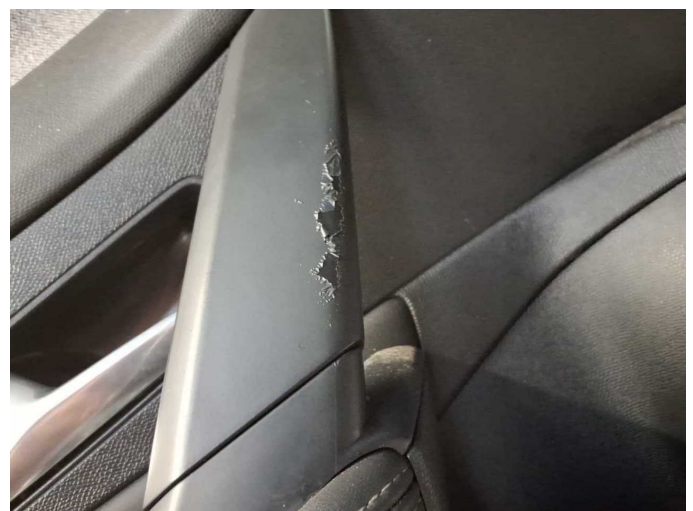
Damage 6: Door - front left side: Door handle - inside - Scratched - Replace

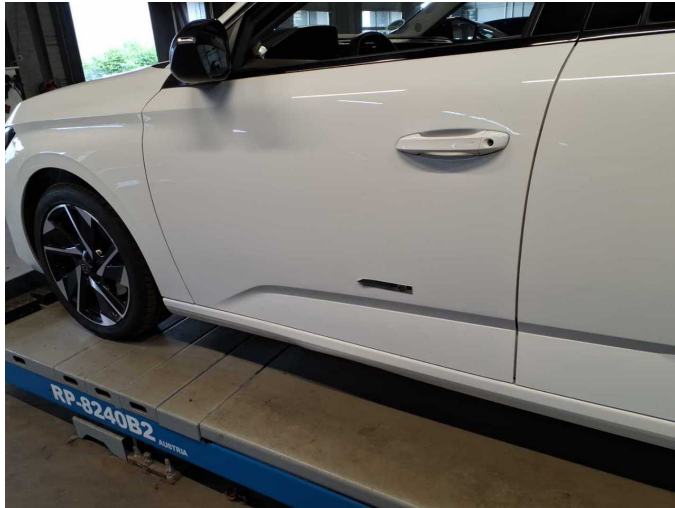
Damage 7: Door - front left side: Door - dent(s) - Smooth repair work

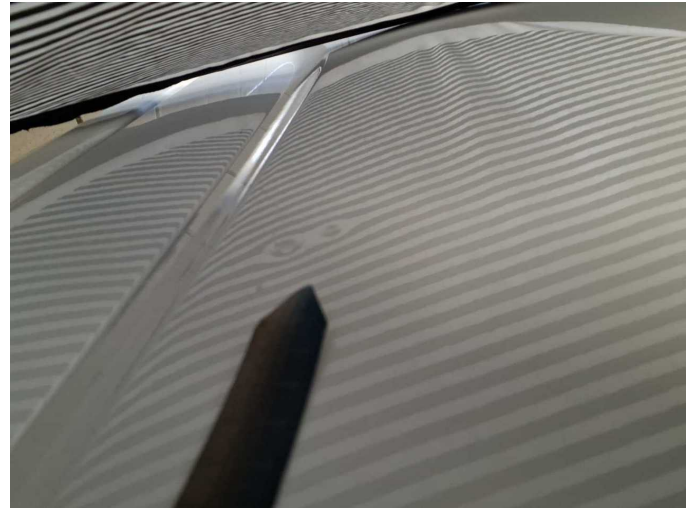
Damage 7: Door - front left side: Door - dent(s) - Smooth repair work

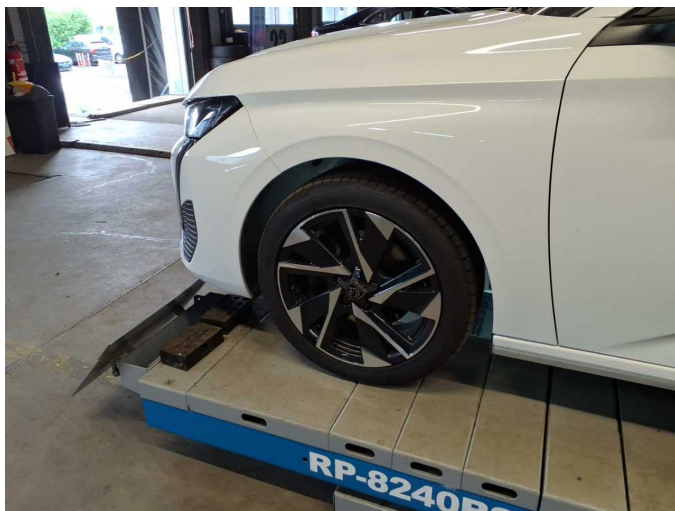
Damage 8: Wheel / tyres: Tyre - front left side - Broken / torn - Replace

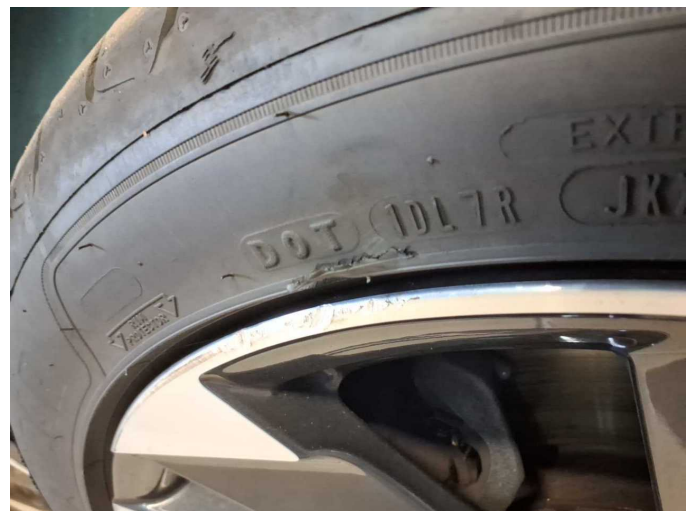
Damage 8: Wheel / tyres: Tyre - front left side - Broken / torn - Replace

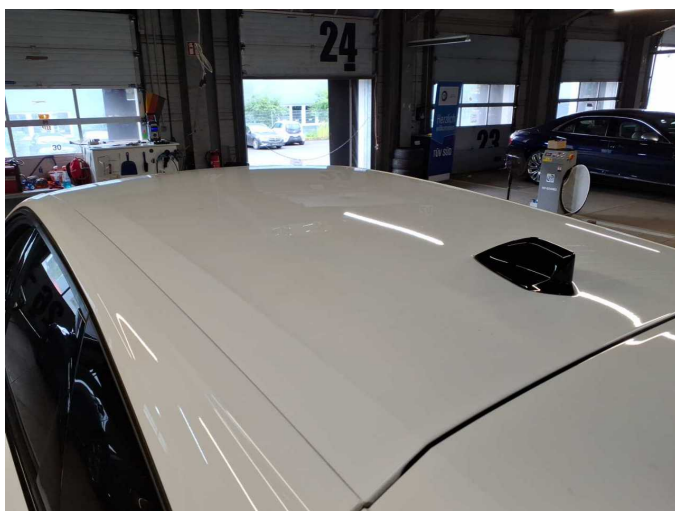
Damage 9: Roof: Roof - dent(s) - Smooth repair work

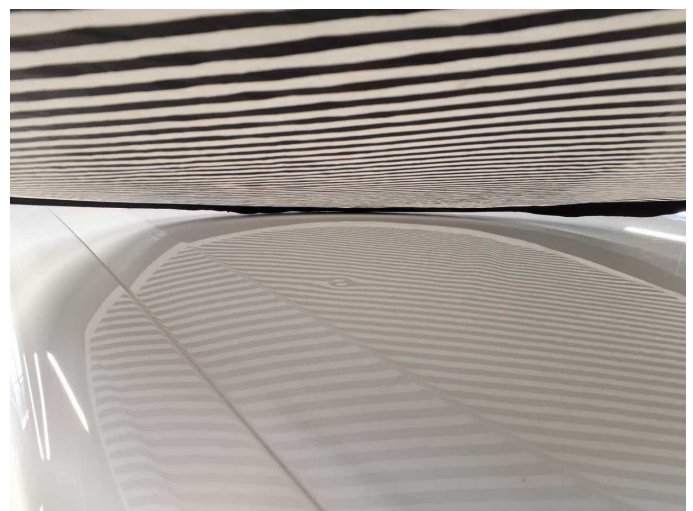
Damage 9: Roof: Roof - dent(s) - Smooth repair work

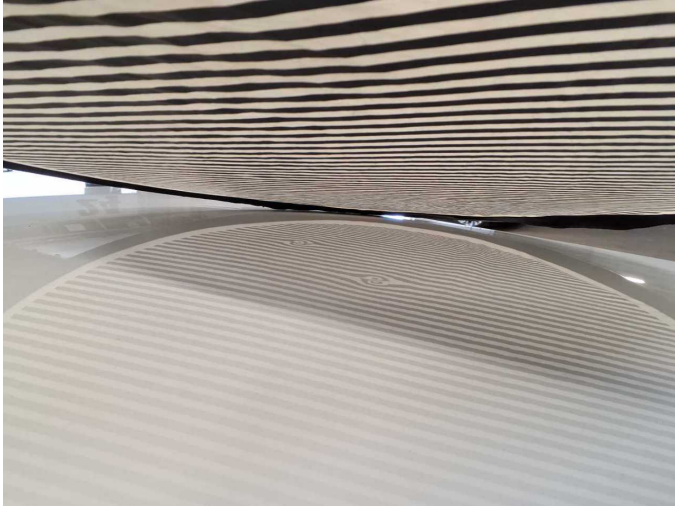
Damage 9: Roof: Roof - dent(s) - Smooth repair work

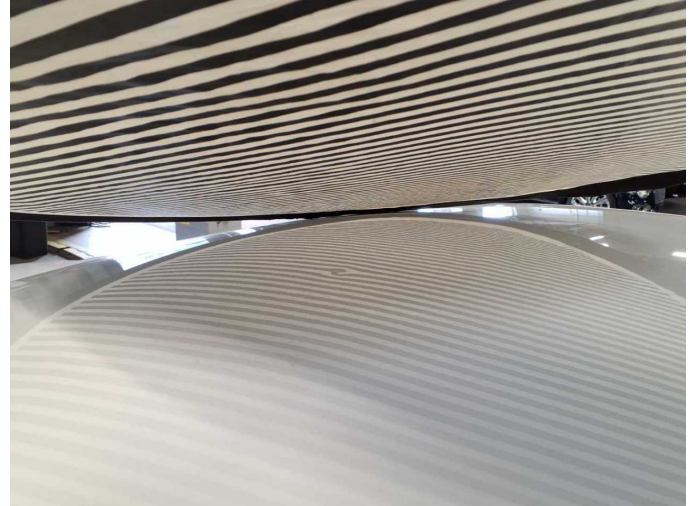
Damage 9: Roof: Roof - dent(s) - Smooth repair work

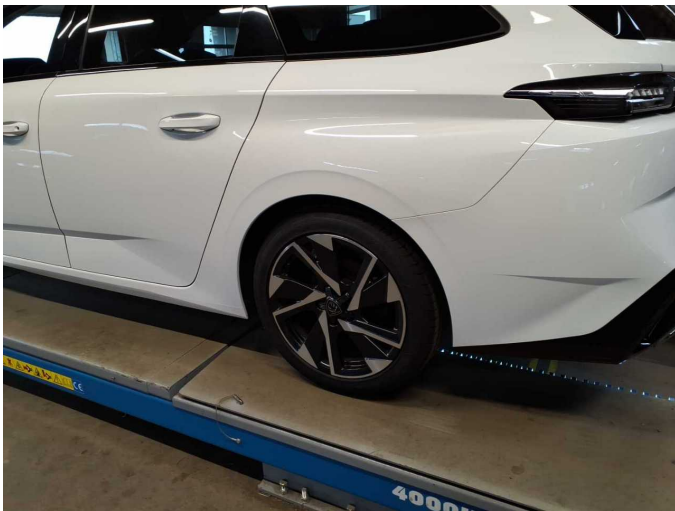
Damage 10: Wheel / tyres: Alloy rim - rear left side (Materialabtrag) - Scratched - Replace

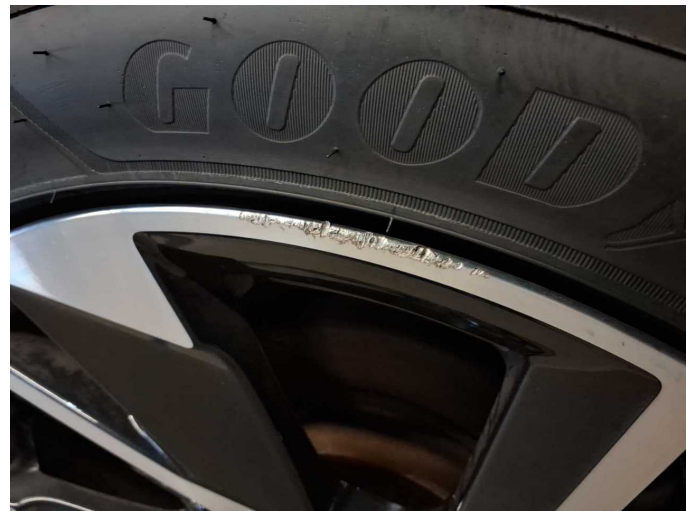
Damage 10: Wheel / tyres: Alloy rim - rear left side (Materialabtrag) - Scratched - Replace

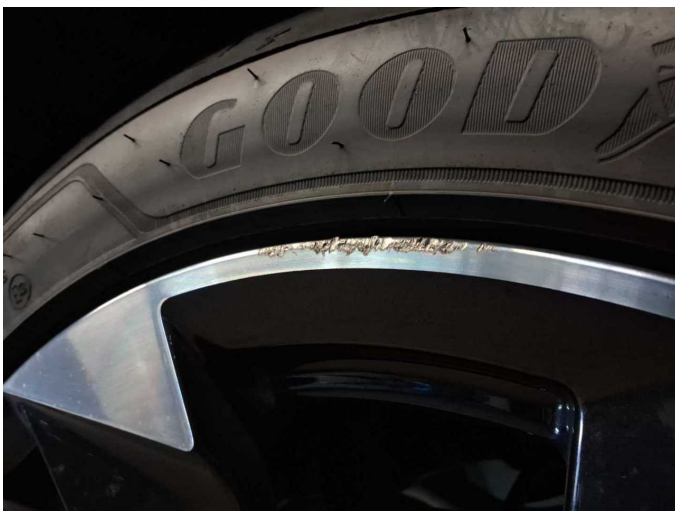
Damage 10: Wheel / tyres: Alloy rim - rear left side (Materialabtrag) - Scratched - Replace

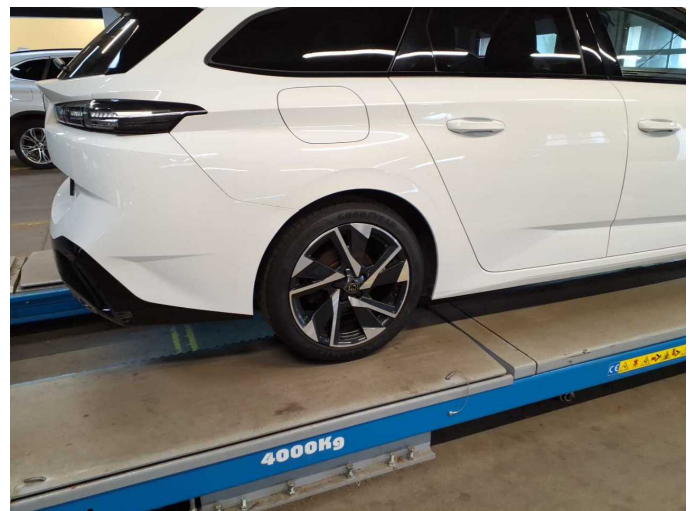
Damage 11: Wheel / tyres: Alloy rim - rear right side - Scratched - Replace

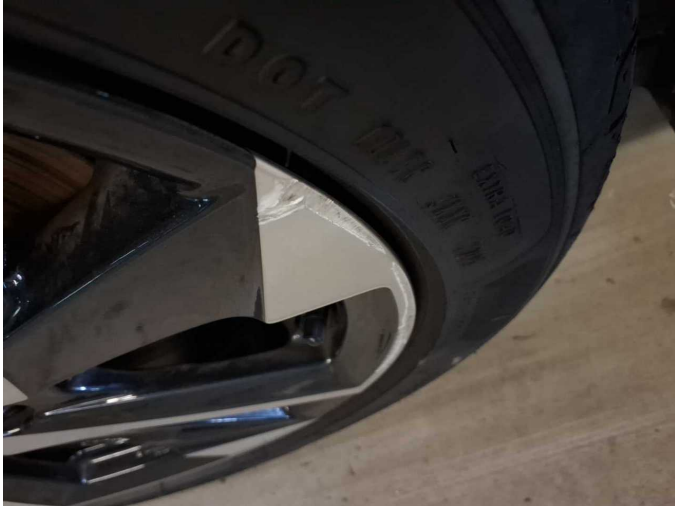
Damage 11: Wheel / tyres: Alloy rim - rear right side - Scratched - Replace

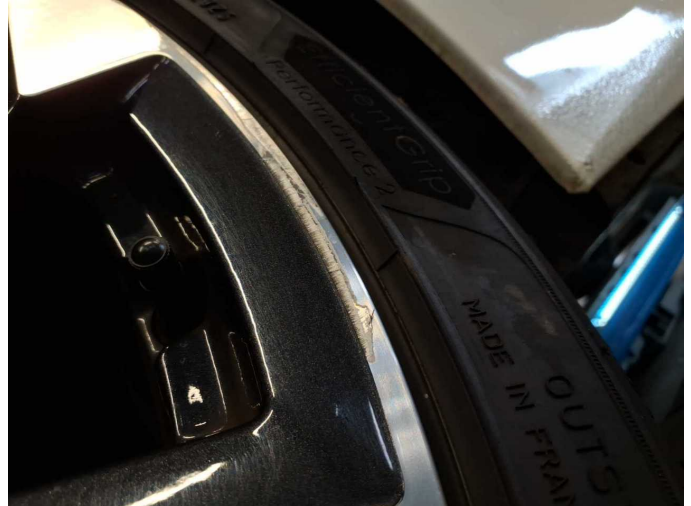
Damage 11: Wheel / tyres: Alloy rim - rear right side - Scratched - Replace

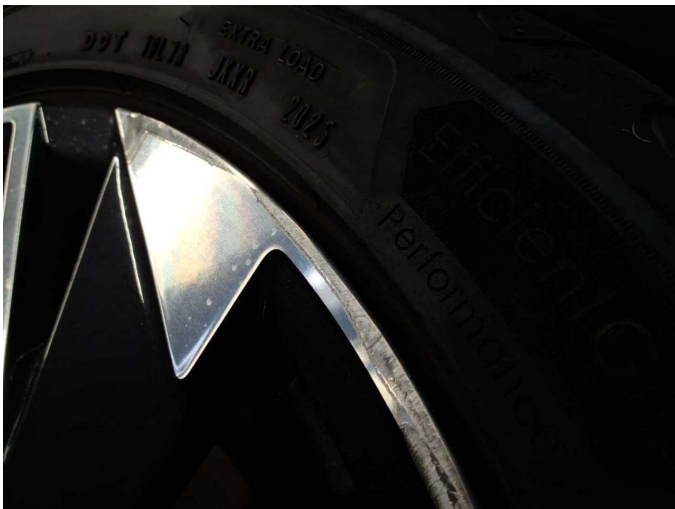
Damage 11: Wheel / tyres: Alloy rim - rear right side - Scratched - Replace

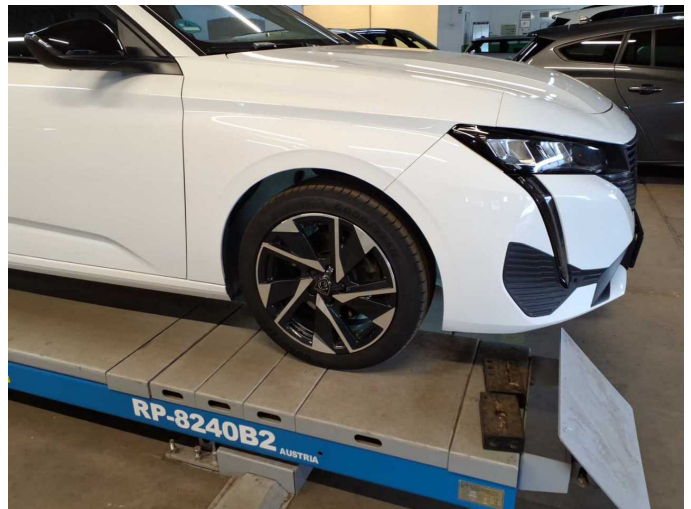
Damage 12: Wheel / tyres: Alloy rim - front right side (Materialabtrag) - Scratched - Replace

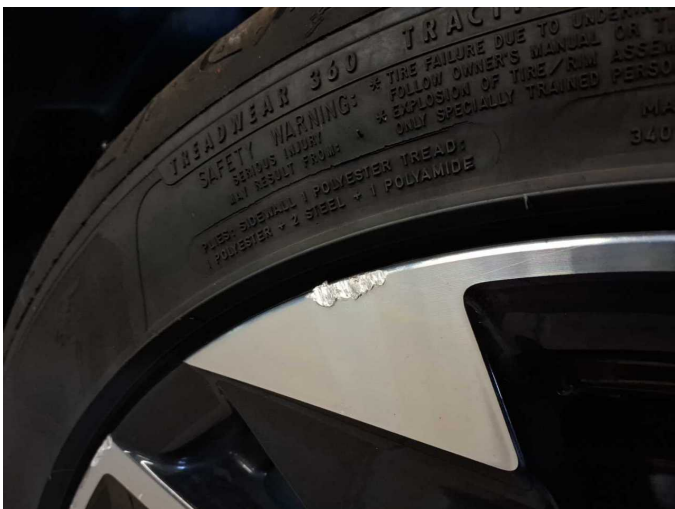
Damage 12: Wheel / tyres: Alloy rim - front right side (Materialabtrag) - Scratched - Replace

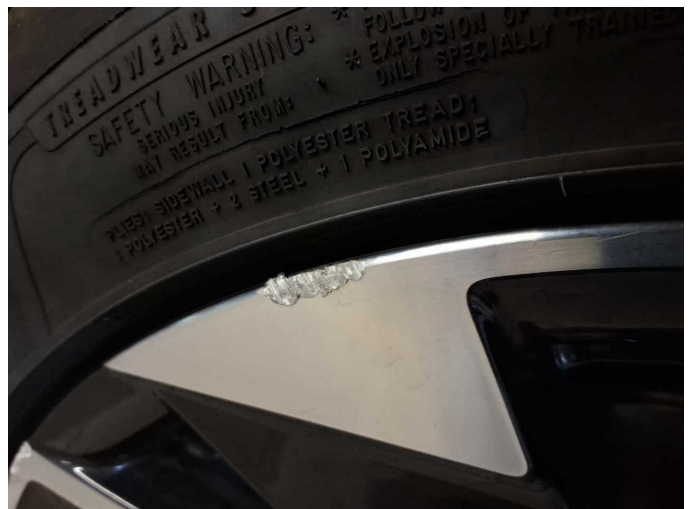
Damage 12: Wheel / tyres: Alloy rim - front right side (Materialabtrag) - Scratched - Replace

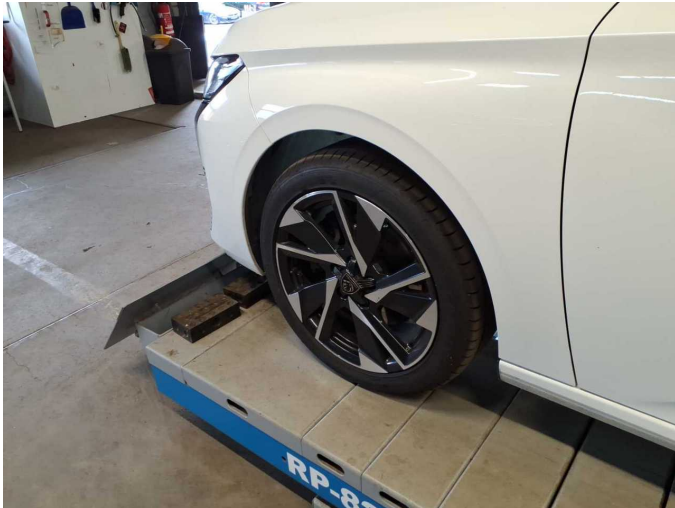
Damage 13: Wheel / tyres: Alloy rim - front left side (Materialabtrag) - Scratched - Replace

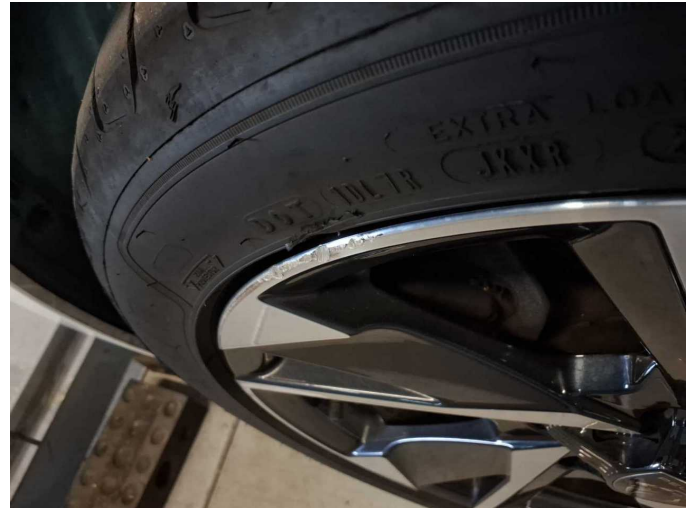
Damage 13: Wheel / tyres: Alloy rim - front left side (Materialabtrag) - Scratched - Replace

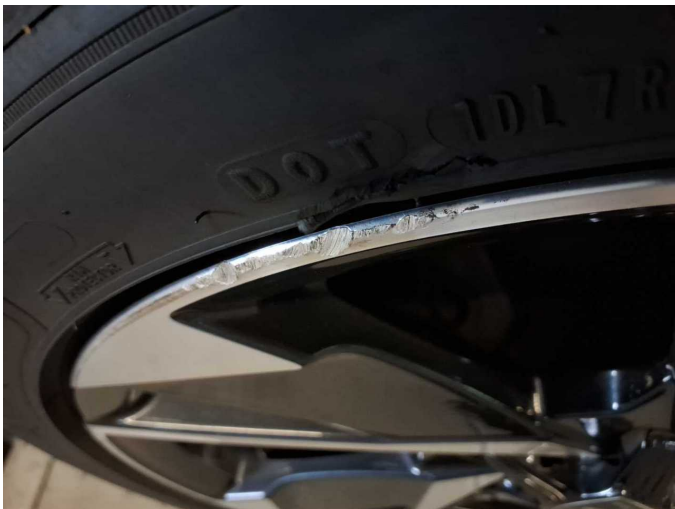
Damage 13: Wheel / tyres: Alloy rim - front left side (Materialabtrag) - Scratched - Replace

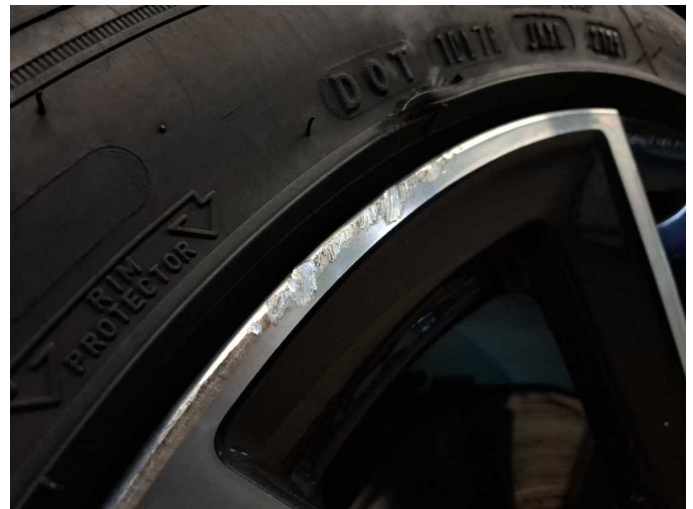
Damage 13: Wheel / tyres: Alloy rim - front left side (Materialabtrag) - Scratched - Replace

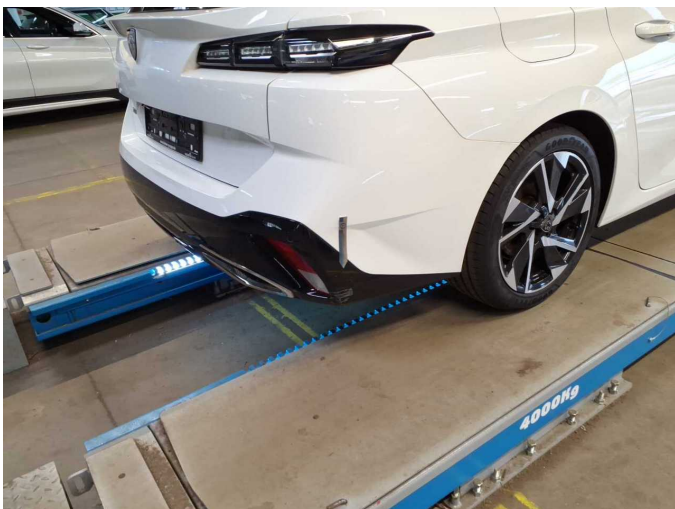
Damage 14: Rear bumper: Spoiler - Scratched - Replace

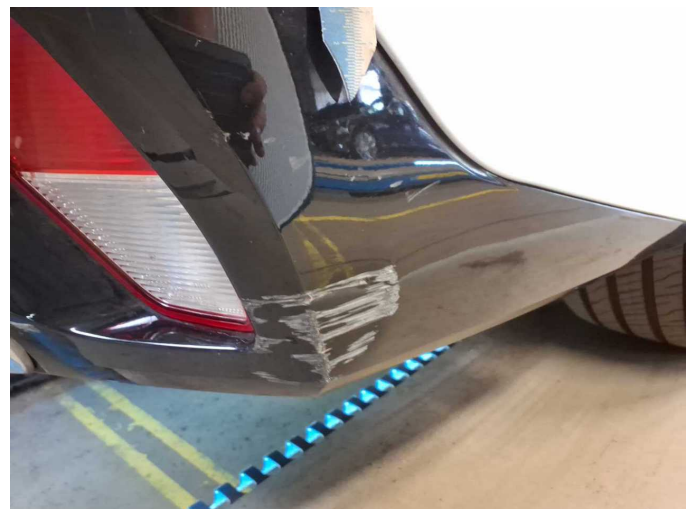
Damage 14: Rear bumper: Spoiler - Scratched - Replace

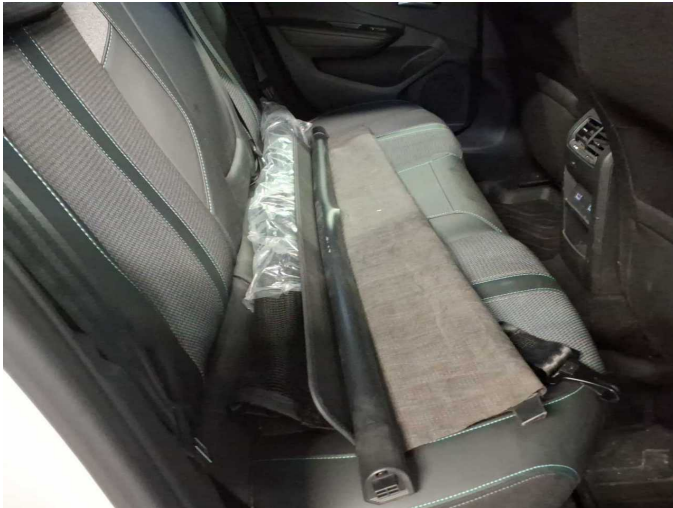
Damage 15: Interior: Boot cover / roller cover - Deformed - Replace

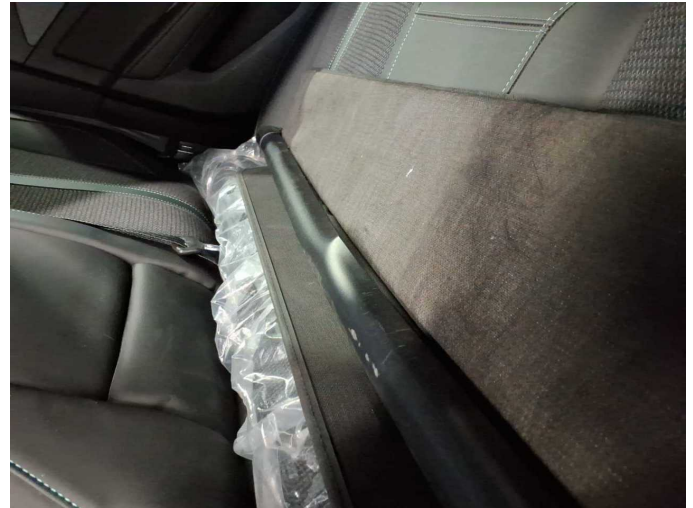
Damage 15: Interior: Boot cover / roller cover - Deformed - Replace

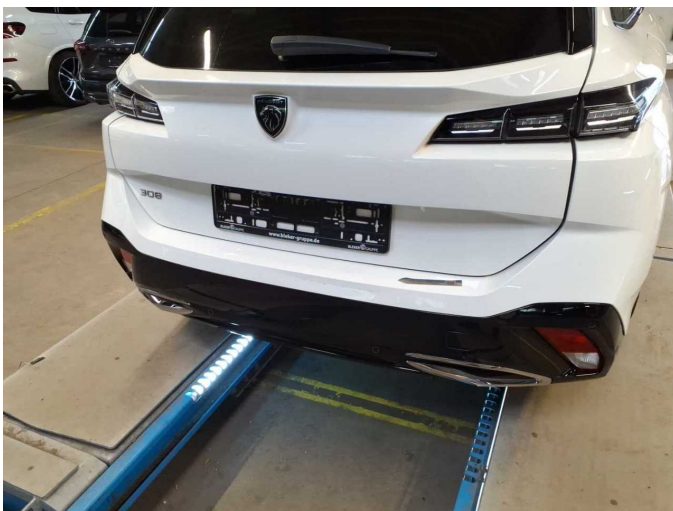
Damage 16: Rear bumper: Rear bumper - Deformed - Replace

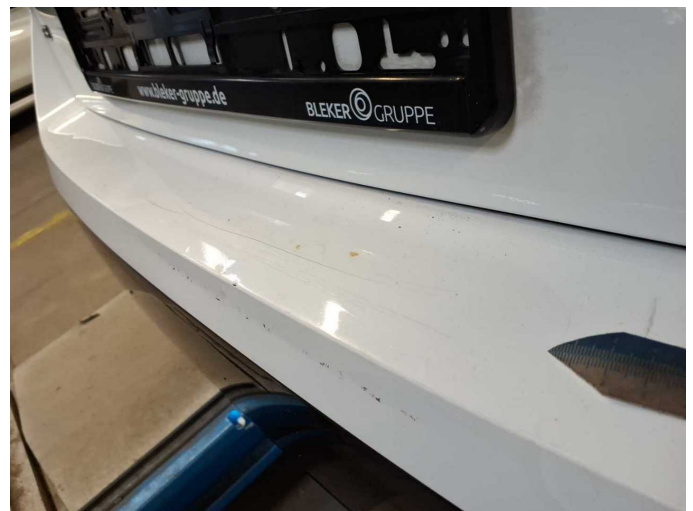
Damage 16: Rear bumper: Rear bumper - Deformed - Replace

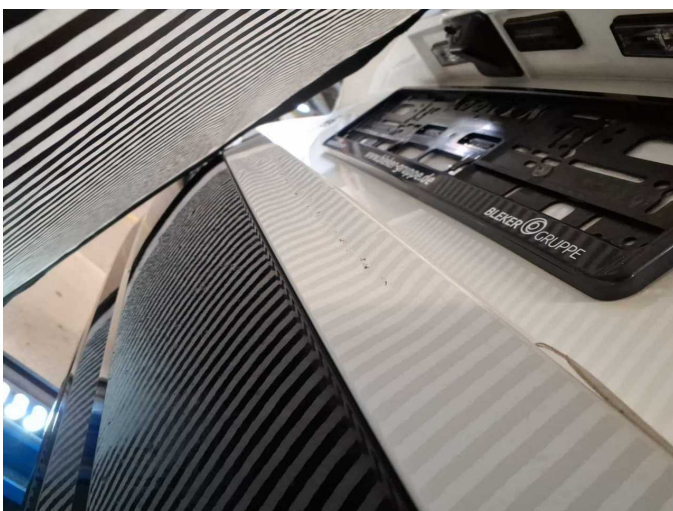
Damage 16: Rear bumper: Rear bumper - Deformed - Replace

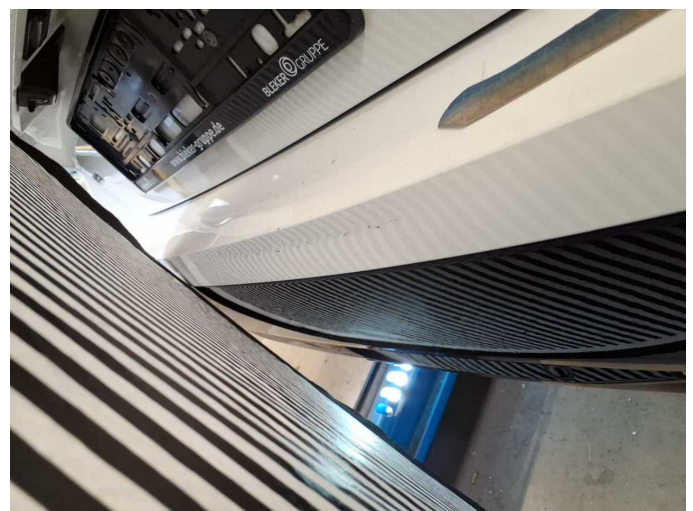
Damage 16: Rear bumper: Rear bumper - Deformed - Replace

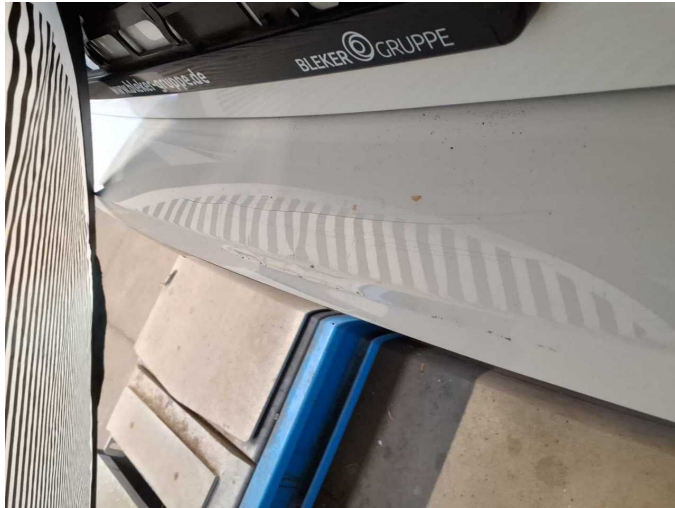
Damage 16: Rear bumper: Rear bumper - Deformed - Replace

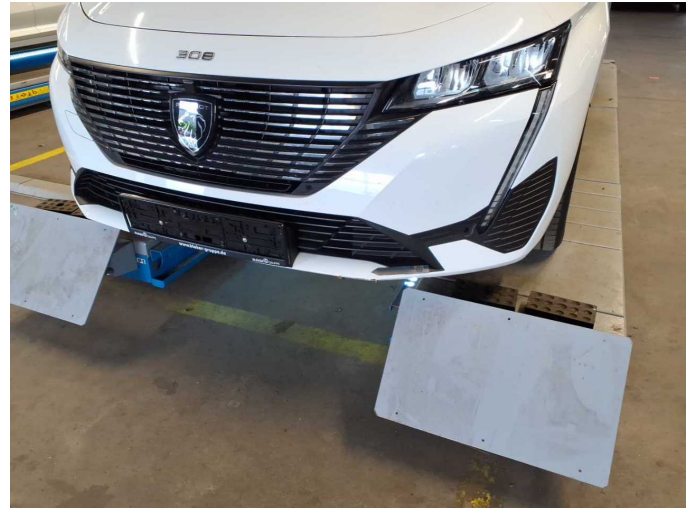
Damage 17: Front bumper: Front bumper - Scratched - Repair and paint

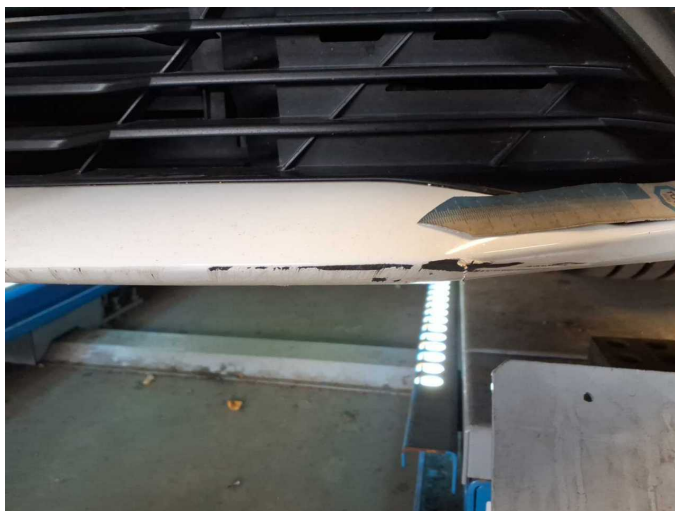
Damage 17: Front bumper: Front bumper - Scratched - Repair and paint

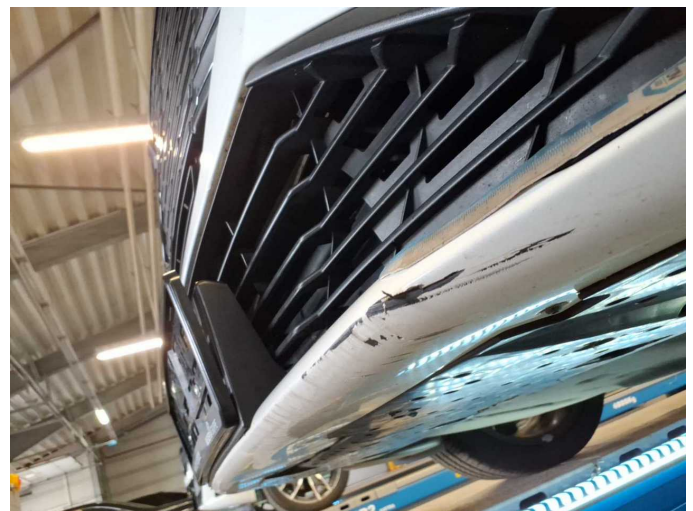
Damage 17: Front bumper: Front bumper - Scratched - Repair and paint

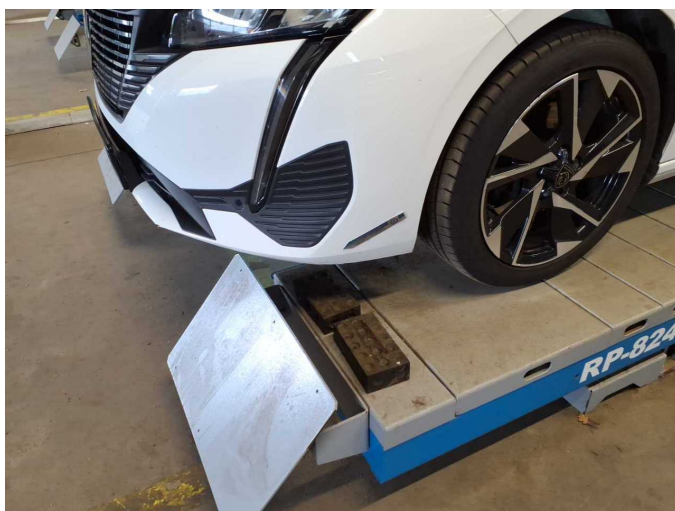
Damage 17: Front bumper: Front bumper - Scratched - Repair and paint

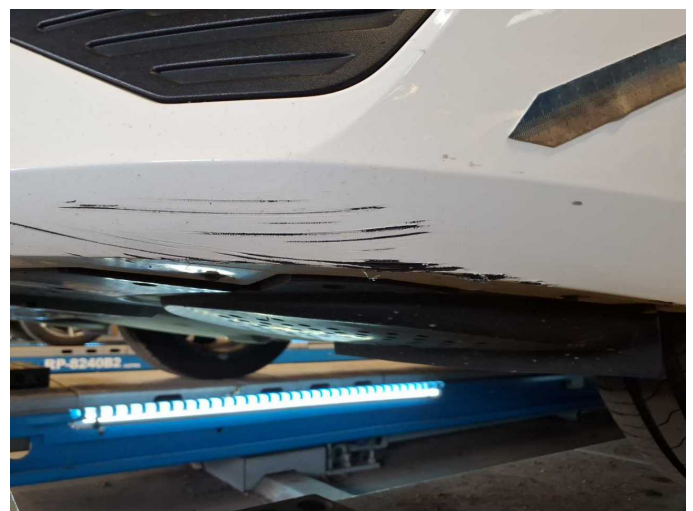
Damage 17: Front bumper: Front bumper - Scratched - Repair and paint

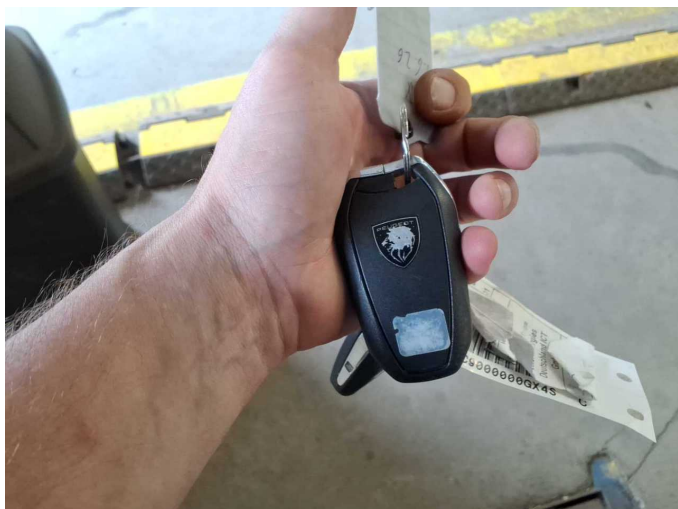
Wear and tear 1: Equipment: Vehicle key with remote control -
Scratch(es) - No deduction
