Expertise

Protocol number: 45970074
Order No. / Reference: 26520688
Inspection date: 10 Jun 2026

Manufacturer: Skoda

Model: Octavia Combi 2.0 TDI DSG Sportline

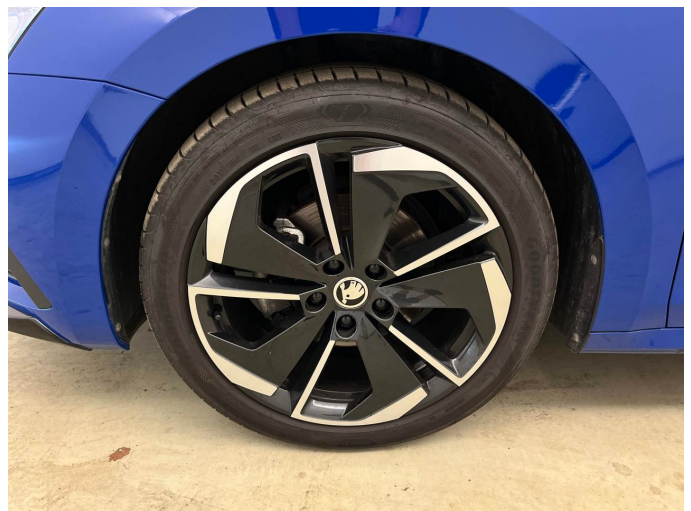
Figure 12: Mounted tyres

- Für den montierten Radsatz wurde kein Nachweis erbracht.
- Winterradsatz ist kein Bestandteil des Auslieferungsumfangs.

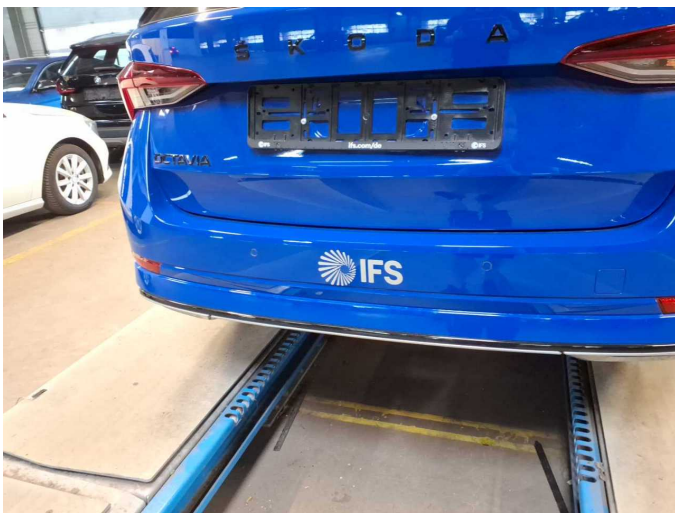
Damage 1: Body: Body - Glued / labelled - De-gue / neutralise

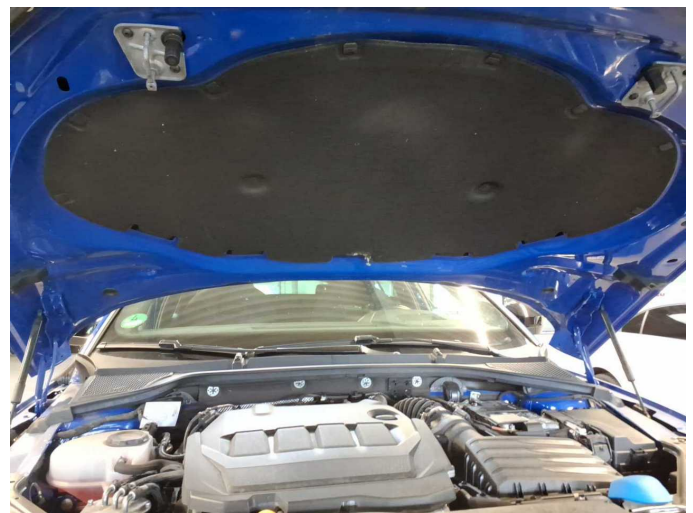
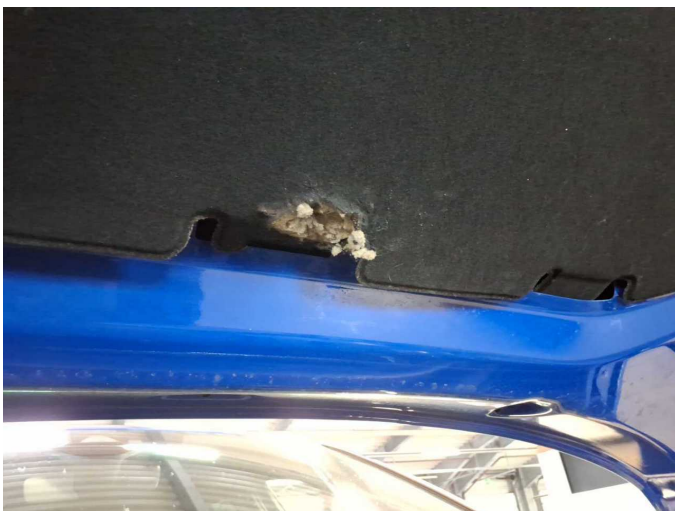
Damage 2: Bonnet: Insulation lining - Damage caused by marten / rodent - Replace

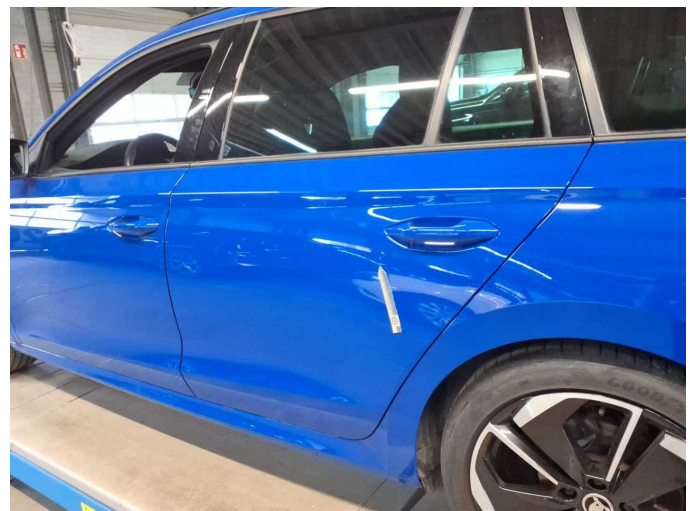
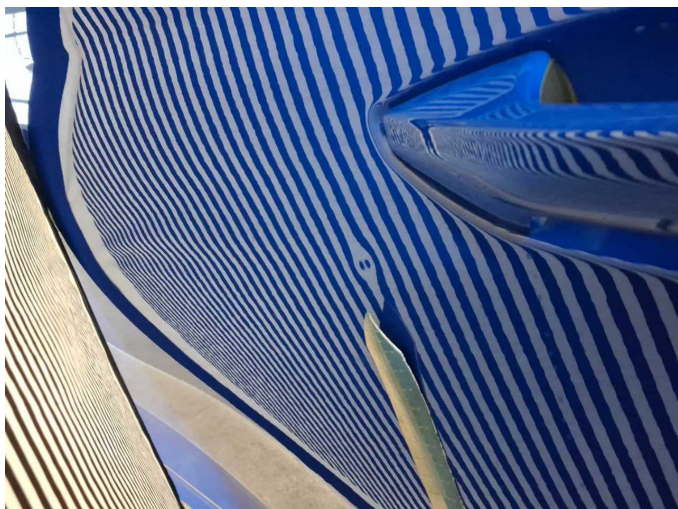
Damage 3: Door - rear left side: Door - dent(s) - Smooth repair work
