## Expertise

Protocol number: 45853145  
Order No. / Reference: 26306830  
Inspection date: 8 Jun 2026

Manufacturer: Opel

Model: Astra Sports Tourer 1.2 Turbo Automatik GS

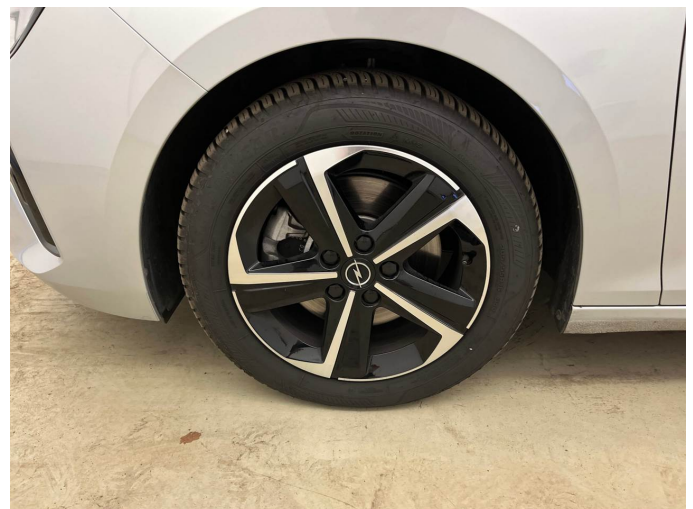
Figure 12: Mounted tyres

#	Tyre size	Type of tyre	Manufacturer	Tread depth
1)	205/55 R16 94V	All-season tyres on Light alloy	Goodyear	6mm / 6mm
2)	205/55 R16 94V	All-season tyres on Light alloy	Goodyear	6mm / 6mm

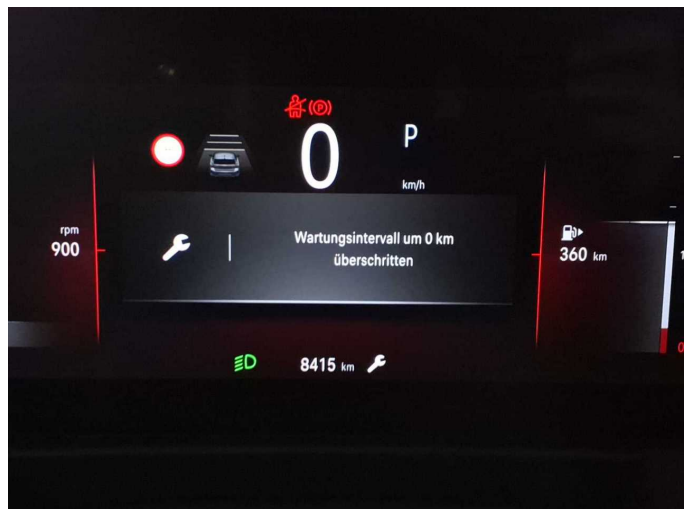
No.	Component group	Description
1	Misc.	Inspection / maintenance - Due - Perform

Damage 1: Misc.: Inspection / maintenance - Due - Perform
