Expertise

Protocol number: 46478526  
Order No. / Reference: 26603139  
Inspection date: 13 Jul 2026

Manufacturer: Opel

Model: Grandland X Plug-in-Hybrid 1.6 DI Start/Stop Aut Business  
Elegance

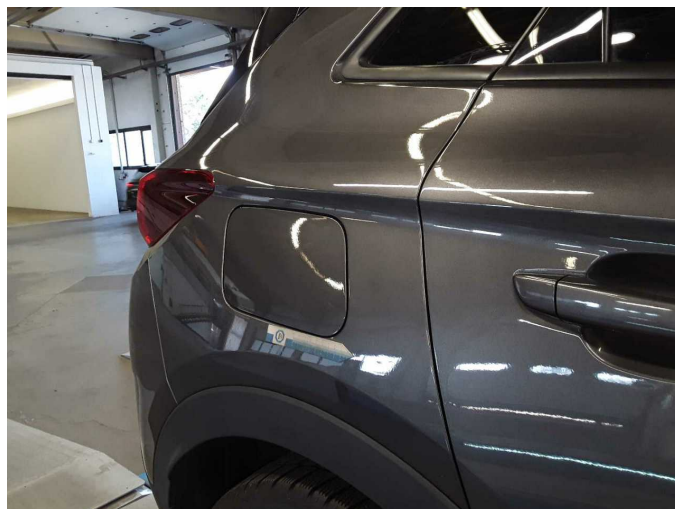
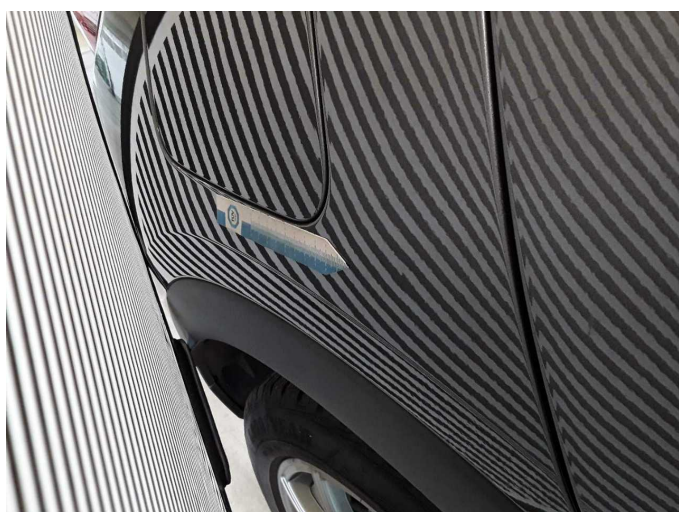
| No. | Component group | Description |
|---|---|---|
| 1 | Side panel - rear right side | Side panel - dent(s) - Smooth repair work |

**Damage 1:** Side panel - rear right side: Side panel - dent(s) - Smooth repair work

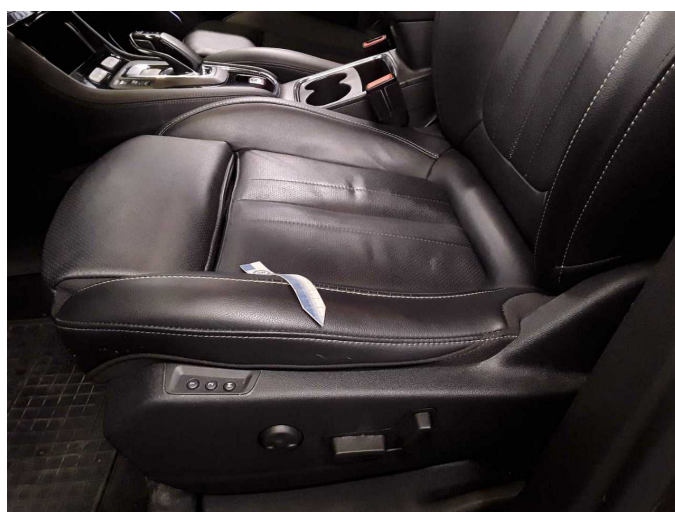
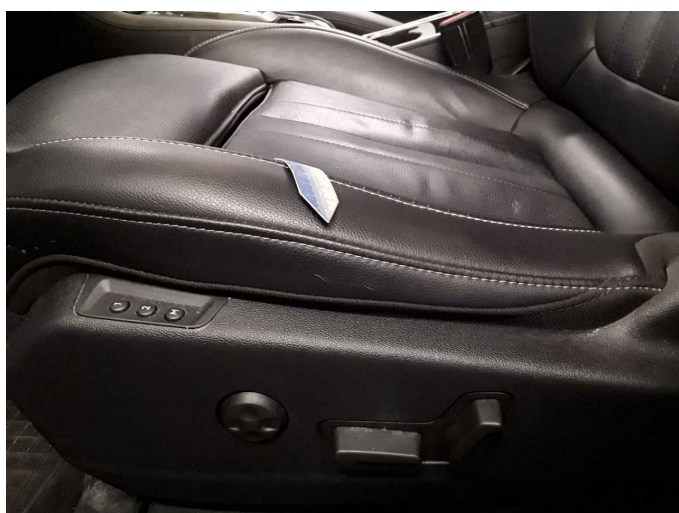
| No. | Component group | Description |
|---|---|---|
| 2 | Seat - front | Seat cover - left side - Porous / cracked - Smart repair |

**Damage 2:** Seat - front: Seat cover - left side - Porous / cracked - Smart repair

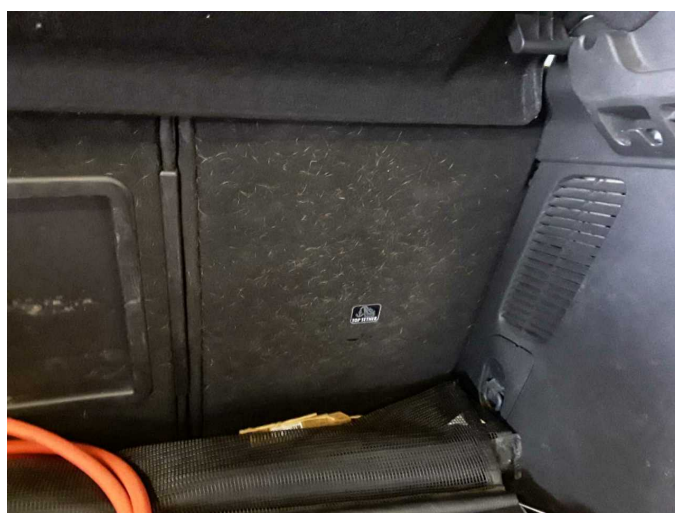
| No. | Component group | Description |
|---|---|---|
| 4 | Interior | Interior (Hundehaare) - Soiled - Conditioning |

**Damage 4:** Interior: Interior (Hundehaare) - Soiled - Conditioning

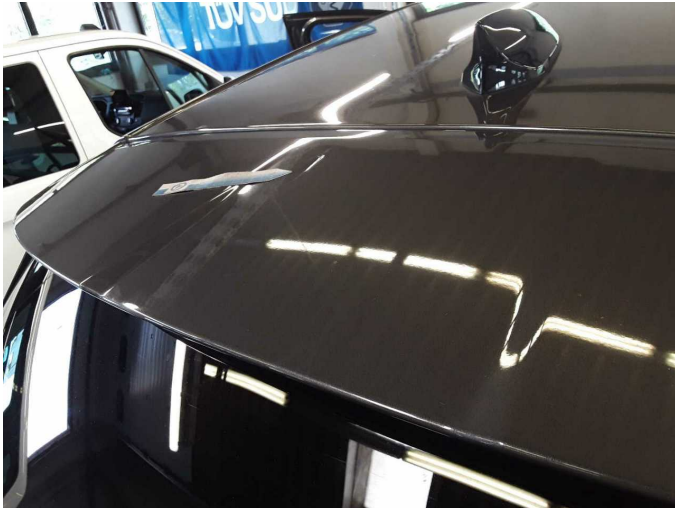
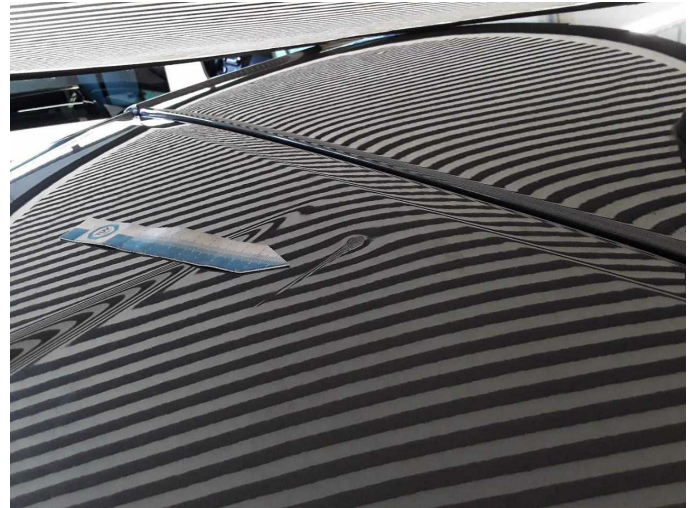
| No. | Component group | Description |
|---|---|---|
| 5 | Boot lid / rear door | Rear spoiler - Dent / paintcoat damage - Smart repair |

**Damage 5:** Boot lid / rear door: Rear spoiler - Dent / paintcoat damage - Smart repair

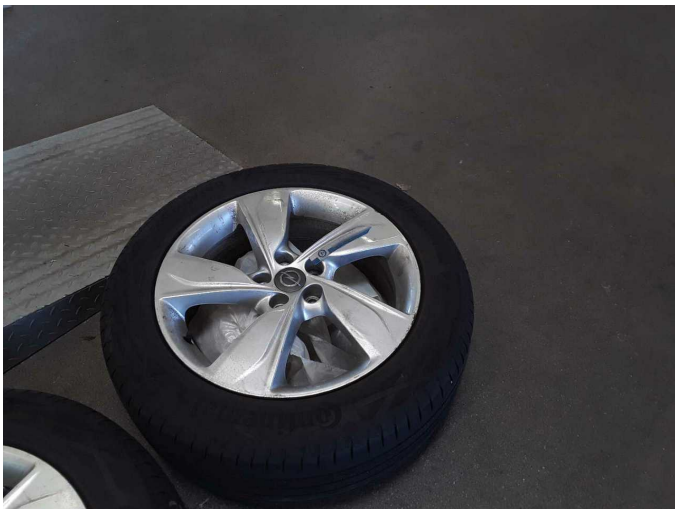
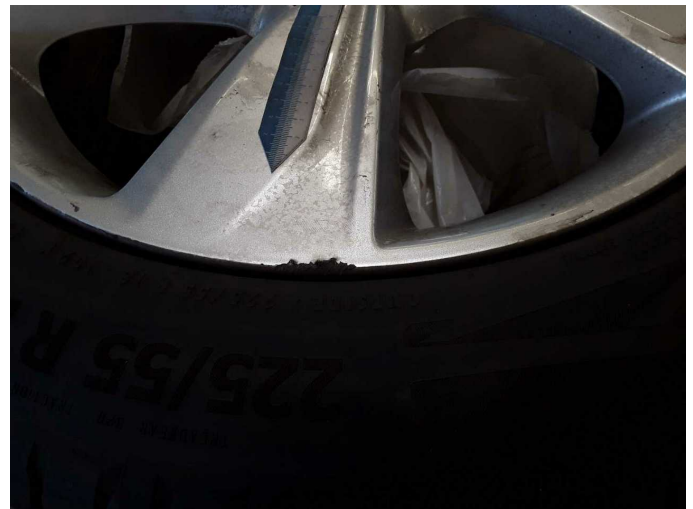
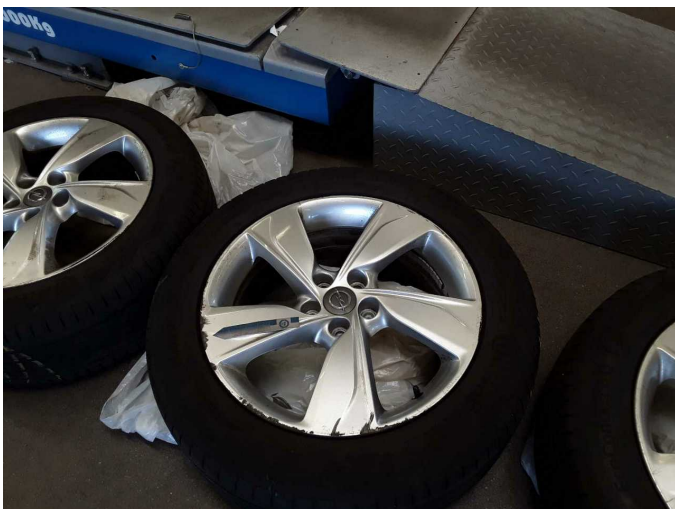
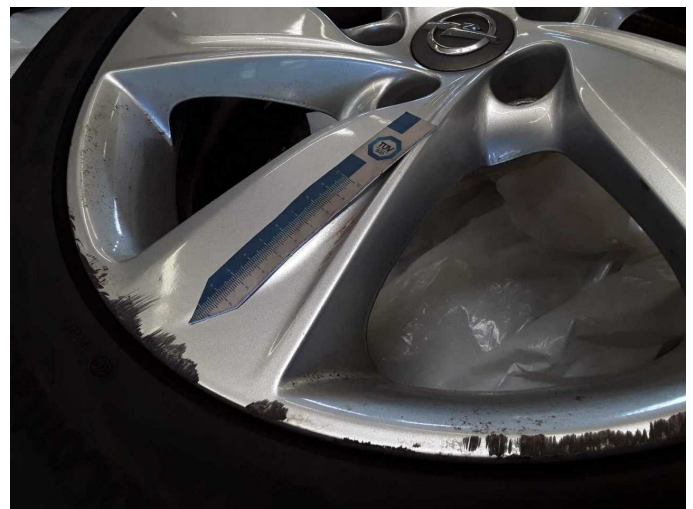
| No. | Component group | Description |
|---|---|---|
| 6 | 2nd wheel set | 2 alloy rims - Scratched - Loss in value |

**Damage 6:** 2nd wheel set: 2 alloy rims - Scratched - Loss in value

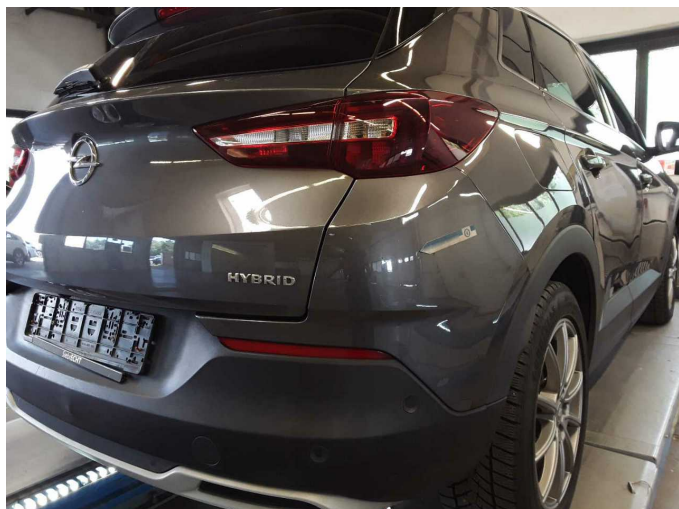
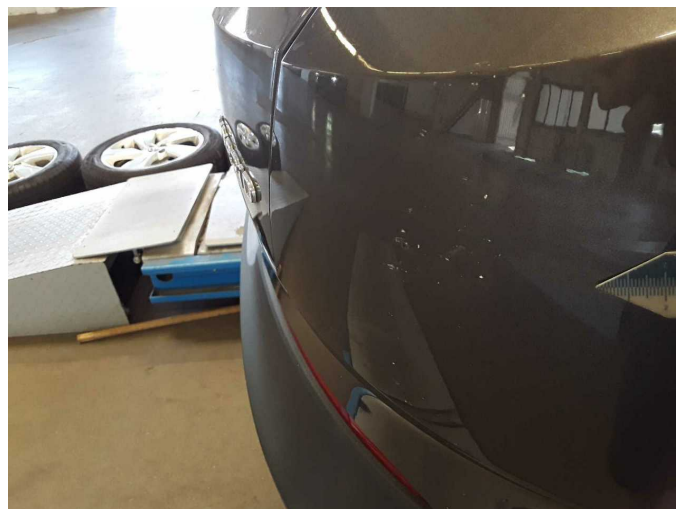
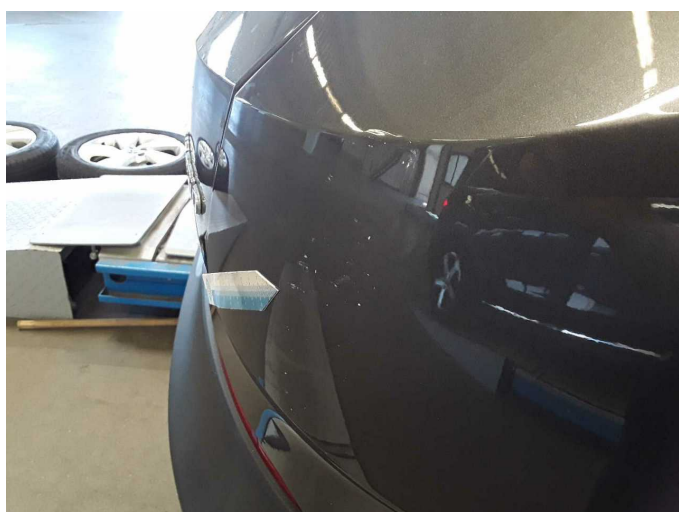
| No. | Component group | Description |
|---|---|---|
| 8 | Rear bumper | Rear bumper (Ecke) - Scratch(es) - Paint |

**Damage 8:** Rear bumper: Rear bumper (Ecke) - Scratch(es) - Paint

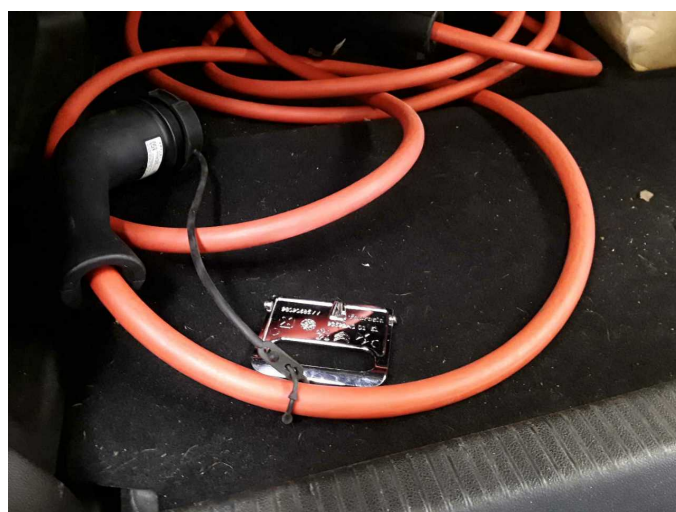
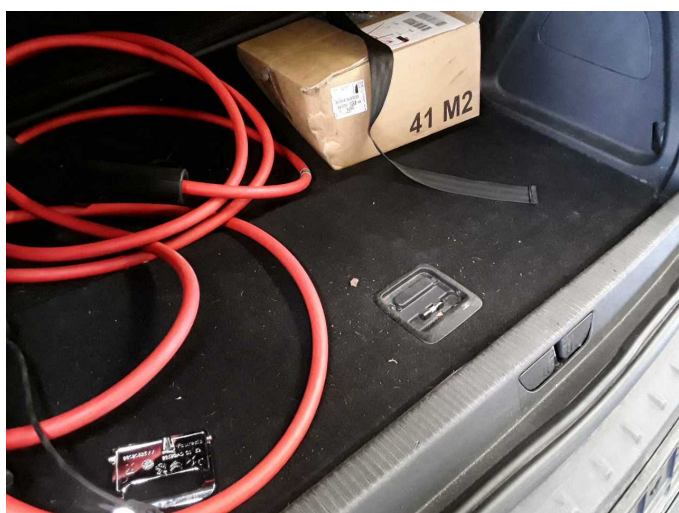
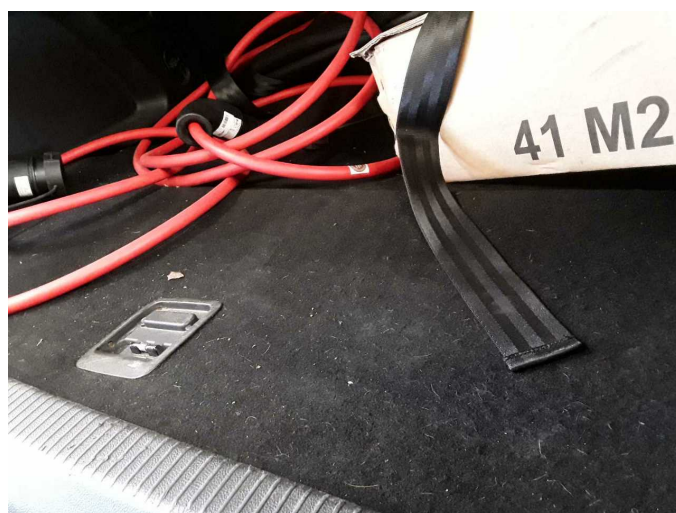
| No. | Component group | Description |
|---|---|---|
| 9 | Interior | Cargo area floor (Beschädigt) - Deformed - Replace |

**Damage 9:** Interior: Cargo area floor (Beschädigt) - Deformed - Replace

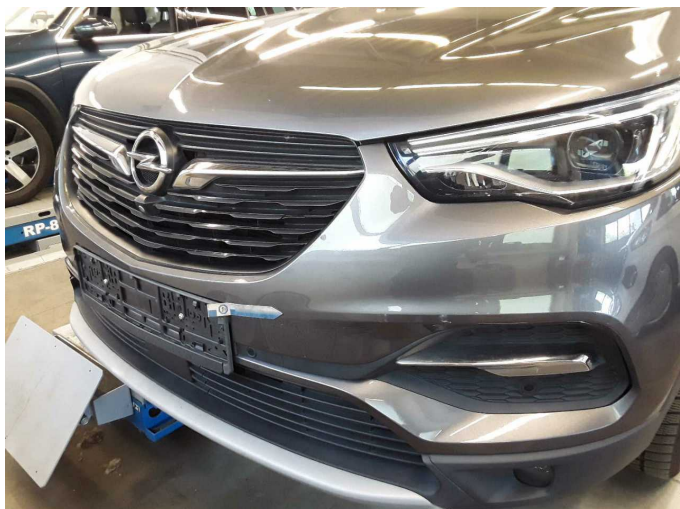
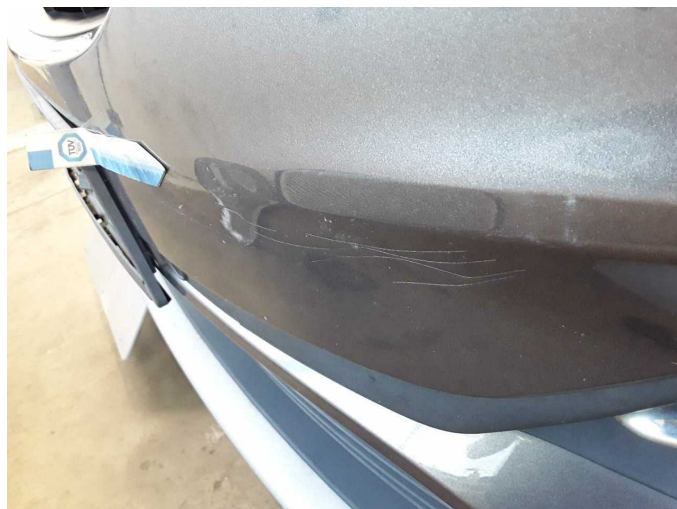
| No. | Component group | Description |
|---|---|---|
| 10 | Front bumper | Front bumper - Scratch(es) - Paint |

**Damage 10:** Front bumper: Front bumper - Scratch(es) - Paint

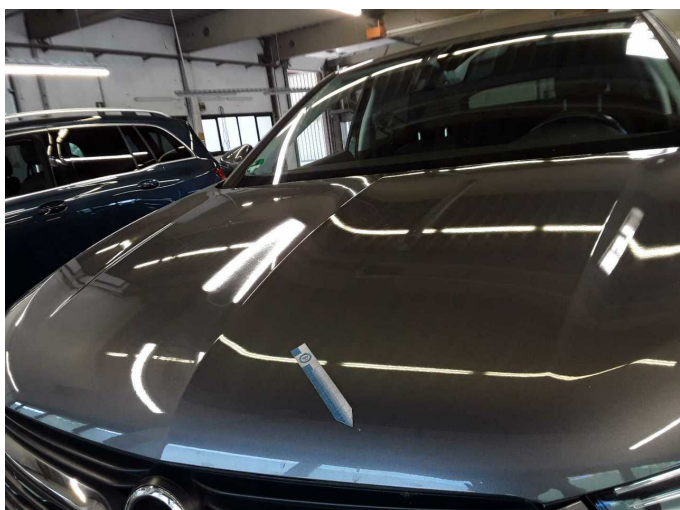
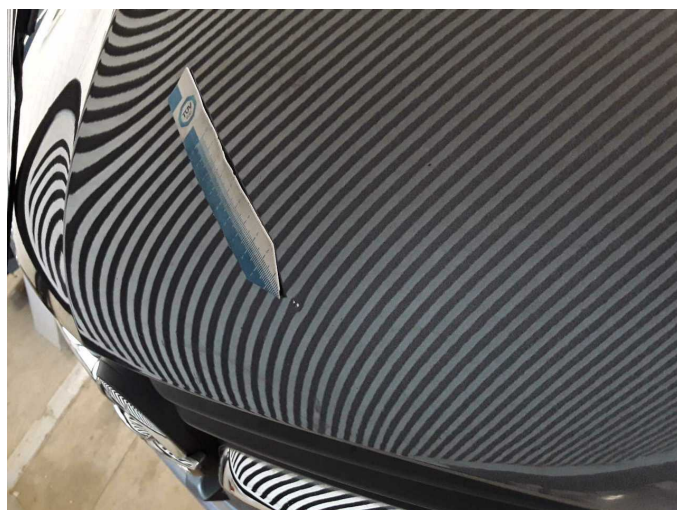
| No. | Component group | Description |
|---|---|---|
| 11 | Bonnet | Bonnet - Dent / paintcoat damage - Repair and paint |

**Damage 11:** Bonnet: Bonnet - Dent / paintcoat damage - Repair and paint

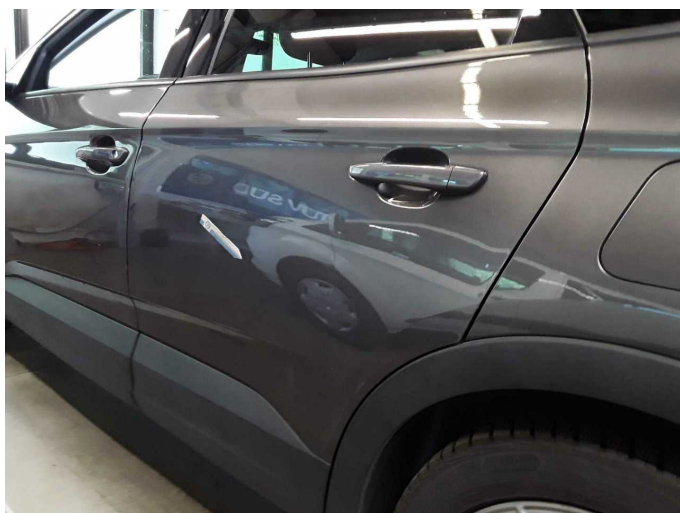
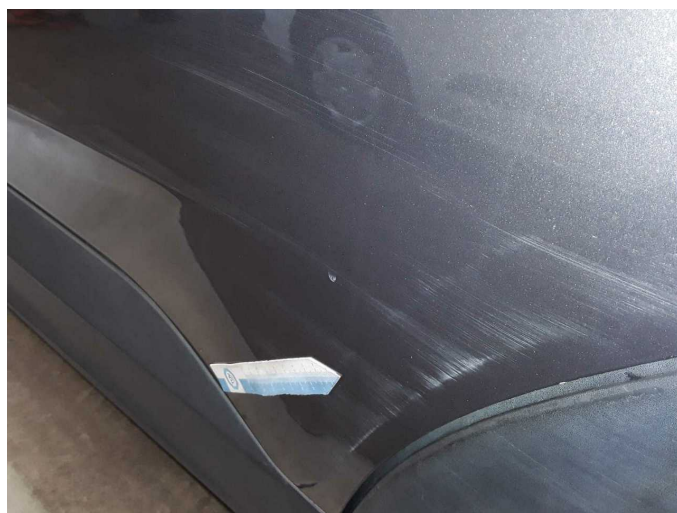
| No. | Component group | Description |
|---|---|---|
| 12 | Door - rear left side | Door - Scratch(es) - Paint |

**Damage 12:** Door - rear left side: Door - Scratch(es) - Paint

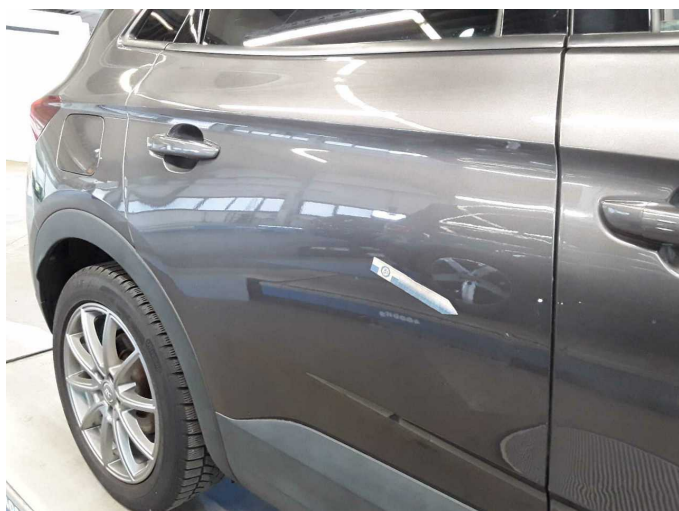
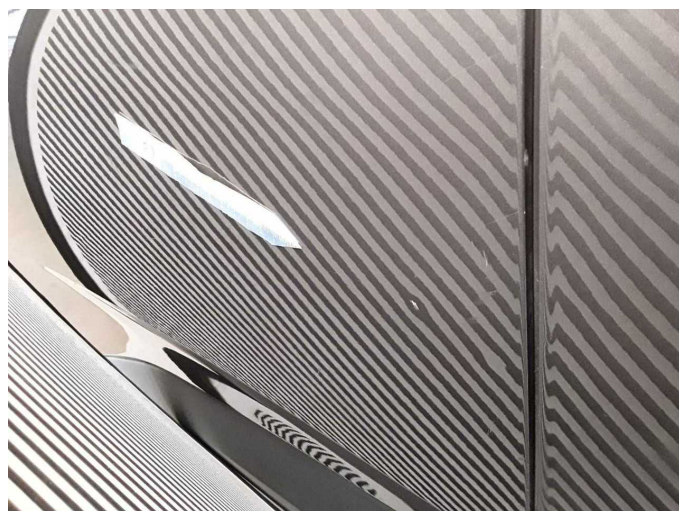
| No. | Component group | Description |
|---|---|---|
| 13 | Door - rear right side | Door - Dent / paintcoat damage - Repair and paint |

**Damage 13:** Door - rear right side: Door - Dent / paintcoat damage - Repair and paint

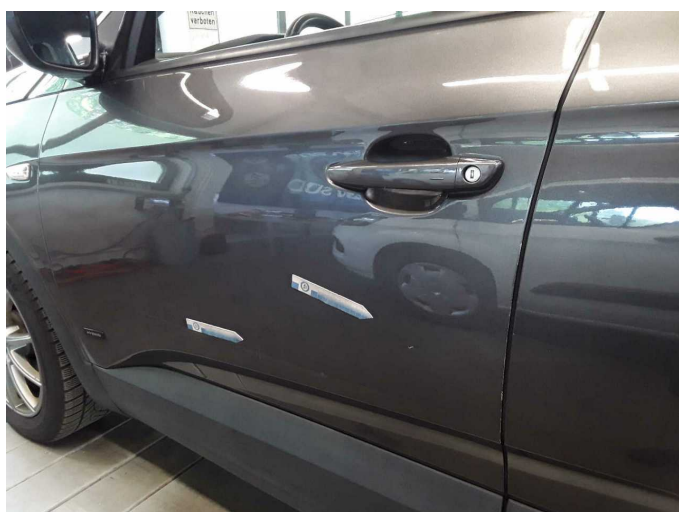
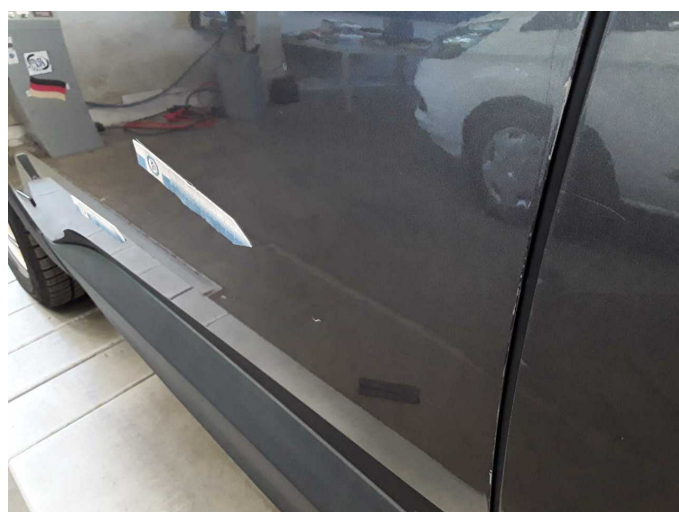
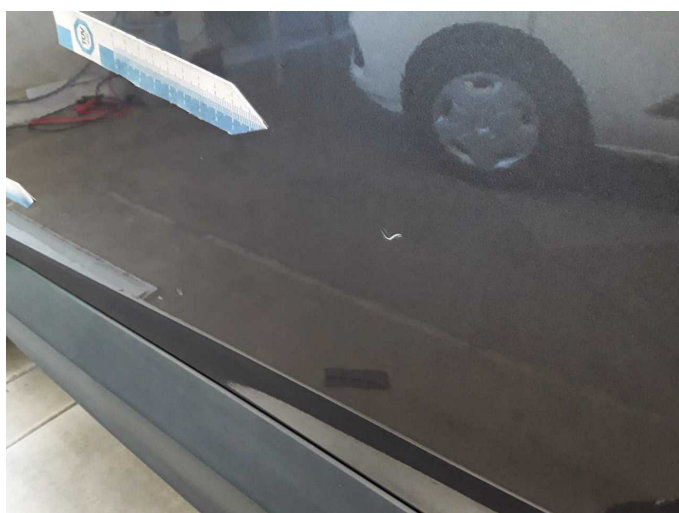
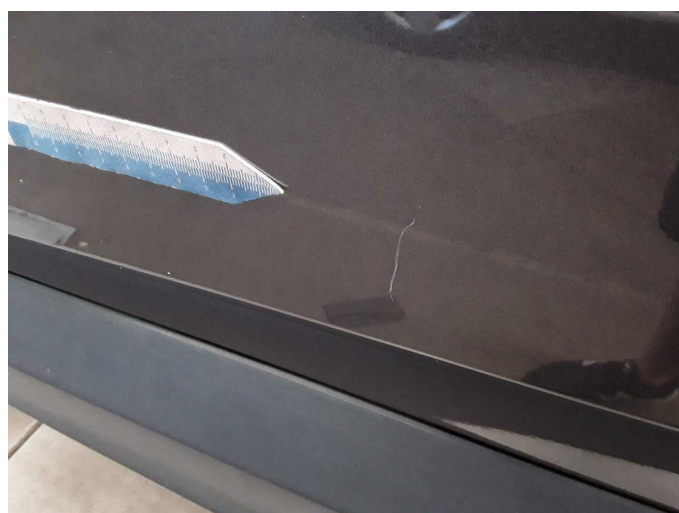
| No. | Component group | Description |
|---|---|---|
| 14 | Door - front left side | Door - Scratch(es) - Paint |

**Damage 14:** Door - front left side: Door - Scratch(es) - Paint

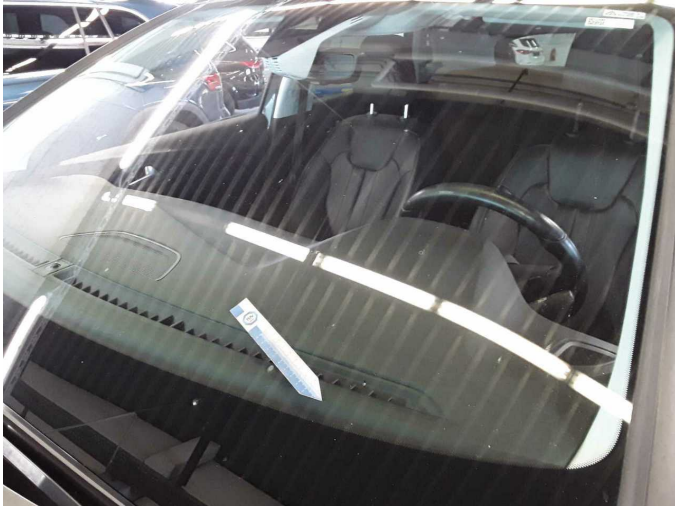
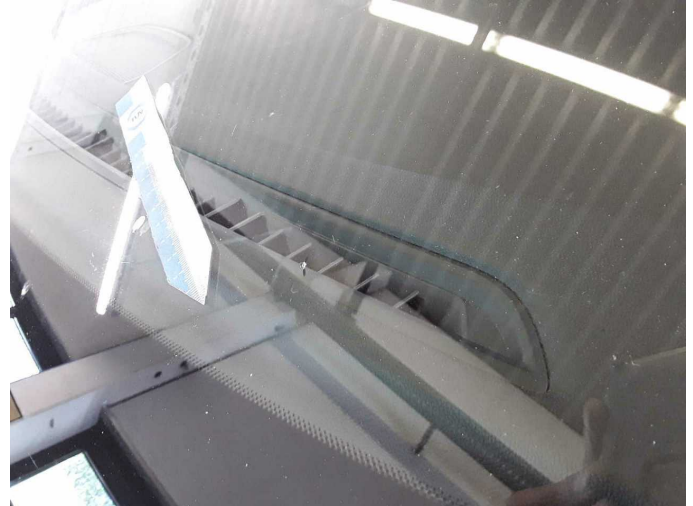
| No. | Component group | Description |
|---|---|---|
| 15 | Vehicle glazing | Windscreen (Rissbildung) - Stone chips - Replace |

**Damage 15:** Vehicle glazing: Windscreen (Rissbildung) - Stone chips - Replace

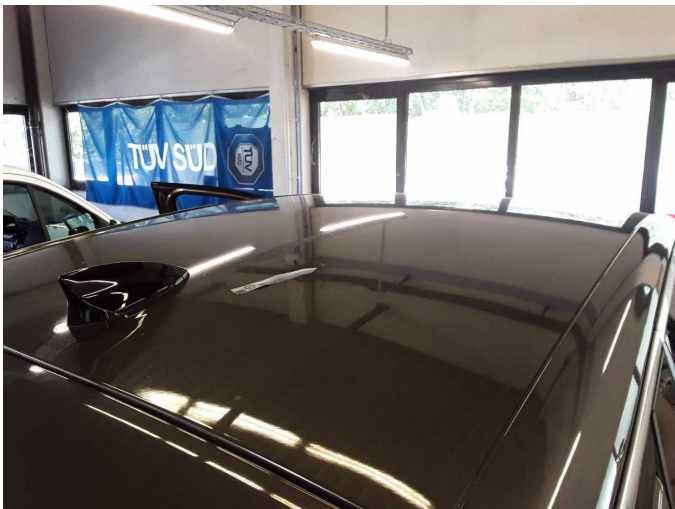
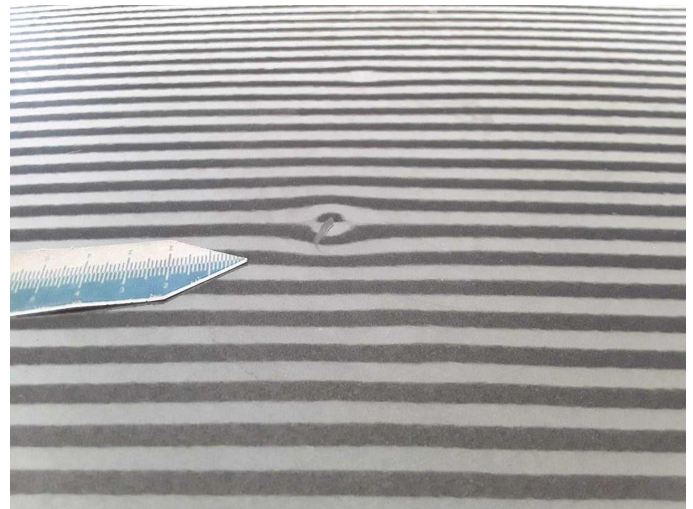
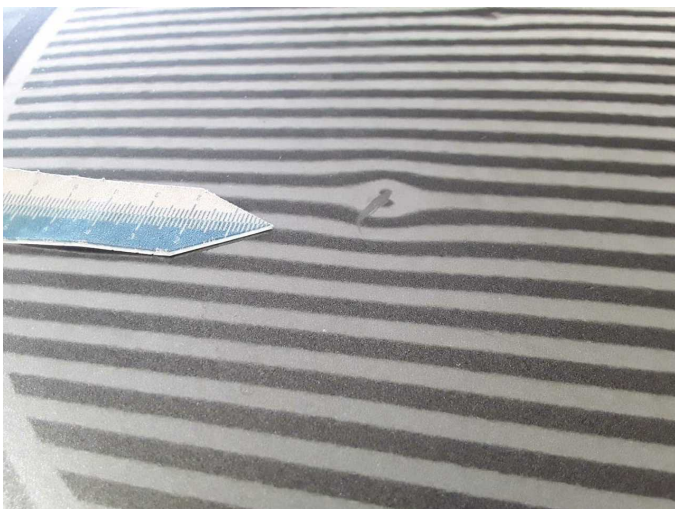
| No. | Component group | Description |
|---|---|---|
| 16 | Roof | Roof - Dent / paintcoat damage - Repair and paint |

**Damage 16:** Roof: Roof - Dent / paintcoat damage - Repair and paint

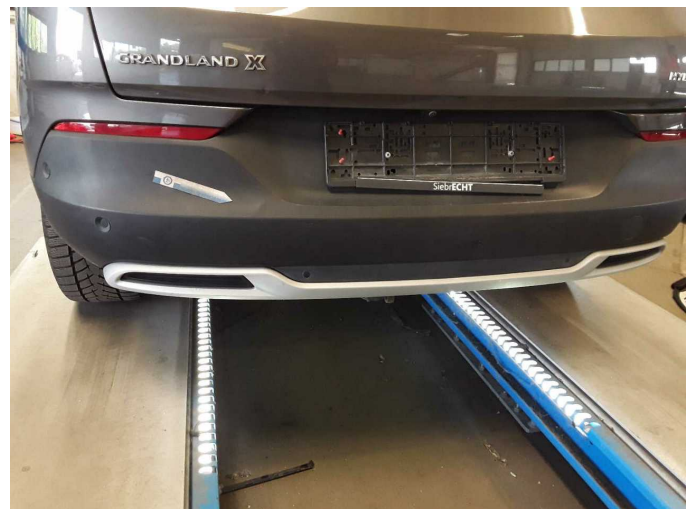
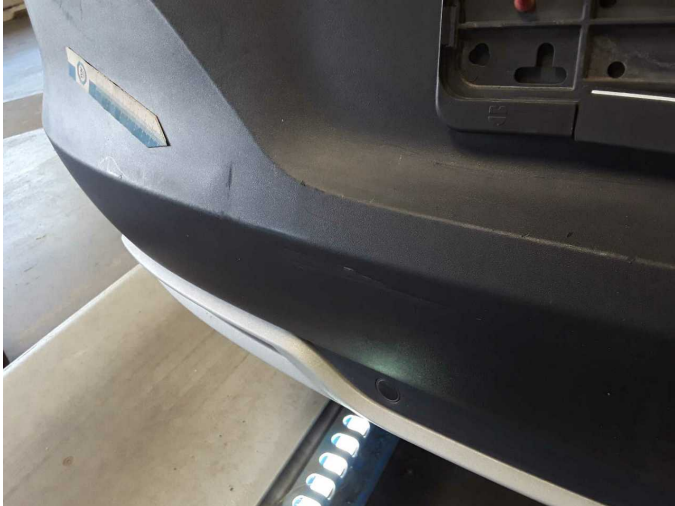
| No. | Component group | Description |
|---|---|---|
| 1 | Rear bumper | Rear bumper (unpainted) - Scratch(es) - No deduction |

**Wear and tear 1:** Rear bumper: Rear bumper (unpainted) - Scratch(es) - No deduction

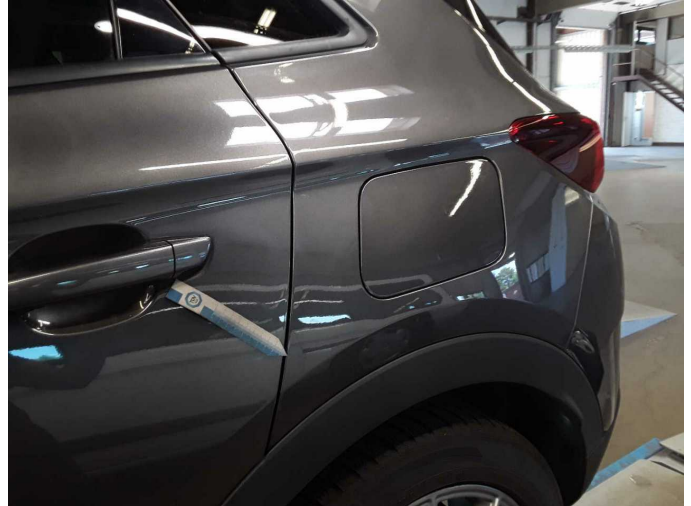
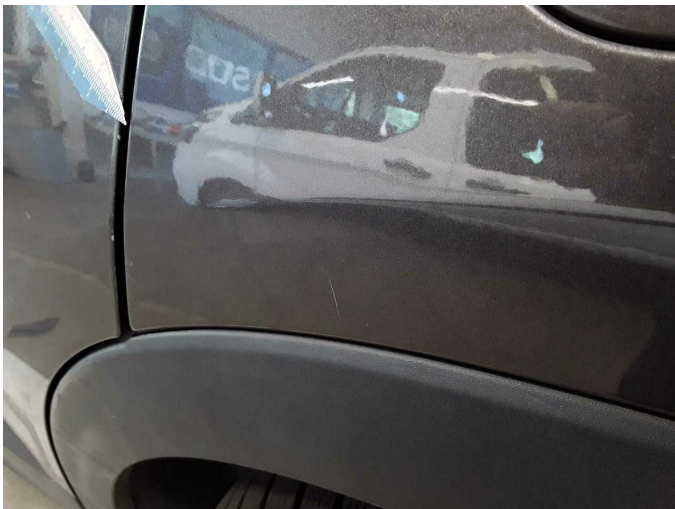
| No. | Component group | Description |
|---|---|---|
| 4 | Side panel - rear left side | Side panel - Scratch(es) - Cover / polish |

**Wear and tear 4:** Side panel - rear left side: Side panel - Scratch(es) - Cover / polish

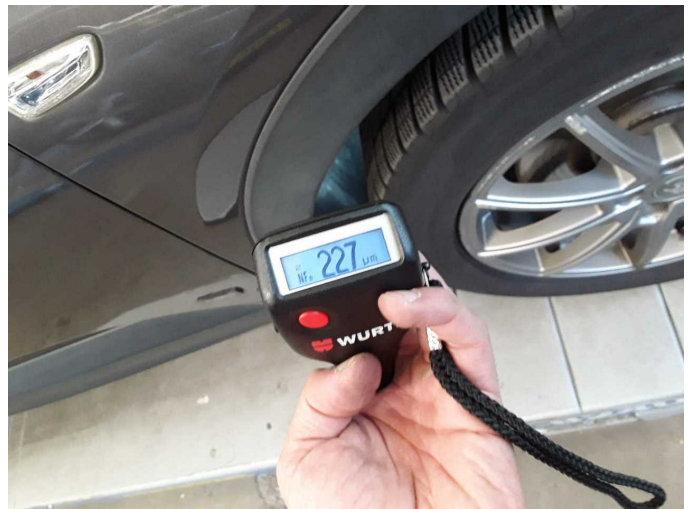
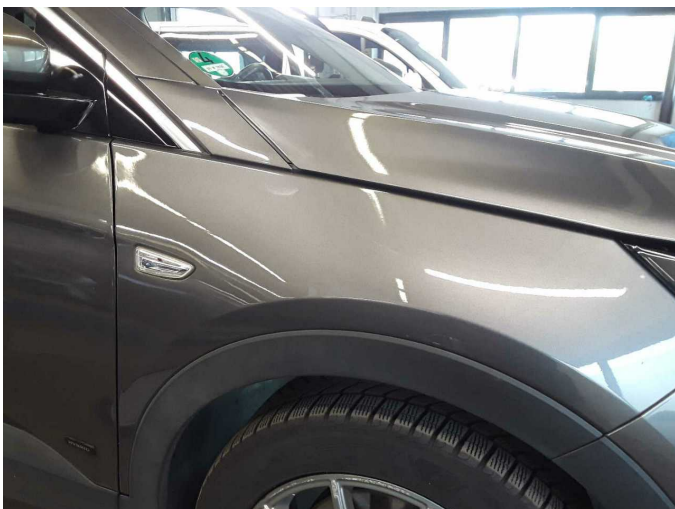
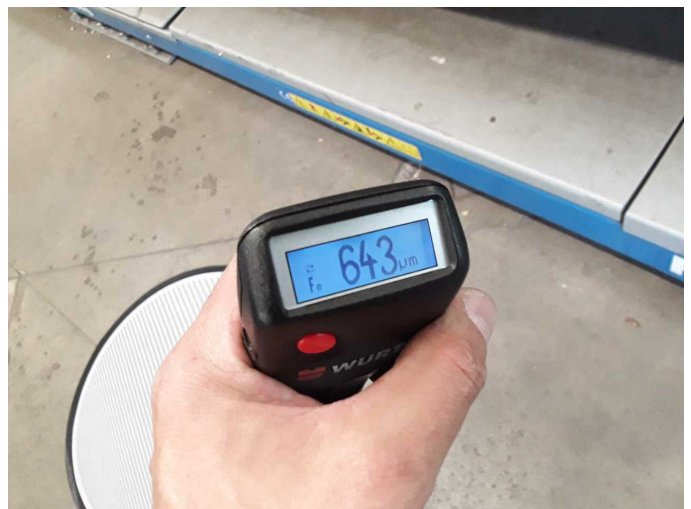
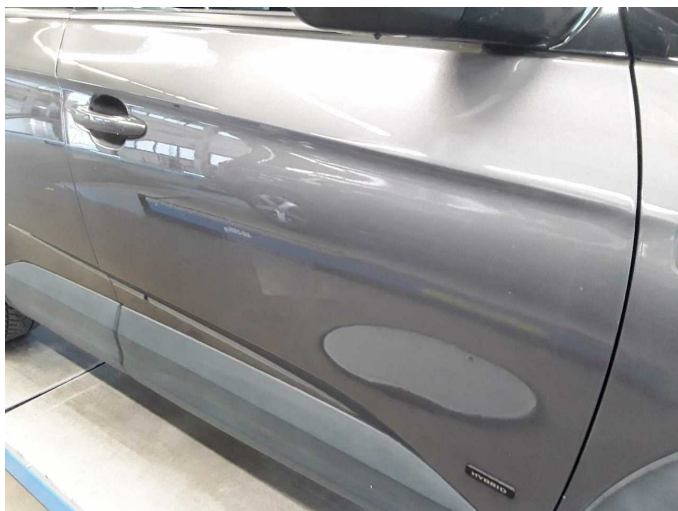
| No. | Repainting |
|---|---|
| 1 | Mudguard - right side, Door - front right side, Professionally carried out, Invoice of repair done Non-existent |

**Repainting 1:** Mudguard - right side, Door - front right side
