Expertise

Protocol number: 46495903  
Order No. / Reference: 26028759  
Inspection date: 13 Jul 2026

Manufacturer: Mercedes-Benz

Model: Vito 116 CDI Lang HA PRO Kasten

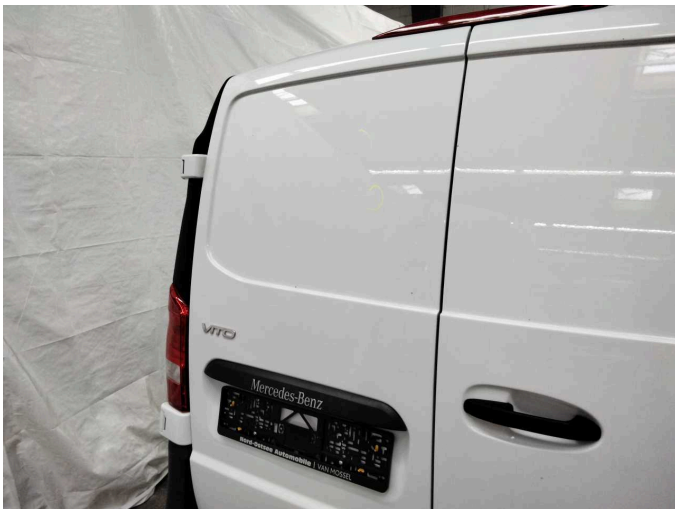
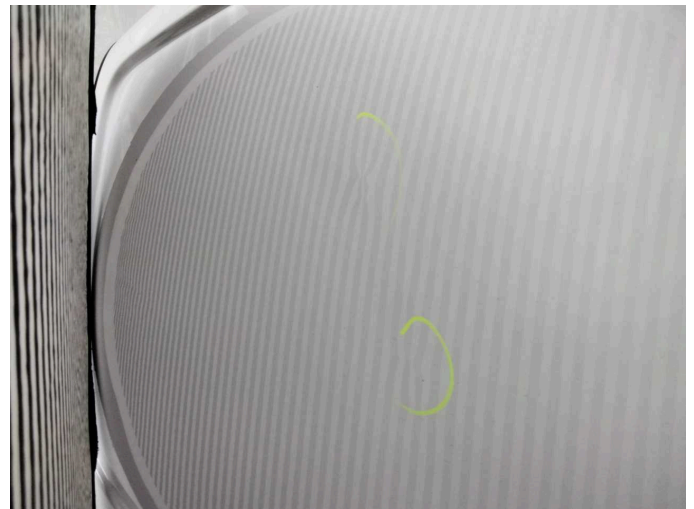
| No. | Component group | Description |
|---|---|---|
| 1 | Boot lid / rear door | Rear door - left side - dent(s) - Smooth repair work |

Damage 1: Boot lid / rear door: Rear door - left side - dent(s) - Smooth repair work

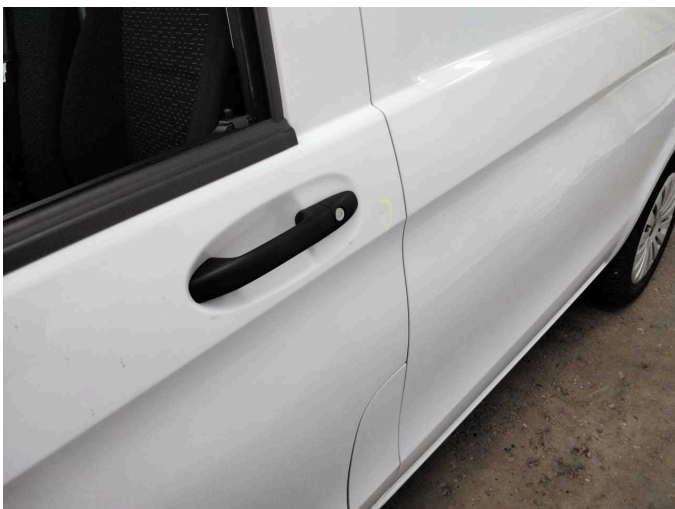
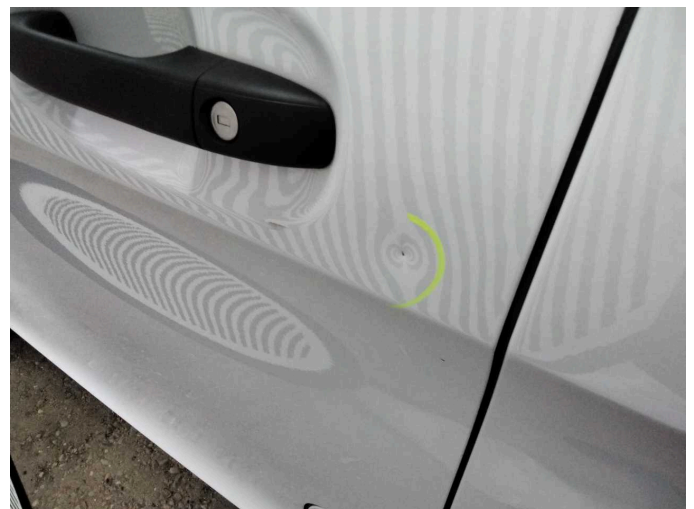
| No. | Component group | Description |
|---|---|---|
| 2 | Door - front left side | Door - Dent / paintcoat damage - Smart repair |

Damage 2: Door - front left side: Door - Dent / paintcoat damage - Smart repair

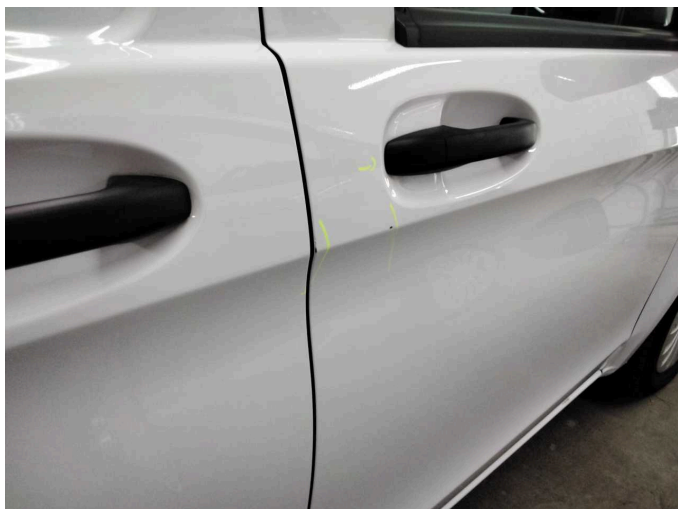
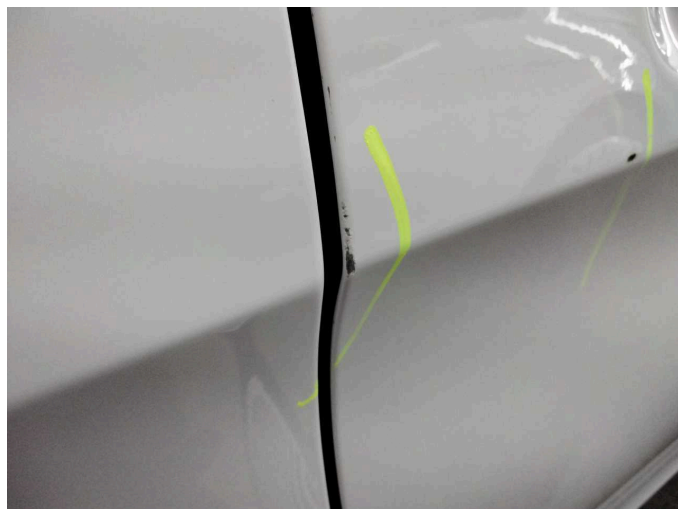
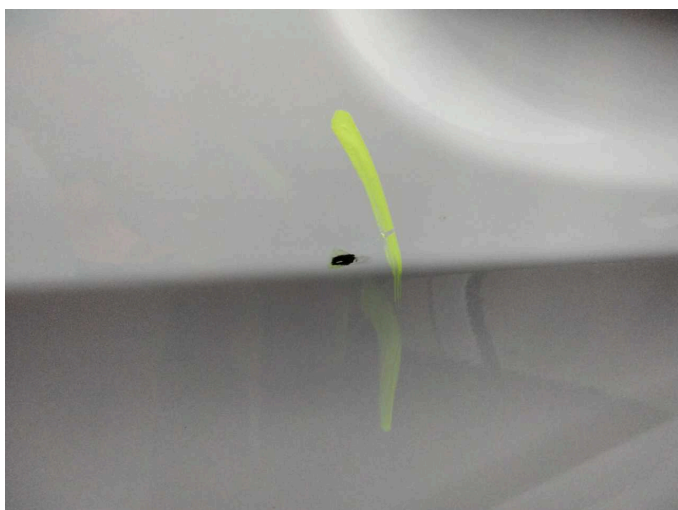
| No. | Component group | Description |
|---|---|---|
| 3 | Door - front right side | Door - Scratch(es) - Smart repair |

**Damage 3:** Door - front right side: Door - Scratch(es) - Smart repair

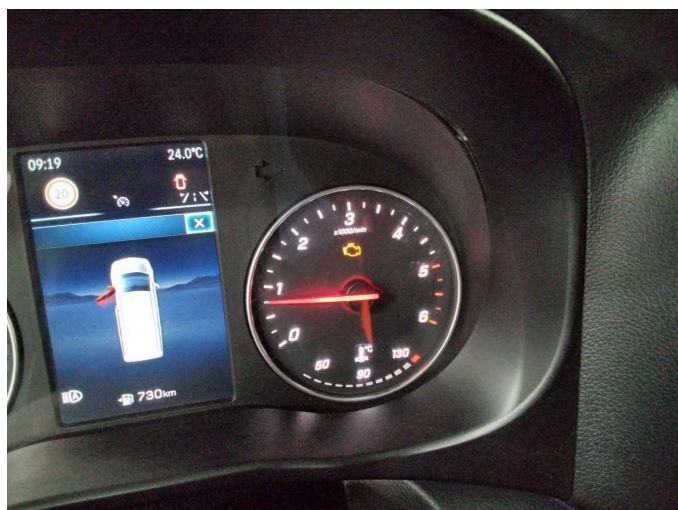
| No. | Component group | Description |
|---|---|---|
| 4 | Instrument panel | Indicator light (Mkl) - on - Perform diagnosis |

**Damage 4:** Instrument panel: Indicator light (Mkl) - on - Perform diagnosis

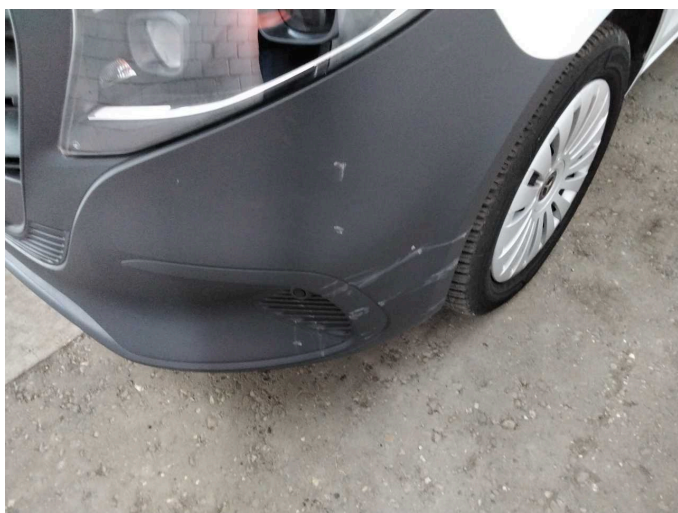
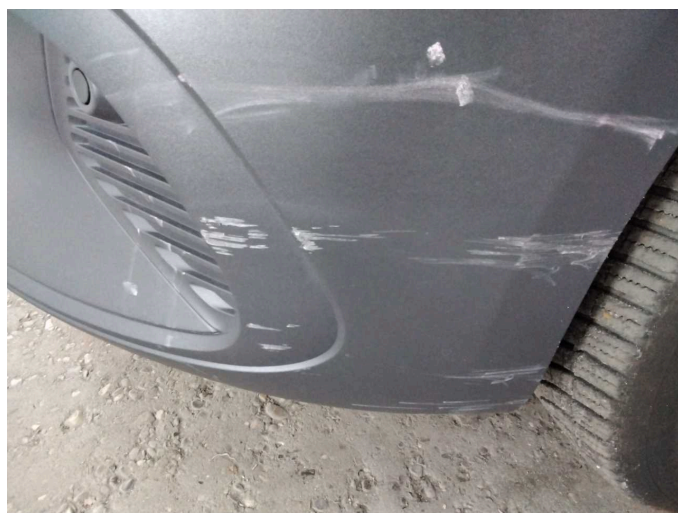
| No. | Component group | Description |
|---|---|---|
| 5 | Front bumper | Front bumper - Scratch(es) - Replace |

**Damage 5:** Front bumper: Front bumper - Scratch(es) - Replace
