## Expertise

Protocol number: 46363338  
Order No. / Reference: 26649518  
Inspection date: 7 Jul 2026

Manufacturer: Mercedes-Benz

Model: Vito 114 CDI Kompakt HA Aut. BASE

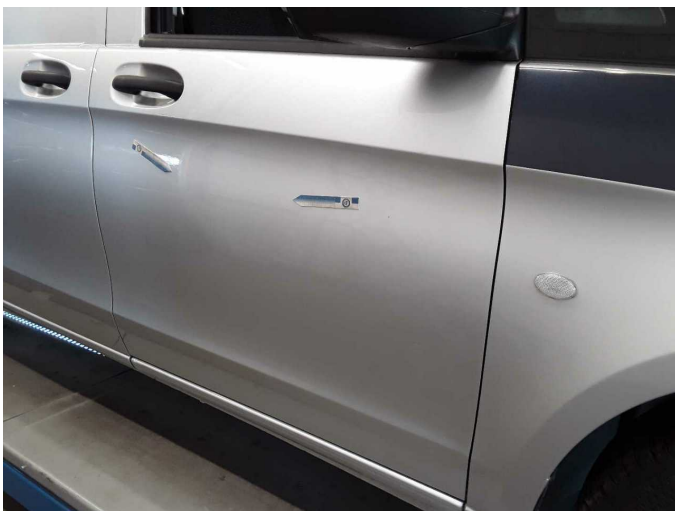
**Damage 1:** Door - front right side: Door (Lack Matt, Mehrkosten möglich)  
- Unprofessionally repaired - Conditioning

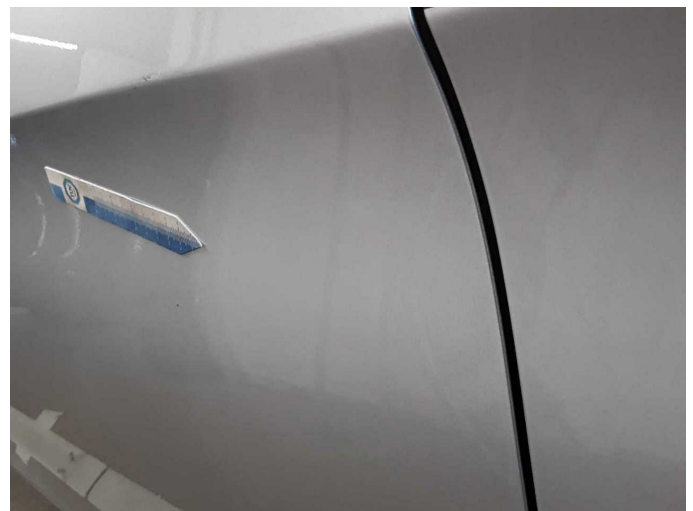
**Damage 1:** Door - front right side: Door (Lack Matt, Mehrkosten möglich)  
- Unprofessionally repaired - Conditioning

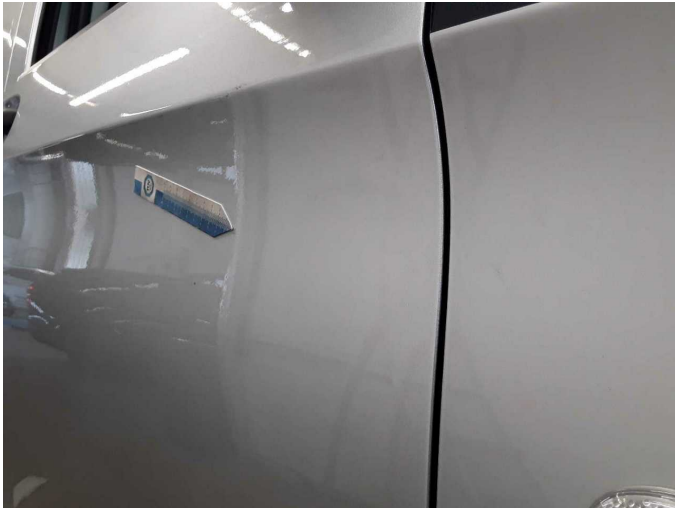
**Damage 1:** Door - front right side: Door (Lack Matt, Mehrkosten möglich) - Unprofessionally repaired - Conditioning

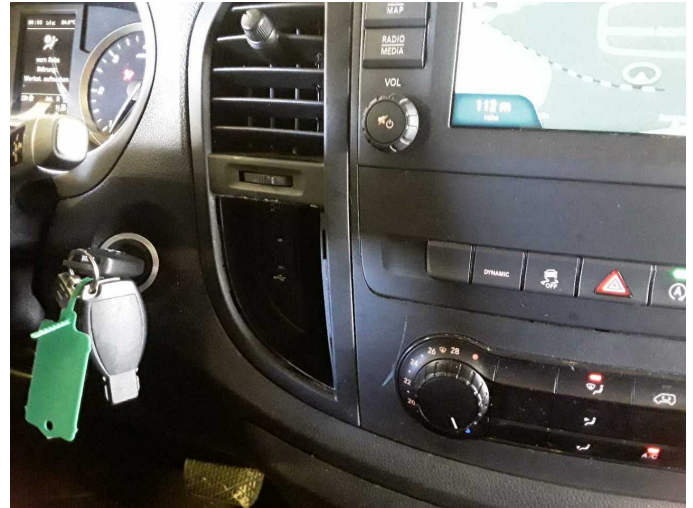
**Damage 2:** Instrument panel: Stowage compartment - Broken / torn - Replace

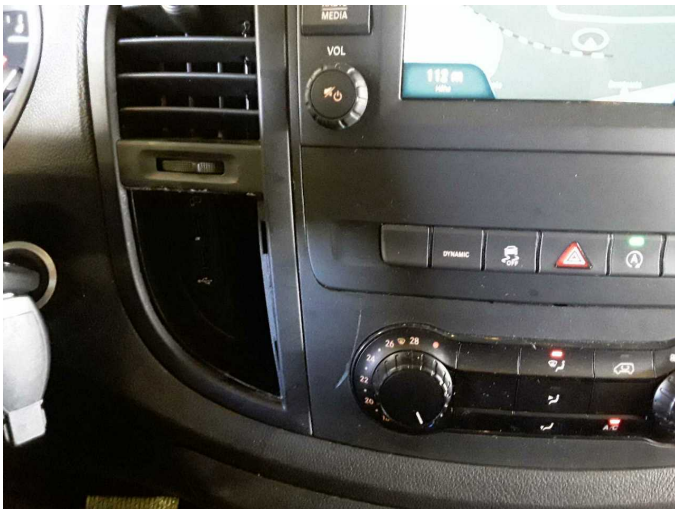
**Damage 2:** Instrument panel: Stowage compartment - Broken / torn - Replace

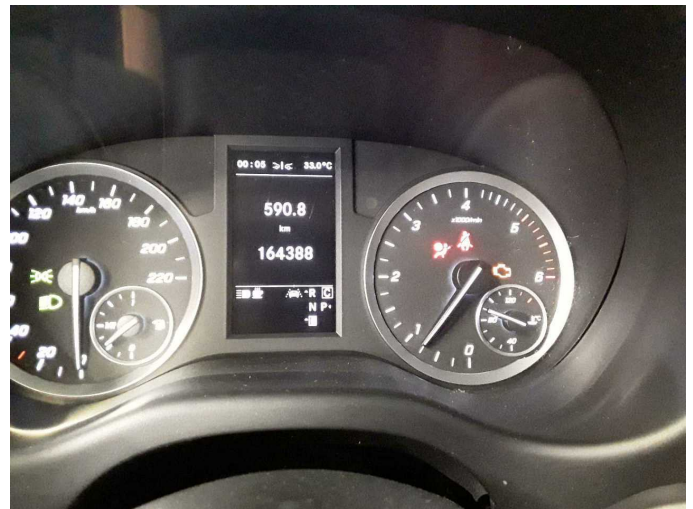
**Damage 3:** Airbag systems: Airbag - front left side (und Motorkontrolle leuchtet, nicht fahrbereit) - Functional / admissibility - Perform diagnosis

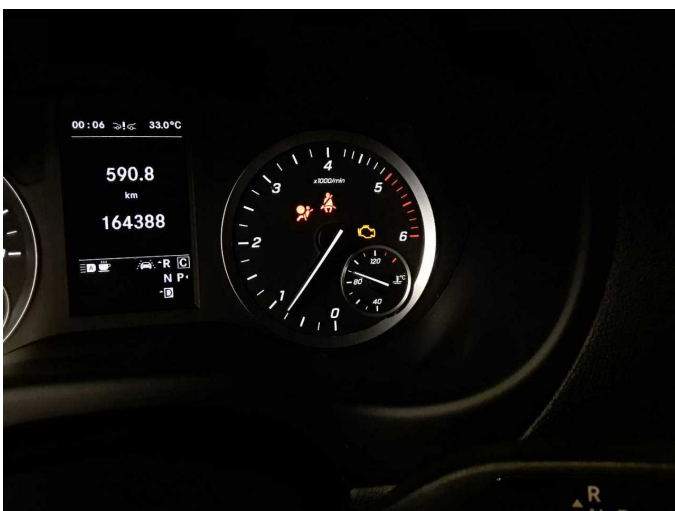
**Damage 3:** Airbag systems: Airbag - front left side (und Motorkontrolle leuchtet, nicht fahrbereit) - Functional / admissibility - Perform diagnosis

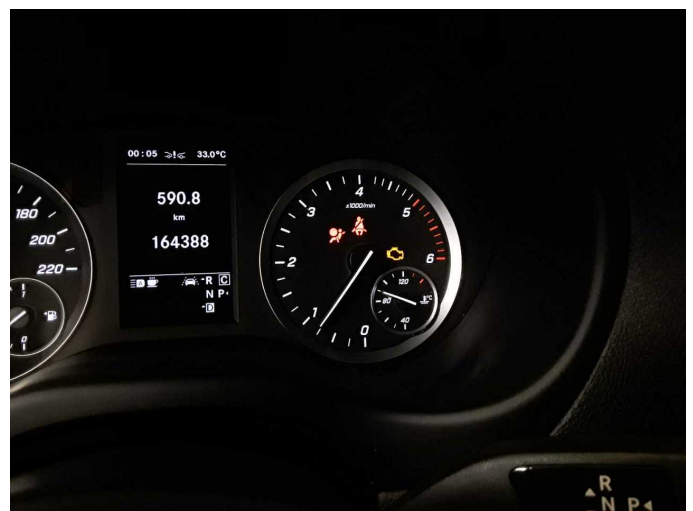
**Damage 3:** Airbag systems: Airbag - front left side (und Motorkontrolle leuchtet, nicht fahrbereit) - Functional / admissibility - Perform diagnosis

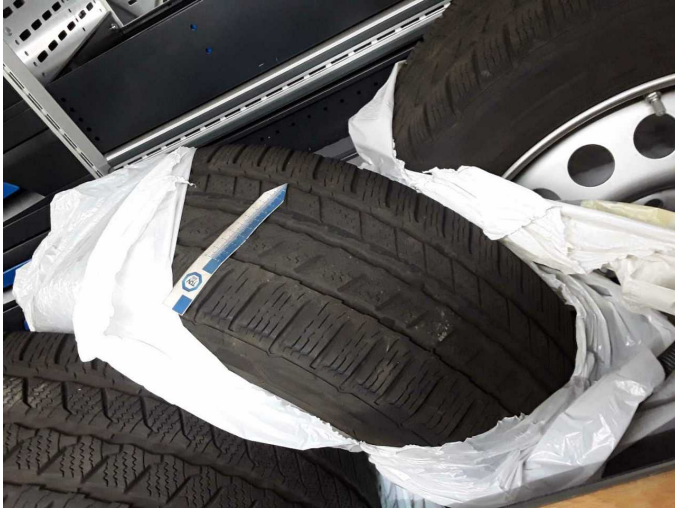
**Damage 4:** 2nd wheel set: 2 tyres - Does not meet the leasing specifications - Replace

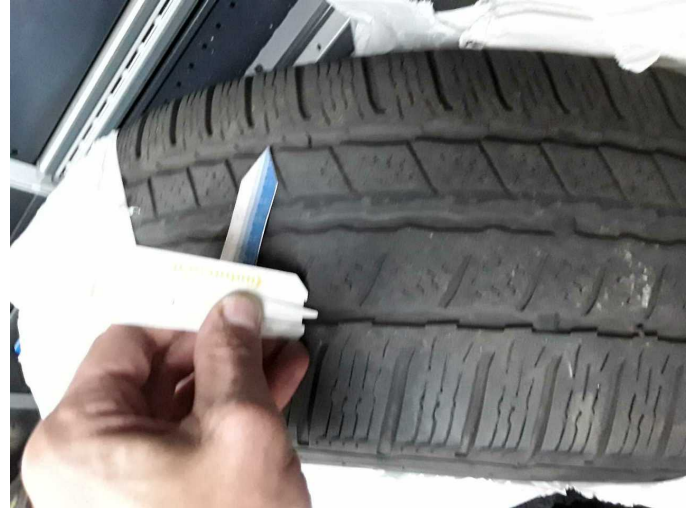
**Damage 4:** 2nd wheel set: 2 tyres - Does not meet the leasing specifications - Replace

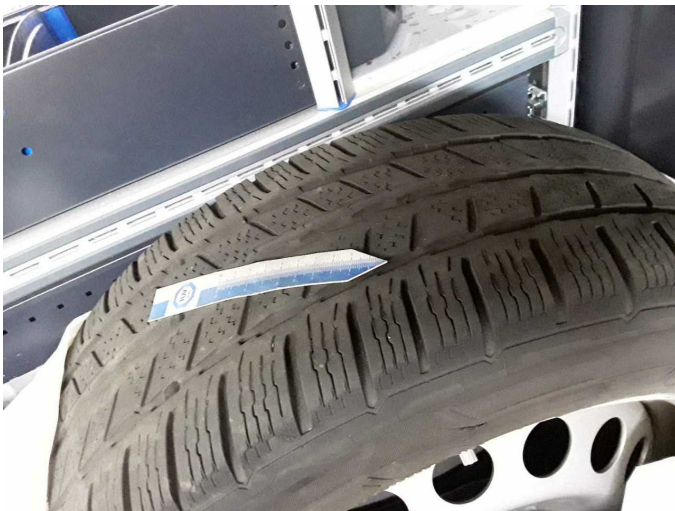
**Damage 4:** 2nd wheel set: 2 tyres - Does not meet the leasing specifications - Replace

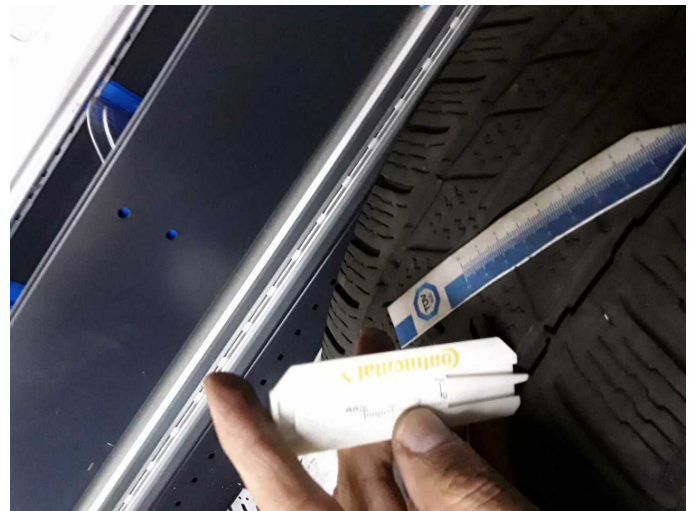
**Damage 4:** 2nd wheel set: 2 tyres - Does not meet the leasing specifications - Replace

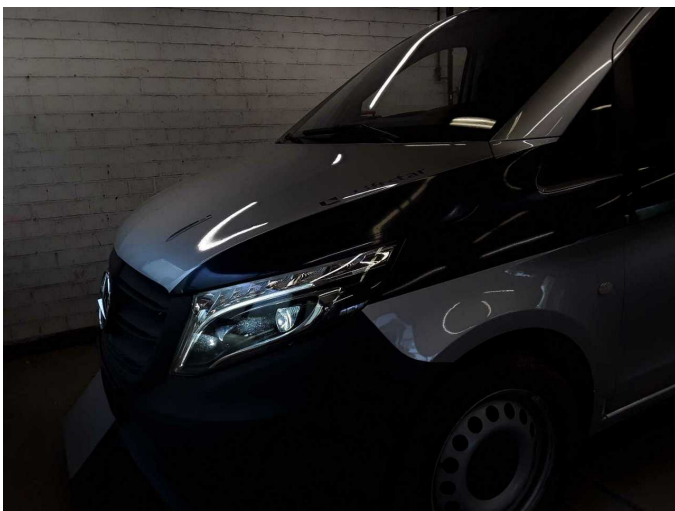
**Damage 5:** Body: Body - Glued / labelled - De-glue / neutralise

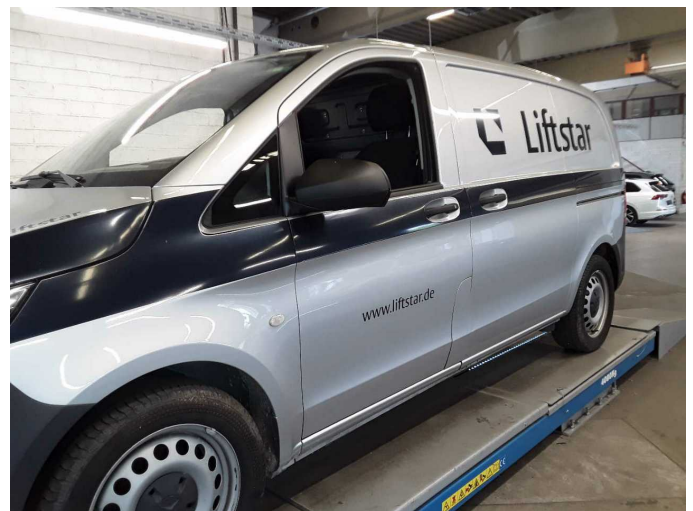
**Damage 5:** Body: Body - Glued / labelled - De-glue / neutralise

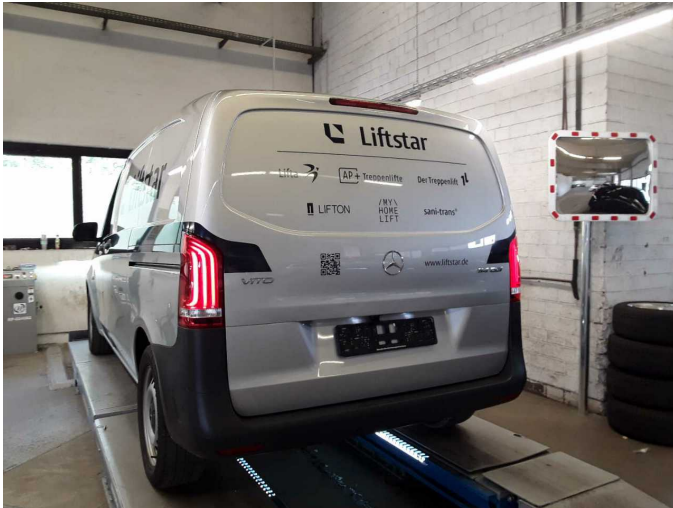
**Damage 5:** Body: Body - Glued / labelled - De-glude / neutralise

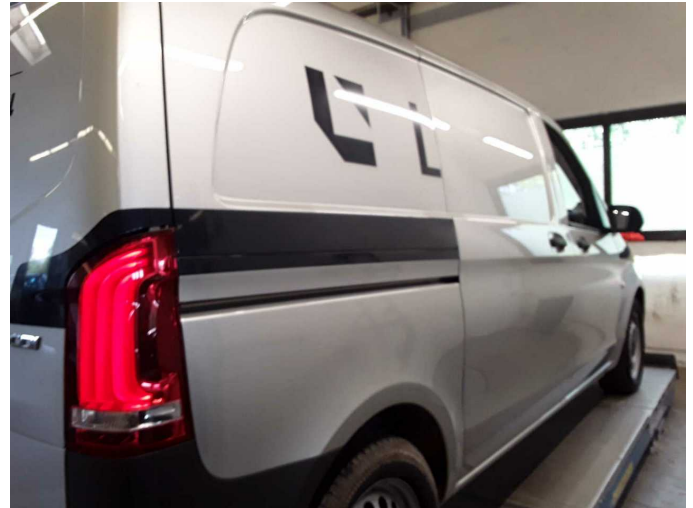
**Damage 5:** Body: Body - Glued / labelled - De-glude / neutralise

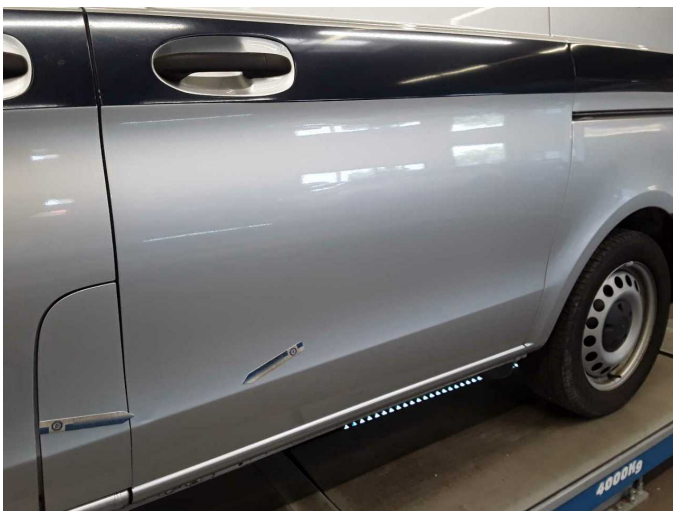
**Damage 6:** Sliding door - left side: Sliding door - Dent / paintcoat damage - Repair and paint

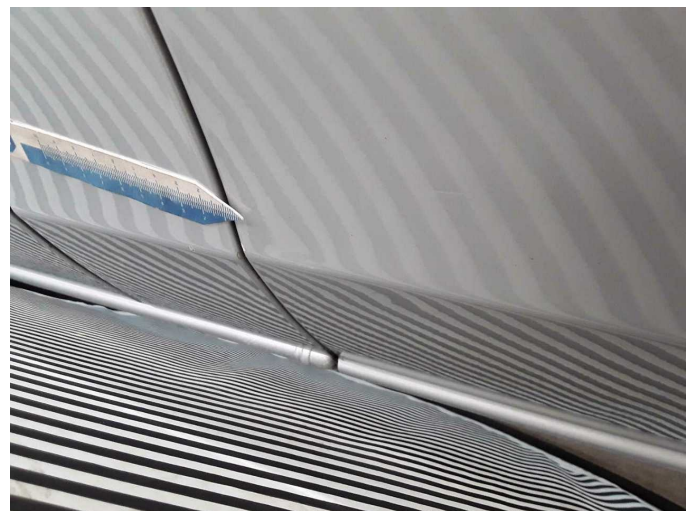
**Damage 6:** Sliding door - left side: Sliding door - Dent / paintcoat damage - Repair and paint

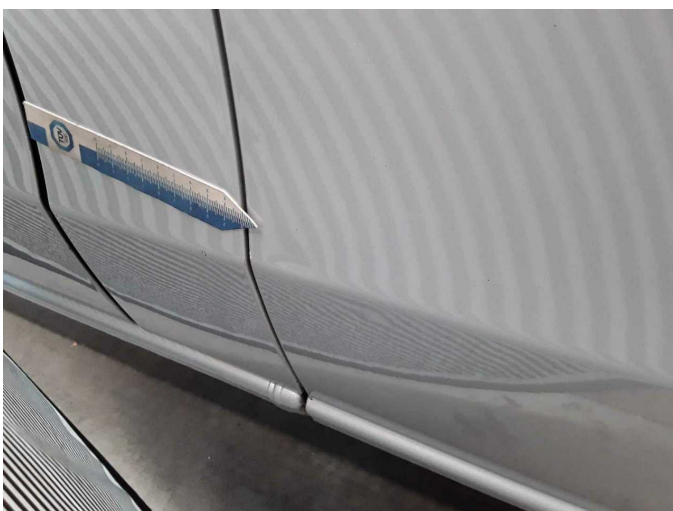
**Damage 6:** Sliding door - left side: Sliding door - Dent / paintcoat damage - Repair and paint

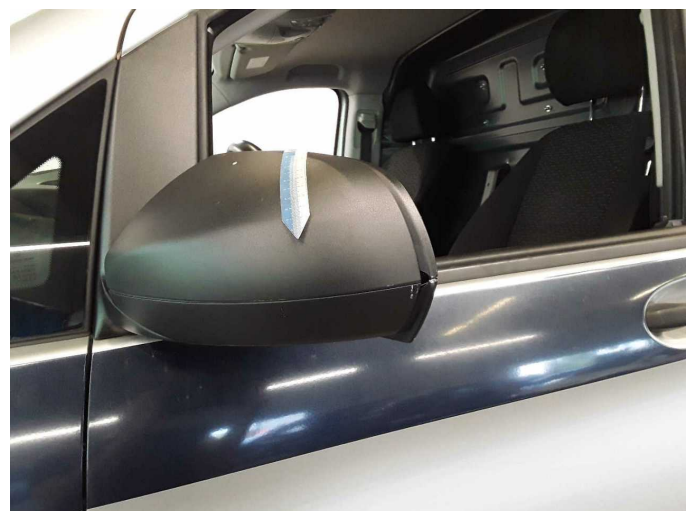
**Damage 7:** Wing mirror - left side: Mirror housing - Broken / torn - Replace

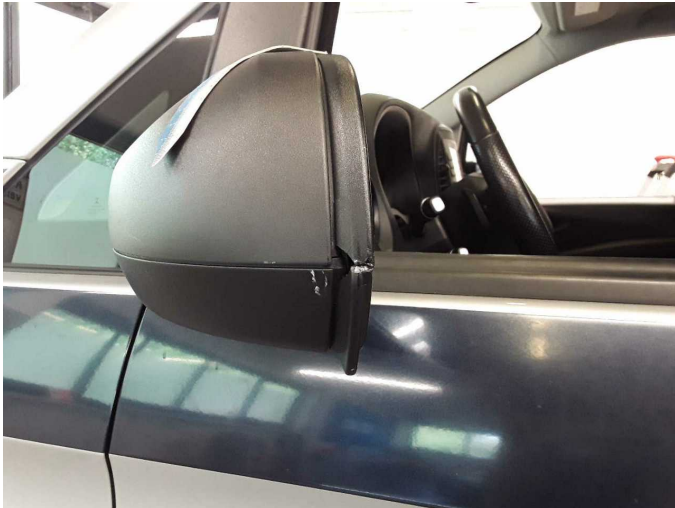
**Damage 7:** Wing mirror - left side: Mirror housing - Broken / torn - Replace

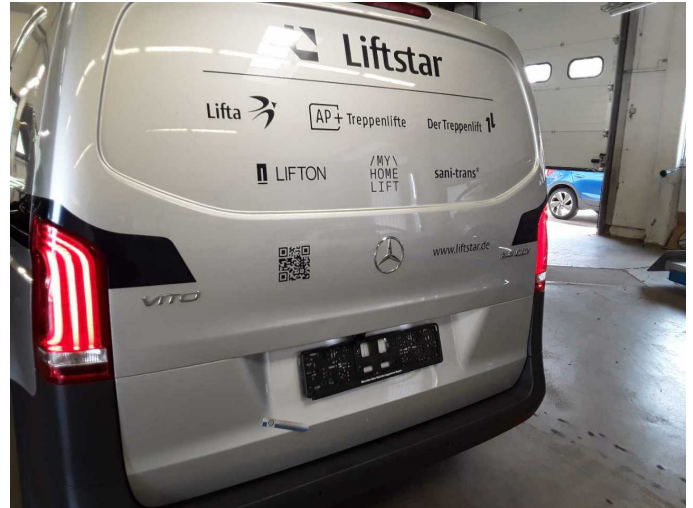
**Damage 8:** Boot lid / rear door: Boot lid - Scratch(es) - Paint

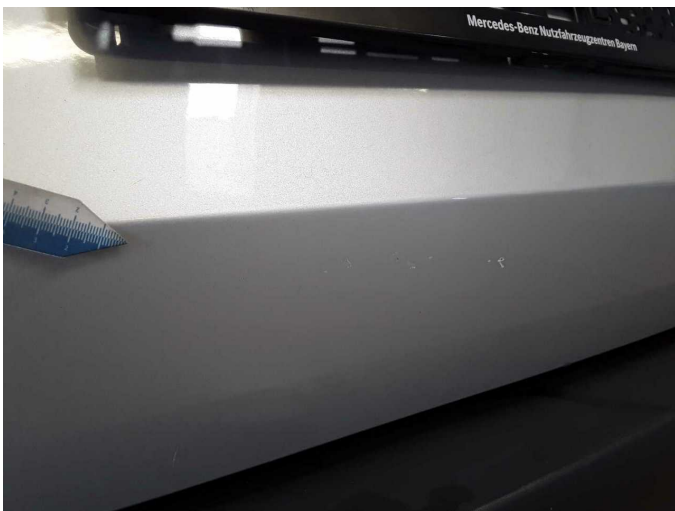
**Damage 8:** Boot lid / rear door: Boot lid - Scratch(es) - Paint

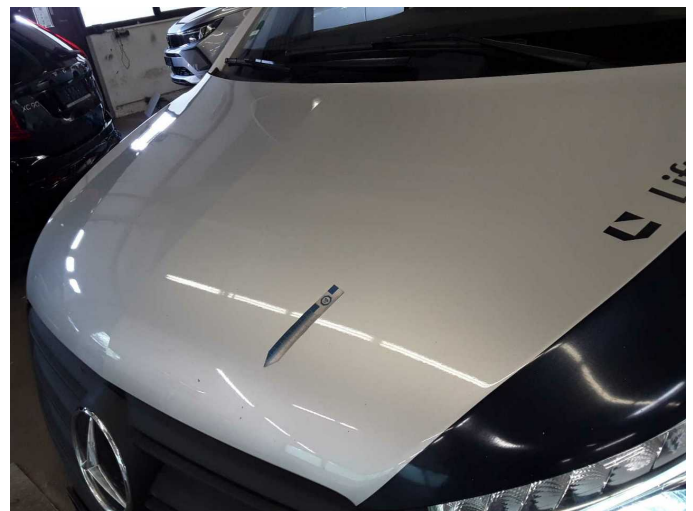
**Damage 9:** Bonnet: Bonnet - Dent / paintcoat damage - Repair and paint

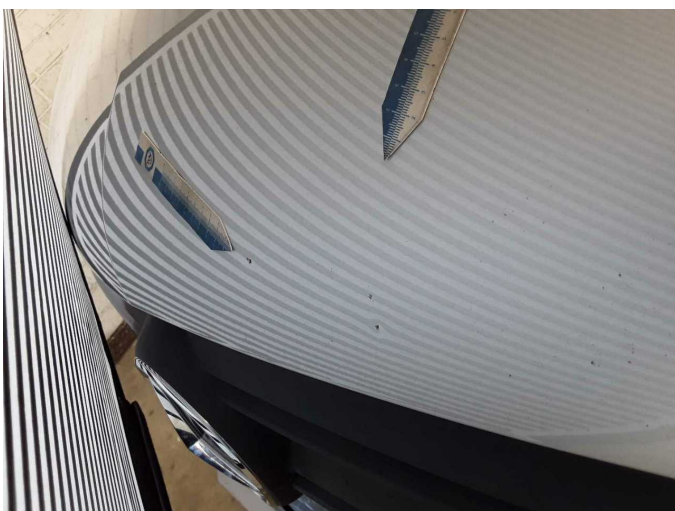
**Damage 9:** Bonnet: Bonnet - Dent / paintcoat damage - Repair and paint

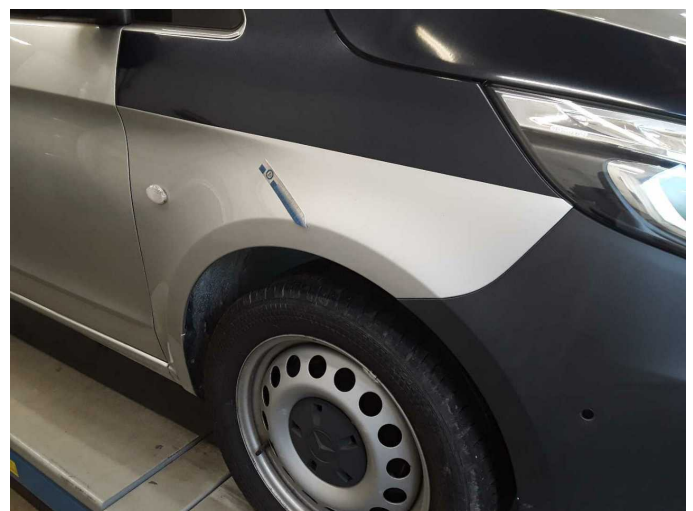
**Wear and tear 1:** Mudguard - right side: Mudguard - right side - Scratch(es) - No deduction

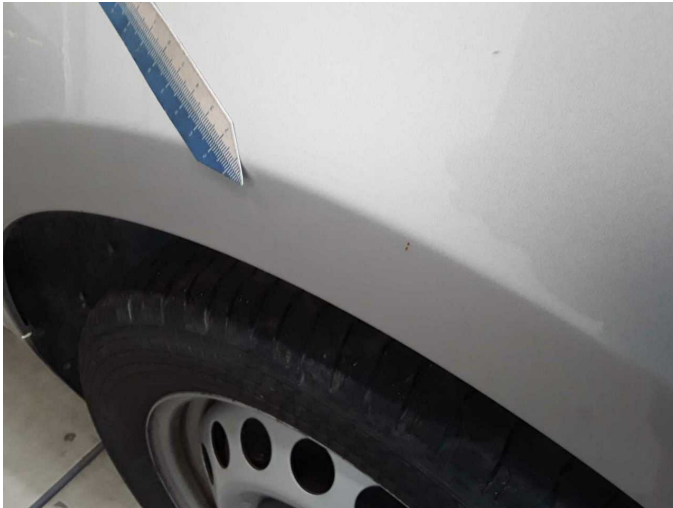
**Wear and tear 1:** Mudguard - right side: Mudguard - right side - Scratch(es) - No deduction

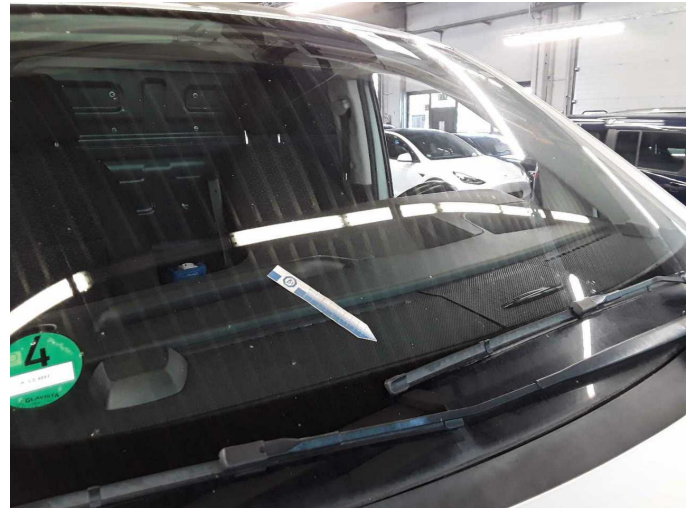
**Wear and tear 5:** Vehicle glazing: Windscreen (Rissbildung) - Stone chips - No deduction

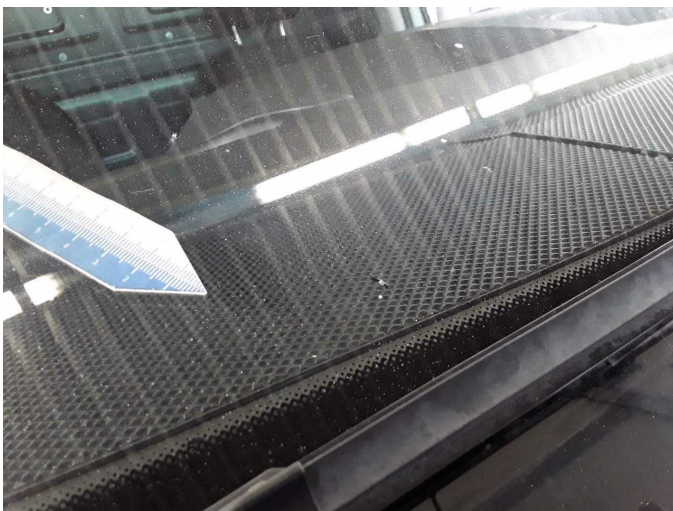
**Wear and tear 5:** Vehicle glazing: Windscreen (Rissbildung) - Stone chips - No deduction

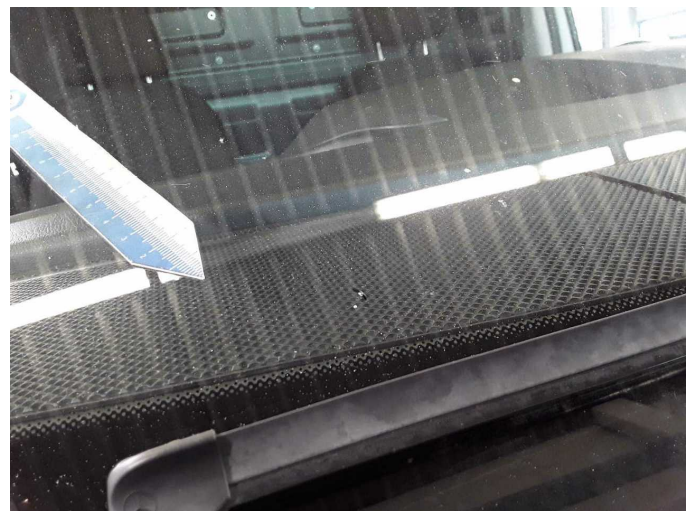
**Wear and tear 5:** Vehicle glazing: Windscreen (Rissbildung) - Stone chips - No deduction

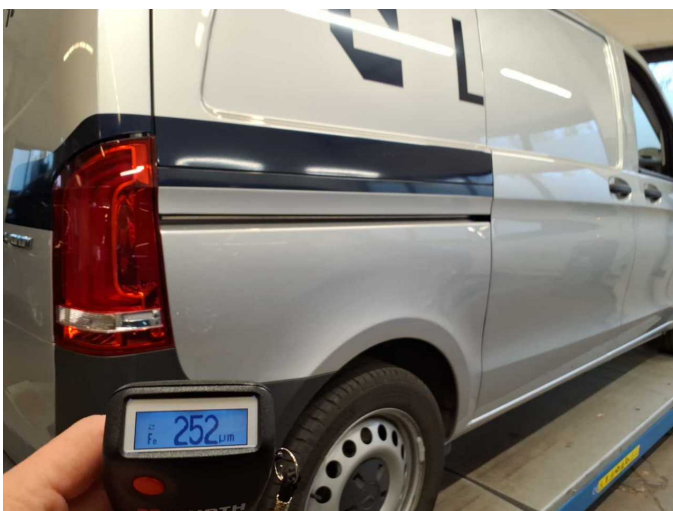
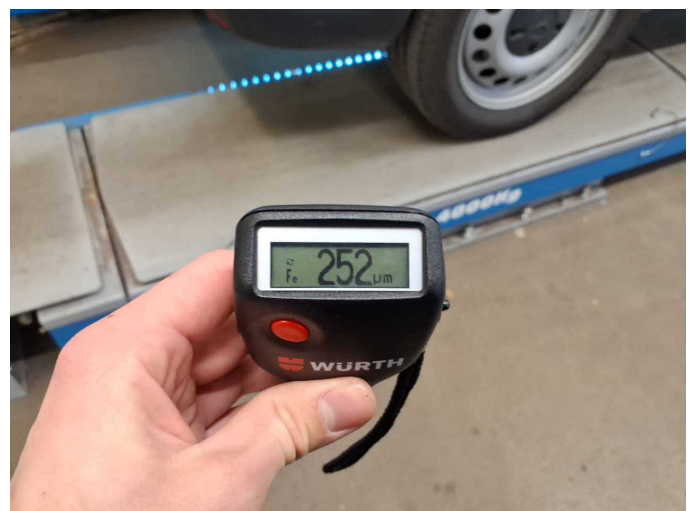
**Repainting 1:** Side panel - rear right side

No.	Repainting
1	Side panel - rear right side, Professionally carried out, Invoice of repair done Non-existent
2	Door - rear right side, Professionally carried out, Invoice of repair done Non-existent
3	Door - front right side, Unprofessionally carried out, Invoice of repair done Non-existent

Side panel - rear right side	252 µm	Door - rear right side	252 µm
Door - front right side	192 µm
