Expertise

Protocol number: 46442996  
Order No. / Reference: 26566824  
Inspection date: 10 Jul 2026

| Manufacturer: Seat | Model: Cupra Born 170kW/77kWh |
| VIN: VSSZZK10RP029475 | |

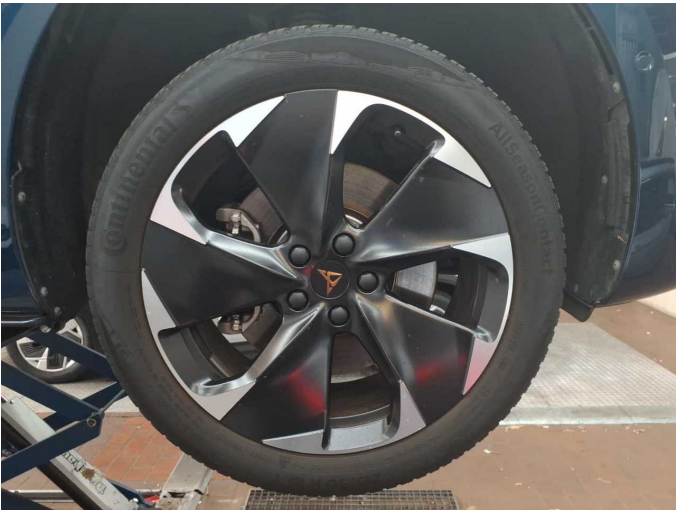
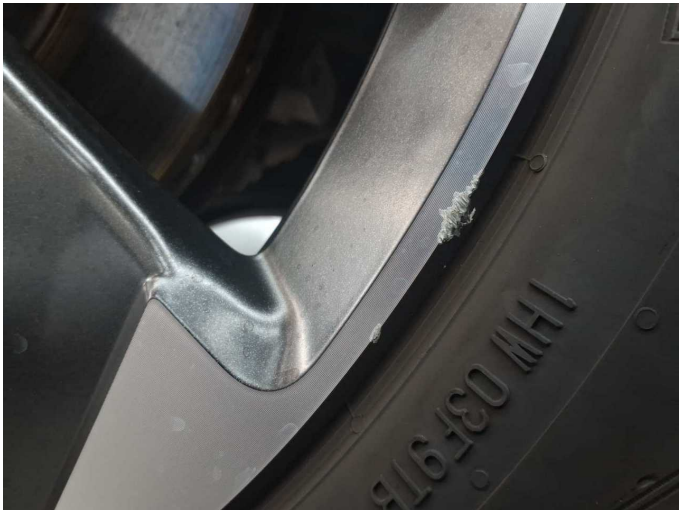
| No. | Component group | Description |
|---|---|---|
| 1 | Wheel / tyres | Alloy rim - front right side - Scratched - Loss in value |

Damage 1: Wheel / tyres: Alloy rim - front right side - Scratched - Loss in value

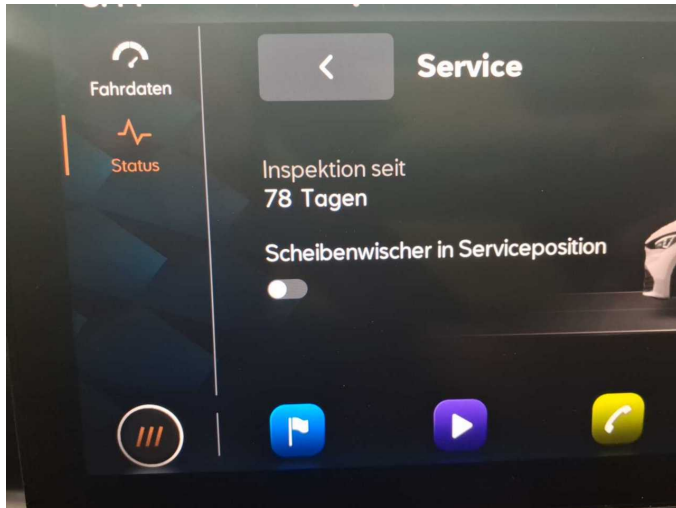
| <b>Maintenance booklet / proof</b> | digital evidence / incomplete | <b>Next maintenance in</b> | -78 Tag(e) |

| No. | Component group | Description |
|---|---|---|
| 2 | Misc. | Inspection / maintenance - Expired - Replace |

**Damage 2:** Misc.: Inspection / maintenance - Expired - Replace

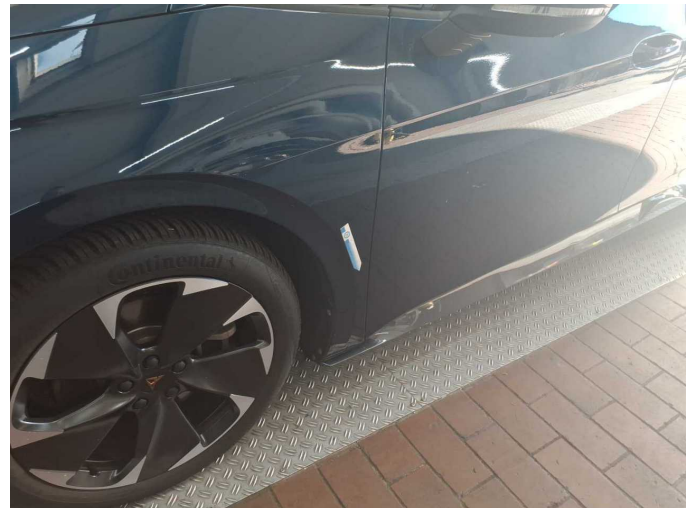
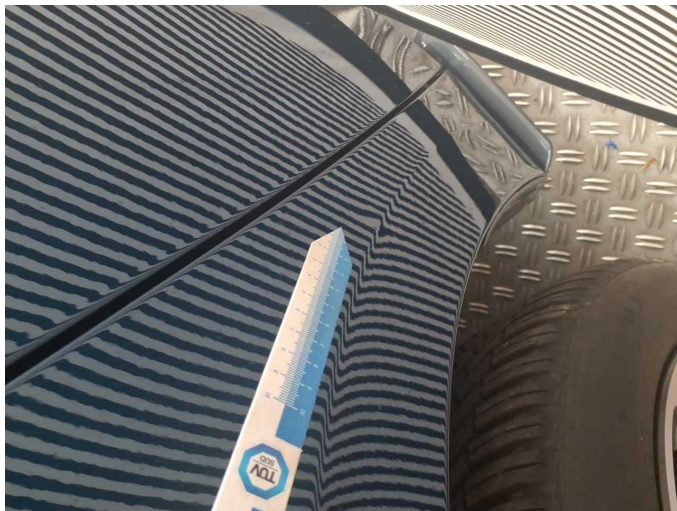
| No. | Component group | Description |
|---|---|---|
| 3 | Mudguard - left side | Mudguard - left side (Kante) - dent(s) - Paint |

**Damage 3:** Mudguard - left side: Mudguard - left side (Kante) - dent(s) - Paint
