Expertise

Protocol number: 46031059
Order No. / Reference: 26505269
Inspection date: 17 Jun 2026

Model: Tiguan 2.0 TDI SCR DSG Life

VIN: WVGZZZ5NZNW033418

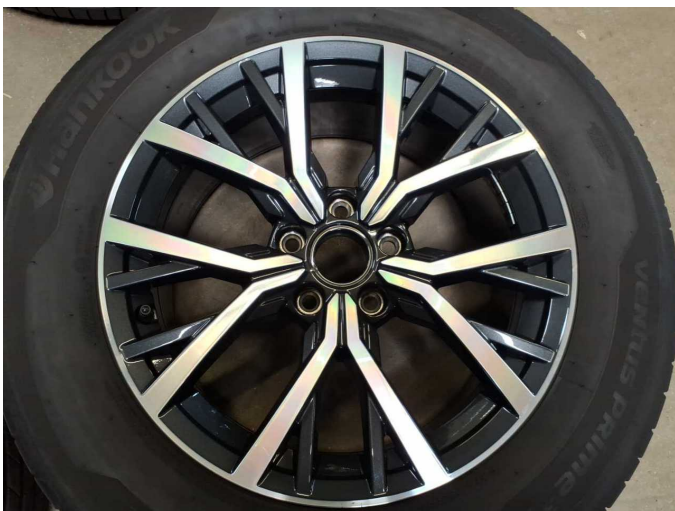
Damage 2: Wheel / tyres: Hubcap - Missing - Replace

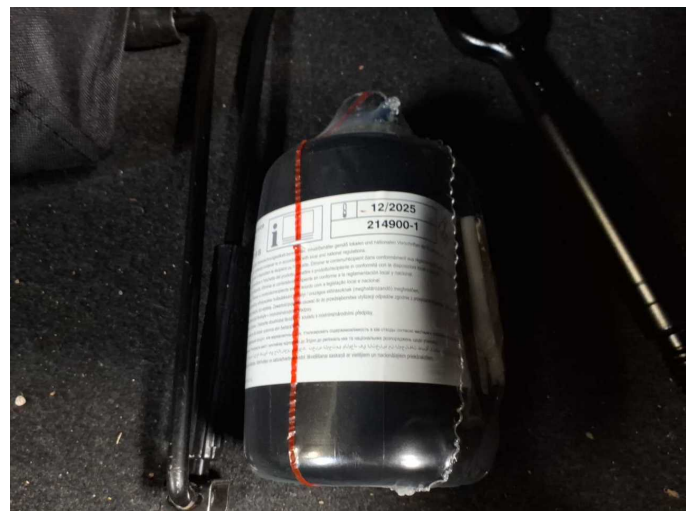
Damage 3: Equipment: Tirefit filler - Expired - Replace

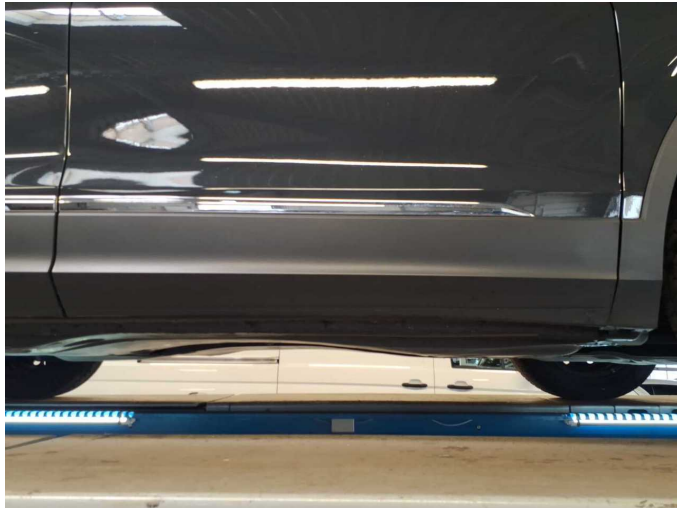
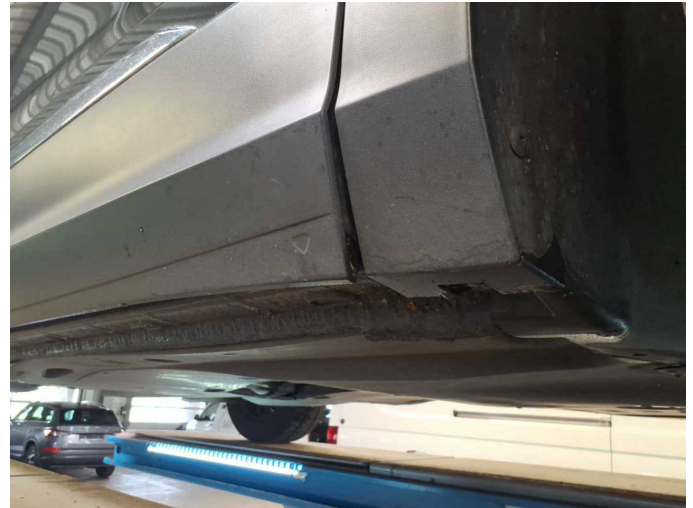
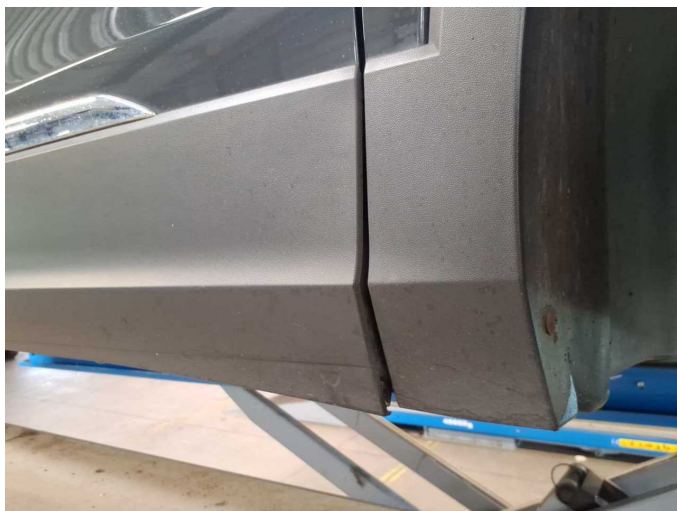
Damage 4: Door - front right side: Brightware - lower - Malposition - Un- / install

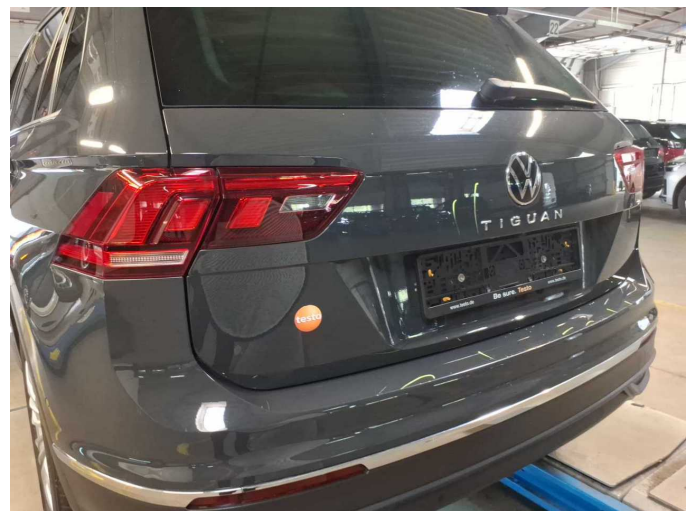
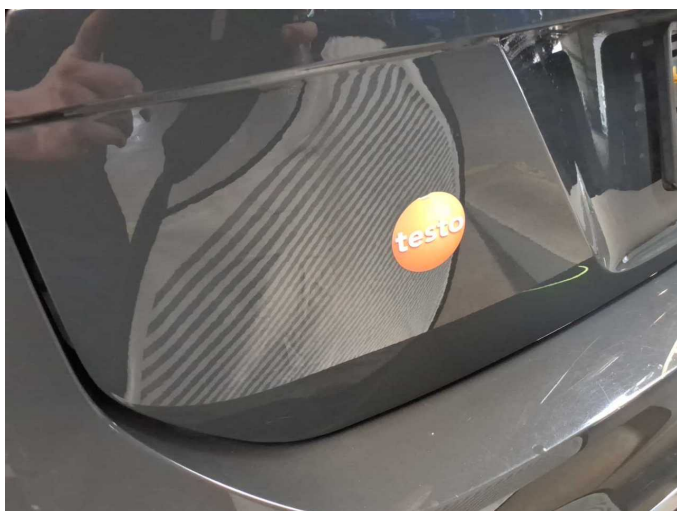
Damage 5: Boot lid / rear door: Boot lid - Glued / labelled - De-glue / neutralise

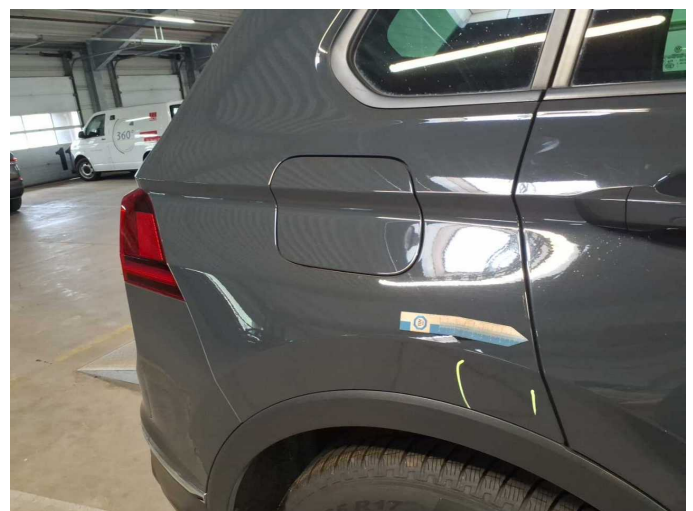
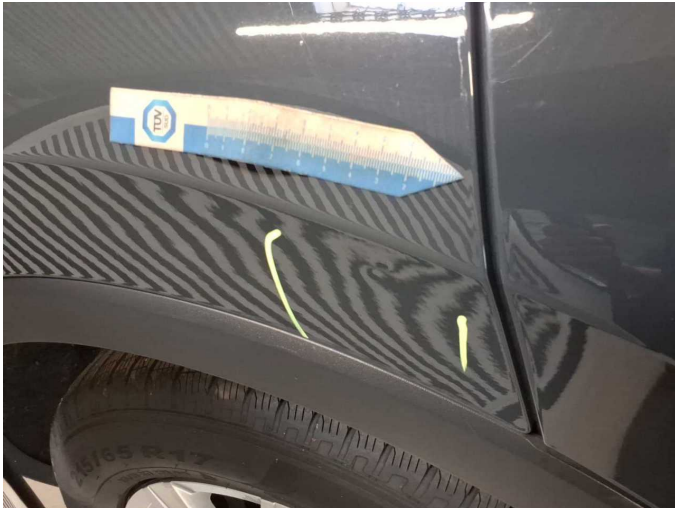
Damage 6: Side panel - rear right side: Side panel - dent(s) - Smooth repair work

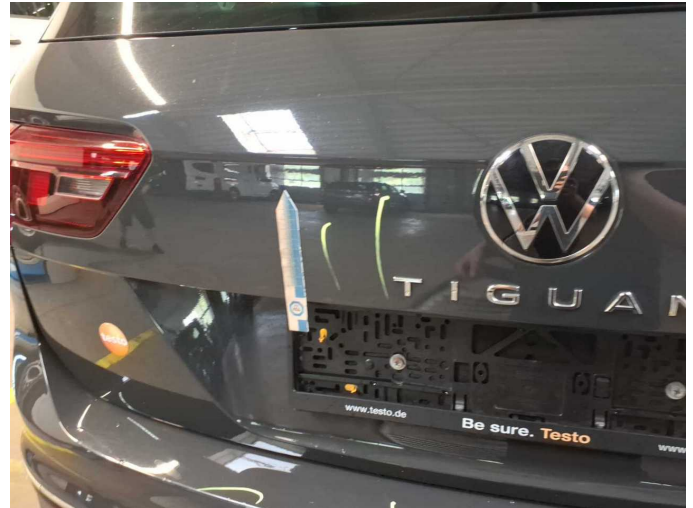
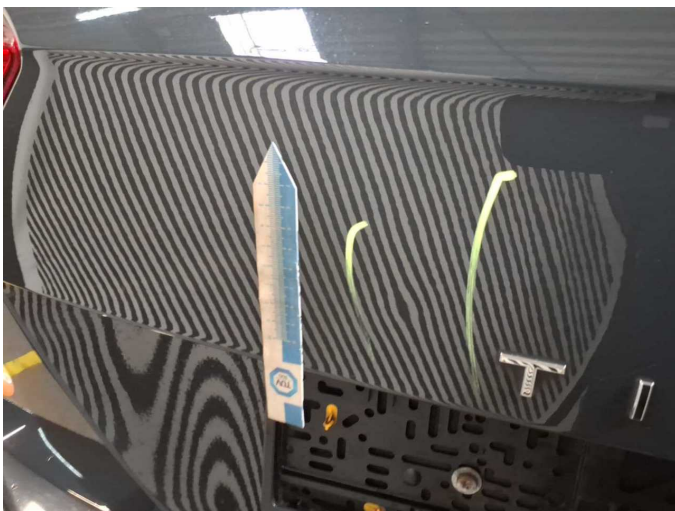
Damage 7: Boot lid / rear door: Boot lid - dent(s) - Smooth repair work

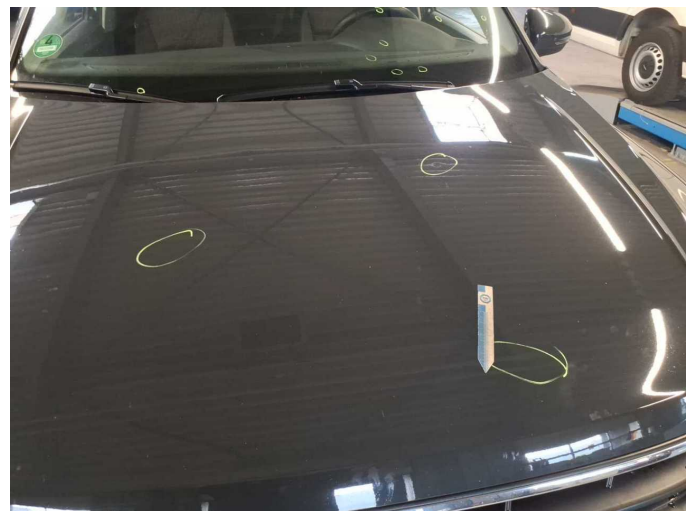
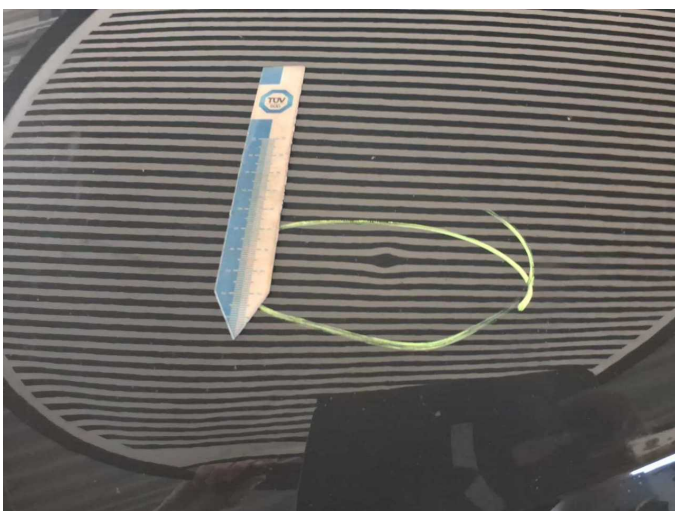
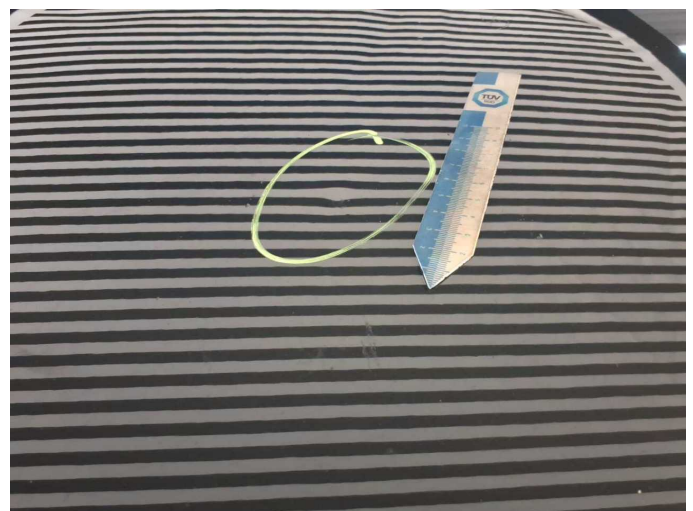
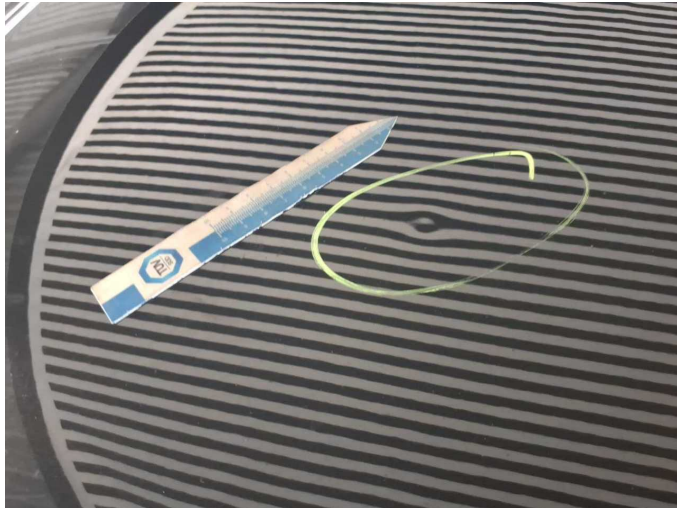
Damage 8: Bonnet: Bonnet - dent(s) - Smooth repair work

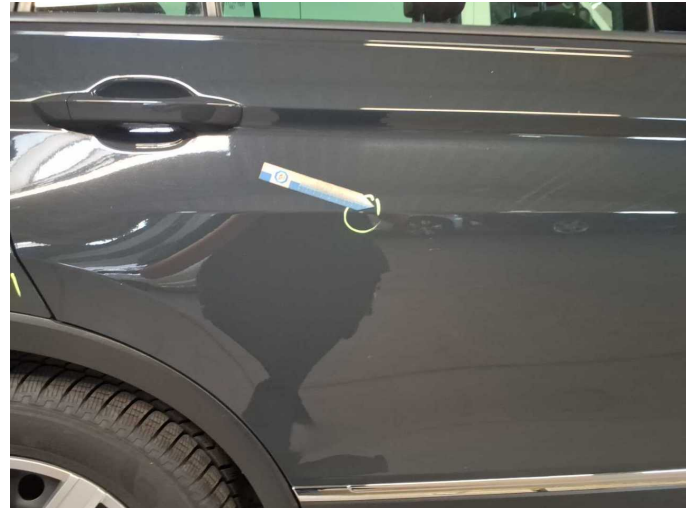
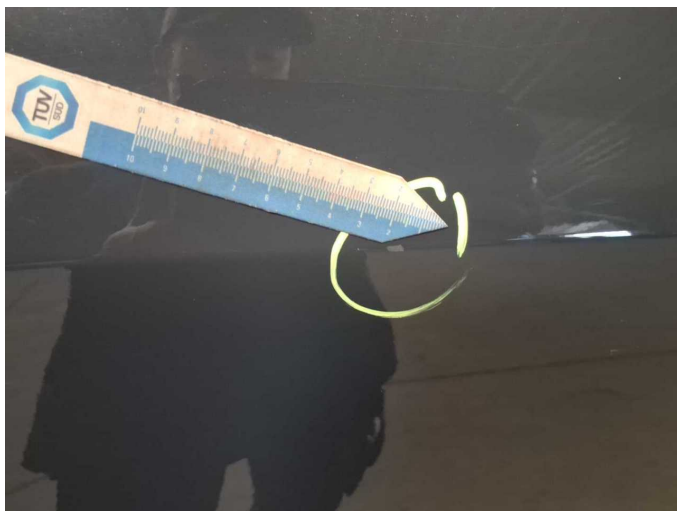
Damage 9: Door - rear right side: Door - Scratch(es) - Smart repair

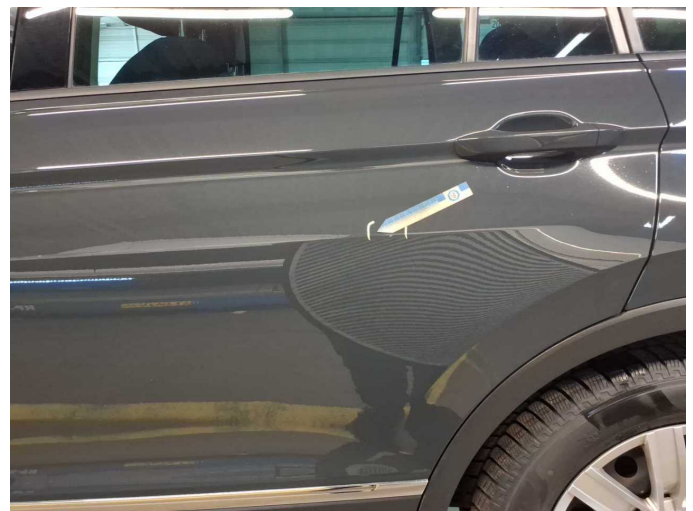
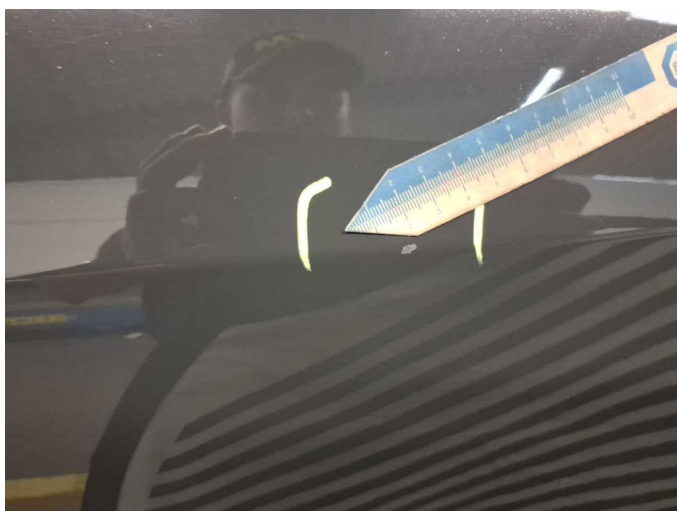
Damage 10: Door - rear left side: Door - Scratch(es) - Smart repair

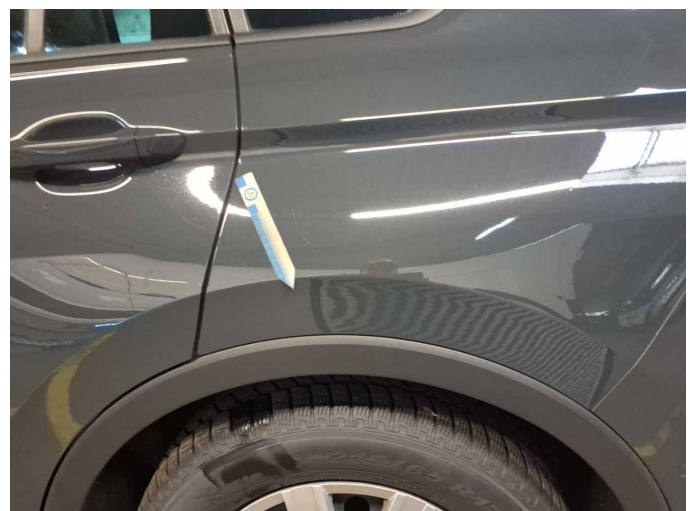
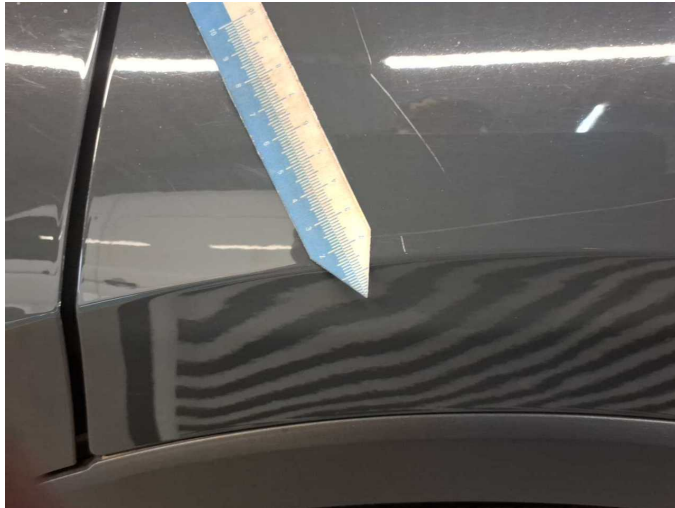
Damage 11: Side panel - rear left side: Side panel - Scratch(es) - Smart repair

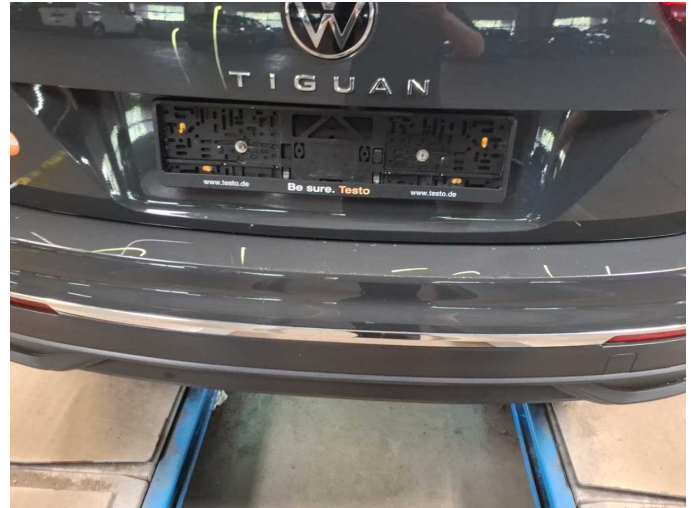
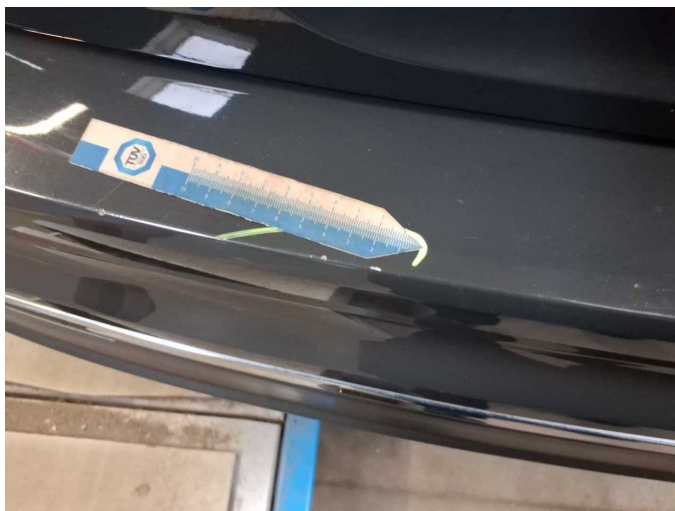
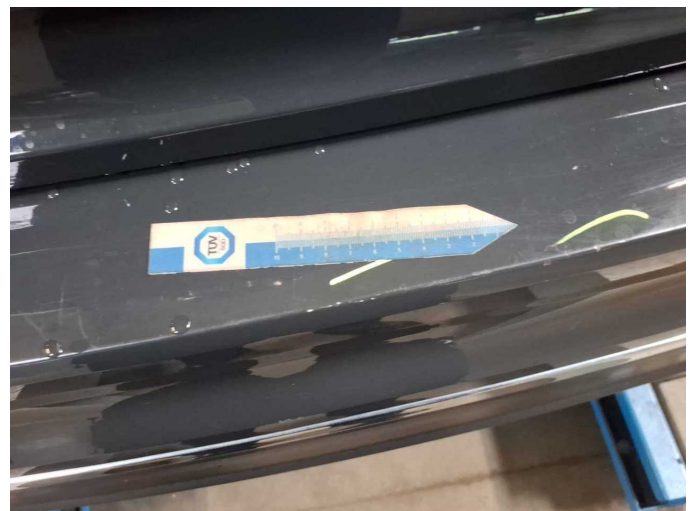
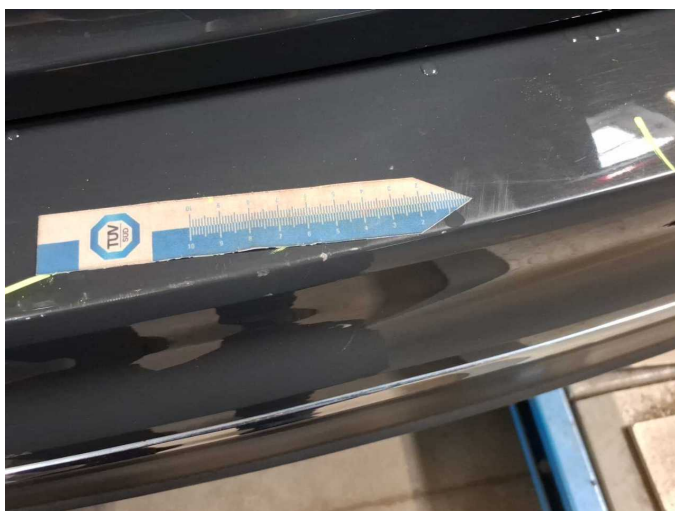
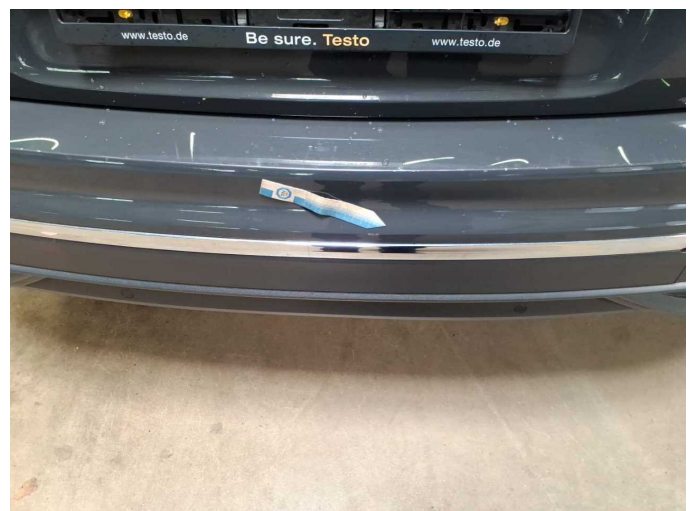
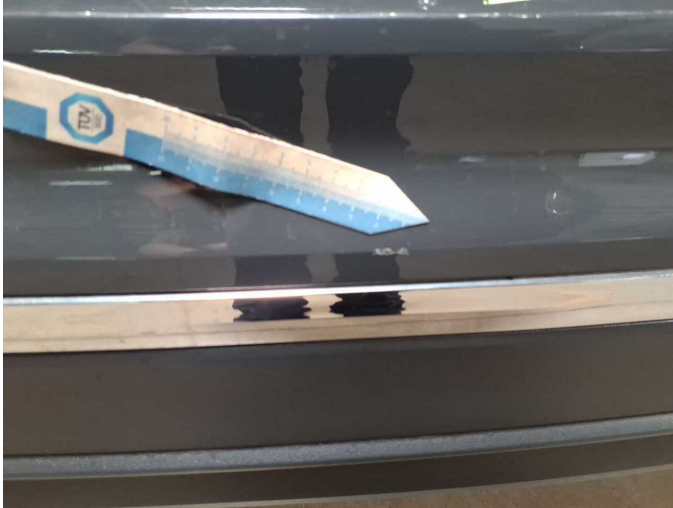
Damage 12: Rear bumper: Rear bumper - Scratch(es) - Paint

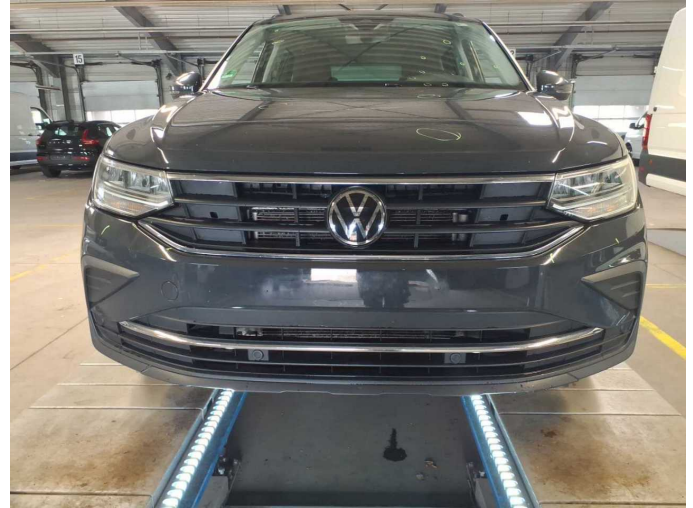
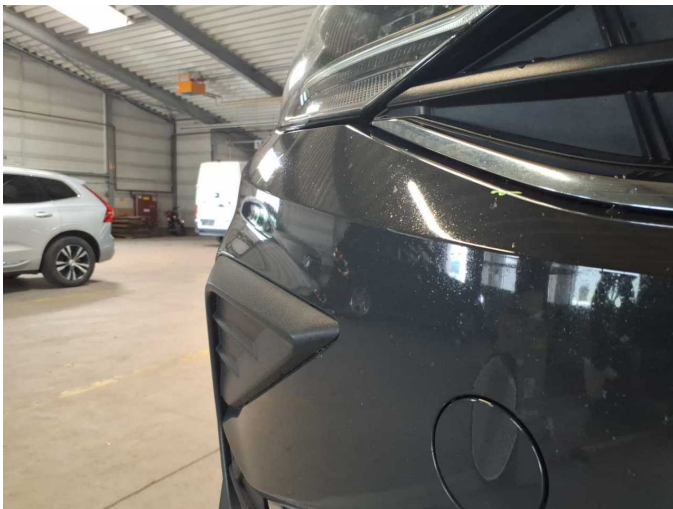
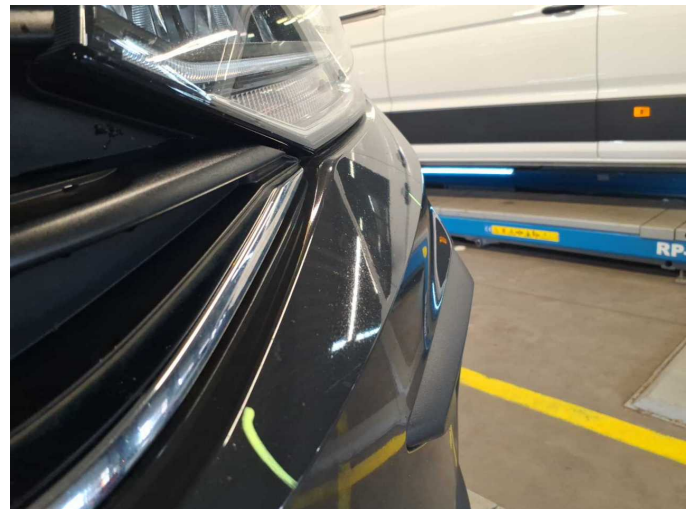
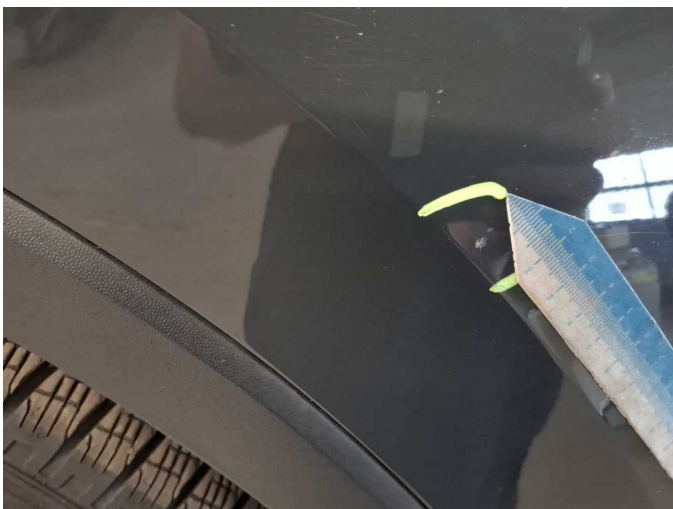
Damage 13: Front bumper: Front bumper (Sandstrahleffekt) - Stone chips - Paint

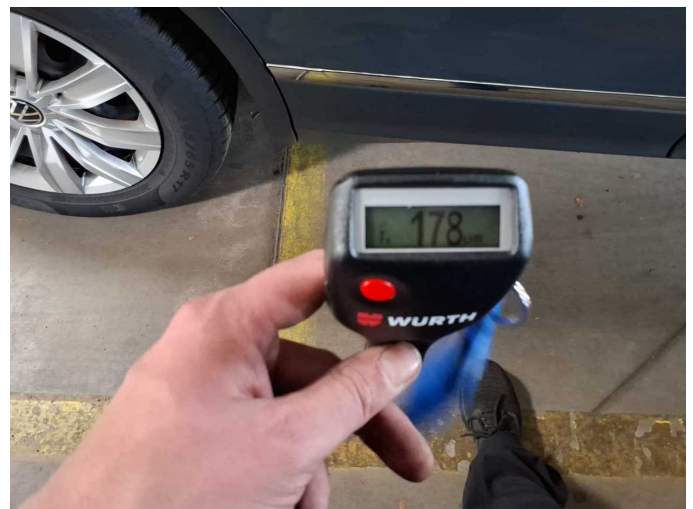
No.	Repainting
1	Door - rear right side, Professionally carried out, Invoice of repair done Non-existent
2	Door - front right side, Professionally carried out, Invoice of repair done Non-existent

Repainting 1: Door - rear right side

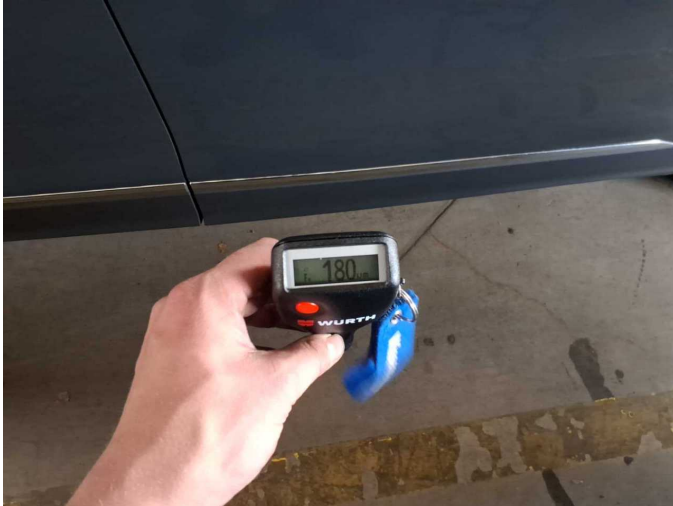
Repainting 2: Door - front right side

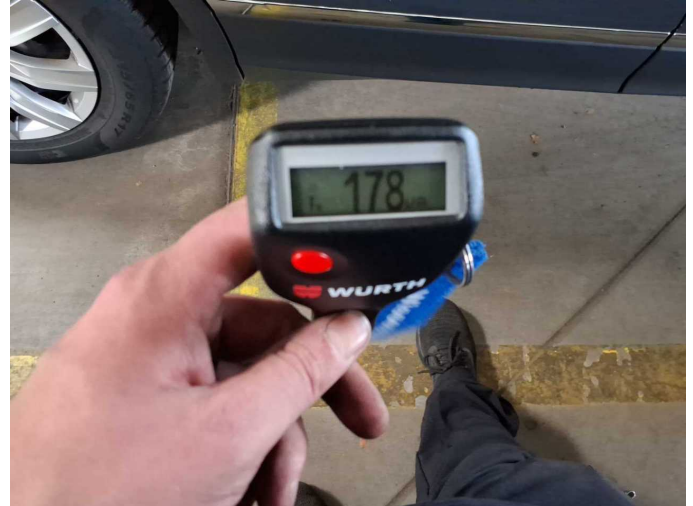
Door - rear right side: 178 µm

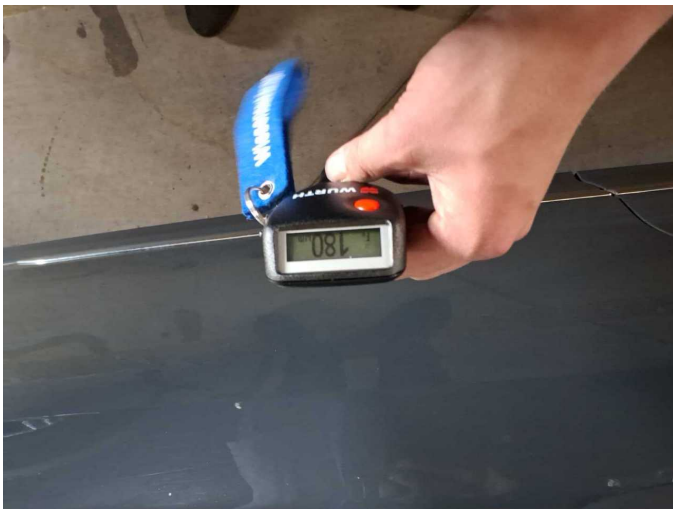
Door - front right side: 180 µm
