Expertise

Protocol number: 46896083  
Order No. / Reference: 26591774  
Inspection date: 30 Jul 2026

| Manufacturer: Opel | Model: Insignia Sports Tourer 2.0 Diesel Aut. Business |
| VIN: W0VZT8GP3N1007371 | |

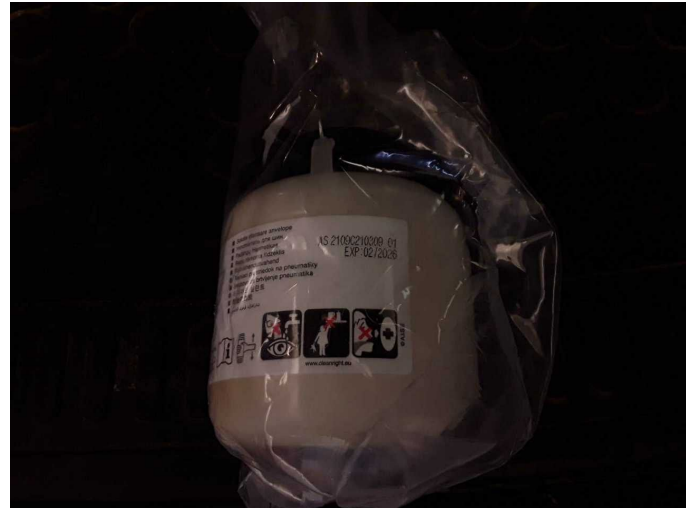
| No. | Component group | Description |
|---|---|---|
| 1 | Equipment | Tirefit filler - Expired - Replace |

**Damage 1:** Equipment: Tirefit filler - Expired - Replace

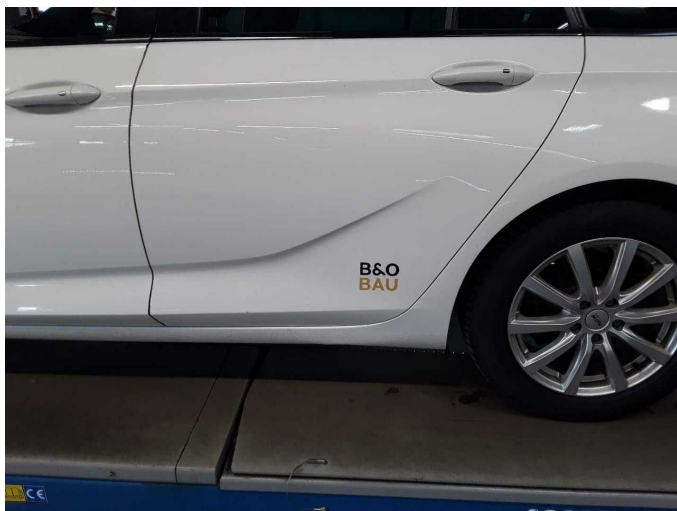
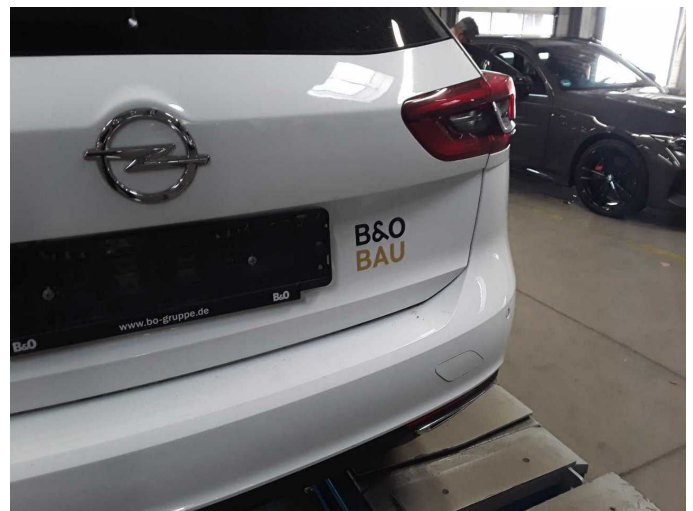
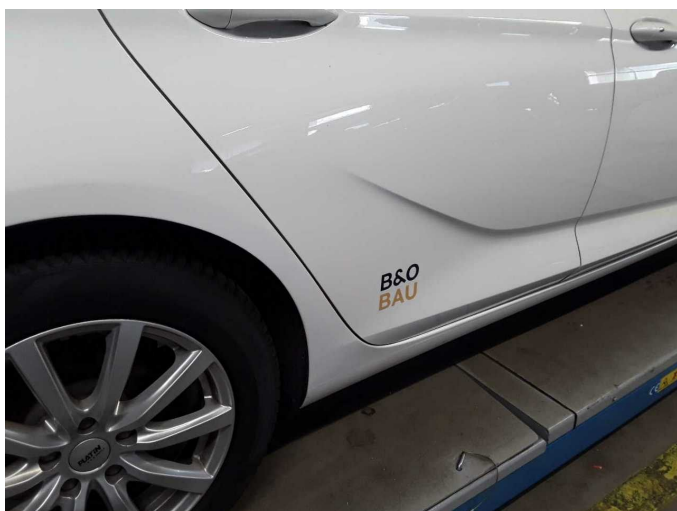
| No. | Component group | Description |
|---|---|---|
| 2 | Body | Body - Glued / labelled - Remove |

**Damage 2:** Body: Body - Glued / labelled - Remove

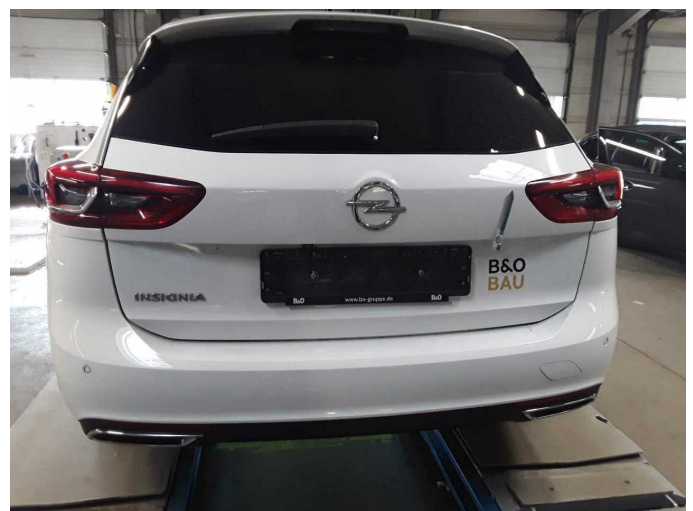
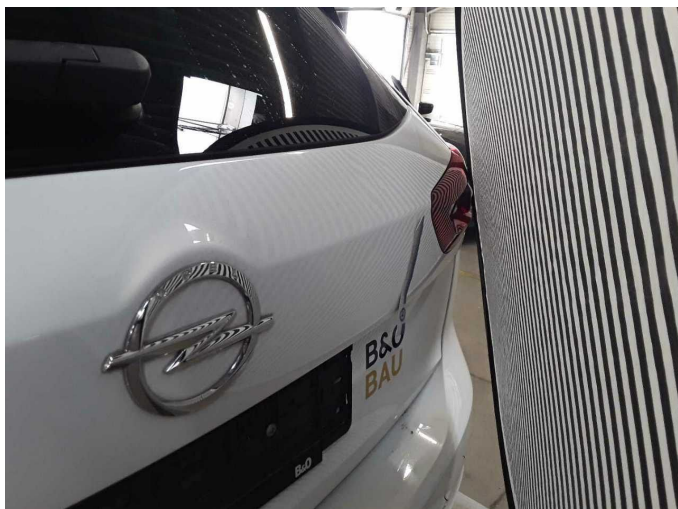
| No. | Component group | Description |
|---|---|---|
| 3 | Boot lid / rear door | Boot lid - dent(s) - Smooth repair work |

**Damage 3:** Boot lid / rear door: Boot lid - dent(s) - Smooth repair work

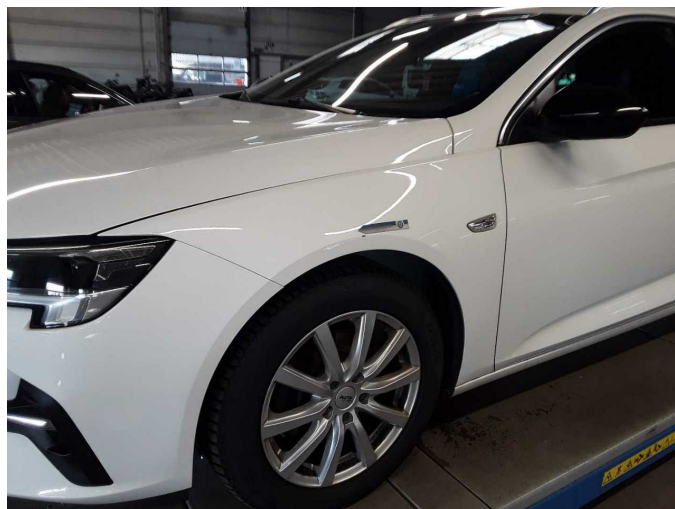
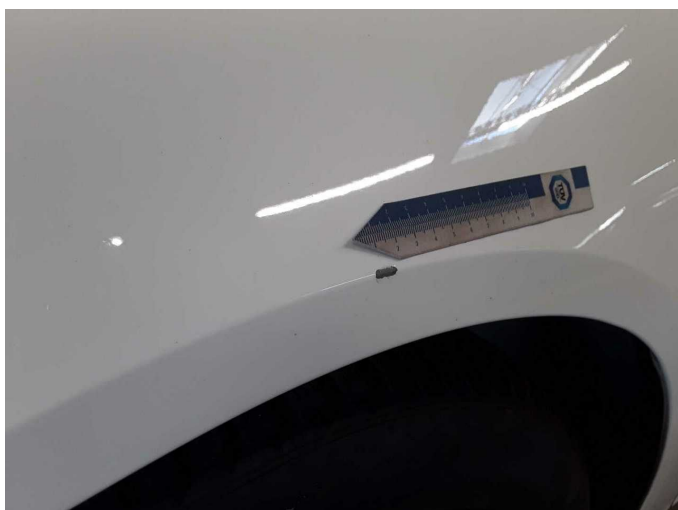
| No. | Component group | Description |
|---|---|---|
| 4 | Mudguard - left side | Mudguard - left side - Scratch(es) - Smart repair |

**Damage 4:** Mudguard - left side: Mudguard - left side - Scratch(es) - Smart repair

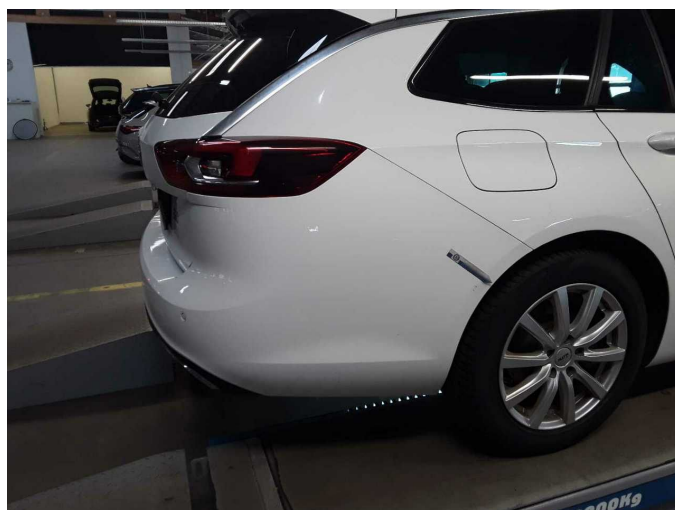
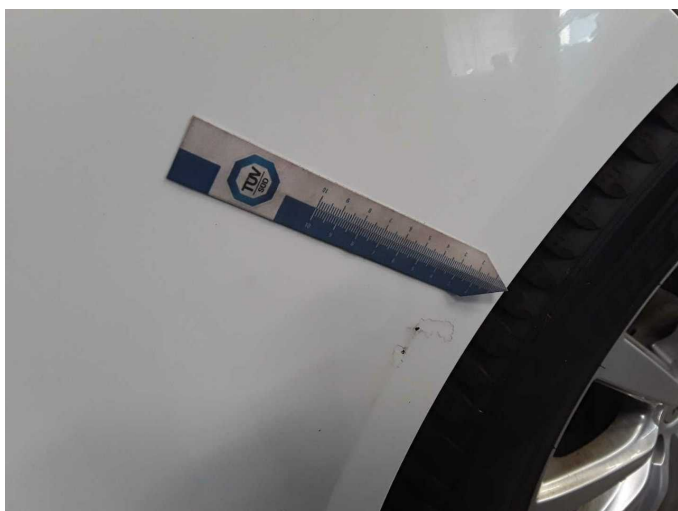
| No. | Component group | Description |
|---|---|---|
| 5 | Rear bumper | Rear bumper - Scratch(es) - Smart repair |

**Damage 5:** Rear bumper: Rear bumper - Scratch(es) - Smart repair

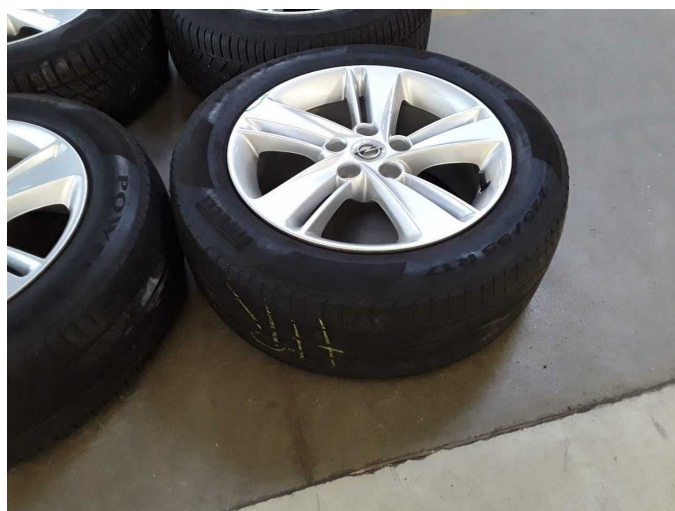
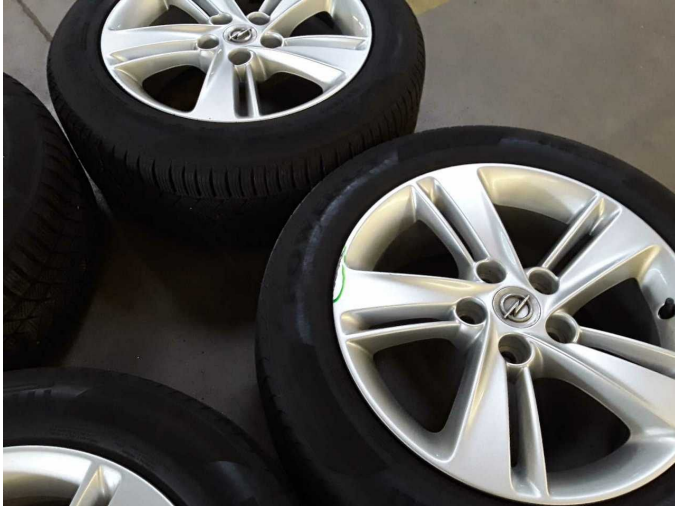
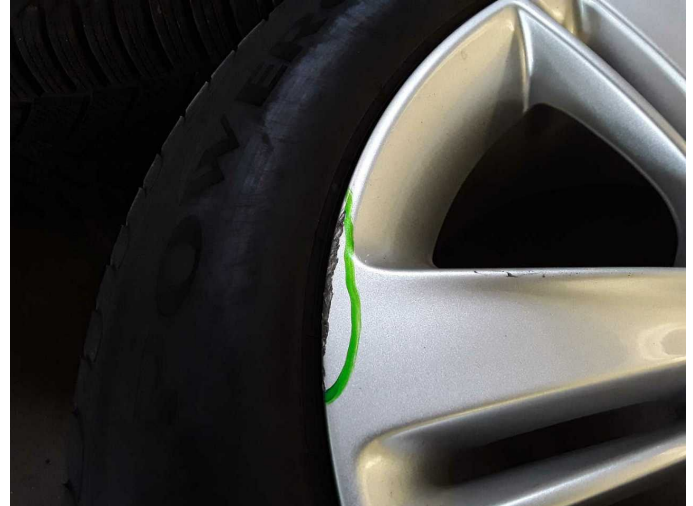
| No. | Component group | Description |
|---|---|---|
| 6 | 2nd wheel set | 1 alloy rim (Materialabtrag) - Scratched - Loss in value |

**Damage 6:** 2nd wheel set: 1 alloy rim (Materialabtrag) - Scratched - Loss in value

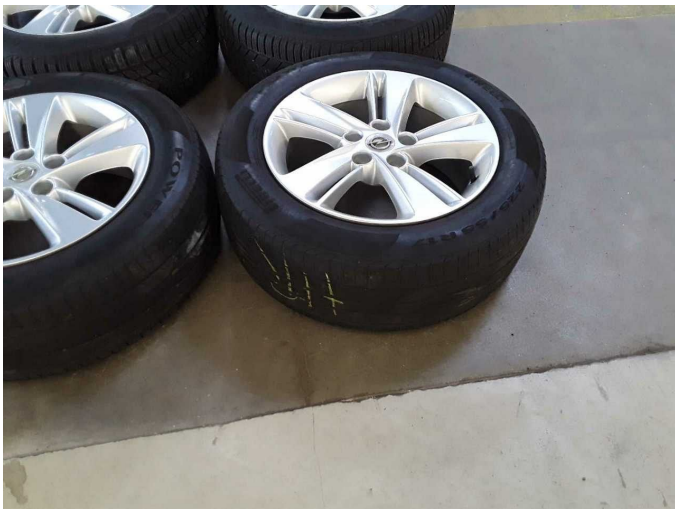
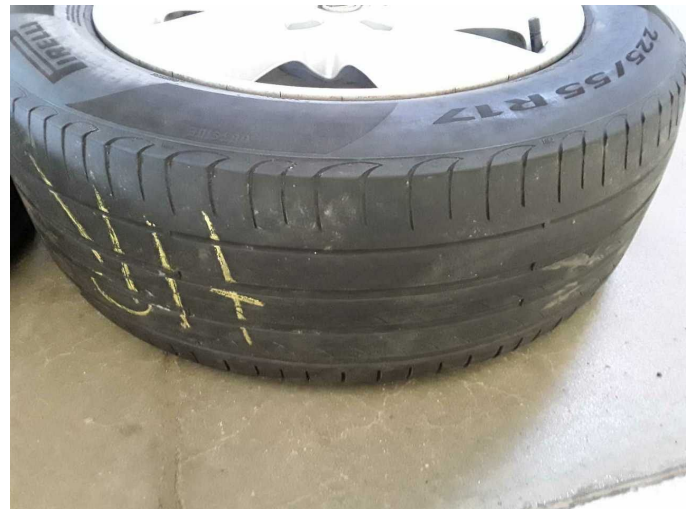
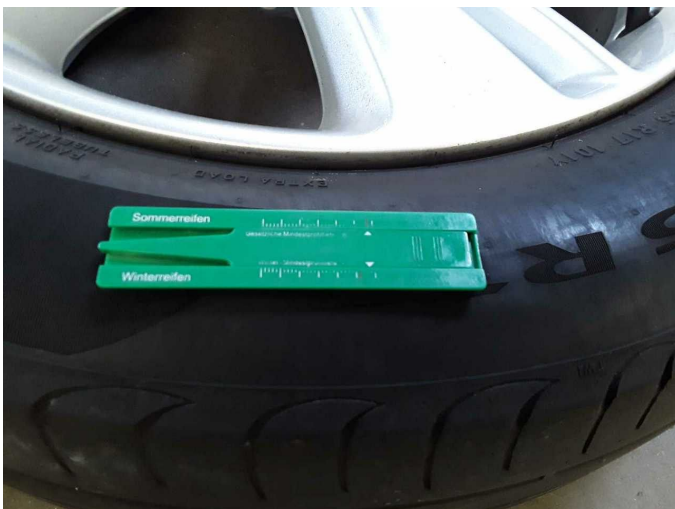
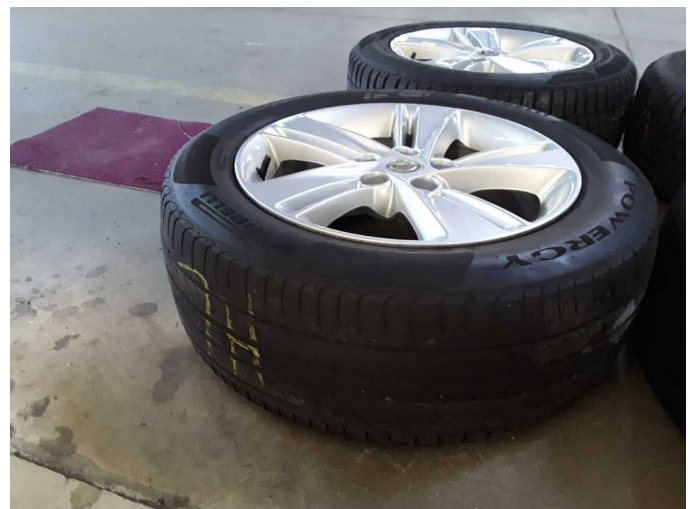
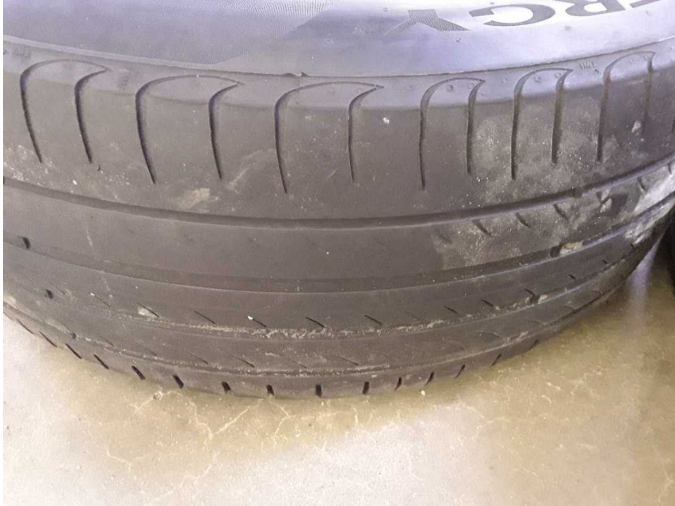
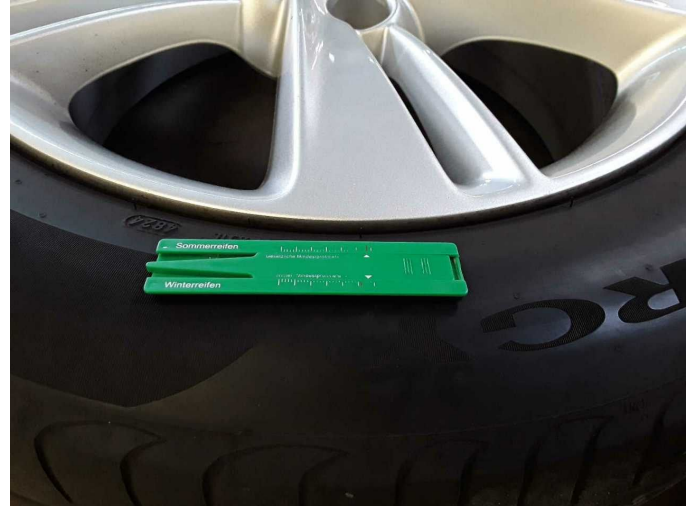
| No. | Component group | Description |
|---|---|---|
| 7 | 2nd wheel set | 2 tyres (<2mm) - Does not meet the leasing specifications - Replace |

**Damage 7:** 2nd wheel set: 2 tyres (<2mm) - Does not meet the leasing specifications - Replace

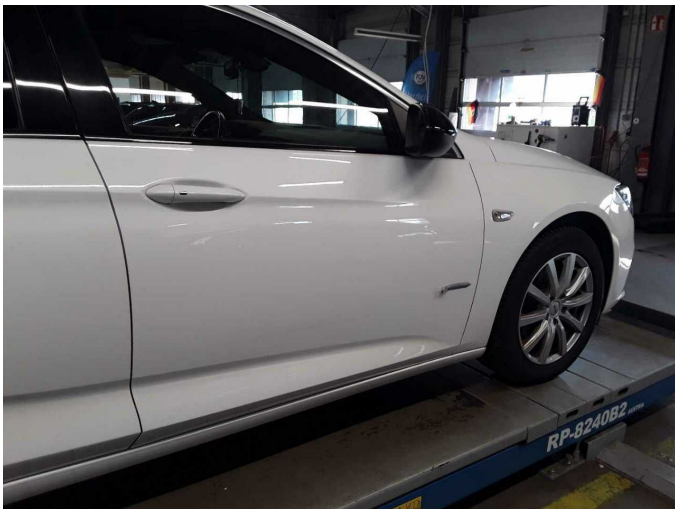
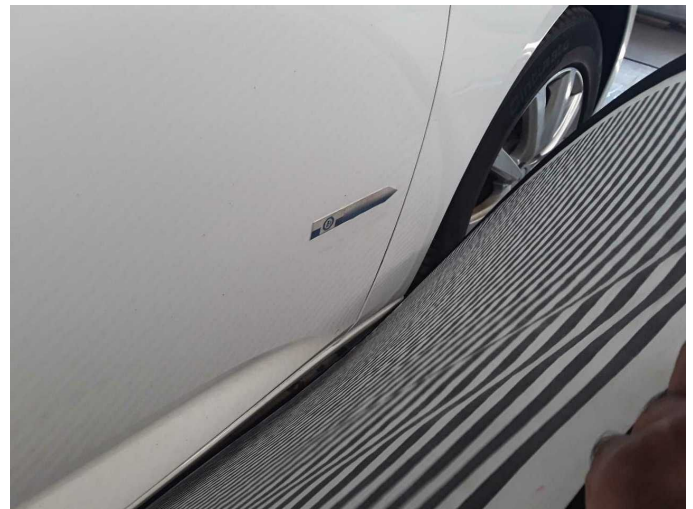
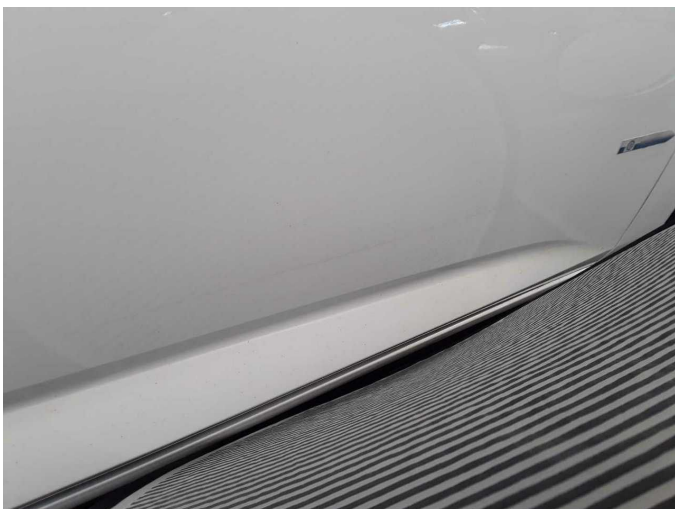
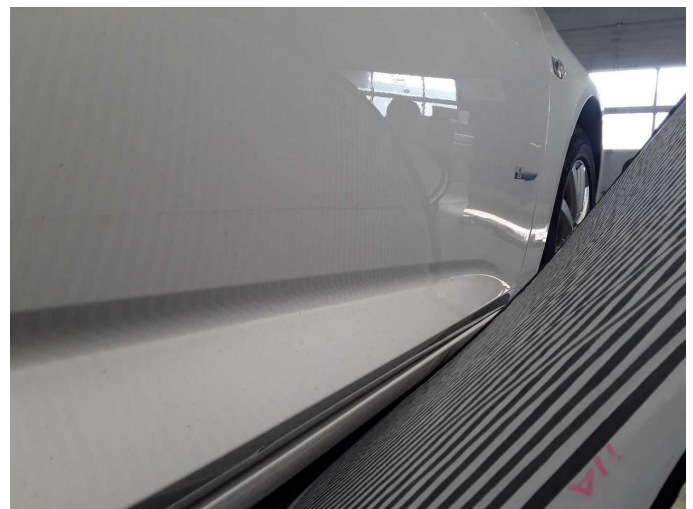
| No. | Component group | Description |
|---|---|---|
| 8 | Door - front right side | Door - Dent / paintcoat damage - Repair and paint |

**Damage 8:** Door - front right side: Door - Dent / paintcoat damage - Repair and paint

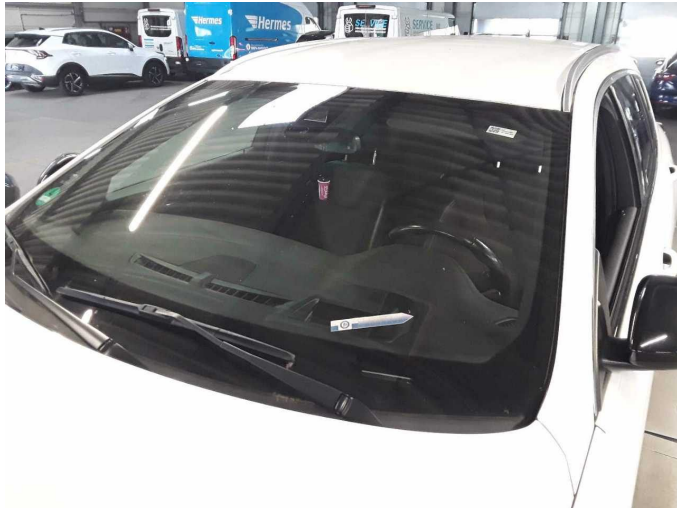
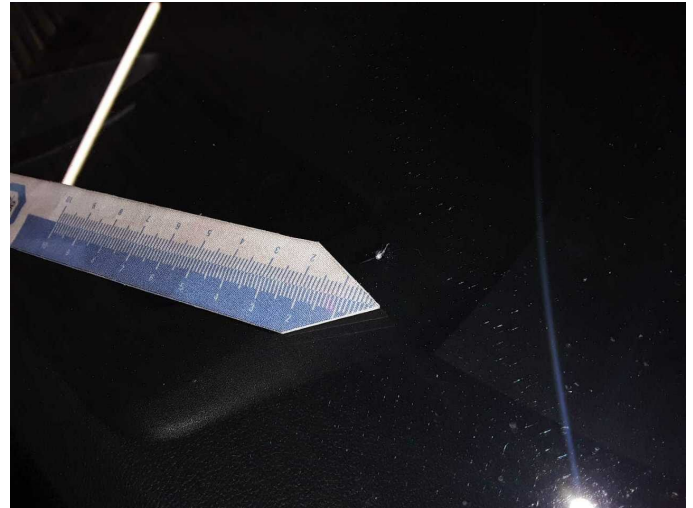
| No. | Component group | Description |
|---|---|---|
| 9 | Vehicle glazing | Windscreen (im Sichtbereich) - Broken / torn - Replace |

**Damage 9:** Vehicle glazing: Windscreen (im Sichtbereich) - Broken / torn - Replace

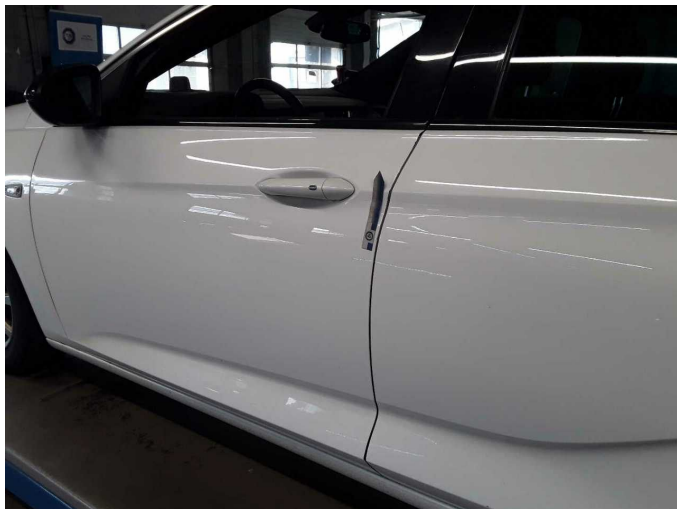
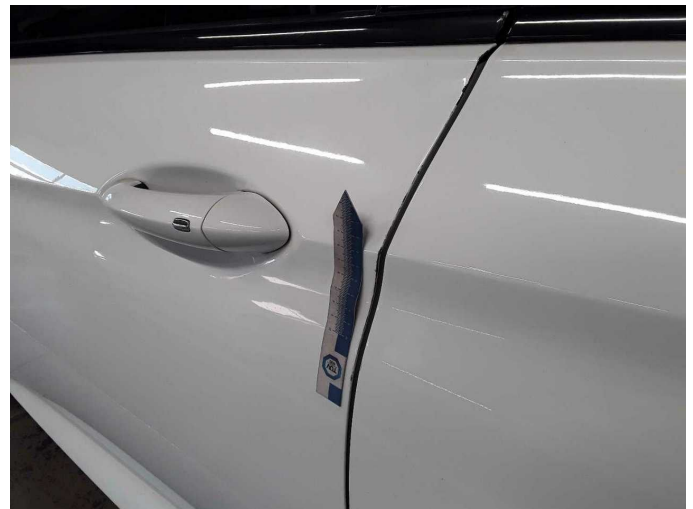
| No. | Component group | Description |
|---|---|---|
| 2 | Door - front left side | Door edge - Scratch(es) - Cover / polish |

**Wear and tear 2:** Door - front left side: Door edge - Scratch(es) - Cover / polish
