Expertise

Protocol number: 46282085  
Order No. / Reference: 26698763  
Inspection date: 2 Jul 2026

| Manufacturer: Ford | Model: Transit Custom 320 L2H1 LKW VA Autm. Trend |

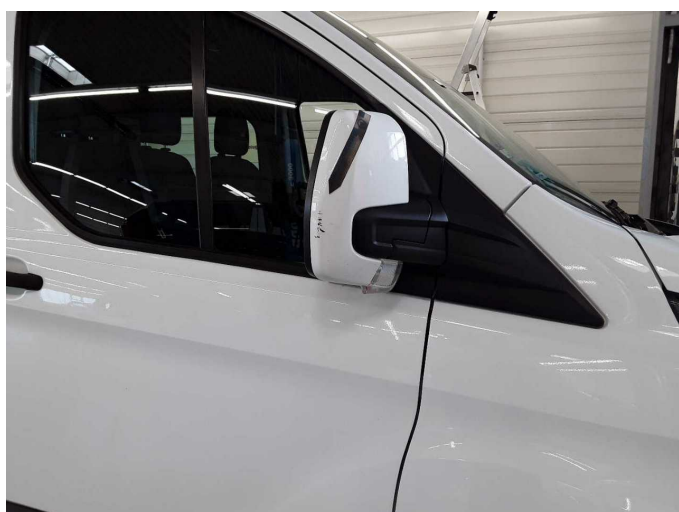
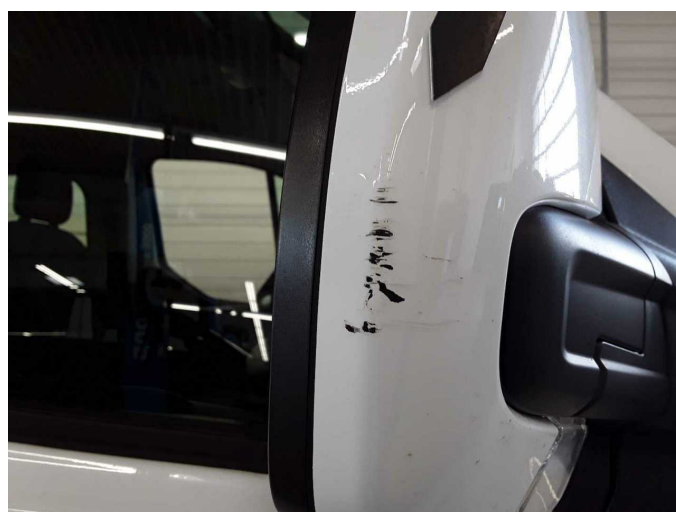
| No. | Component group | Description |
|---|---|---|
| 1 | Wing mirror - right side | Cap - Scratch(es) - Smart repair |

Damage 1: Wing mirror - right side: Cap - Scratch(es) - Smart repair

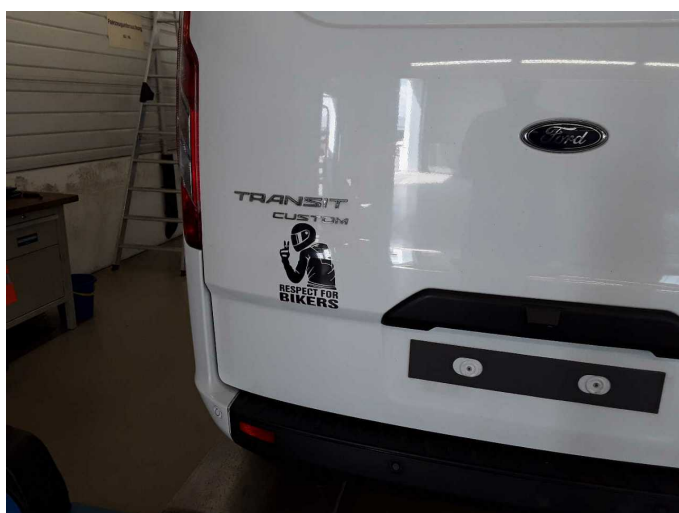
| No. | Component group | Description |
|---|---|---|
| 2 | Body | Body (Zusatzkosten können entstehen) - Glued / labelled - De-glue / neutralise |

Damage 2: Body: Body (Zusatzkosten können entstehen) - Glued / labelled - De-glue / neutralise

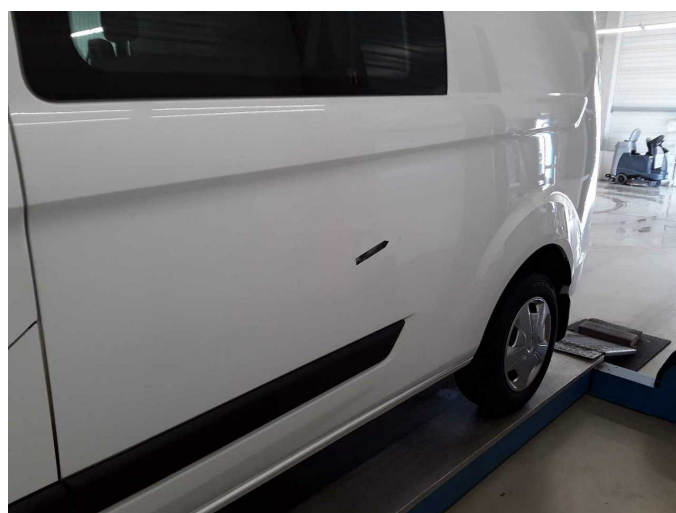
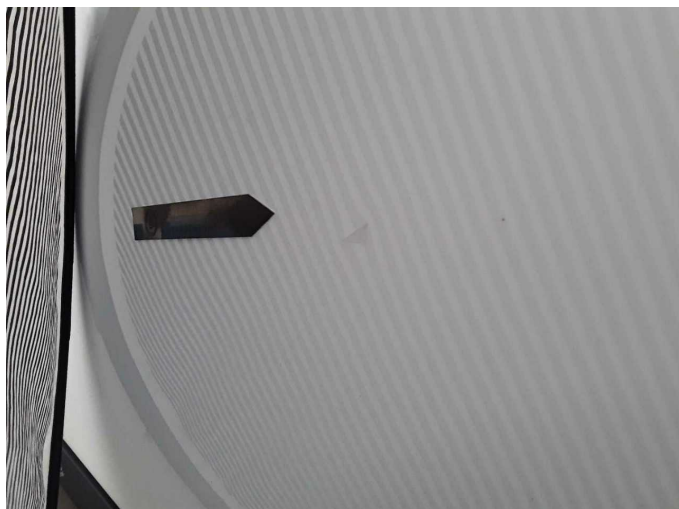
| No. | Component group | Description |
|---|---|---|
| 3 | Side panel - rear left side | Side panel - dent(s) - Smart repair |

Damage 3: Side panel - rear left side: Side panel - dent(s) - Smart repair

**Damage 3:** Side panel - rear left side: Side panel - dent(s) - Smart repair

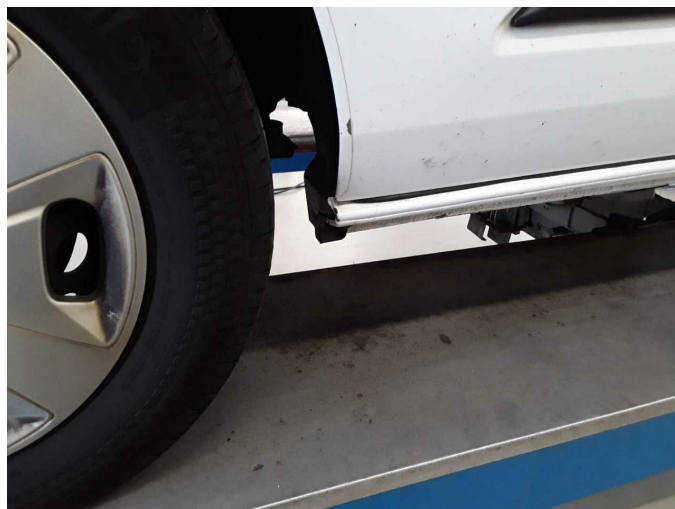
| No. | Component group | Description |
|---|---|---|
| 4 | Mudguard - left side | Mud flap - Missing - Replace |

**Damage 4:** Mudguard - left side: Mud flap - Missing - Replace

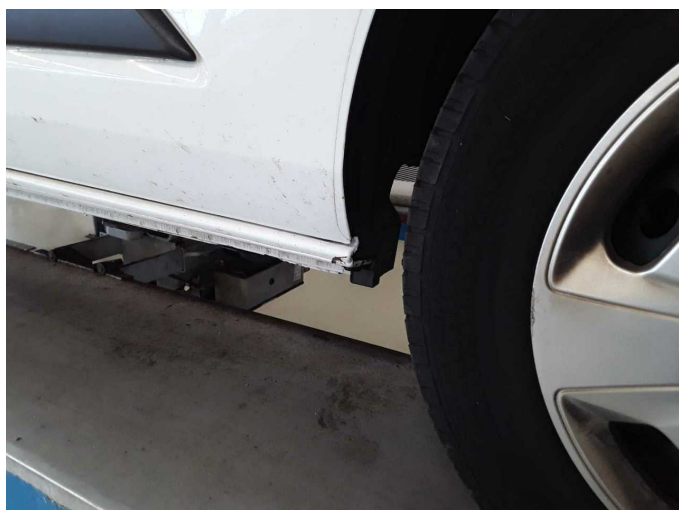
| No. | Component group | Description |
|---|---|---|
| 5 | Mudguard - right side | Mud flap - Missing - Replace |

**Damage 5:** Mudguard - right side: Mud flap - Missing - Replace

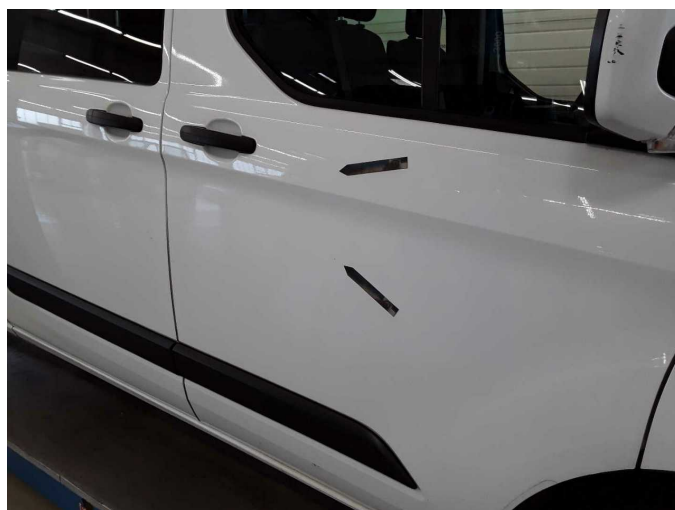
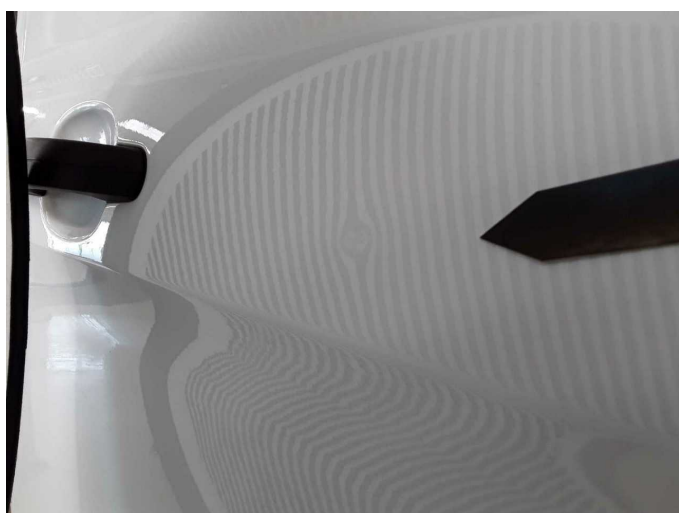
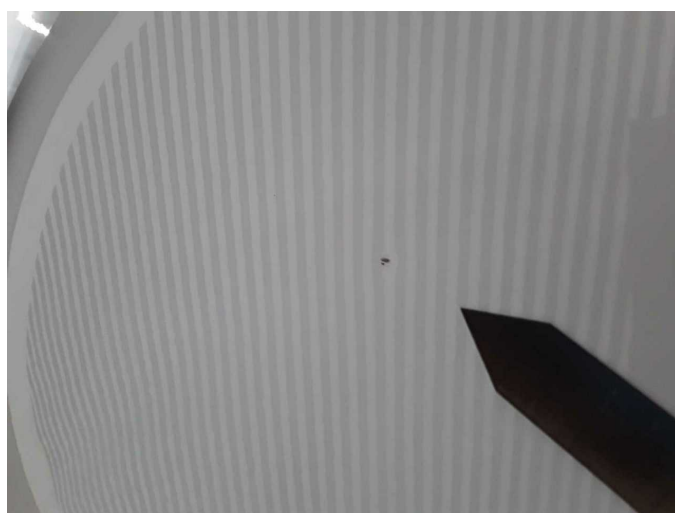
| No. | Component group | Description |
|---|---|---|
| 6 | Door - front right side | Door - Dent / paintcoat damage - Smart repair |

**Damage 6:** Door - front right side: Door - Dent / paintcoat damage - Smart repair

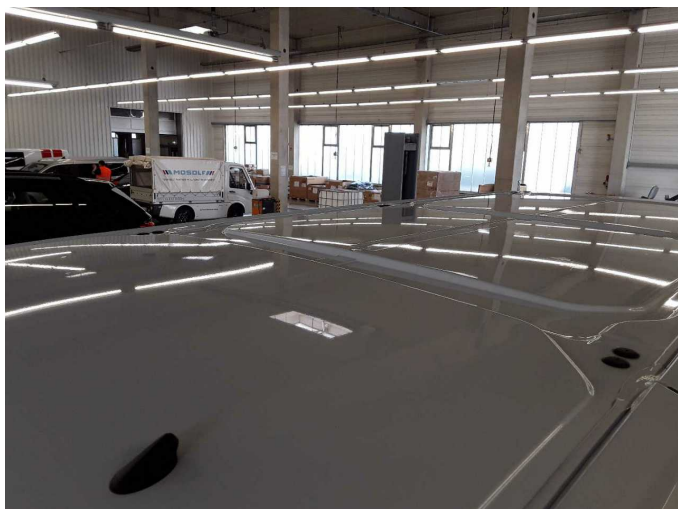
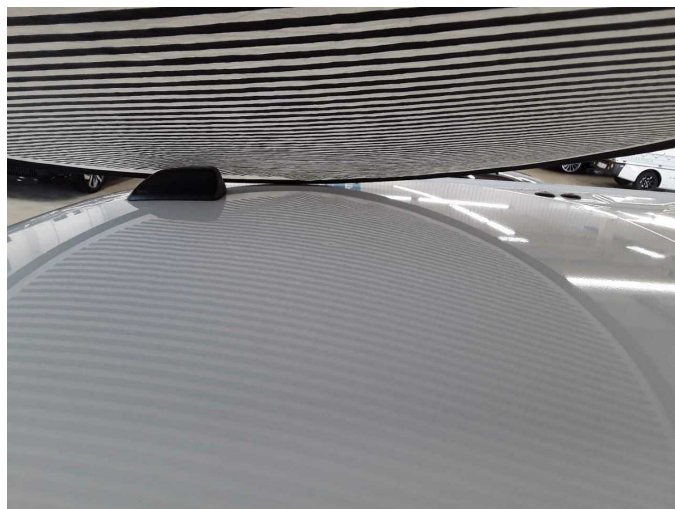
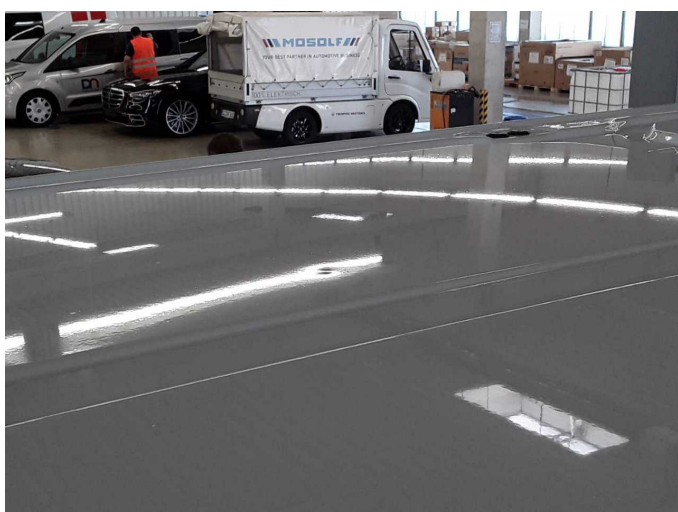
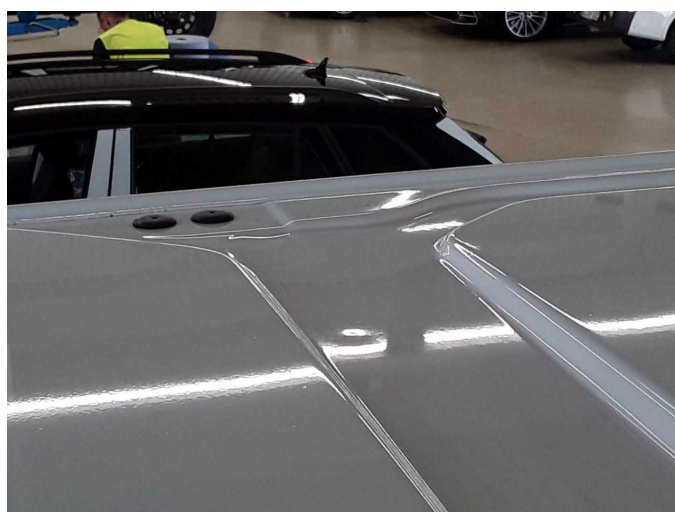
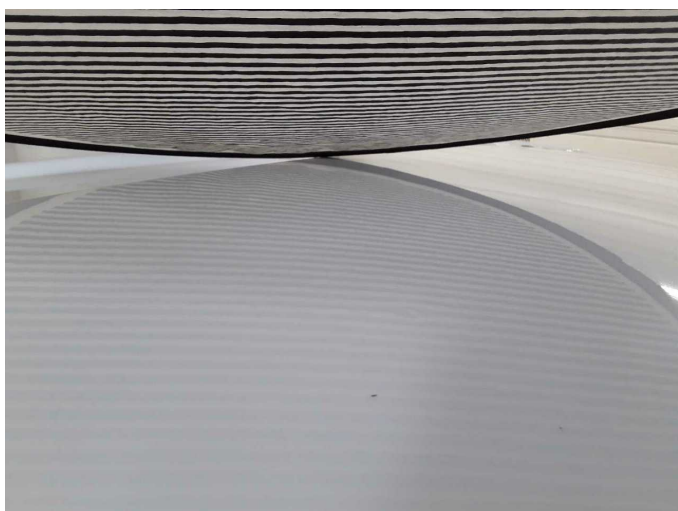
| No. | Component group | Description |
|---|---|---|
| 7 | Roof | Roof - dent(s) - Smart repair |

**Damage 7:** Roof: Roof - dent(s) - Smart repair

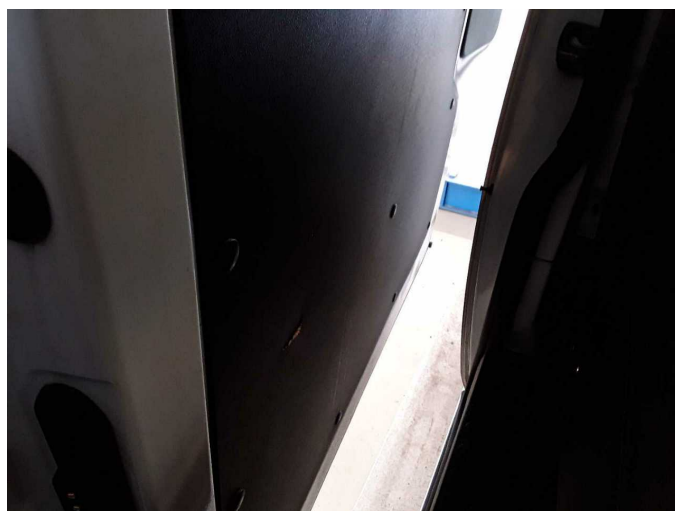
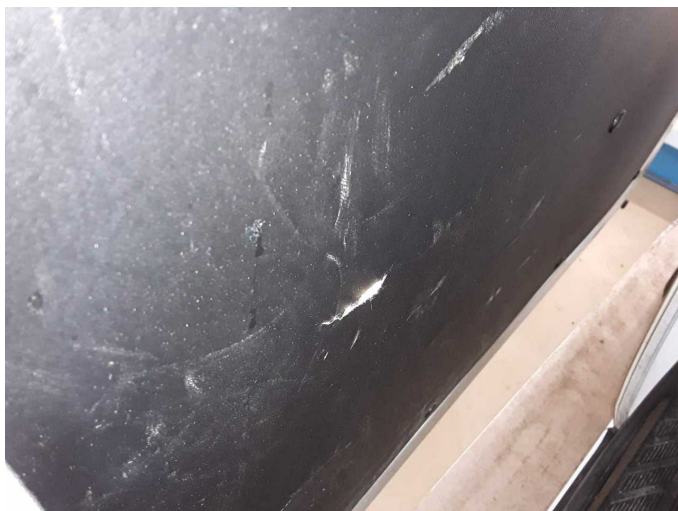
| No. | Component group | Description |
|---|---|---|
| 8 | Sliding door, right | Trim washable - lower - Broken / torn - Replace |

**Damage 8:** Sliding door, right: Trim washable - lower - Broken / torn - Replace

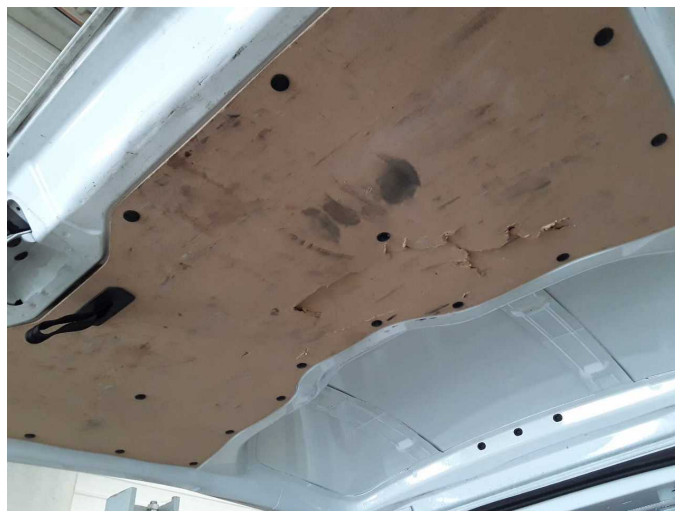
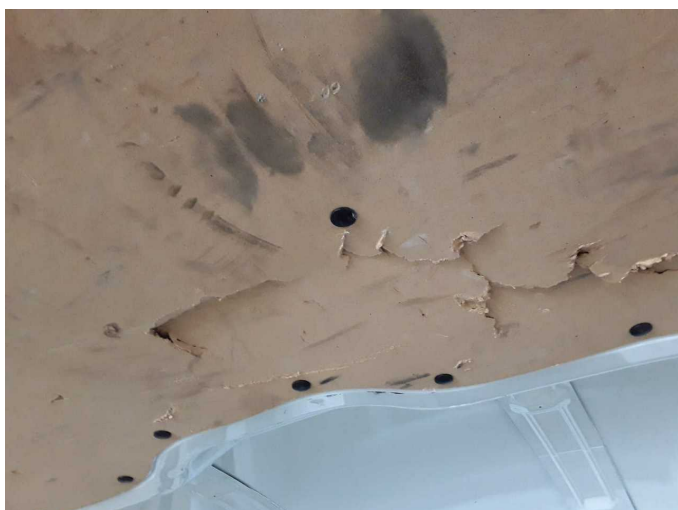
| No. | Component group | Description |
|---|---|---|
| 9 | Boot lid / rear door | Trim hard fibre - lower - Broken / torn - Replace |

**Damage 9:** Boot lid / rear door: Trim hard fibre - lower - Broken / torn - Replace

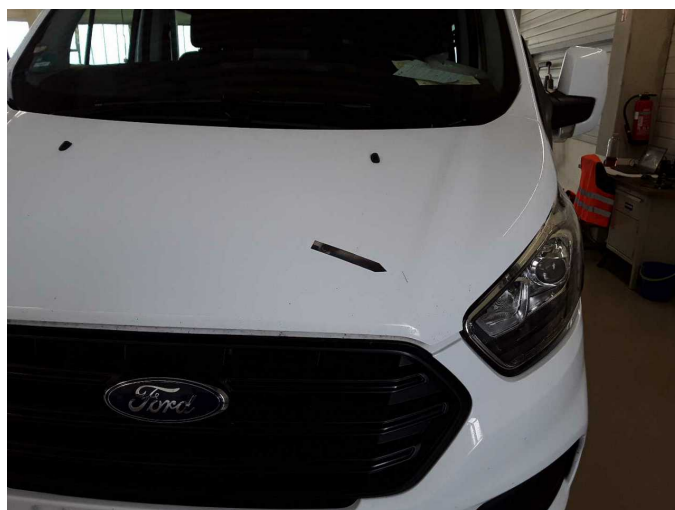
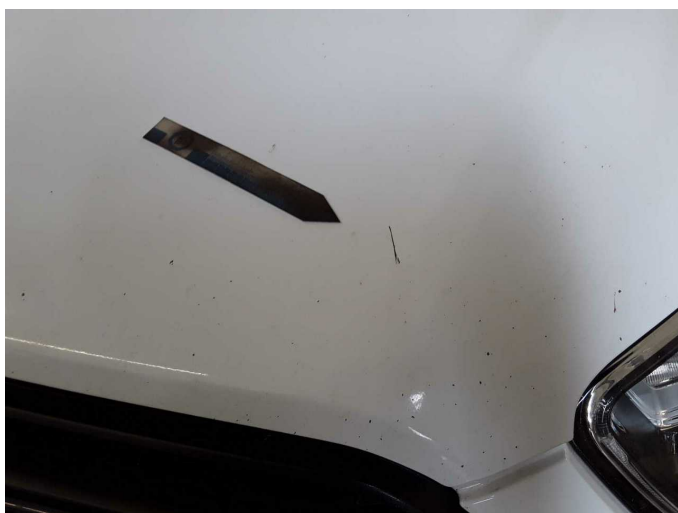
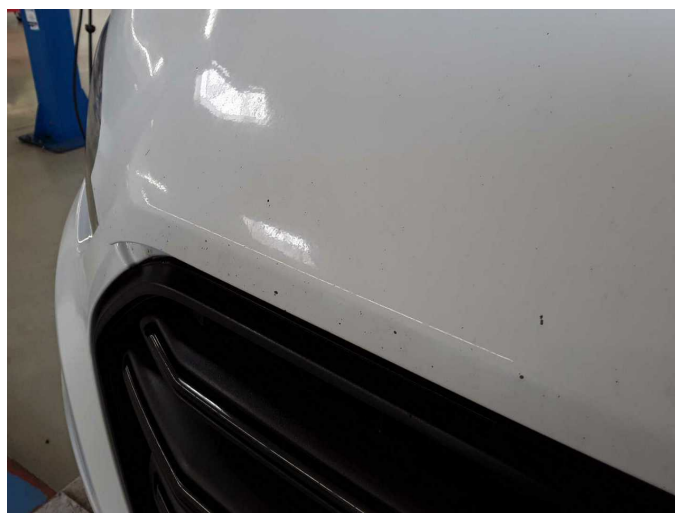
| No. | Component group | Description |
|---|---|---|
| 10 | Bonnet | Bonnet (Steinschläge) - Scratch(es) - Paint |

**Damage 10:** Bonnet: Bonnet (Steinschläge) - Scratch(es) - Paint

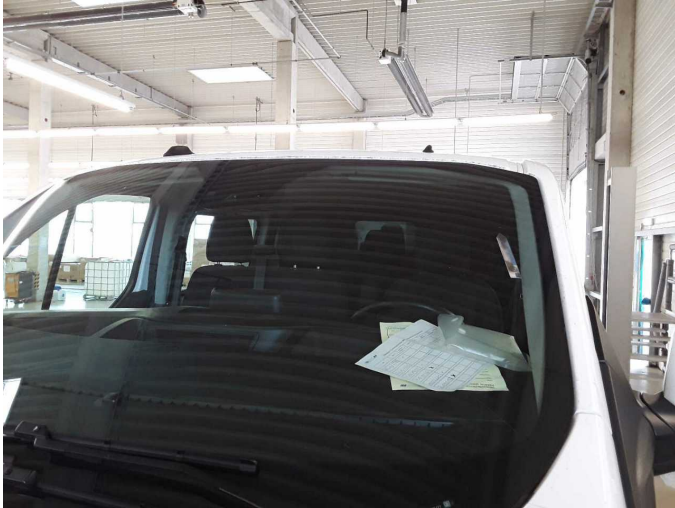
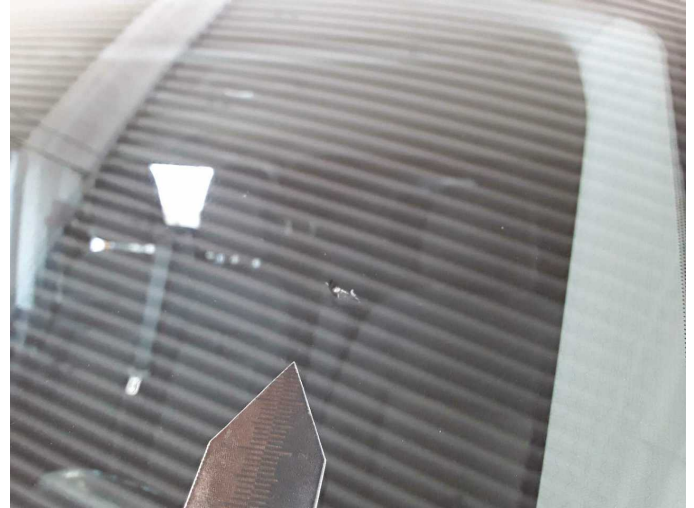
| No. | Component group | Description |
|---|---|---|
| 11 | Vehicle glazing | Windscreen with lane departure assistant - Stone chips - repair according to calculation |

**Damage 11:** Vehicle glazing: Windscreen with lane departure assistant - Stone chips - repair according to calculation
