Expertise

Protocol number: 46632691  
Order No. / Reference: 26621611  
Inspection date: 15 Jul 2026

Model: GLC-Coupe 300 e 4Matic 9G-TRONIC Exclusive

VIN: W1N2533531G015324

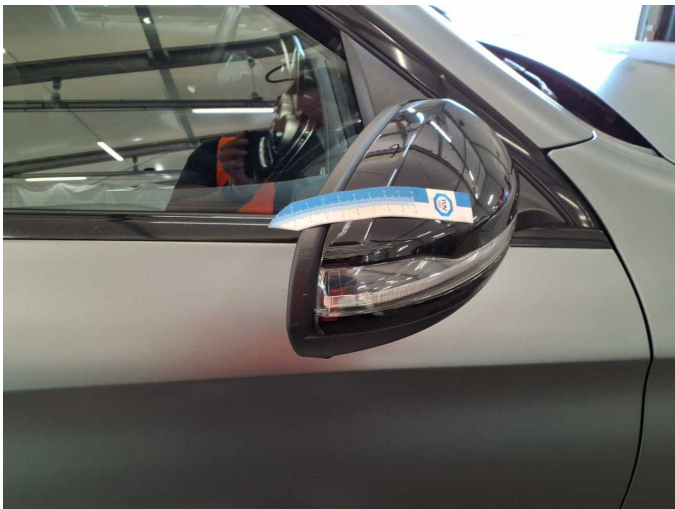
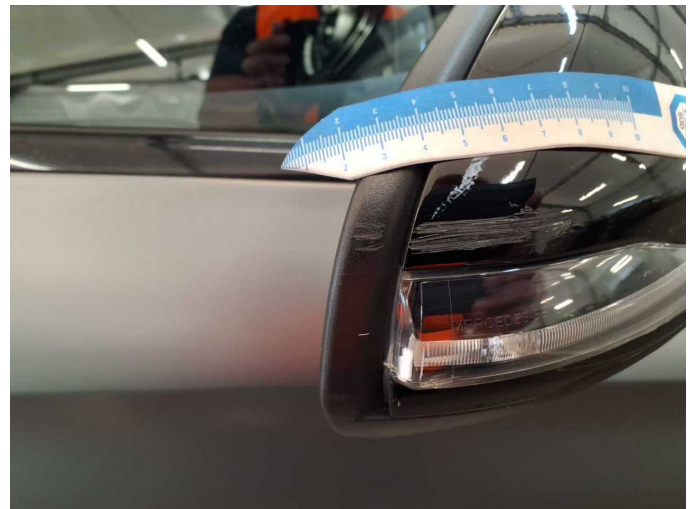
| No. | Component group | Description |
|---|---|---|
| 1 | Wing mirror - right side | Mirror housing - Scratched - Smart repair |

**Damage 1:** Wing mirror - right side: Mirror housing - Scratched - Smart repair

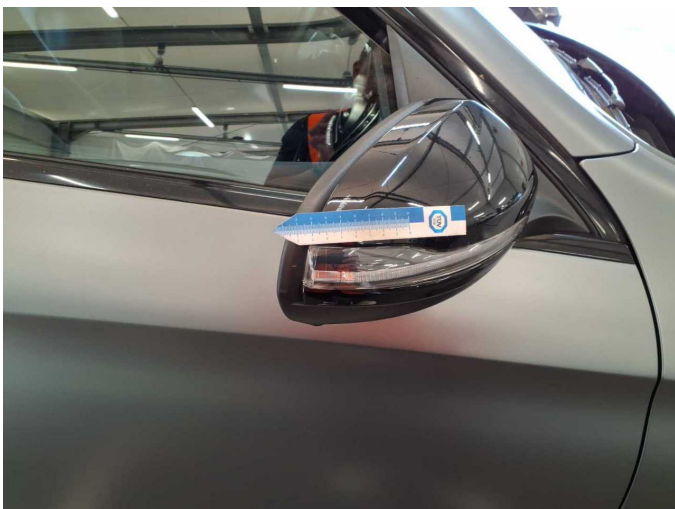
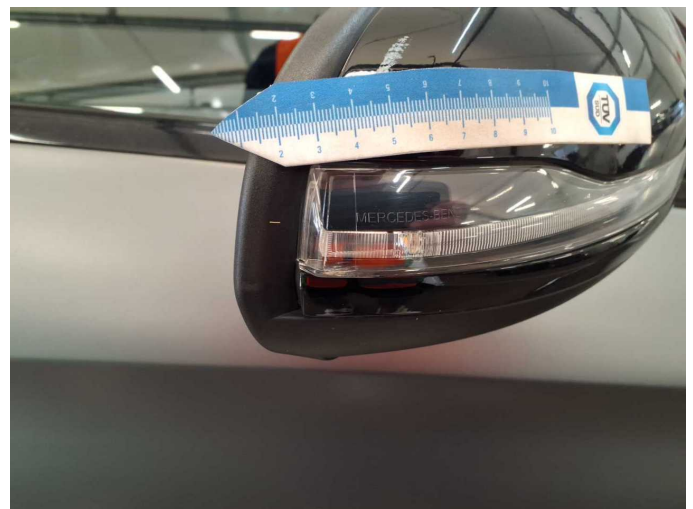
| No. | Component group | Description |
|---|---|---|
| 2 | Indicator - front | Mirror - right side - Scratched - Replace |

**Damage 2:** Indicator - front: Mirror - right side - Scratched - Replace

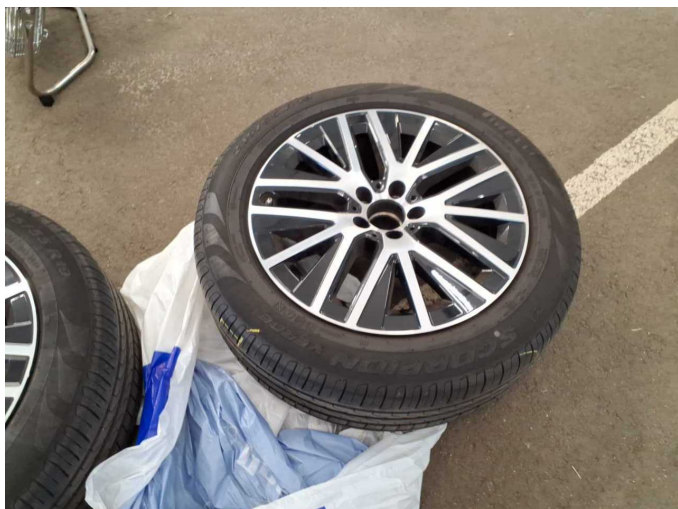
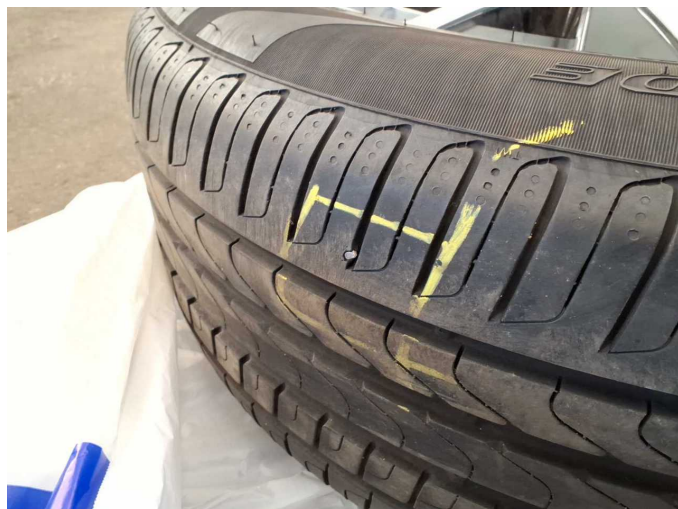
| No. | Component group | Description |
|---|---|---|
| 3 | 2nd wheel set | 1 tyre (Fremdkörper in Lauffläche) - Damaged - Replace |

**Damage 3:** 2nd wheel set: 1 tyre (Fremdkörper in Lauffläche) - Damaged  
- Replace

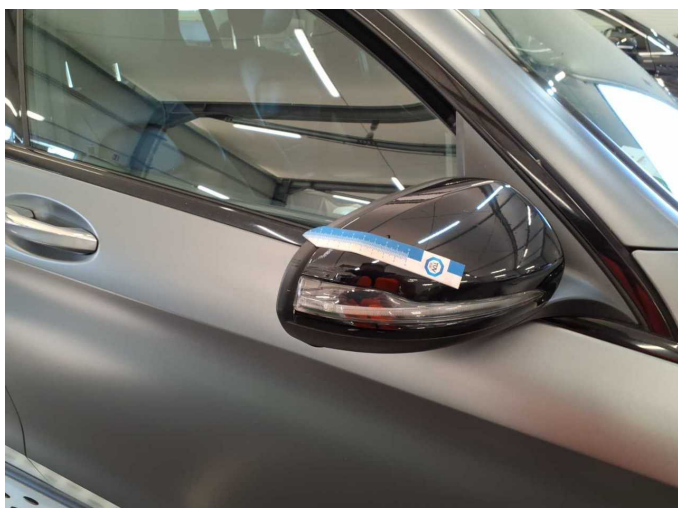
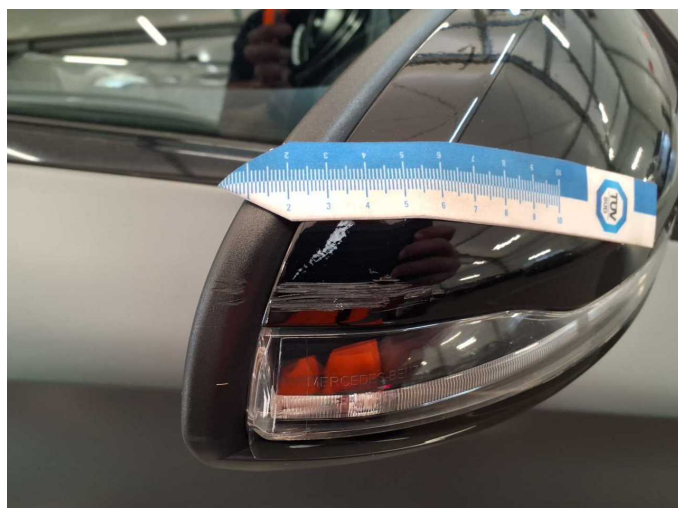
| No. | Component group | Description |
|---|---|---|
| 4 | Wing mirror - right side | Cap (Mit Materialabtrag) - Scratched - Paint |

**Damage 4:** Wing mirror - right side: Cap (Mit Materialabtrag) - Scratched  
- Paint

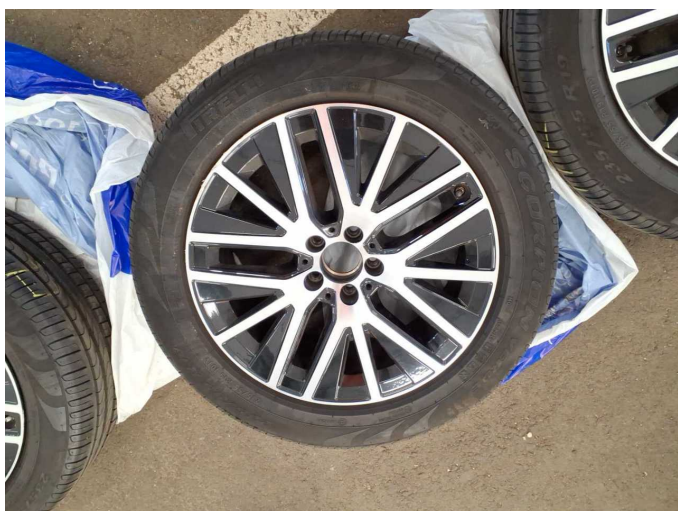
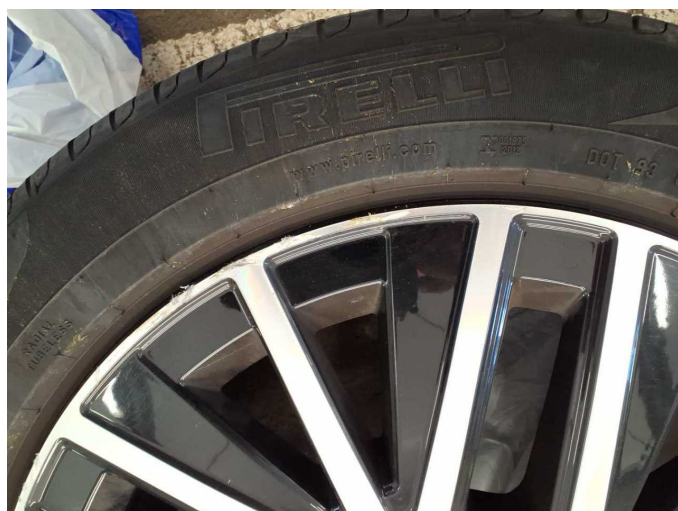
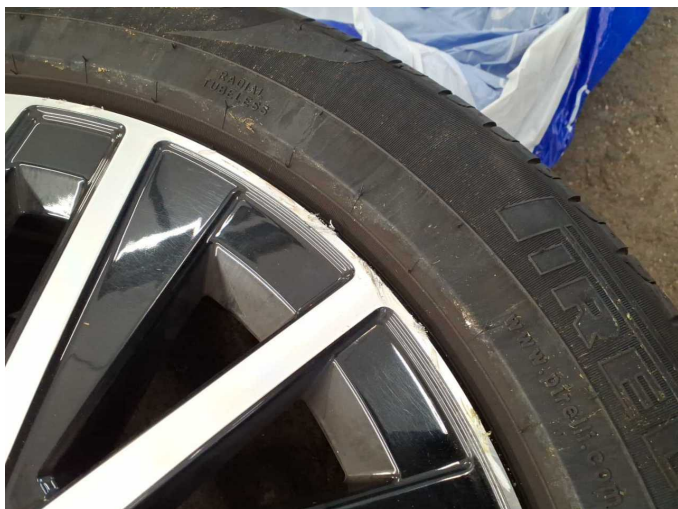
| No. | Component group | Description |
|---|---|---|
| 5 | 2nd wheel set | 1 alloy rim (Mit Materialabtrag) - Scratched - Loss in value |

**Damage 5:** 2nd wheel set: 1 alloy rim (Mit Materialabtrag) - Scratched -  
Loss in value

**Damage 5:** 2nd wheel set: 1 alloy rim (Mit Materialabtrag) - Scratched - Loss in value

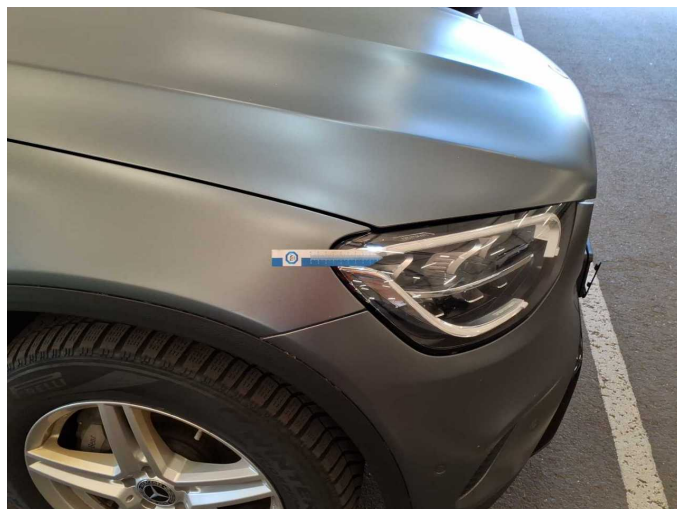
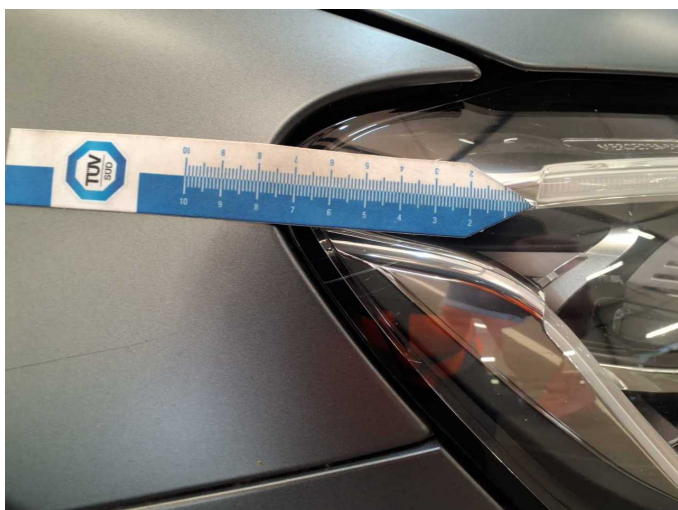
| No. | Component group | Description |
|---|---|---|
| 6 | Headlight | Headlight - right side (Außerhalb des Leuchtbereichs) - Scratch(es) - Loss in value |

**Damage 6:** Headlight: Headlight - right side (Außerhalb des Leuchtbereichs) - Scratch(es) - Loss in value

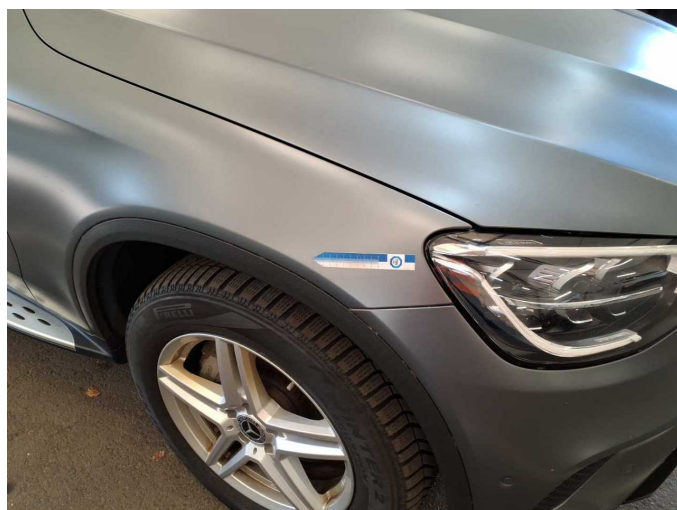
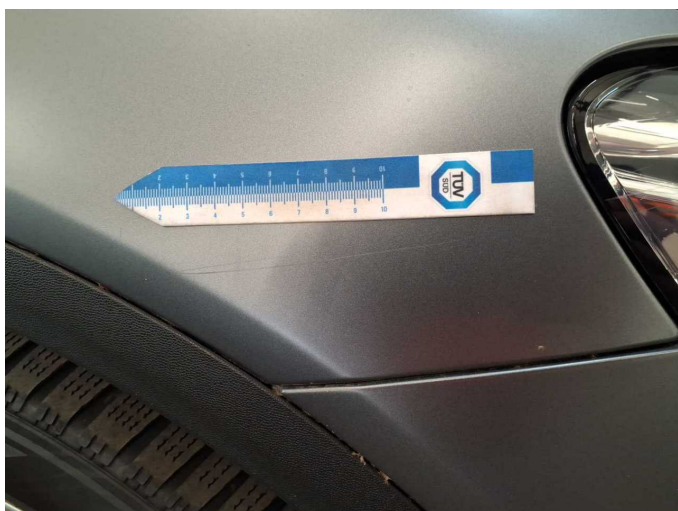
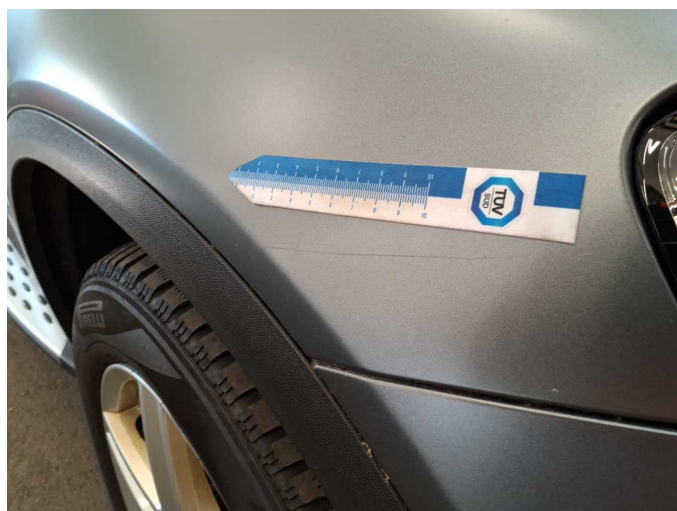
| No. | Component group | Description |
|---|---|---|
| 7 | Mudguard - right side | Mudguard - right side - Scratch(es) - Paint |

**Damage 7:** Mudguard - right side: Mudguard - right side - Scratch(es) - Paint

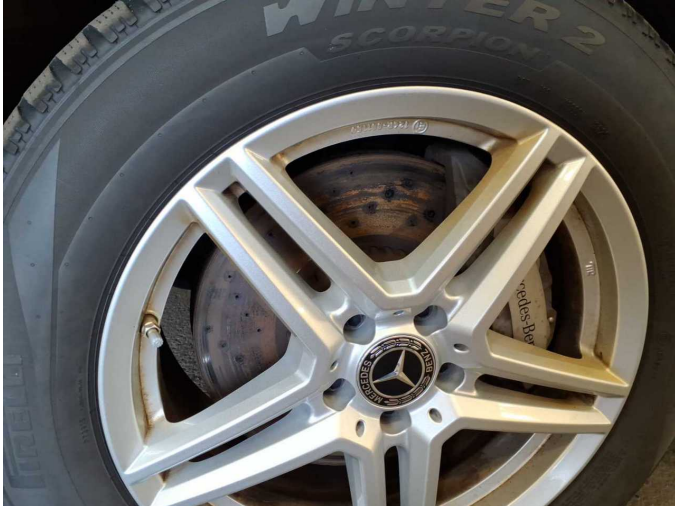
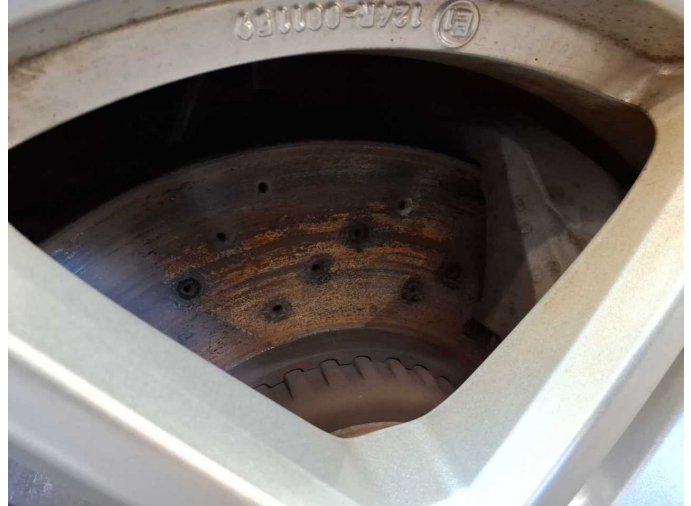
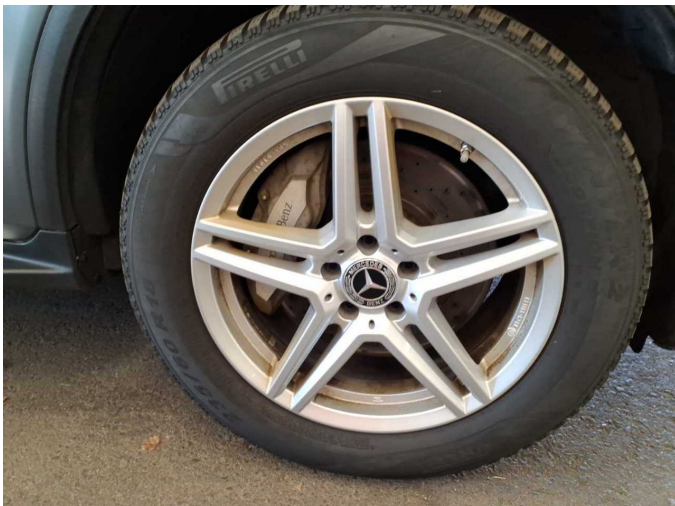
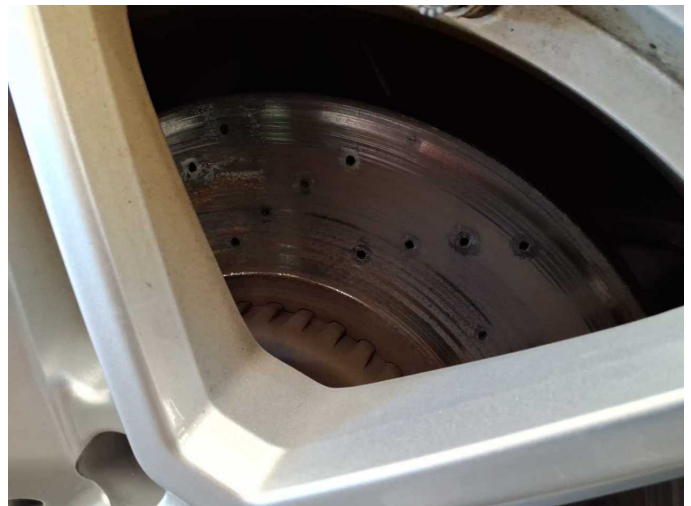
| No. | Component group | Description |
|---|---|---|
| 8 | Braking system | Brake discs and brake pads - front (Tragbild mangelhaft, Rost) - Corrosion - Replace |

**Damage 8:** Braking system: Brake discs and brake pads - front (Tragbild mangelhaft, Rost) - Corrosion - Replace

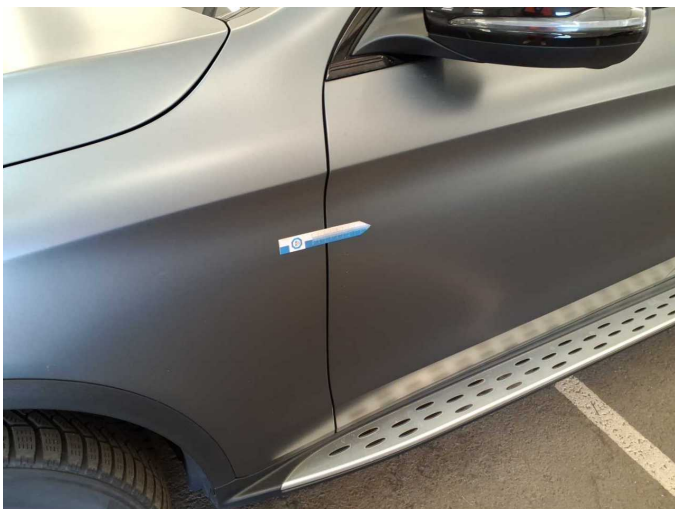
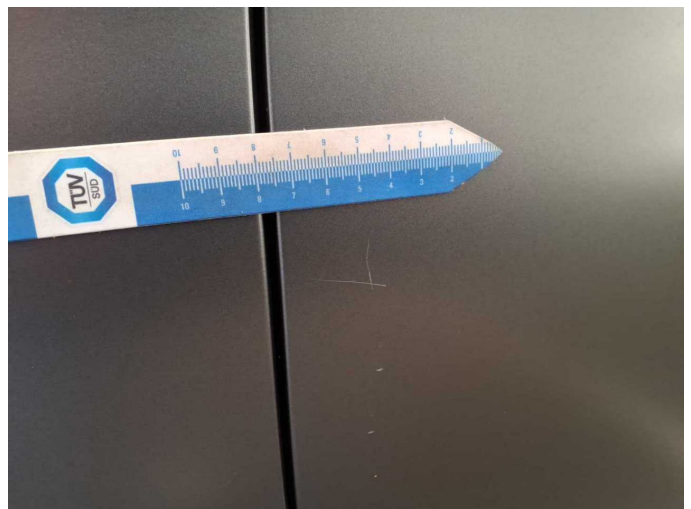
| No. | Component group | Description |
|---|---|---|
| 9 | Door - front left side | Door - Scratch(es) - Paint |

**Damage 9:** Door - front left side: Door - Scratch(es) - Paint

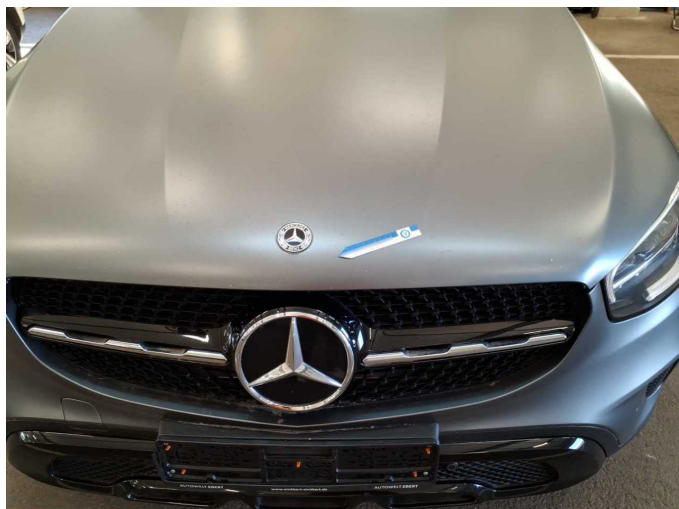
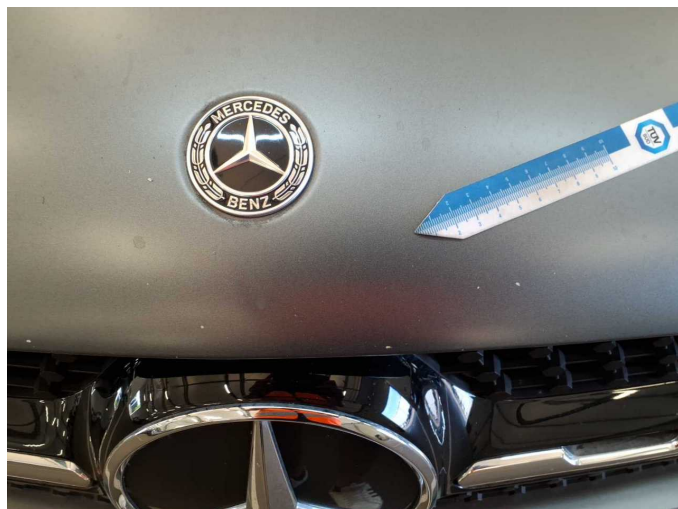
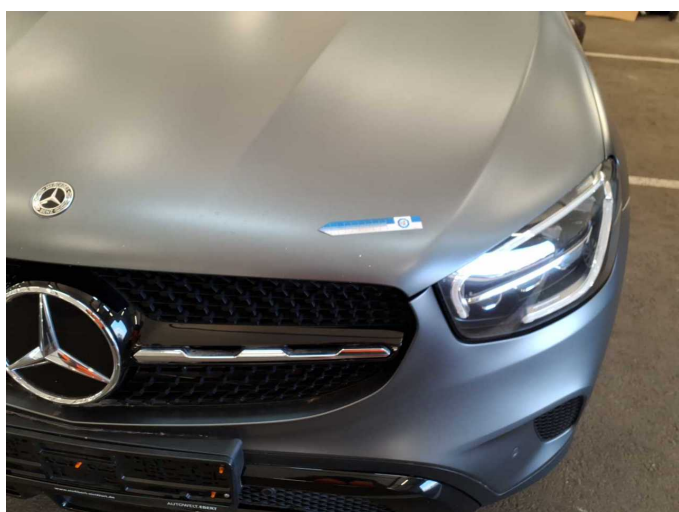
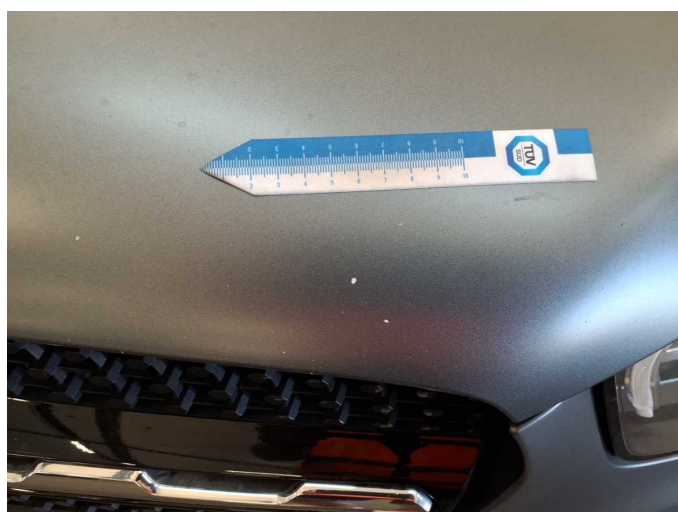
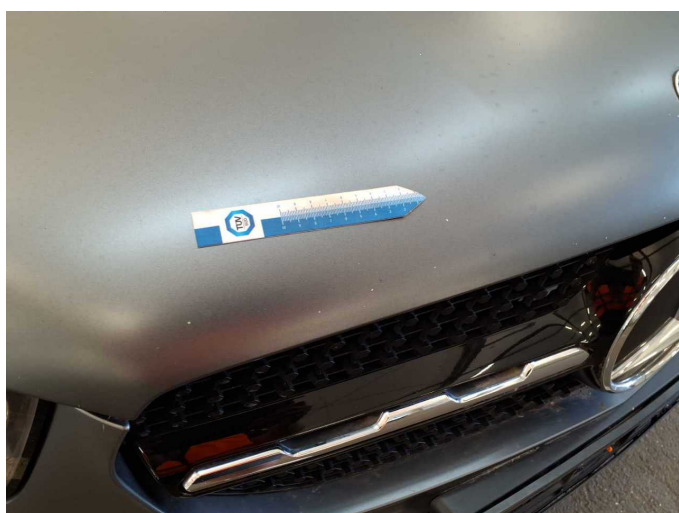
| No. | Component group | Description |
|---|---|---|
| 10 | Bonnet | Bonnet - Stone chips - Paint |

**Damage 10:** Bonnet: Bonnet - Stone chips - Paint

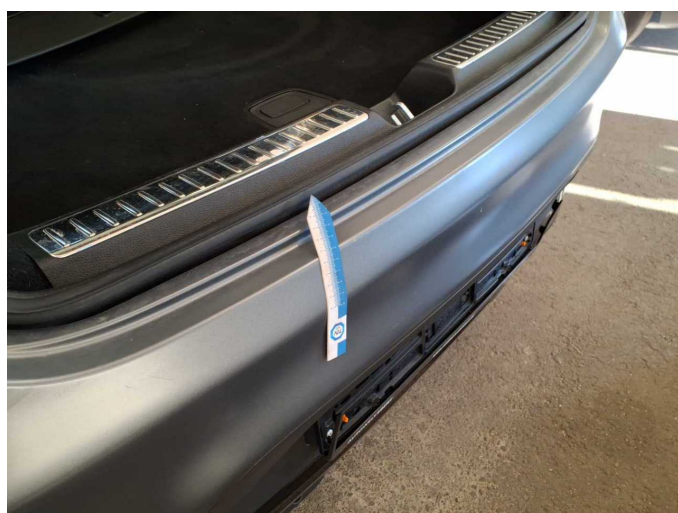
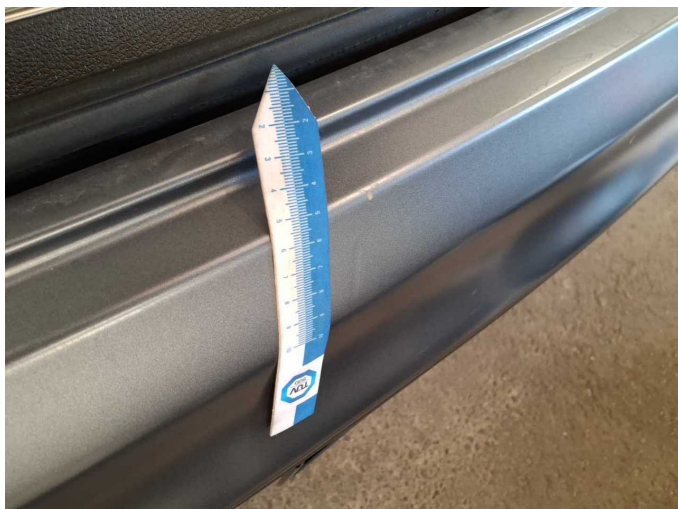
| No. | Component group | Description |
|---|---|---|
| 11 | Rear bumper | Rear bumper - Deformed - Repair and paint |

**Damage 11:** Rear bumper: Rear bumper - Deformed - Repair and paint

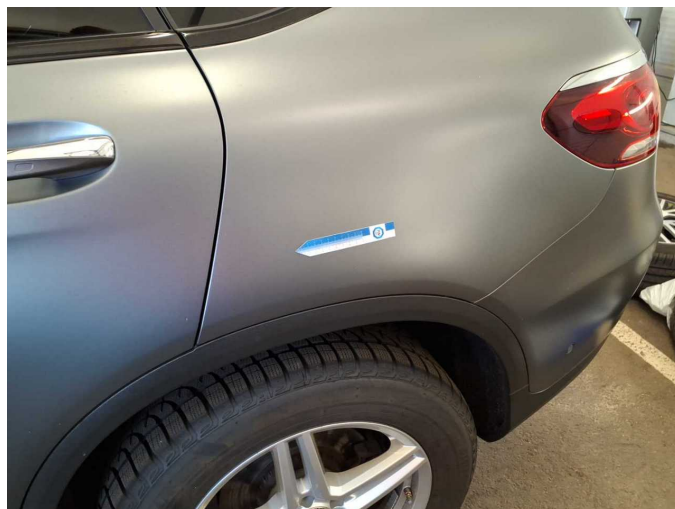
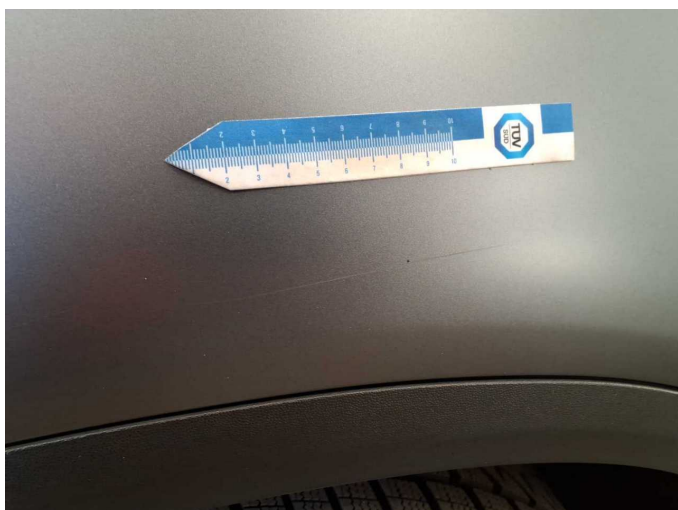
| No. | Component group | Description |
|---|---|---|
| 12 | Side panel - rear left side | Side panel - Scratch(es) - Paint |

**Damage 12:** Side panel - rear left side: Side panel - Scratch(es) - Paint

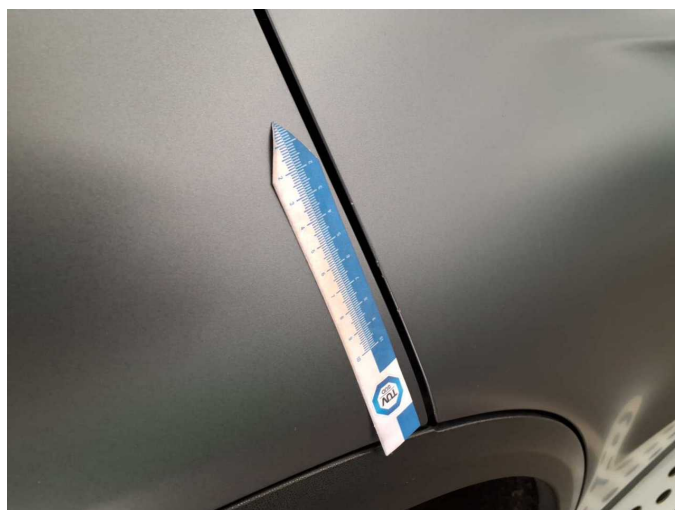
| No. | Component group | Description |
|---|---|---|
| 1 | Door - rear right side | Door edge - Scratch(es) - No deduction |

**Wear and tear 1:** Door - rear right side: Door edge - Scratch(es) - No deduction

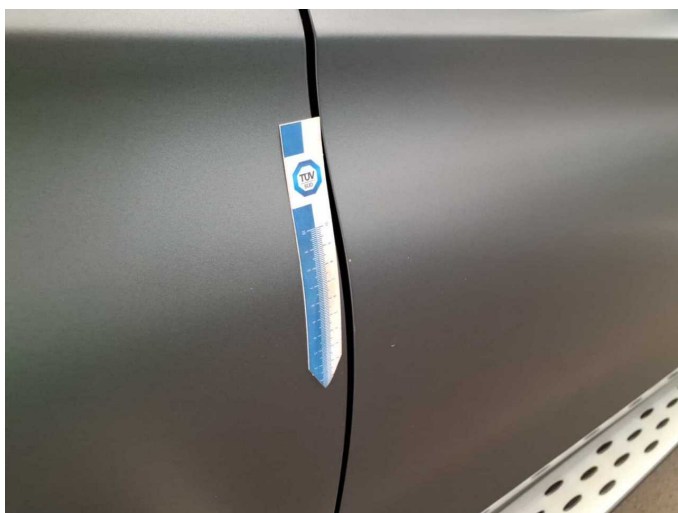
| No. | Component group | Description |
|---|---|---|
| 2 | Door - front right side | Door edge - Scratch(es) - No deduction |

**Wear and tear 2:** Door - front right side: Door edge - Scratch(es) - No deduction

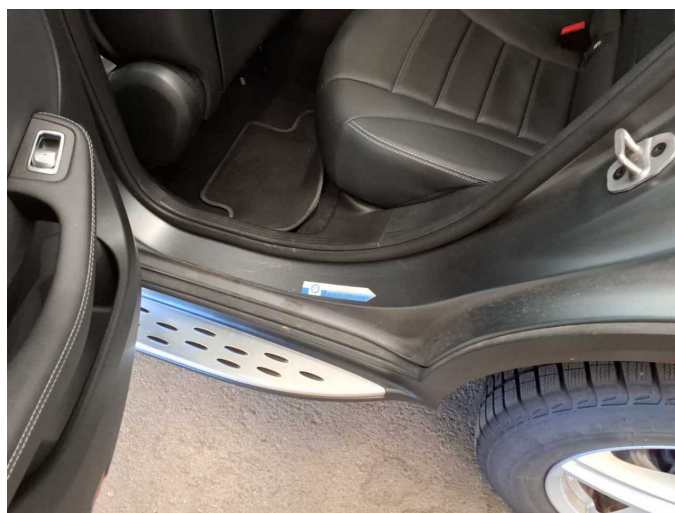
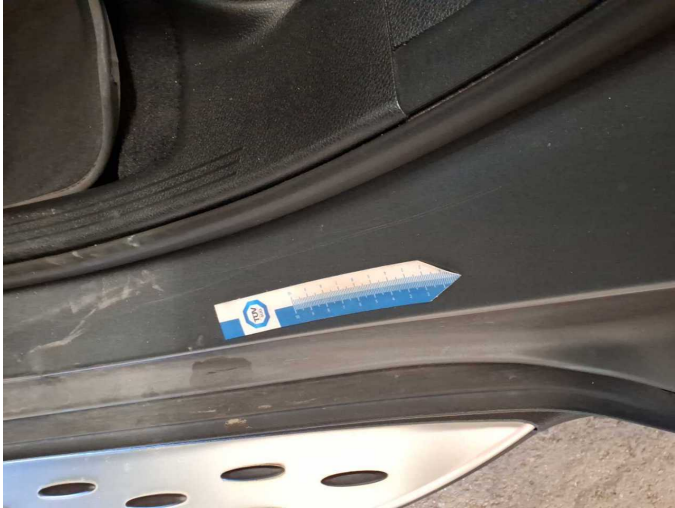
| No. | Component group | Description |
|---|---|---|
| 3 | Side panel - rear left side | Sill - Scratch(es) - No deduction |

**Wear and tear 3:** Side panel - rear left side: Sill - Scratch(es) - No deduction

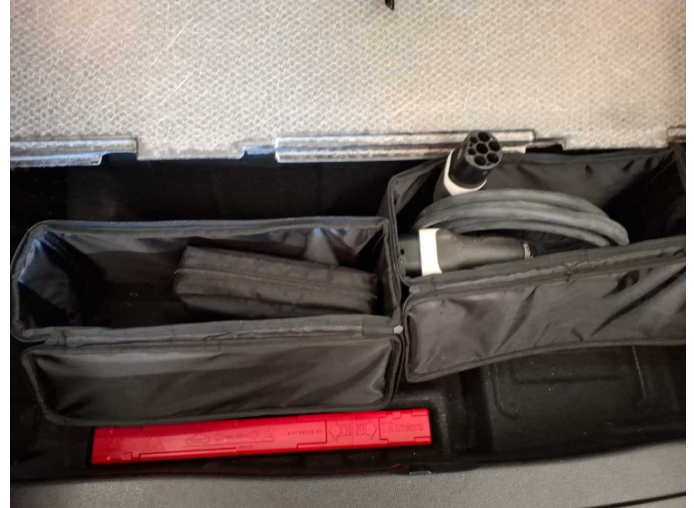
Equipment - charging cable (Ladekabel für Haushaltssteckdose)

**Missing part 1:** Equipment: charging cable (Ladekabel für Haushaltssteckdose) - Missing - Replace
