Expertise

Protocol number: 46402005  
Order No. / Reference: 26637766  
Inspection date: 7 Jul 2026

Manufacturer: Peugeot

Model: 3008 BlueHDi 130 Stop & Start EAT8 Allure

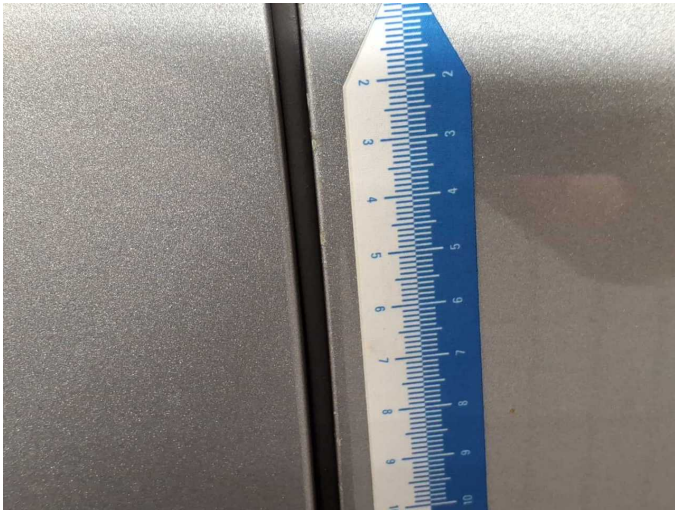
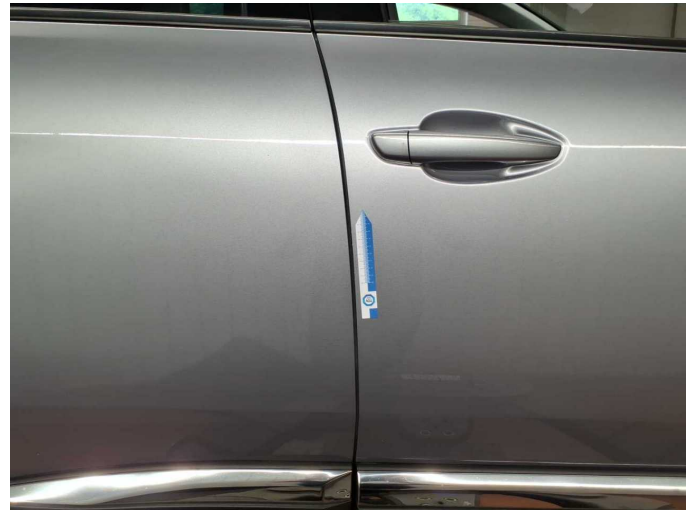
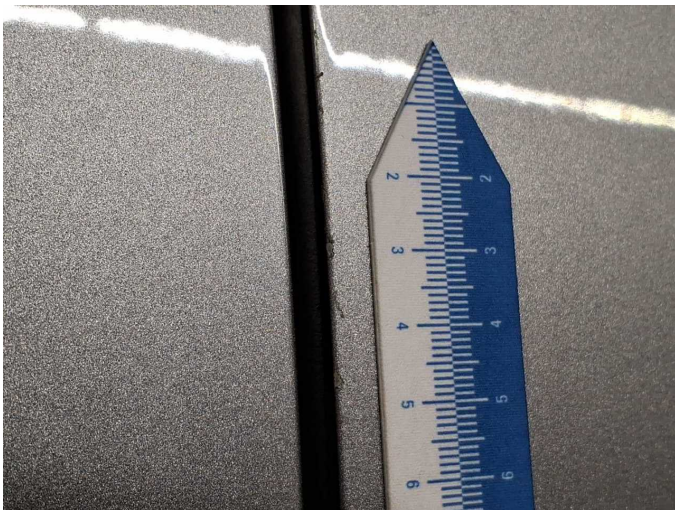
| No. | Component group | Description |
|---|---|---|
| 1 | Door - front right side | Door edge - Scratch(es) - Smart repair |

Damage 1: Door - front right side: Door edge - Scratch(es) - Smart repair

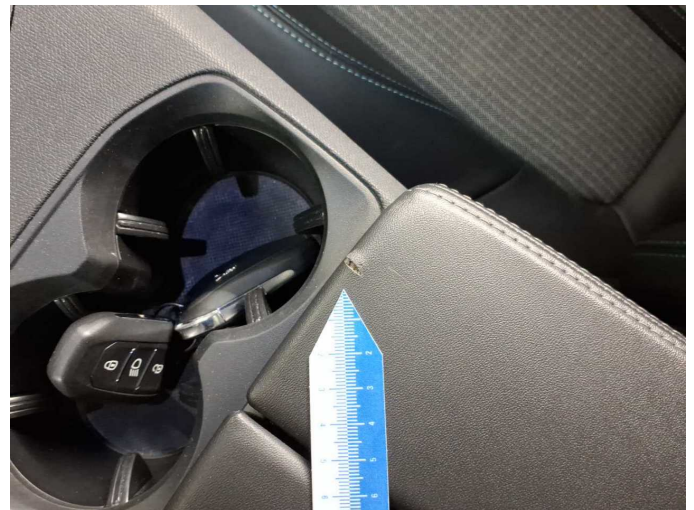
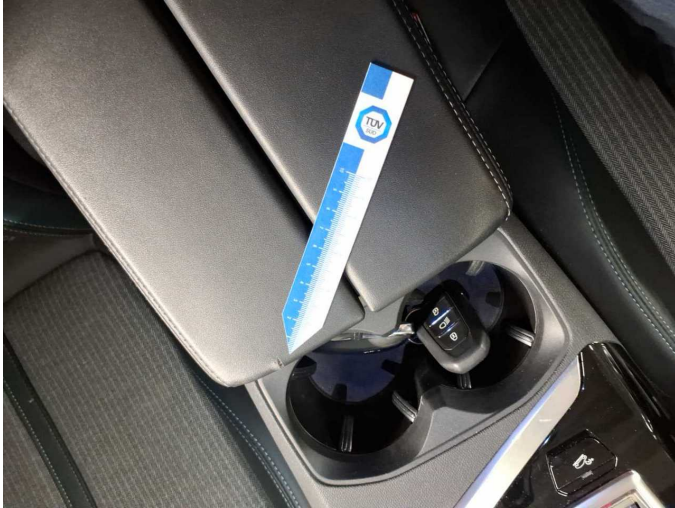
| No. | Component group | Description |
|---|---|---|
| 2 | Instrument panel | Centre console - front - Scratch(es) - Smart repair |

Damage 2: Instrument panel: Centre console - front - Scratch(es) - Smart repair

**Damage 2:** Instrument panel: Centre console - front - Scratch(es) - Smart repair

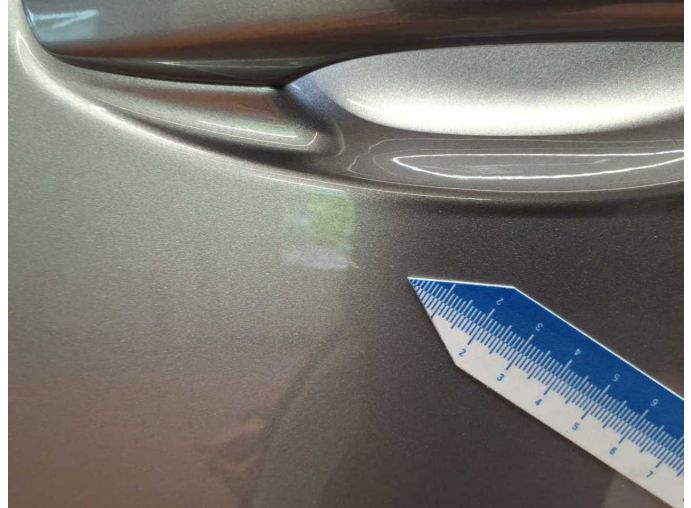
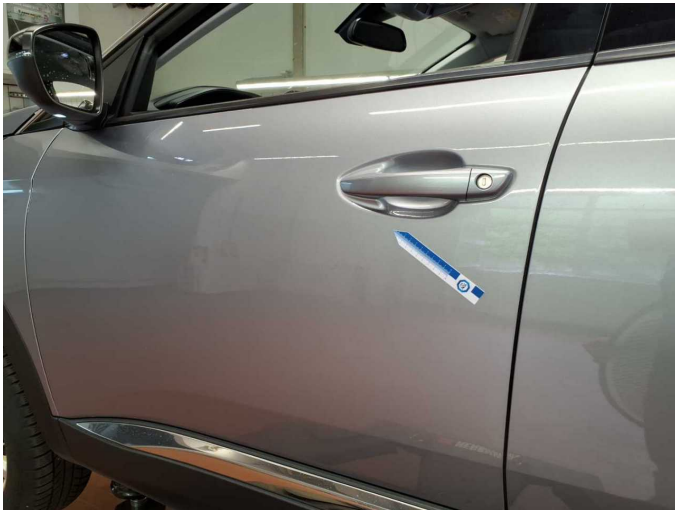
| No. | Component group | Description |
|---|---|---|
| 3 | Door - front left side | Door - Scratch(es) - Smart repair |

**Damage 3:** Door - front left side: Door - Scratch(es) - Smart repair

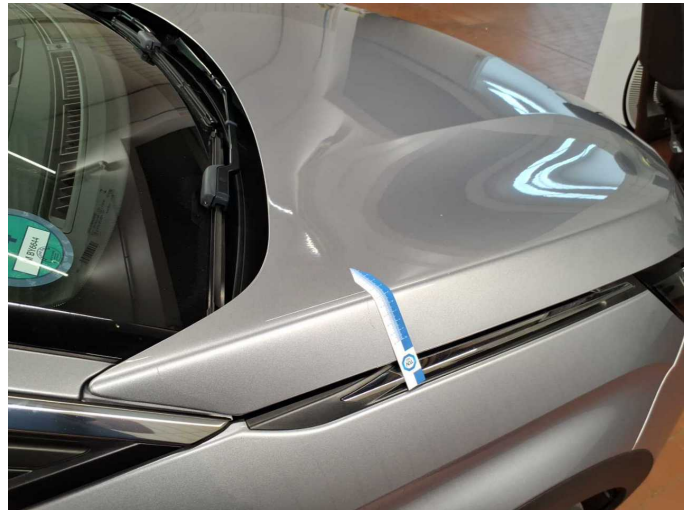
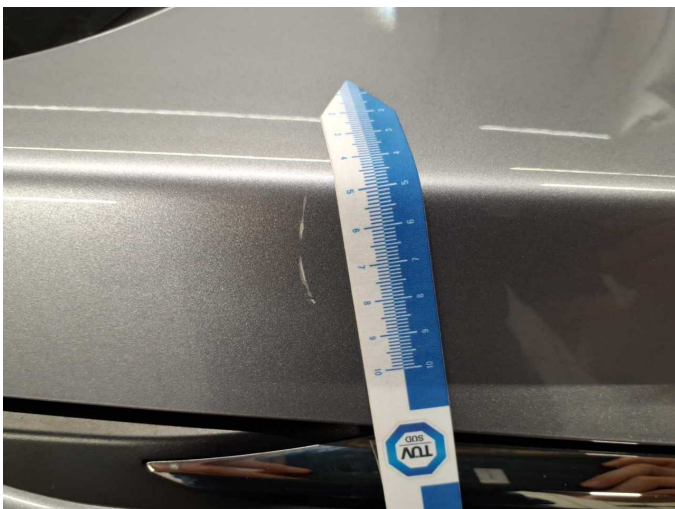
| No. | Component group | Description |
|---|---|---|
| 4 | Bonnet | Bonnet - Scratch(es) - Smart repair |

**Damage 4:** Bonnet: Bonnet - Scratch(es) - Smart repair

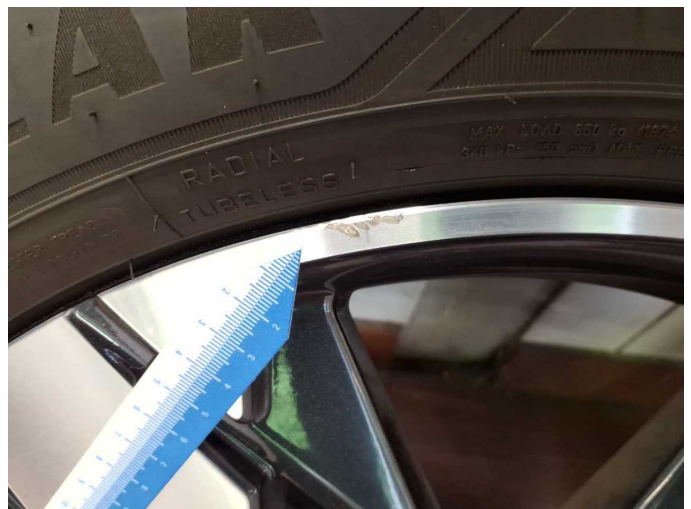
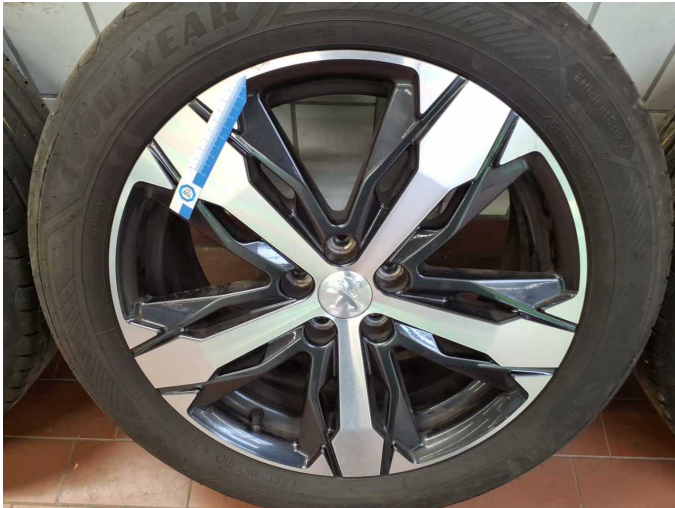
| No. | Component group | Description |
|---|---|---|
| 5 | 2nd wheel set | 1 alloy rim - Scratch(es) - Loss in value |

**Damage 5:** 2nd wheel set: 1 alloy rim - Scratch(es) - Loss in value

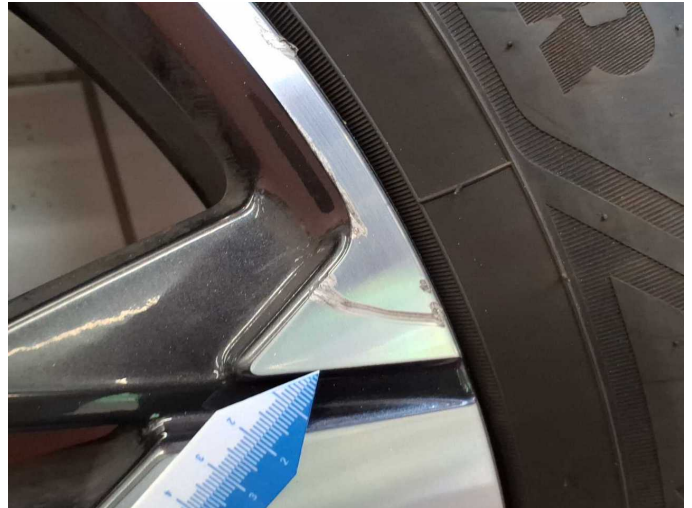
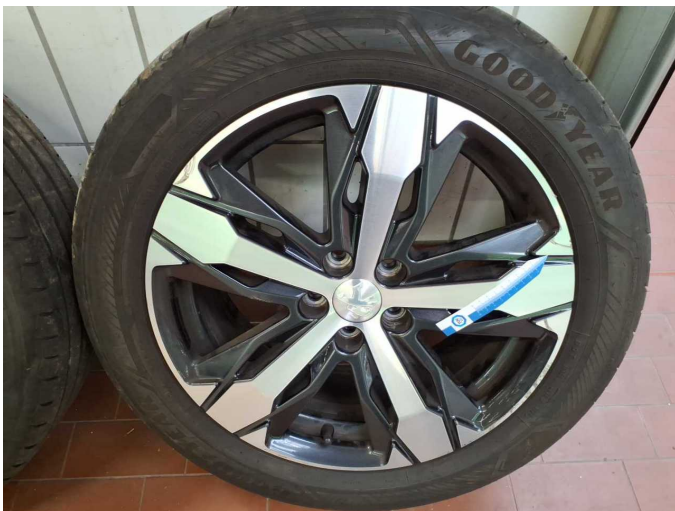
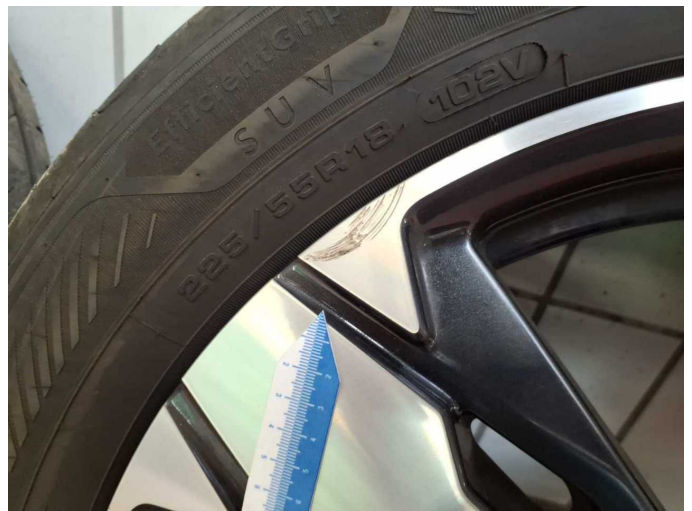
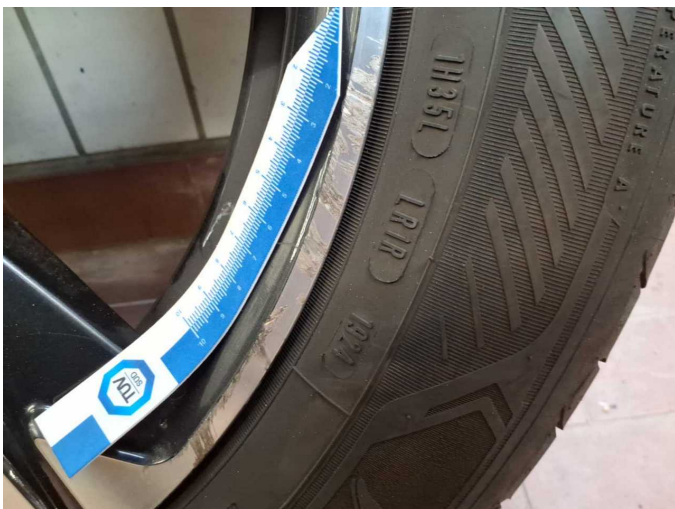
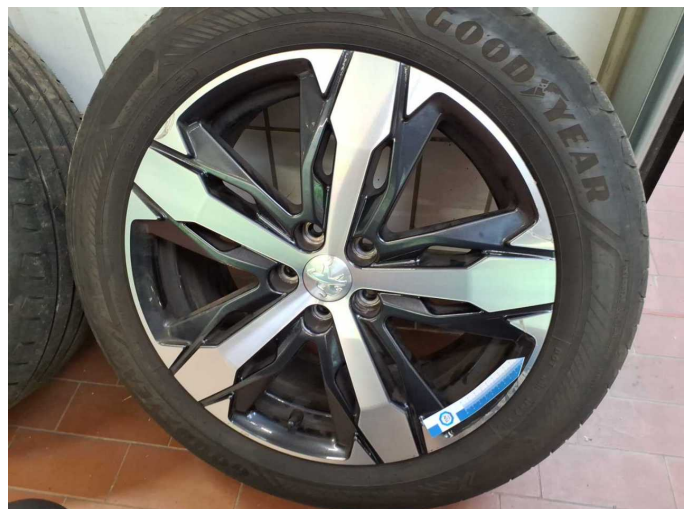
| No. | Component group | Description |
|---|---|---|
| 6 | 2nd wheel set | 1 alloy rim - Scratch(es) - Loss in value |

**Damage 6:** 2nd wheel set: 1 alloy rim - Scratch(es) - Loss in value

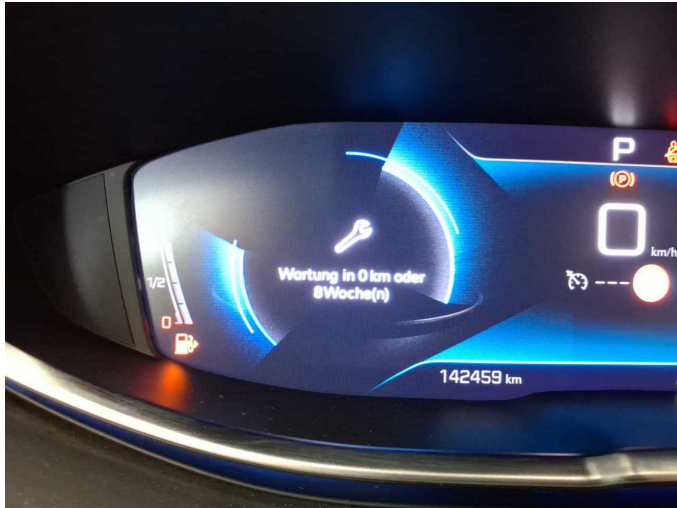
| No. | Component group | Description |
|---|---|---|
| 7 | Misc. | Inspection / maintenance - Due - Perform |

**Damage 7:** Misc.: Inspection / maintenance - Due - Perform

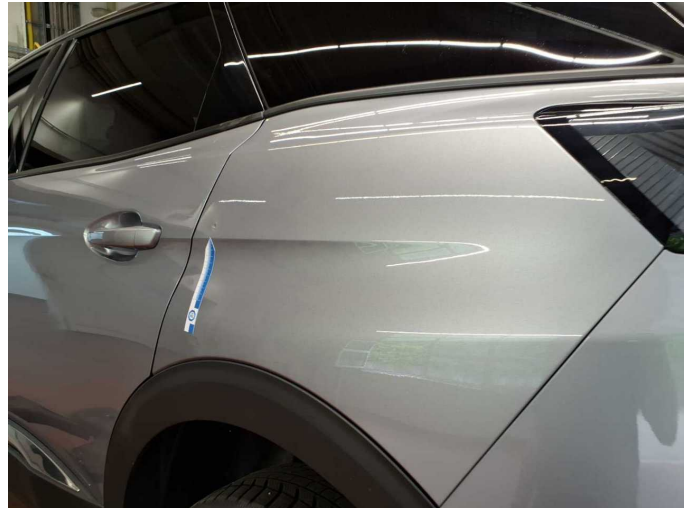
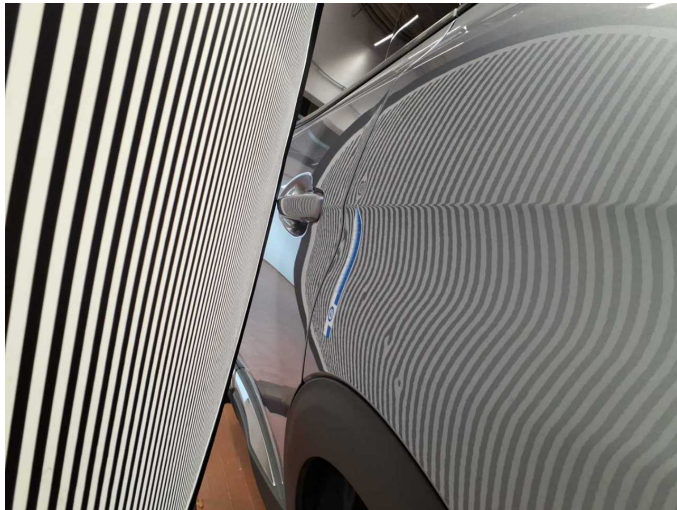
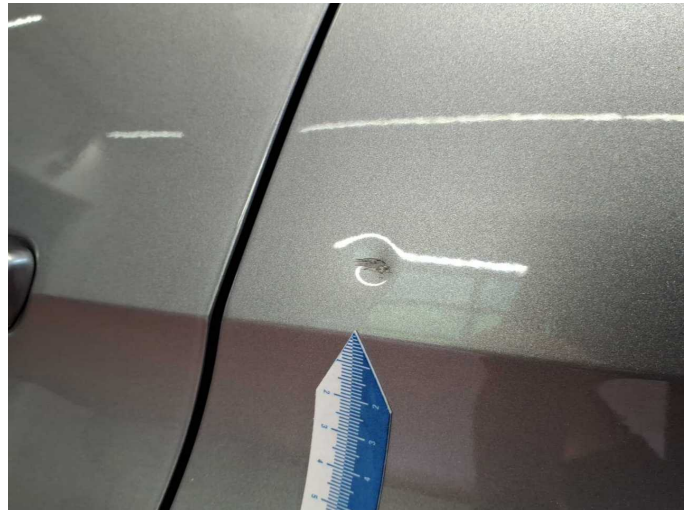
| No. | Component group | Description |
|---|---|---|
| 8 | Side panel - rear left side | Side panel - Dent / paintcoat damage - Repair and paint |

**Damage 8:** Side panel - rear left side: Side panel - Dent / paintcoat damage - Repair and paint

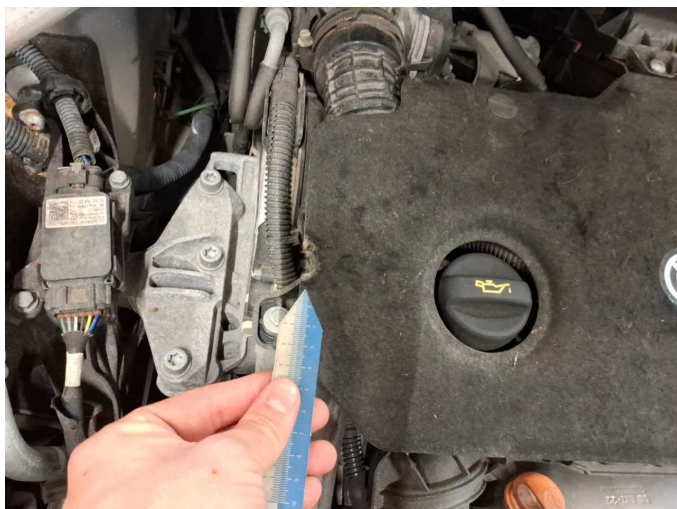
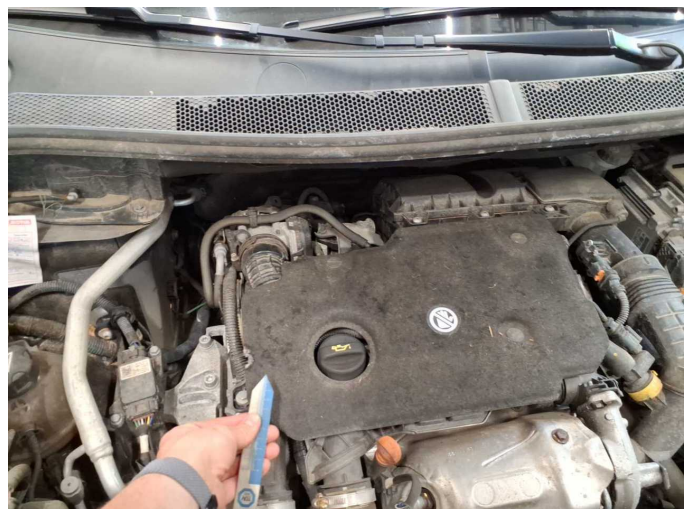
| No. | Component group | Description |
|---|---|---|
| 1 | Engine | Engine cover - Broken / torn - No deduction |

**Wear and tear 1:** Engine: Engine cover - Broken / torn - No deduction

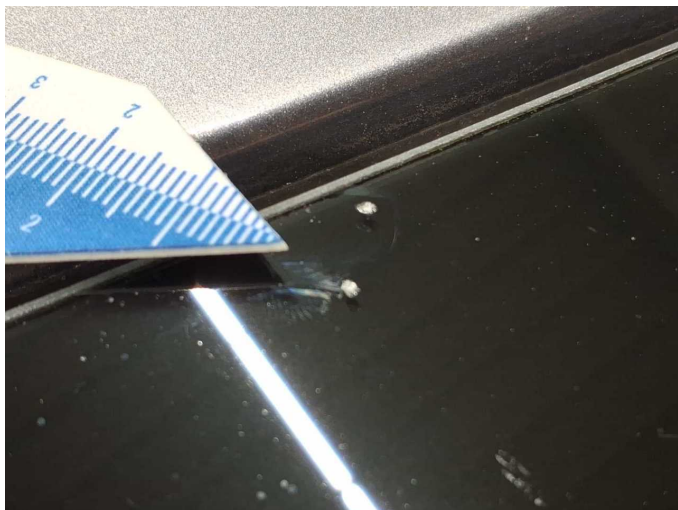
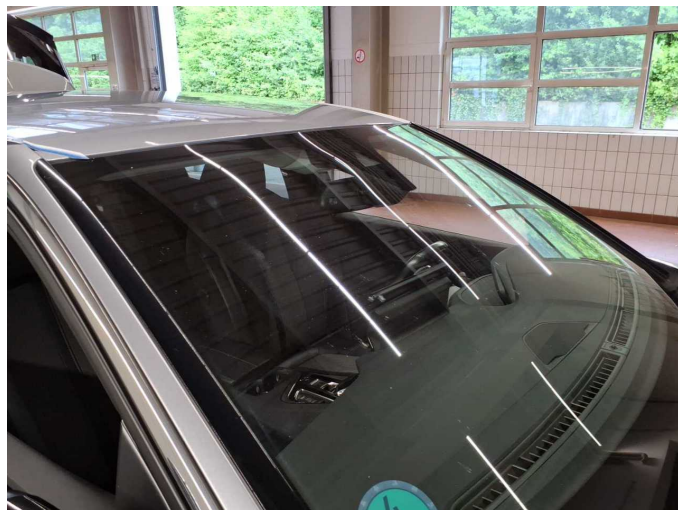
| No. | Component group | Description |
|---|---|---|
| 4 | Vehicle glazing | Windscreen - Stone chips - No deduction |

**Wear and tear 4:** Vehicle glazing: Windscreen - Stone chips - No deduction

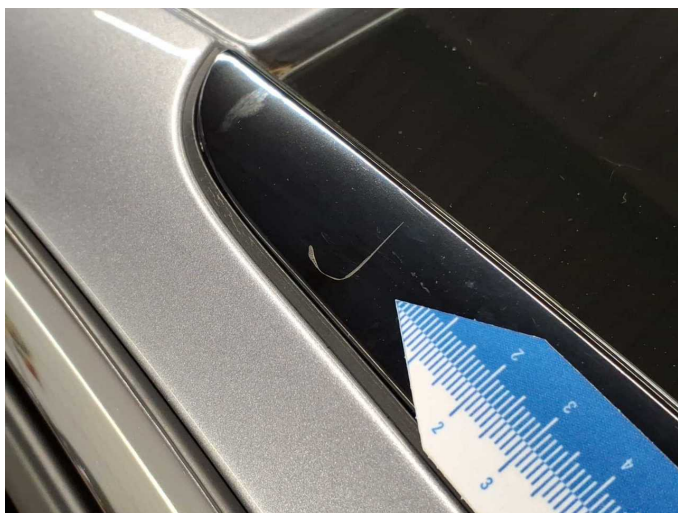
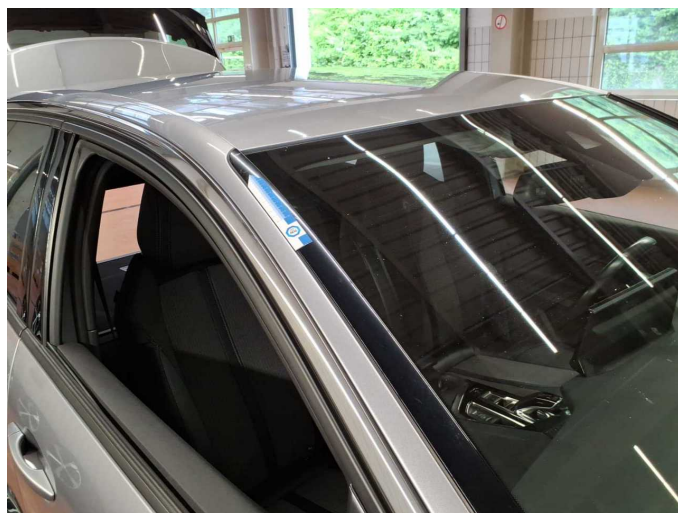
| No. | Component group | Description |
|---|---|---|
| 5 | Roof | Cowl - right side - Scratch(es) - No deduction |

**Wear and tear 5:** Roof: Cowl - right side - Scratch(es) - No deduction
