Expertise

Protocol number: 46454173  
Order No. / Reference: 26726995  
Inspection date: 9 Jul 2026

Manufacturer: Opel

Model: Mokka 1.2 DI Turbo Business Elegance

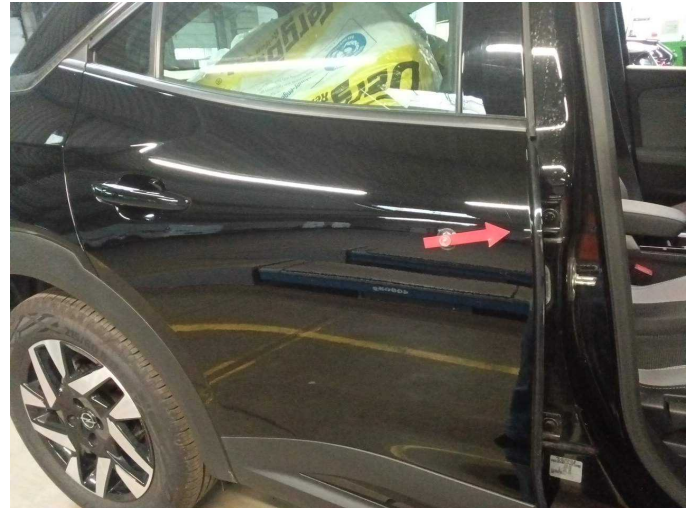
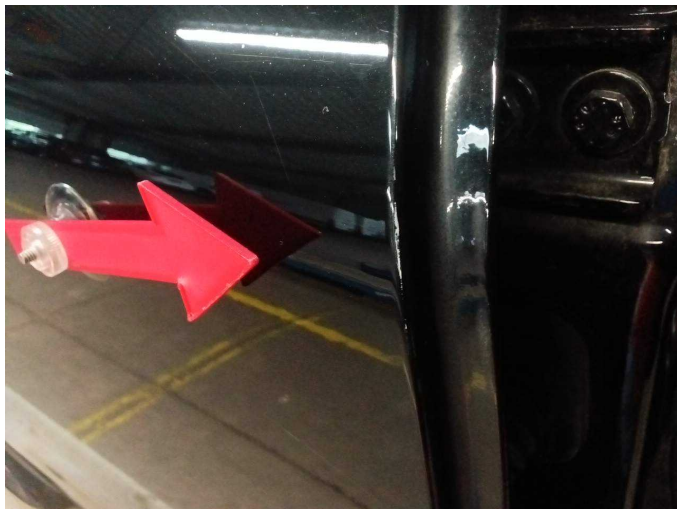
| No. | Component group | Description |
|---|---|---|
| 1 | Door - rear right side | Door edge - Scratch(es) - Smart repair |

**Damage 1:** Door - rear right side: Door edge - Scratch(es) - Smart repair

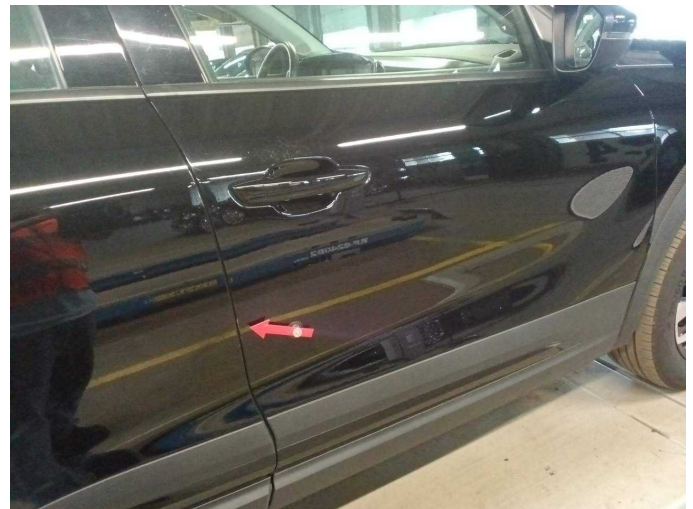
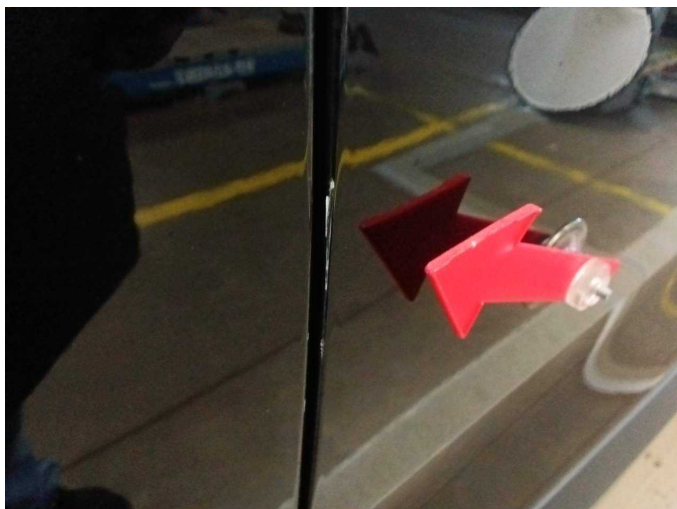
| No. | Component group | Description |
|---|---|---|
| 2 | Door - front right side | Door edge - Scratch(es) - Smart repair |

**Damage 2:** Door - front right side: Door edge - Scratch(es) - Smart repair

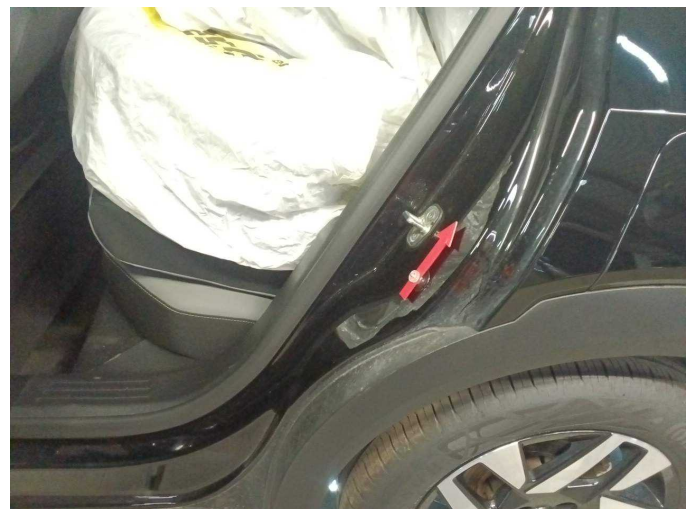
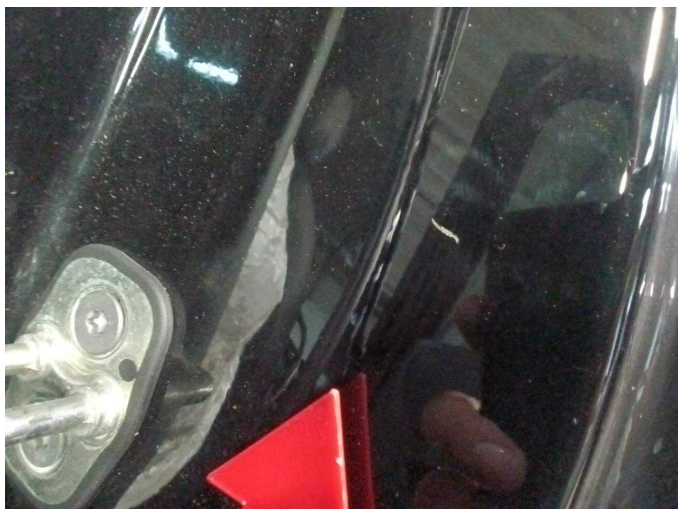
| No. | Component group | Description |
|---|---|---|
| 3 | Side panel - rear left side | Sill - Scratch(es) - Smart repair |

**Damage 3:** Side panel - rear left side: Sill - Scratch(es) - Smart repair

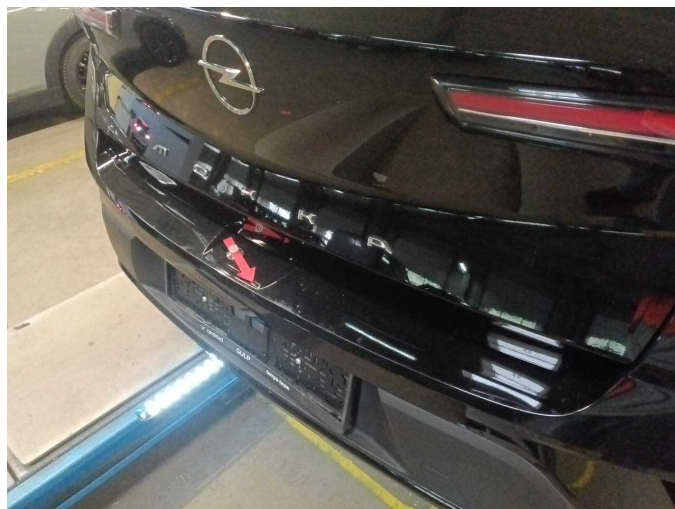
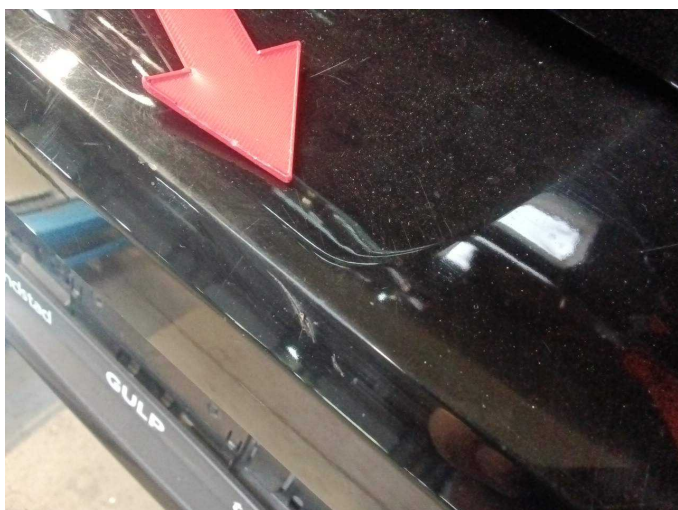
| No. | Component group | Description |
|---|---|---|
| 4 | Rear bumper | Rear bumper - Scratch(es) - Smart repair |

**Damage 4:** Rear bumper: Rear bumper - Scratch(es) - Smart repair

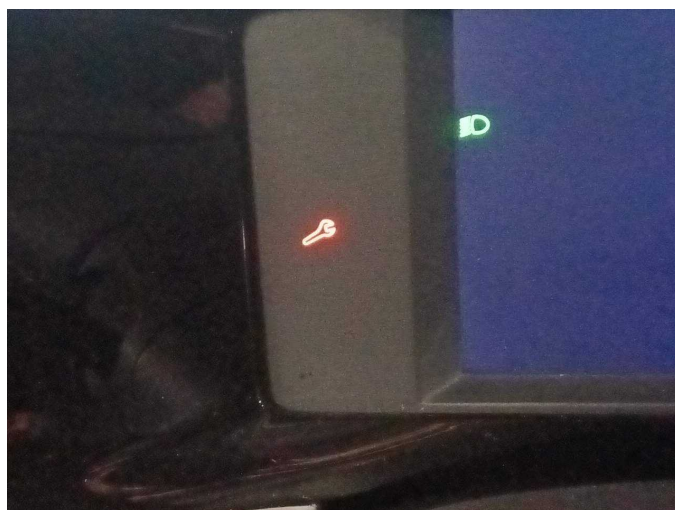
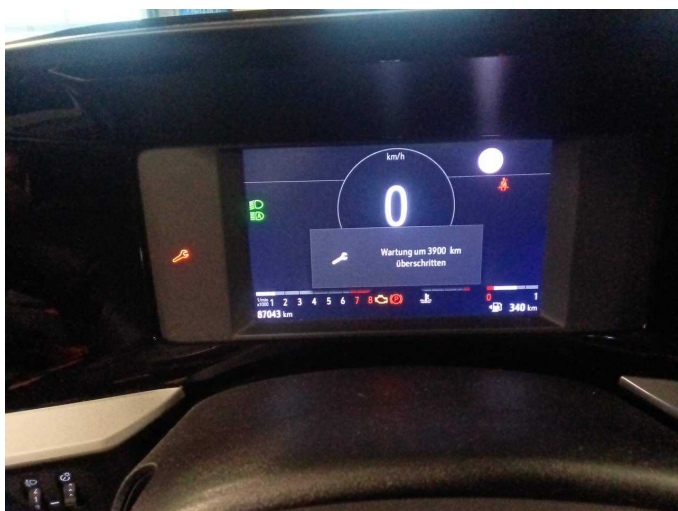
| No. | Component group | Description |
|---|---|---|
| 5 | Misc. | Inspection / maintenance - Due - Perform |

**Damage 5:** Misc.: Inspection / maintenance - Due - Perform

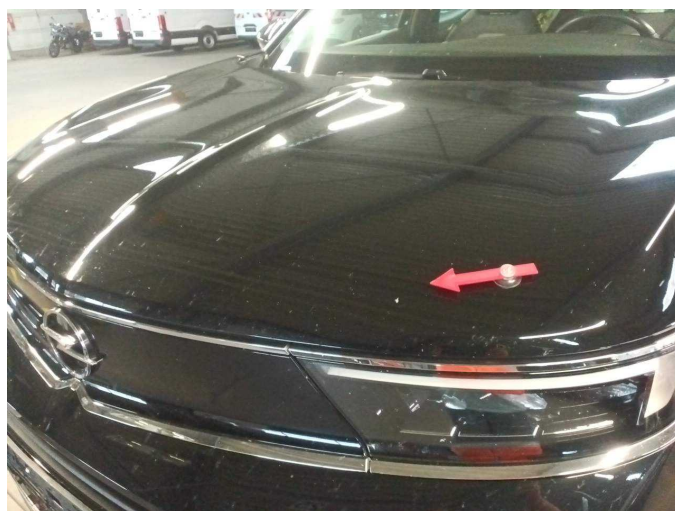
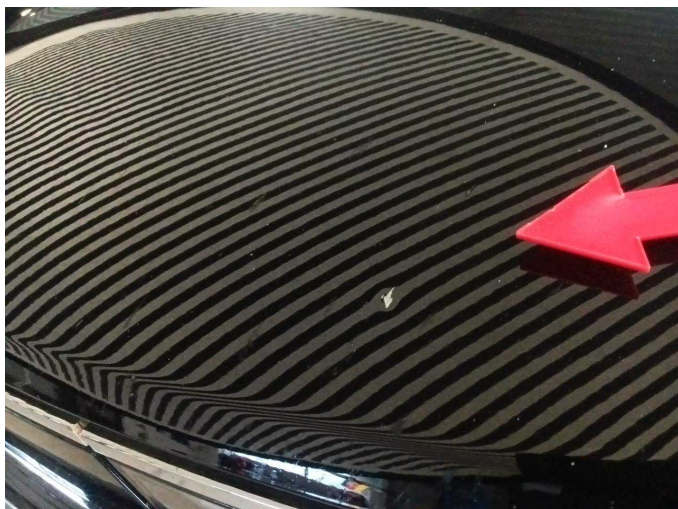
| No. | Component group | Description |
|---|---|---|
| 6 | Bonnet | Bonnet - Dent / paintcoat damage - Repair and paint |

**Damage 6:** Bonnet: Bonnet - Dent / paintcoat damage - Repair and paint

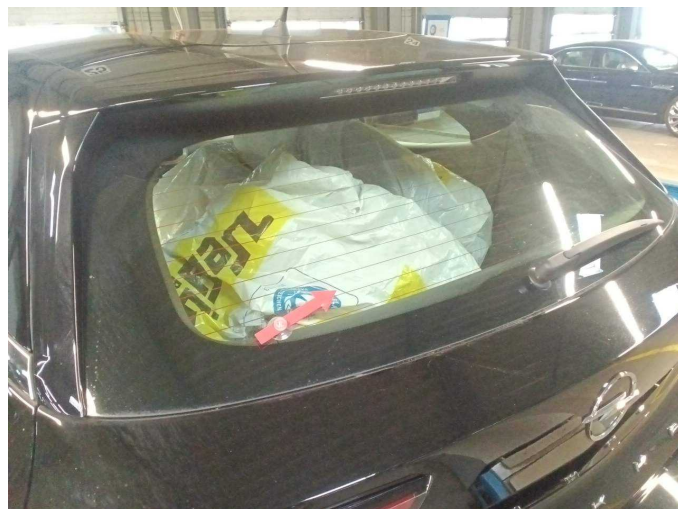
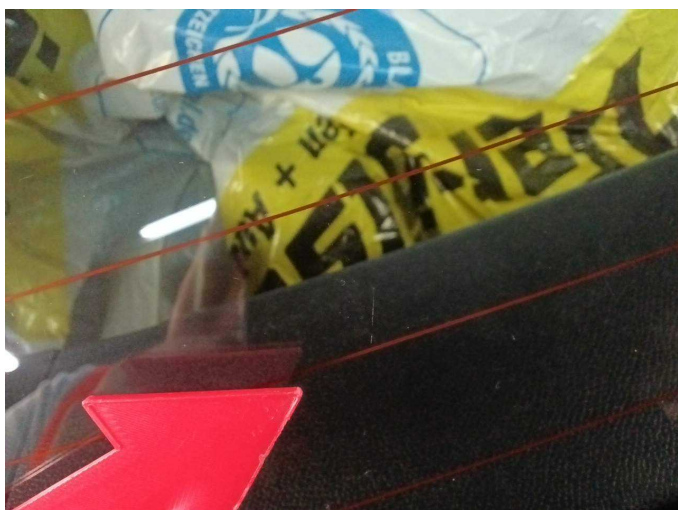
| No. | Component group | Description |
|---|---|---|
| 7 | Vehicle glazing | Rear window - Scratch(es) - Replace |

**Damage 7:** Vehicle glazing: Rear window - Scratch(es) - Replace

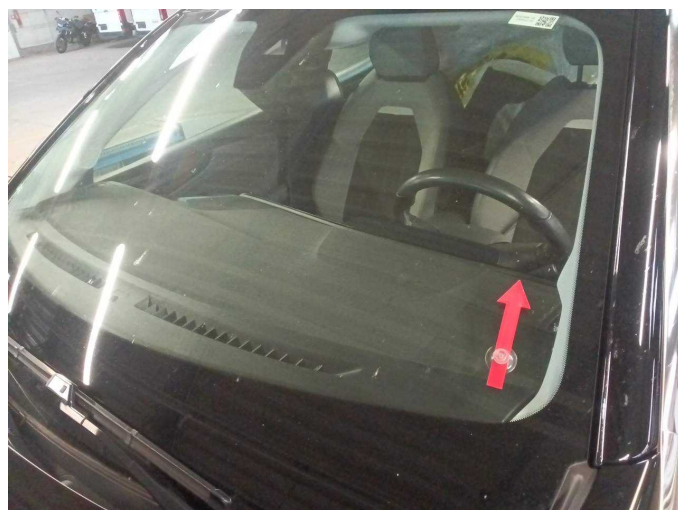
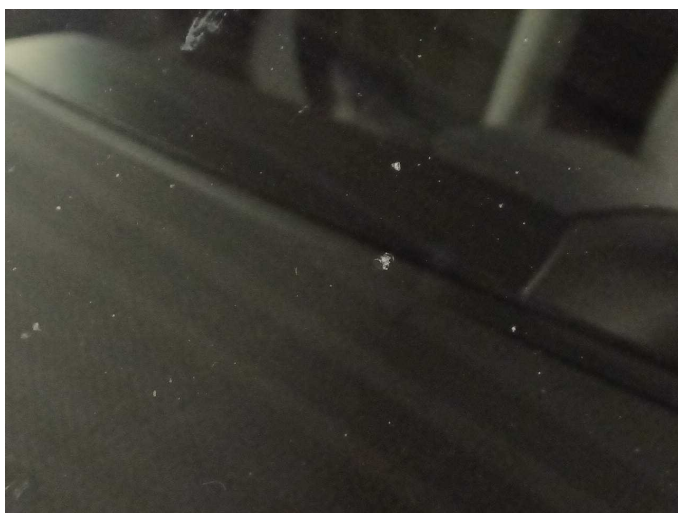
| No. | Component group | Description |
|---|---|---|
| 1 | Vehicle glazing | Windscreen - Stone chips - No deduction |

**Wear and tear 1:** Vehicle glazing: Windscreen - Stone chips - No deduction

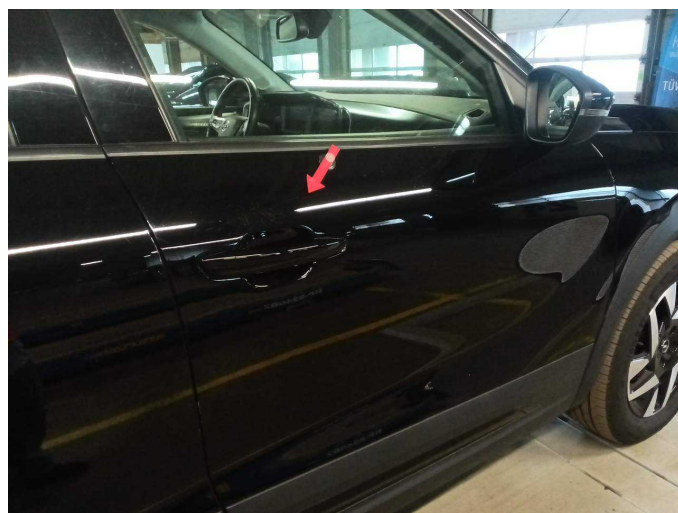
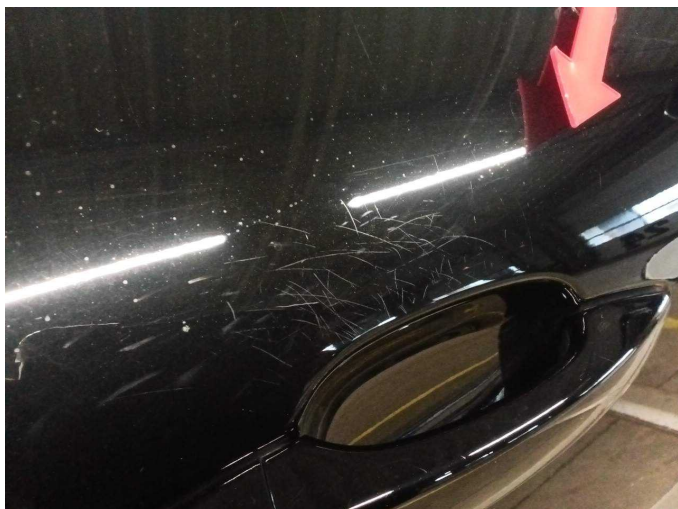
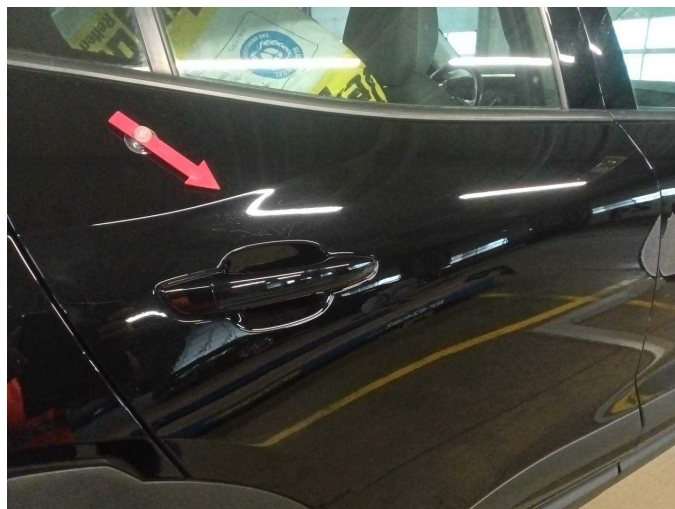
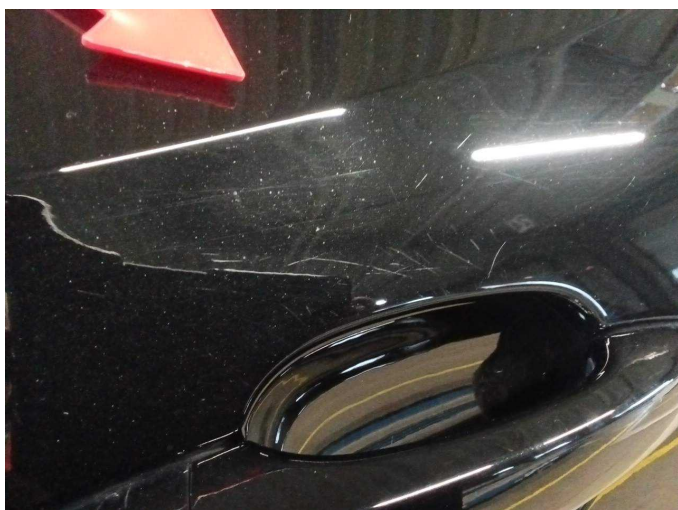
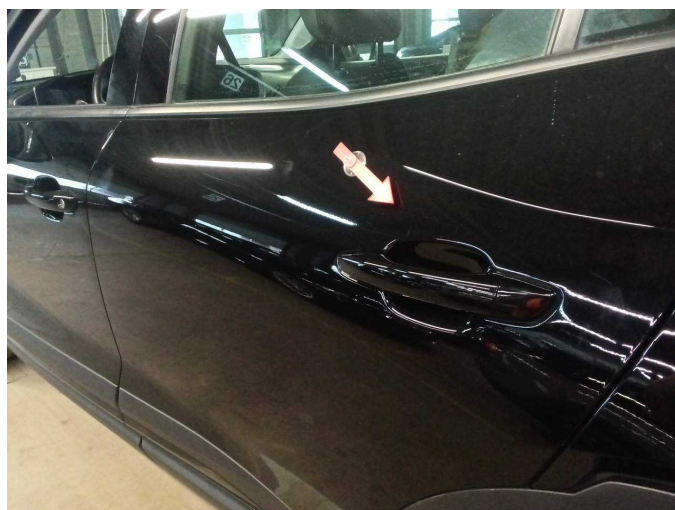
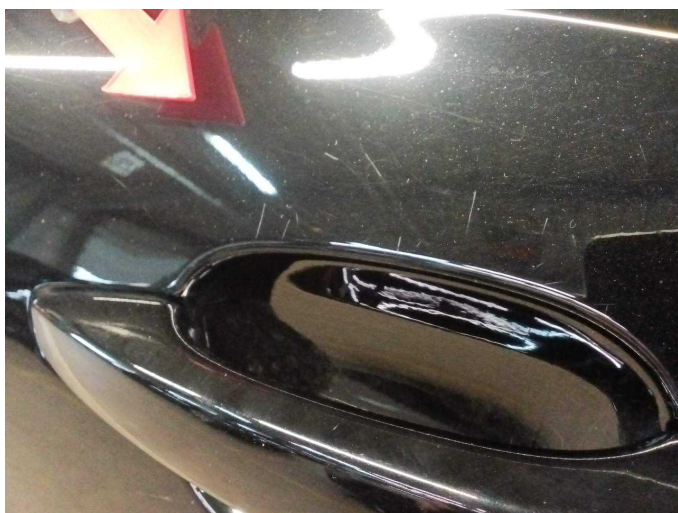
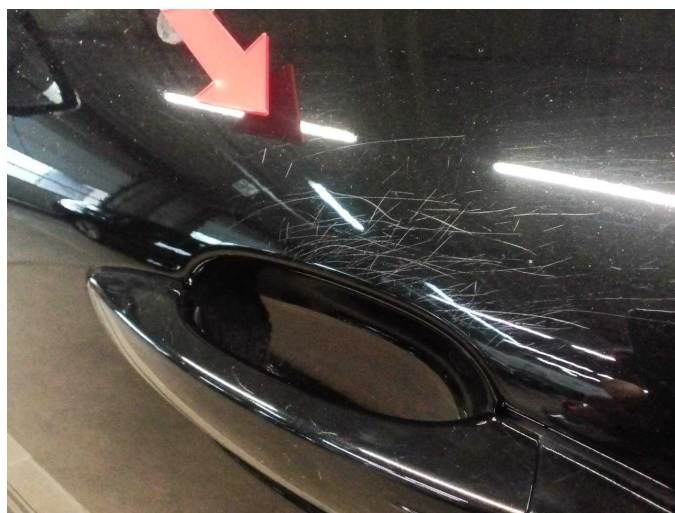
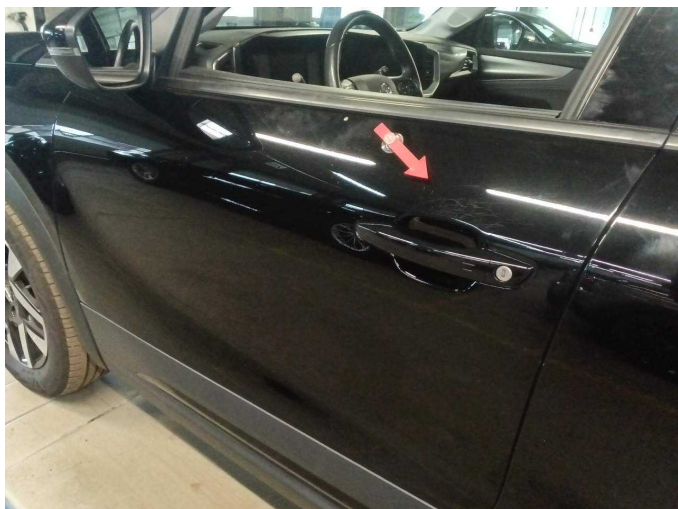
| No. | Component group | Description |
|---|---|---|
| 2 | Body | Body - Scratch(es) - No deduction |

**Wear and tear 2:** Body: Body - Scratch(es) - No deduction
