Expertise

Protocol number: 46233915  
Order No. / Reference: 26568352  
Inspection date: 30 Jun 2026

Manufacturer: Ford

Model: Transit Custom 320 L1H1 LKW VA Trend

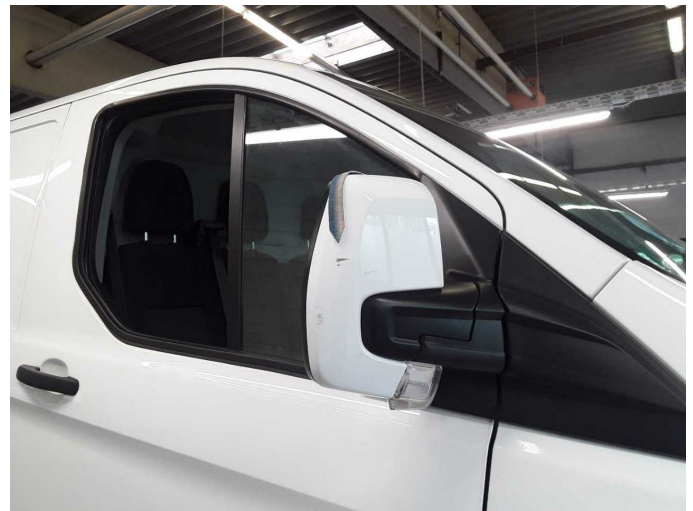
| No. | Component group | Description |
|---|---|---|
| 2 | Wing mirror - right side | Cap - Scratch(es) - Smart repair |

Damage 2: Wing mirror - right side: Cap - Scratch(es) - Smart repair

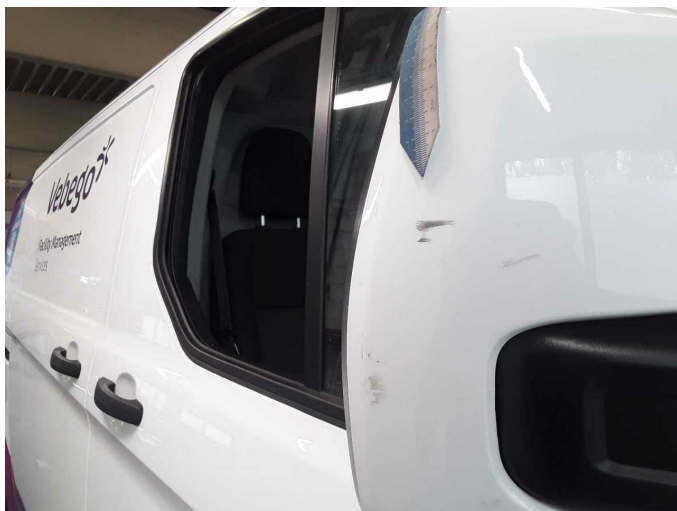
Damage 2: Wing mirror - right side: Cap - Scratch(es) - Smart repair

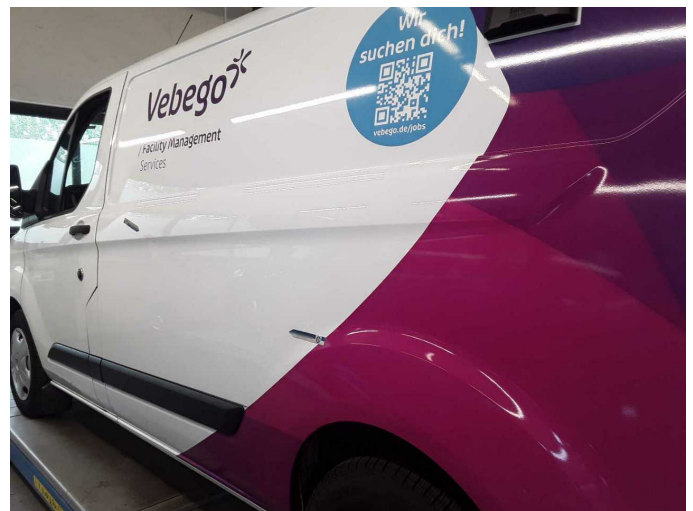
| No. | Component group | Description |
|---|---|---|
| 3 | Side panel - rear left side | Side panel - Deformed - Smooth repair work |

Damage 3: Side panel - rear left side: Side panel - Deformed - Smooth repair work

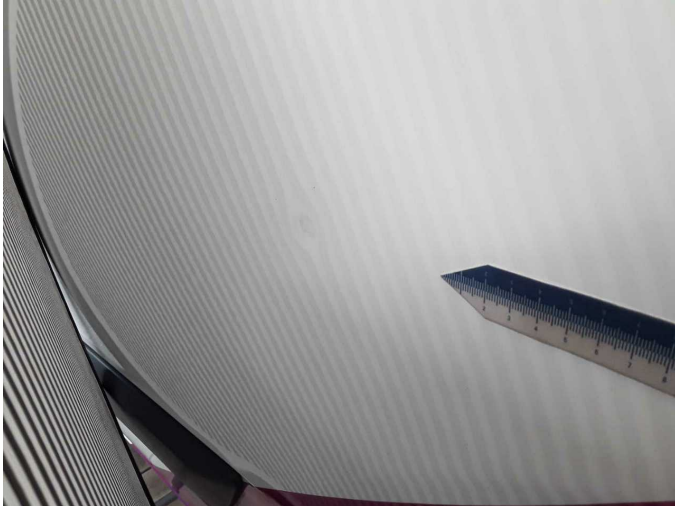
**Damage 3:** Side panel - rear left side: Side panel - Deformed - Smooth repair work

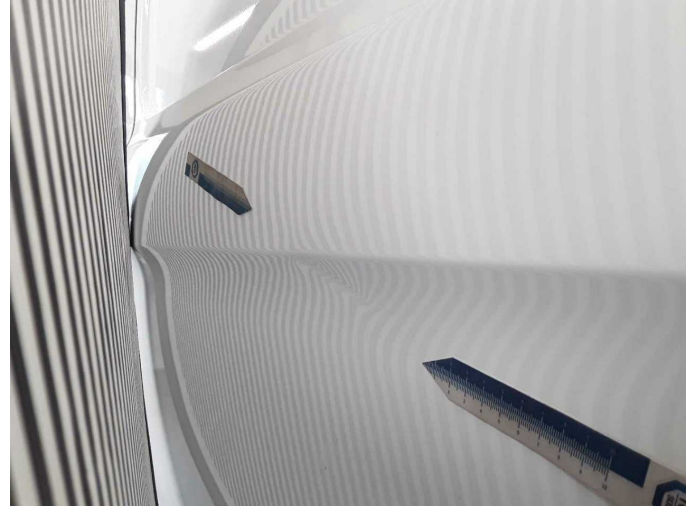
**Damage 3:** Side panel - rear left side: Side panel - Deformed - Smooth repair work

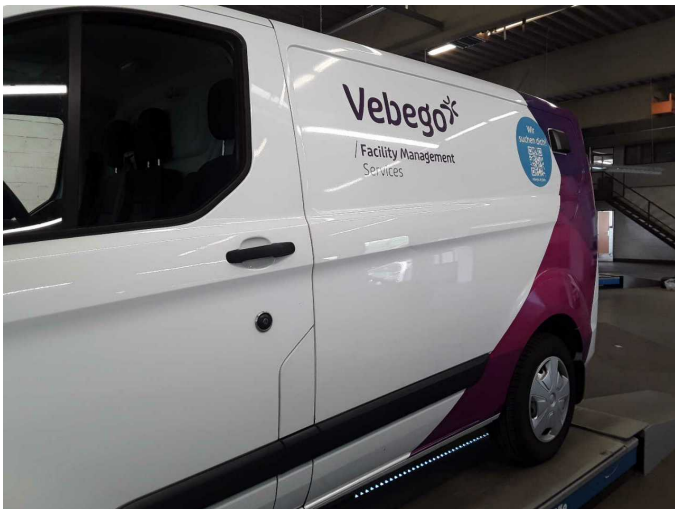
| No. | Component group | Description |
|---|---|---|
| 4 | Body | Body (Folgekosten möglich) - Glued / labelled - De-glue / neutralise |

**Damage 4:** Body: Body (Folgekosten möglich) - Glued / labelled - De-glue / neutralise

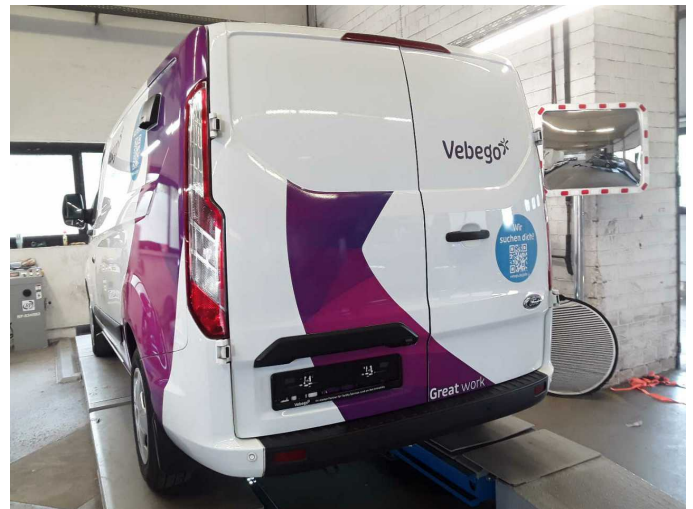
**Damage 4:** Body: Body (Folgekosten möglich) - Glued / labelled - De-glue / neutralise

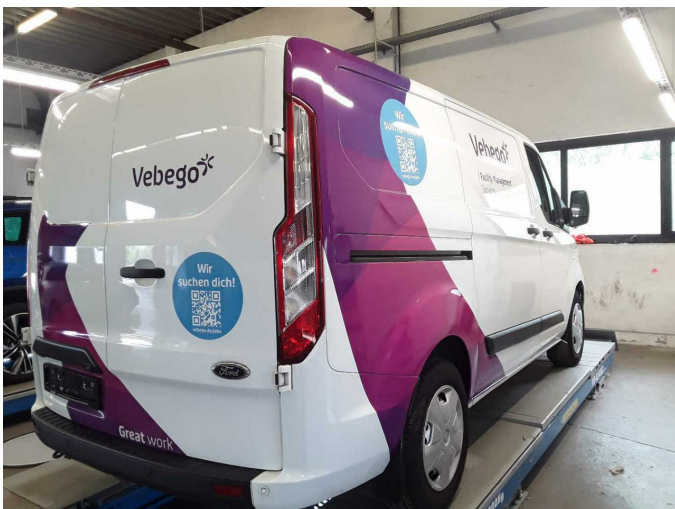
**Damage 4:** Body: Body (Folgekosten möglich) - Glued / labelled - De-glue / neutralise

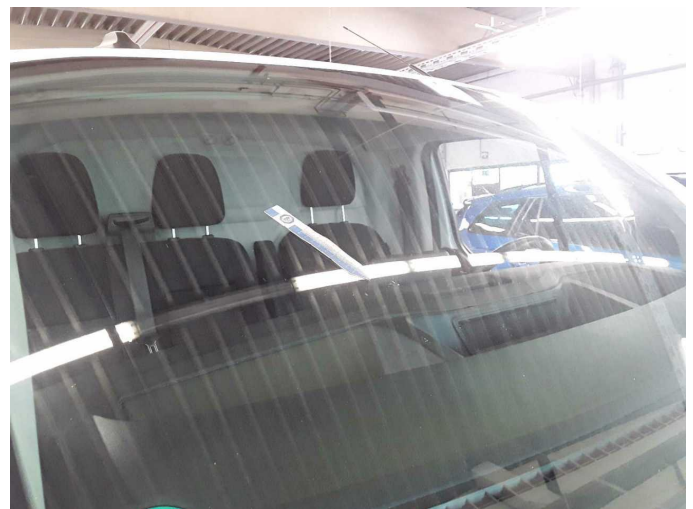
| No. | Component group | Description |
|---|---|---|
| 5 | Vehicle glazing | Windscreen (Rissbildung) - Stone chips - Replace |

**Damage 5:** Vehicle glazing: Windscreen (Rissbildung) - Stone chips - Replace

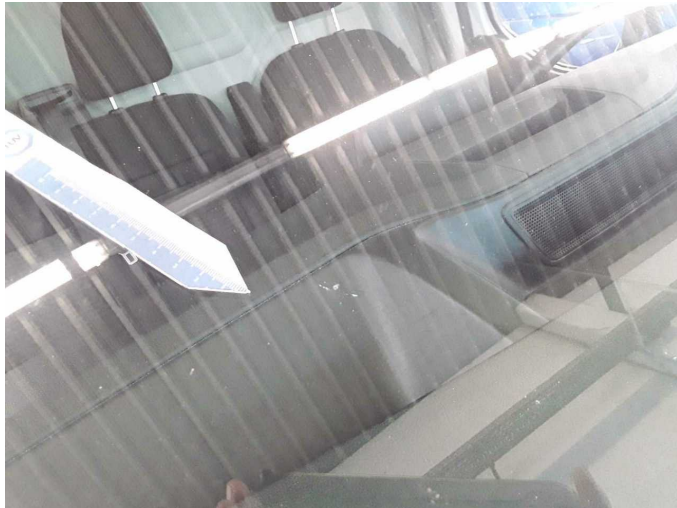
**Damage 5:** Vehicle glazing: Windscreen (Rissbildung) - Stone chips - Replace

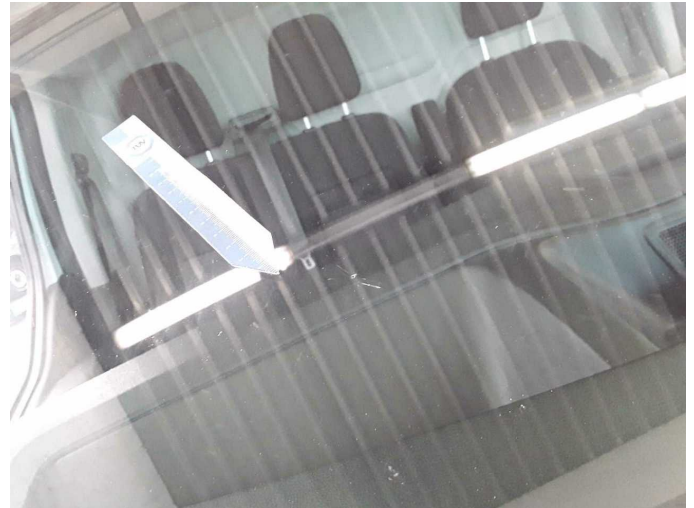
**Damage 5:** Vehicle glazing: Windscreen (Rissbildung) - Stone chips - Replace

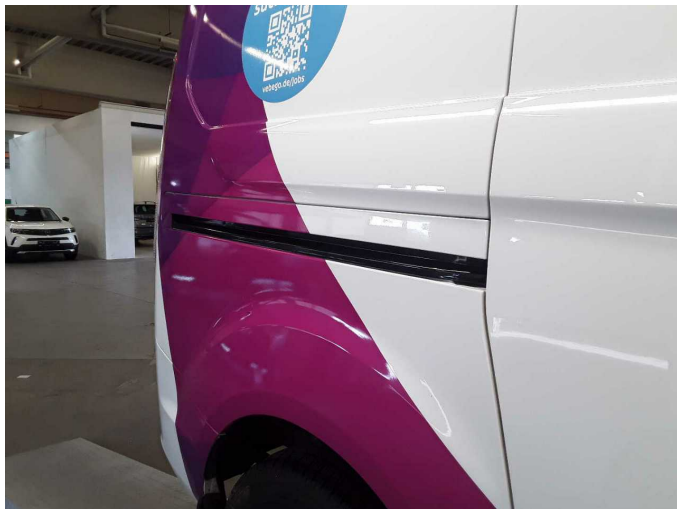
| No. | Repainting |
|---|---|
| 1 | Side panel - rear right side, Door - rear right side, Professionally carried out, Invoice of repair done Non-existent |

**Repainting 1:** Side panel - rear right side, Door - rear right side

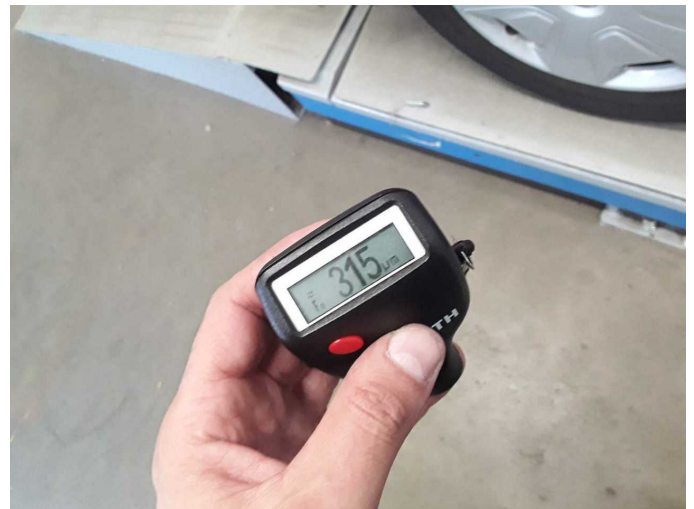
**Repainting 1:** Side panel - rear right side, Door - rear right side

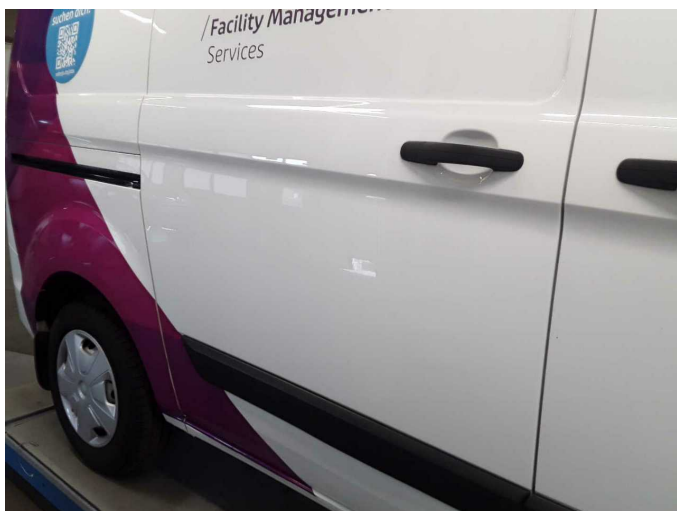
**Repainting 1:** Side panel - rear right side, Door - rear right side

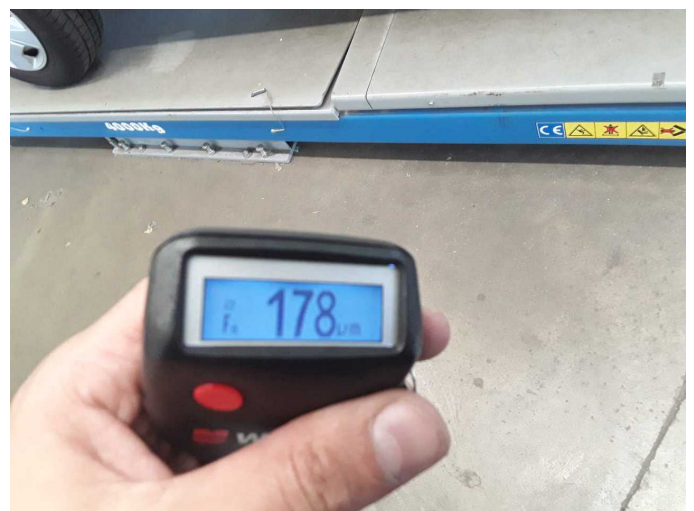
**Repainting 1:** Side panel - rear right side, Door - rear right side
