Expertise

Protocol number: 43976902
Order number / reference: 25927219
Inspection date: 19 Feb 2026

Model: 317 CDI Sprinter Standard HA PRO

VIN: W1V3KBFZ6TP858957

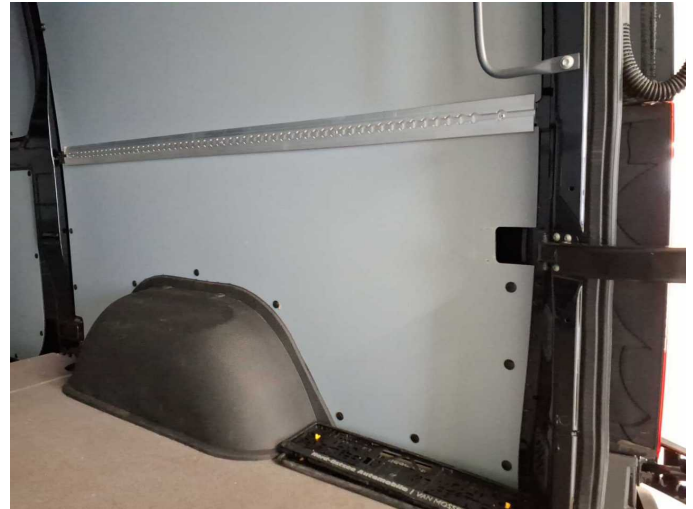
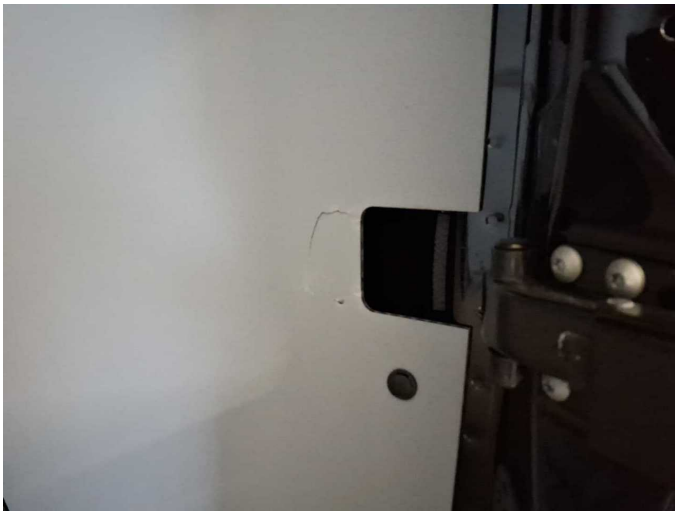
Damage 1: Trim / covers: Cargo area - lining - right side (unten) - Damaged - Loss in value

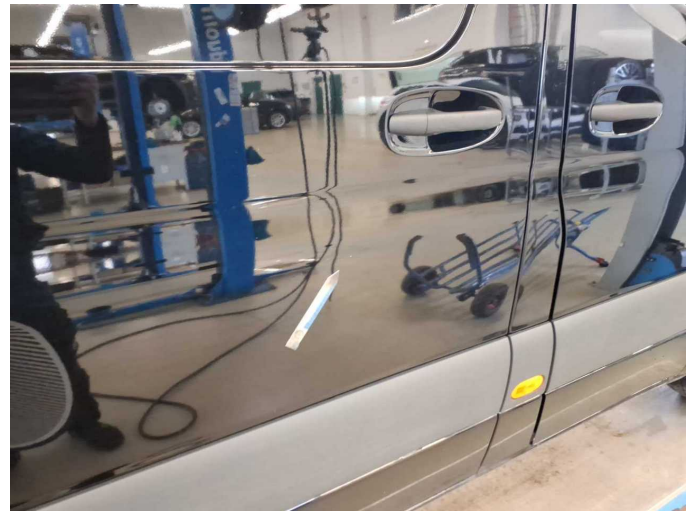
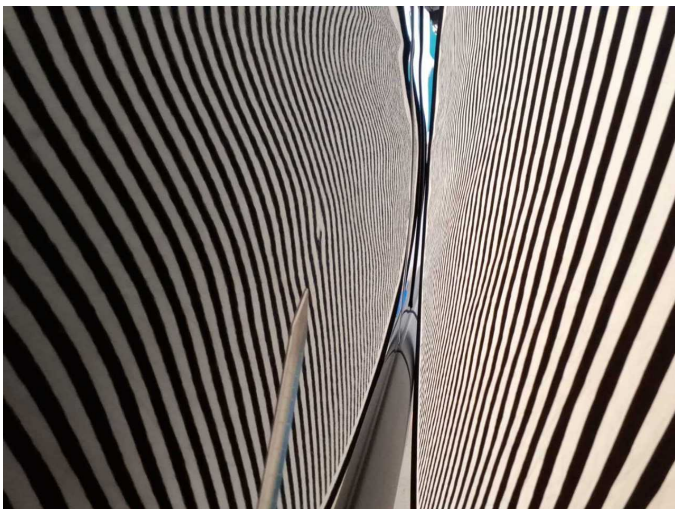
Damage 2: Sliding door, right: Sliding door - dent(s) - Smart repair

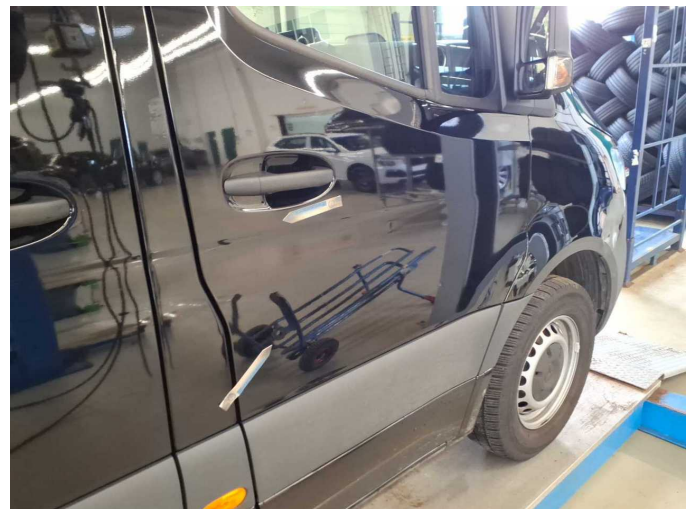
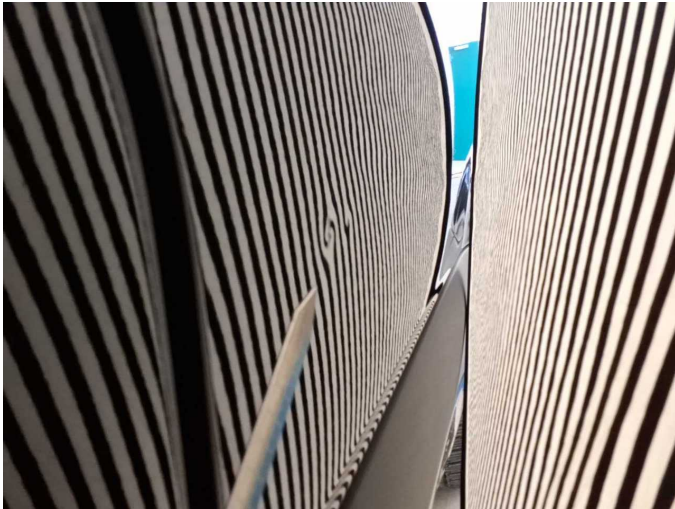
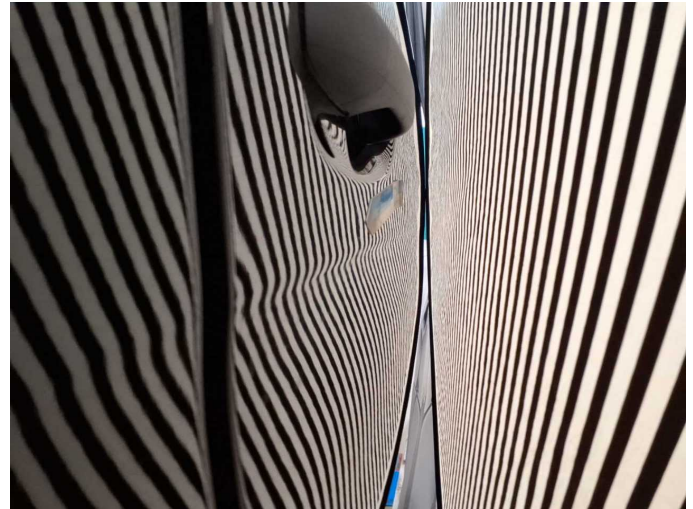
Damage 3: Door - front right side: Door - dent(s) - Smart repair

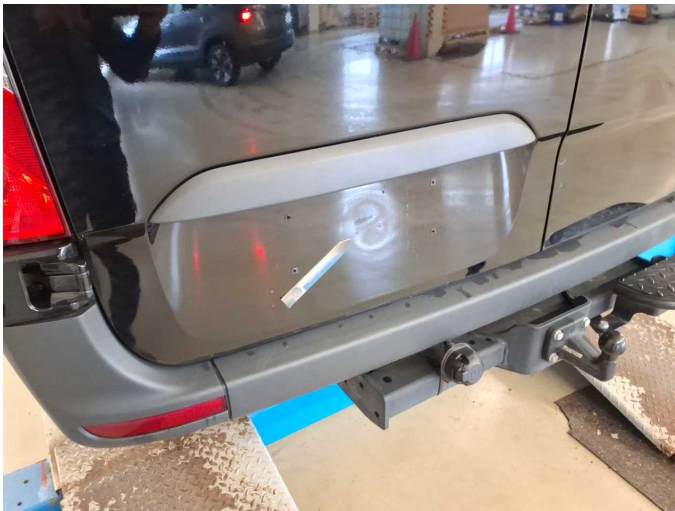
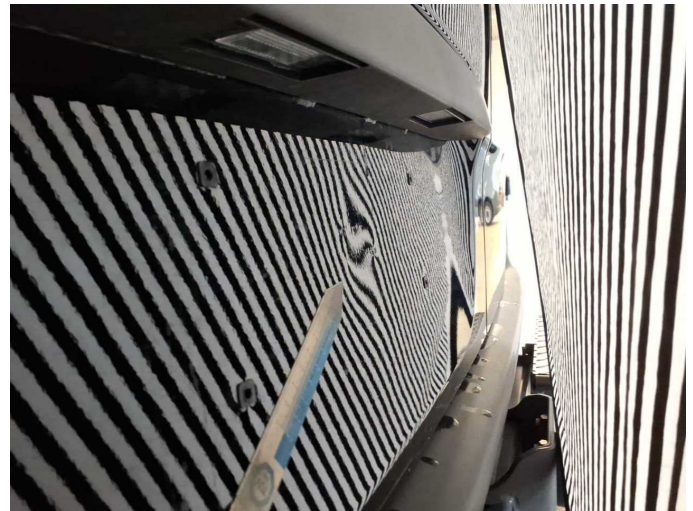
Damage 4: Boot lid / rear door: Rear door - left side - dent(s) - Repair and paint

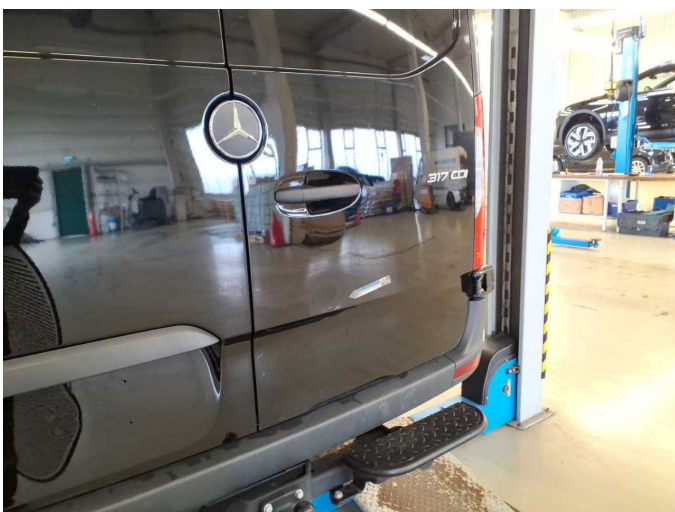
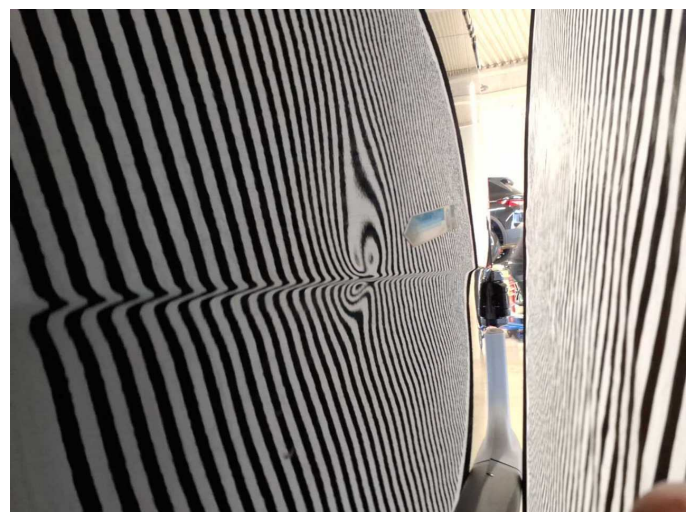
Damage 5: Boot lid / rear door: Rear door - right side - dent(s) - Repair and paint

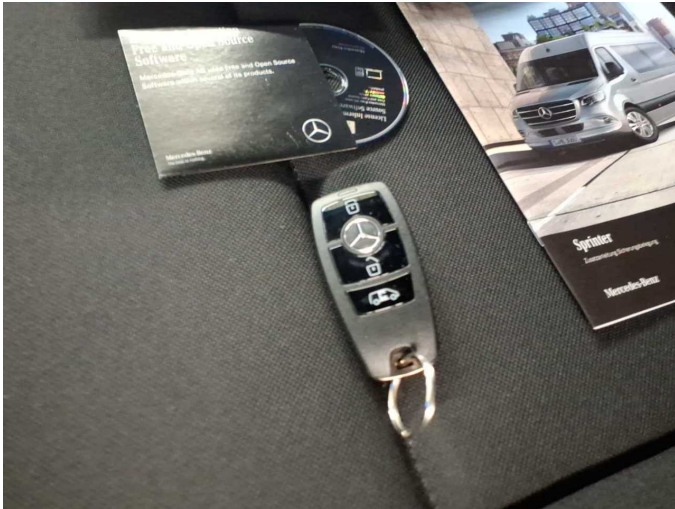
Missing part 1: Equipment: Vehicle key - Missing - Replace

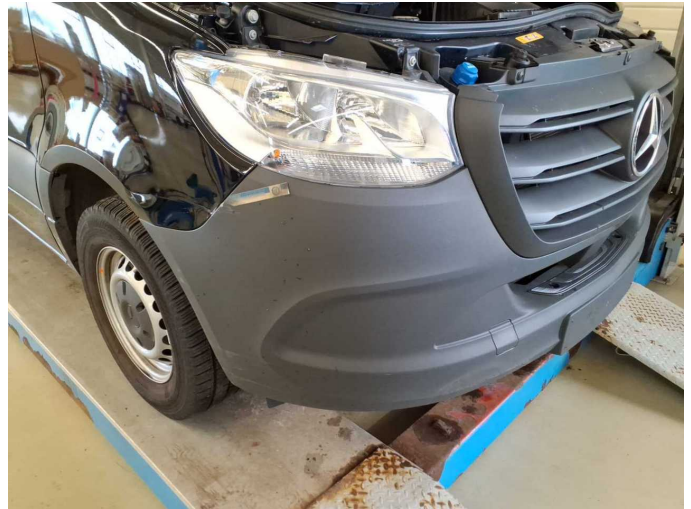
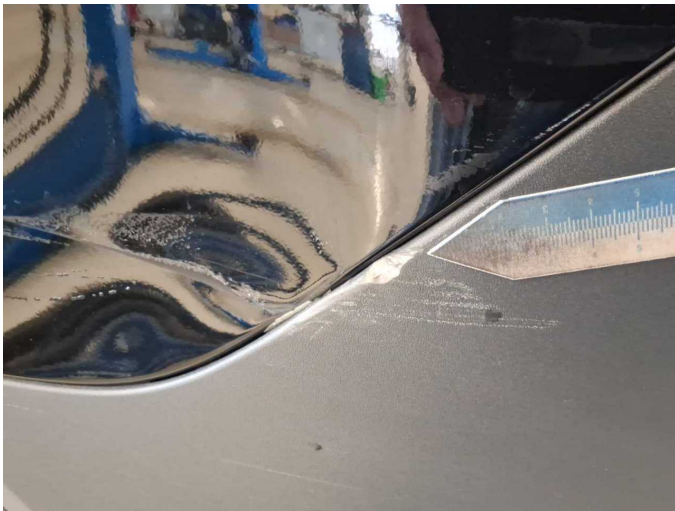
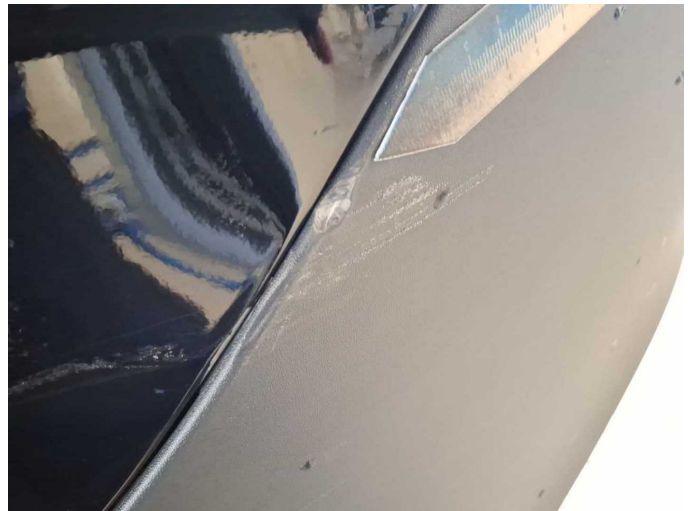
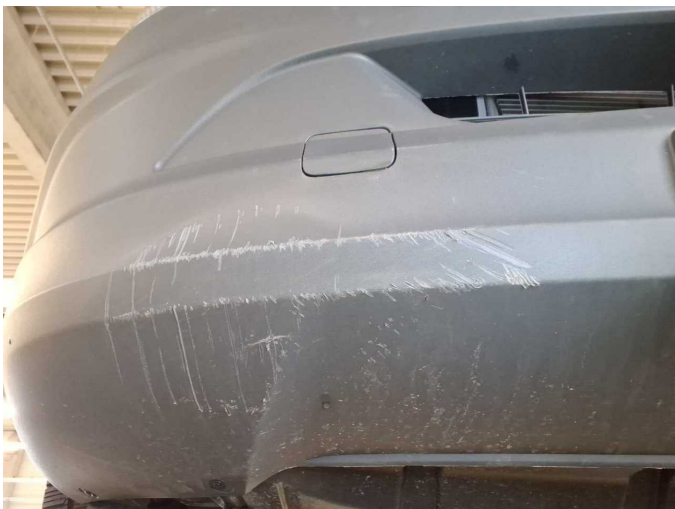
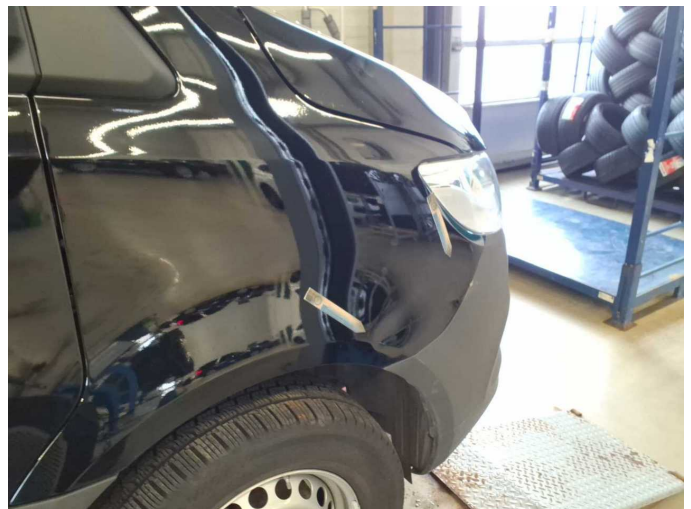
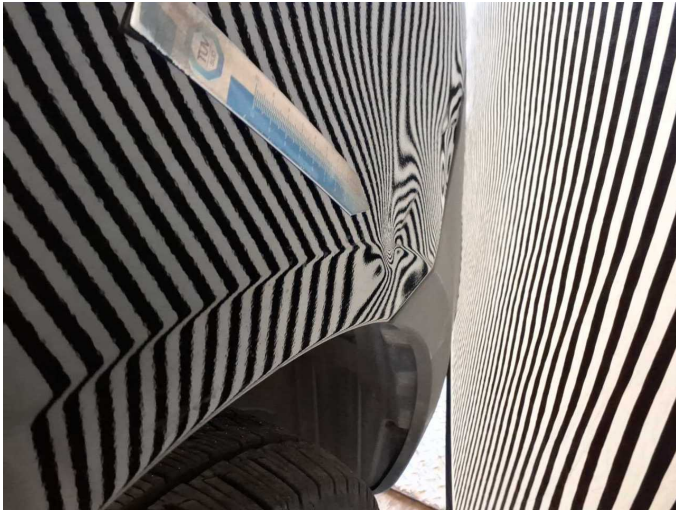
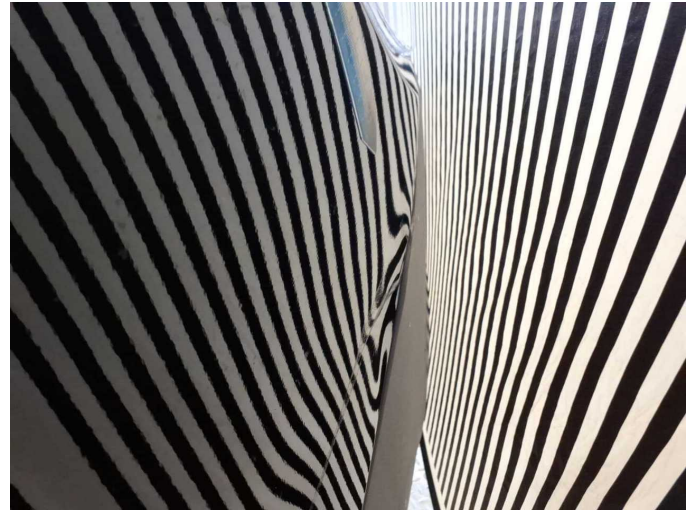
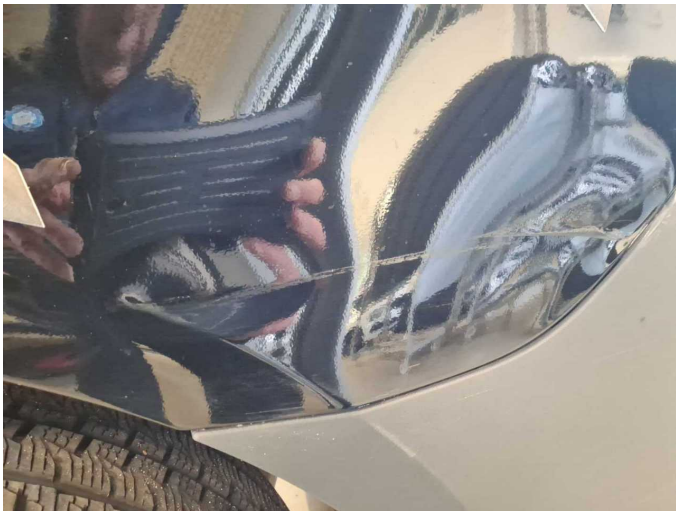
1 Front, Side right

Non-repaired previous damages were found at the vehicle. The necessary repair costs are listed in the expert report or if necessary, are listed in detail in a separately enclosed repair cost calculation.

Accident 1: Front, Side right
