Expertise

Protocol number: 46004401
Order No. / Reference: 26355188
Inspection date: 16 Jun 2026

Manufacturer: Volkswagen

Model: Transporter T6.1 DSG Kurz

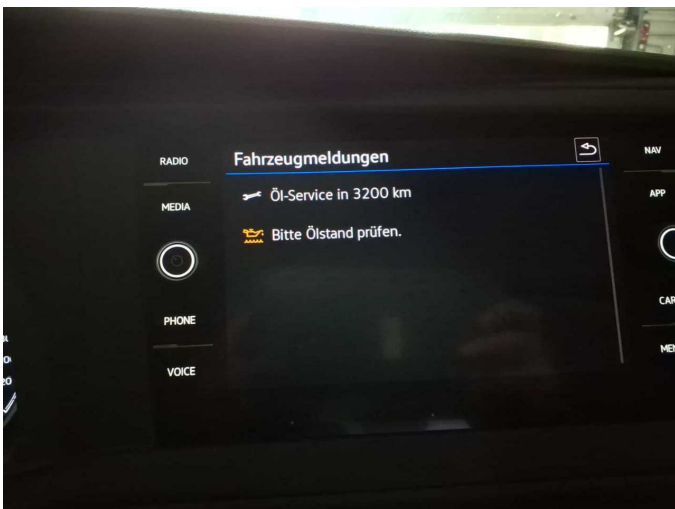
Damage 1: Engine: Engine (Ölstand) - Incomplete - Perform diagnosis

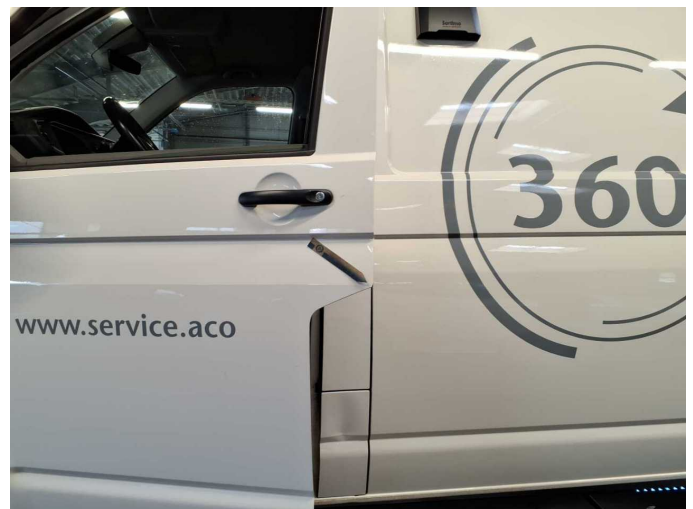
Damage 2: Door - front left side: Door edge - Scratch(es) - Smart repair

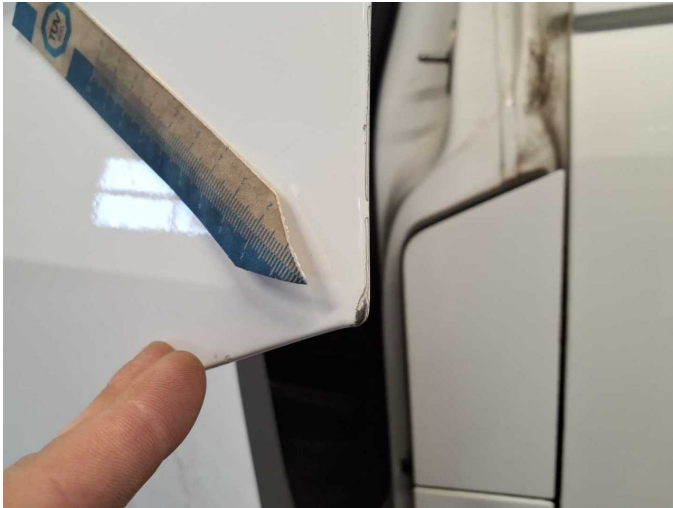
Damage 2: Door - front left side: Door edge - Scratch(es) - Smart repair

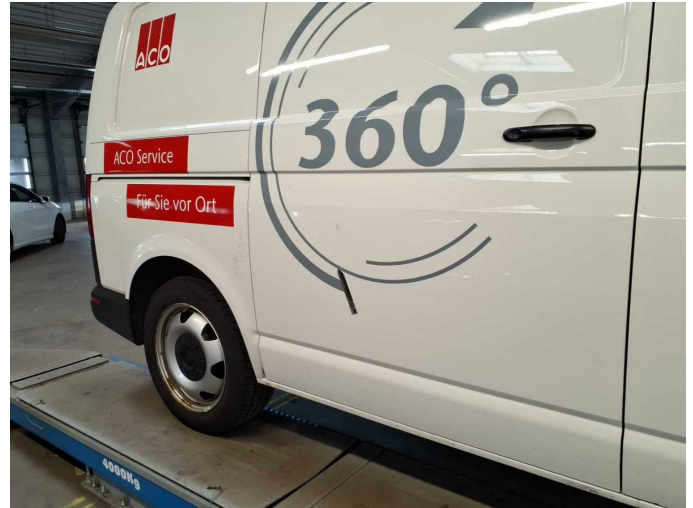
Damage 3: Sliding door, right: Sliding door - dent(s) - Smooth repair work

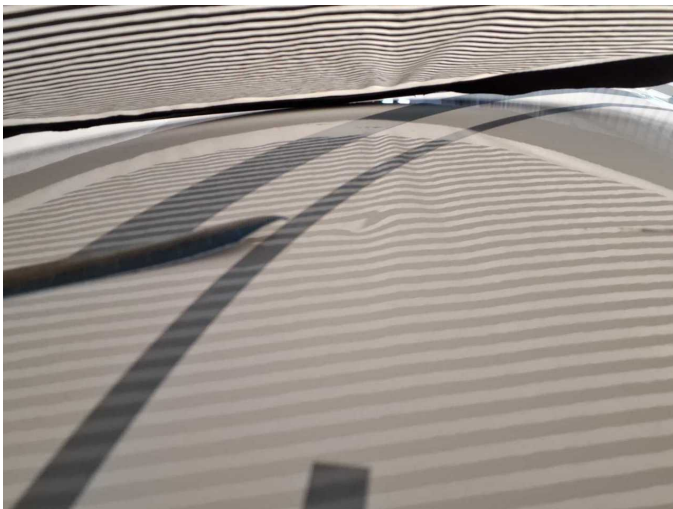
Damage 3: Sliding door, right: Sliding door - dent(s) - Smooth repair work

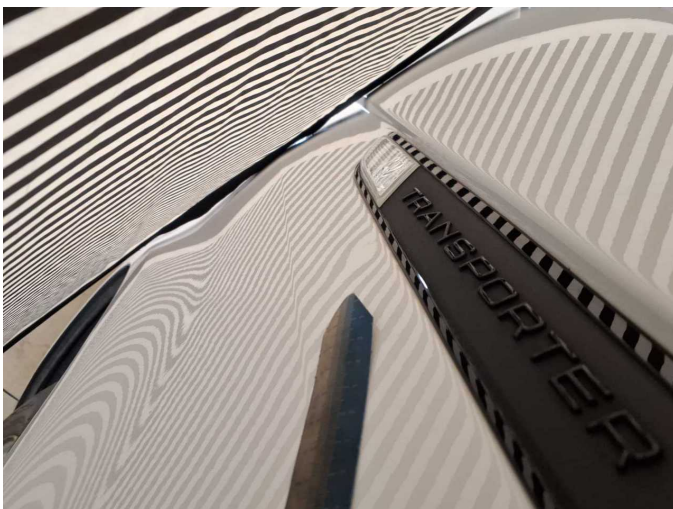
Damage 4: Mudguard - right side: Mudguard - right side - dent(s) - Smooth repair work

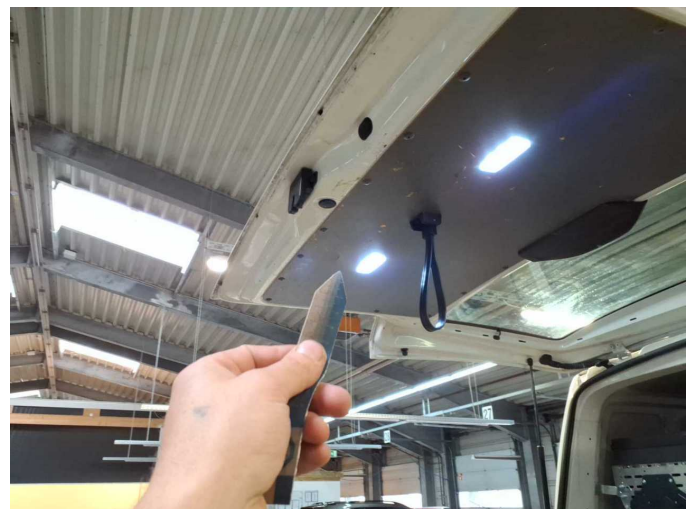
Damage 5: Trim / covers: Boot lid - interior trim - Broken / torn - Replace

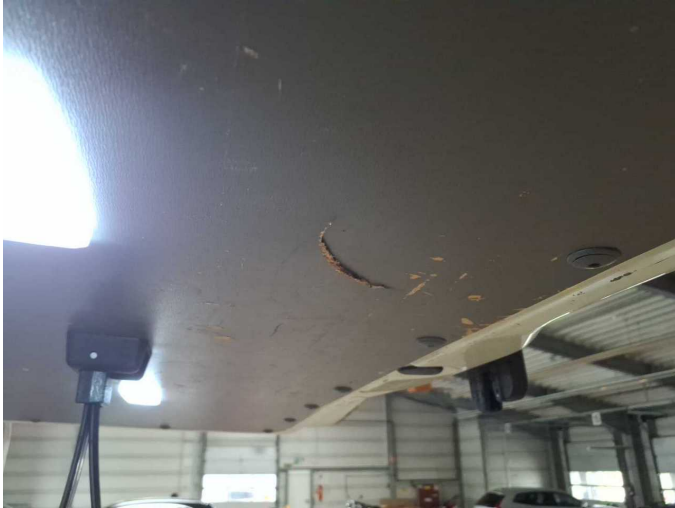
Damage 5: Trim / covers: Boot lid - interior trim - Broken / torn - Replace

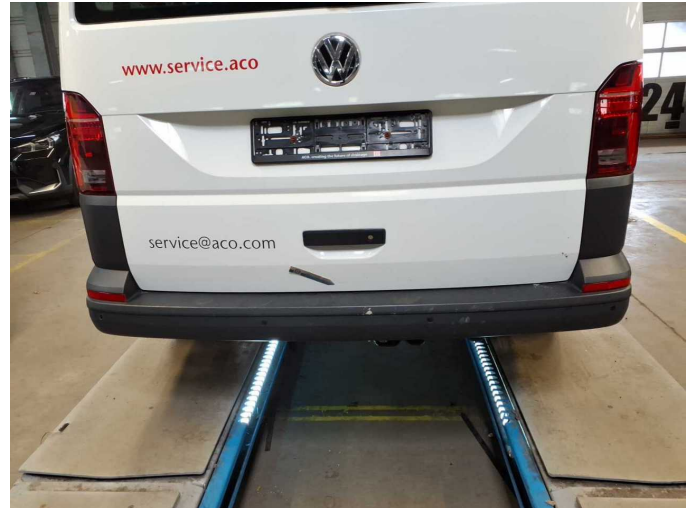
Damage 6: Boot lid / rear door: Boot lid - Dent / paintcoat damage - Smart repair

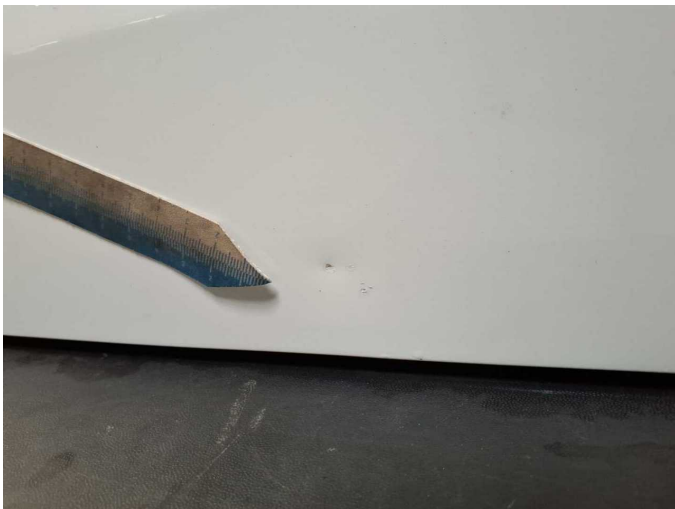
Damage 6: Boot lid / rear door: Boot lid - Dent / paintcoat damage - Smart repair

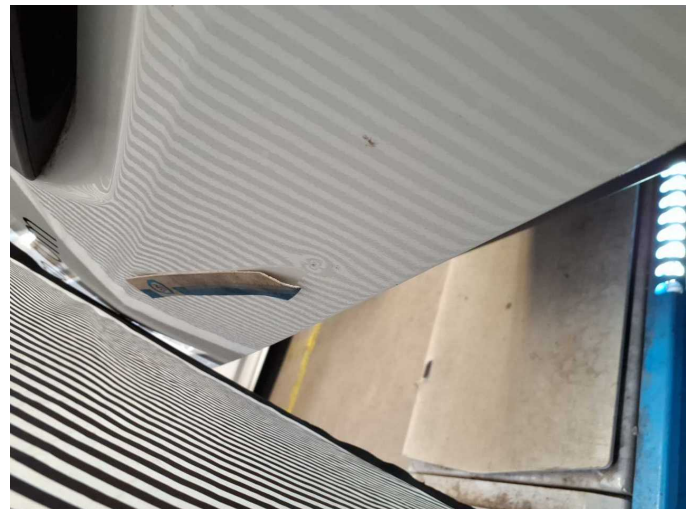
Damage 6: Boot lid / rear door: Boot lid - Dent / paintcoat damage - Smart repair

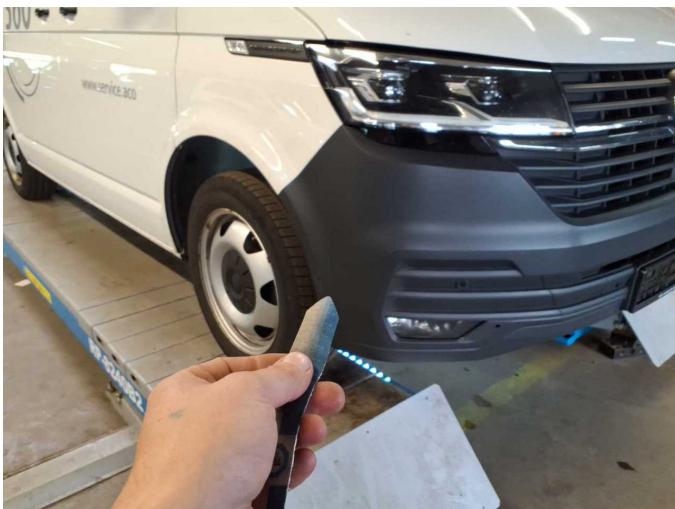
Damage 7: Front bumper: Front bumper (unpainted) - Scratch(es) - Smart repair

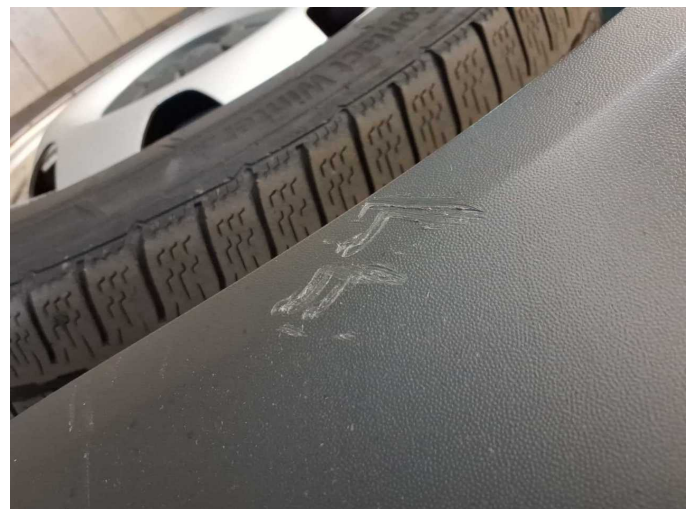
Damage 7: Front bumper: Front bumper (unpainted) - Scratch(es) - Smart repair

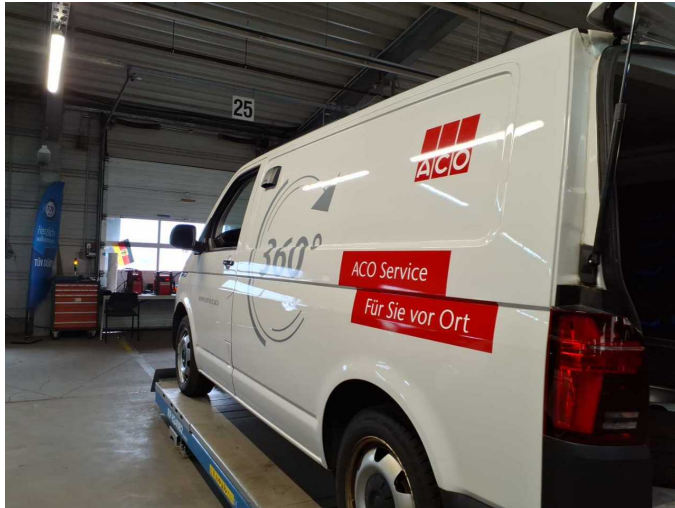
Damage 8: Body: Body - Glued / labelled - De-glude / neutralise

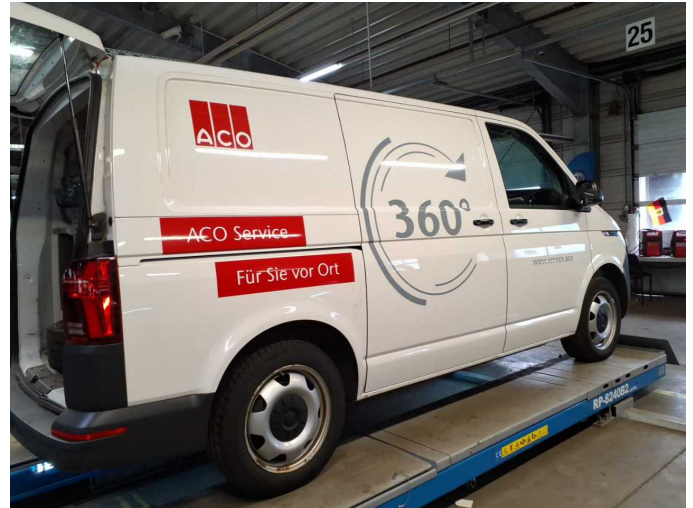
Damage 8: Body: Body - Glued / labelled - De-glude / neutralise

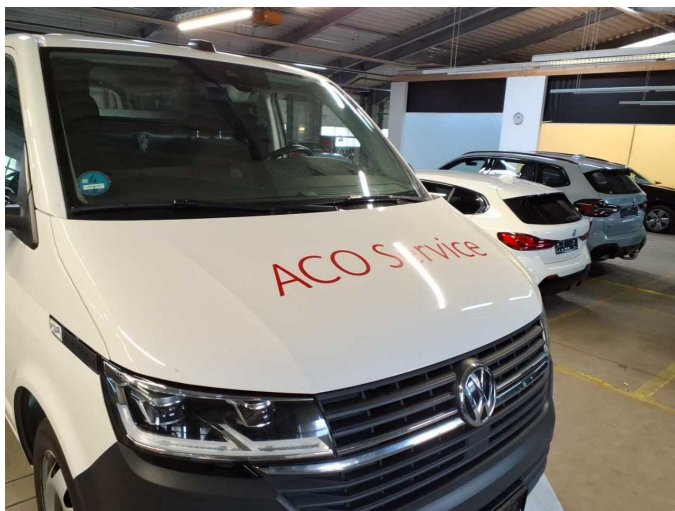
Damage 8: Body: Body - Glued / labelled - De-glude / neutralise

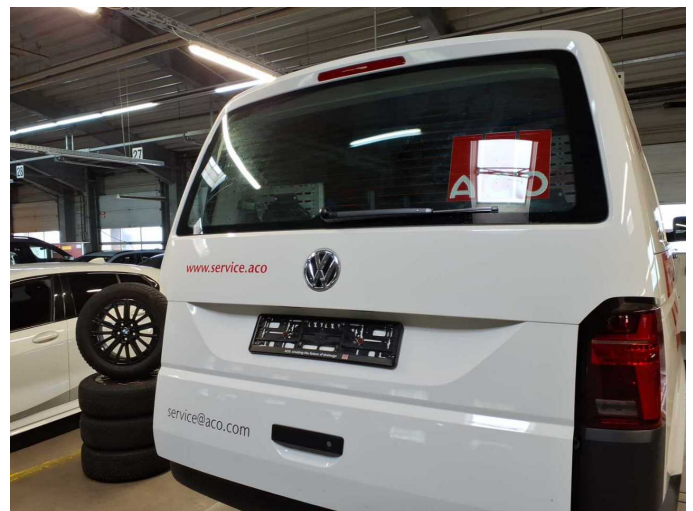
Damage 8: Body: Body - Glued / labelled - De-glude / neutralise

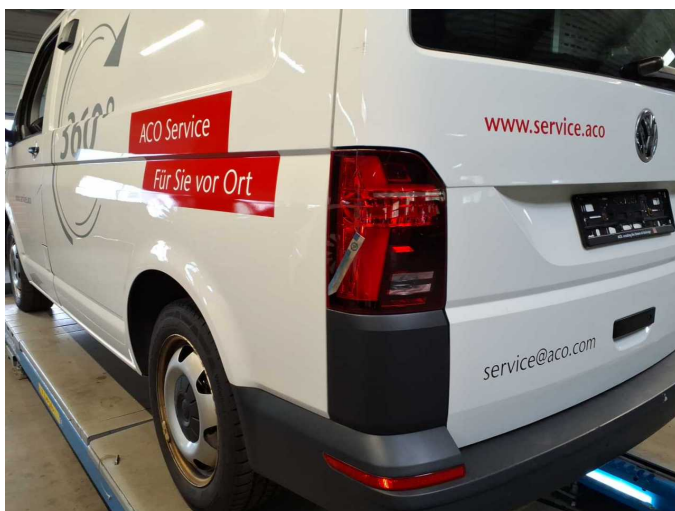
Damage 9: Tail light: Tail lamp - left side - Broken / torn - Replace

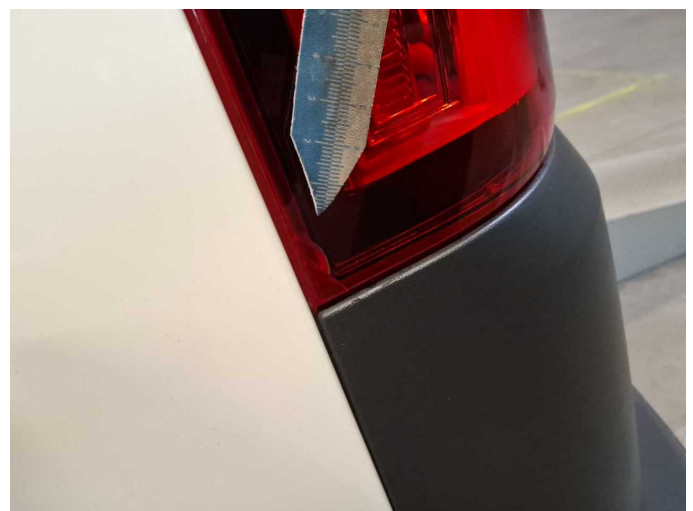
Damage 9: Tail light: Tail lamp - left side - Broken / torn - Replace

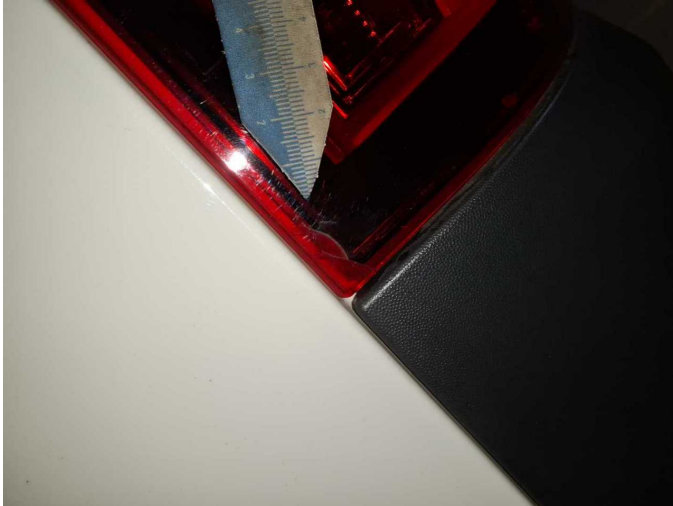
Damage 9: Tail light: Tail lamp - left side - Broken / torn - Replace

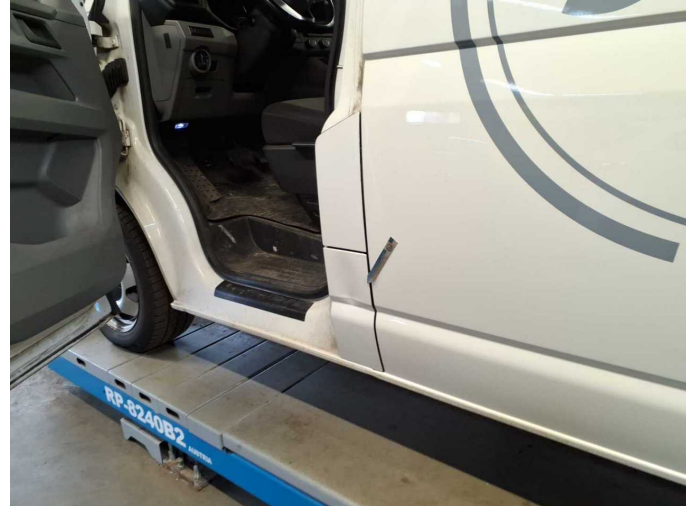
Damage 10: Side panel - rear left side: Side panel (Blende unter'm Tank)
- Deformed - Replace

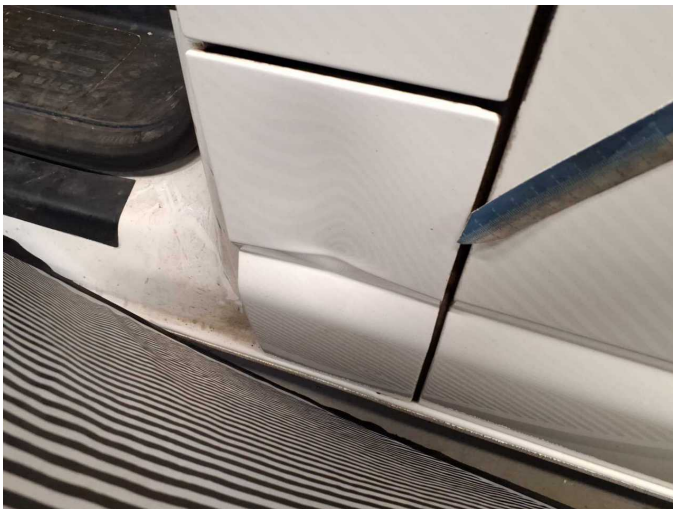
Damage 10: Side panel - rear left side: Side panel (Blende unter'm Tank)
- Deformed - Replace

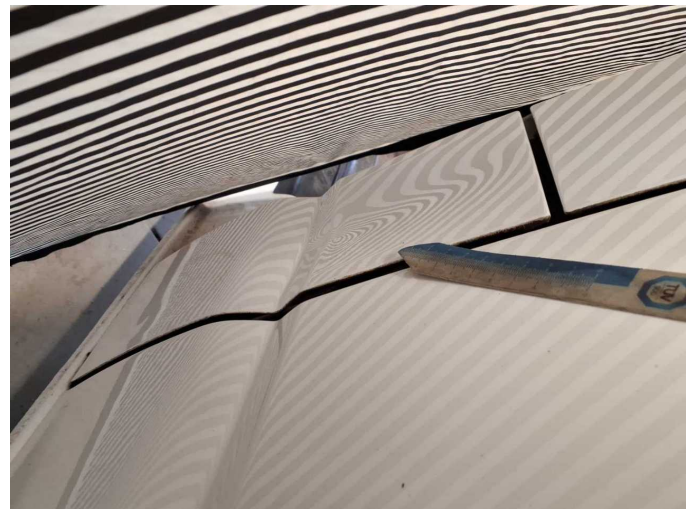
Damage 10: Side panel - rear left side: Side panel (Blende unter'm Tank)
- Deformed - Replace

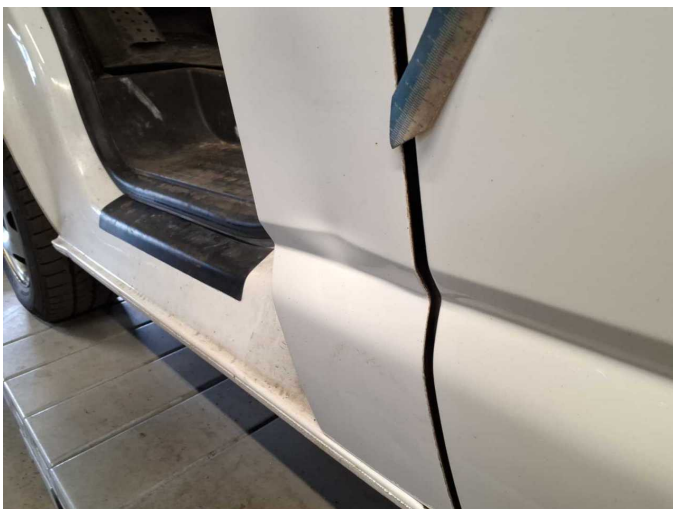
Damage 10: Side panel - rear left side: Side panel (Blende unter'm Tank)
- Deformed - Replace

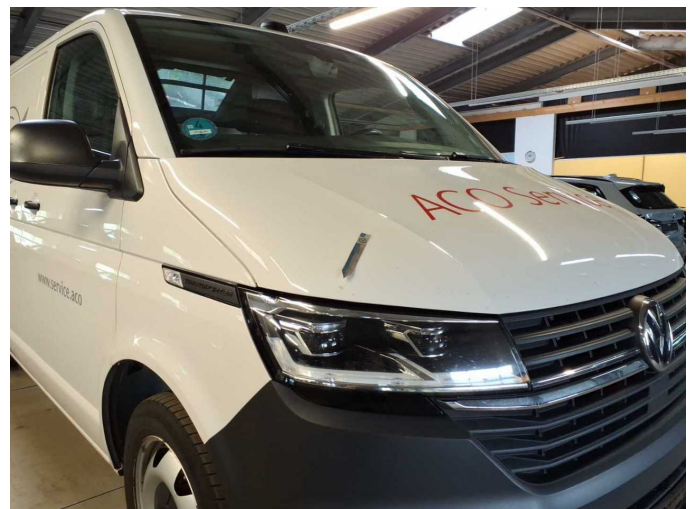
Damage 11: Bonnet: Bonnet - Dent / paintcoat damage - Repair and paint

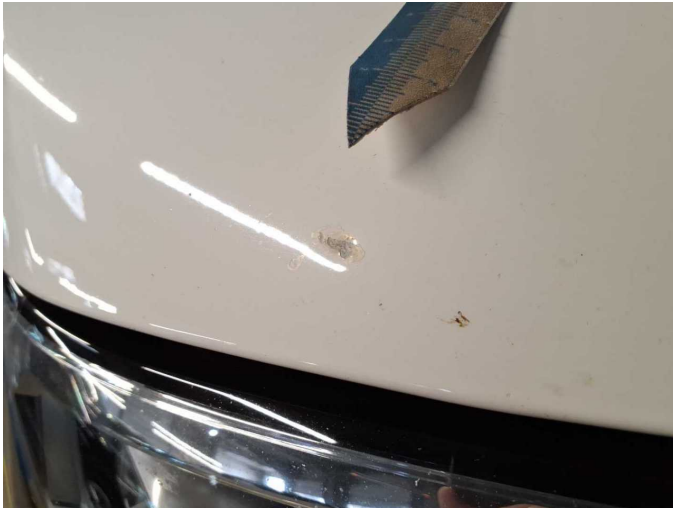
Damage 11: Bonnet: Bonnet - Dent / paintcoat damage - Repair and paint

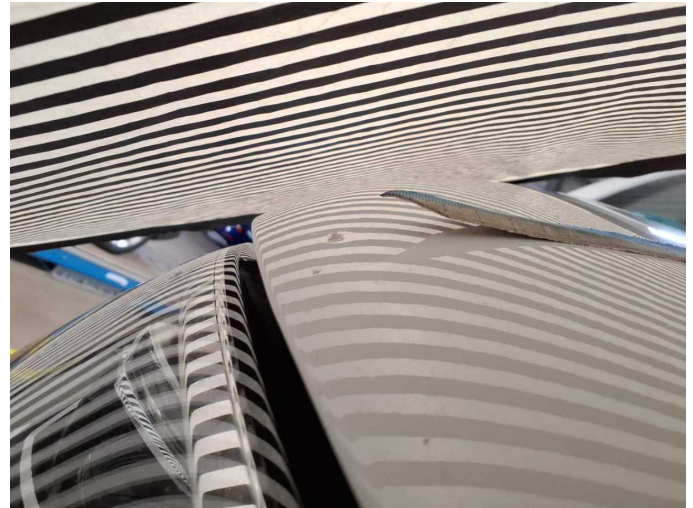
Damage 11: Bonnet: Bonnet - Dent / paintcoat damage - Repair and paint

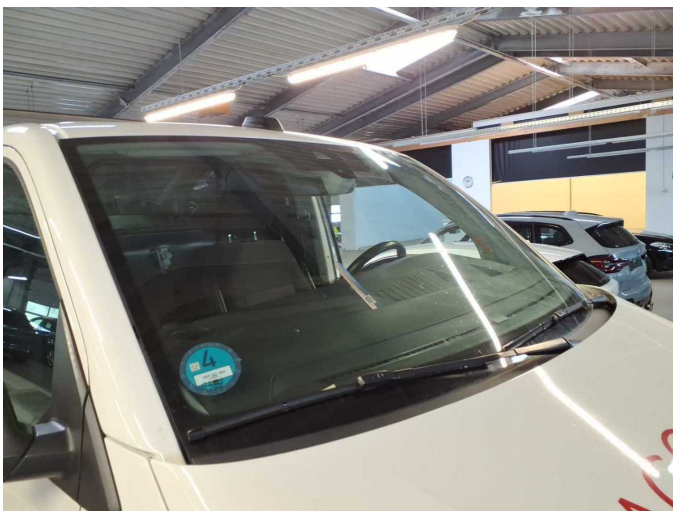
Damage 12: Vehicle glazing: Windscreen (Rissbildung) - Stone chips - repair according to calculation

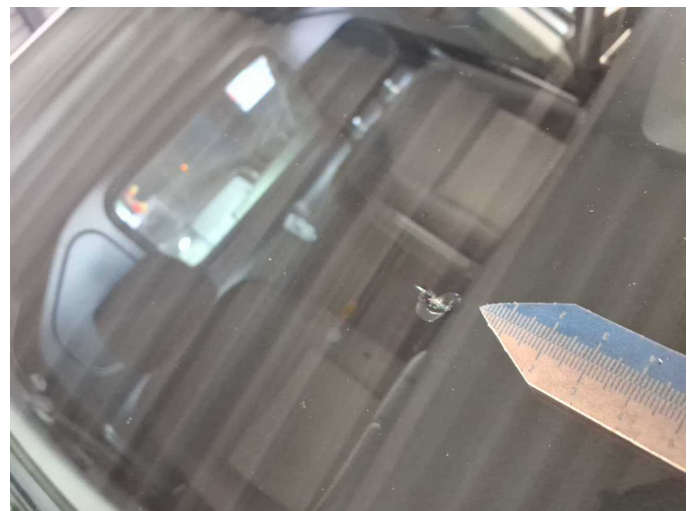
Damage 12: Vehicle glazing: Windscreen (Rissbildung) - Stone chips - repair according to calculation

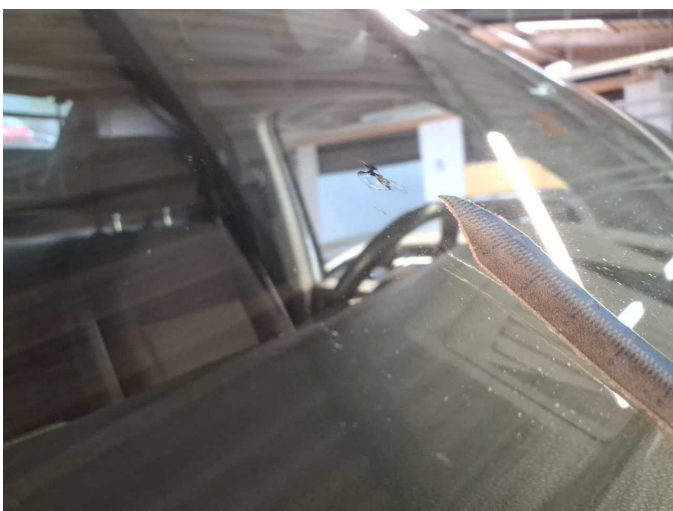
Damage 12: Vehicle glazing: Windscreen (Rissbildung) - Stone chips - repair according to calculation

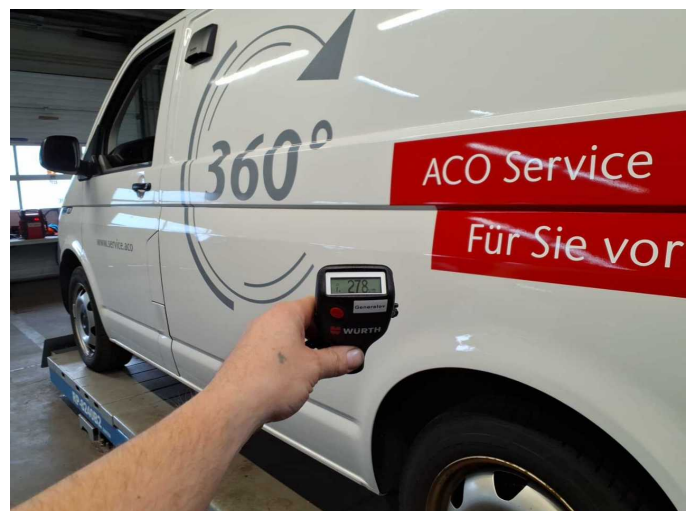
No.	Repainting
1	Side panel - rear left side, Professionally carried out, Invoice of repair done Non-existent

Side panel - rear left side	278 µm
-----------------------------	--------

Repainting 1: Side panel - rear left side
