Expertise

Protocol number: 45478159
Order No. / Reference: 26358685
Inspection date: 13 May 2026

Manufacturer: Renault

Model: Trafic Blue dCi 150 EDC L2H1 Komfort

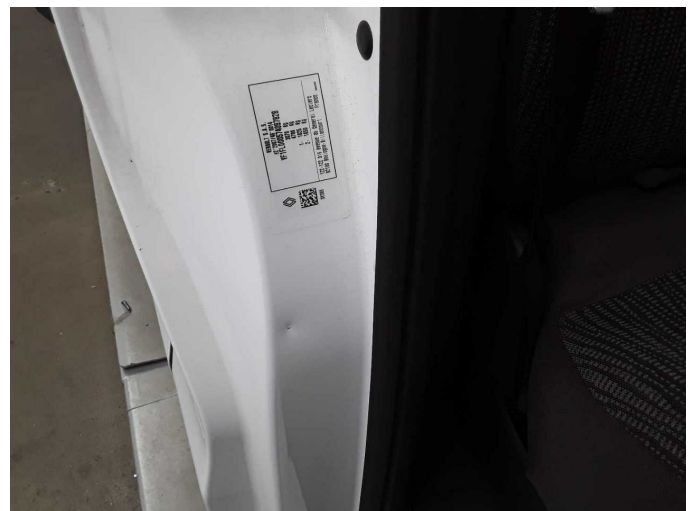
Damage 1: Sill - right side: Sill - Dent / paintcoat damage - Smart repair

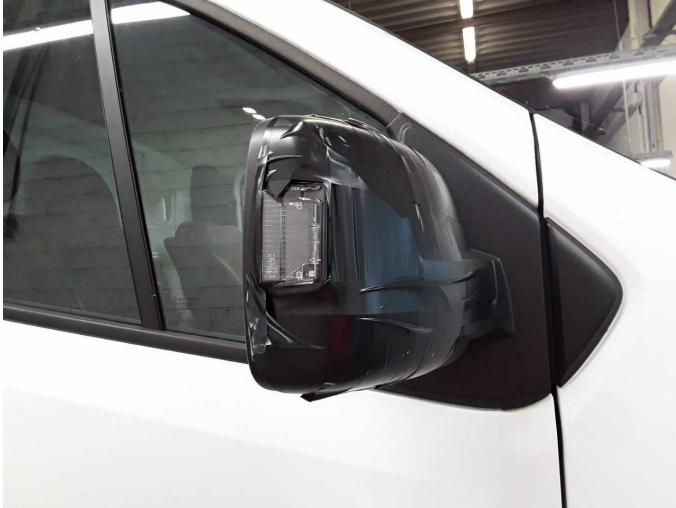
Damage 2: Wing mirror - right side: Mirror housing - Damaged - Replace

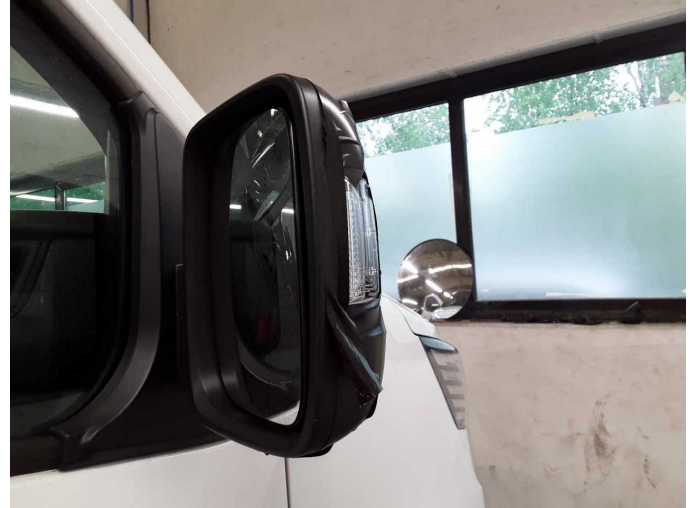
Damage 2: Wing mirror - right side: Mirror housing - Damaged - Replace

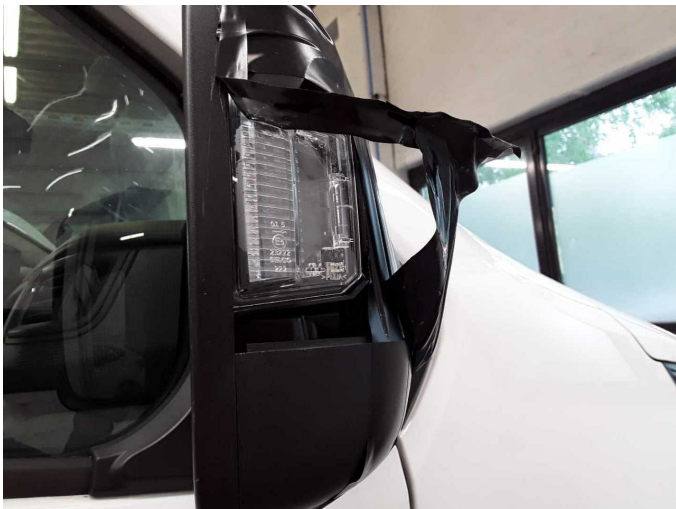
Damage 2: Wing mirror - right side: Mirror housing - Damaged - Replace

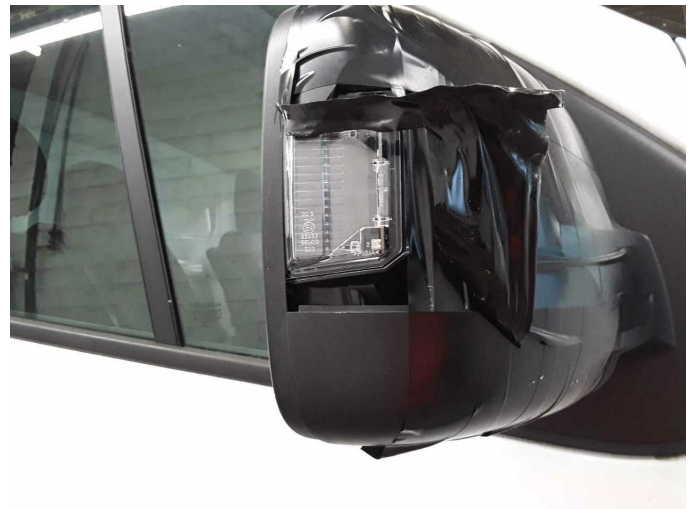
Damage 2: Wing mirror - right side: Mirror housing - Damaged - Replace

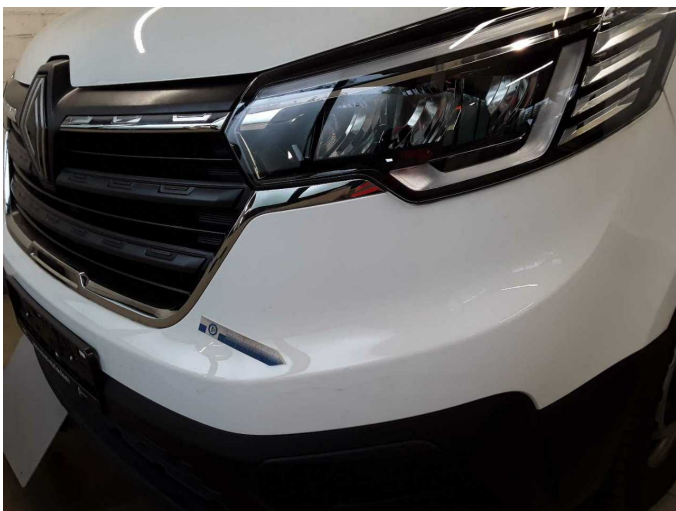
Wear and tear 1: Front bumper: Front bumper - Stone chips - No deduction

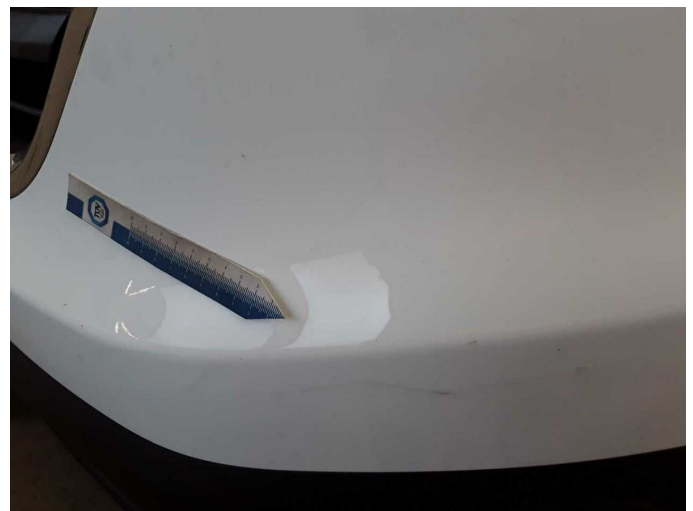
Wear and tear 1: Front bumper: Front bumper - Stone chips - No deduction

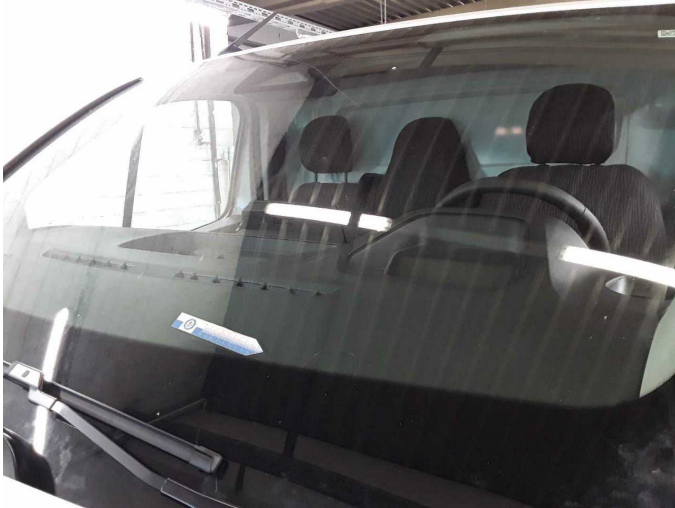
Wear and tear 2: Vehicle glazing: Windscreen - Stone chips - No deduction

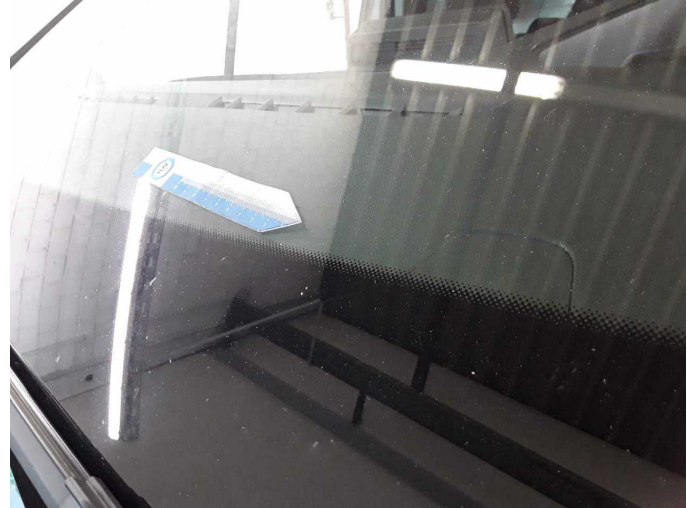
Wear and tear 2: Vehicle glazing: Windscreen - Stone chips - No deduction

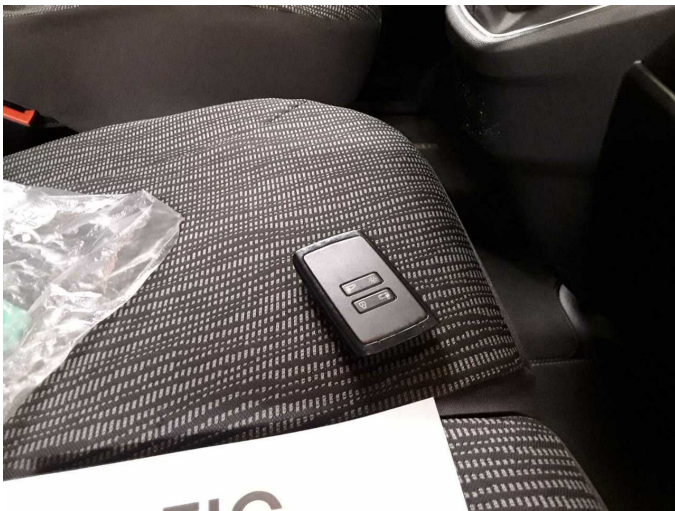
Missing part 1: Equipment: Vehicle key with remote control - Missing - Replace
