Expertise

Protocol number: 46325258
Order No. / Reference: 26574197
Inspection date: 25 Jun 2026

Manufacturer: Mercedes-Benz

Model: eVito Tourer 129 Lang PRO

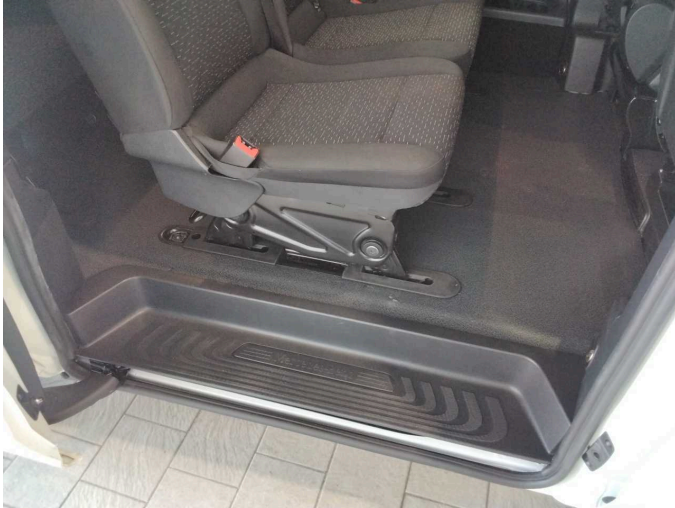
No.	Component group	Description
1	Misc.	Main inspection - No evidence - No deduction
2	Misc.	Inspection / maintenance (Intervall überzogen) - No deduction
3	Trim / covers	Floor covering - front centre - Holes - Loss in value
4	Body	B-pillar - left side - Scratch(es) - Smart repair

Damage 3: Trim / covers: Floor covering - front centre - Holes - Loss in value

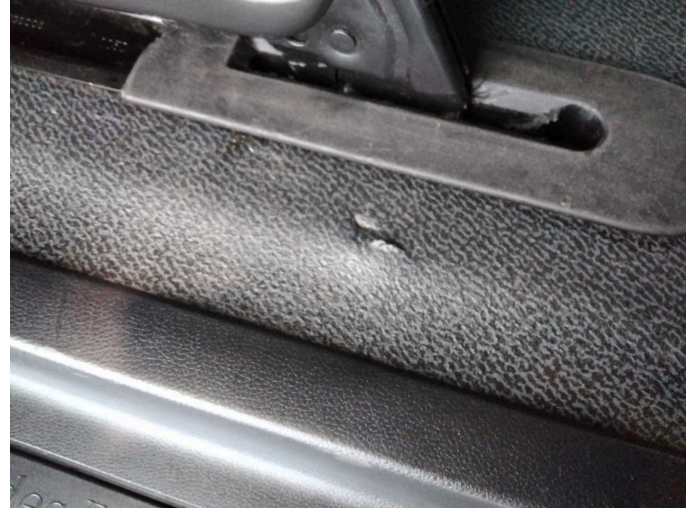
Damage 3: Trim / covers: Floor covering - front centre - Holes - Loss in value

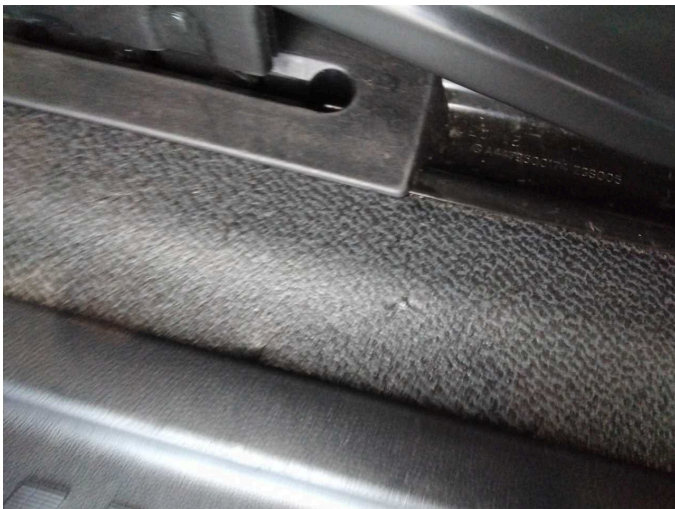
Damage 3: Trim / covers: Floor covering - front centre - Holes - Loss in value

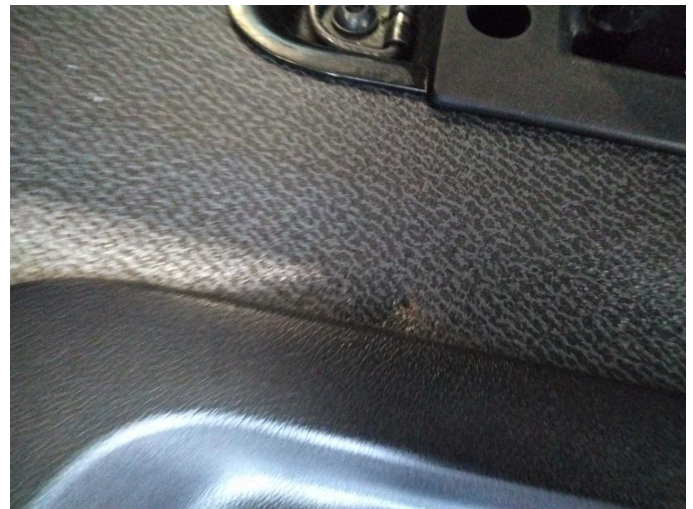
Damage 3: Trim / covers: Floor covering - front centre - Holes - Loss in value

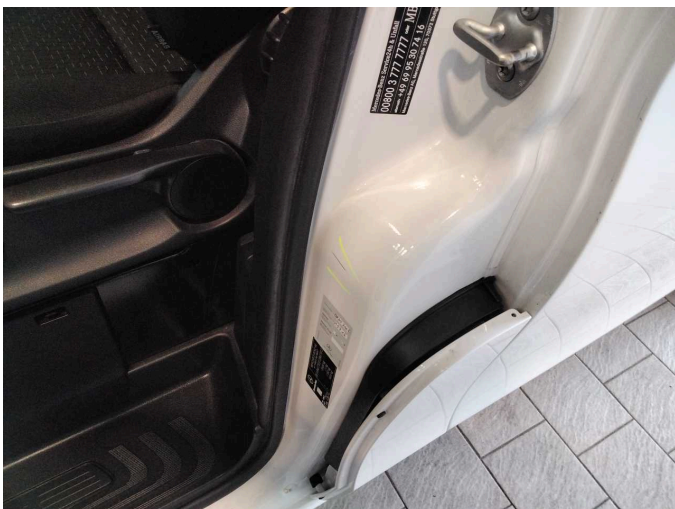
Damage 4: Body: B-pillar - left side - Scratch(es) - Smart repair

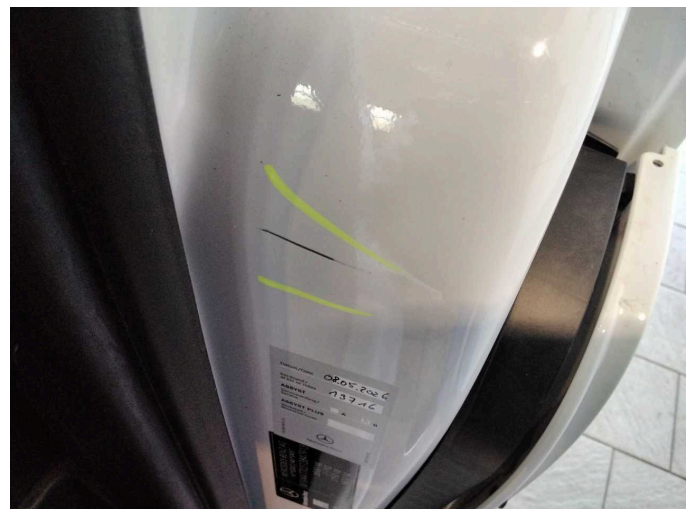
Damage 4: Body: B-pillar - left side - Scratch(es) - Smart repair

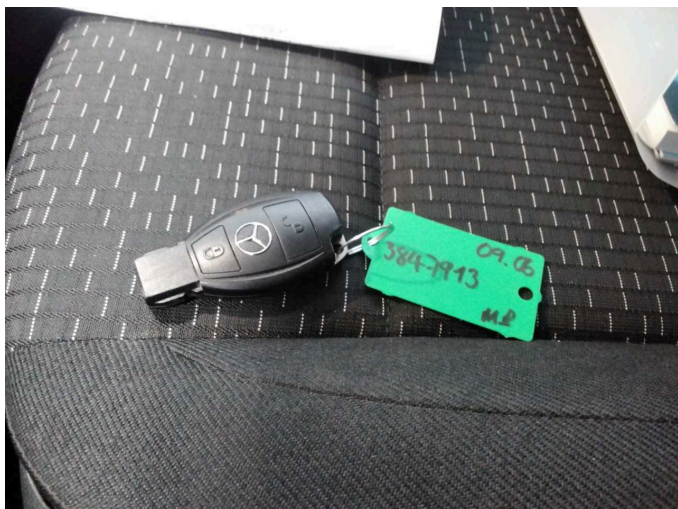
Equipment - Vehicle key

Missing part 1: Equipment: Vehicle key - Missing - Replace
