Expertise

Protocol number: 47186286  
Order No. / Reference: 26258306  
Inspection date: 20 Aug 2026

Manufacturer: Ford

Model: Mondeo Turnier 2.0 EcoBlue Aut. Titanium

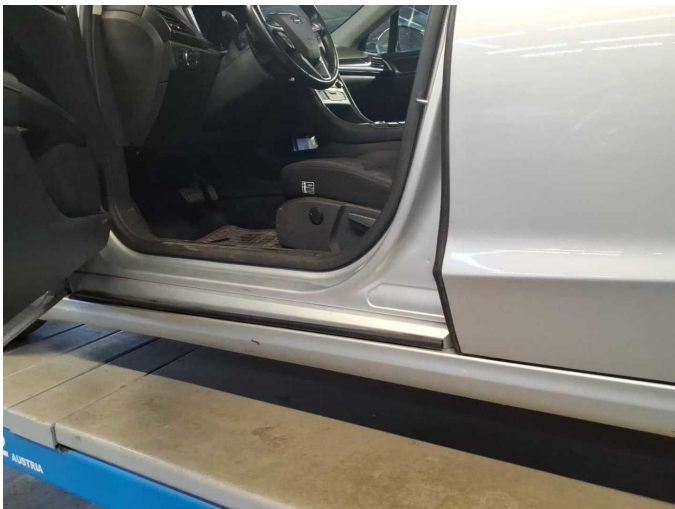
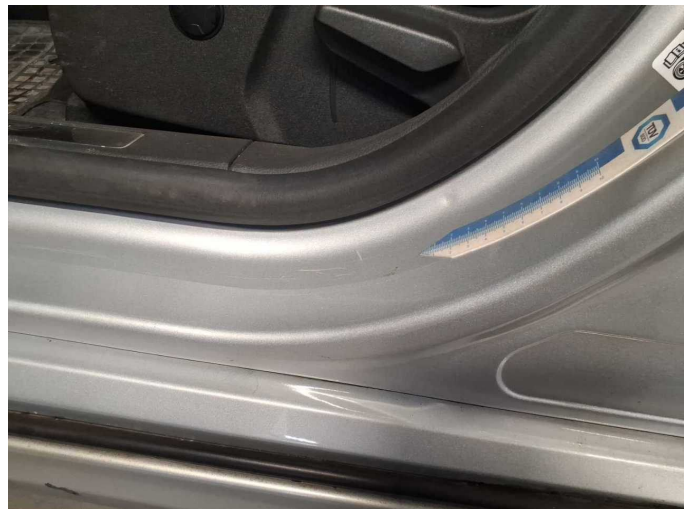
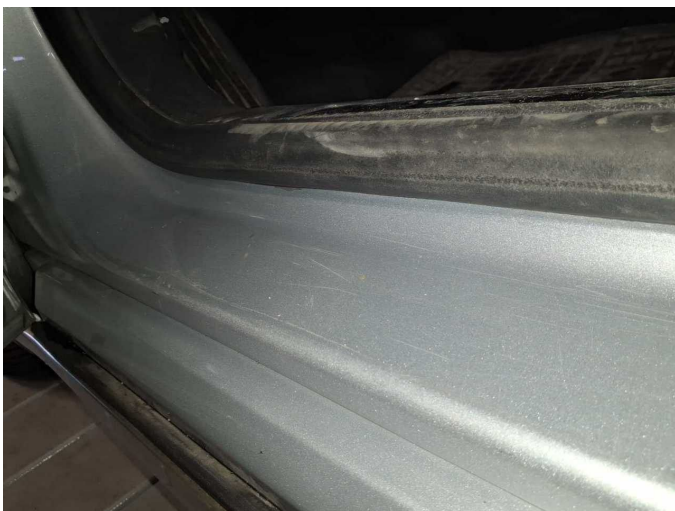
| No. | Component group | Description |
|---|---|---|
| 1 | Sill - left side | Sill - Scratch(es) - Smart repair |

**Damage 1:** Sill - left side: Sill - Scratch(es) - Smart repair

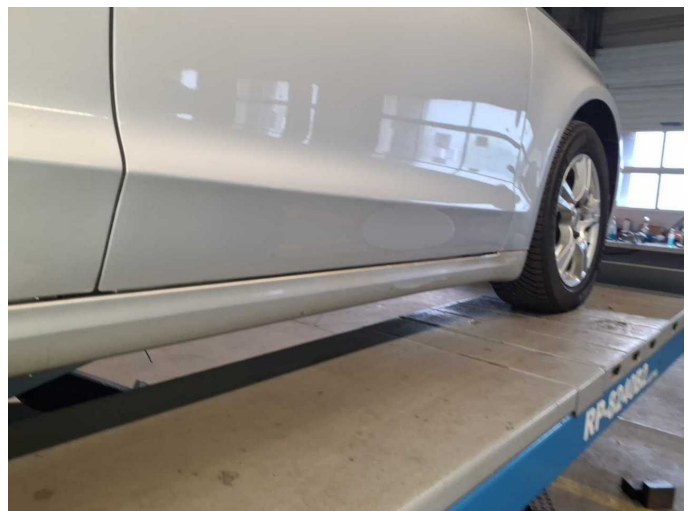
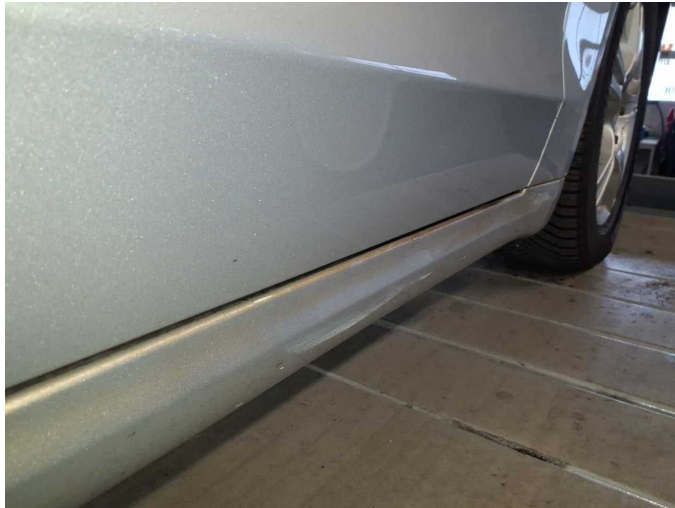
| No. | Component group | Description |
|---|---|---|
| 3 | Sill - right side | Sill - Corrosion - Conditioning |

**Damage 3:** Sill - right side: Sill - Corrosion - Conditioning

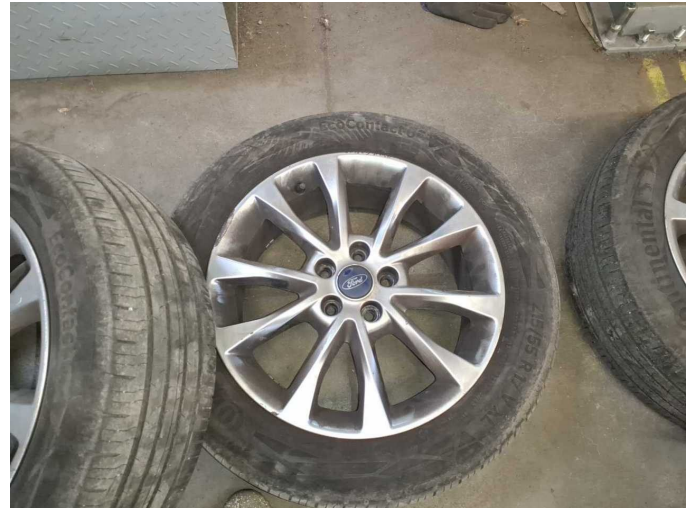
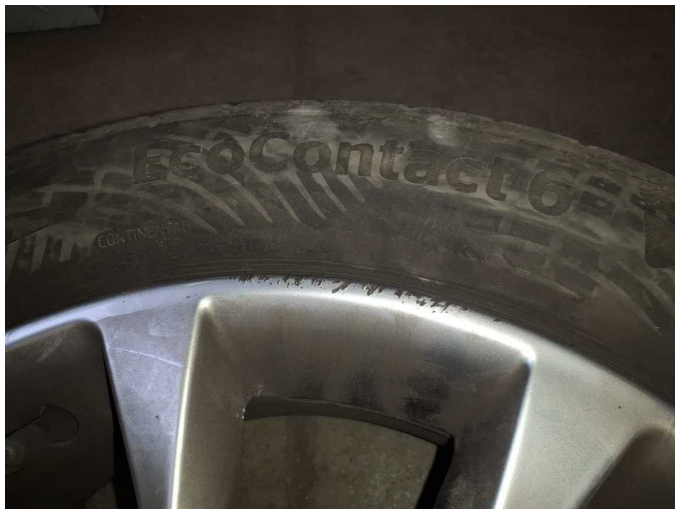
| No. | Component group | Description |
|---|---|---|
| 4 | 2nd wheel set | 1 alloy rim - Scratch(es) - Loss in value |

**Damage 4:** 2nd wheel set: 1 alloy rim - Scratch(es) - Loss in value

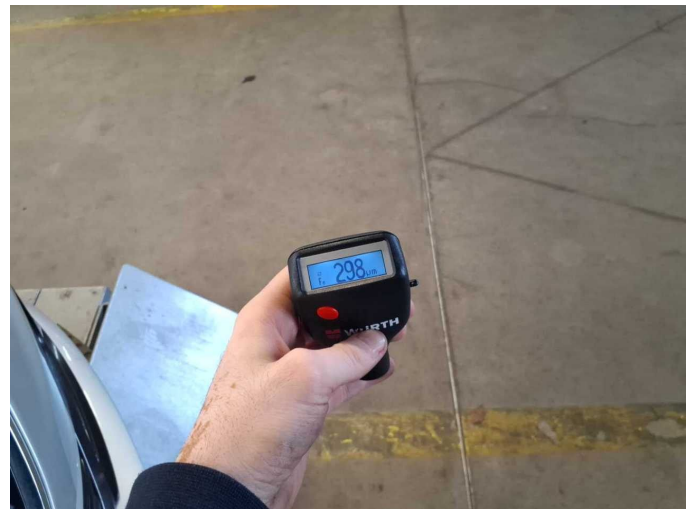
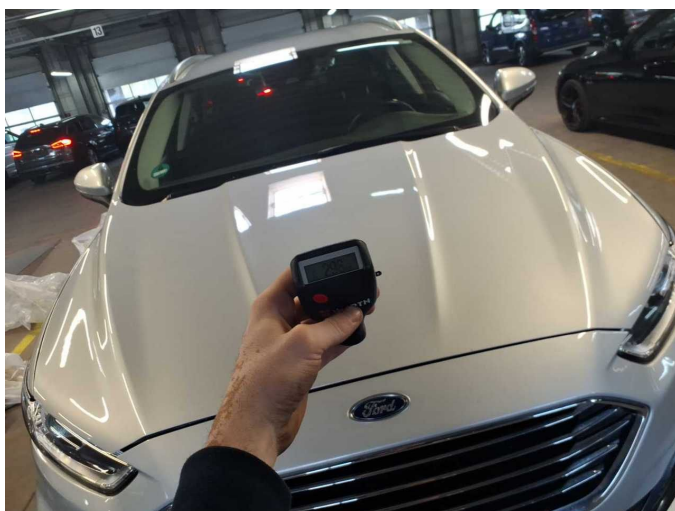
| No. | Repainting |
|---|---|
| 1 | Bonnet |

**Repainting 1:** Bonnet

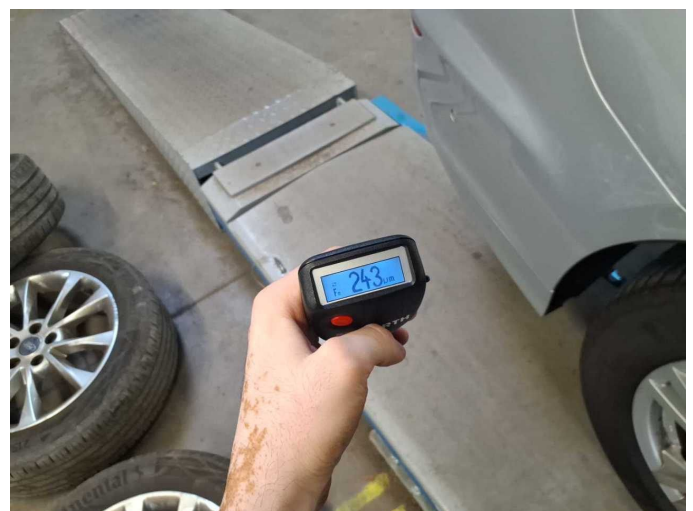
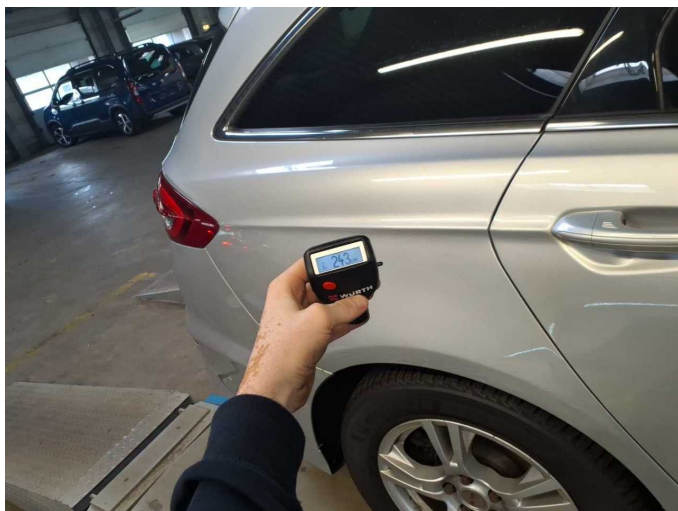
| No. | Repainting |
|---|---|
| 2 | Side panel - rear right side |

**Repainting 2:** Side panel - rear right side
