# MACDAM

## Volkswagen ID.4 '21 BEV

### Vehicle information

### Damage summary

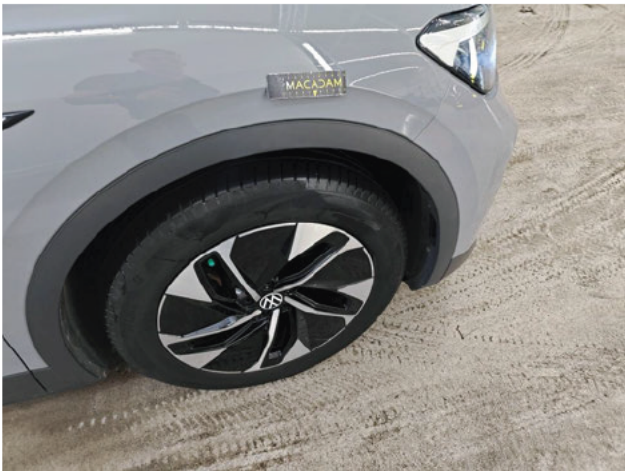
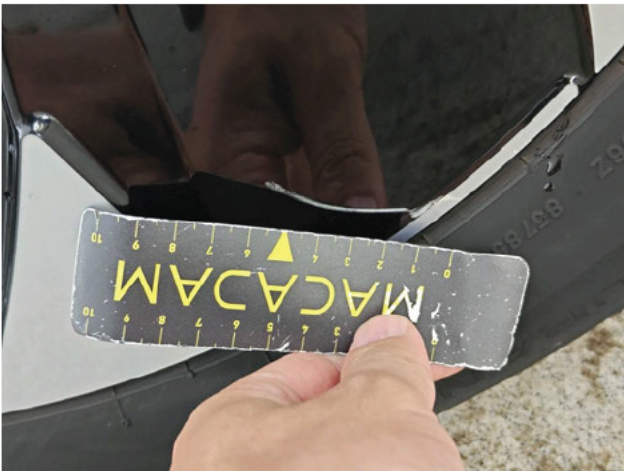
**Alloy rim FR**  
Scratch(es)  
Repair and paint (complete)  
Right

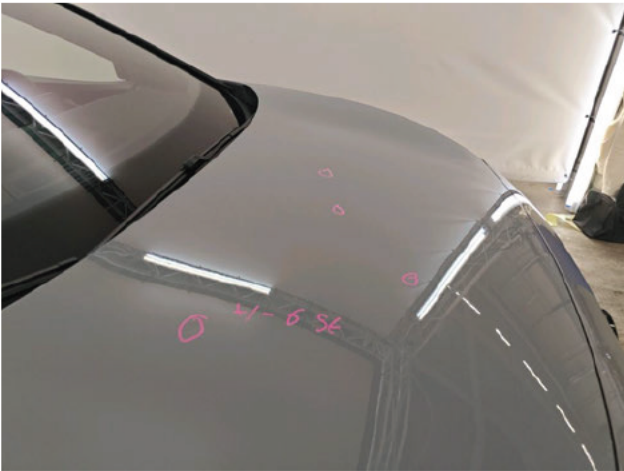
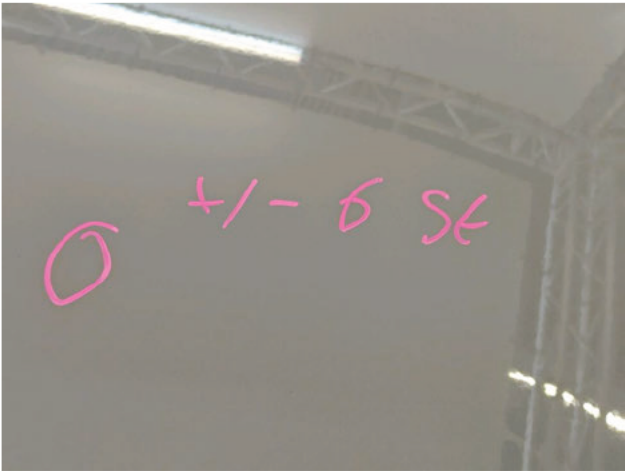
**Bonnet**  
Hail damage  
Paintless dent repair (hail)  
Front

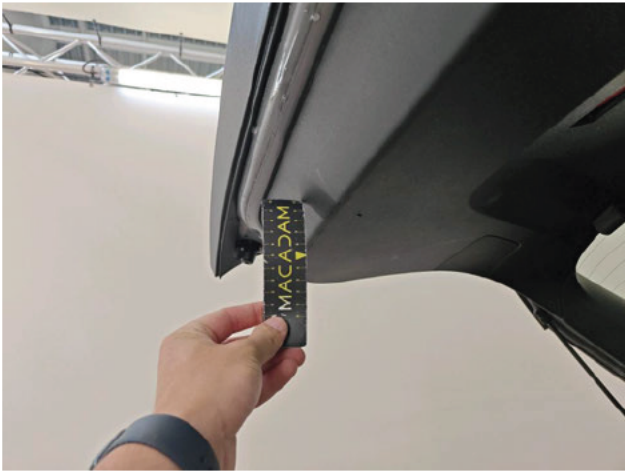
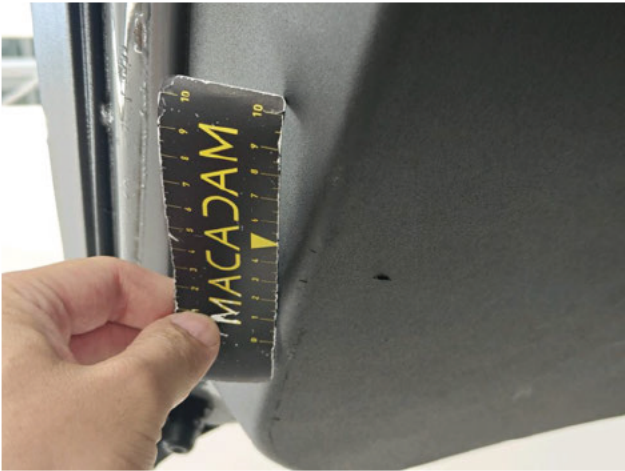
**Boot lid covering R**  
Scratch(es)  
Smart repair  
Rear

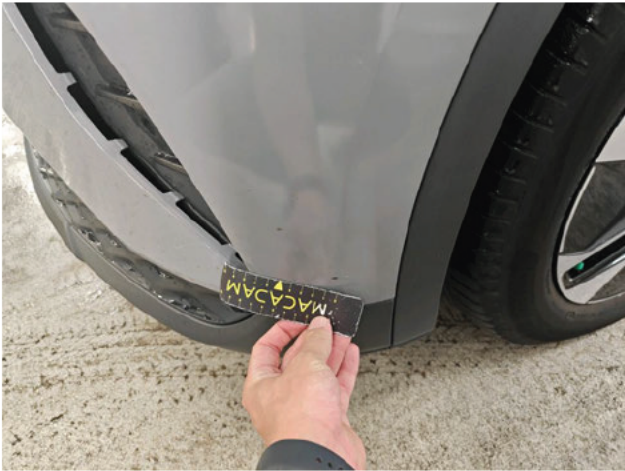
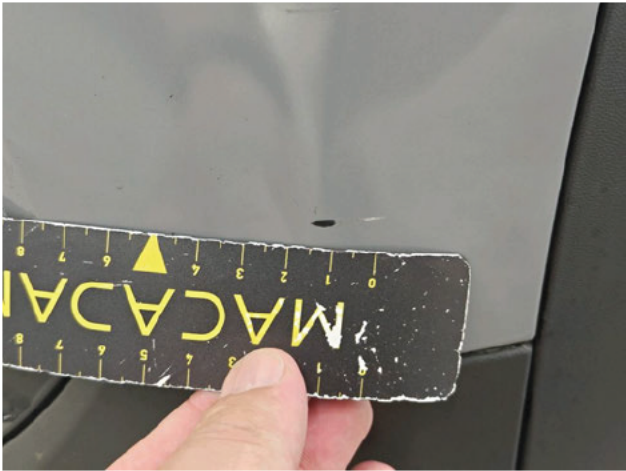
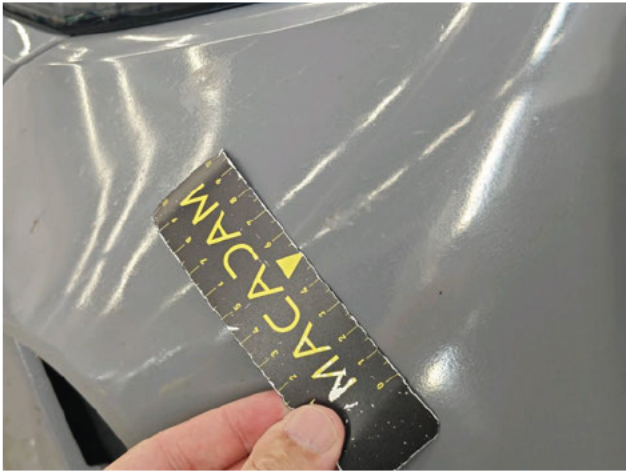
**Bumper F**  
Scratch(es)  
Repair and paint (complete)  
Front

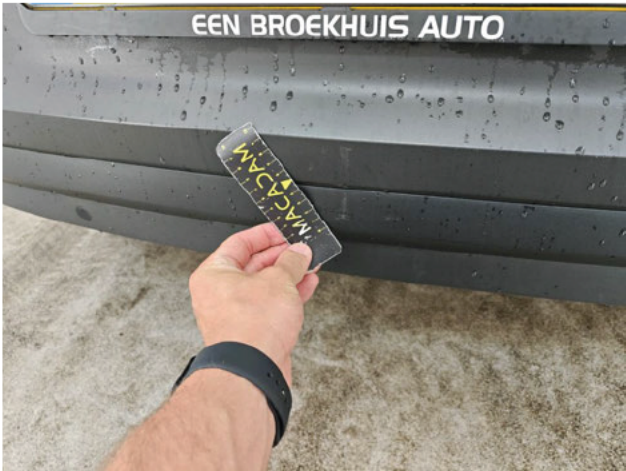
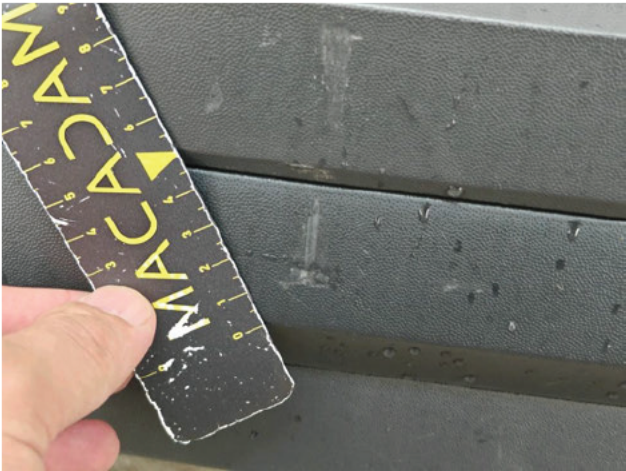
**Bumper R**  
Scratch(es)  
Smart repair  
Rear

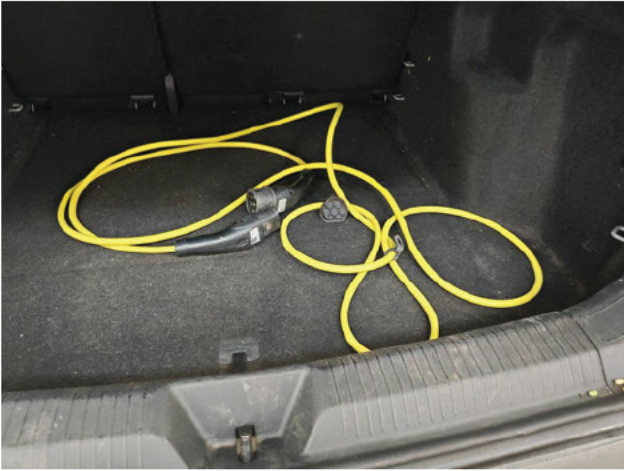
Charging cable (normal)

Missing  
Replace  
Rear

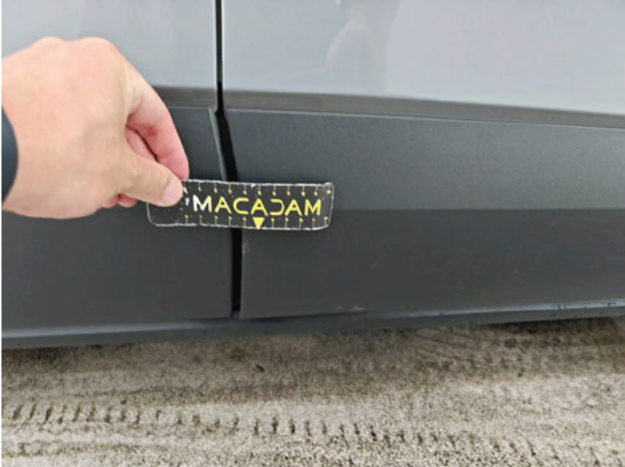
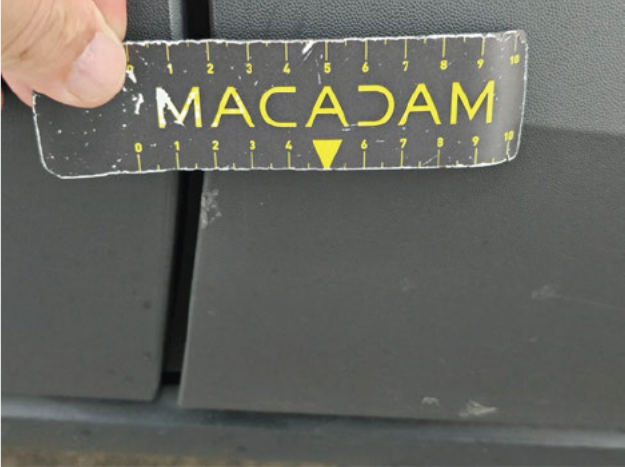
Door trim FR

Scratch(es)  
Replace  
Right

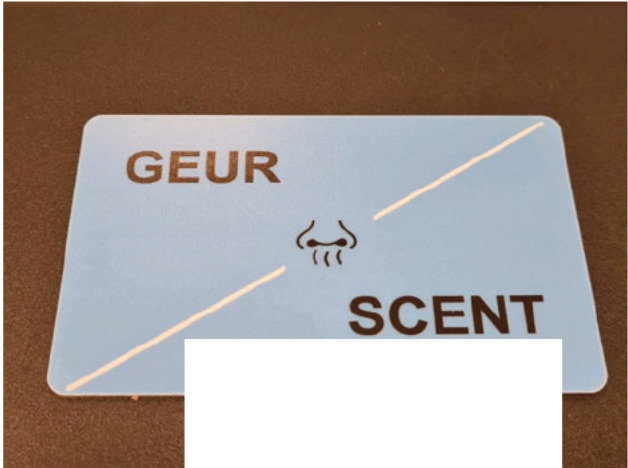
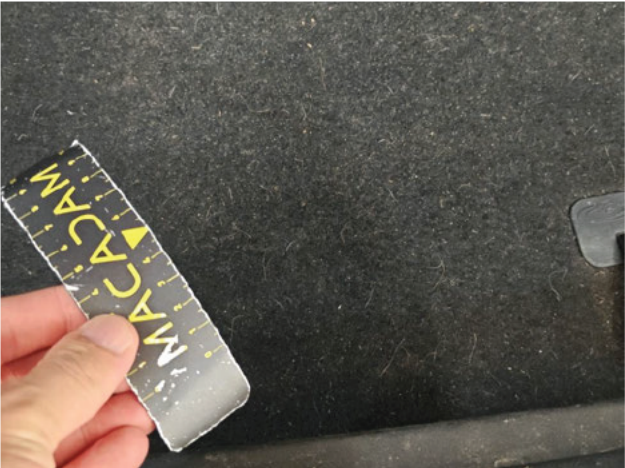
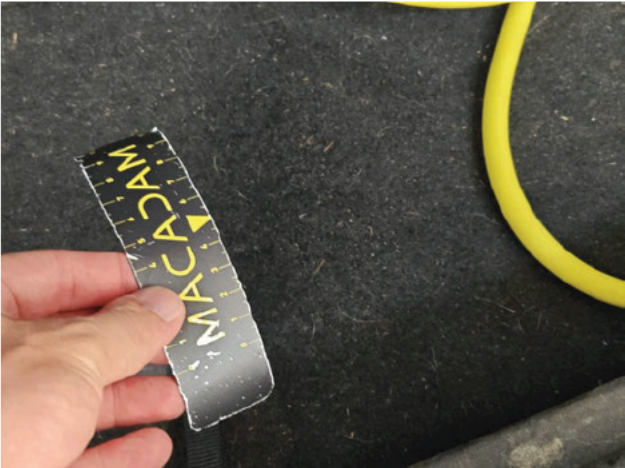
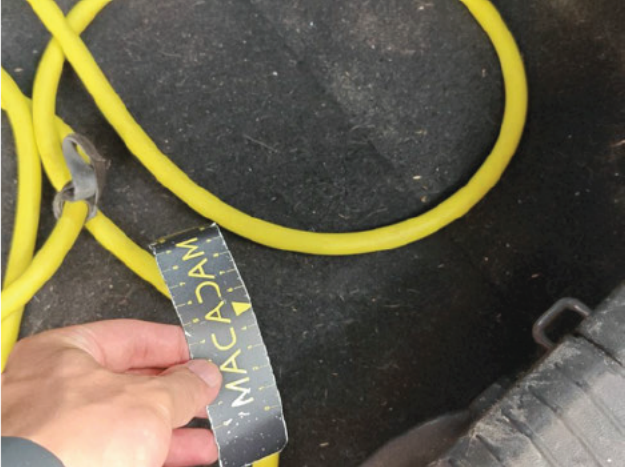
Smell  
Ozone treatment (Animal smell)  
Interior

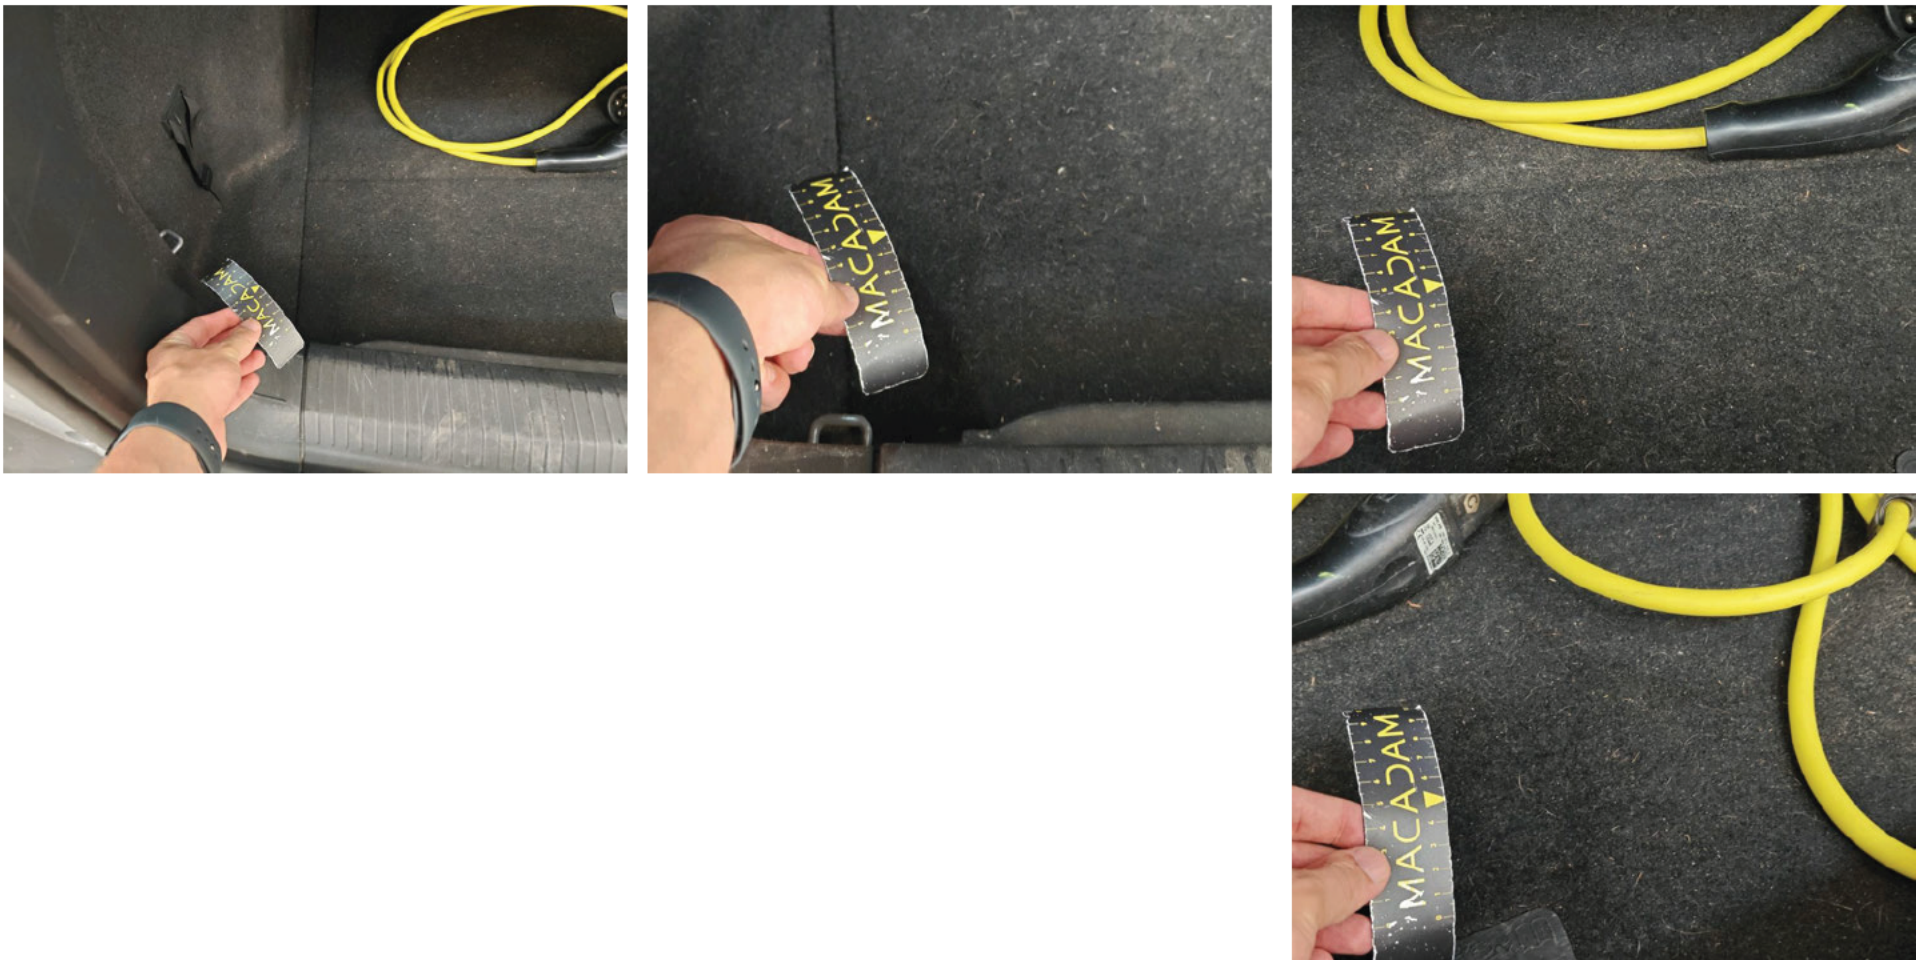
Interior  
Dirty  
Chemical cleaning  
Interior

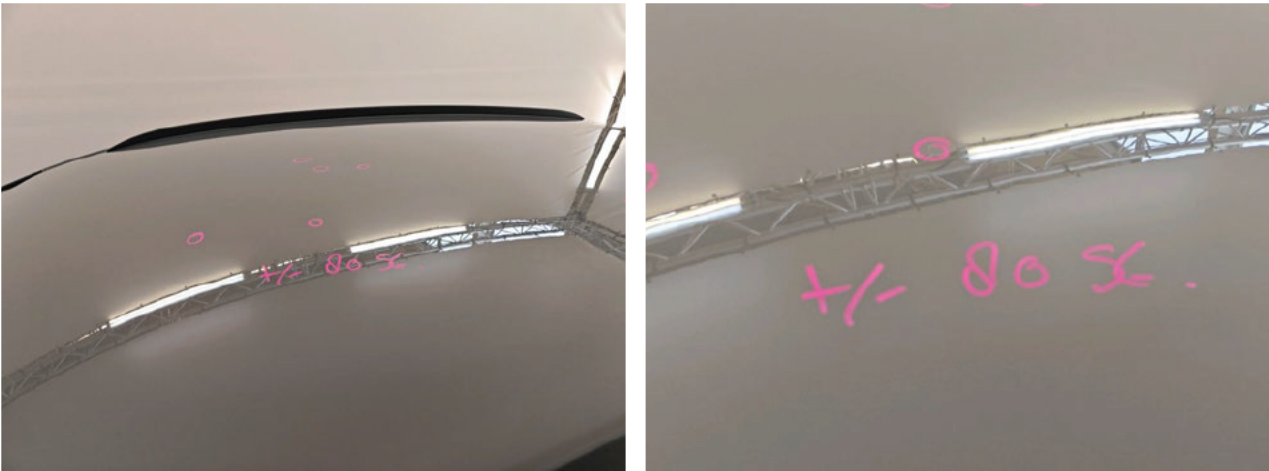
Roof  
Hail damage  
Paintless dent repair (hail)  
Roof & others

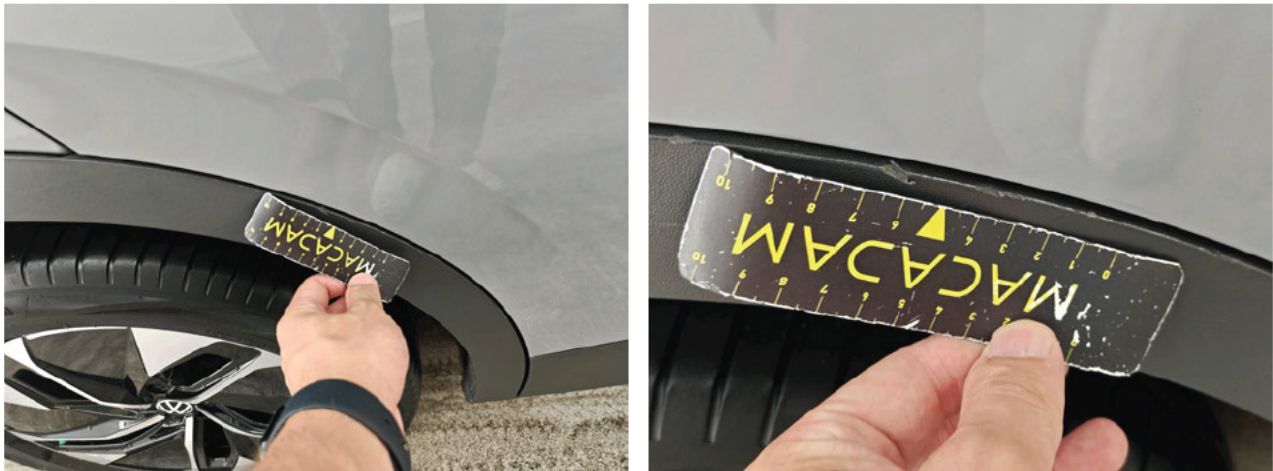
Wing trim RR  
Scratch(es)  
Replace  
Right
