Expertise

Protocol number: 46242816
Order No. / Reference: 26574374
Inspection date: 29 Jun 2026

Model: Astra 1.5 D Start/Stop Sports Tourer Automatik Design&Tech

VIN: W0VBE8EV6M8021705

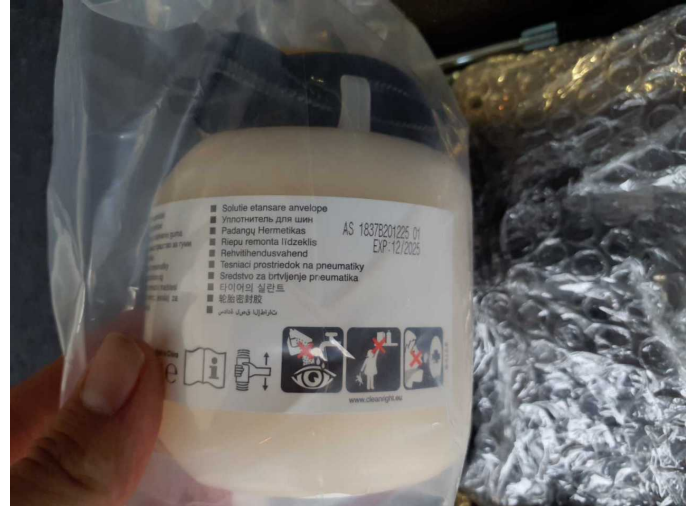
Damage 1: Equipment: Tirefit filler - Expired - Replace

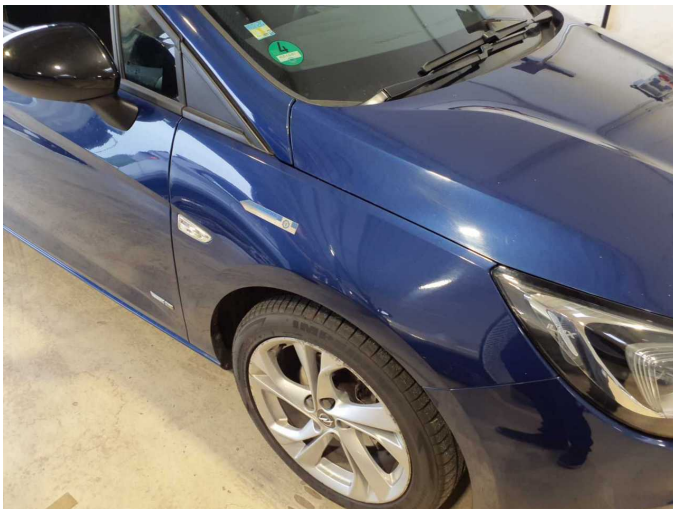
Damage 2: Mudguard - right side: Mudguard - right side - dent(s) - Smooth repair work

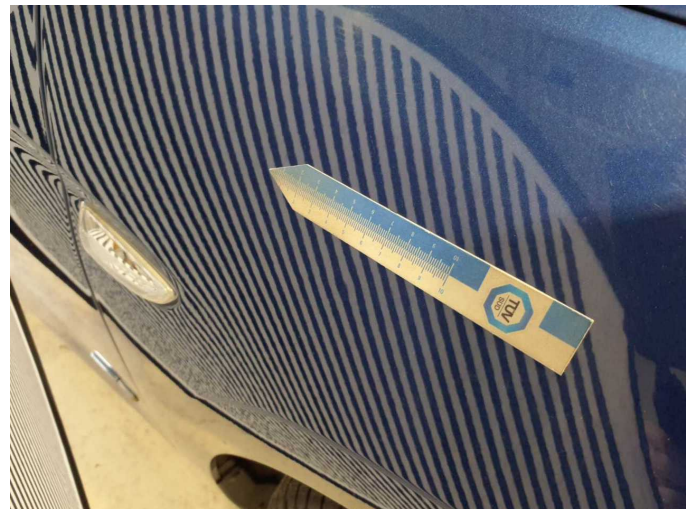
Damage 2: Mudguard - right side: Mudguard - right side - dent(s) - Smooth repair work

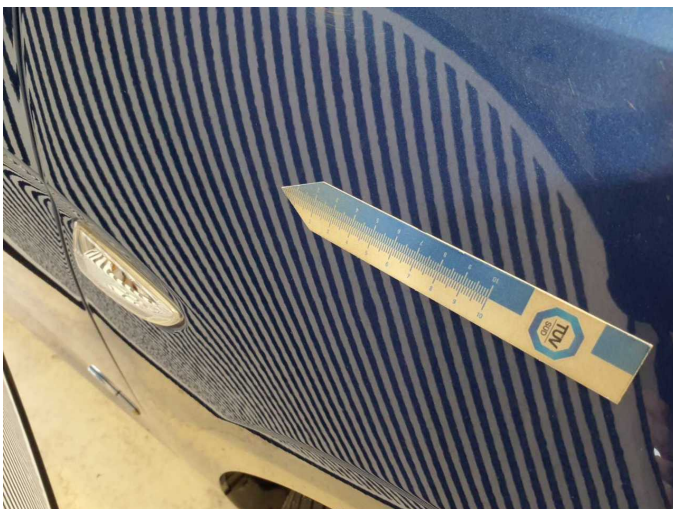
Damage 2: Mudguard - right side: Mudguard - right side - dent(s) - Smooth repair work

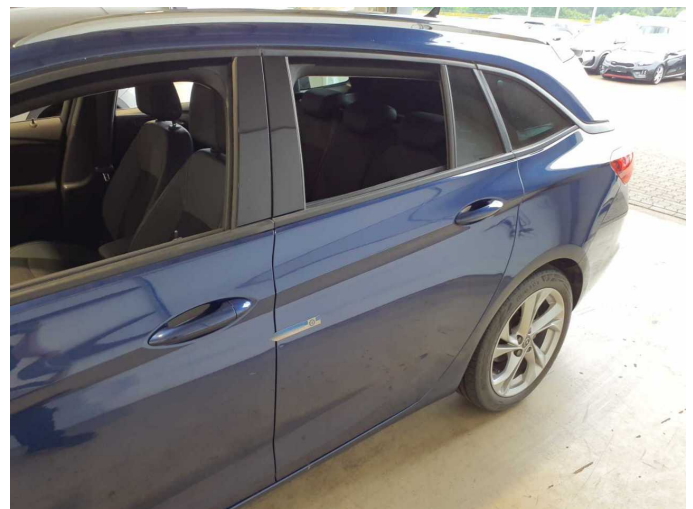
Damage 3: Door - rear left side: Door - dent(s) - Smooth repair work

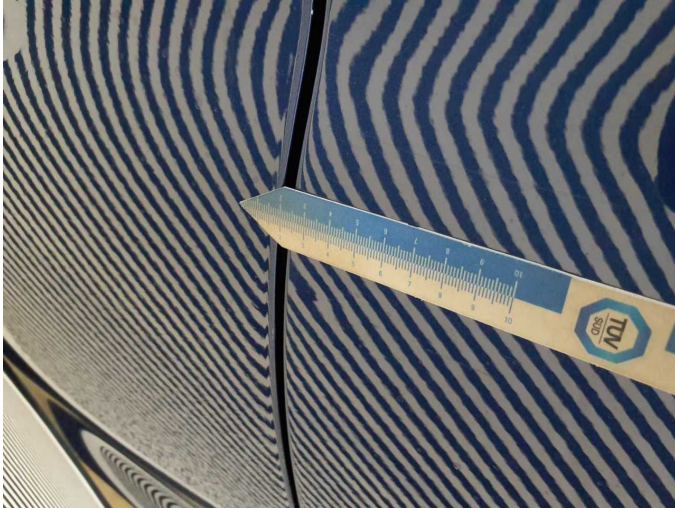
Damage 3: Door - rear left side: Door - dent(s) - Smooth repair work

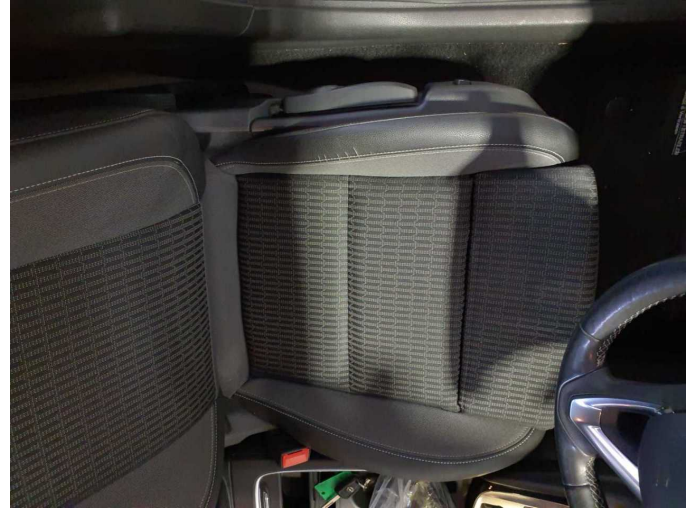
Damage 4: Seat - front: Seat cover - left side - Porous / cracked - Smart repair

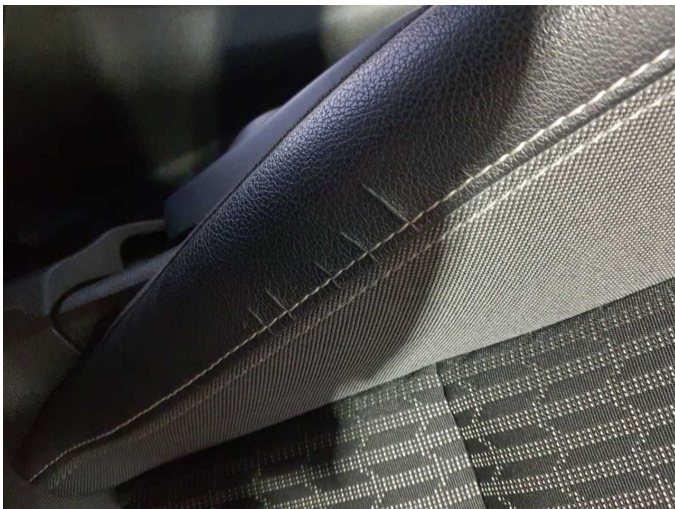
Damage 4: Seat - front: Seat cover - left side - Porous / cracked - Smart repair

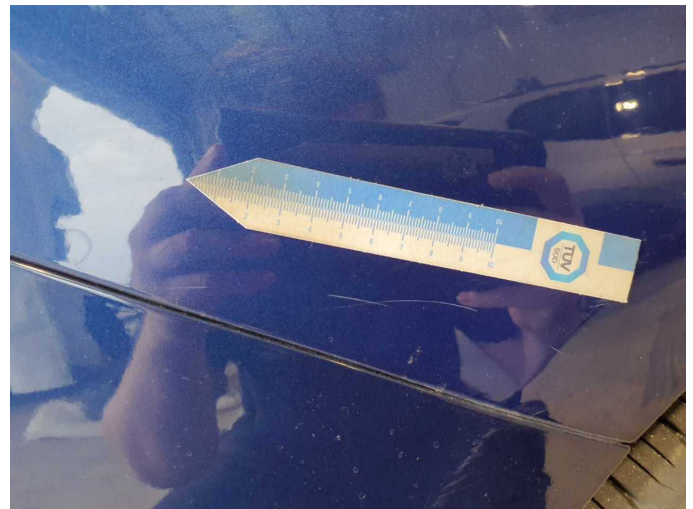
Damage 5: Side panel - rear right side: Side panel - Scratch(es) - Smart repair

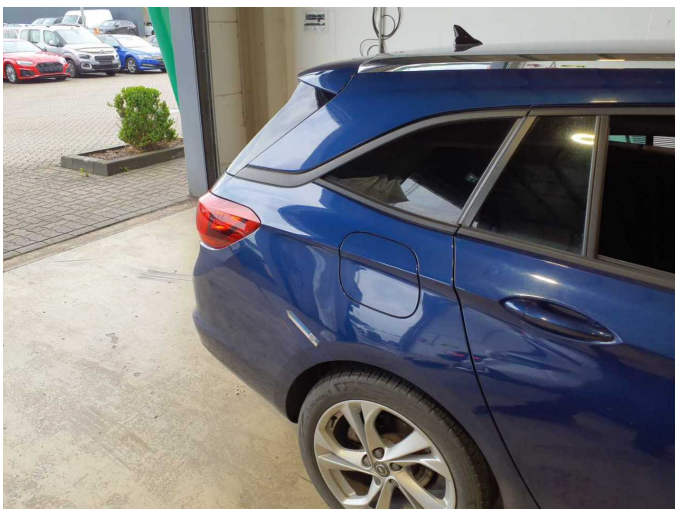
Damage 5: Side panel - rear right side: Side panel - Scratch(es) - Smart repair

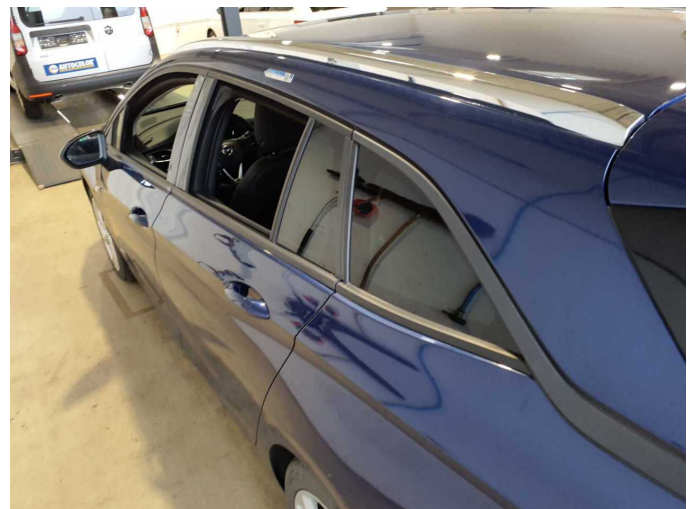
Damage 6: Roof: Roof rail - left side - dent(s) - Smooth repair work

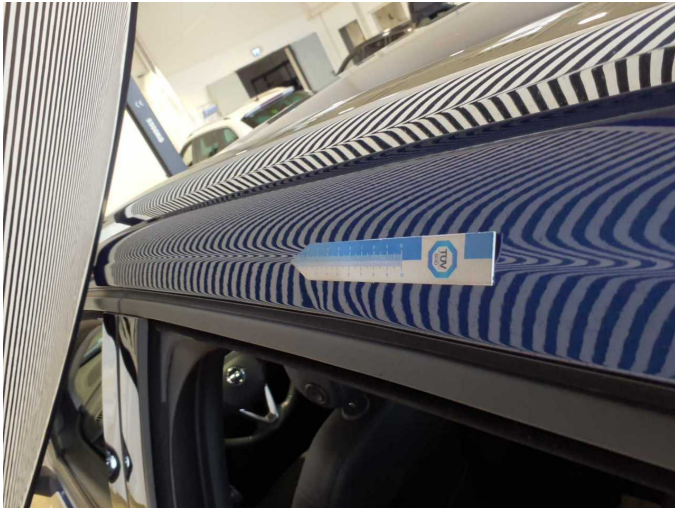
Damage 6: Roof: Roof rail - left side - dent(s) - Smooth repair work

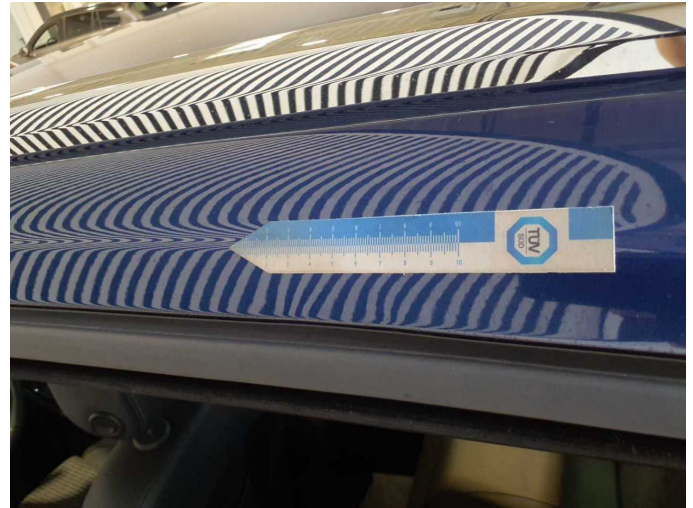
Damage 6: Roof: Roof rail - left side - dent(s) - Smooth repair work

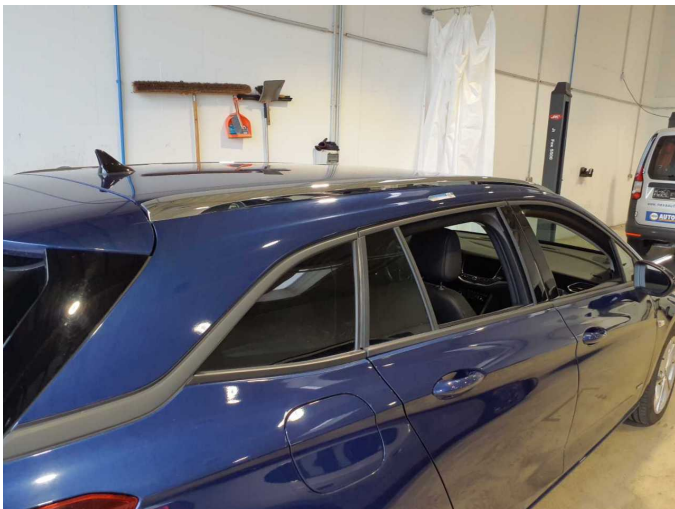
Damage 7: Roof: Roof rail - right side - dent(s) - Smooth repair work

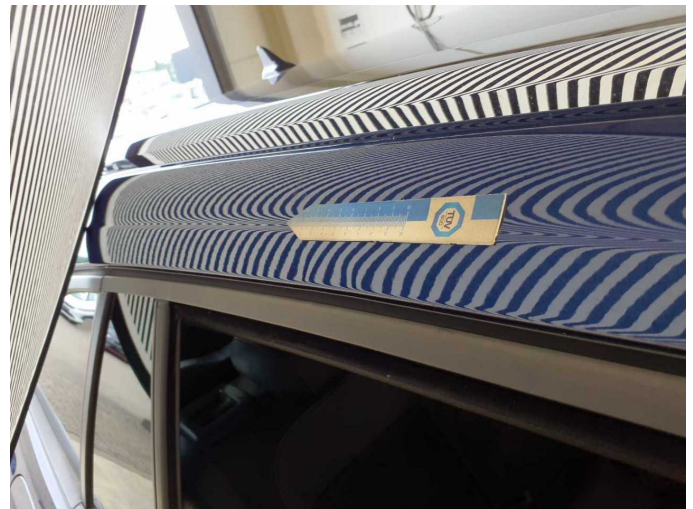
Damage 7: Roof: Roof rail - right side - dent(s) - Smooth repair work

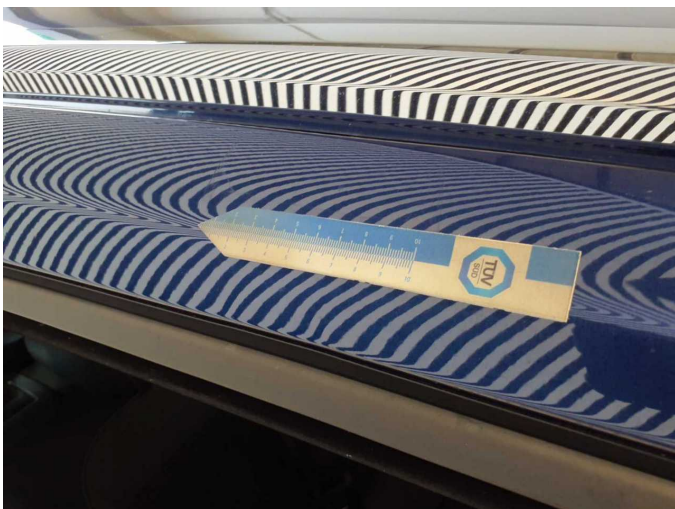
Damage 7: Roof: Roof rail - right side - dent(s) - Smooth repair work

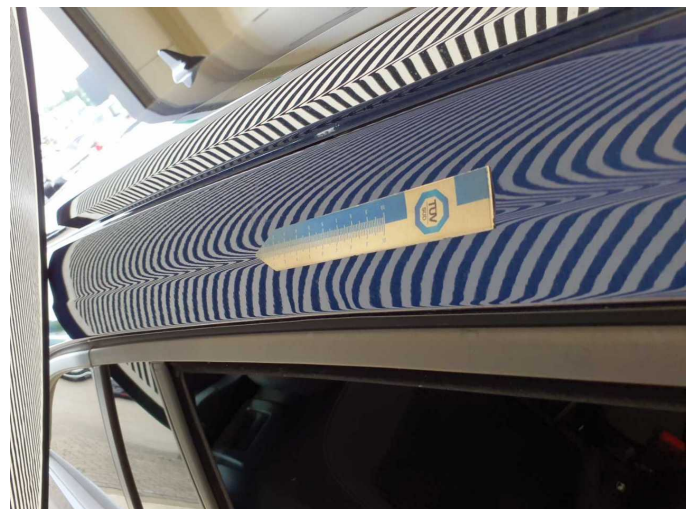
Damage 7: Roof: Roof rail - right side - dent(s) - Smooth repair work

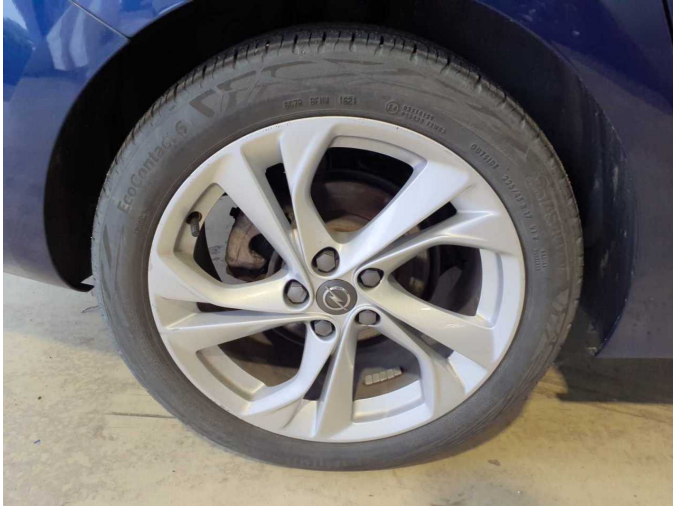
Damage 8: Wheel / tyres: Alloy rim - rear right side - Scratch(es) - Loss in value

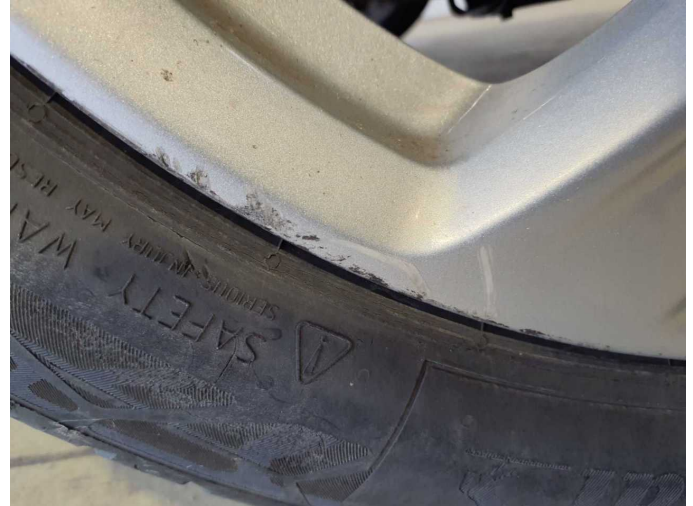
Damage 8: Wheel / tyres: Alloy rim - rear right side - Scratch(es) - Loss in value

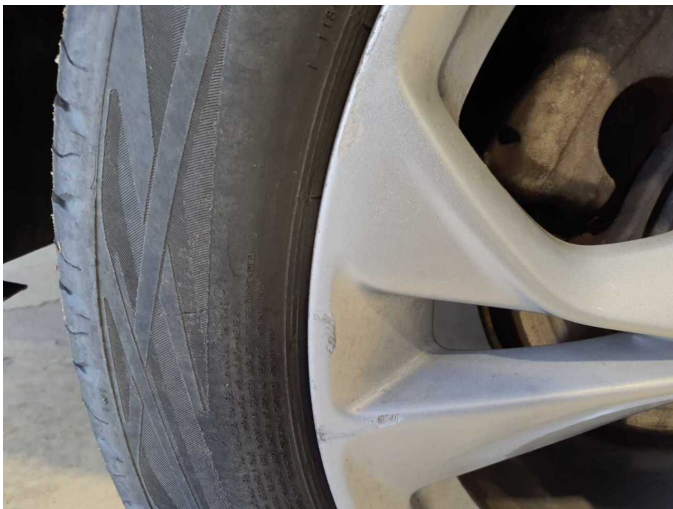
Damage 8: Wheel / tyres: Alloy rim - rear right side - Scratch(es) - Loss in value

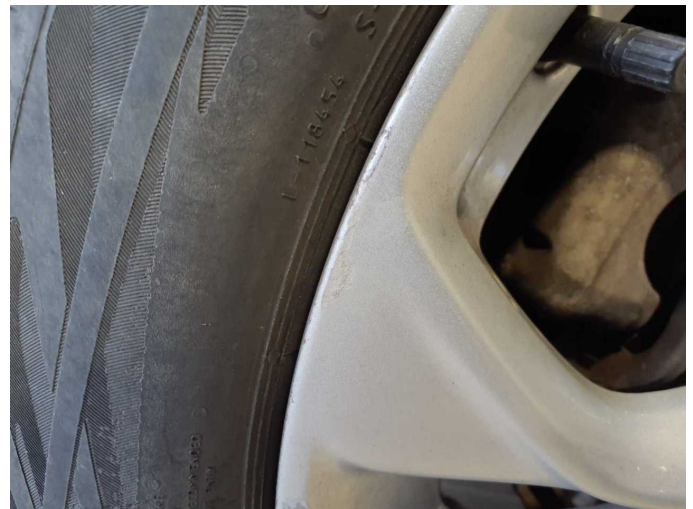
Damage 8: Wheel / tyres: Alloy rim - rear right side - Scratch(es) - Loss in value

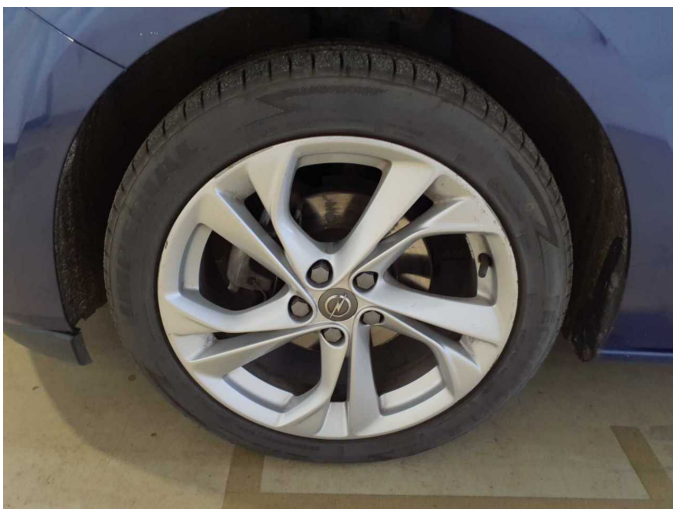
Damage 9: Wheel / tyres: Alloy rim - front left side - Scratch(es) - Loss in value

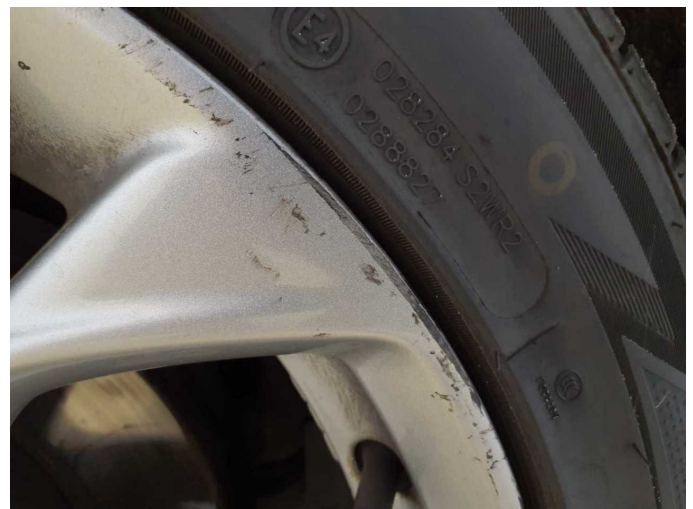
Damage 9: Wheel / tyres: Alloy rim - front left side - Scratch(es) - Loss in value

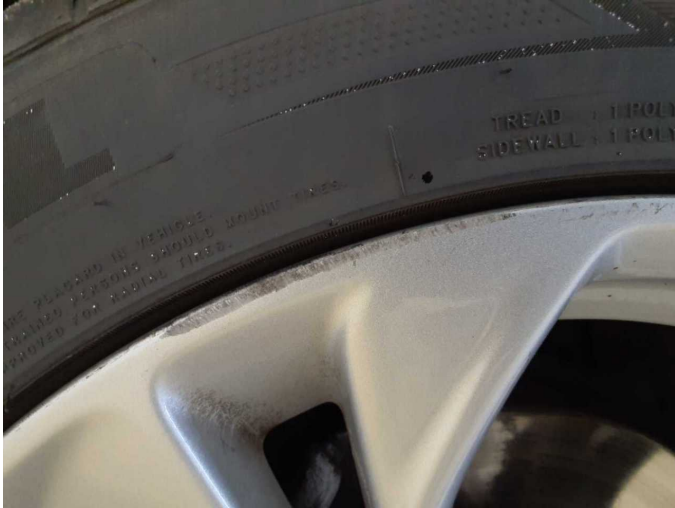
Damage 9: Wheel / tyres: Alloy rim - front left side - Scratch(es) - Loss in value

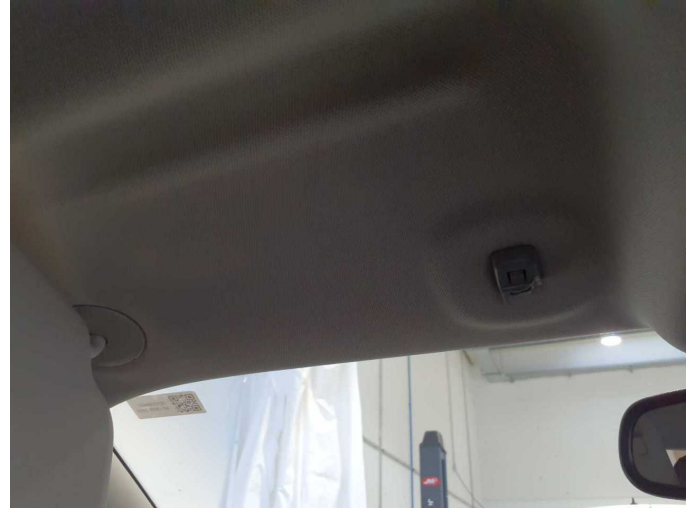
Damage 10: Interior: Sun visor - left side (Halter) - Broken / torn - Replace

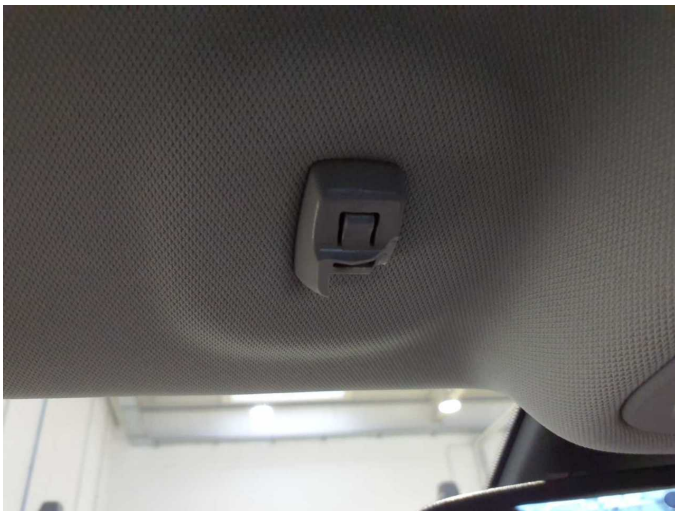
Damage 10: Interior: Sun visor - left side (Halter) - Broken / torn - Replace

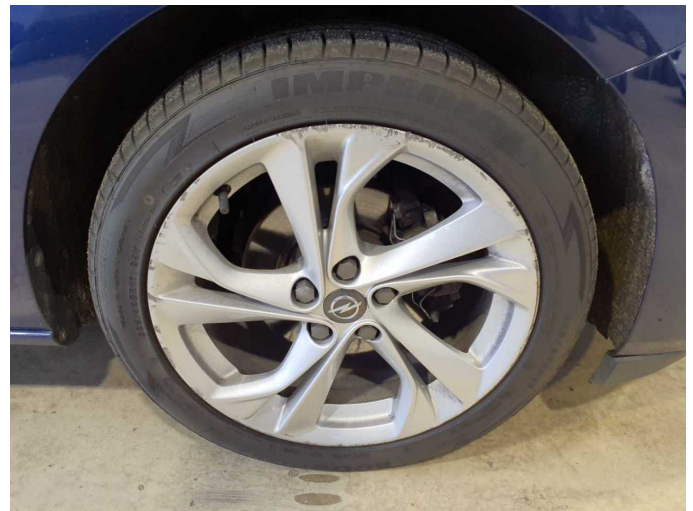
Damage 11: Wheel / tyres: Alloy rim - front right side - Scratch(es) - Replace

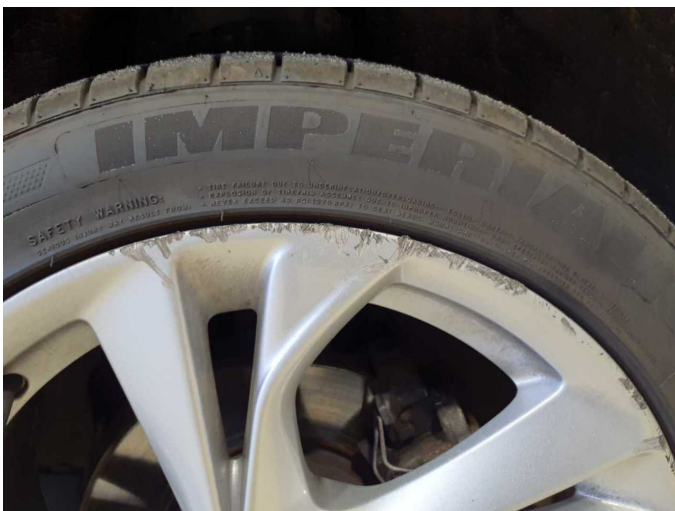
Damage 11: Wheel / tyres: Alloy rim - front right side - Scratch(es) - Replace

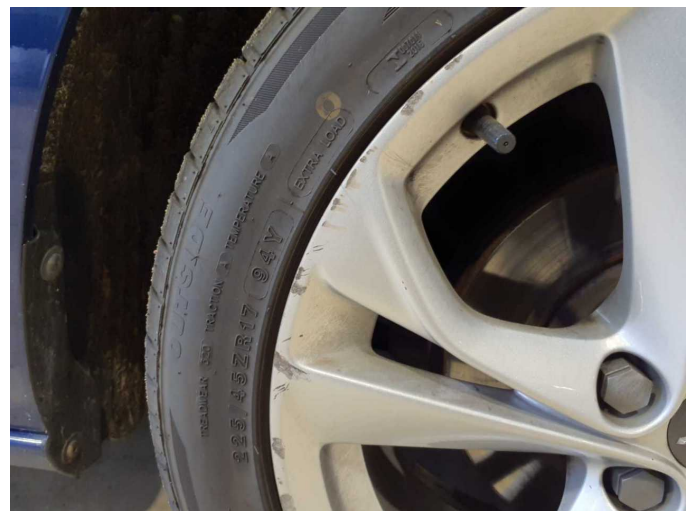
Damage 11: Wheel / tyres: Alloy rim - front right side - Scratch(es) - Replace

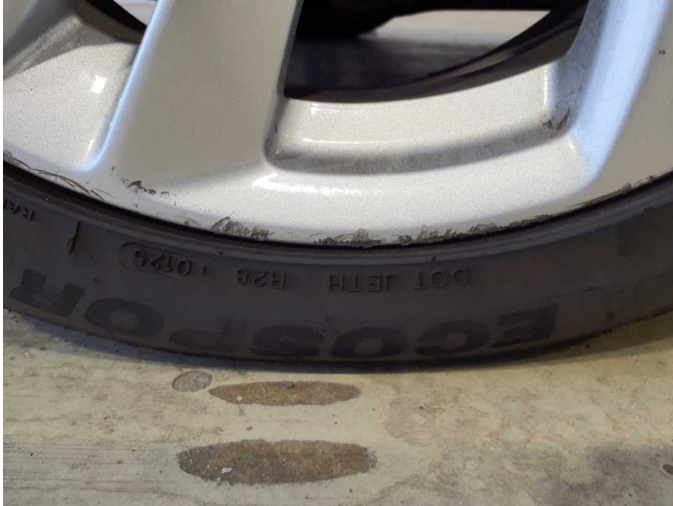
Damage 11: Wheel / tyres: Alloy rim - front right side - Scratch(es) - Replace

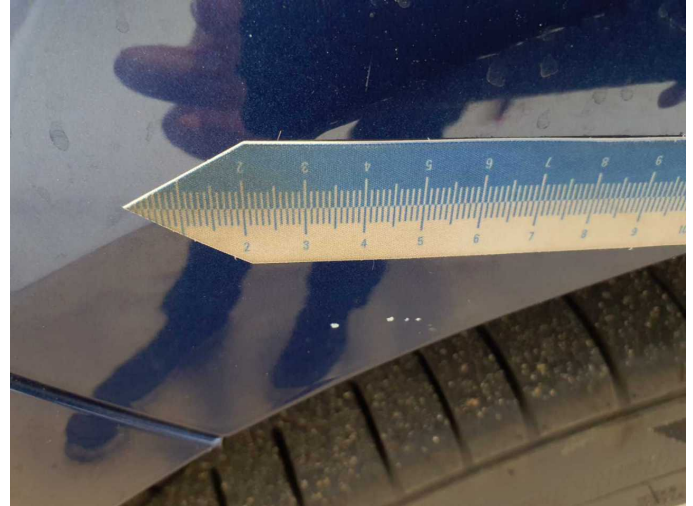
Damage 12: Mudguard - left side: Mudguard - left side - Stone chips - Paint

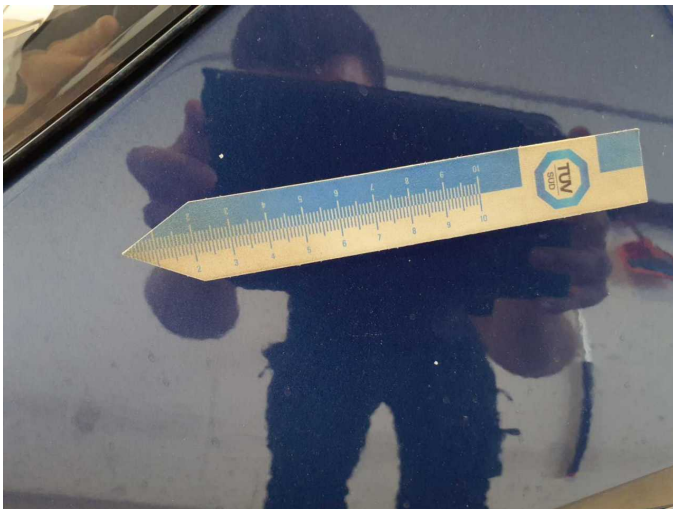
Damage 12: Mudguard - left side: Mudguard - left side - Stone chips - Paint

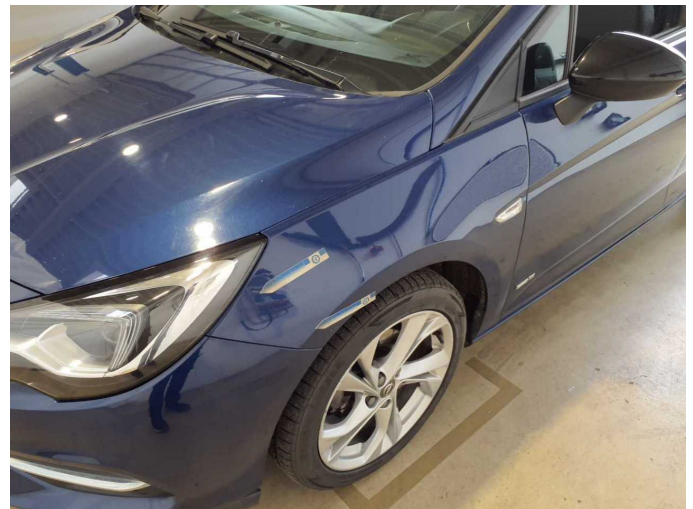
Damage 12: Mudguard - left side: Mudguard - left side - Stone chips - Paint

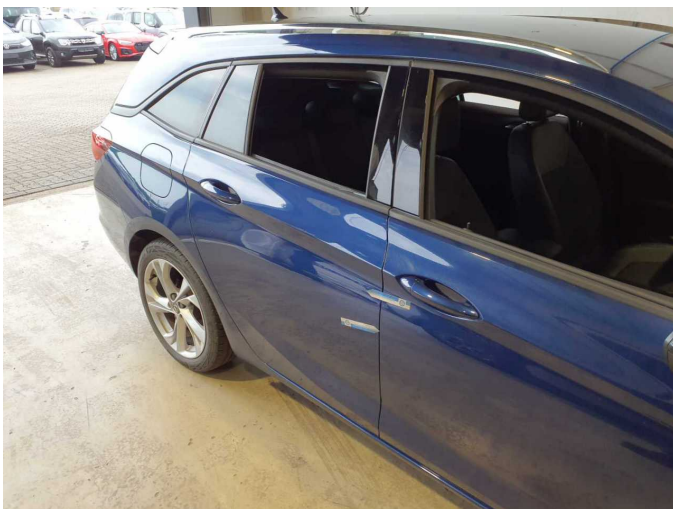
Damage 13: Door - rear right side: Door - Scratch(es) - Paint

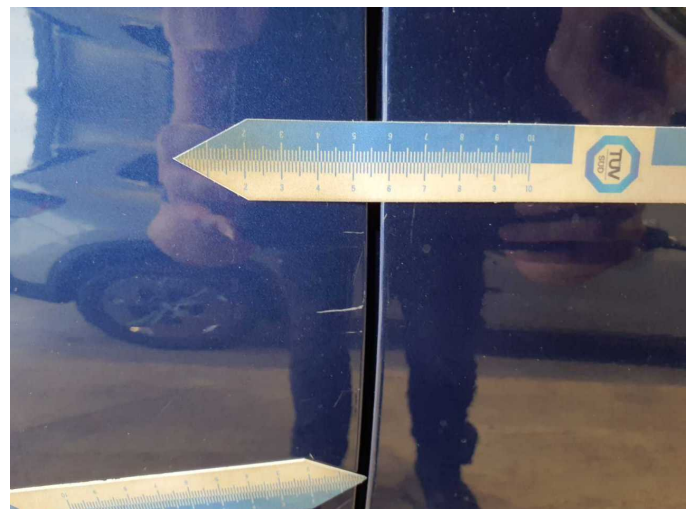
Damage 13: Door - rear right side: Door - Scratch(es) - Paint

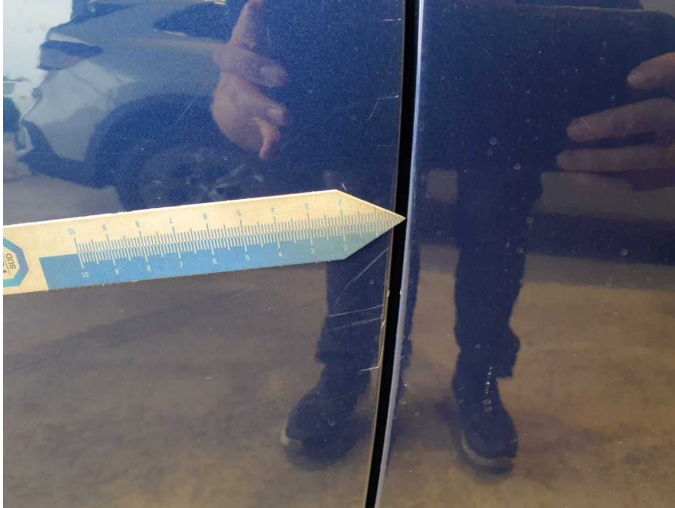
Damage 13: Door - rear right side: Door - Scratch(es) - Paint

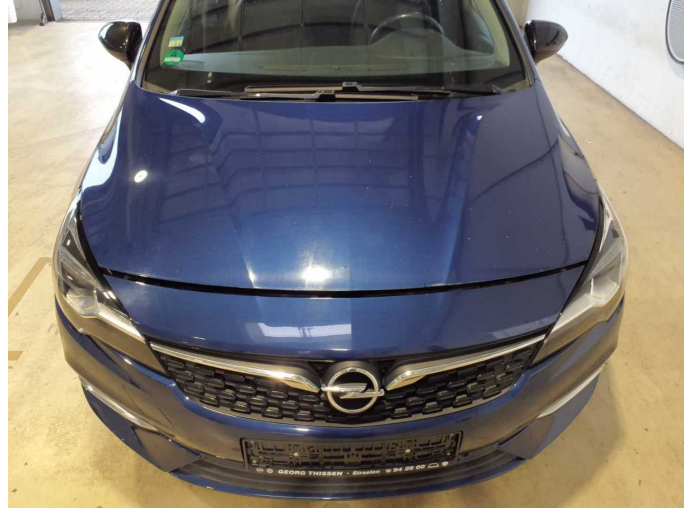
Damage 14: Bonnet: Bonnet - Stone chips - Paint

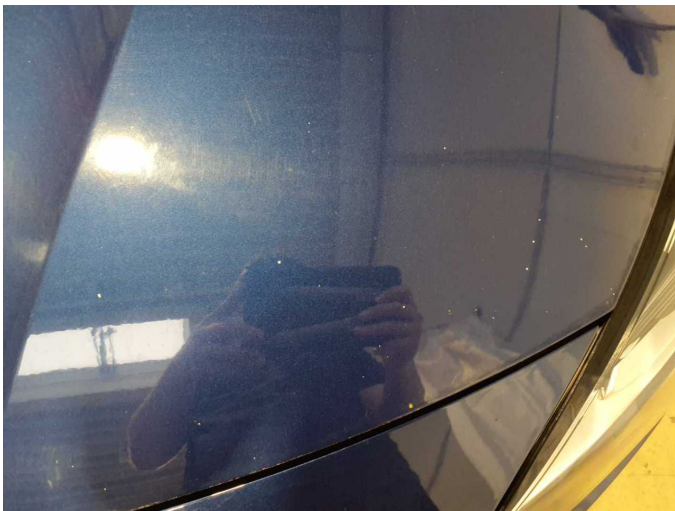
Damage 14: Bonnet: Bonnet - Stone chips - Paint

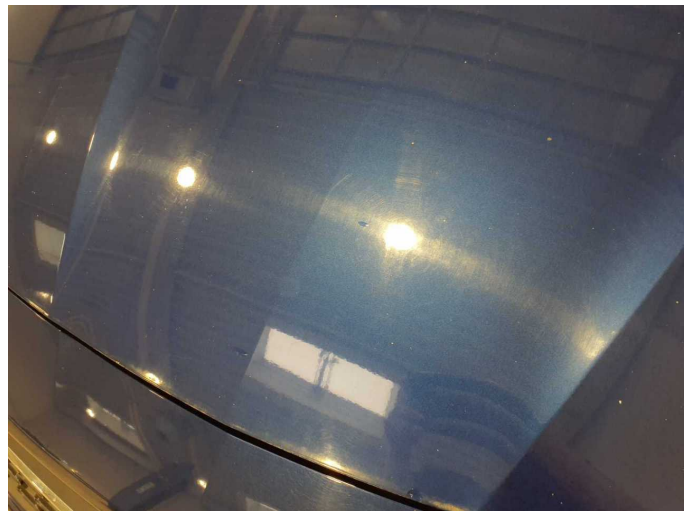
Damage 14: Bonnet: Bonnet - Stone chips - Paint

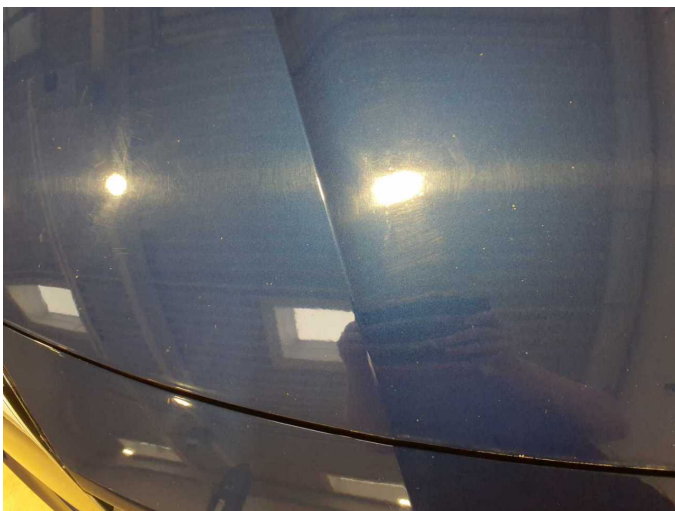
Damage 14: Bonnet: Bonnet - Stone chips - Paint

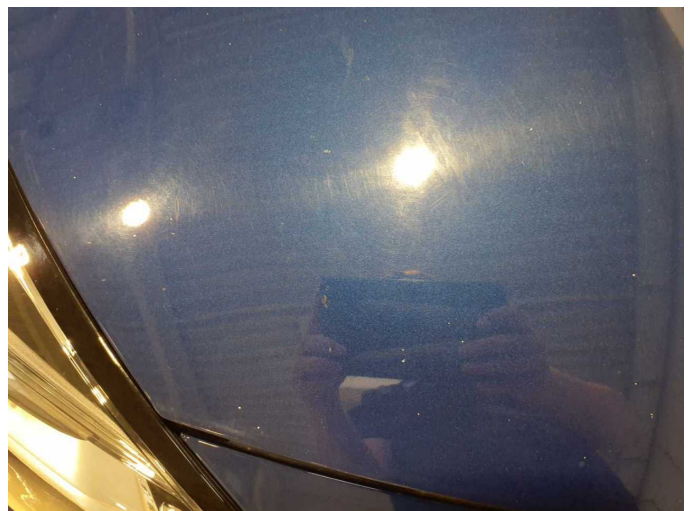
Damage 14: Bonnet: Bonnet - Stone chips - Paint

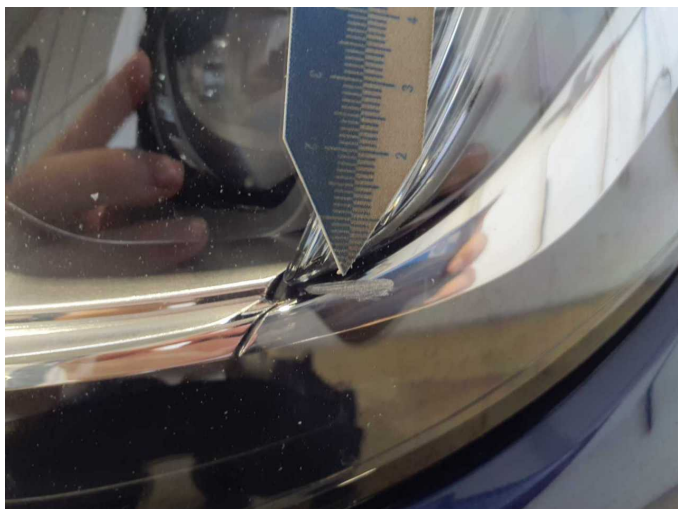
Damage 15: Headlight: Headlight - left side - Broken / torn - repair according to calculation

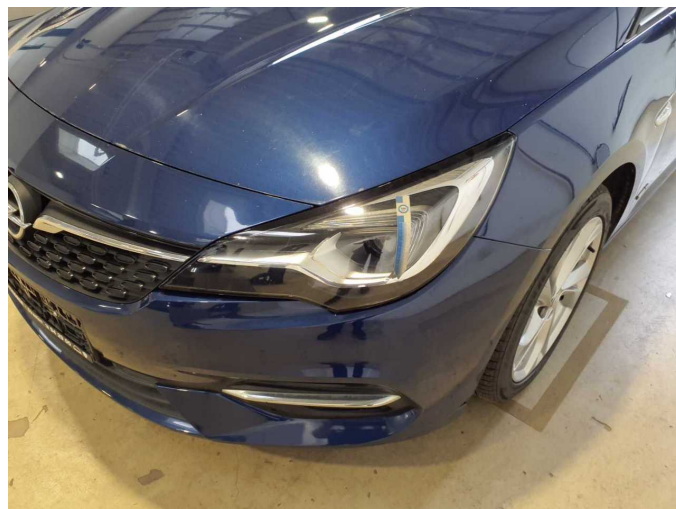
Damage 15: Headlight: Headlight - left side - Broken / torn - repair according to calculation
