Expertise

Protocol number: 46917230  
Order No. / Reference: 26685260  
Inspection date: 3 Aug 2026

Manufacturer: Ford

Model: Mondeo Turnier 2.0 TDCi Start-Stopp Trend

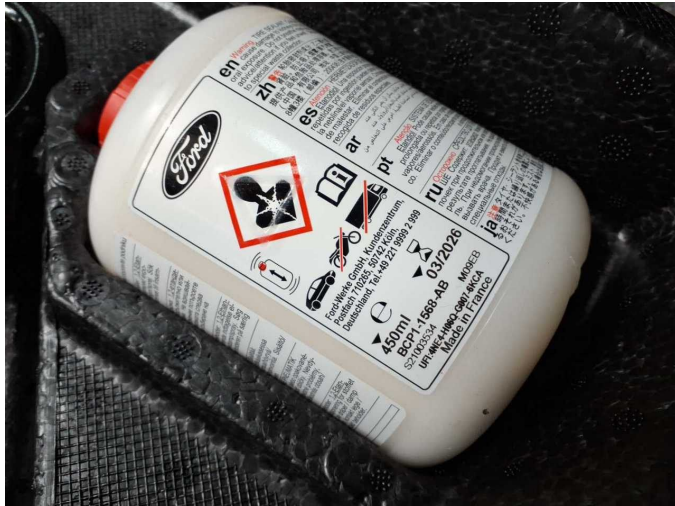
| No. | Component group | Description |
|---|---|---|
| 1 | Equipment | Tirefit filler - Expired - Replace |

**Damage 1:** Equipment: Tirefit filler - Expired - Replace

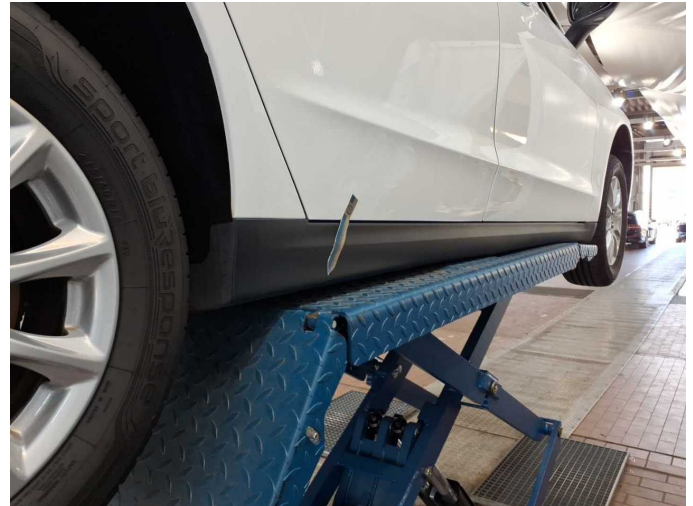
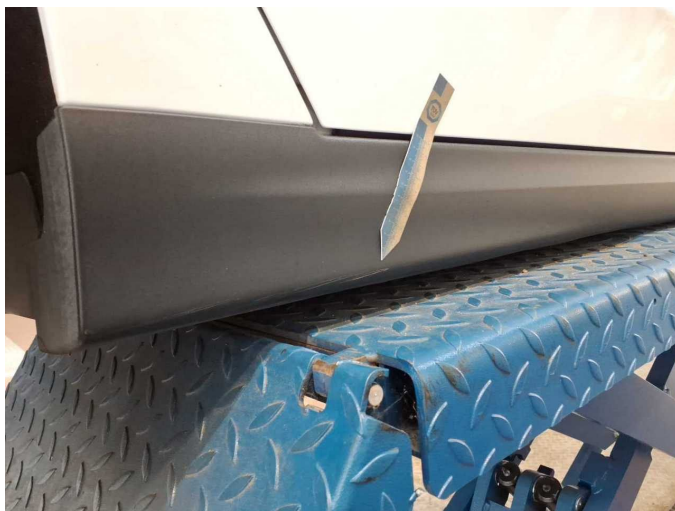
| No. | Component group | Description |
|---|---|---|
| 2 | Sill - right side | Trim - Scratch(es) - Loss in value |

**Damage 2:** Sill - right side: Trim - Scratch(es) - Loss in value

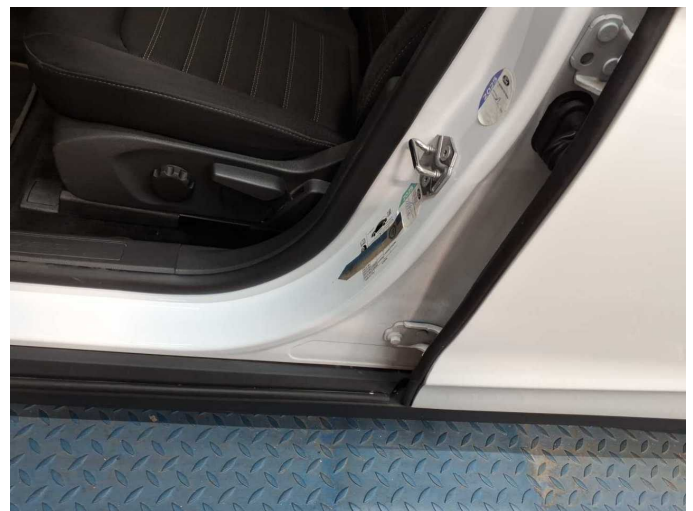
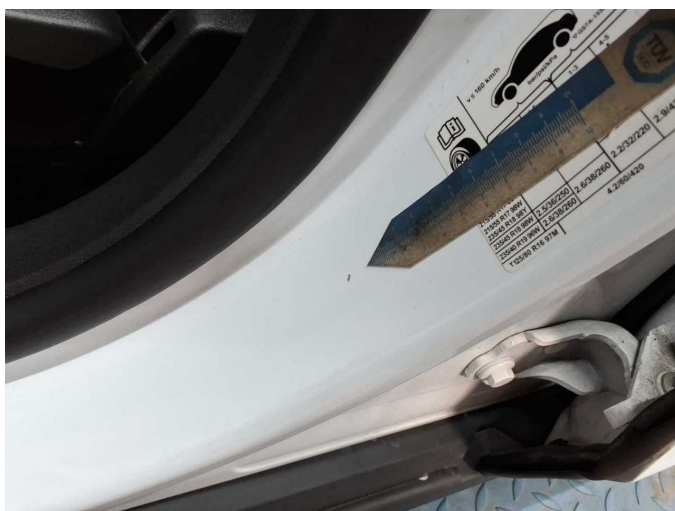
| No. | Component group | Description |
|---|---|---|
| 3 | Side panel - rear left side | Sill - Scratch(es) - Smart repair |

**Damage 3:** Side panel - rear left side: Sill - Scratch(es) - Smart repair

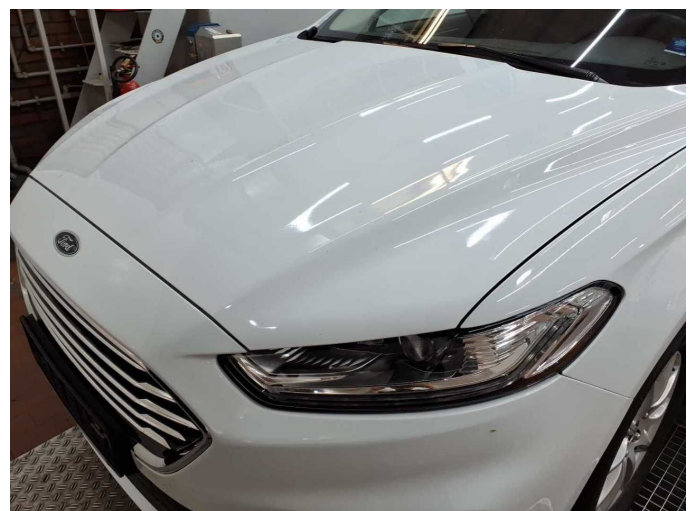
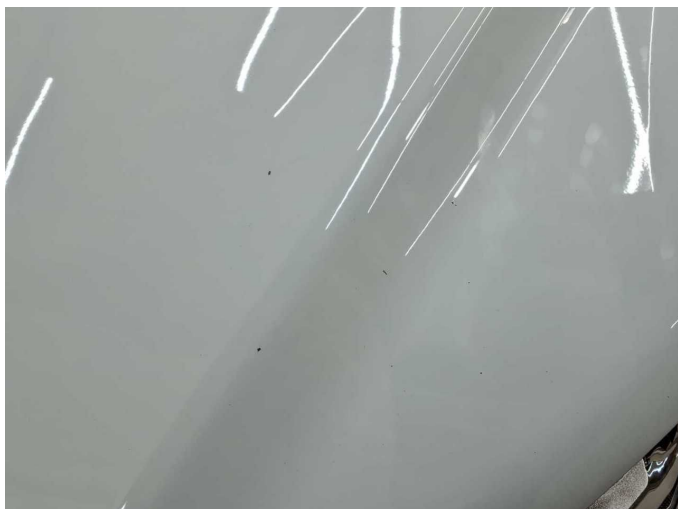
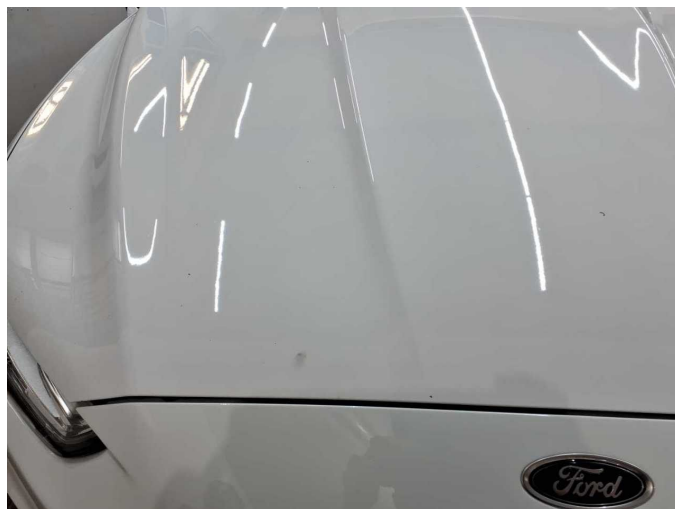
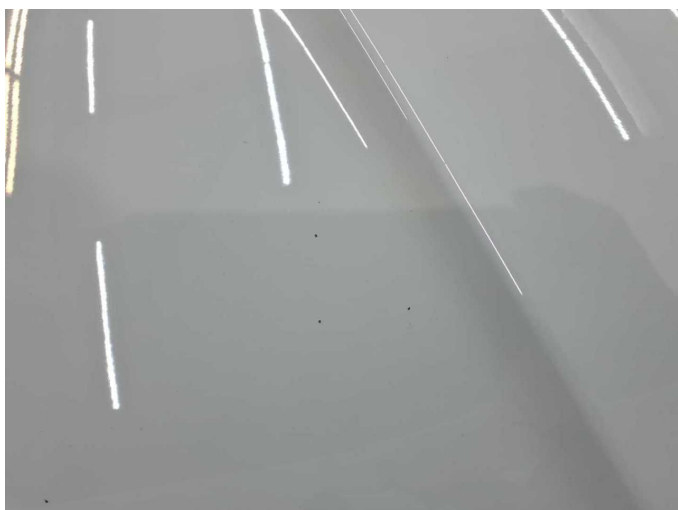
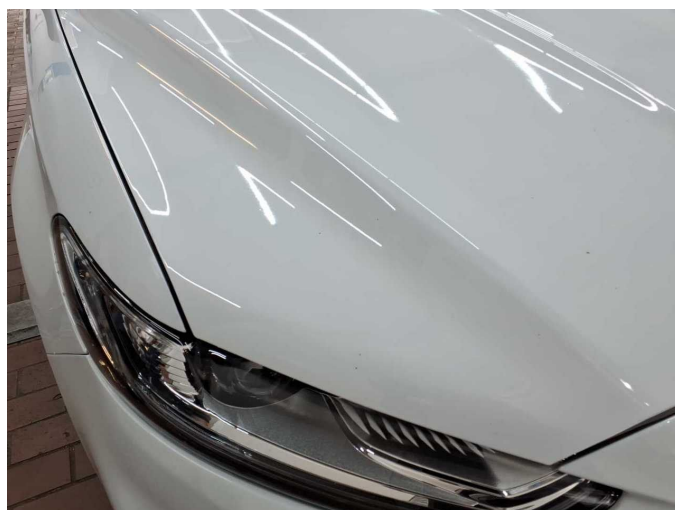
| No. | Component group | Description |
|---|---|---|
| 4 | Bonnet | Bonnet - Stone chips - Paint |

**Damage 4:** Bonnet: Bonnet - Stone chips - Paint

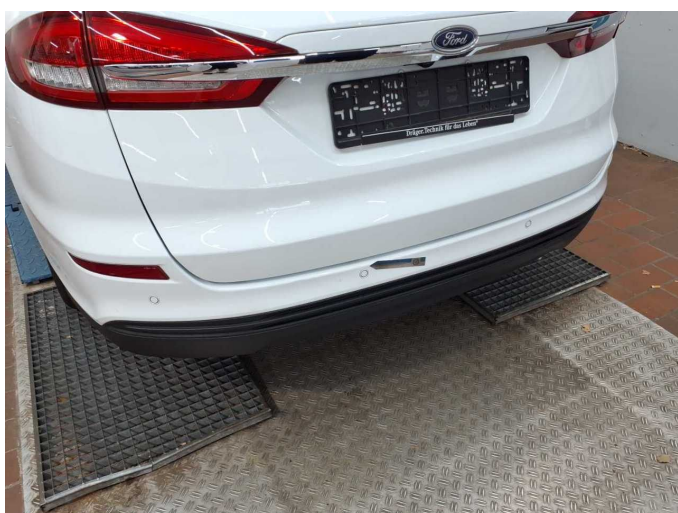
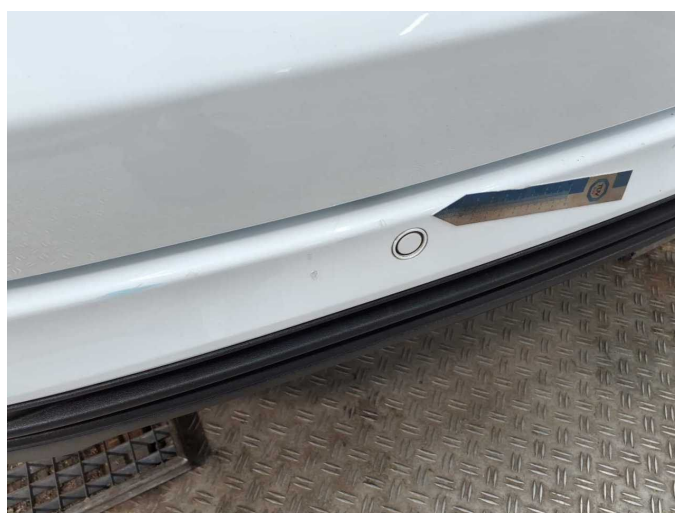
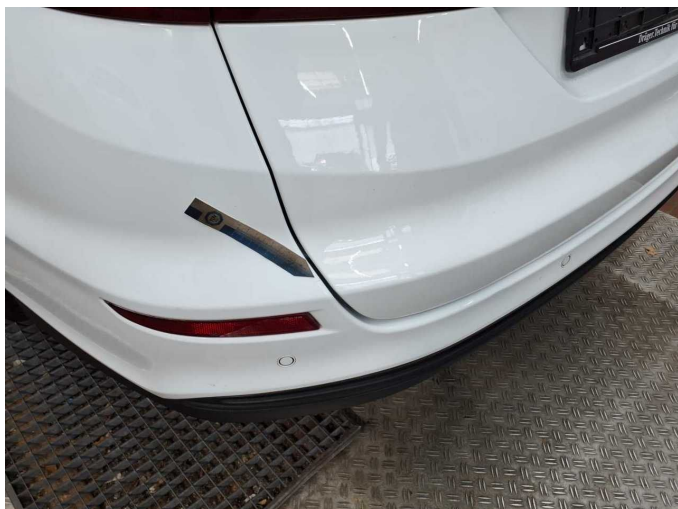
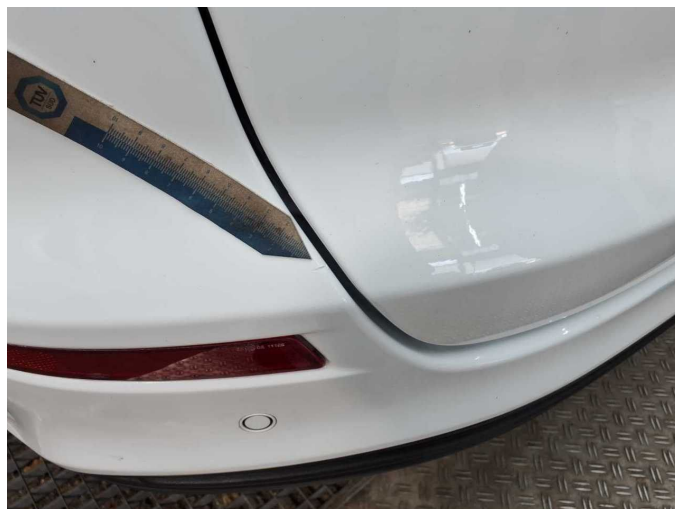
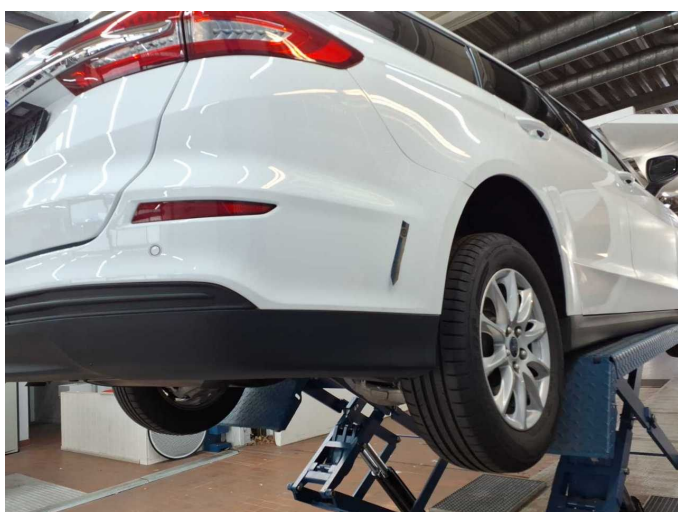
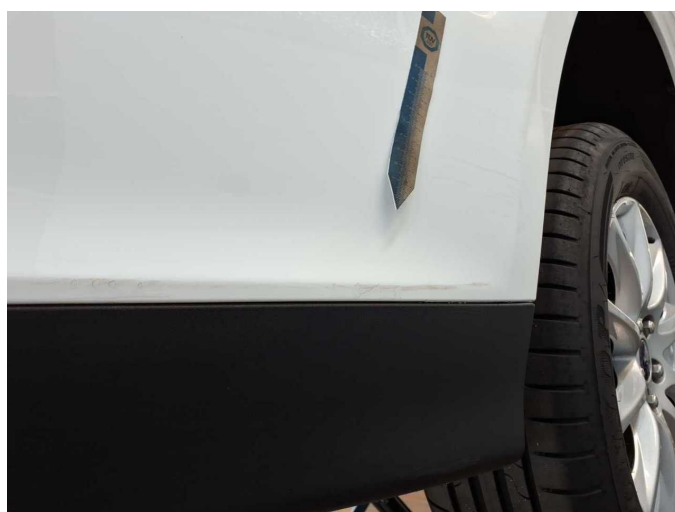
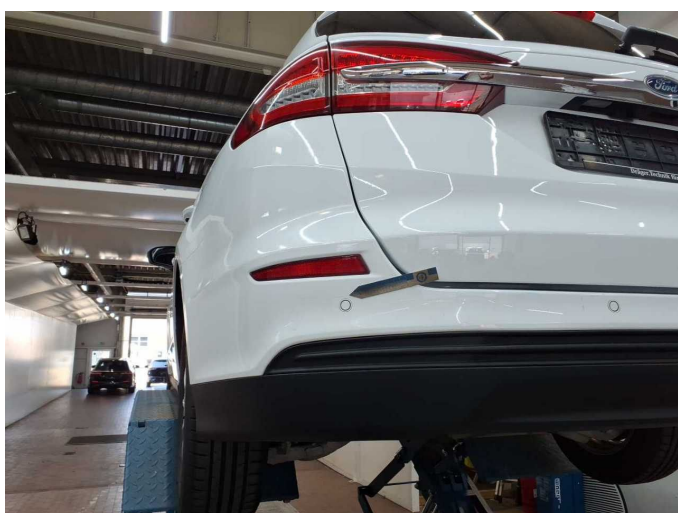
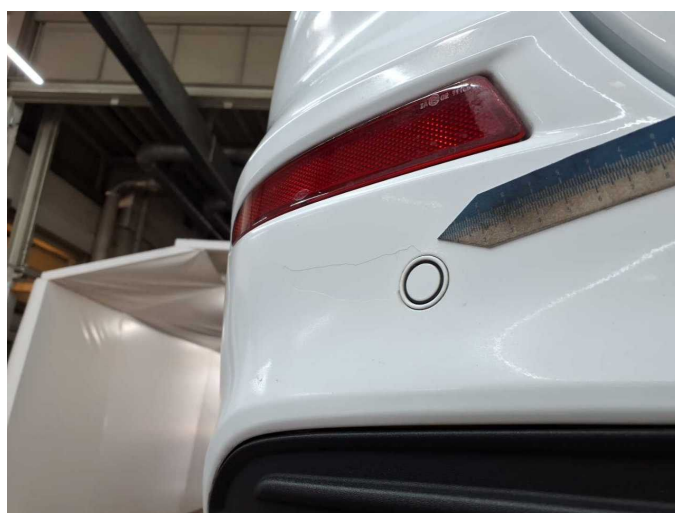
| No. | Component group | Description |
|---|---|---|
| 5 | Rear bumper | Rear bumper - Scratch(es) - Paint |

**Damage 5:** Rear bumper: Rear bumper - Scratch(es) - Paint

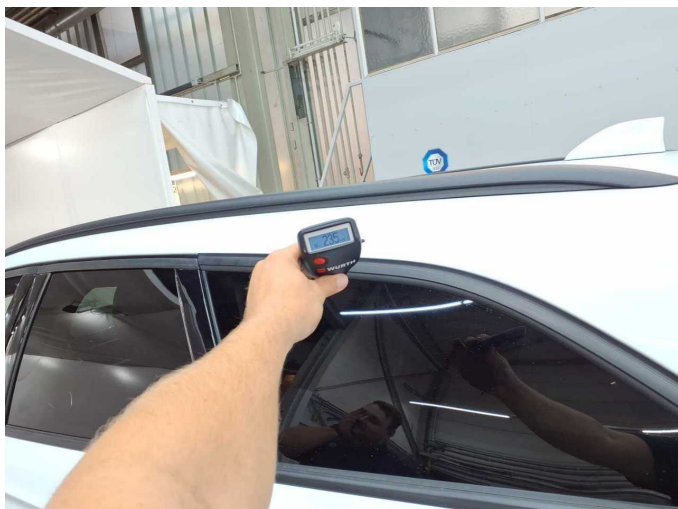
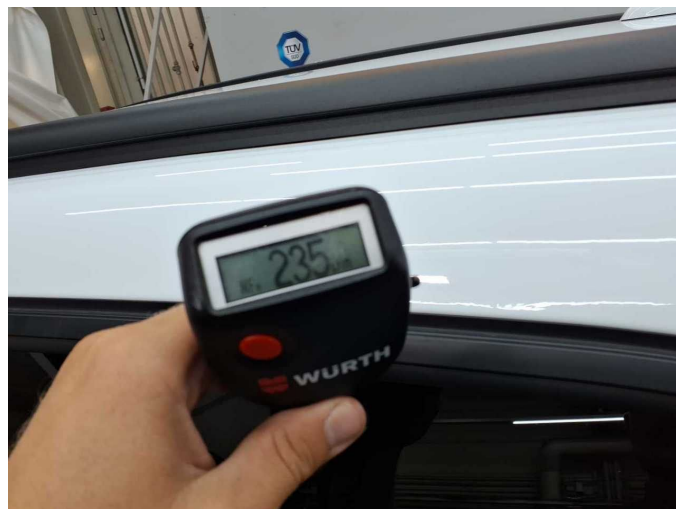
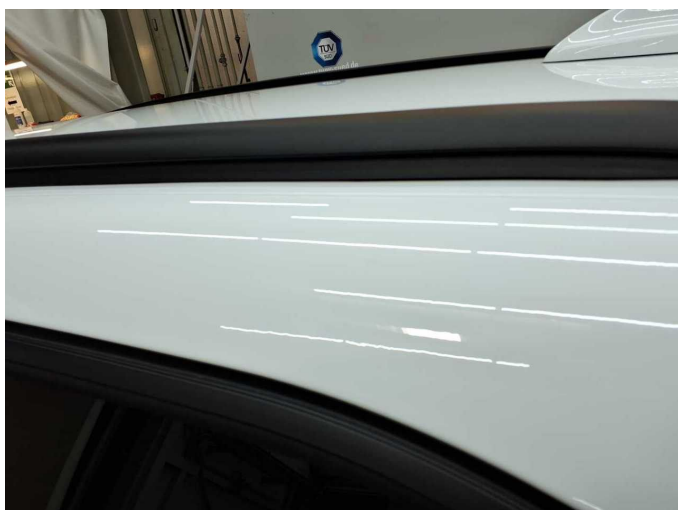
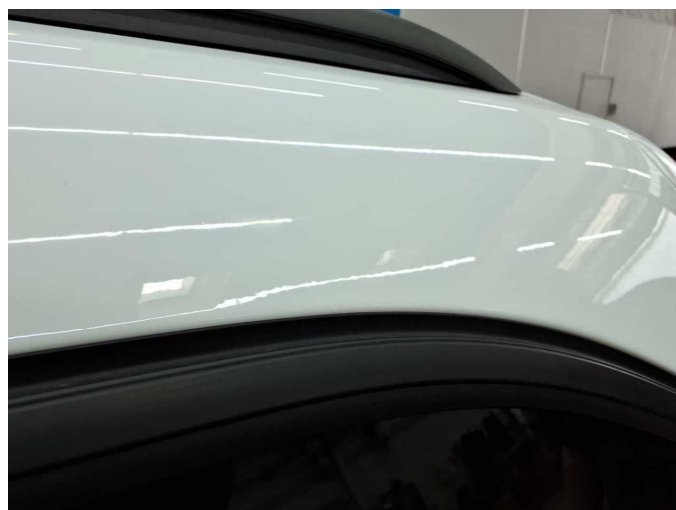
| No. | Component group | Description |
|---|---|---|
| 6 | Roof | Roof rail - left side (Orangenhaut.) - Unprofessionally repaired - Paint |

| No. | Repainting |
|---|---|
| 1 | Roof rail - left side, Side panel - rear left side, Unprofessionally carried out, Invoice of repair done Non-existent |

| Roof rail - left side | 235 µm | Side panel - rear left side | 396 µm |

**Damage 6:** Roof: Roof rail - left side (Orangenhaut.) - Unprofessionally repaired - Paint

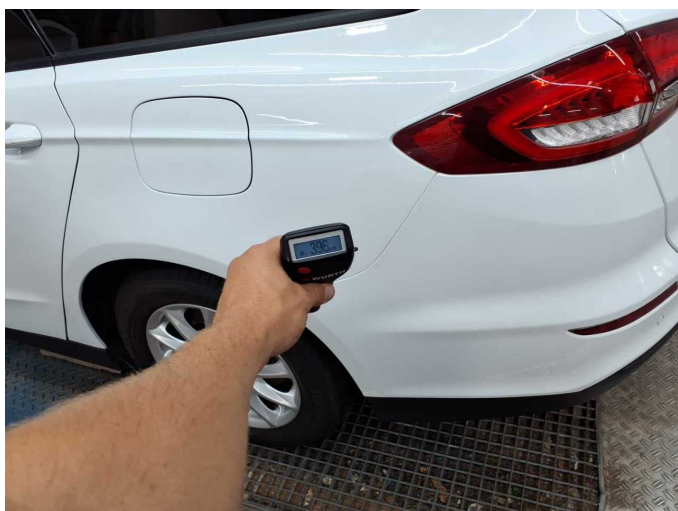
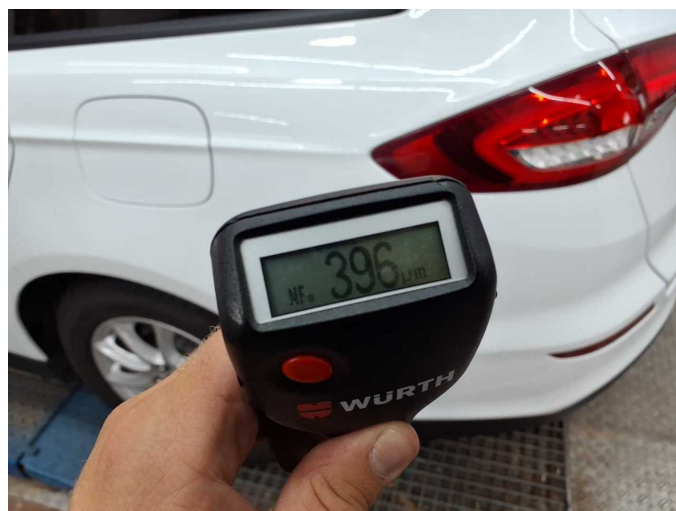
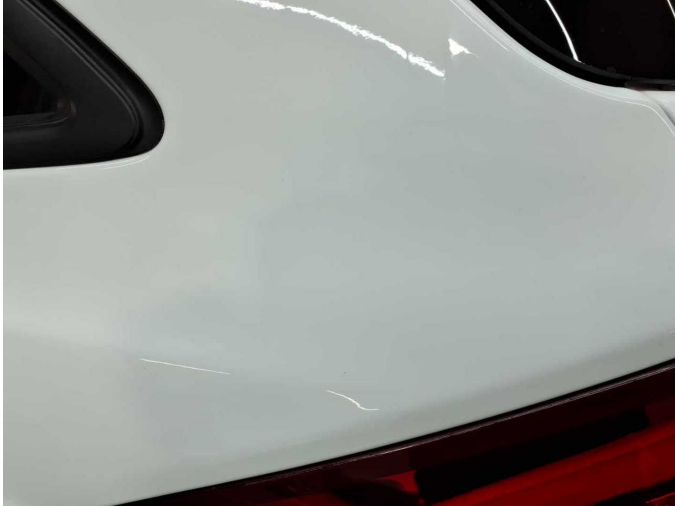
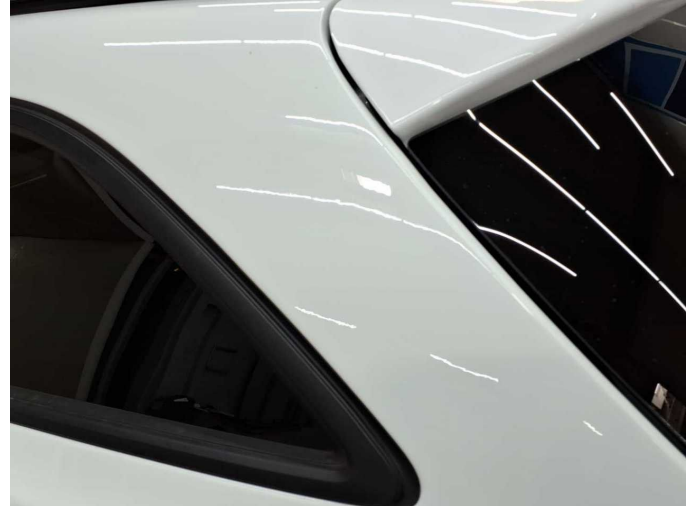
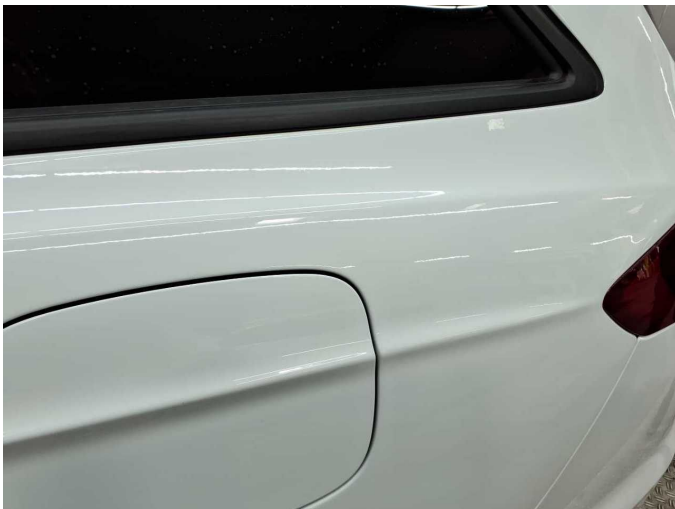
| No. | Component group | Description |
|---|---|---|
| 7 | Side panel - rear left side | Side panel (Orangenhaut) - Unprofessionally repaired - Paint |

**Damage 7:** Side panel - rear left side: Side panel (Orangenhaut) - Unprofessionally repaired - Paint

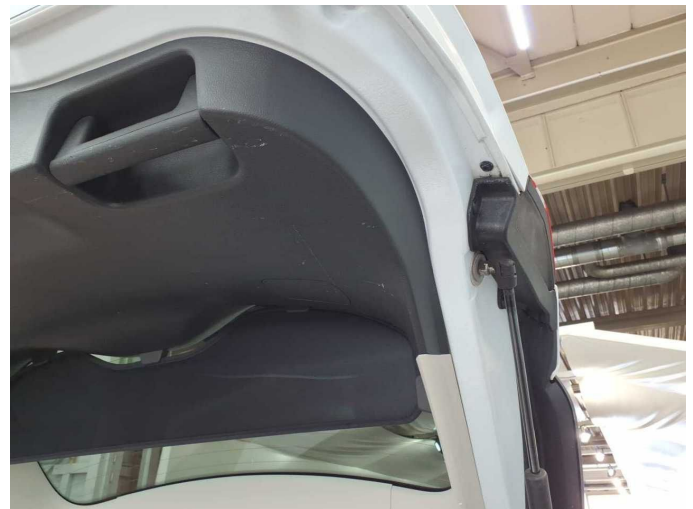
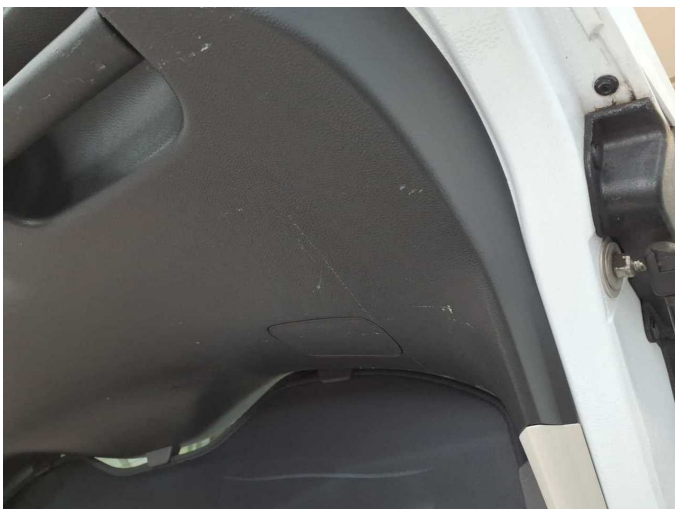
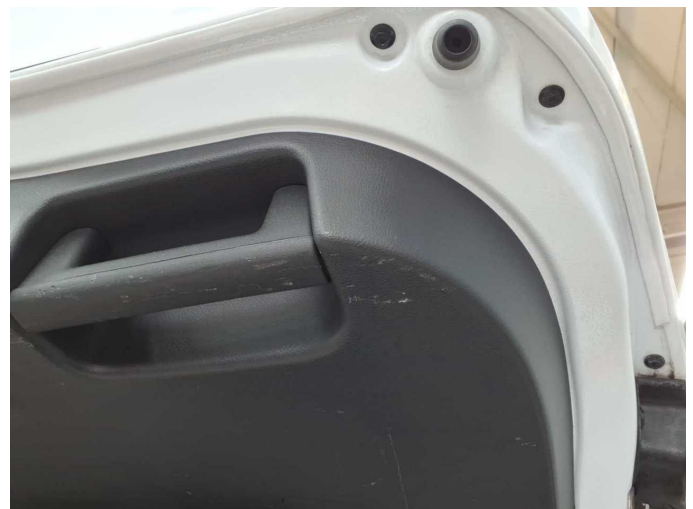
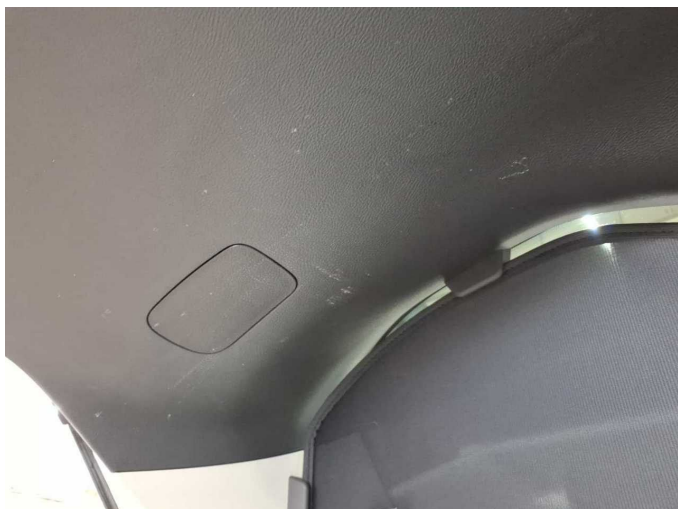
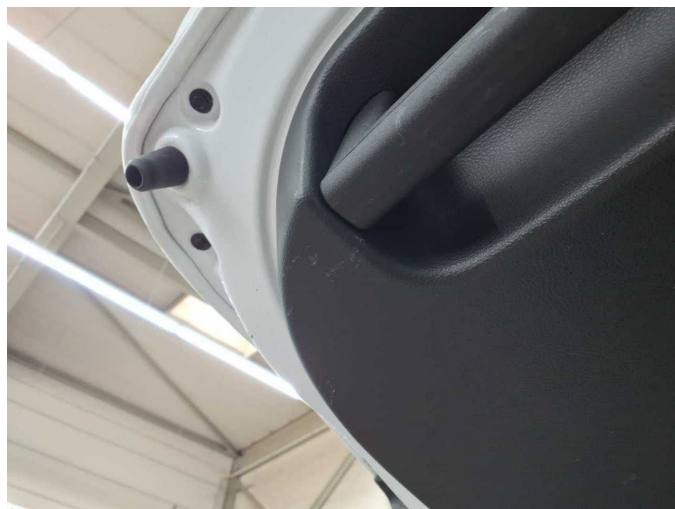
| No. | Component group | Description |
|---|---|---|
| 1 | Trim / covers | Boot lid - interior trim - Scratch(es) - No deduction |

**Wear and tear 1:** Trim / covers: Boot lid - interior trim - Scratch(es) - No deduction
