Expertise

Protocol number: 46902477  
Order No. / Reference: 26734139  
Inspection date: 5 Aug 2026

Manufacturer: Volkswagen

Model: Passat Variant 2.0 TDI SCR DSG Business

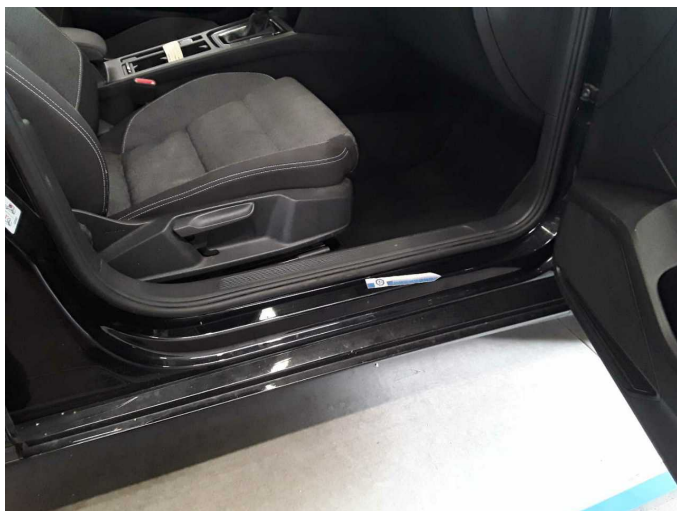
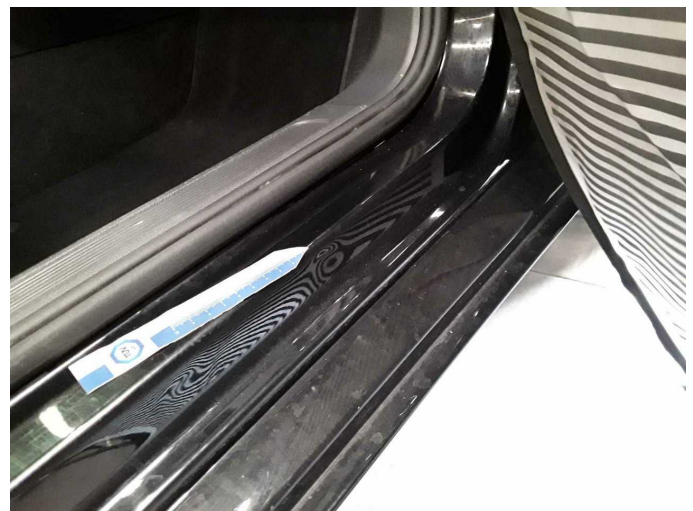
| No. | Component group | Description |
|---|---|---|
| 2 | Sill - right side | Sill - dent(s) - Smooth repair work |

Damage 2: Sill - right side: Sill - dent(s) - Smooth repair work

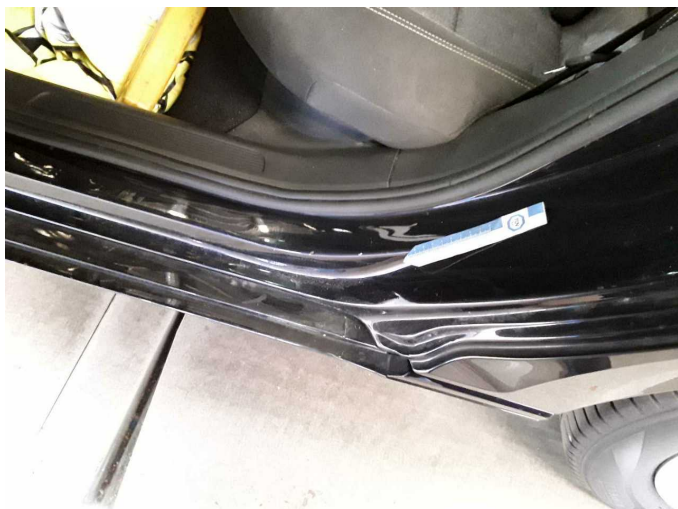
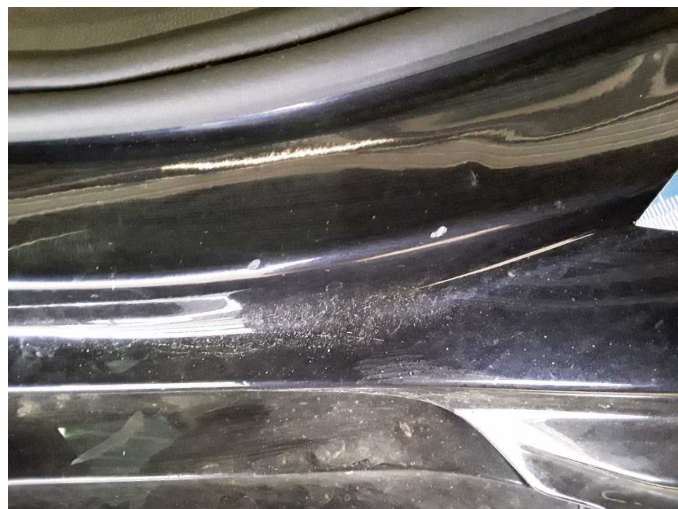
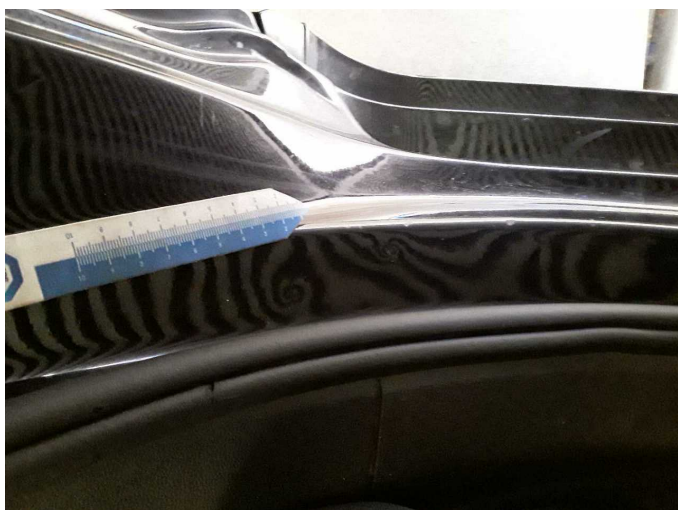
| No. | Component group | Description |
|---|---|---|
| 3 | Side panel - rear left side | Sill - Dent / paintcoat damage - Smart repair |

**Damage 3:** Side panel - rear left side: Sill - Dent / paintcoat damage - Smart repair

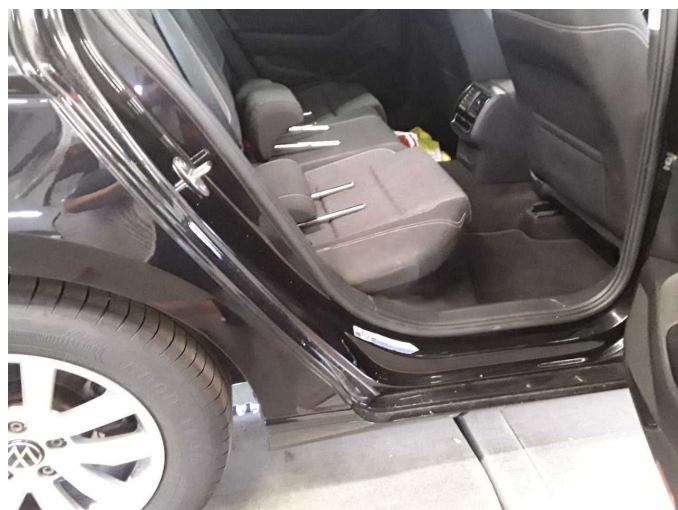
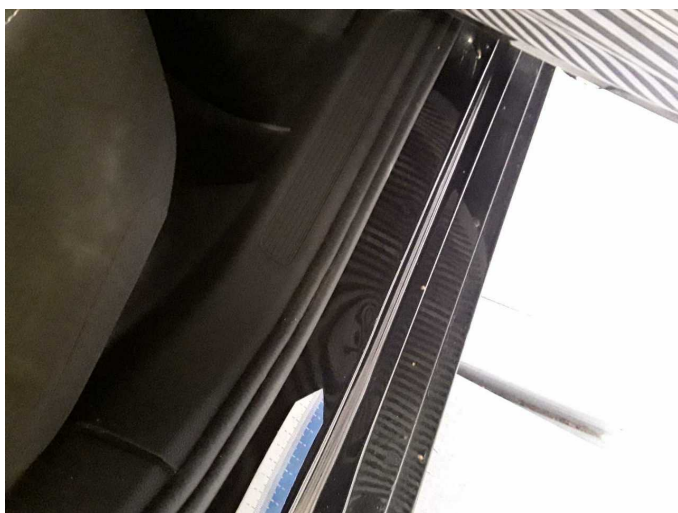
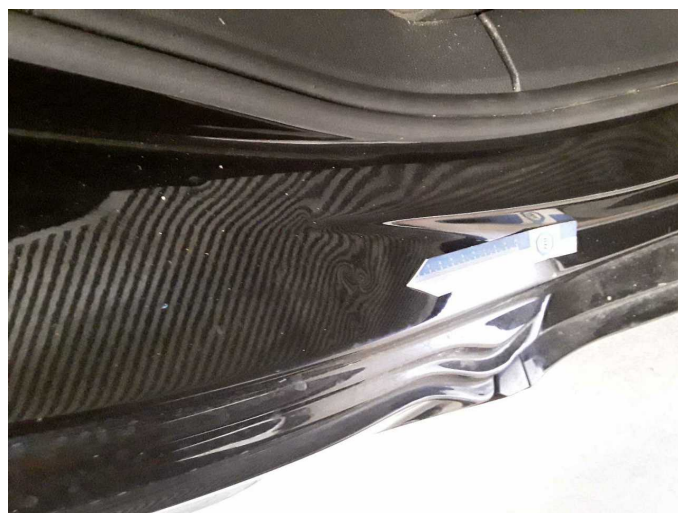
| No. | Component group | Description |
|---|---|---|
| 4 | Side panel - rear right side | Sill - dent(s) - Smooth repair work |

**Damage 4:** Side panel - rear right side: Sill - dent(s) - Smooth repair work

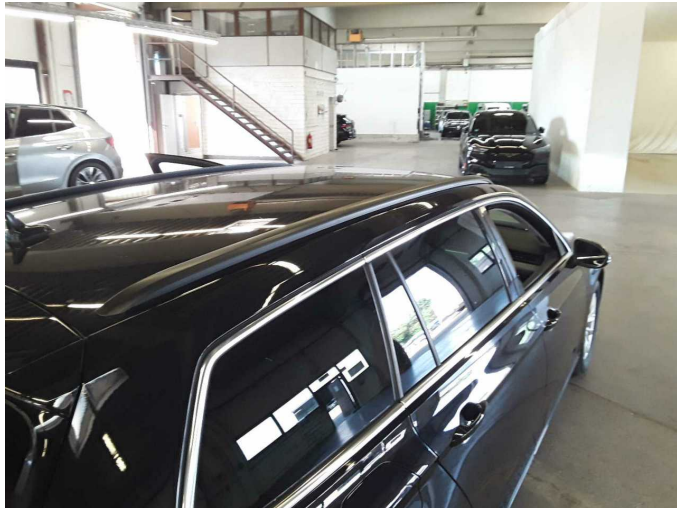
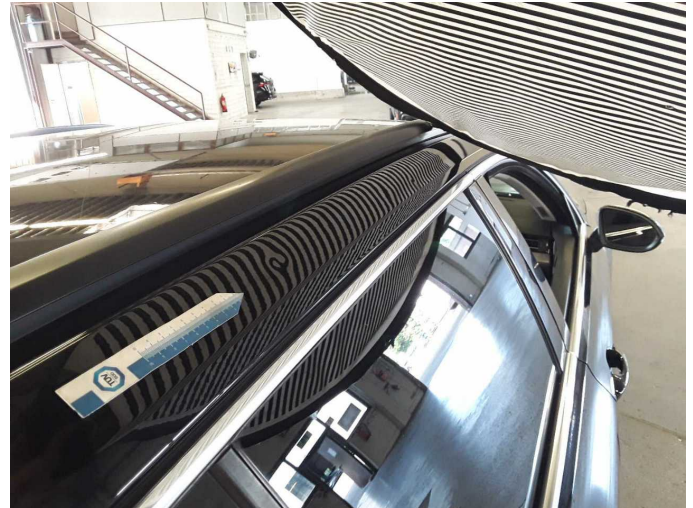
| No. | Component group | Description |
|---|---|---|
| 5 | Roof | Roof rail - right side - dent(s) - Smooth repair work |

**Damage 5:** Roof: Roof rail - right side - dent(s) - Smooth repair work

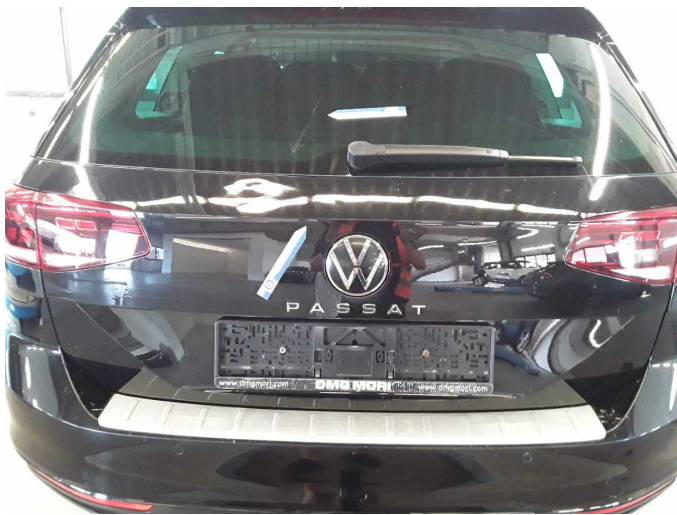
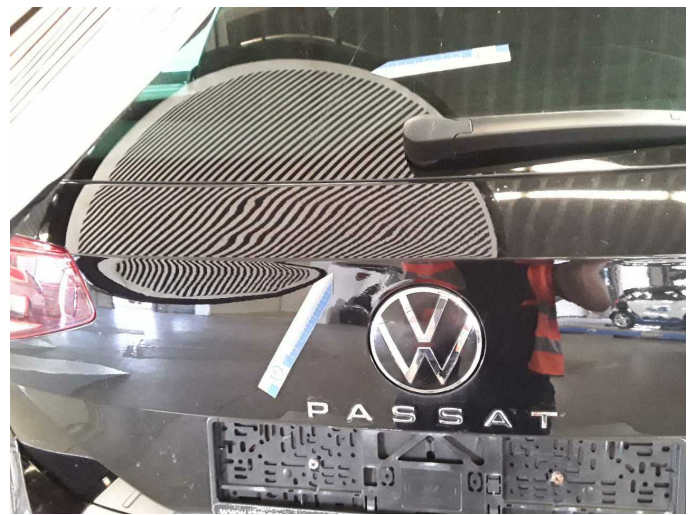
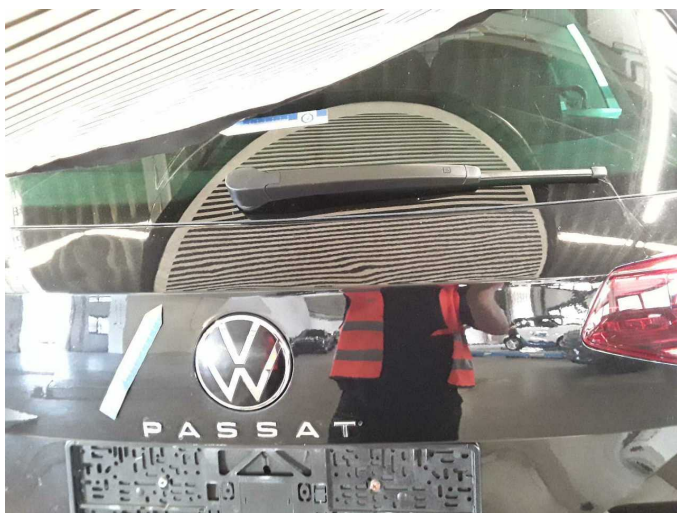
| No. | Component group | Description |
|---|---|---|
| 6 | Boot lid / rear door | Boot lid - dent(s) - Smooth repair work |

**Damage 6:** Boot lid / rear door: Boot lid - dent(s) - Smooth repair work

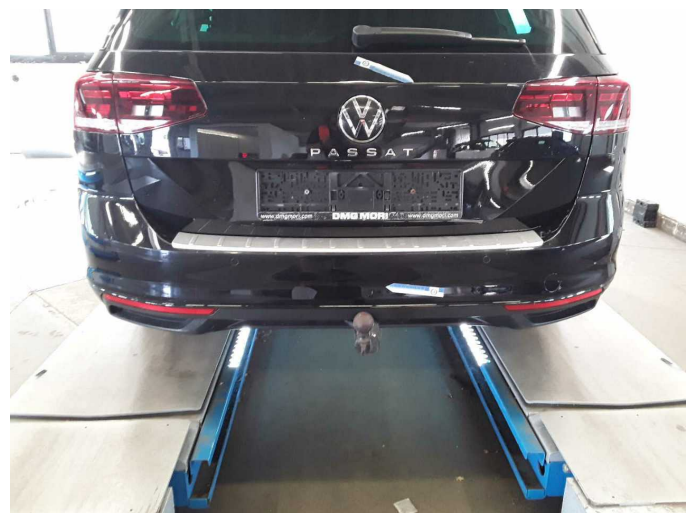
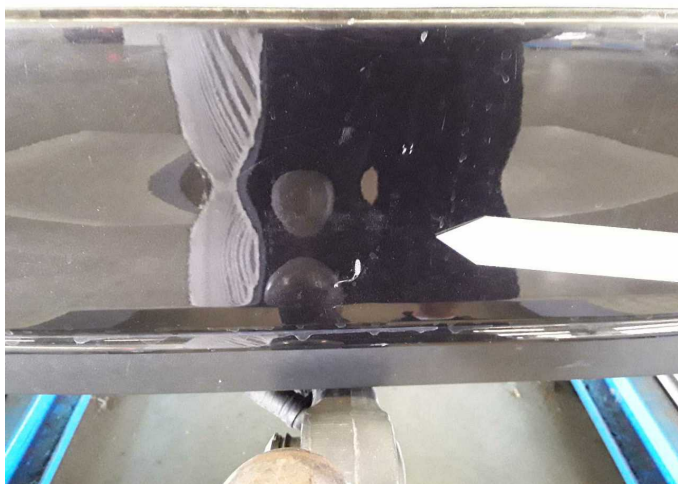
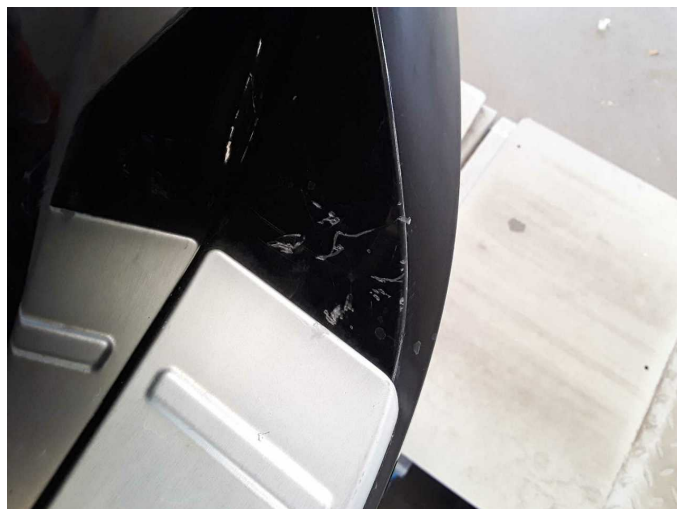
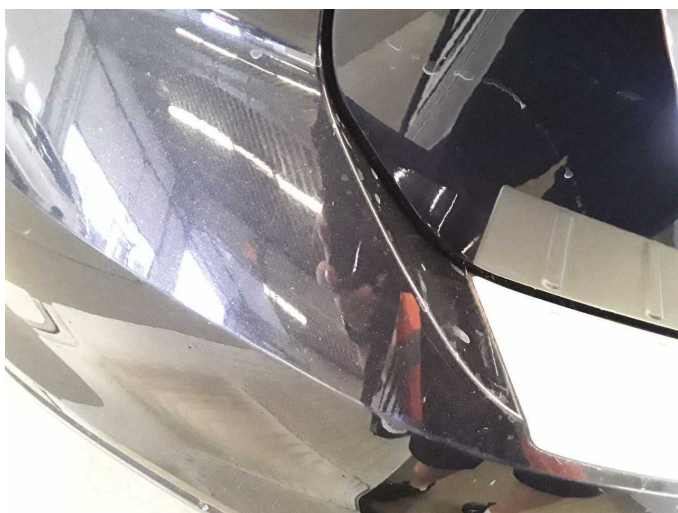
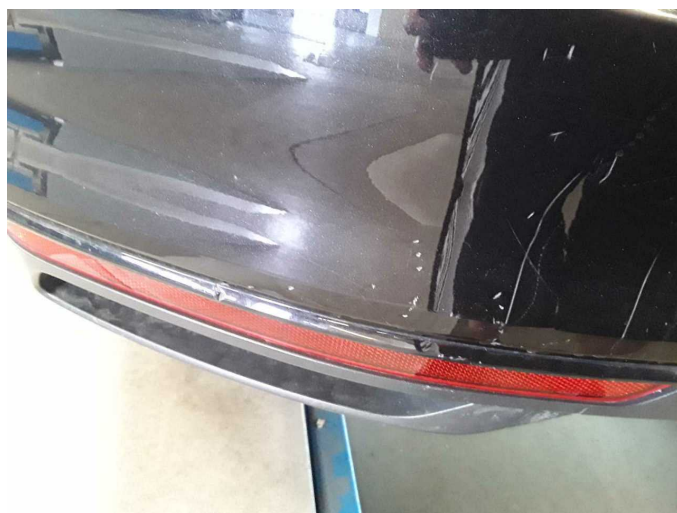
| No. | Component group | Description |
|---|---|---|
| 7 | Rear bumper | Rear bumper - Scratched - Paint |

**Damage 7:** Rear bumper: Rear bumper - Scratched - Paint

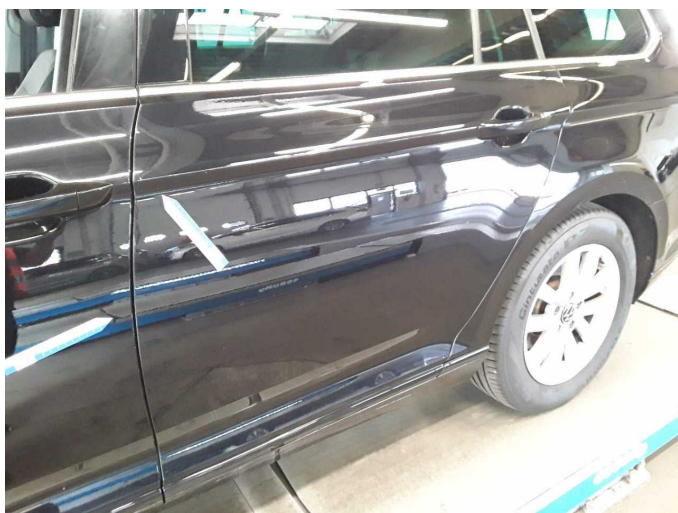
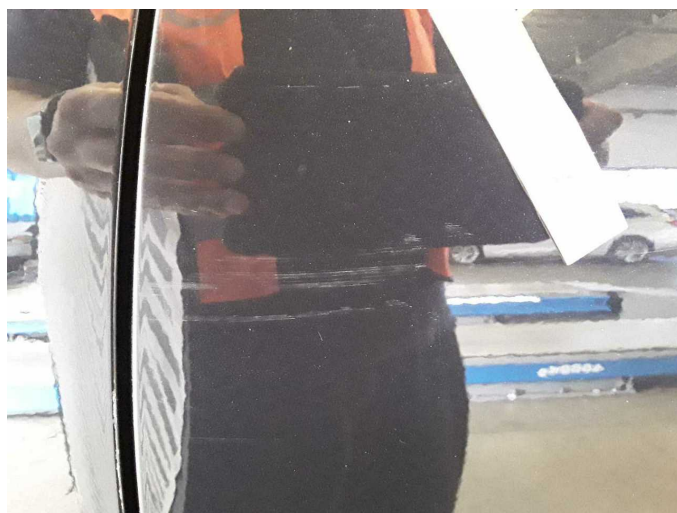
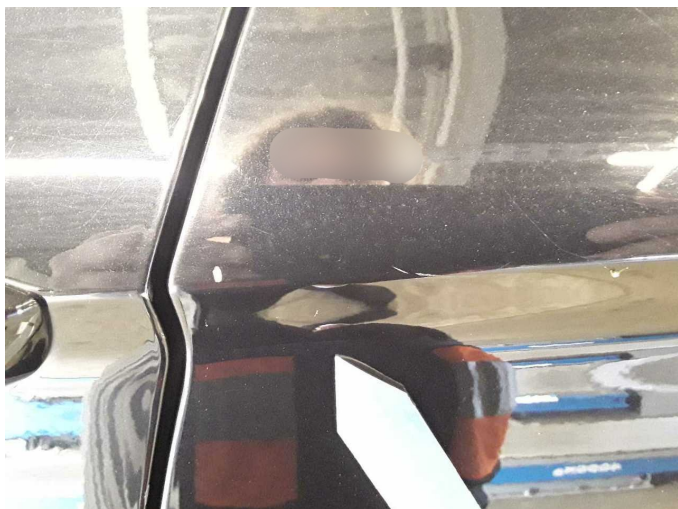
| No. | Component group | Description |
|---|---|---|
| 8 | Door - rear left side | Door - Scratched - Paint |

**Damage 8:** Door - rear left side: Door - Scratched - Paint

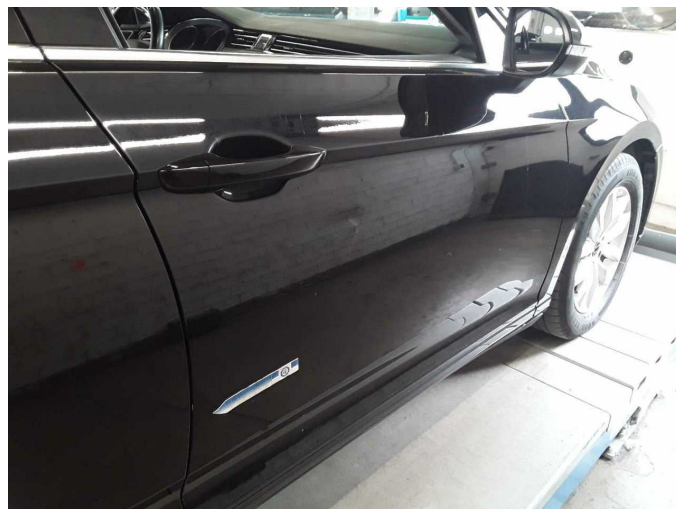
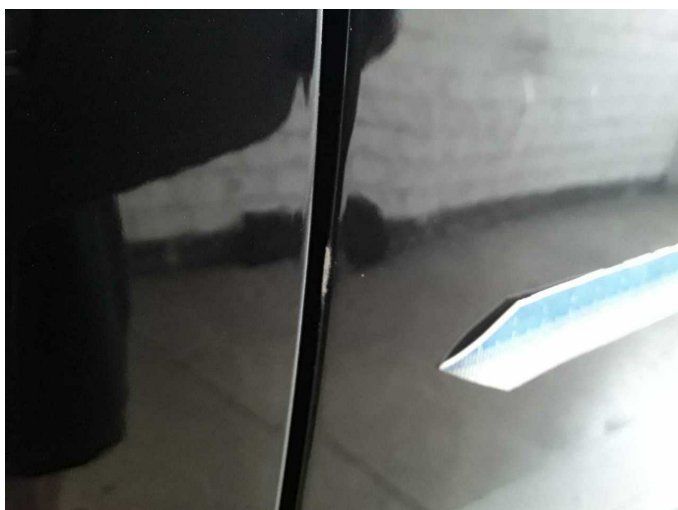
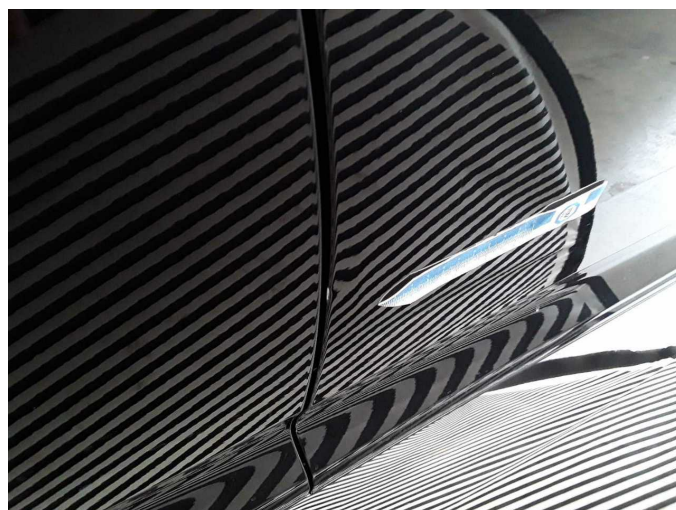
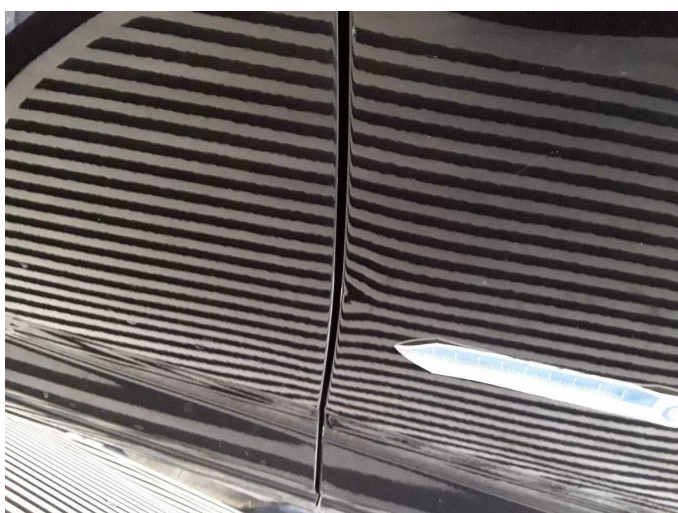
| No. | Component group | Description |
|---|---|---|
| 9 | Door - front right side | Door - Dent / paintcoat damage - Repair and paint |

**Damage 9:** Door - front right side: Door - Dent / paintcoat damage - Repair and paint

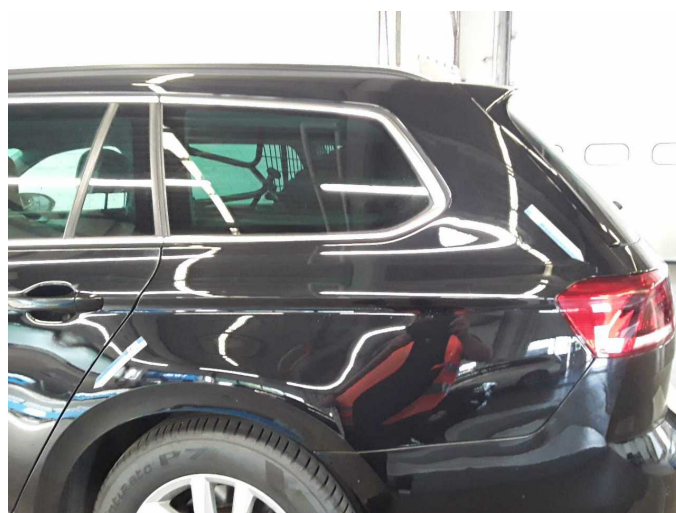
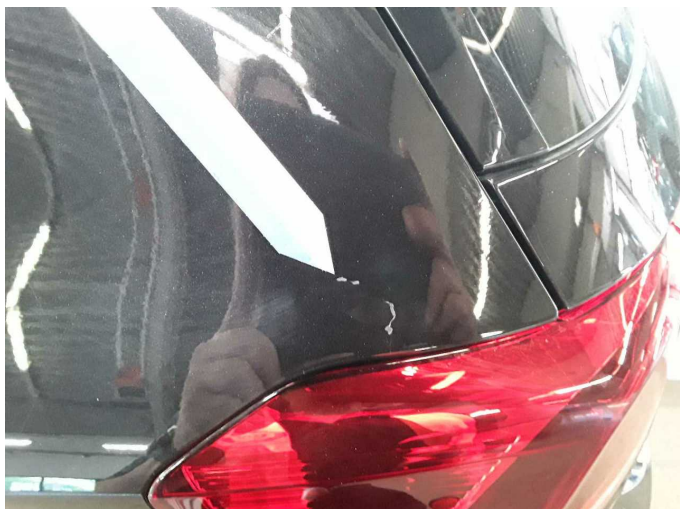
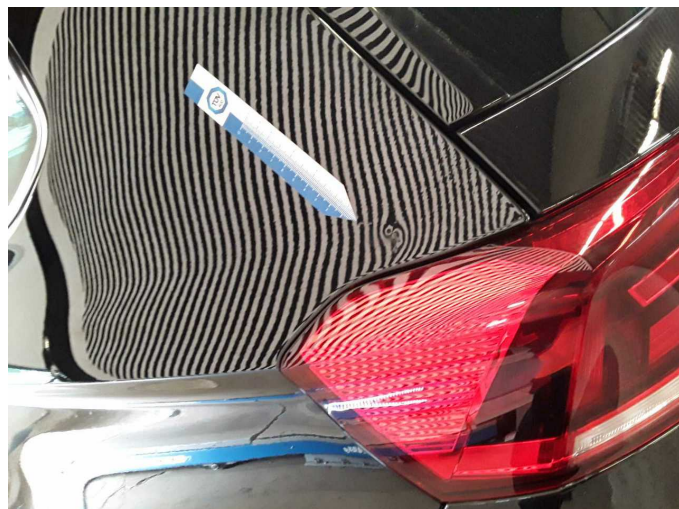
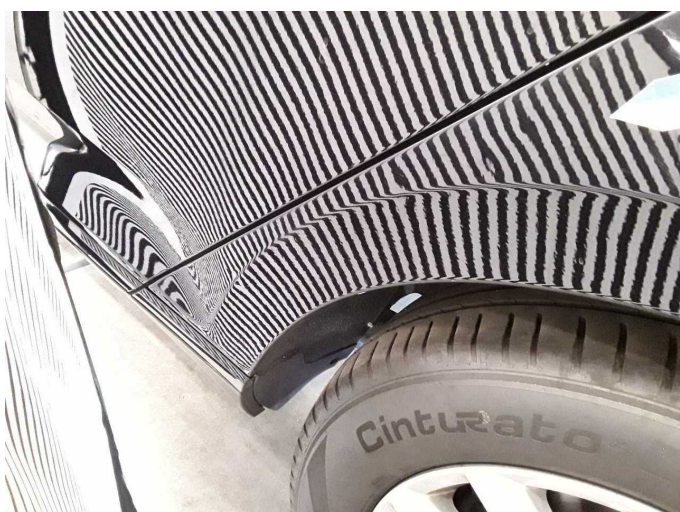
| No. | Component group | Description |
|---|---|---|
| 10 | Side panel - rear left side | Side panel - Dent / paintcoat damage - Repair and paint |

**Damage 10:** Side panel - rear left side: Side panel - Dent / paintcoat damage - Repair and paint

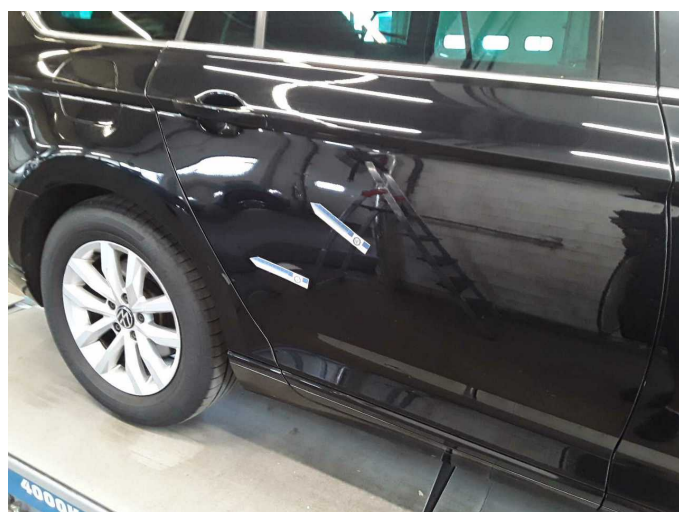
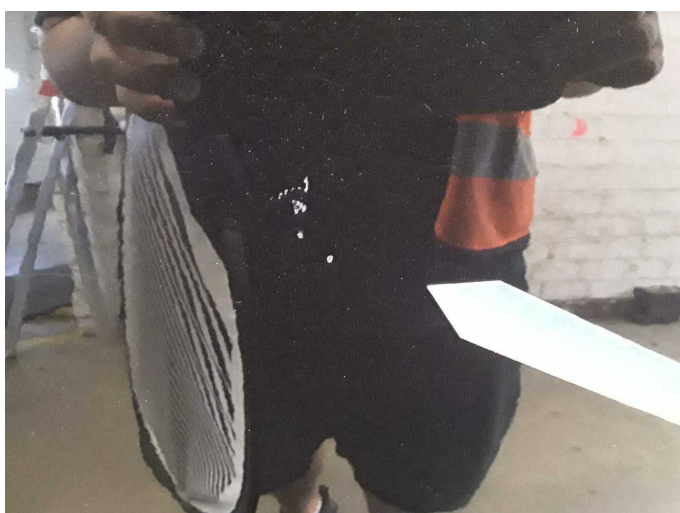
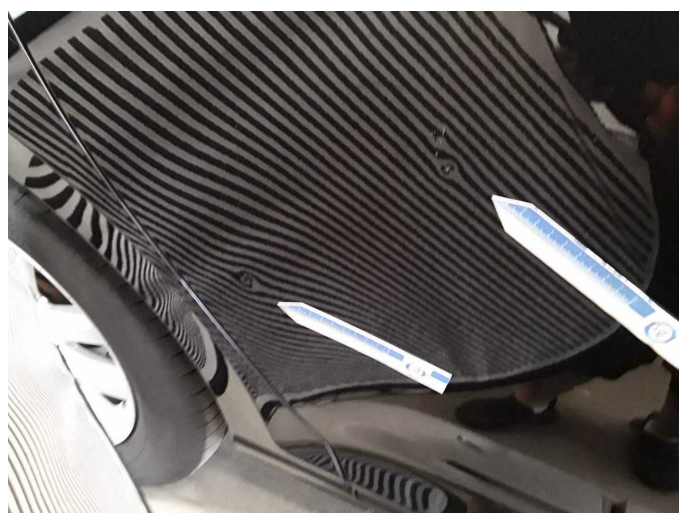
| No. | Component group | Description |
|---|---|---|
| 11 | Door - rear right side | Door - Dent / paintcoat damage - Repair and paint |

**Damage 11:** Door - rear right side: Door - Dent / paintcoat damage - Repair and paint

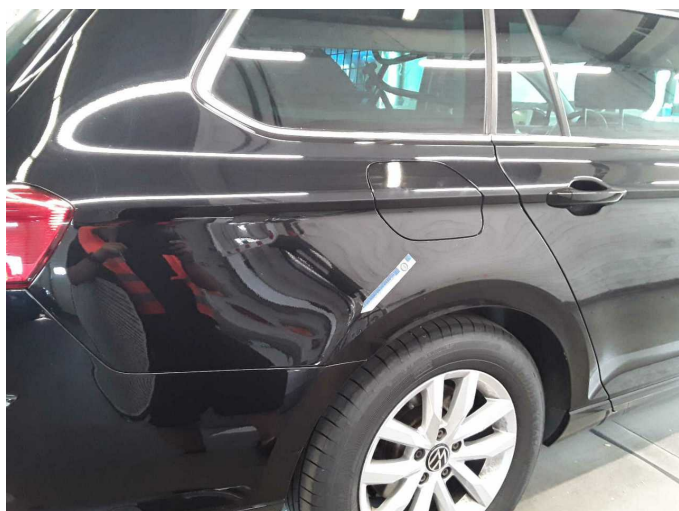
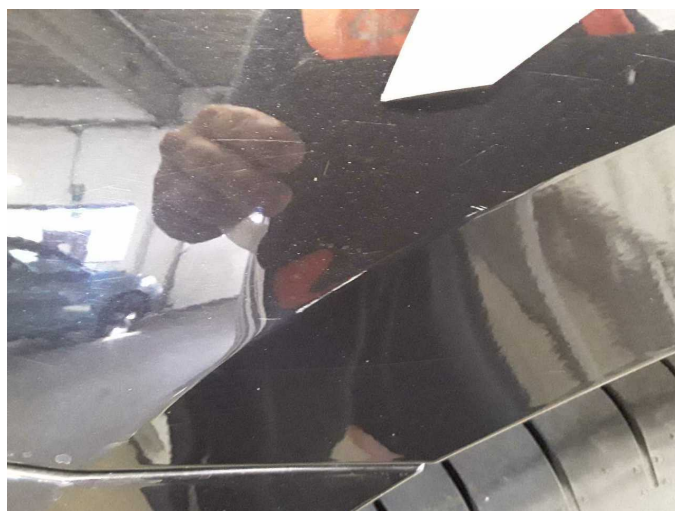
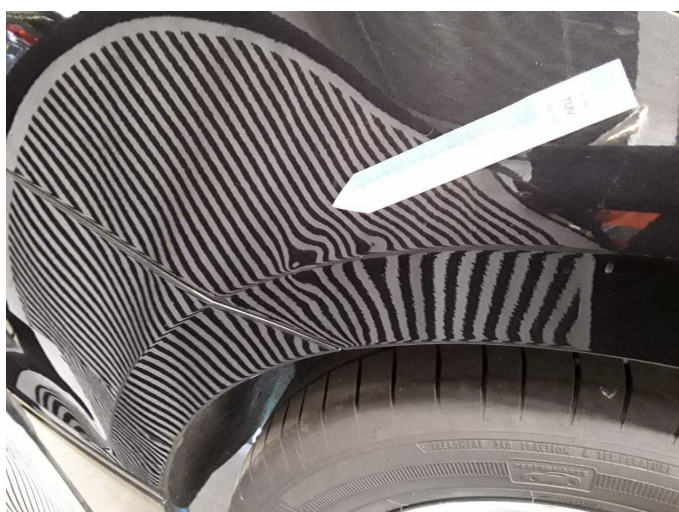
| No. | Component group | Description |
|---|---|---|
| 12 | Side panel - rear right side | Side panel - Dent / paintcoat damage - Repair and paint |

**Damage 12:** Side panel - rear right side: Side panel - Dent / paintcoat damage - Repair and paint

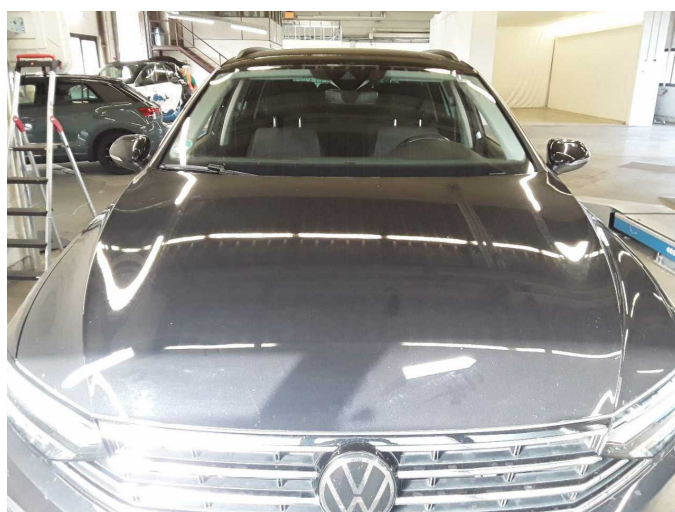
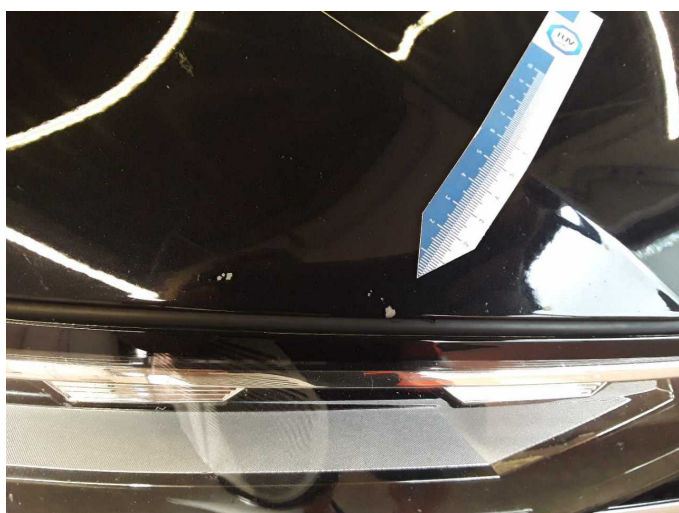
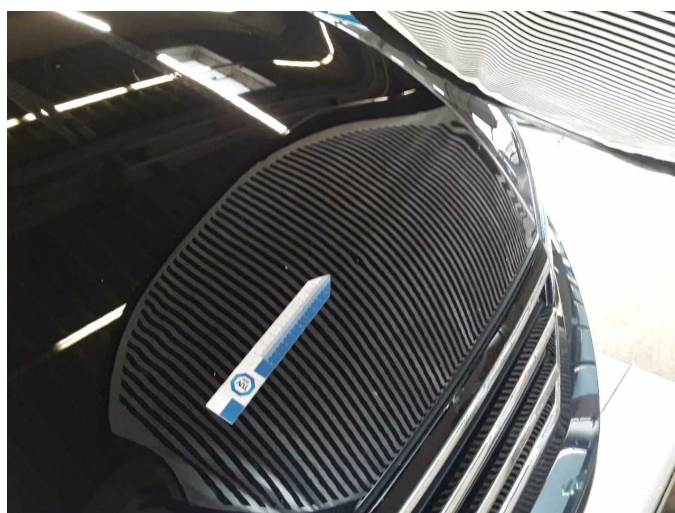
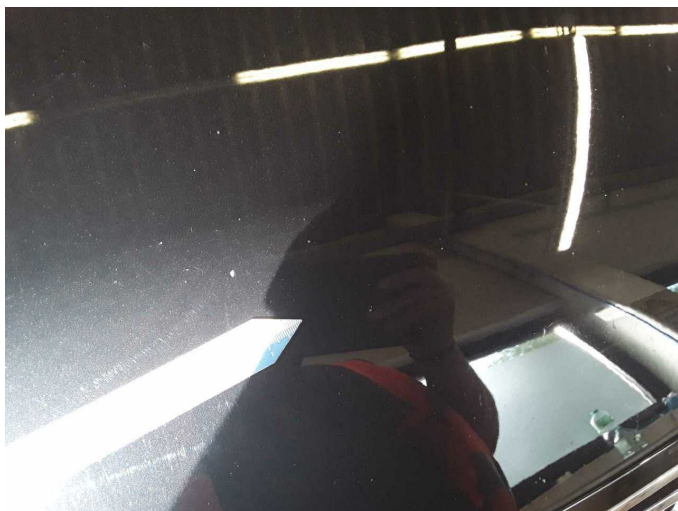
| No. | Component group | Description |
|---|---|---|
| 13 | Bonnet | Bonnet - Dent / paintcoat damage - Repair and paint |

**Damage 13:** Bonnet: Bonnet - Dent / paintcoat damage - Repair and paint

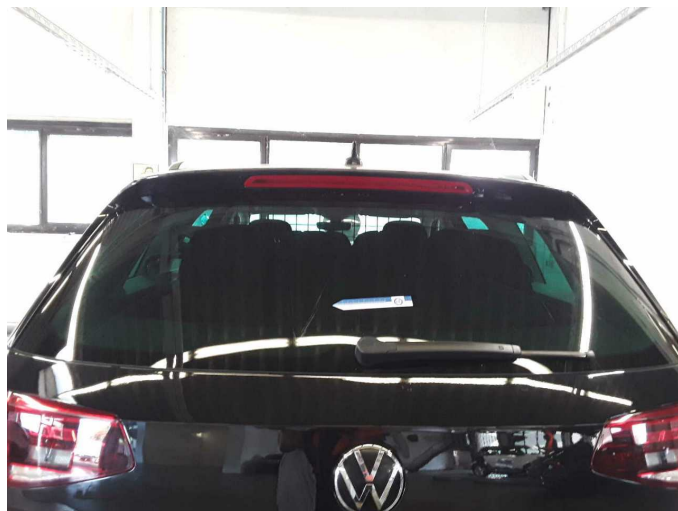
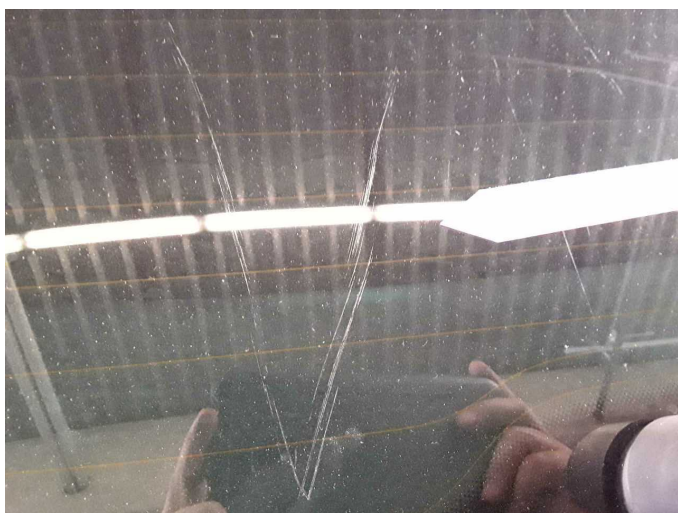
| No. | Component group | Description |
|---|---|---|
| 14 | Vehicle glazing | Rear window - Scratch(es) - Replace |

**Damage 14:** Vehicle glazing: Rear window - Scratch(es) - Replace

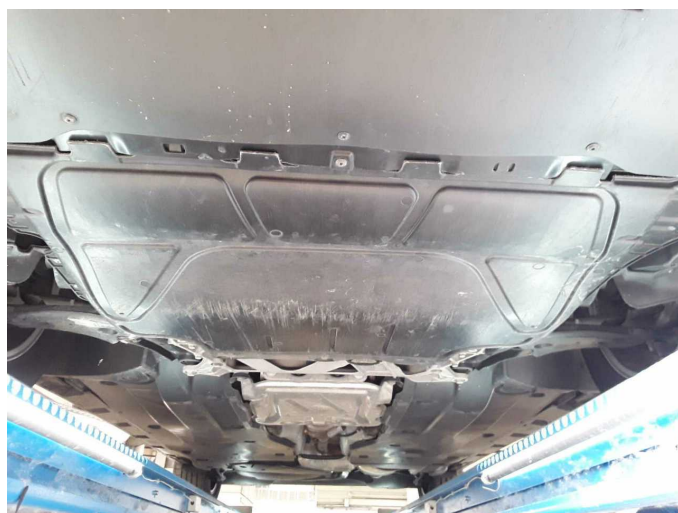
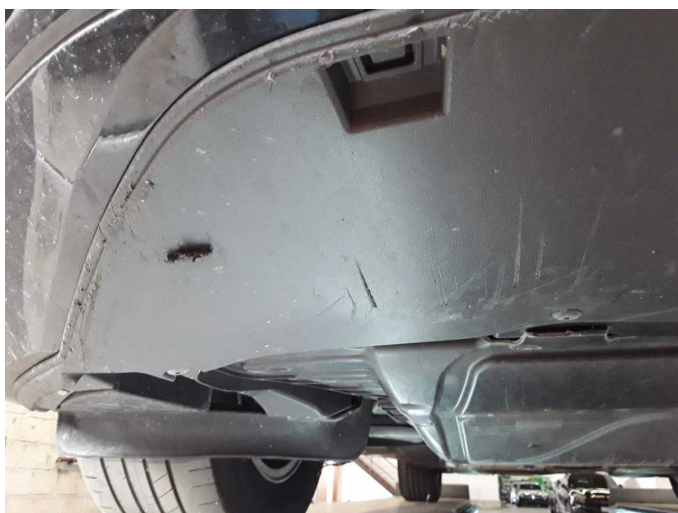
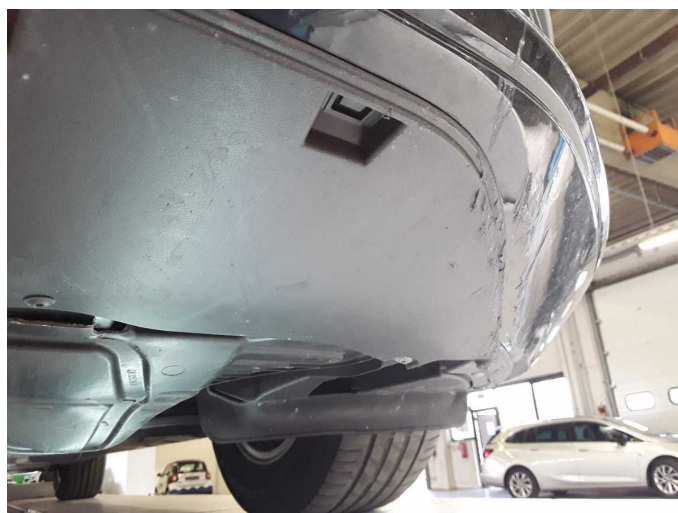
| No. | Component group | Description |
|---|---|---|
| 1 | Body | Underbody panelling - Scratched - No deduction |

**Wear and tear 1:** Body: Underbody panelling - Scratched - No deduction

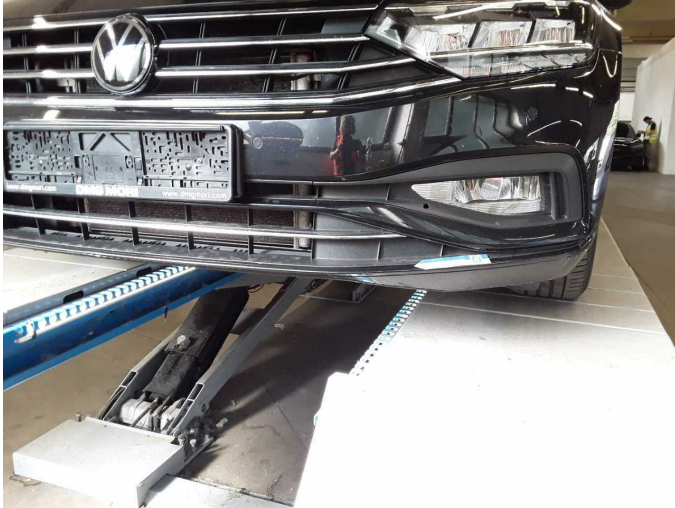
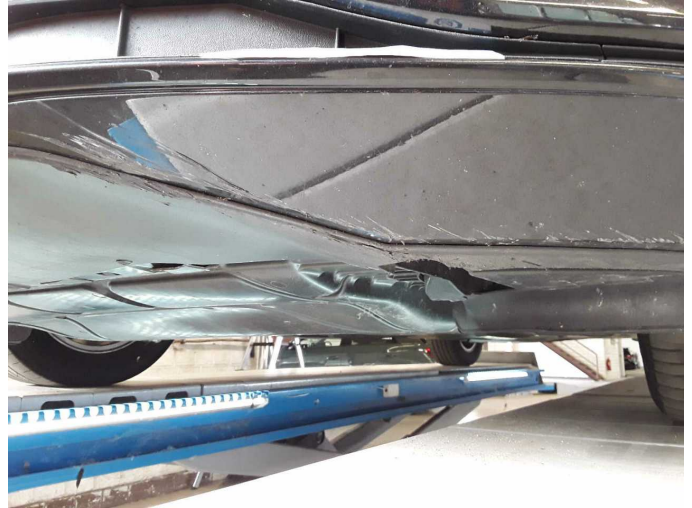
| No. | Component group | Description |
|---|---|---|
| 2 | Front bumper | Front bumper - Scratched - No deduction |

**Wear and tear 2:** Front bumper: Front bumper - Scratched - No deduction

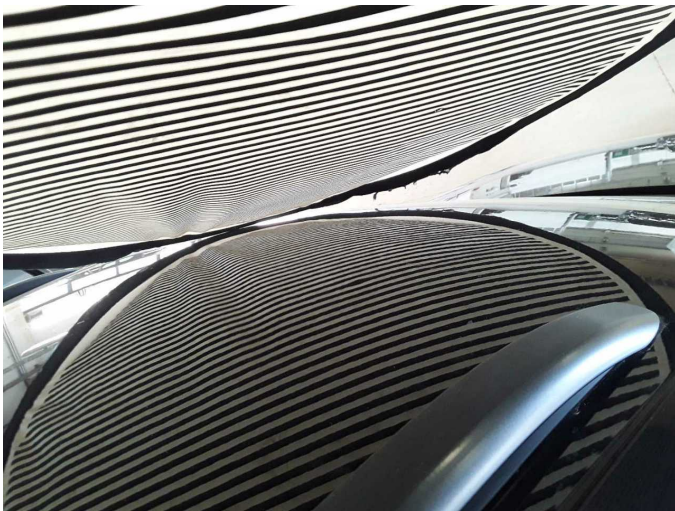
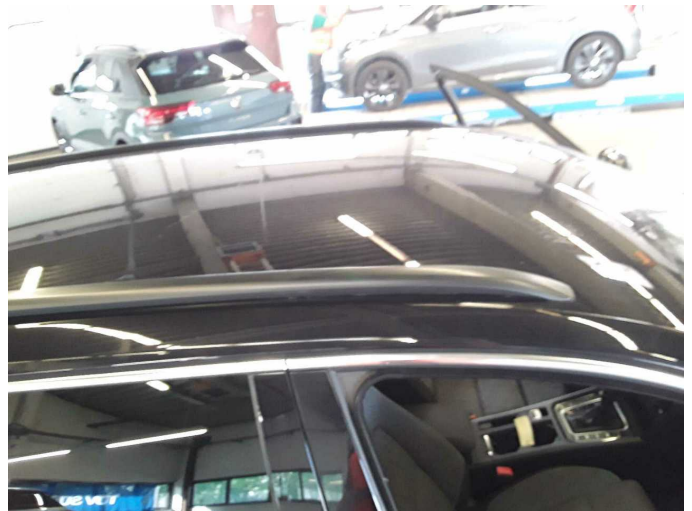
| No. | Component group | Description |
|---|---|---|
| 3 | Roof | Roof - dent(s) - No deduction |

**Wear and tear 3:** Roof: Roof - dent(s) - No deduction

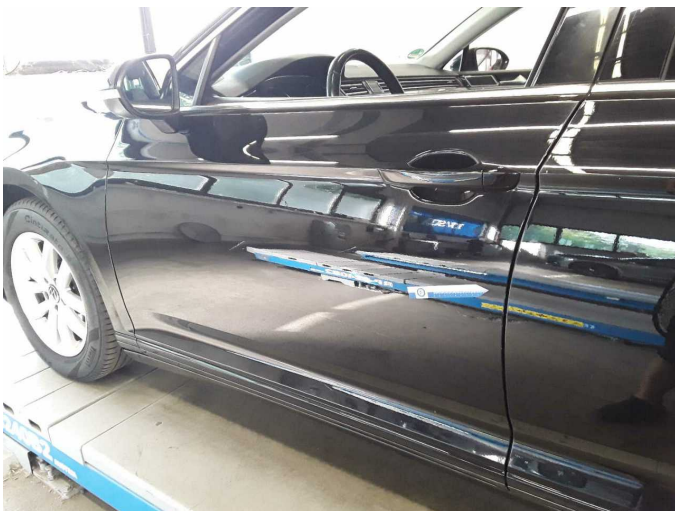
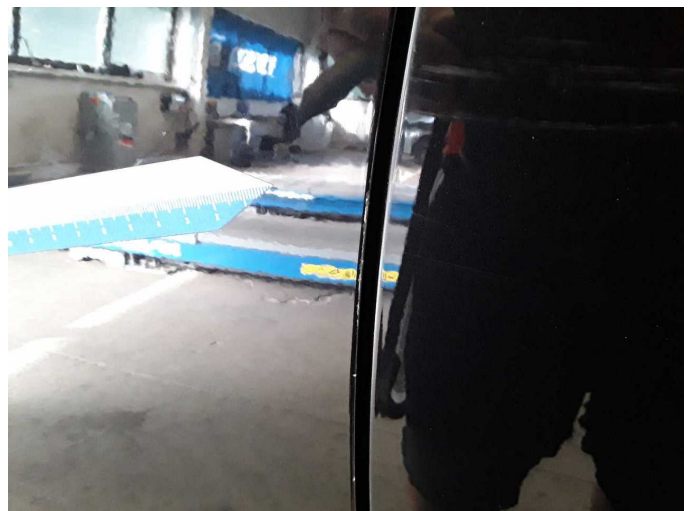
| No. | Component group | Description |
|---|---|---|
| 4 | Door - front left side | Door edge - Scratched - Cover / polish |

**Wear and tear 4:** Door - front left side: Door edge - Scratched - Cover / polish

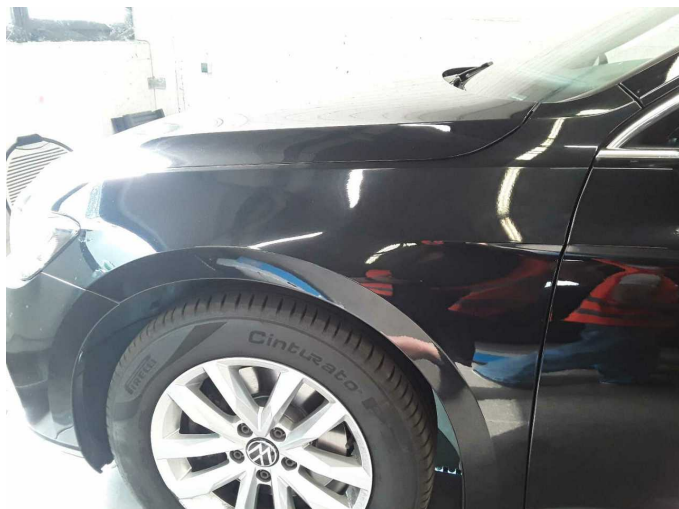
| No. | Repainting |
|---|---|
| 1 | Mudguard - left side |

| Mudguard - left side | 162 µm |

**Repainting 1:** Mudguard - left side
