Expertise

Protocol number: 46630303  
Order No. / Reference: 26287926  
Inspection date: 15 Jul 2026

Manufacturer: Ford

Model: Focus Turnier 1.5 EcoBlue Start-Stopp-System Aut. TITANIUM  
STYLE

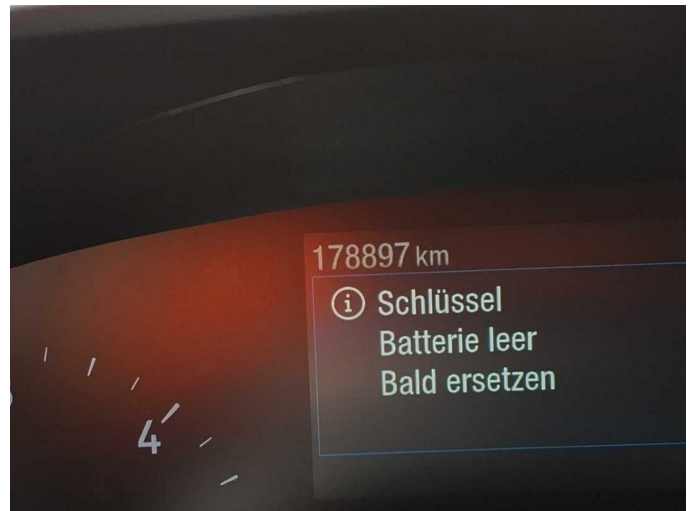
| No. | Component group | Description |
|---|---|---|
| 1 | Equipment | Vehicle key (Batterie) - Empty - Replace |

Damage 1: Equipment: Vehicle key (Batterie) - Empty - Replace

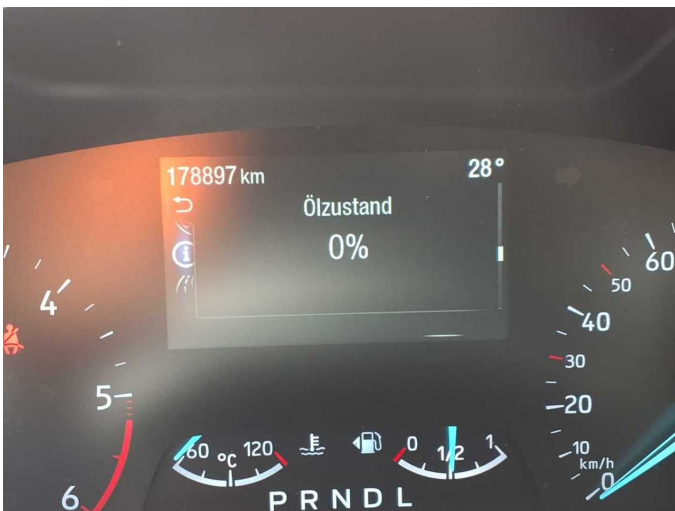
| No. | Component group | Description |
|---|---|---|
| 2 | Misc. | Inspection / maintenance - Due - Perform |

Damage 2: Misc.: Inspection / maintenance - Due - Perform

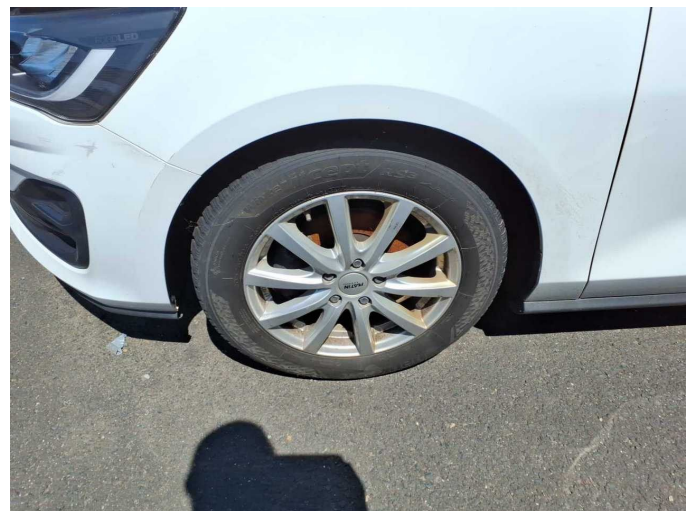
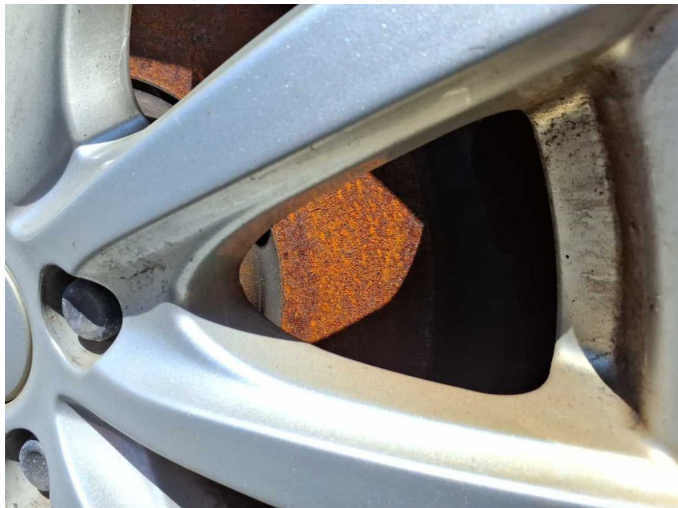
| No. | Component group | Description |
|---|---|---|
| 3 | Braking system | Brake discs - front - Corrosion - Replace |

Damage 3: Braking system: Brake discs - front - Corrosion - Replace

**Damage 3:** Braking system: Brake discs - front - Corrosion - Replace

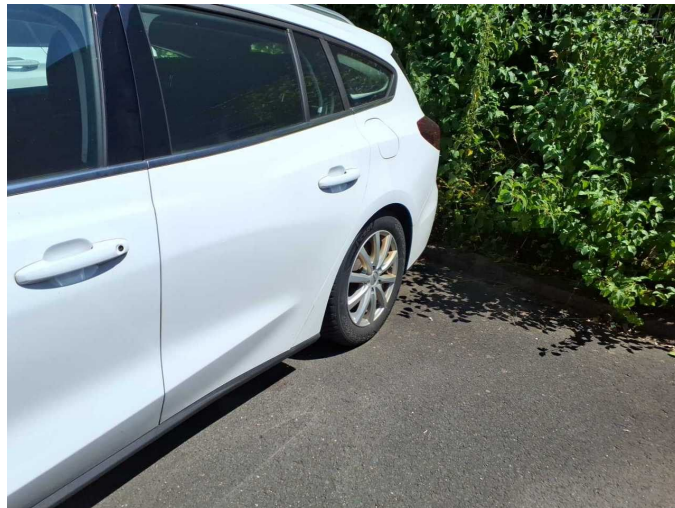
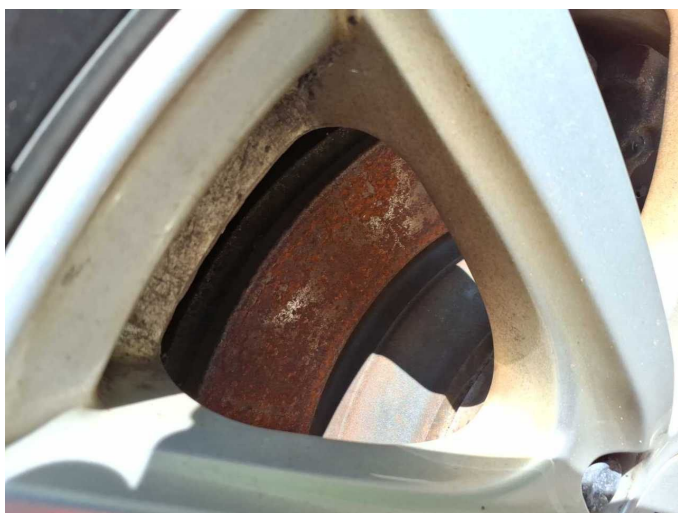
| No. | Component group | Description |
|---|---|---|
| 4 | Braking system | Brake discs - rear - Corrosion - Replace |

**Damage 4:** Braking system: Brake discs - rear - Corrosion - Replace

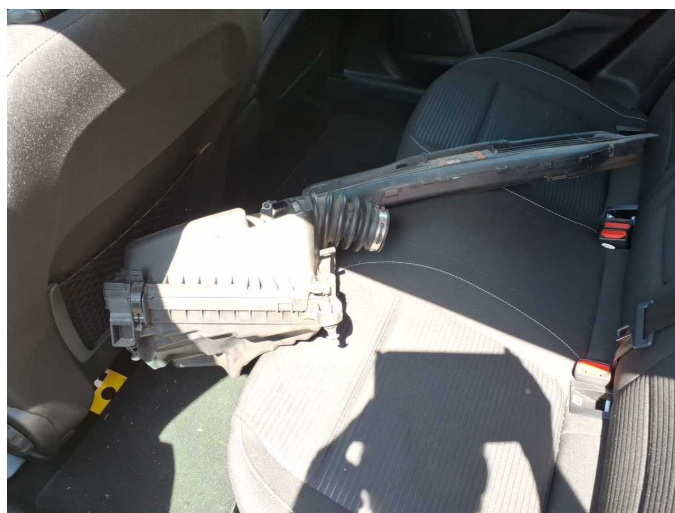
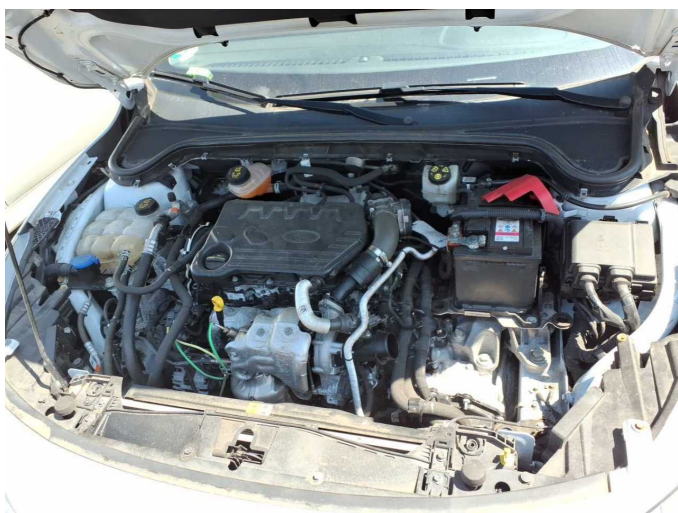
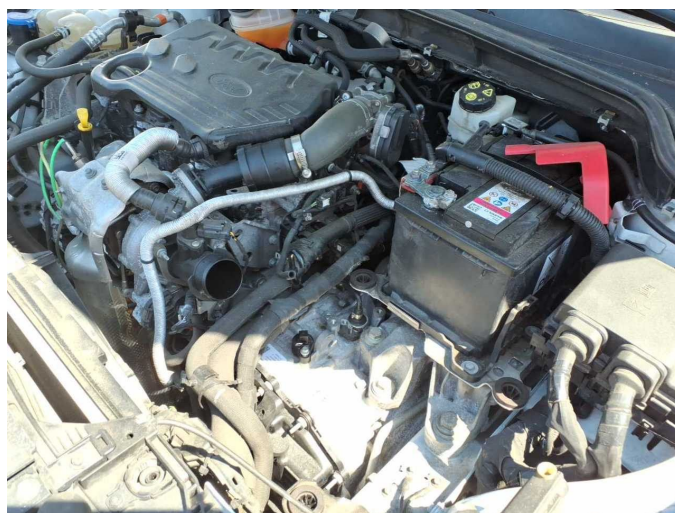
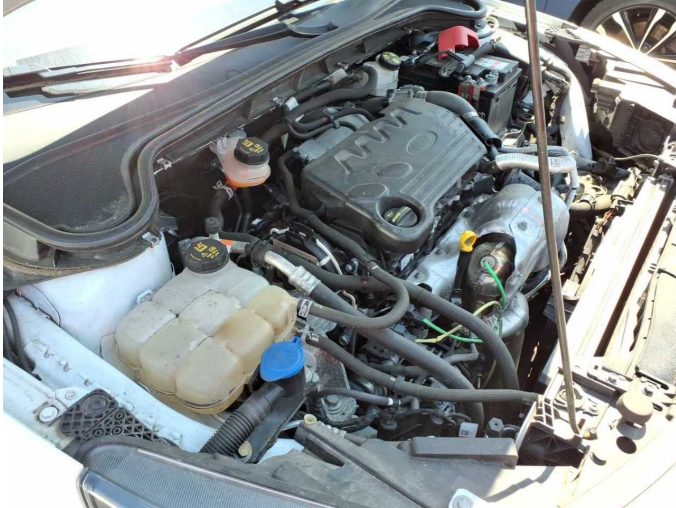
| Engine function test | An engine test run could not be performed.<br>This is due to the following reason.:<br>Motorschaden/ Batterie Leer |

| No. | Component group | Description |
|---|---|---|
| 5 | Engine | Engine - Non-operational - repair according to calculation |

**Damage 5:** Engine: Engine - Non-operational - repair according to calculation

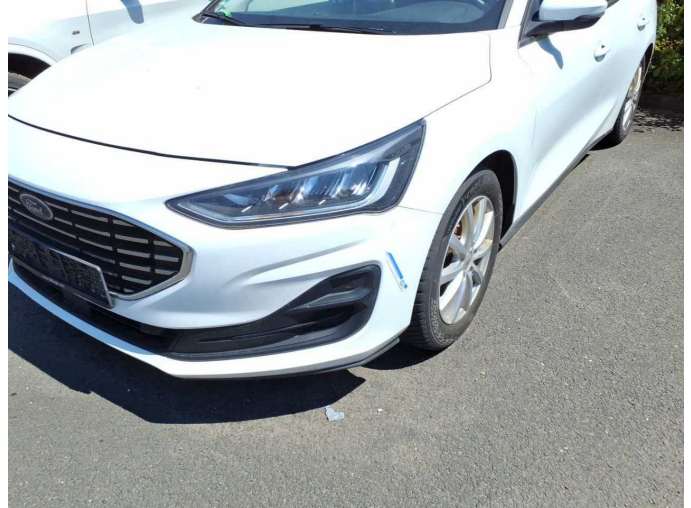
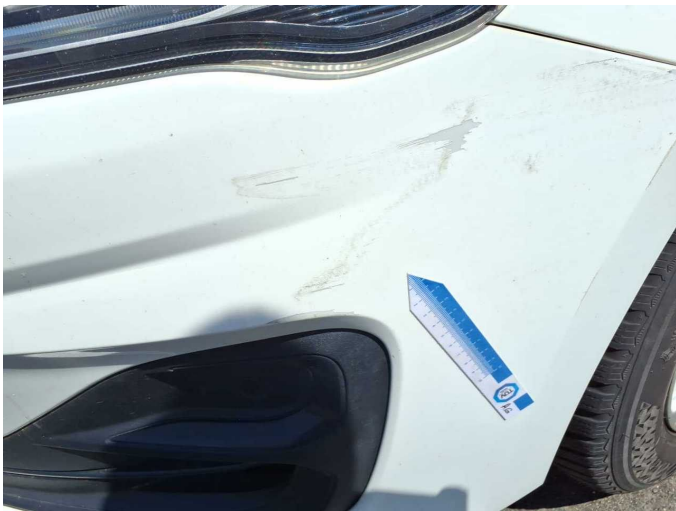
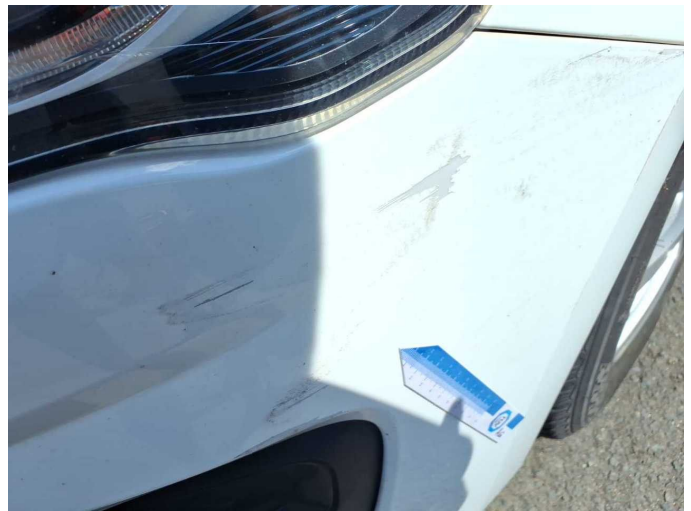
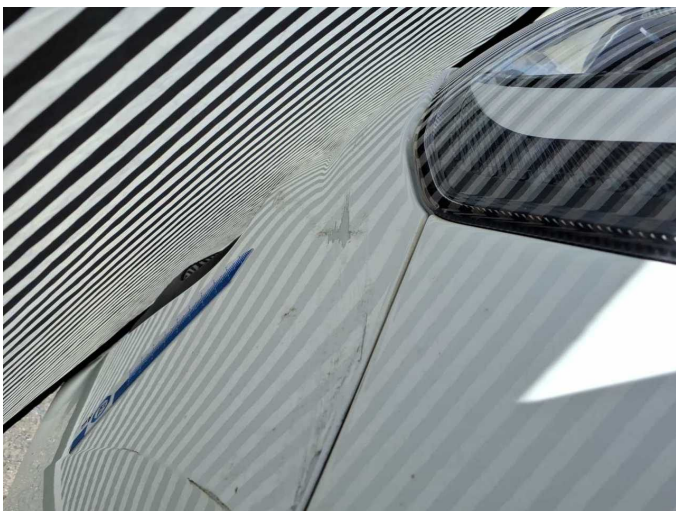
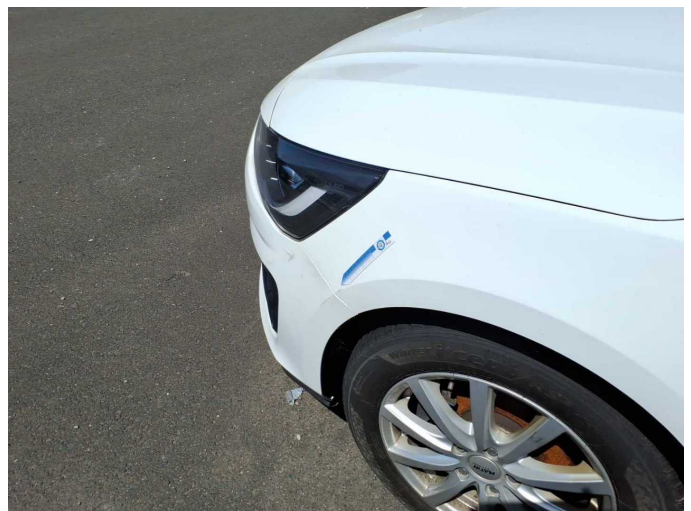
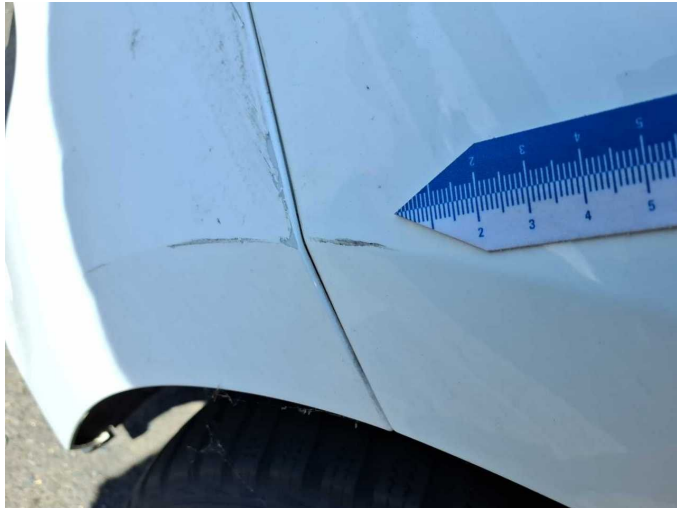
| No. | Accident |
|---|---|
| 1 | Front, Side - left |

**Accident 1:** Front, Side - left

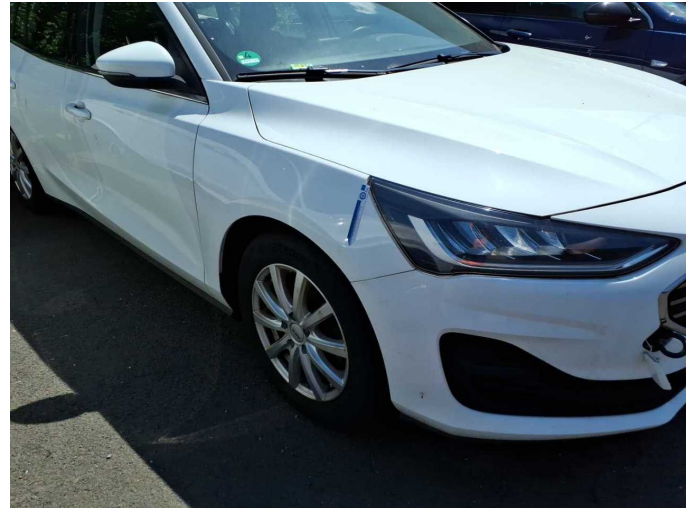
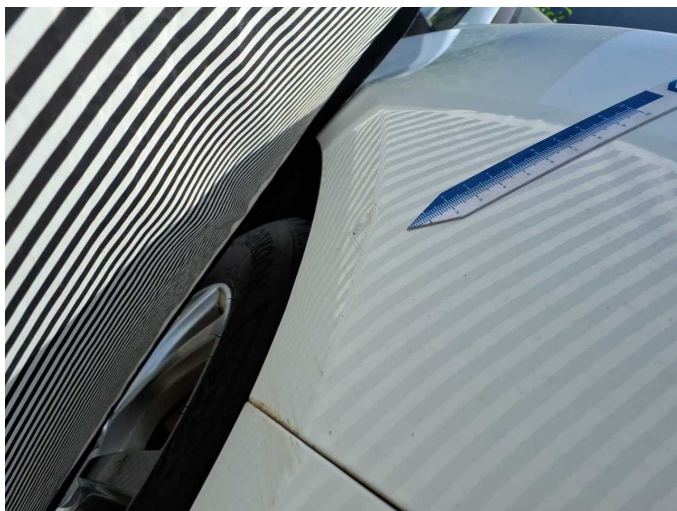
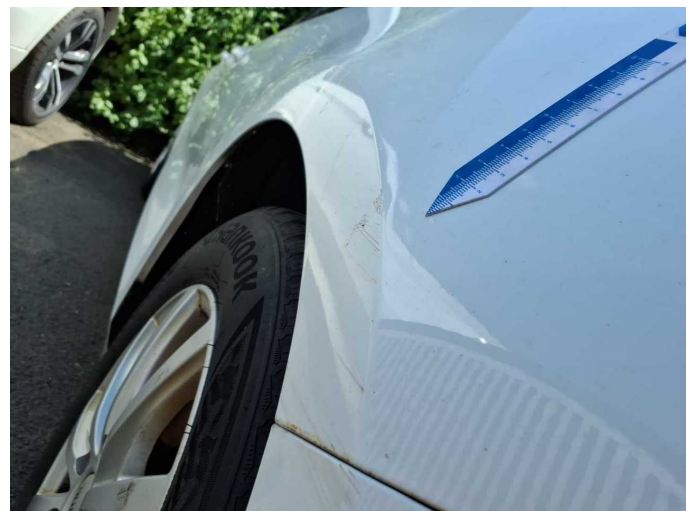
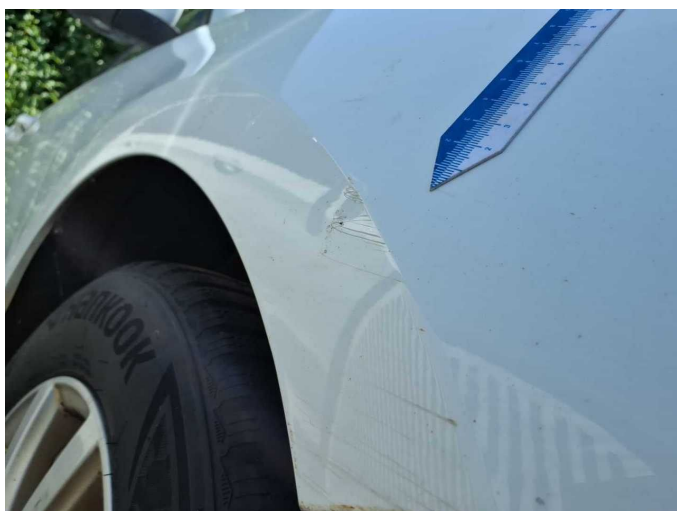
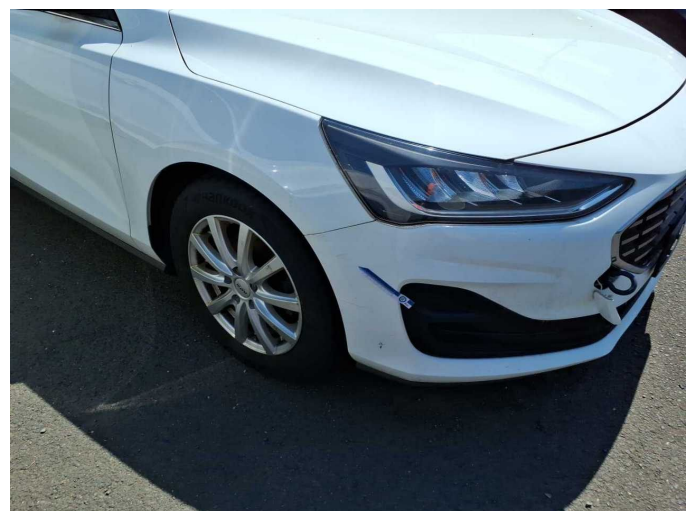
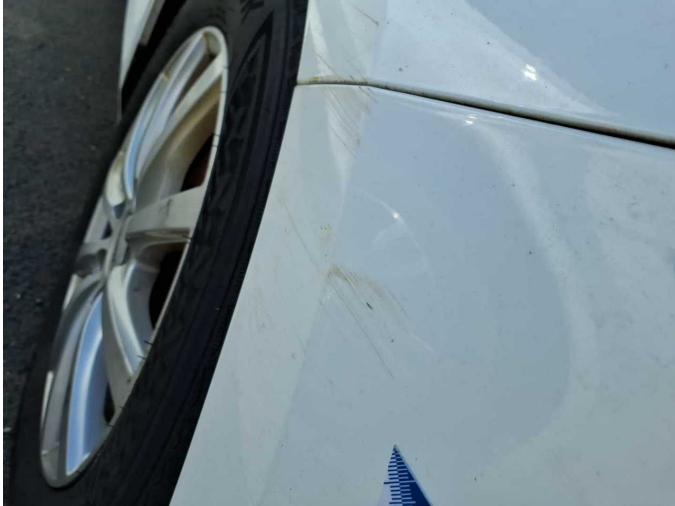
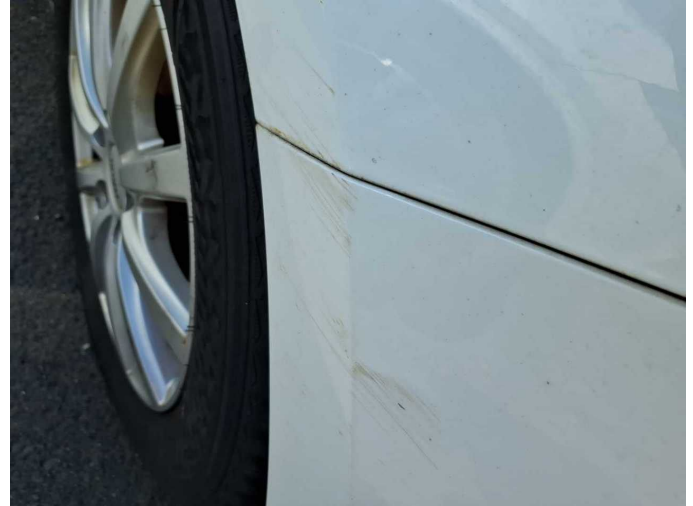
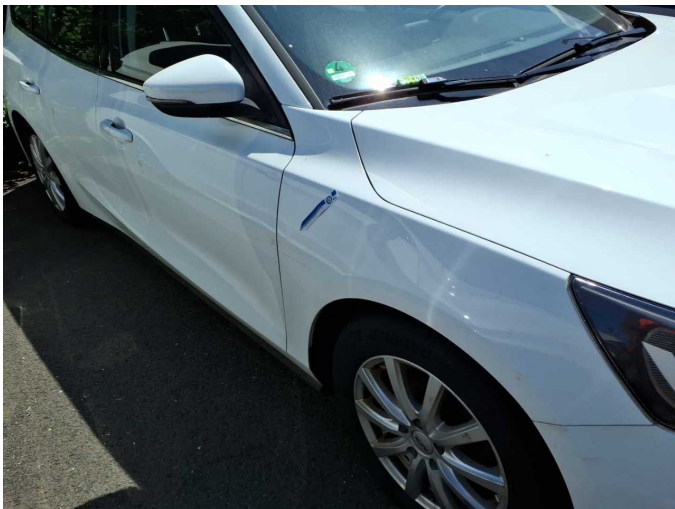
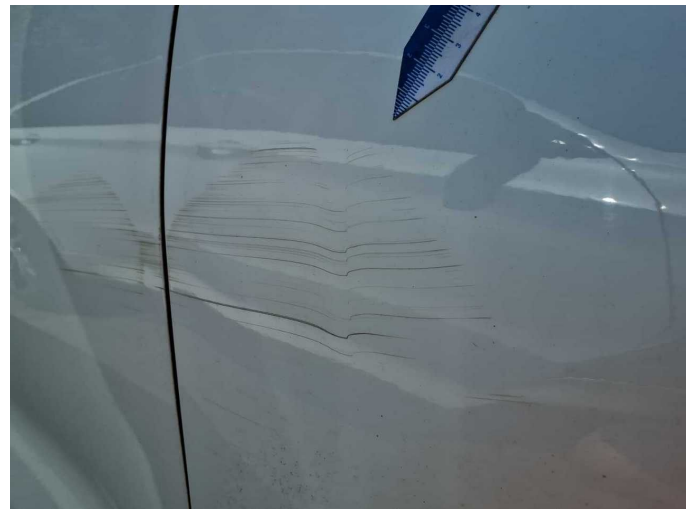
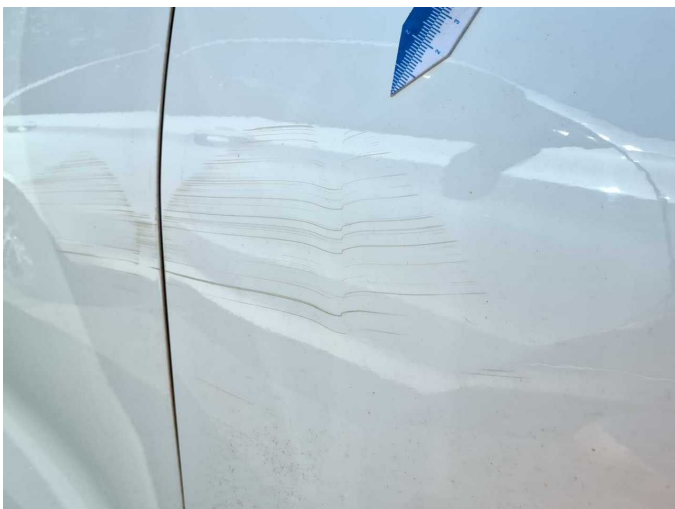
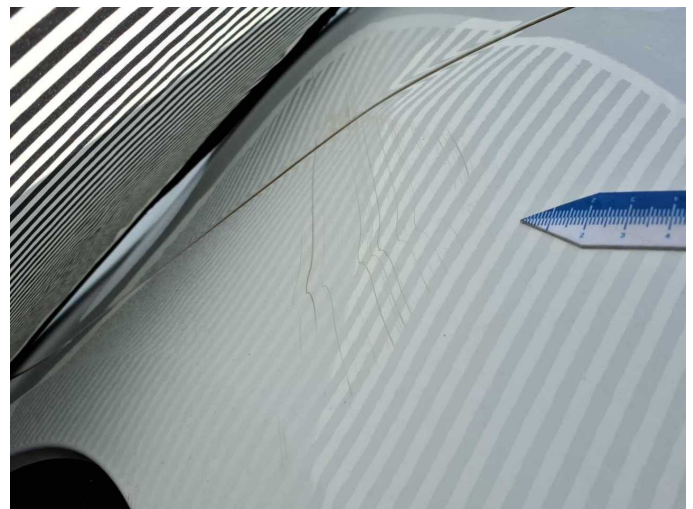
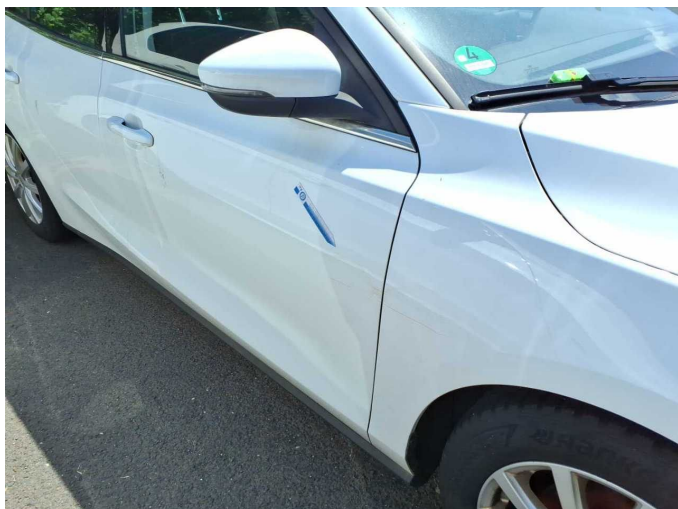
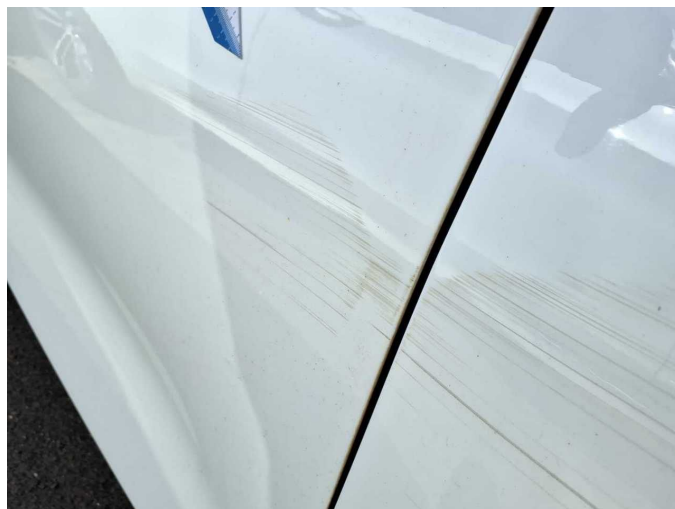
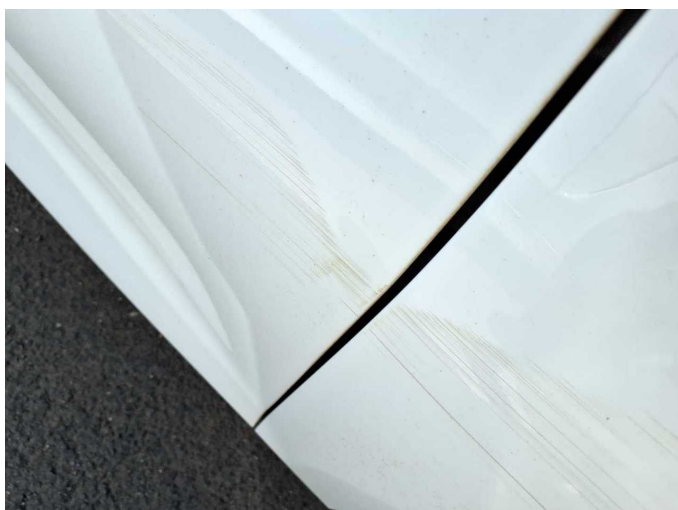
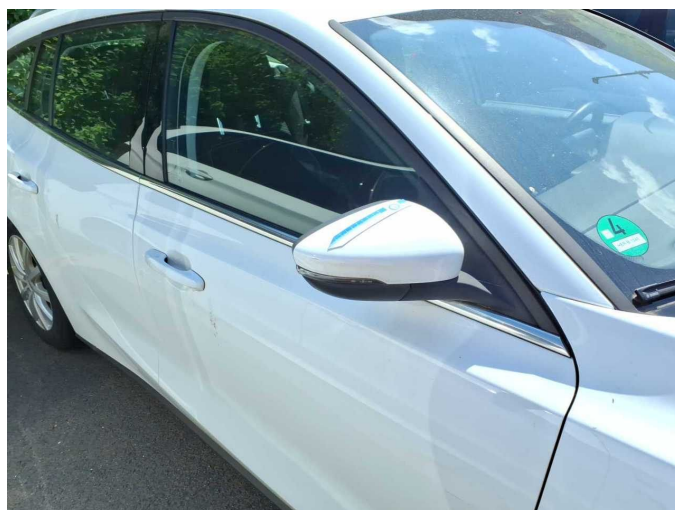
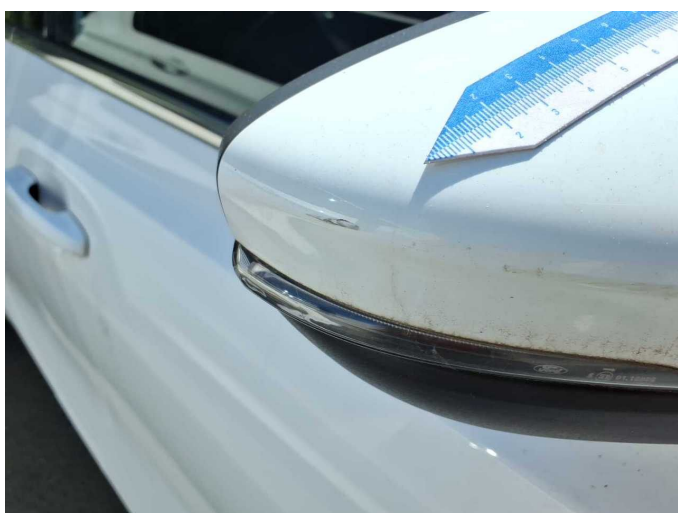
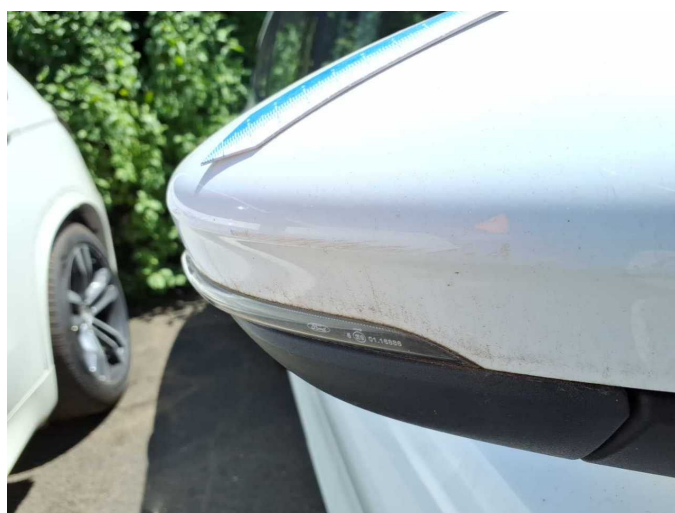
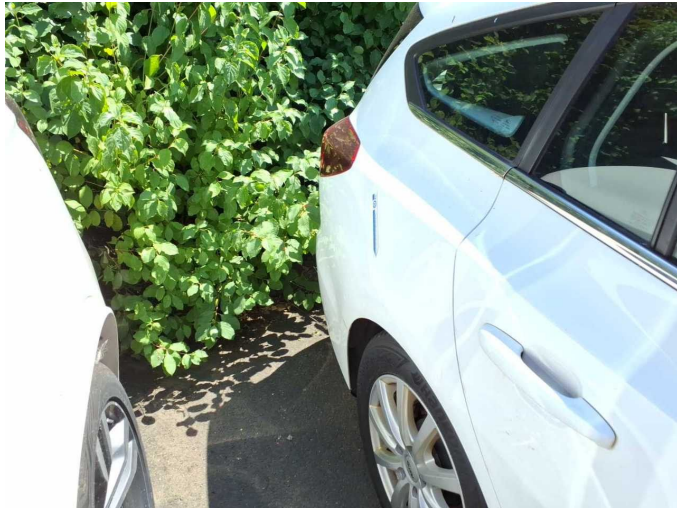
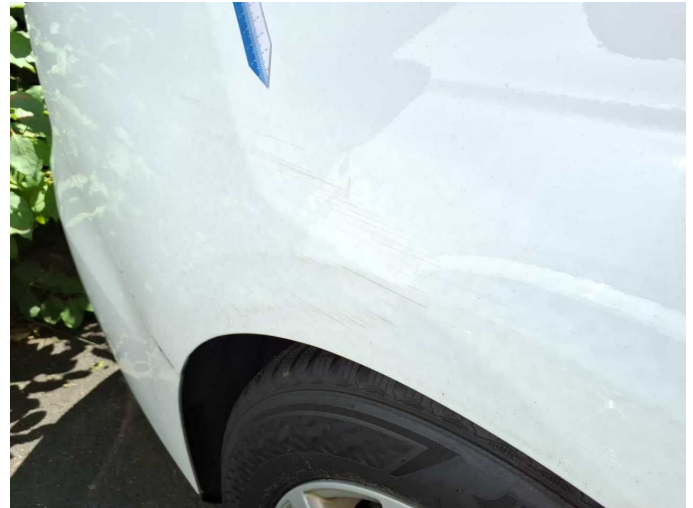
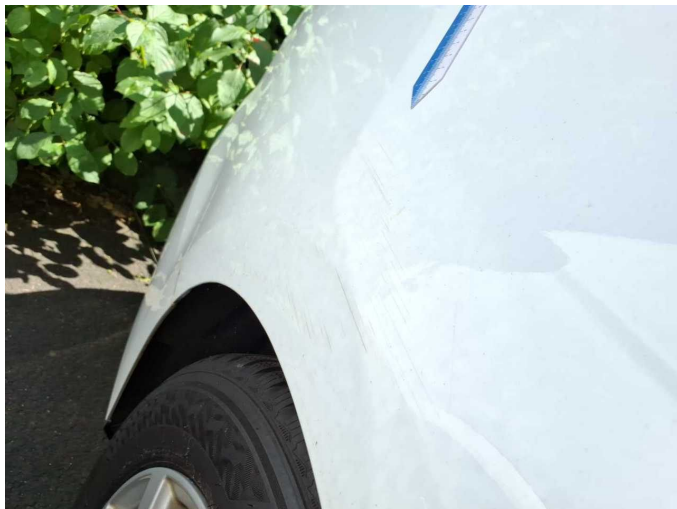
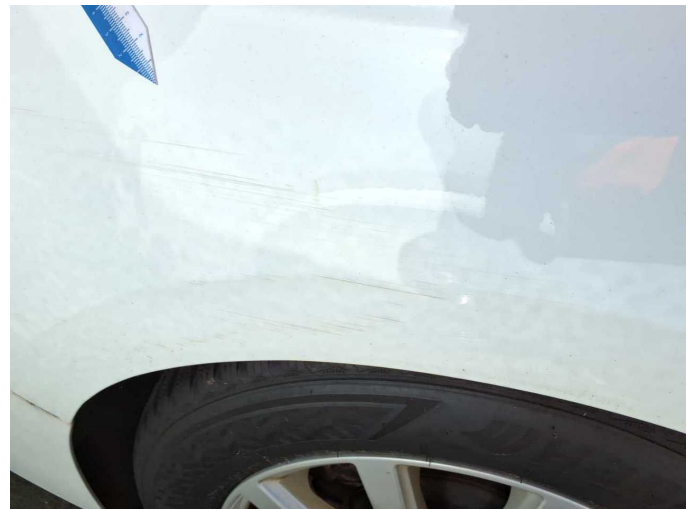
| No. | Accident |
|---|---|
| 2 | Side right |

**Accident 2:** Side right

**Accident 2: Side right**
