Expertise

Protocol number: 46653862  
Order No. / Reference: 26621839  
Inspection date: 22 Jul 2026

Model: Zafira Life 2.0 D M Aut. Edition

VIN: VXEEVHZ7NZ024899

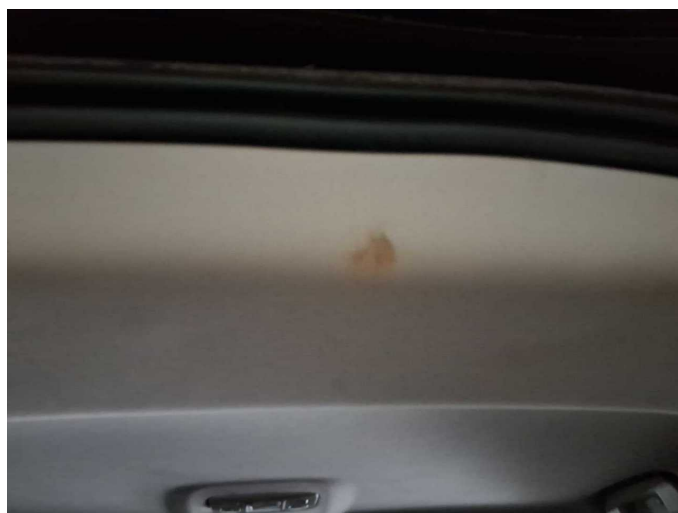
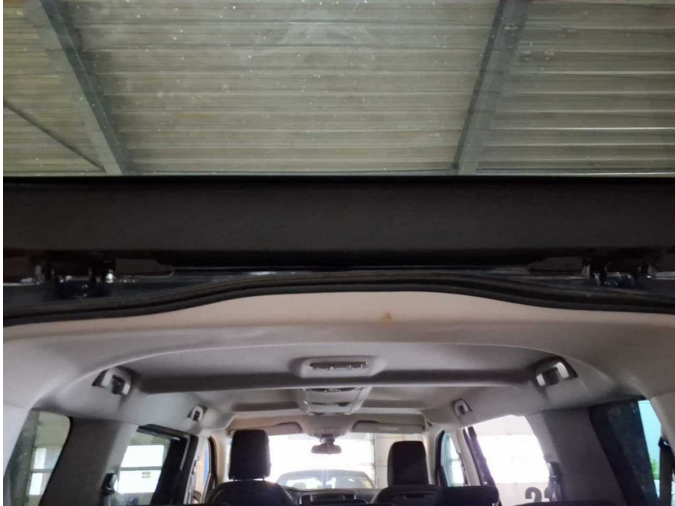
| No. | Component group | Description |
|---|---|---|
| 4 | Trim / covers | Roof lining - Soiled - Clean |

**Damage 4:** Trim / covers: Roof lining - Soiled - Clean

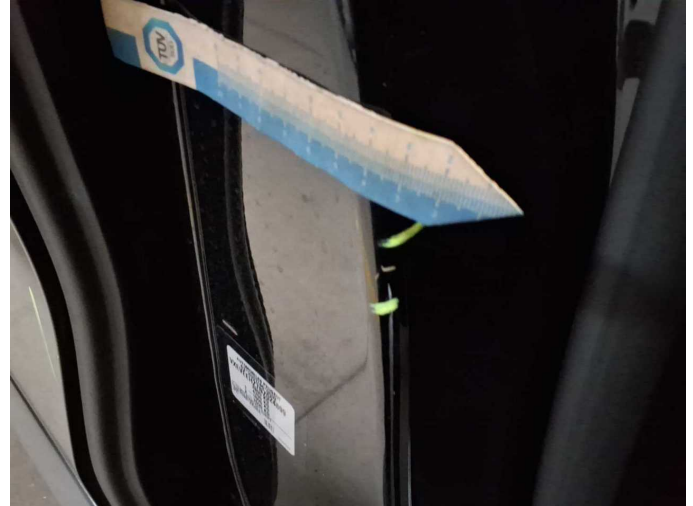
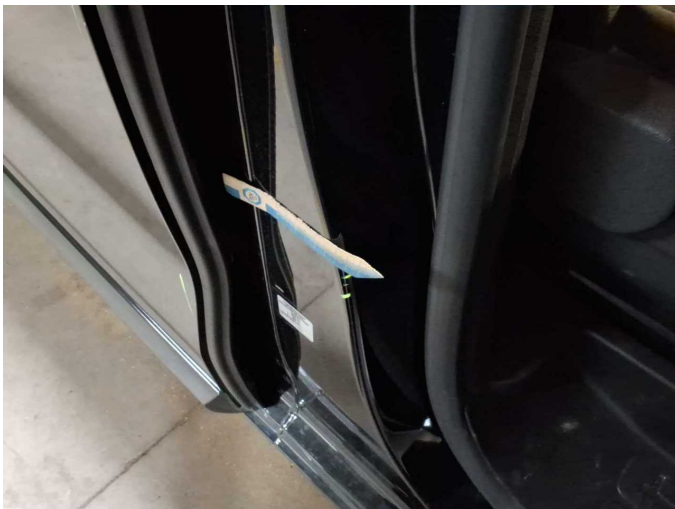
| No. | Component group | Description |
|---|---|---|
| 5 | Body | B-pillar - right side - Scratch(es) - Smart repair |

**Damage 5:** Body: B-pillar - right side - Scratch(es) - Smart repair

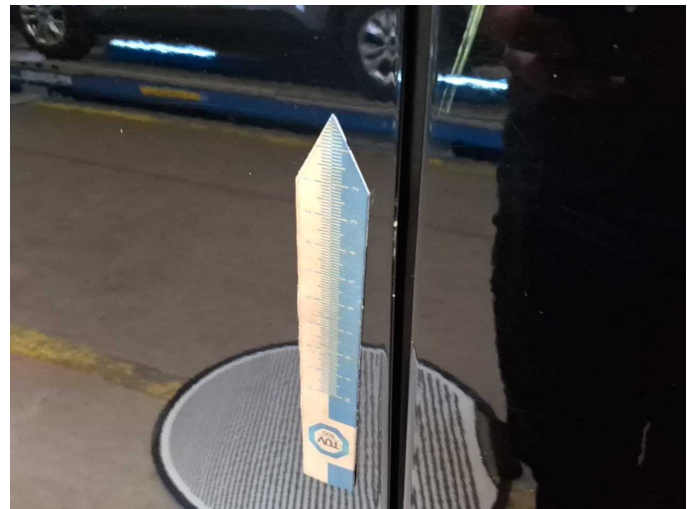
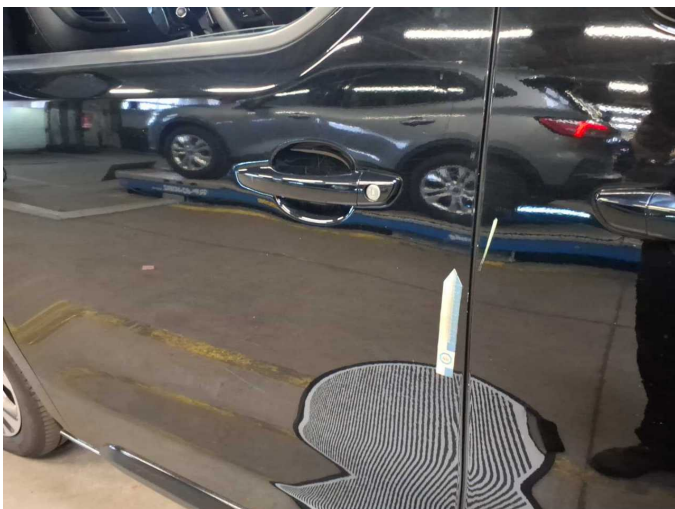
| No. | Component group | Description |
|---|---|---|
| 6 | Door - front left side | Door - Scratch(es) - Smart repair |

**Damage 6:** Door - front left side: Door - Scratch(es) - Smart repair

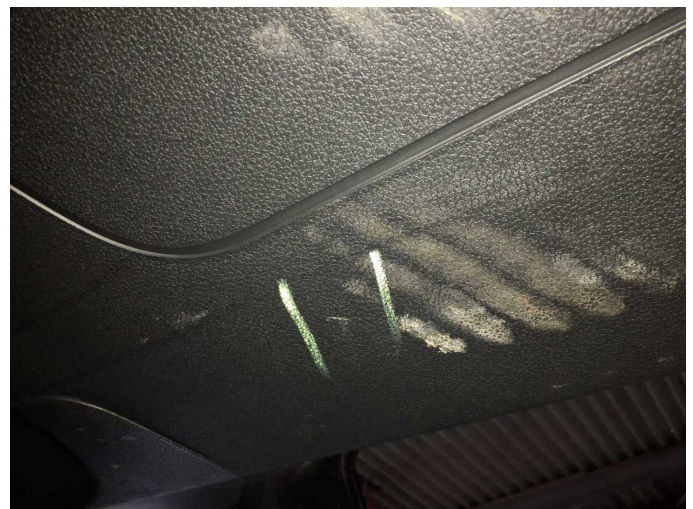
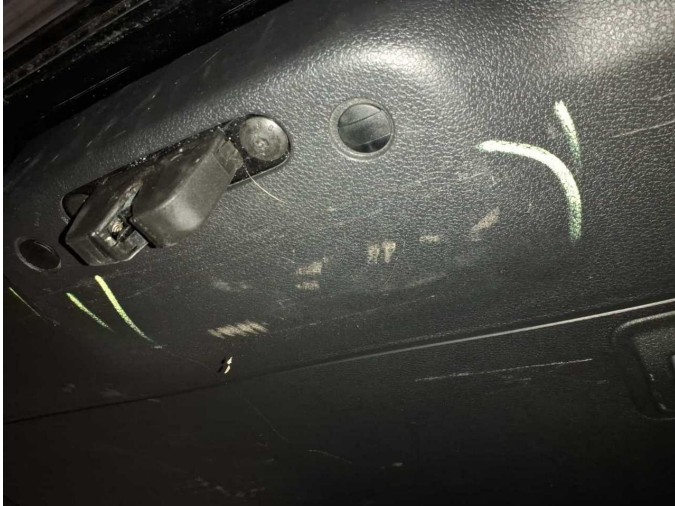
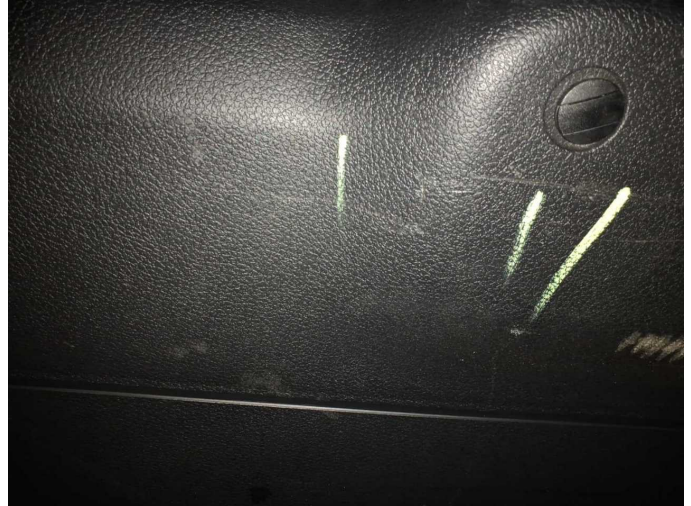
| No. | Component group | Description |
|---|---|---|
| 7 | Trim / covers | Boot lid - interior trim - Scratched - Smart repair |

**Damage 7:** Trim / covers: Boot lid - interior trim - Scratched - Smart repair

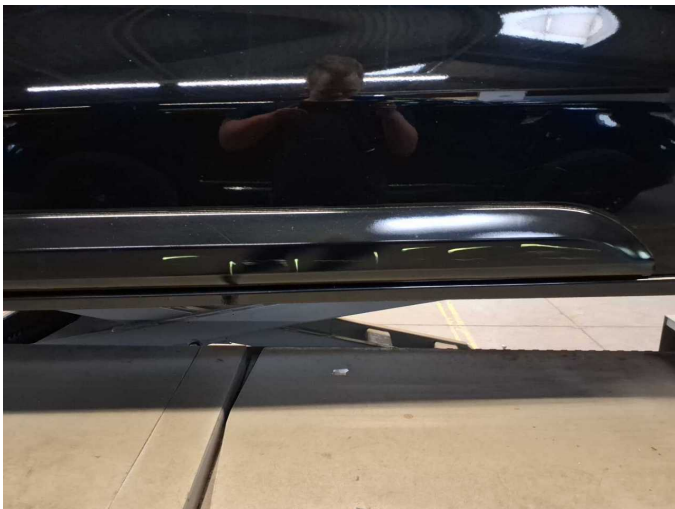
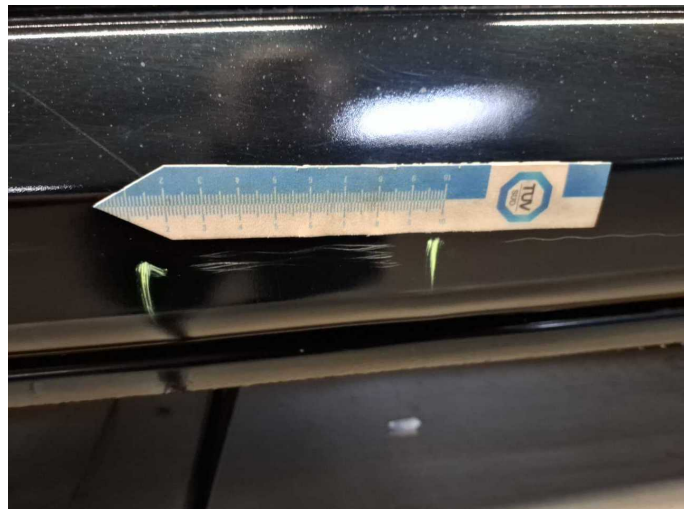
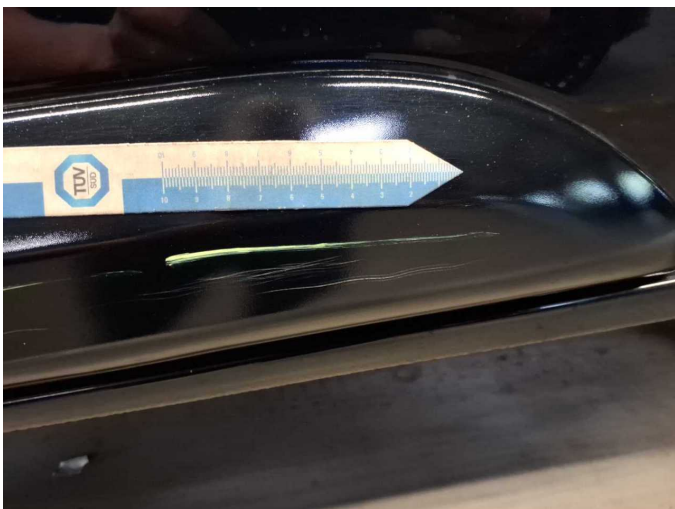
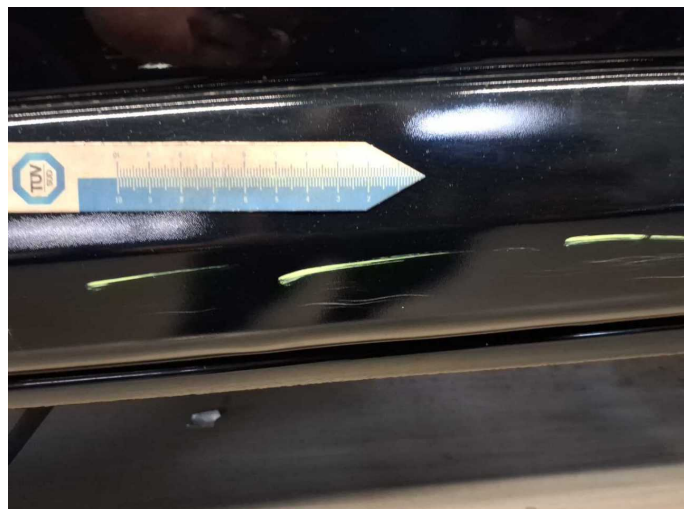
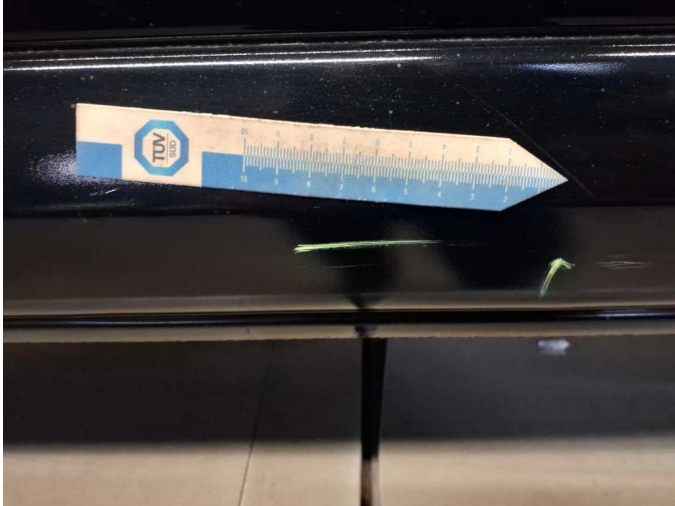
| No. | Component group | Description |
|---|---|---|
| 8 | Sliding door - left side | Trim (Außen) - Scratch(es) - Replace |

**Damage 8:** Sliding door - left side: Trim (Außen) - Scratch(es) - Replace

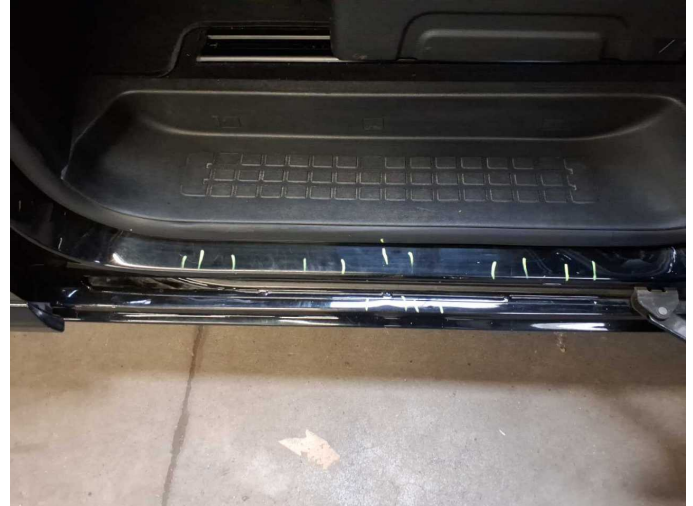
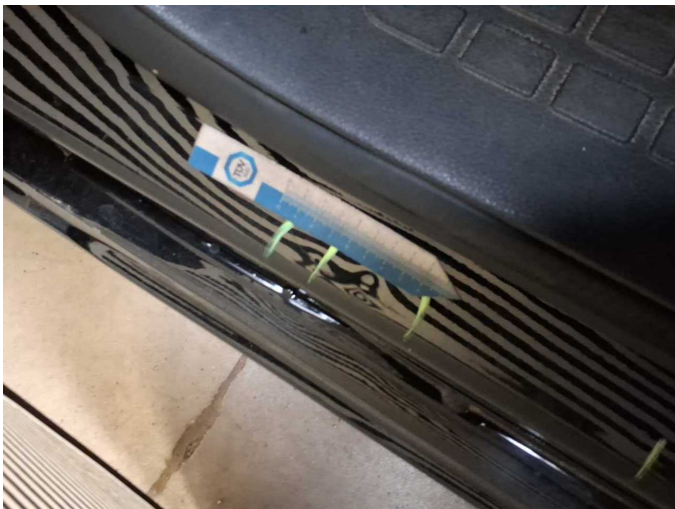
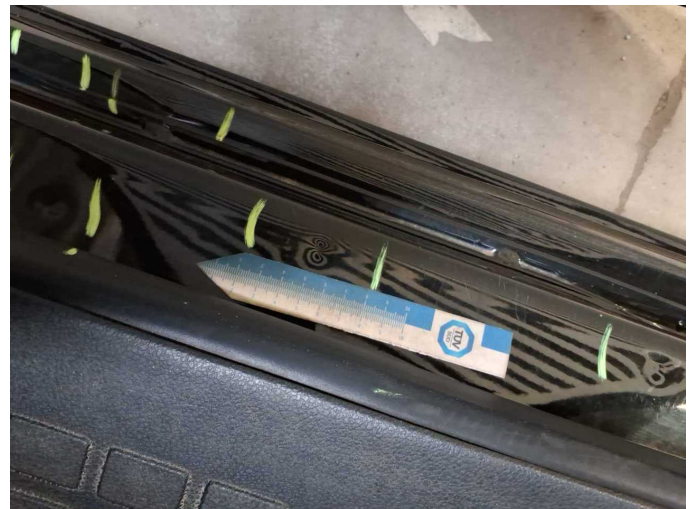
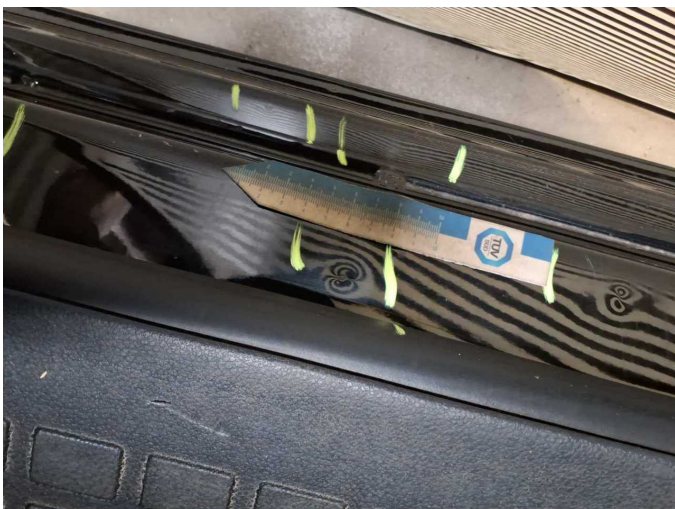
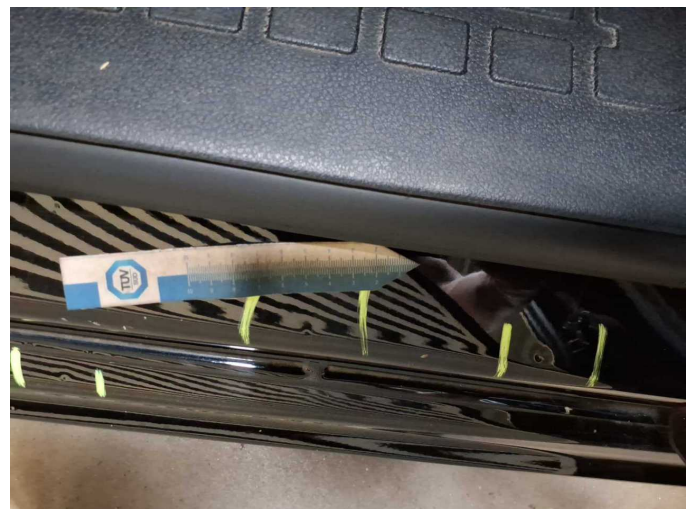
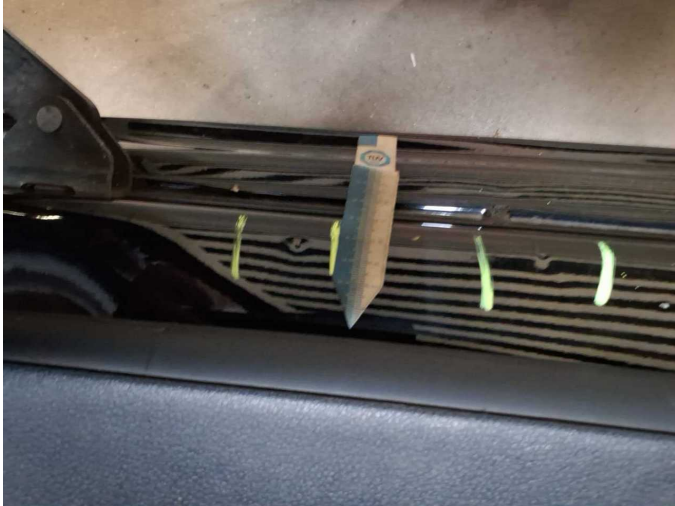
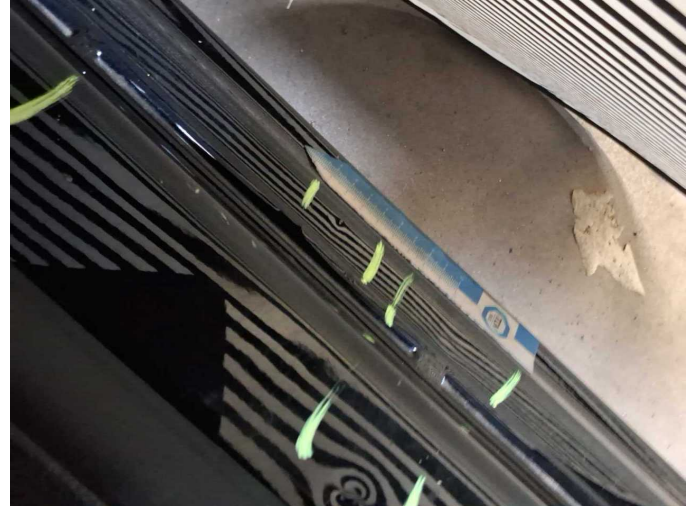
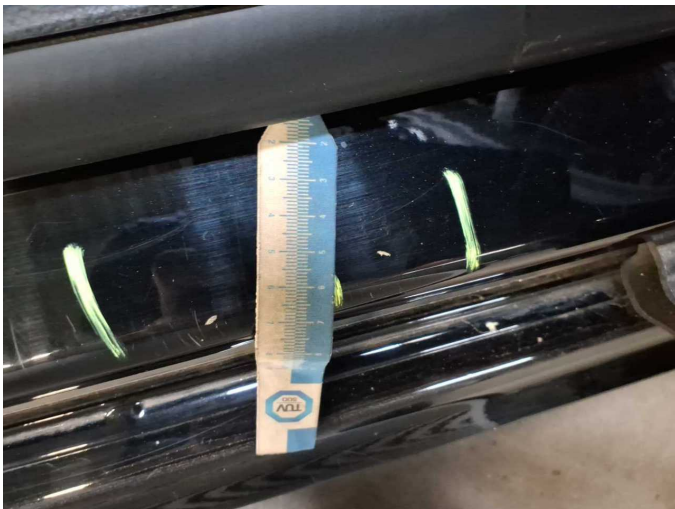
| No. | Component group | Description |
|---|---|---|
| 9 | Sill - left side | Sill - Dent / paintcoat damage - Smart repair |

**Damage 9:** Sill - left side: Sill - Dent / paintcoat damage - Smart repair

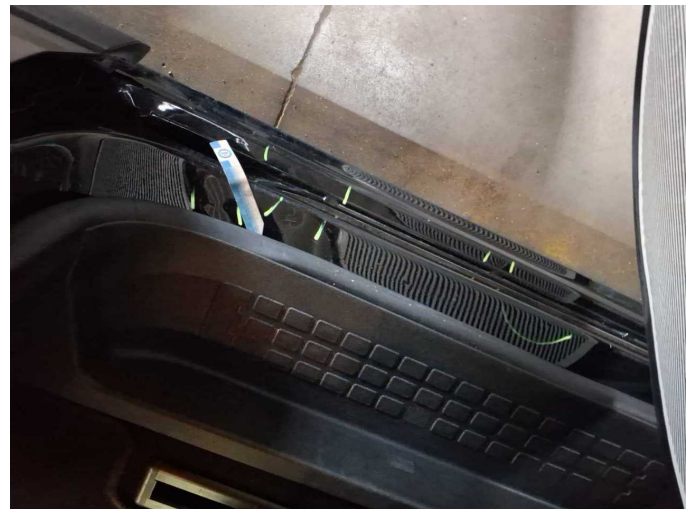
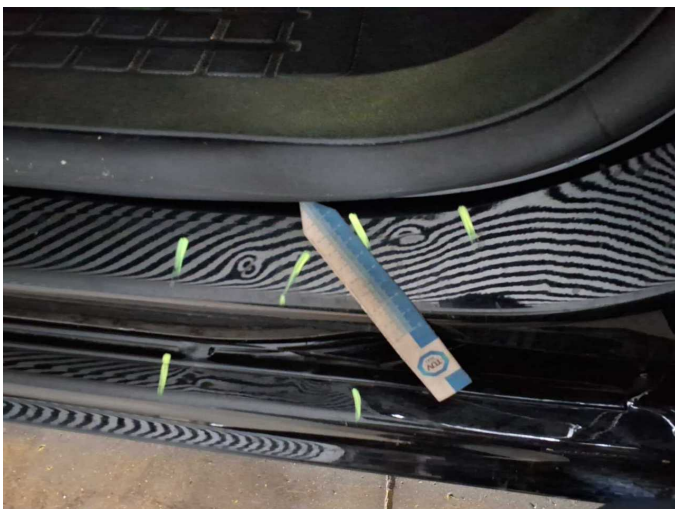
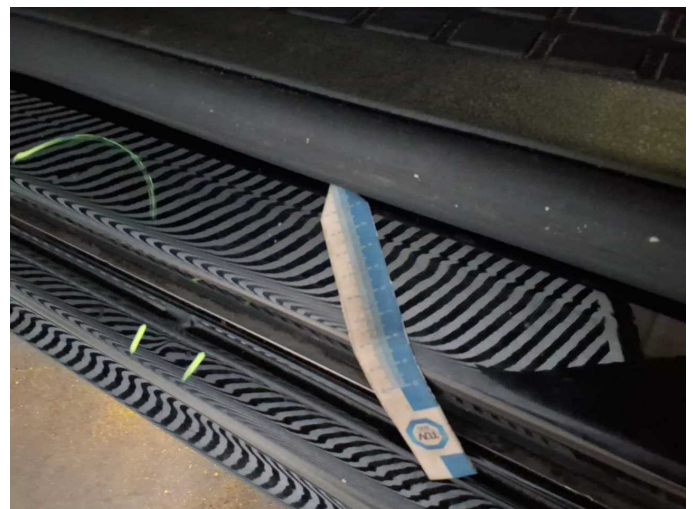
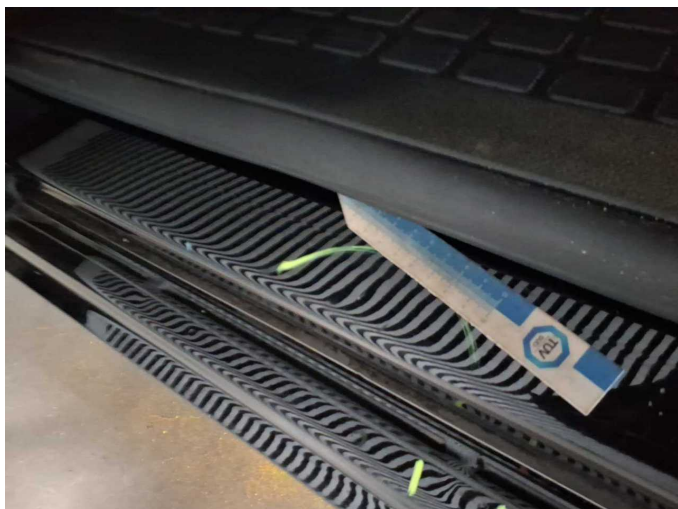
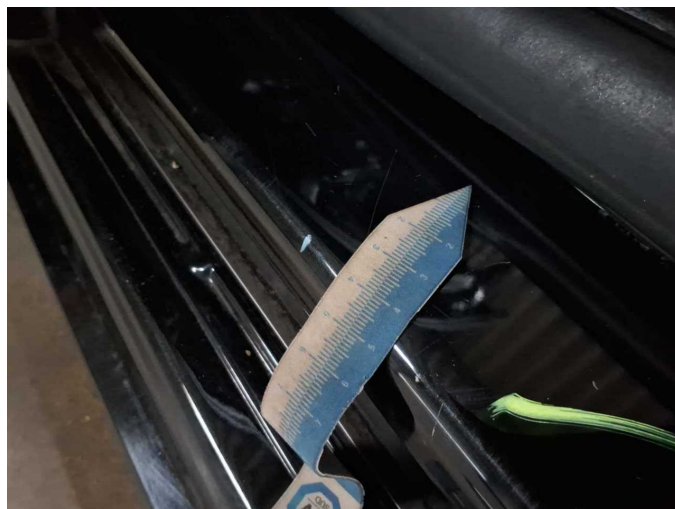
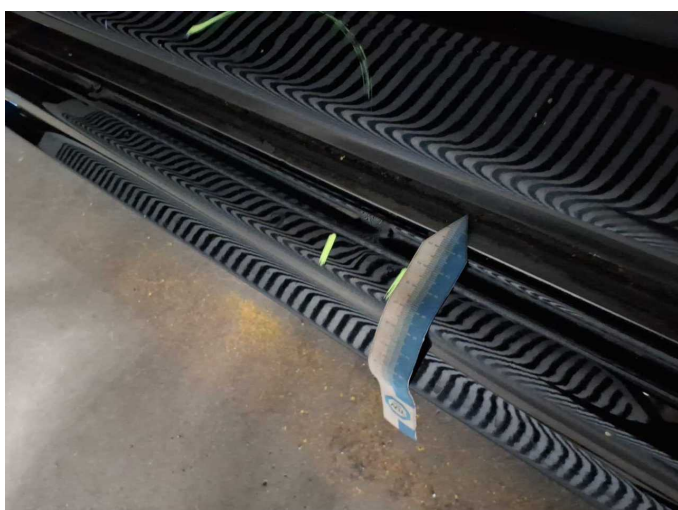
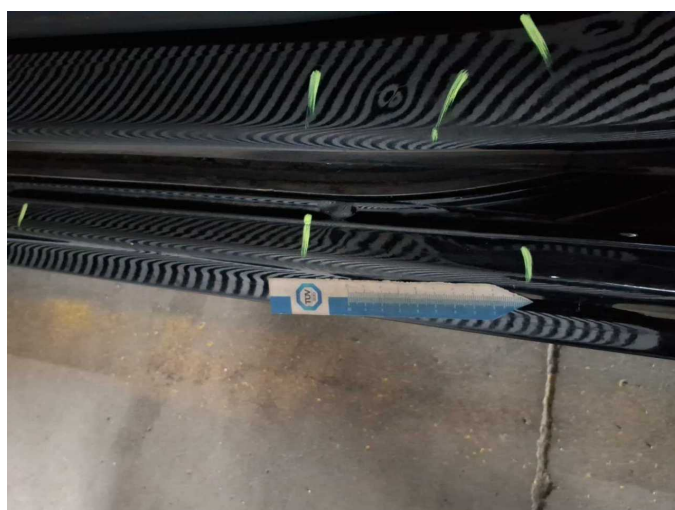
| No. | Component group | Description |
|---|---|---|
| 10 | Sill - right side | Sill - Dent / paintcoat damage - Smart repair |

**Damage 10:** Sill - right side: Sill - Dent / paintcoat damage - Smart repair

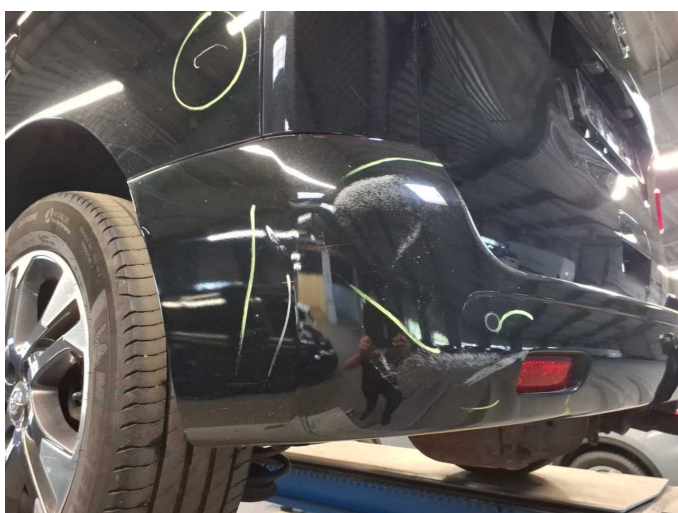
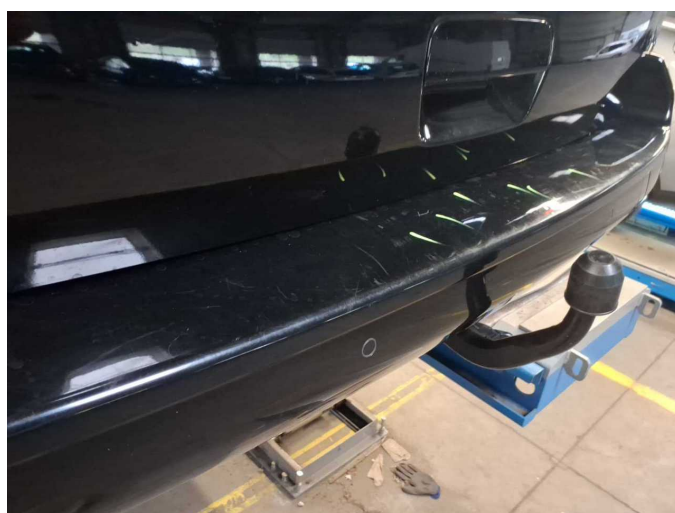
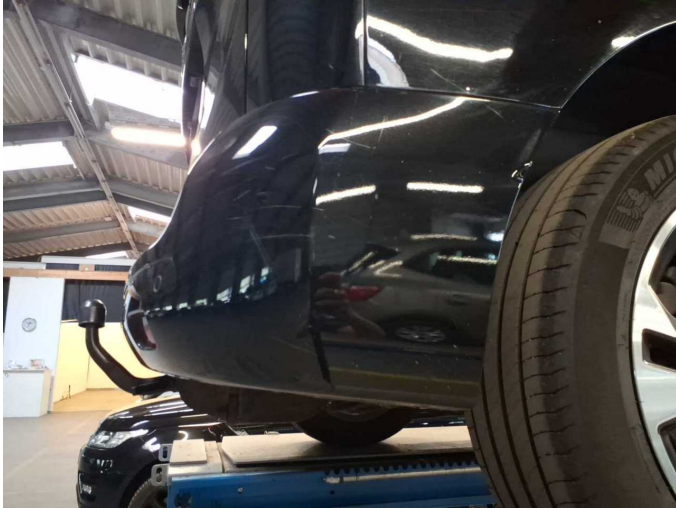
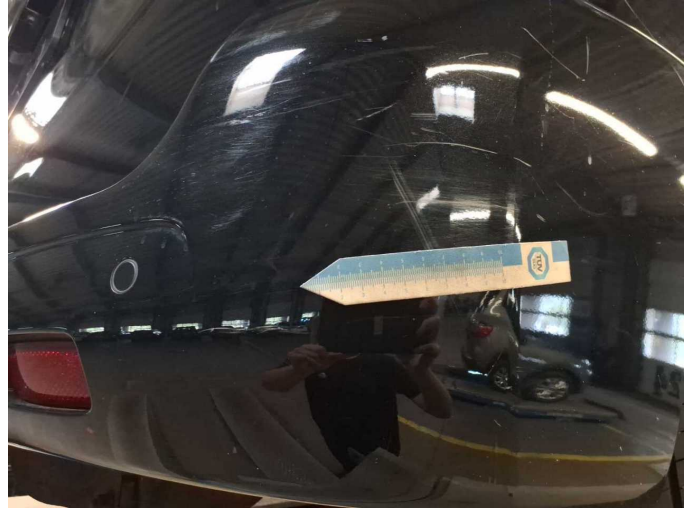
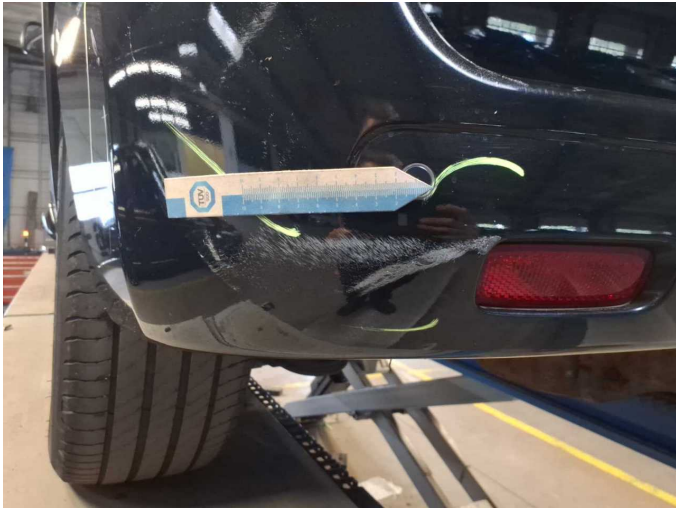
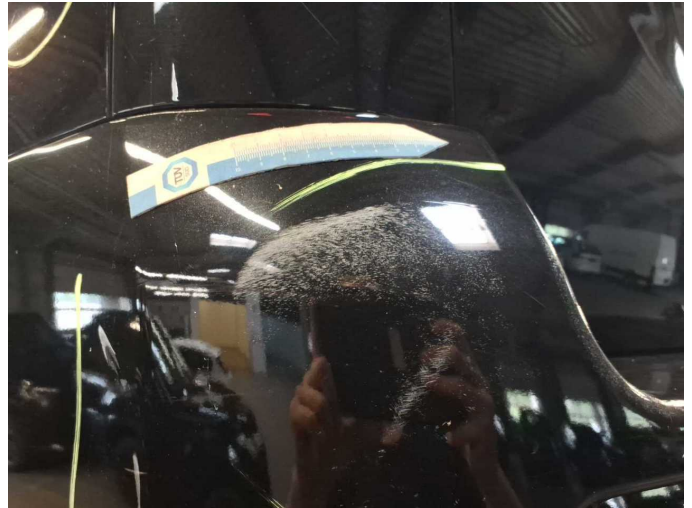
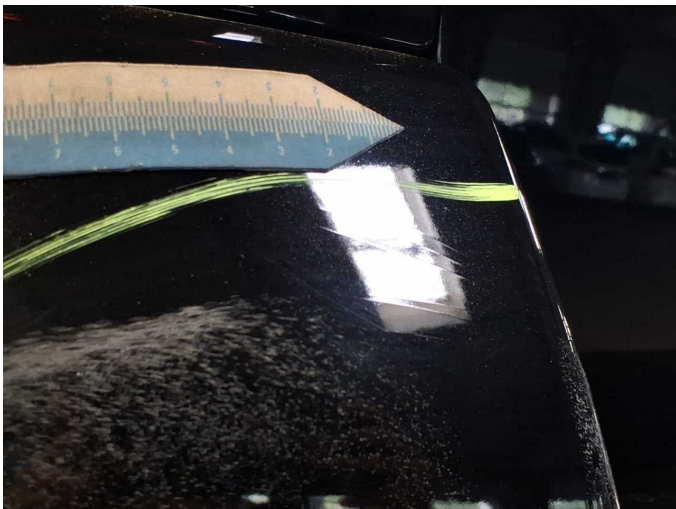
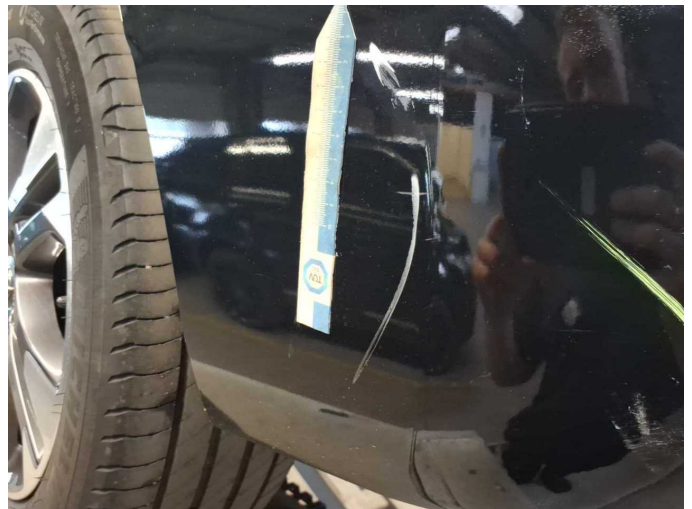
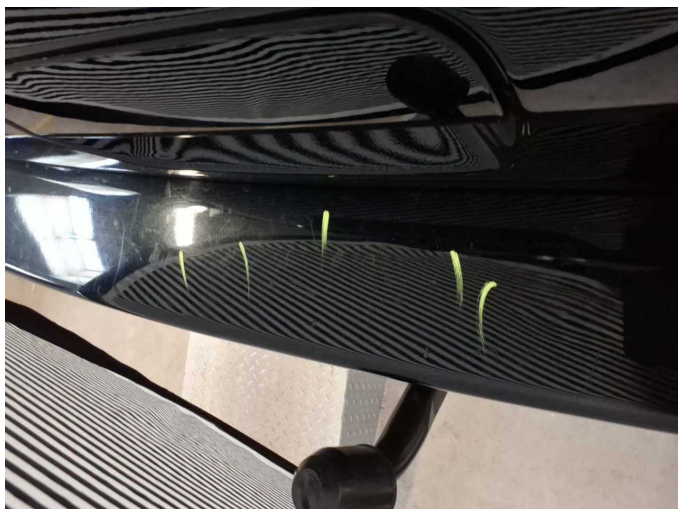
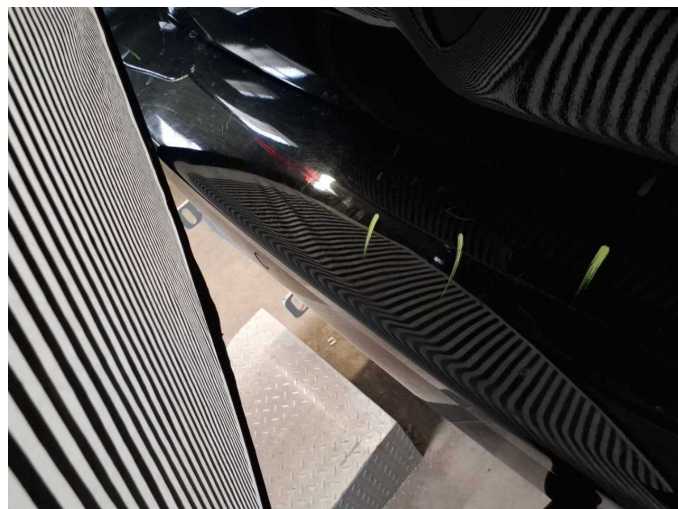
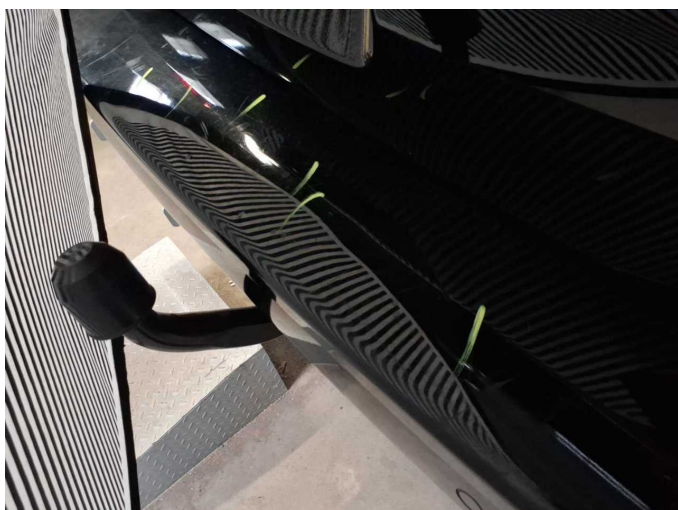
| No. | Component group | Description |
|---|---|---|
| 11 | Rear bumper | Rear bumper - Dent / paintcoat damage - Repair and paint |

**Damage 11:** Rear bumper: Rear bumper - Dent / paintcoat damage - Repair and paint

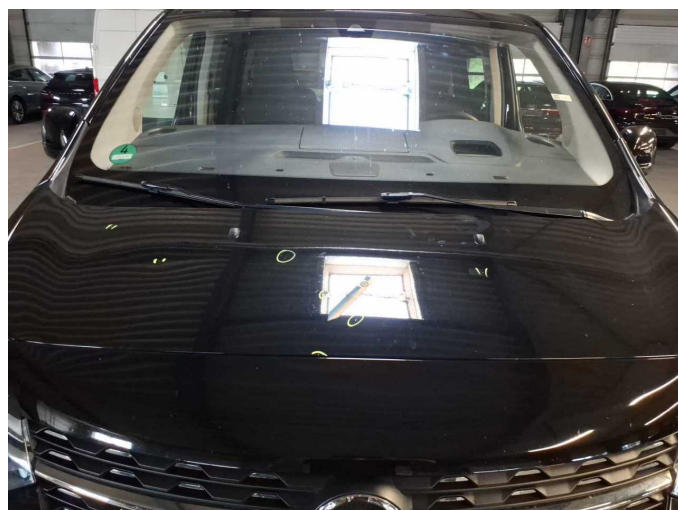
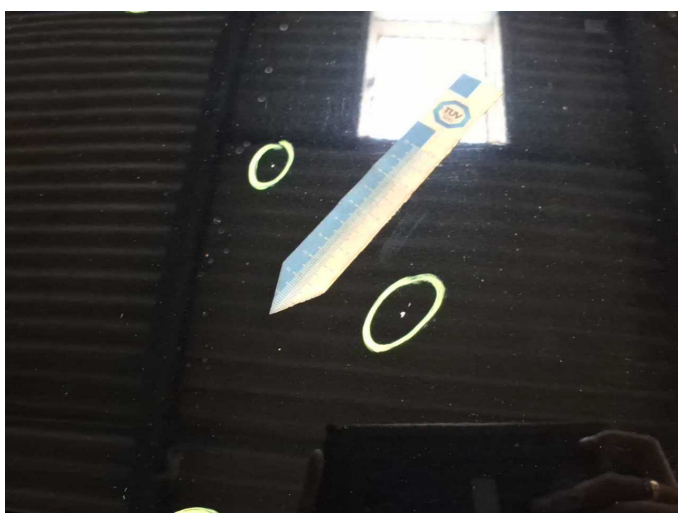
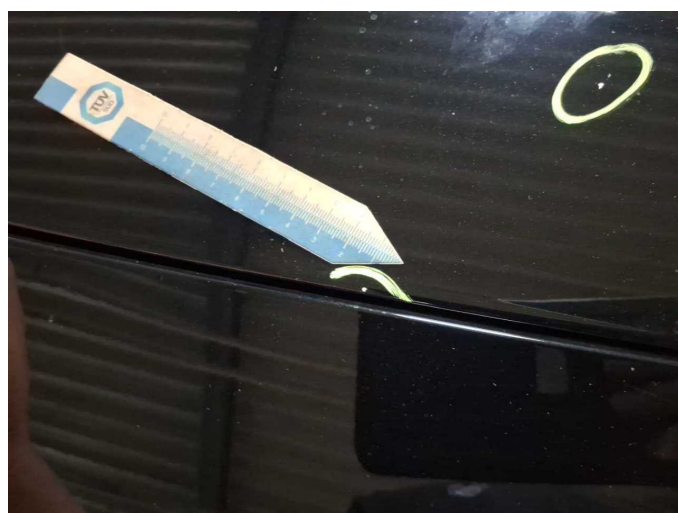
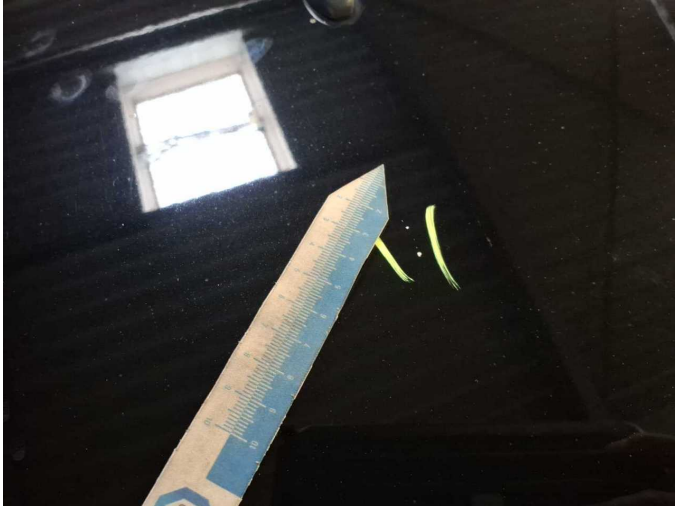
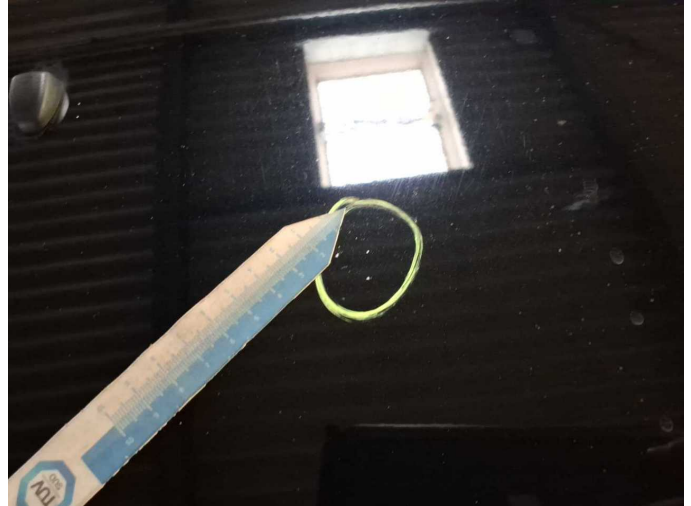
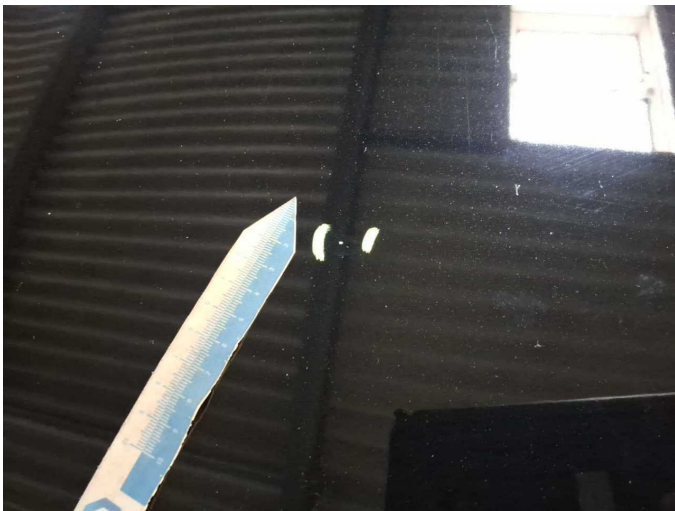
| No. | Component group | Description |
|---|---|---|
| 12 | Bonnet | Bonnet - Stone chips - Paint |

**Damage 12:** Bonnet: Bonnet - Stone chips - Paint

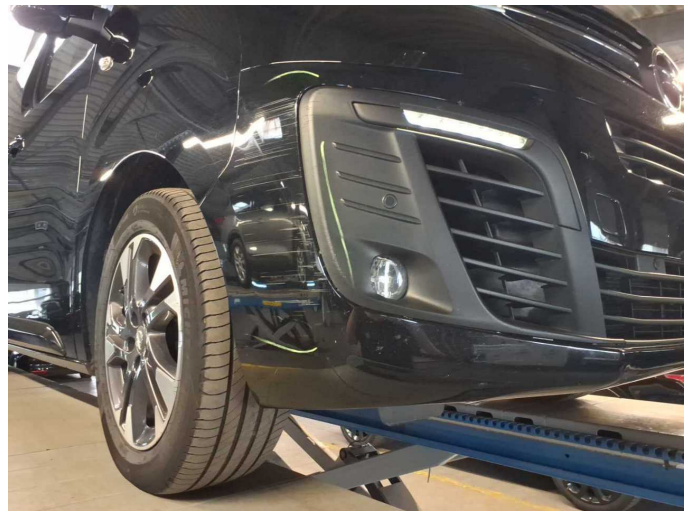
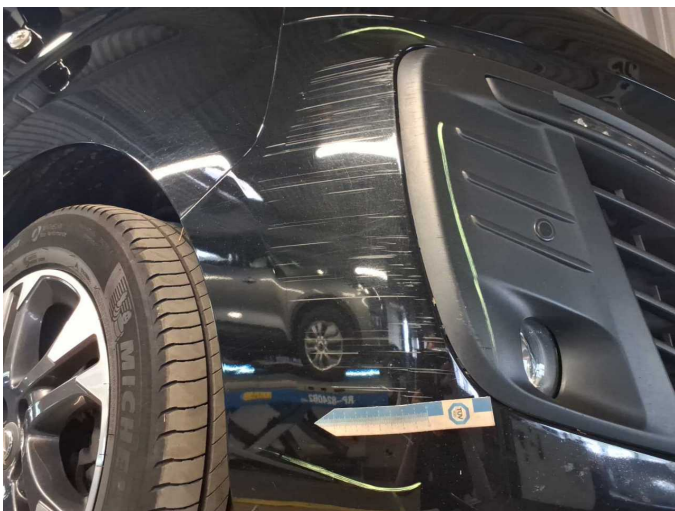
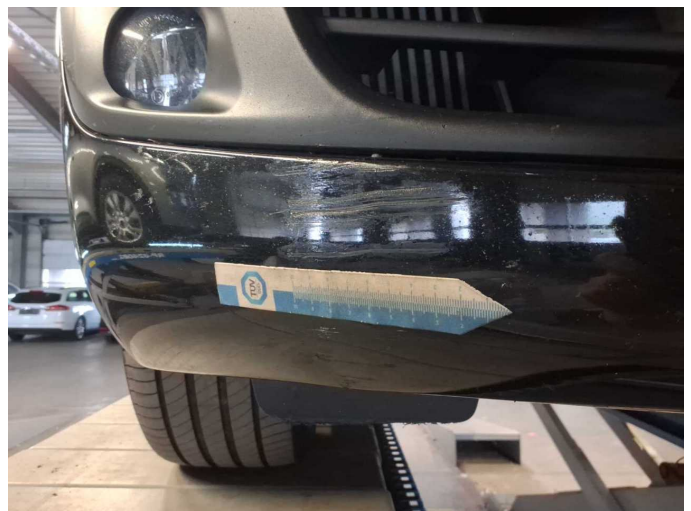
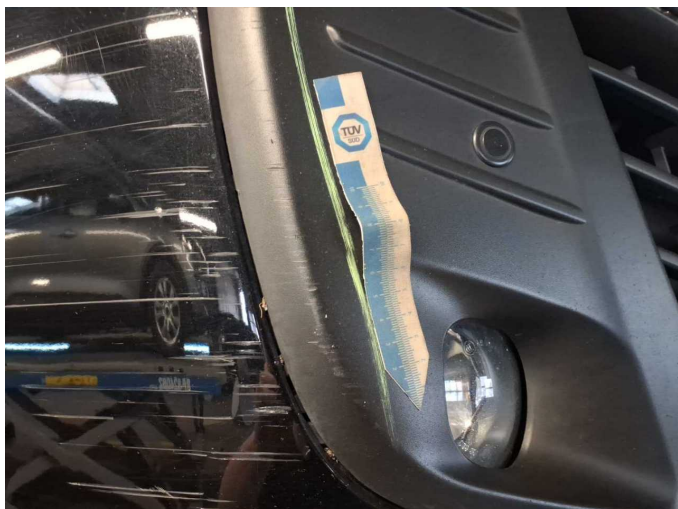
| No. | Component group | Description |
|---|---|---|
| 13 | Front bumper | Front bumper (+ Blende) - Scratched - Paint |

**Damage 13:** Front bumper: Front bumper (+ Blende) - Scratched - Paint

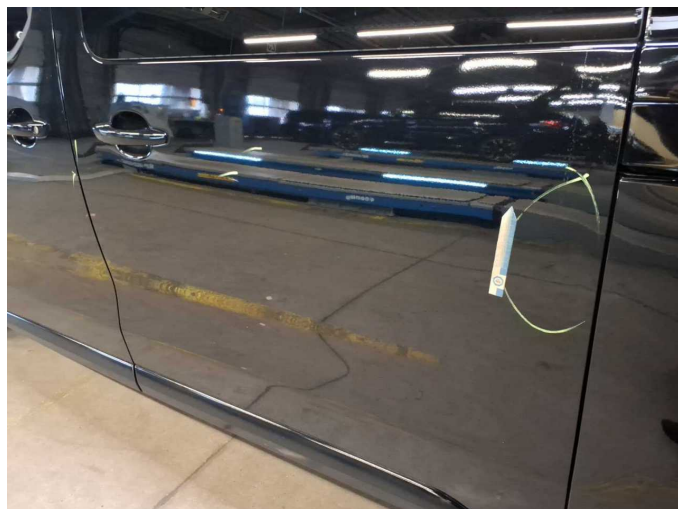
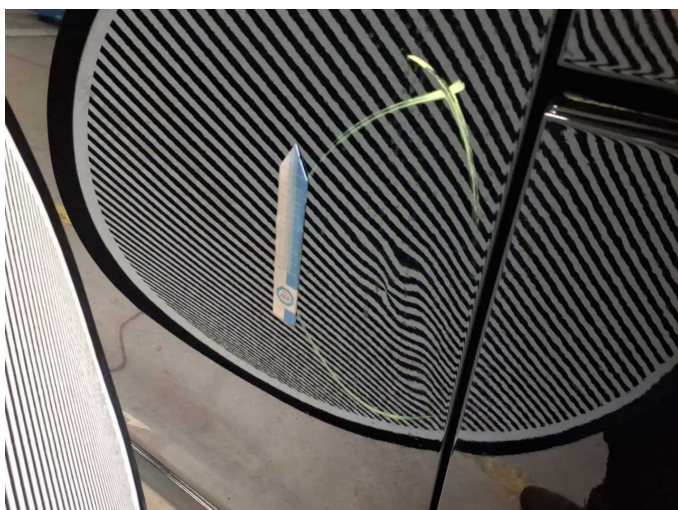
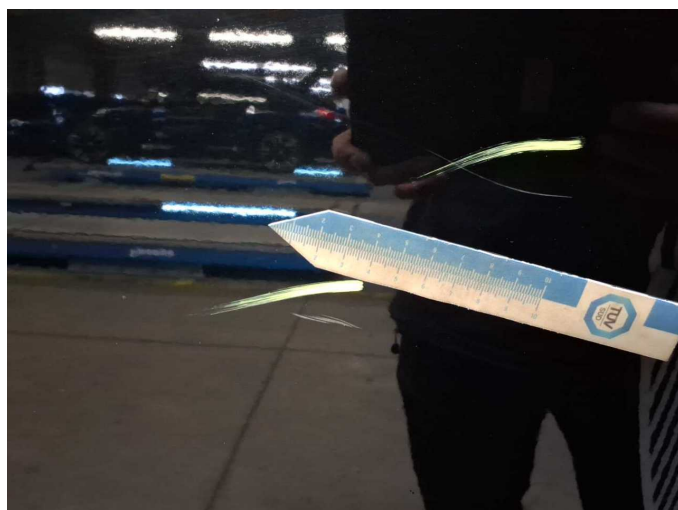
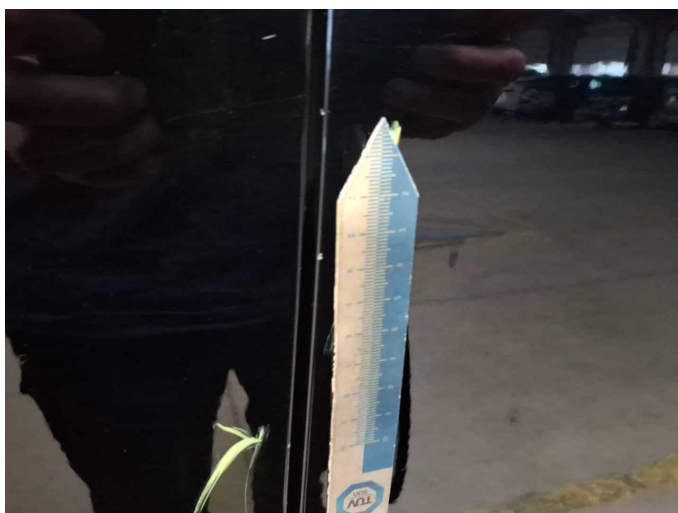
| No. | Component group | Description |
|---|---|---|
| 14 | Sliding door - left side | Sliding door - Dent / paintcoat damage - Repair and paint |

**Damage 14:** Sliding door - left side: Sliding door - Dent / paintcoat damage - Repair and paint

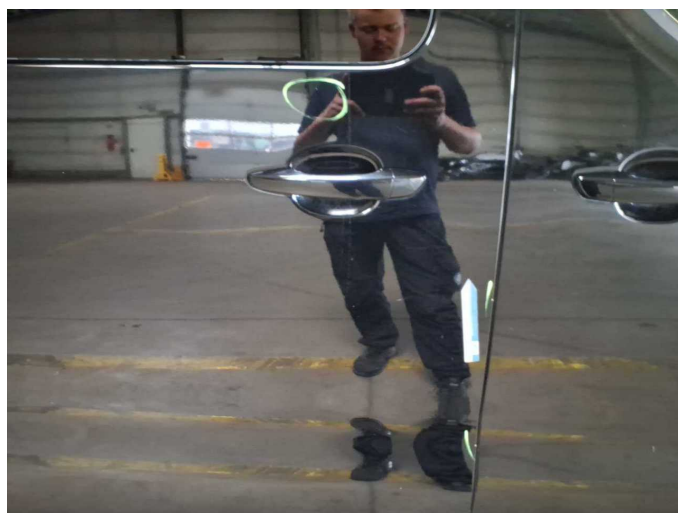
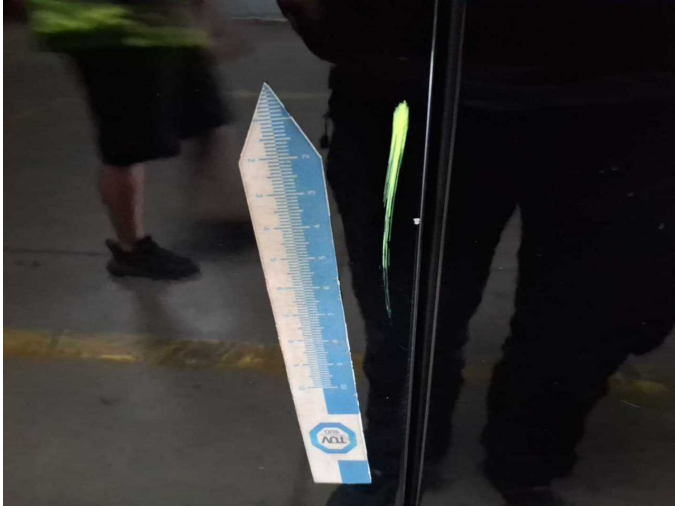
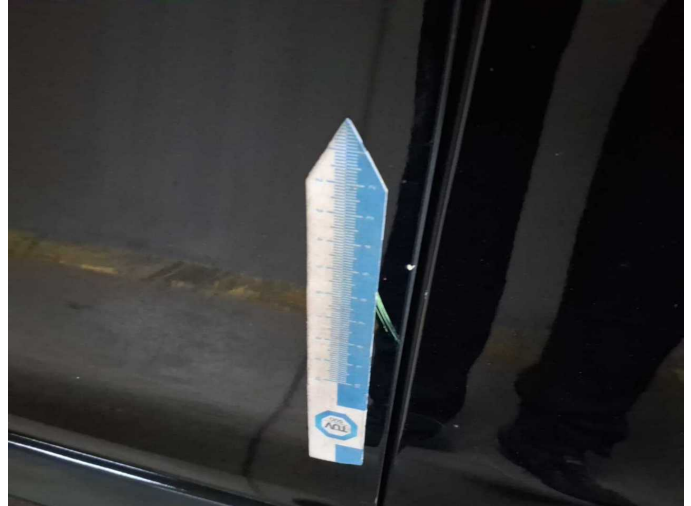
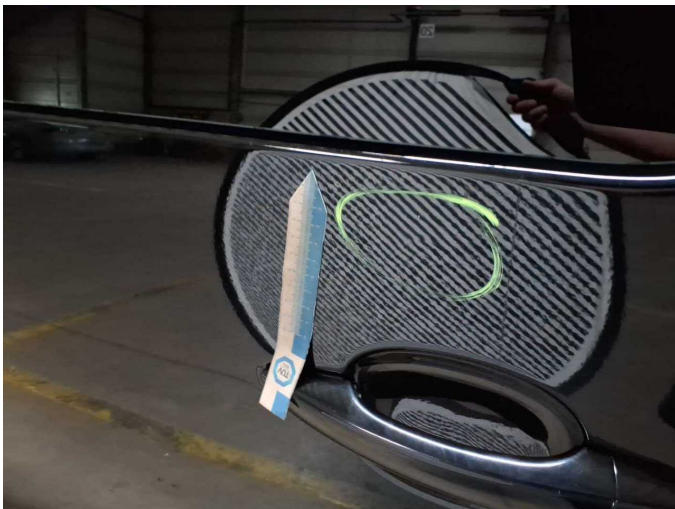
| No. | Component group | Description |
|---|---|---|
| 15 | Sliding door, right | Sliding door - Dent / paintcoat damage - Repair and paint |

**Damage 15:** Sliding door, right: Sliding door - Dent / paintcoat damage - Repair and paint

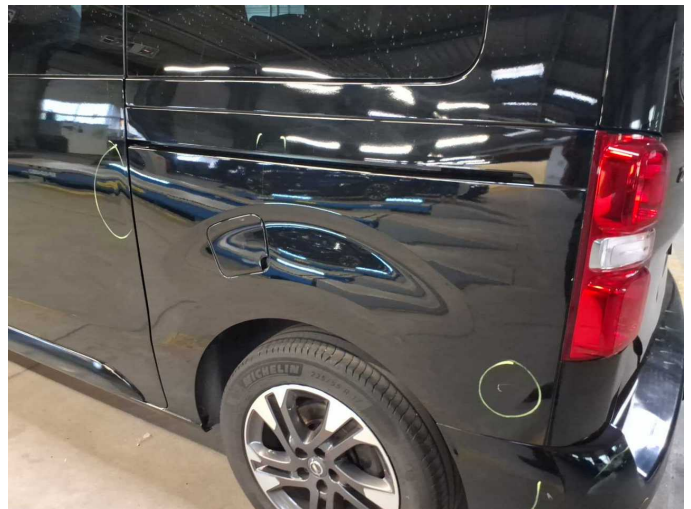
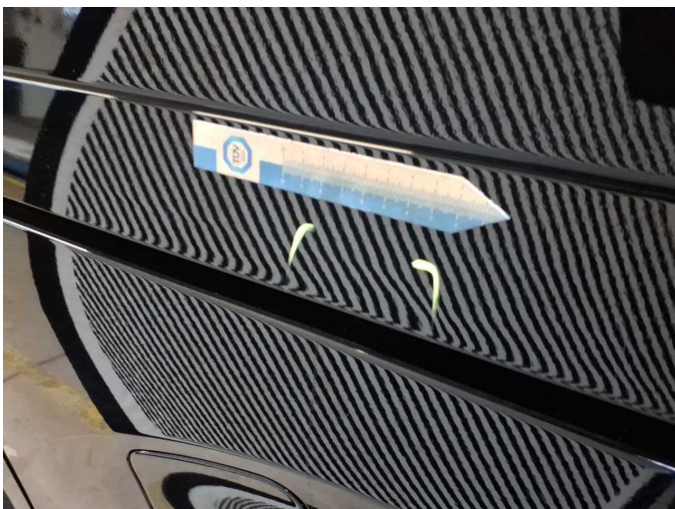
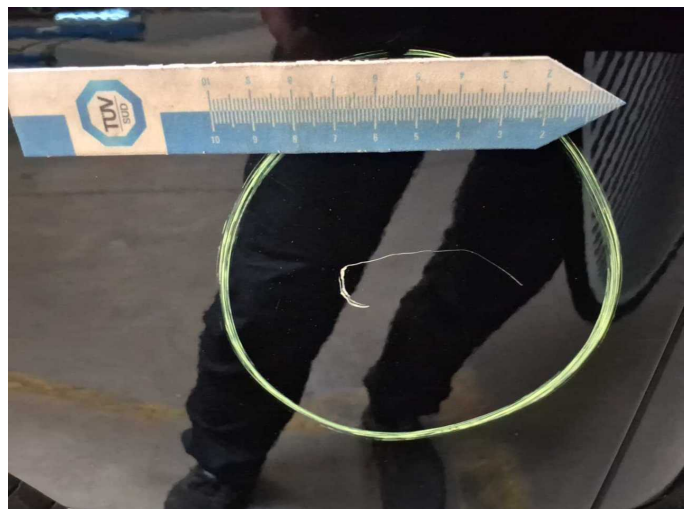
| No. | Component group | Description |
|---|---|---|
| 16 | Side panel - rear left side | Side panel - Dent / paintcoat damage - Repair and paint |

**Damage 16:** Side panel - rear left side: Side panel - Dent / paintcoat damage - Repair and paint
