Expertise

Protocol number: 46653862  
Order No. / Reference: 26621839  
Inspection date: 22 Jul 2026

Model: Zafira Life 2.0 D M Aut. Edition

VIN: VXEEVHZ7NZ024899

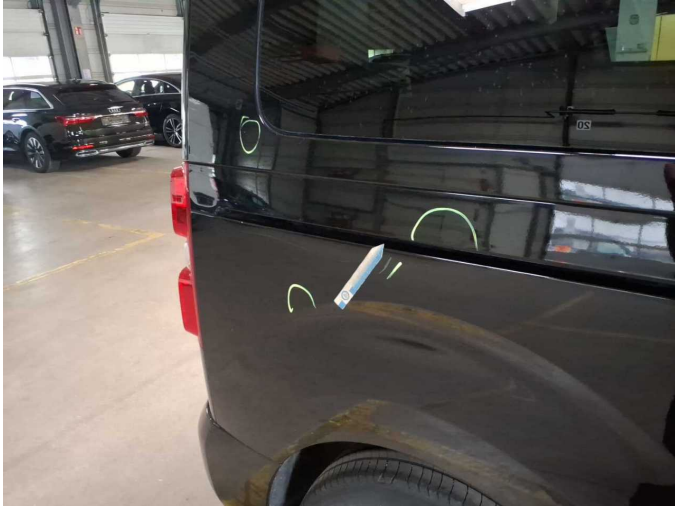
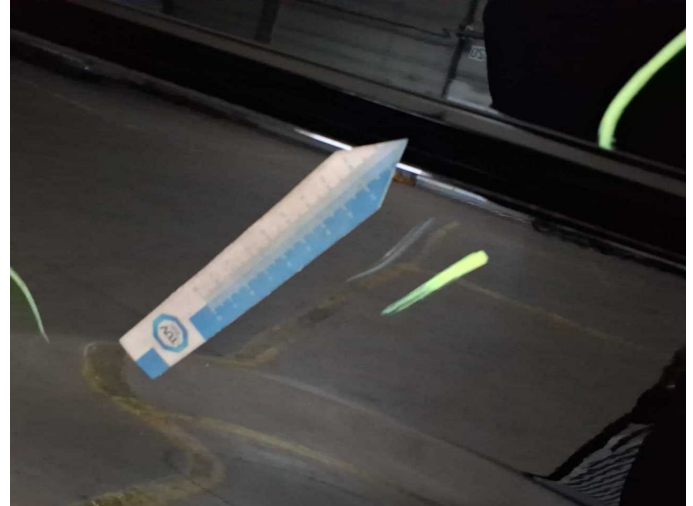
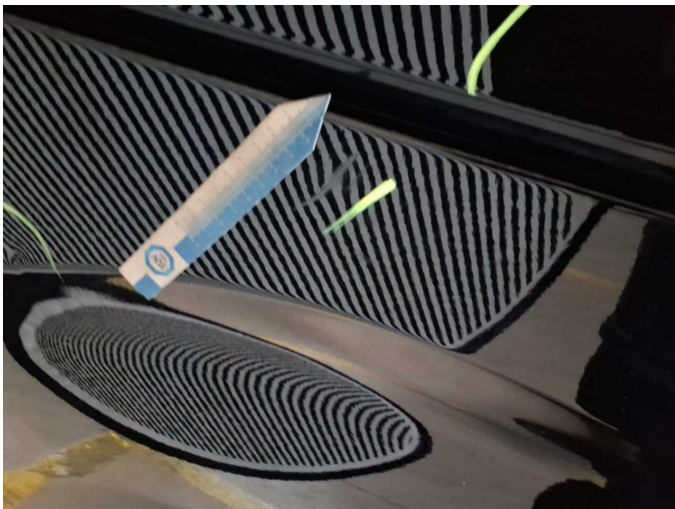
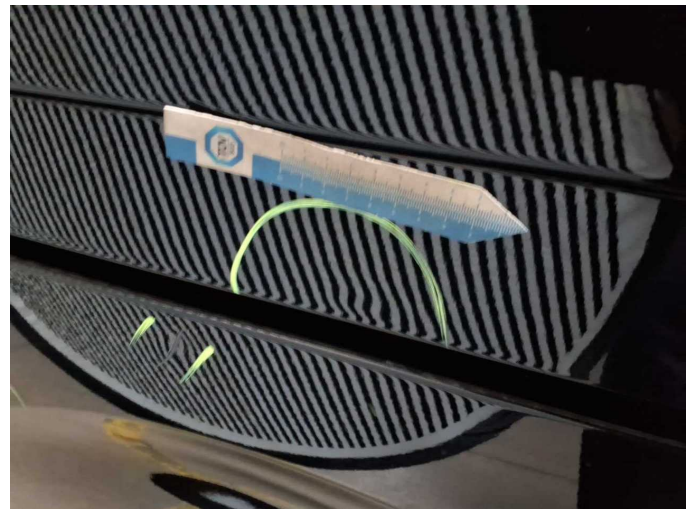
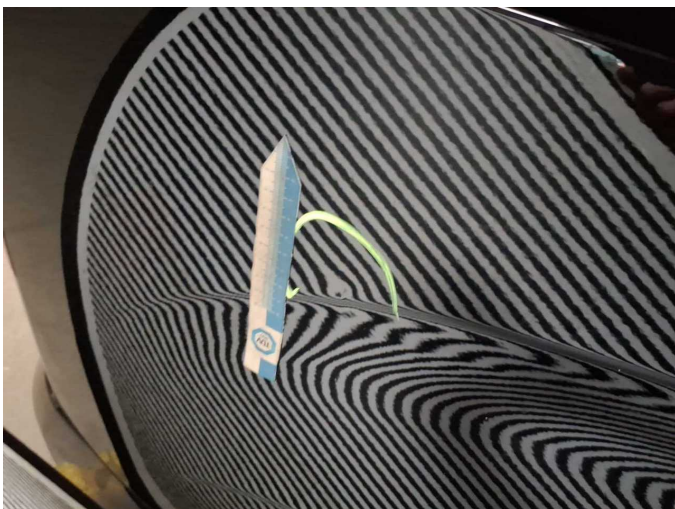
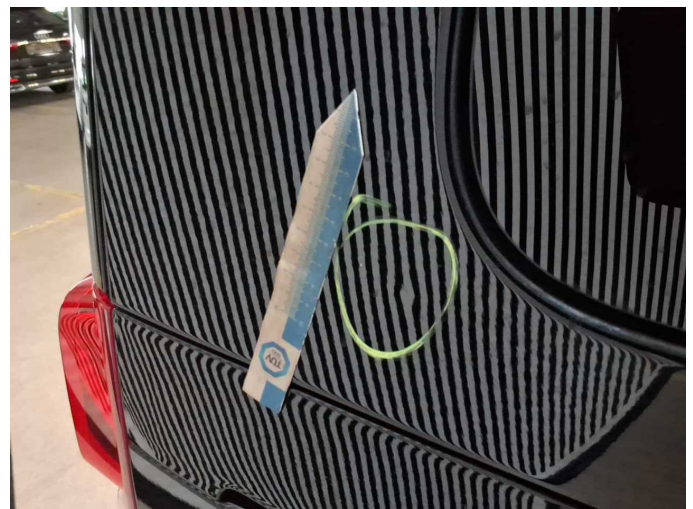
| No. | Component group | Description |
|---|---|---|
| 17 | Side panel - rear right side | Side panel - Dent / paintcoat damage - Repair and paint |

**Damage 17:** Side panel - rear right side: Side panel - Dent / paintcoat damage - Repair and paint

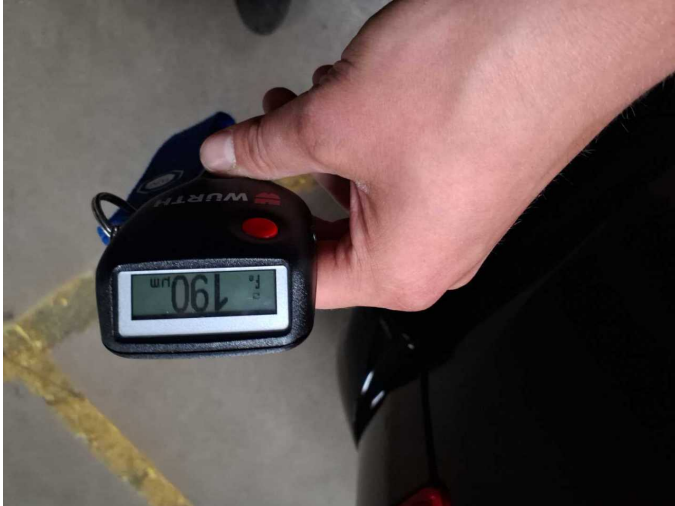
Boot lid / rear door 190 µm

**Repainting 1:** Boot lid / rear door

**Boot lid / rear door:** 190 µm
